File Number MV2016L3-0001
Type of Operation Type B - MUNICIPAL
Location Mackenzie River, Fort Providence NT.

An inspection of the above noted operation was conducted on June 14th, 2022 by Water Resource Officers, Joshua Gauthier and Wendy Bidwell. Enclosed is a copy of the Municipal Water Use Inspection Report.

MUNICIPAL WATER USE INSPECTION REPORT

LICENCE #:	MV2016L3-0001	EXPIRY DATE:	January 30, 2031
LICENCEE:	Hamlet of Fort Providence	PREVIOUS INSPECTION:	September 21, 2021
COMPANY REP:	Susan Christie	INSPECTION DATE:	June 14, 2022

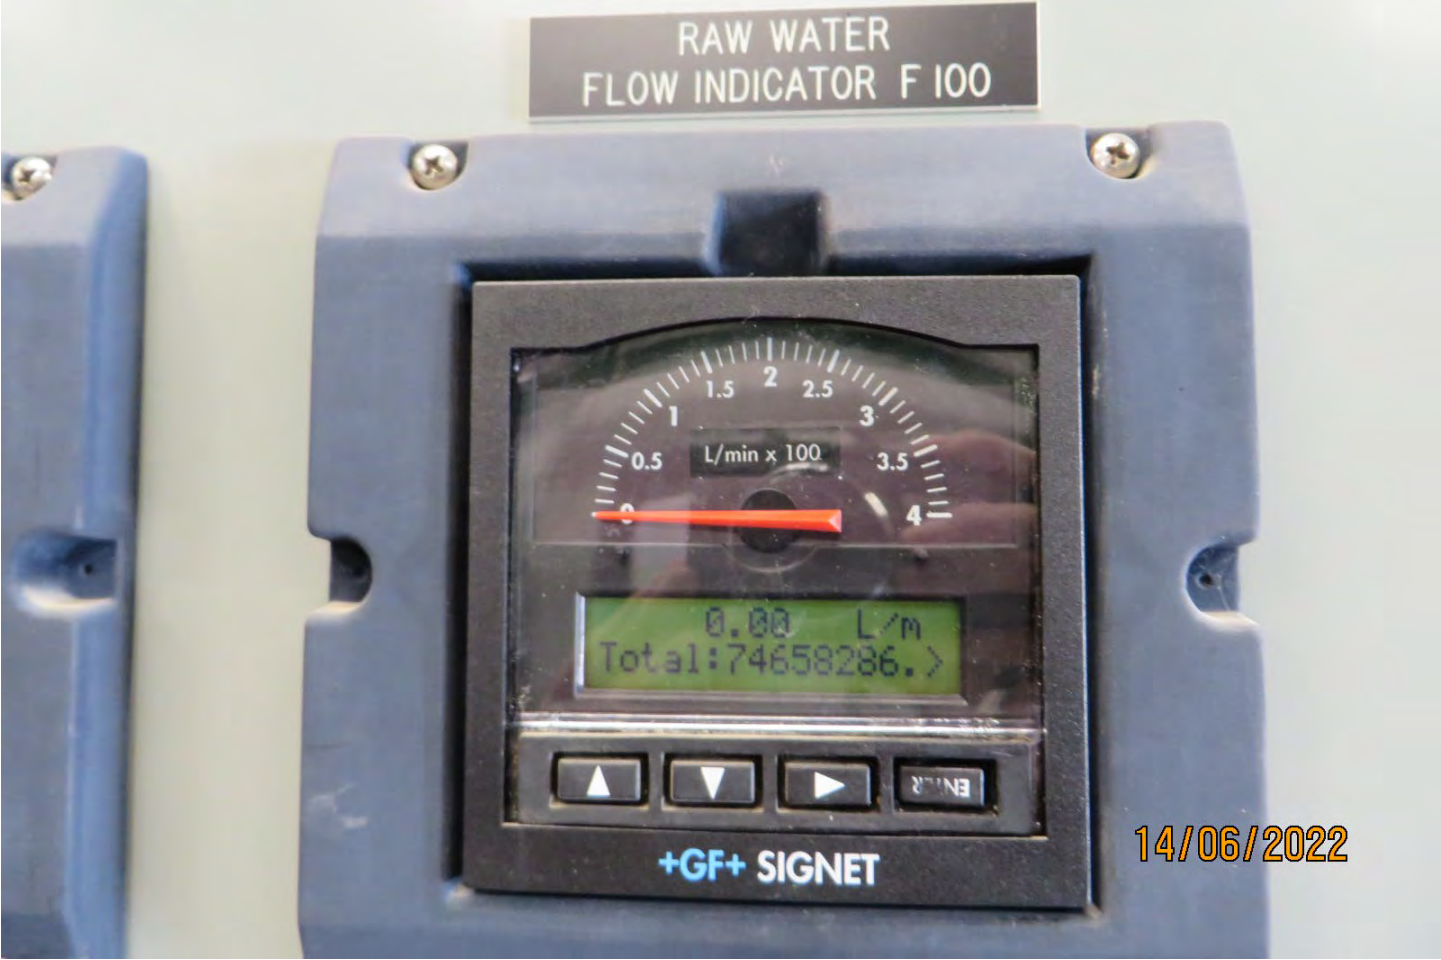
Figure 2

Water Treatment Plant (WTP) – Raw water flow meter/data logger.

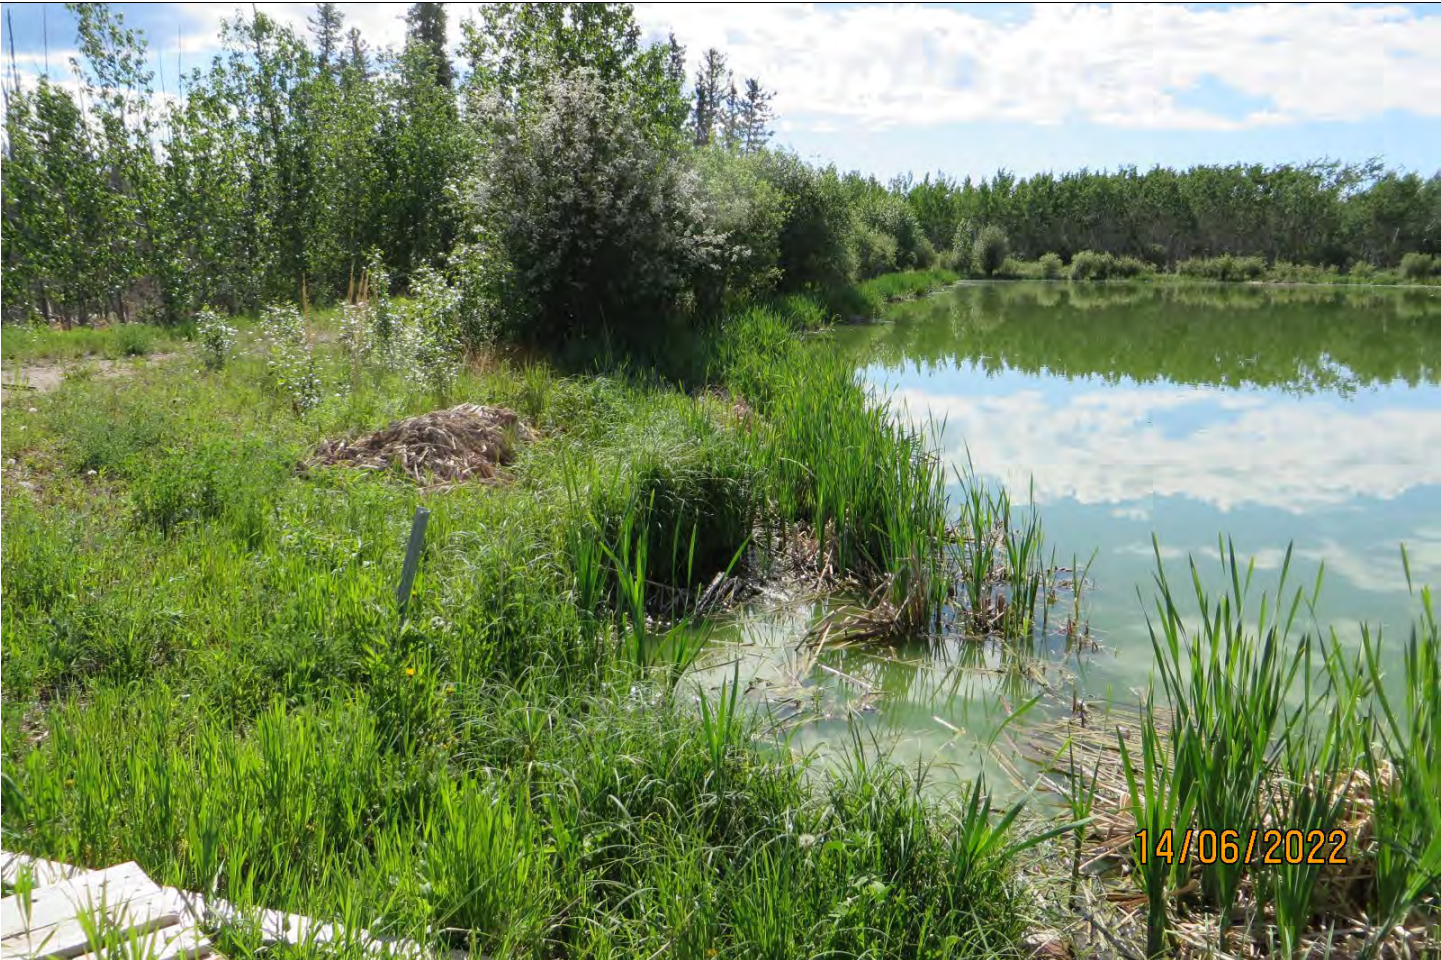
Figure 8
Sewage Lagoon – SNP Station 1412-2

At the time of inspection the freeboard in all five lagoon cells was acceptable, but cells will require decanting if effluent levels increase. Facility requires brushing of vegetation around all the cells. Any vegetation, or debris is to be removed to ensure proper operation and functioning of the treatment cells. Please forward results of any recent sampling at SNP 1412-2 (Lagoon Outflow to Wetland) to the Inspector for review.

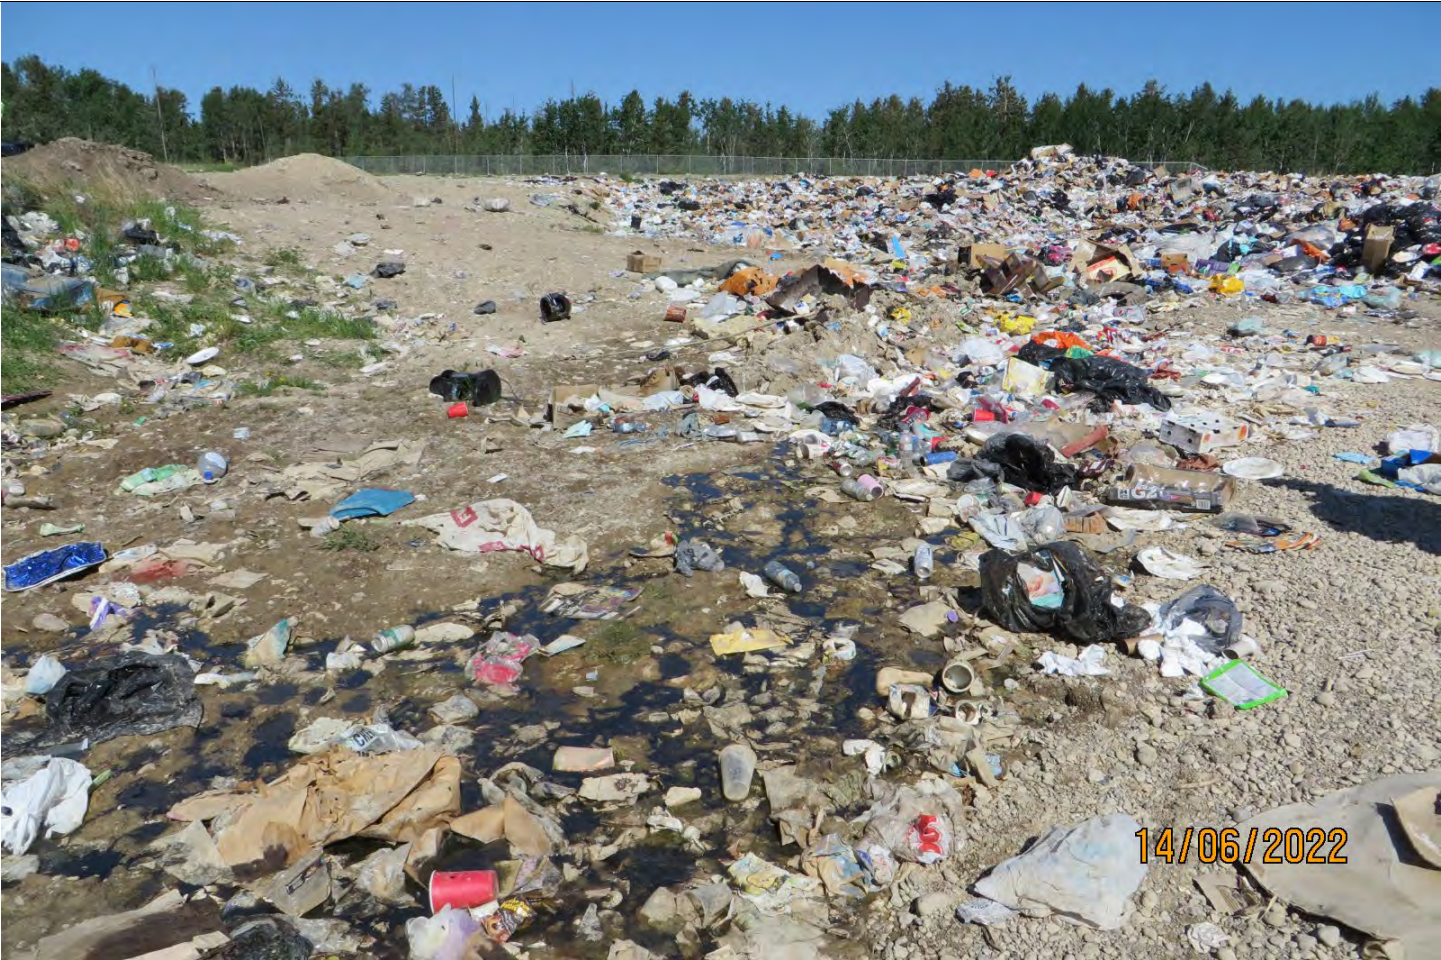
Figure 11
Landfill - Domestic waste pile looking North

At the time of inspection all domestic waste was being deposited central to the new cell of the landfill. The landfill attendant (Mr. Mcleod) has mentioned repeatedly that proper equipment is needed to manage the landfill more effectively and efficiently. The inspector acknowledges that the current lack of a compactor and dozer for this facility has lead to some undesirable conditions for the Hamlet. The facility is also currently dealing with the issue of pooling leachate underneath the domestic waste pile that is preventing access to the active cell. Further discussions and planning with MACA and MVLWB on how to manage and mitigate this ongoing issue is required.

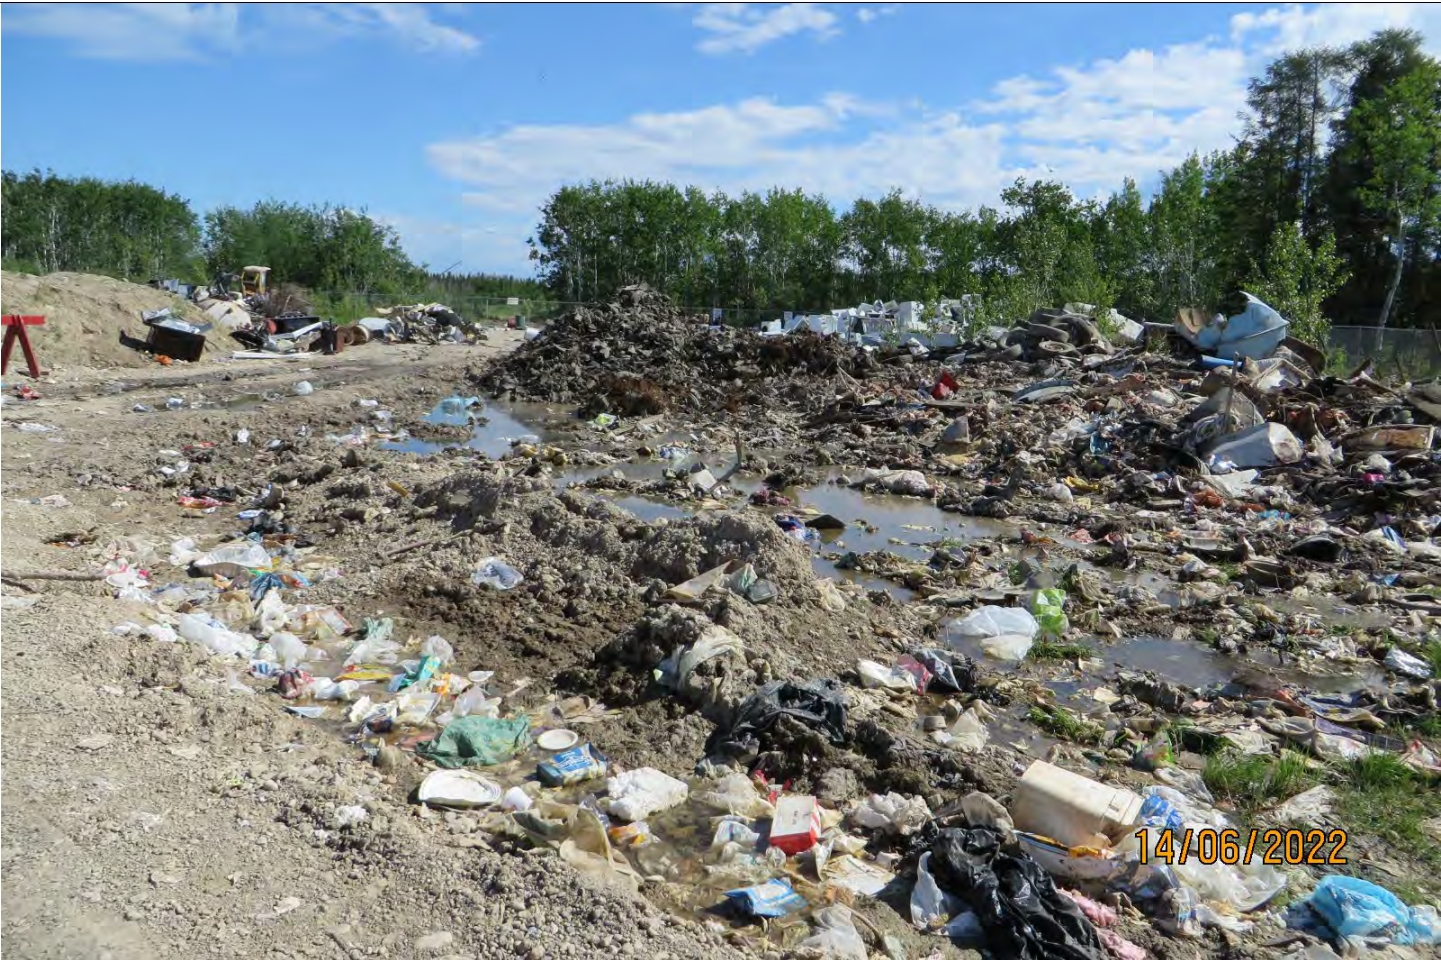
Figure 12
Landfill – Pooling water and old tire shreds

Segregated waste streams need to be identified with signage for ease of organization and to inform land fill Users (i.e. Haz. Waste Area, Appliance Waste, Tires, etc.). More oversight of landfill activities is required to prevent the dumping of undesirable wastes. Better segregation of waste streams around the domestic waste pile is still required, especially the stockpiled vehicles and scrap metals. Majority of stored tires onsite were shredded. The remaining intact tires were not shredded due some of them having rims still attached.

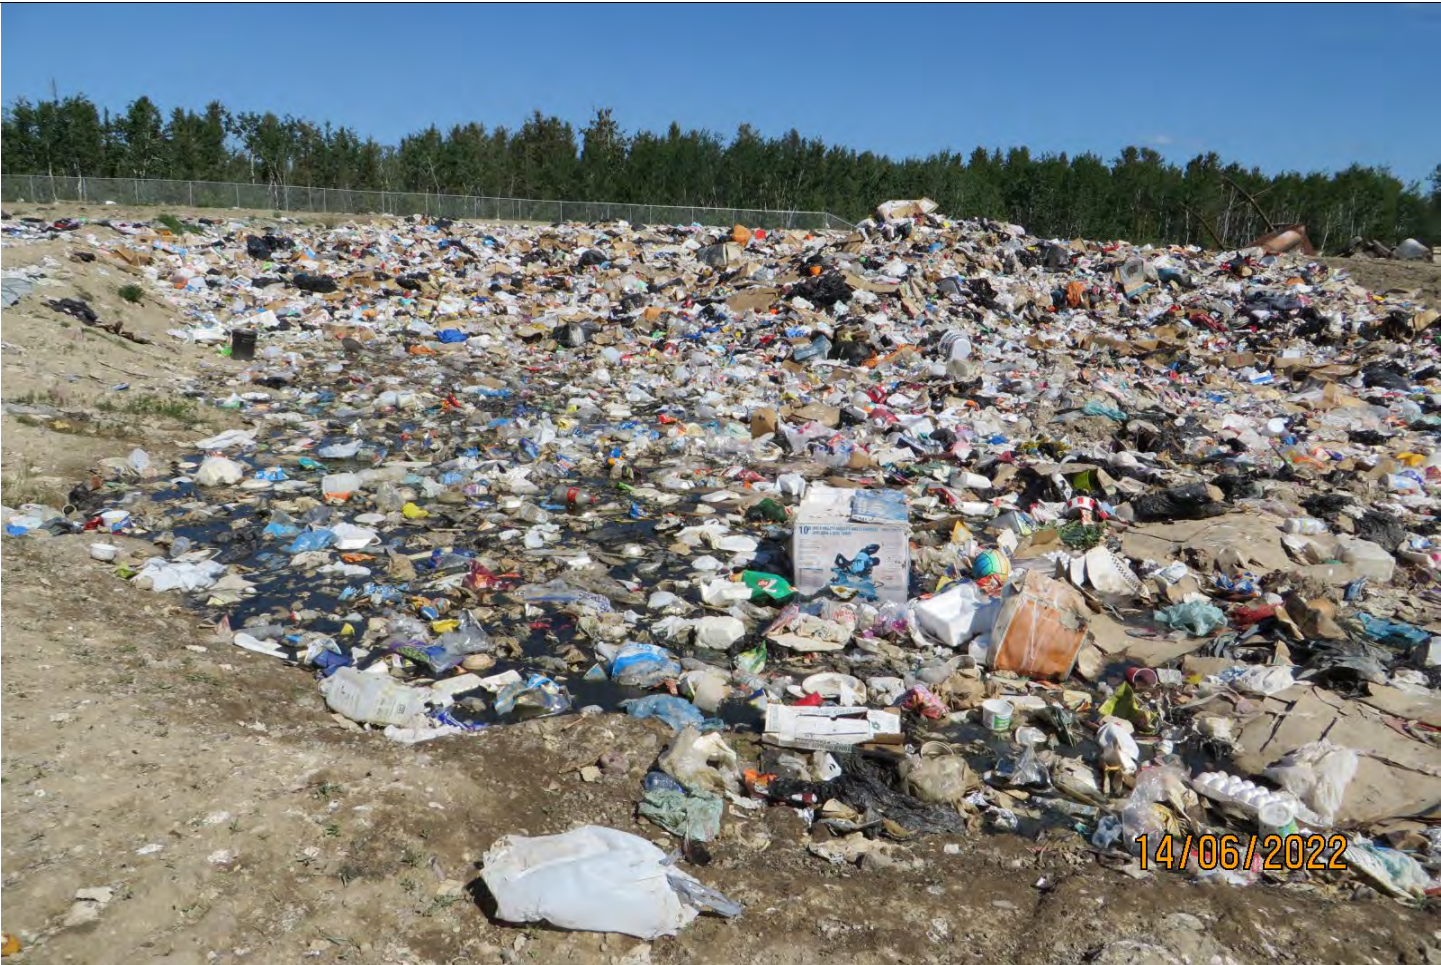
Figure 14
Landfill – Current domestic waste cell being used and leachate clearly visible

The most critical concern that was noted during the inspection was the pooling leachate at the domestic waste landfill area. This issue will need to be addressed moving forward as it is impairing the functioning of the landfill and not allowing access to the active cell. There should be some consideration put into developing a proper, engineered leachate drainage/catchment system/structure (i.e lined evaporative leachate sump), so this issue doesn't reoccur each year and hamper operations at the facility.

1. Operational maintenance work to be completed at domestic waste area in regards to the pooling leachate. Licence Condition D.18
2. Hazardous waste area needs to be properly maintained to prevent accidental spills by containerizing waste oils and other hazardous waste appropriately. Licence Condition D.20
3. Outstanding submission of the Operation and Maintenance Plan for the Sewage Disposal facilities to the MVLWB since July 7th, 2017. Licence Condition E.3.
4. Outstanding submission of Operation and Maintenance Plan for the Water Treatment Plant to the MVLWB since July 7th, 2017. Licence Condition E.4.

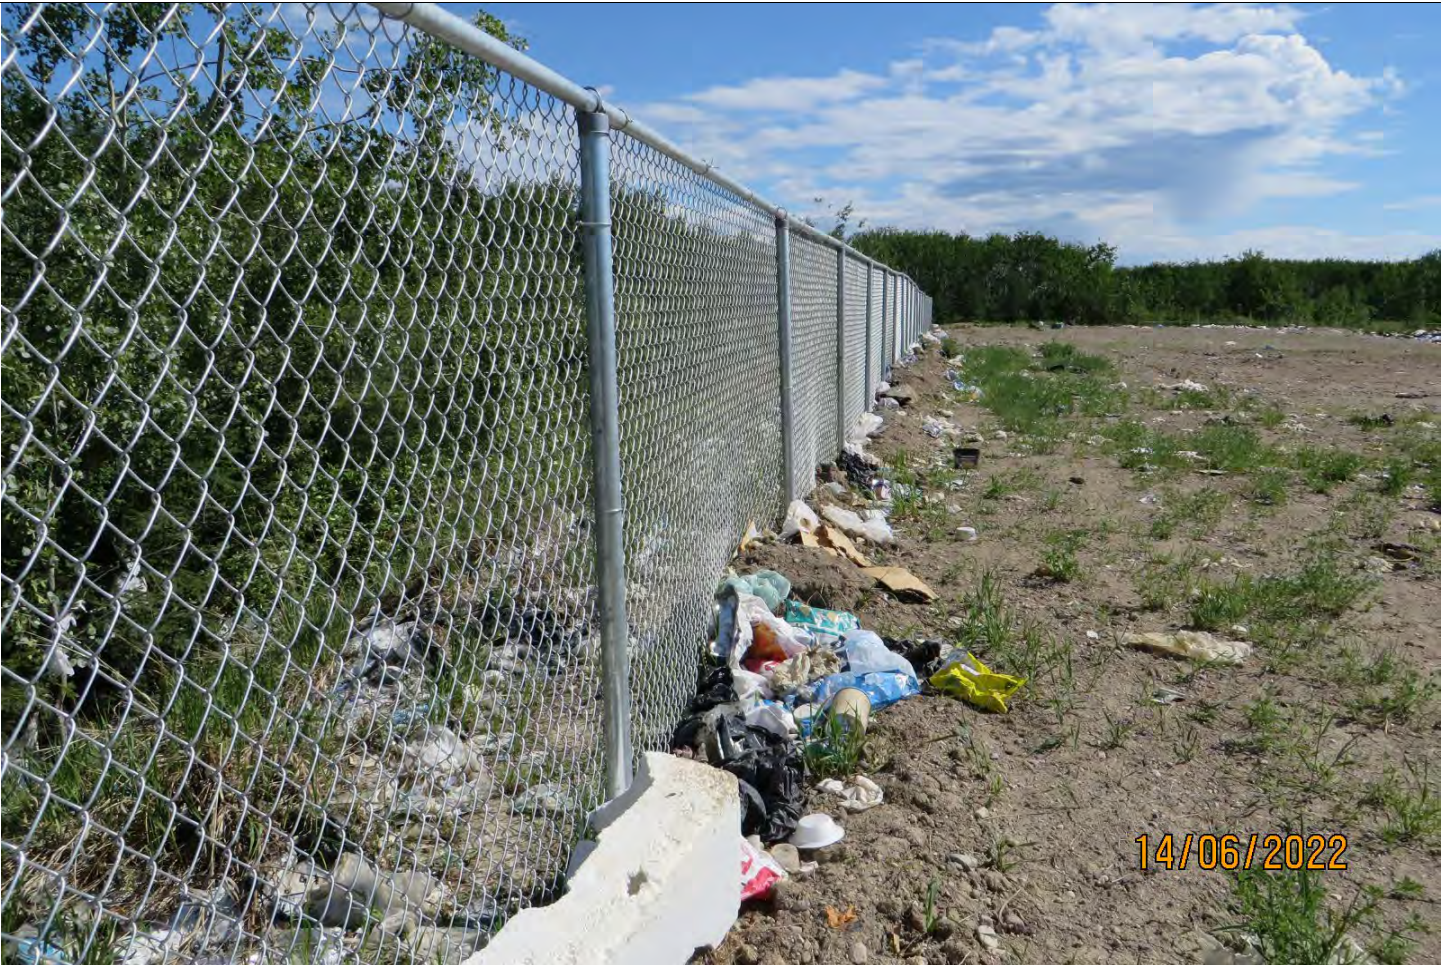
Figure 16
Landfill – Northern perimeter of domestic waste pile.

More frequent cover at this facility would limit wind blown waste. Copious windblown debris was still noted in all areas of the facility, but concentrated in fenced perimeter areas. The north and west perimeter areas of the main waste pile had the most windblown debris. Lack of cover in the active domestic waste cell, the cooking grease disposal pit and poor management of hazardous wastes has attracted wildlife. Evidence of bears accessing and scavenging on wastes was present at the time of inspection (Figure 20). This issue must be addressed as soon as possible. The Construction, Demolition and Oversized waste pile across from the domestic waste area has some waste items that should not be there (Figure 26 & 27). Used vehicle batteries and some appliances have been left in this area, and now the attendant must move them to the appropriate location. This may be due to the inaccessibility of the designated areas within the domestic waste area, but most likely due to unsupervised tipping by Users. This is why the landfill could use a part time Attendent to guide and direct Users.The construction waste was recently covered, but the main concern is the unsupervised Users at the landfill dropping waste in the wrong areas.

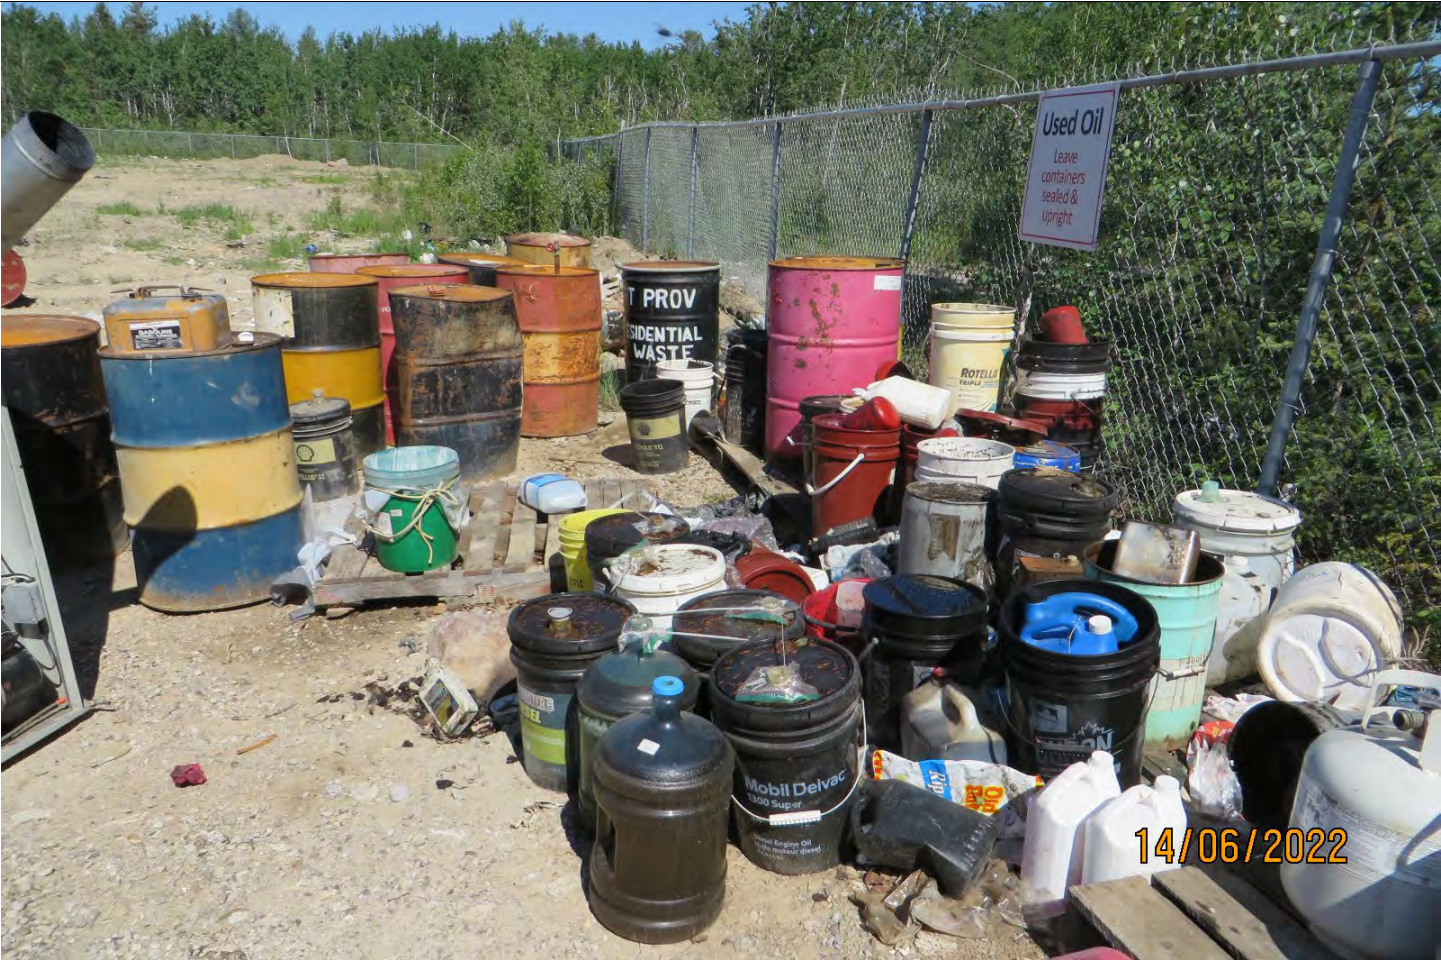
Figure 21
Landfill – Hazardous waste area with many open and improperly stored oils

The hazardous waste area is in poor condition and spills were noted at the time of inspection. Wastes are not contained ,or appropriately stored on site. There were many containers (buckets, bins, used oil containers, etc.) that were placed in one area, but many were open, or not sealed. It is recommended that the Hamlet acquire a plastic tote to properly store oils and chemicals in one container. This will make it easier to manage this area, if the Hamlet continues to be a receiver of these wastes. This would also help with reducing the risk of spills in this area. Any spills in this area must be cleaned up.

Clean up and better management of the Hazardous waste area is also required. Reducing wildlife attractants with more frequent cover and controlling access to the landfill (i.e. reinforced perimeter fencing that prevents access by bears) is also required.
