Ptarmigan Mine Fencing Project – Land Use Permit MV2016X0026 Closure Request

Ptarmigan and Tom Mine Project Update MV2016X0026

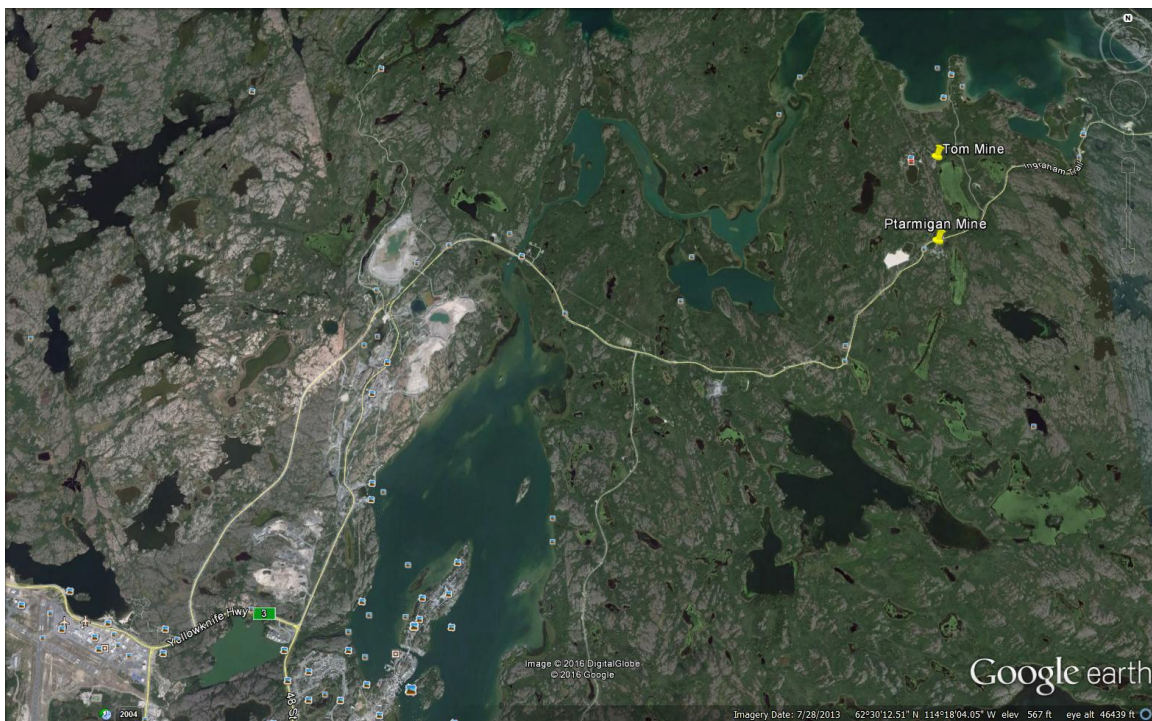
Figure 1 – Ptarmigan and Tom Mines along the Ingraham Trail, near Yellowknife, NT

Ptarmigan Mine and Tom Mine are former gold exploration sites, located on the Ingraham Trail, 15 kilometers northeast of Yellowknife. Coordinates of the Ptarmigan Mine shaft are N 62° 31' 10", W 114° 11' 51" (N62.519444, W114.1975), NTS Sheet 85 J-9, **Figures 1-3**. Both sites are located on GNWT Commissioner's Land and are classified as Excepted Waste Sites in the Northwest Territories Lands and Resources Devolution Agreement, whereby responsibility for waste sites created prior to devolution shall be determined pursuant to separate negotiations between the Government of Canada and the GNWT.

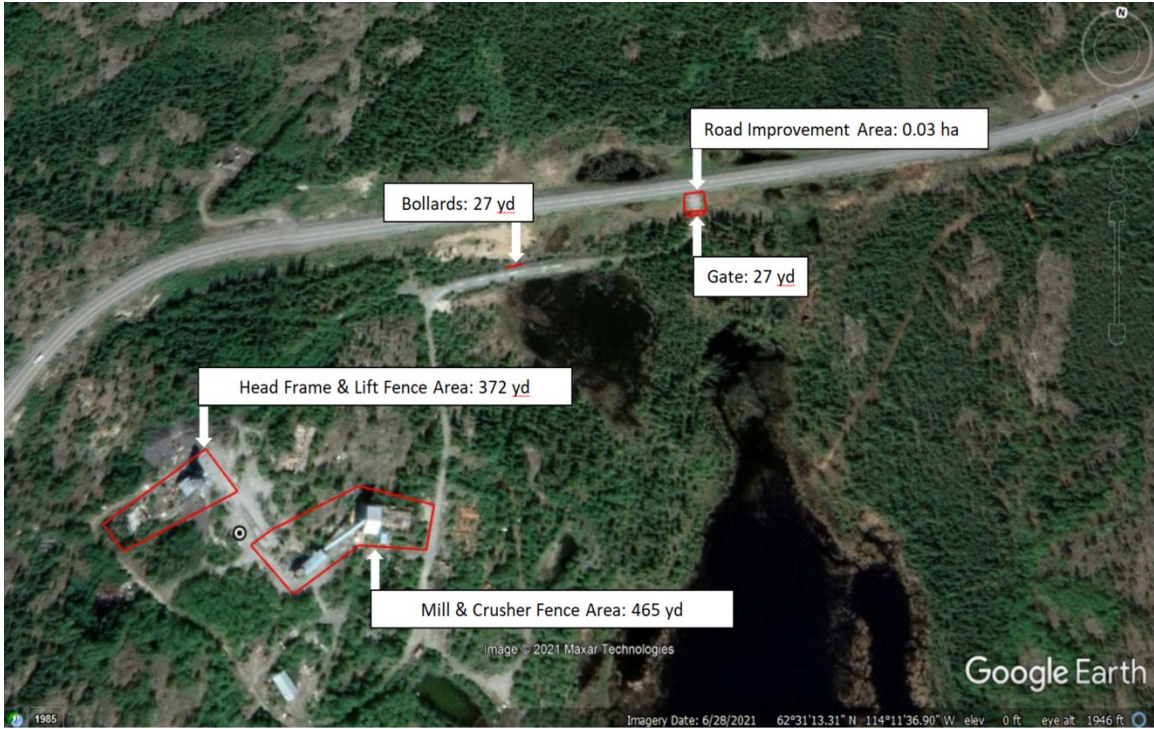
Figure 2 – The Ptarmigan Mine safety fence alignment and road improvements (red lines)

A 10 foot high wire mesh fence was constructed and completed at the Ptarmigan and Tom Mines during the winter of 2016/17. As shown in **Figures 2 and 3**, the Ptarmigan mine head frame was enclosed in one fenced area and the crusher, gallery and mill buildings in another. A fence section and gate was installed at the Ptarmigan Mine point of entry to deter access to the site. See **Figure 2**.

The work included the installation of a culvert to maintain appropriate drainage along the highway ditch. There is currently no existing watercourse in the ditch. This work occurred in the area along the Ingraham Trail as shown in **Figure 2** and saw improvements totaling 0.03 ha.

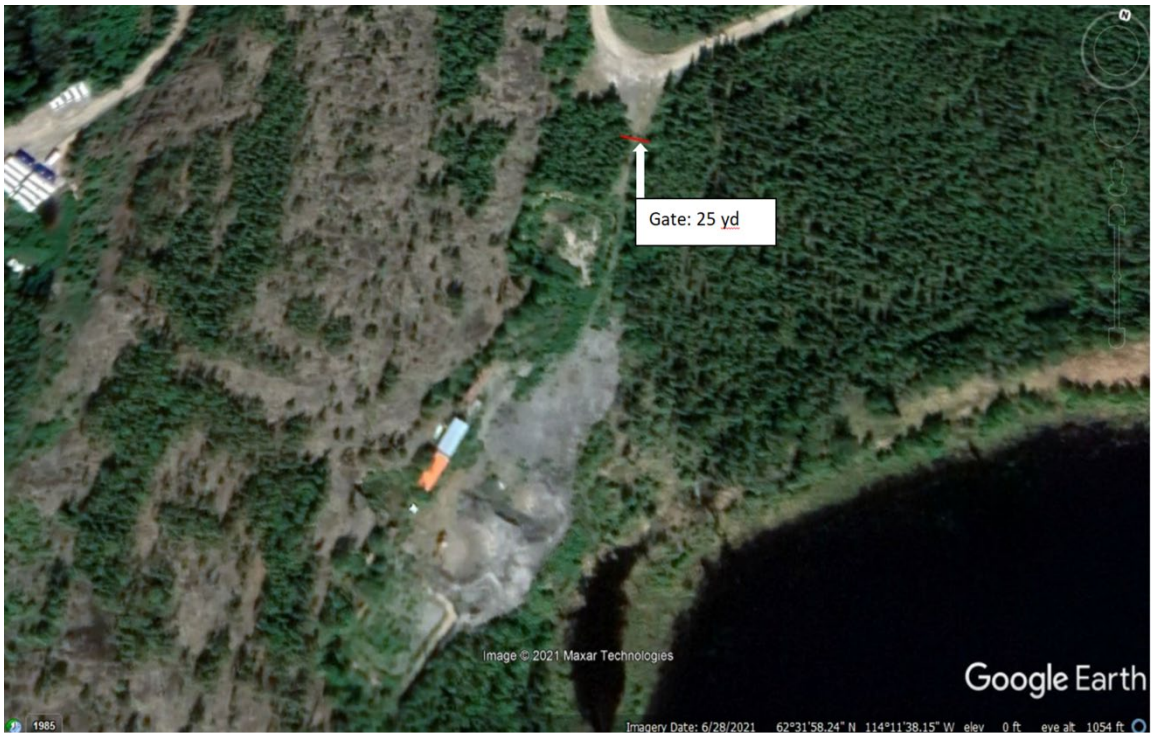
Figure 3 – Tom Mine safety fence and gate (red lines)

A 10 foot high wire mesh fence section and gate was installed at the Tom Mine to deter access to the site. See **Figure 3**. Wire mesh fencing was grouted into place over hole on one side of the previously barricaded mine shaft opening. See Figure 12.

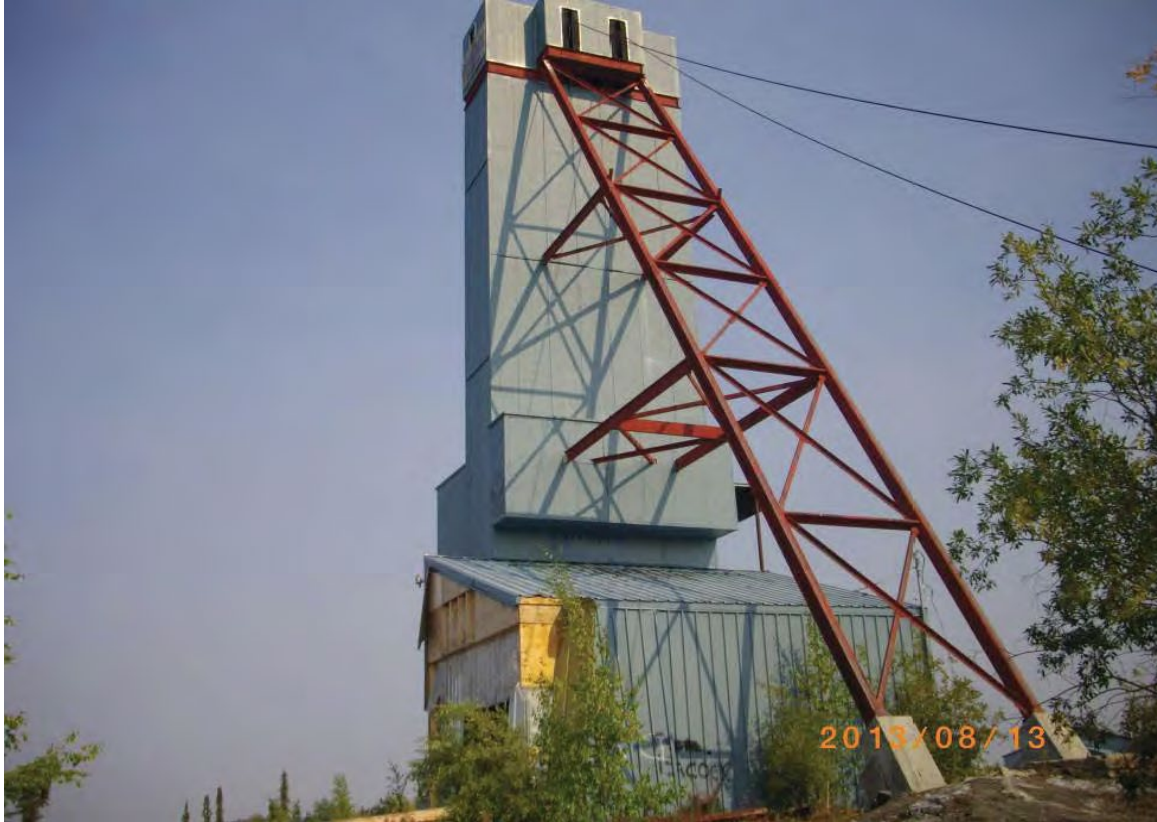
Figure 4 – Ptarmigan Mine headframe

The mine sites pose potential safety hazards to anyone venturing onto the sites. As seen in **Figures 4 - 7**, the Ptarmigan Mine includes tall structures such as a head frame, crusher building and gallery. Anyone climbing these structures is in danger of falling from height. Standing near the structures exposes one to hazards of falling objects.

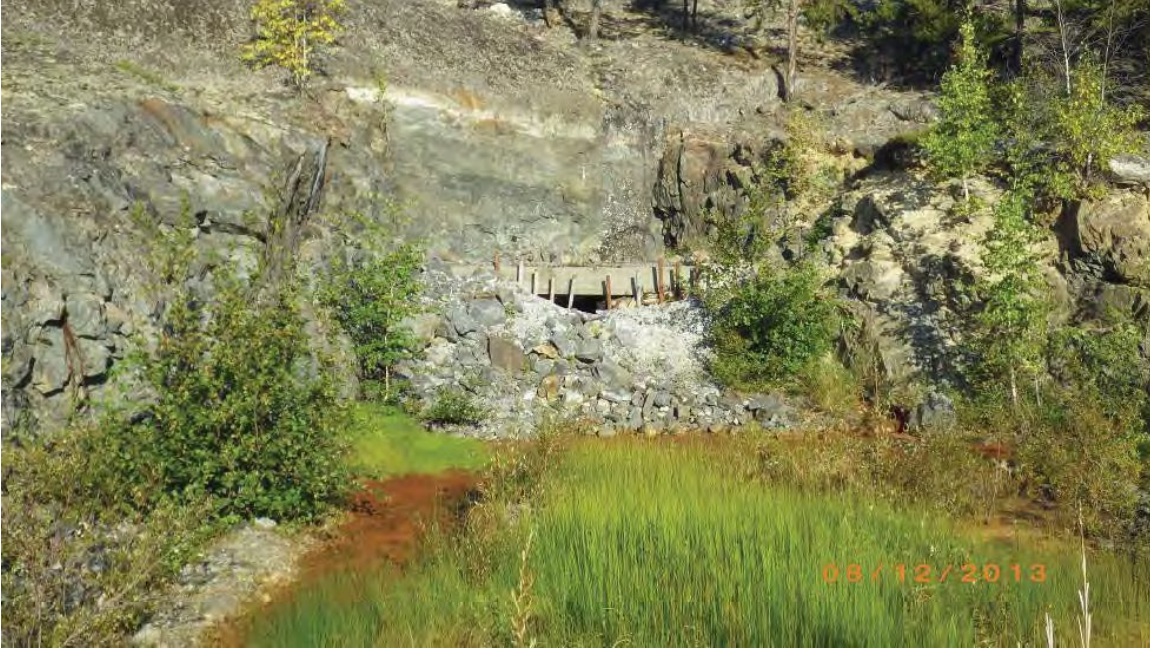
Figure 8 – Tom Mine decline portal

The Tom mine has underground workings that are accessible from the surface, see **Figure 8**. Past efforts to secure these mine openings are proving inadequate as shown in **Figure 9**. The underground workings that are filled with groundwater are accessible from the surface. Anyone venturing underground through these openings is exposed to drowning, and other hazards, see **Figure 10**.

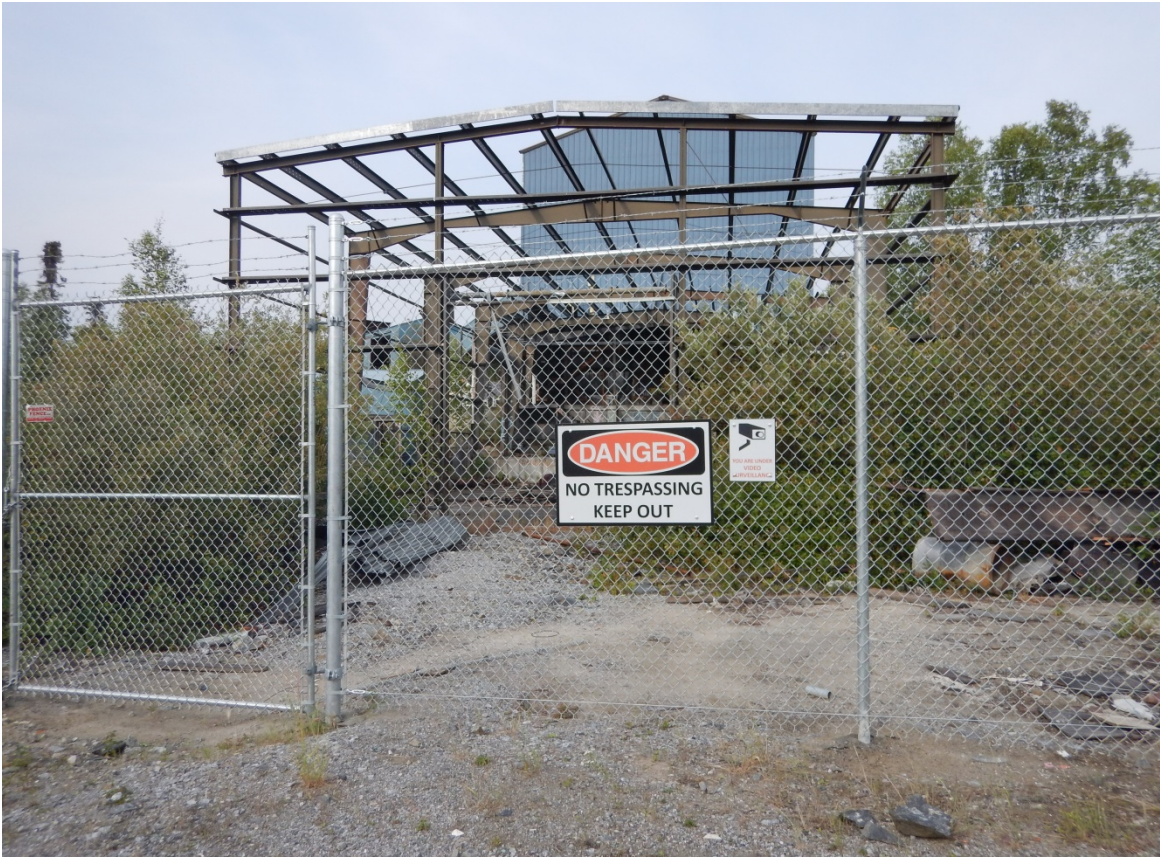
Figure 11 - Fence installation at Ptarmigan Mine

An example of the fence construction at Ptarmigan Mine is shown in **Figure 11**.

Heavy equipment such as a RC Interoc AN 109 drill rig, air compressor, D6 dozer, and C3 Cat excavator were used for drilling of the fence post holes and access road upgrades and maintenance activities. The wire mesh fence and gate is supported using metal posts inserted into the ground. Soil conditions at the Ptarmigan and Tom Mines are gravel and exposed bedrock. This type of terrain required the use of an Air Track drill to drill the holes and the posts were secured in ground using a suitable cement paste.

The total length of fencing and gates installed was 916 yards for both Ptarmigan and Tom Mines. The top sections of the fences at both sites have barbed wire to deter access to the mine sites. The 10 foot high fence was a recommendation that would help prevent wildlife from entering the enclosed area and becoming trapped.
