<b>File Number</b>	<b>MV2017Q0033</b>
<b>Type of Operation</b>	<b>QUARRY SITE - Existing</b>
<b>Location</b>	2017QP0028- Hwy 1 Km 518

## ENVIRONMENTAL INSPECTION REPORT

<b>Permittee:</b>	Nogha Enterprises	<b>Permit Expiry Date:</b>	May 23, 2023
<b>Land Use Permit No.</b>	MV2017Q0033	<b>Previous Inspection:</b>	New
<b>Quarrying Permit No.</b>	17/0028	<b>Inspection Date:</b>	October 10, 2019
<b>Contractor:</b>		<b>Subcontractor:</b>	
<b>Location(s) Inspected:</b>	2017QP0028- Hwy 1 Km 518		
<b>Current Stage of Operation:</b>	Ongoing		
<b>Program Modifications Approved:</b>	N/A

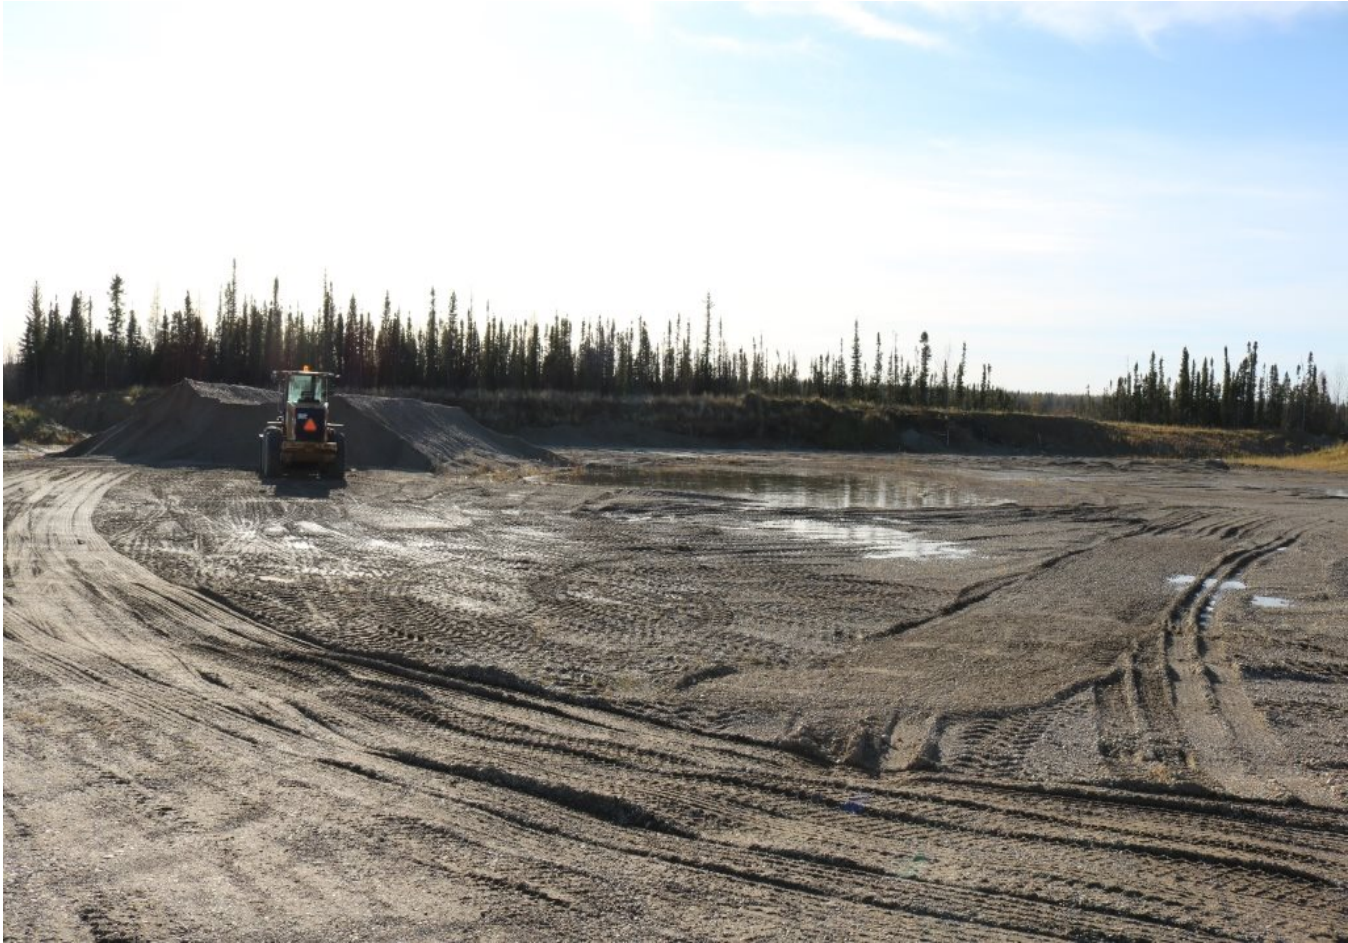
**Figure 1**

Inspectors from the Department of Lands inspected the 2017QP0028 quarry permit on October 10, 2019. There was one (1) stockpile on site with some pooling water around the stockpile and throughout the site. There was one (1) loader on site with no drip tray underneath. There was no apparent staining underneath the loader at the time of inspection.

**Overview of the site with pooling water**

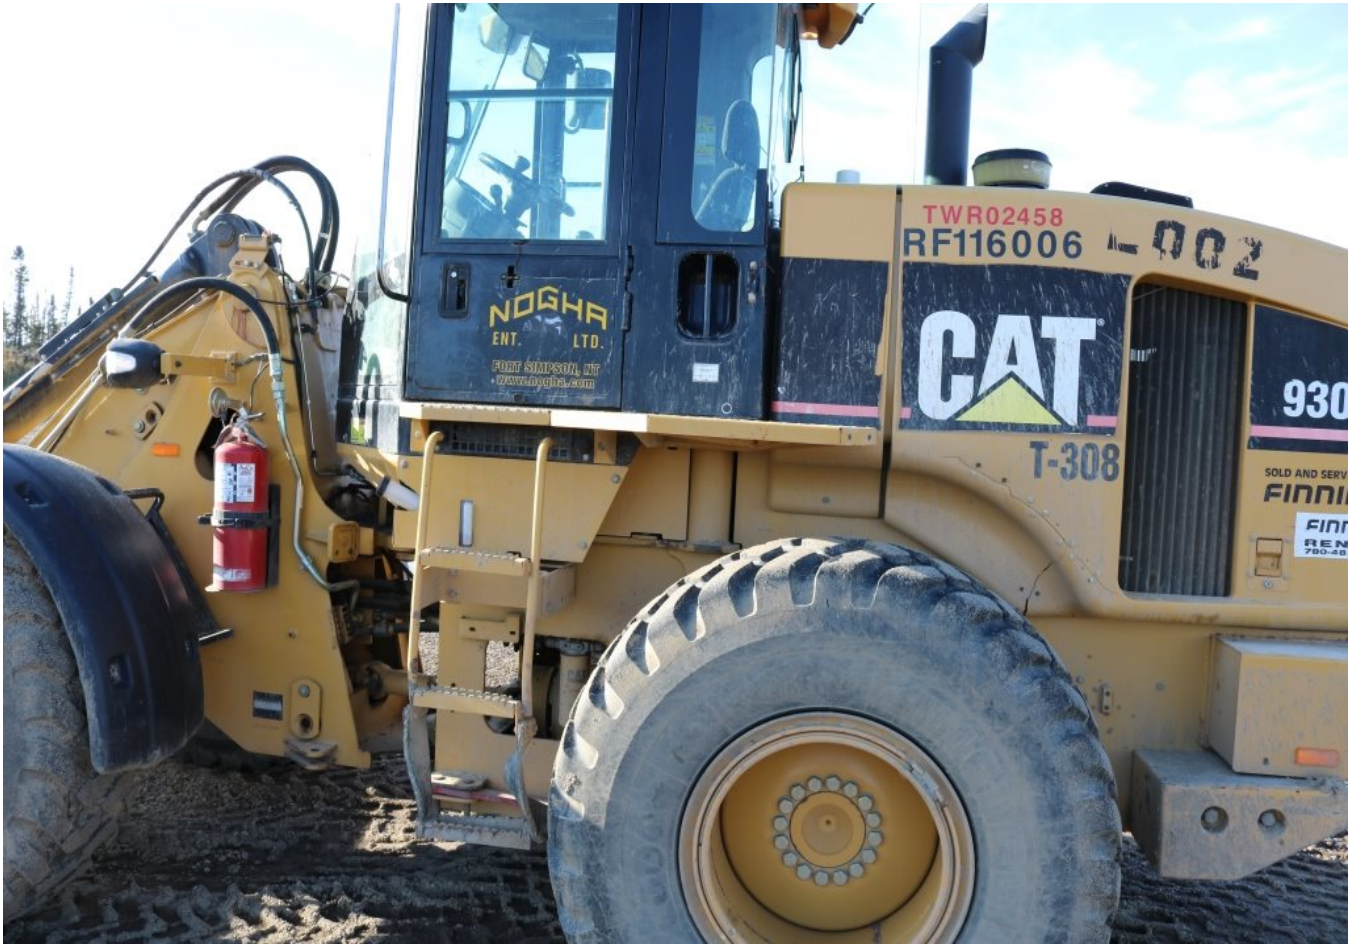
**26(1)(m) Fuel Storage**

**Figure 2**  
**Loader on site with no drip tray underneath**

**32. Drip Trays:** All equipment that may be parked for two hours or more, shall have a haz-mat/drip tray under it or be sufficiently diapered. Leaky equipment shall be repaired immediately.

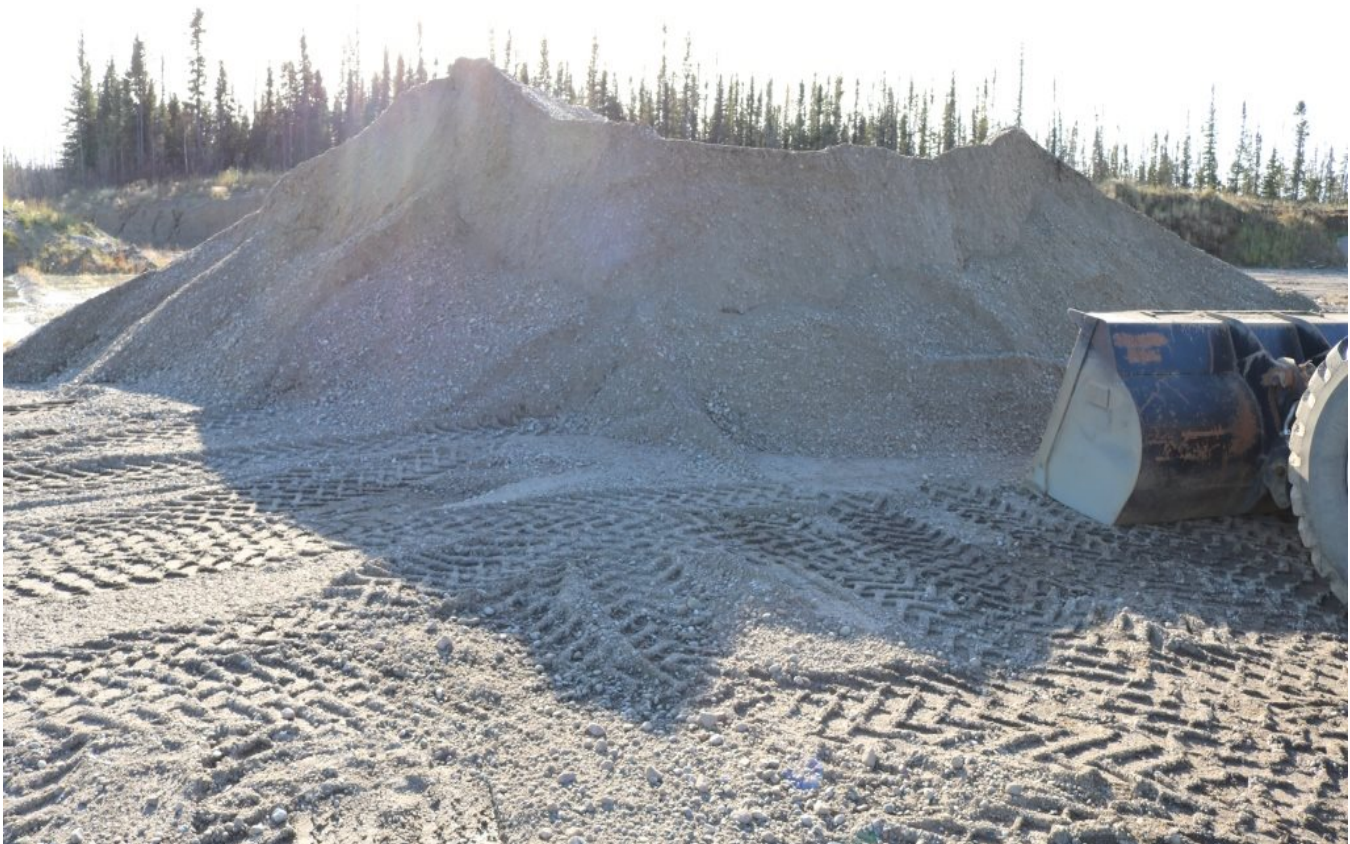
**Figure 3**  
**Stockpile on site**
