<b>File Number</b>	<b>MV2019L1-0001</b>
<b>Type of Operation</b>	<b>CLASS A - INDUSTRIAL</b>
<b>Location</b>	<b>Jackfish Lake, NT</b>

## INDUSTRIAL WATER USE INSPECTION REPORT

<b>LICENCE #:</b>	<b>MV2019L1-0001</b>	<b>EXPIRY DATE:</b>	<b>October 17, 2044</b>
<b>LICENCEE:</b>	<b>Northwest Territories Power Corporation</b>	<b>PREVIOUS INSPECTION:</b>	<b>September 1, 2022</b>
<b>COMPANY REP:</b>	<b>Matt Miller</b>	<b>INSPECTION DATE:</b>	<b>August 09, 2023</b>

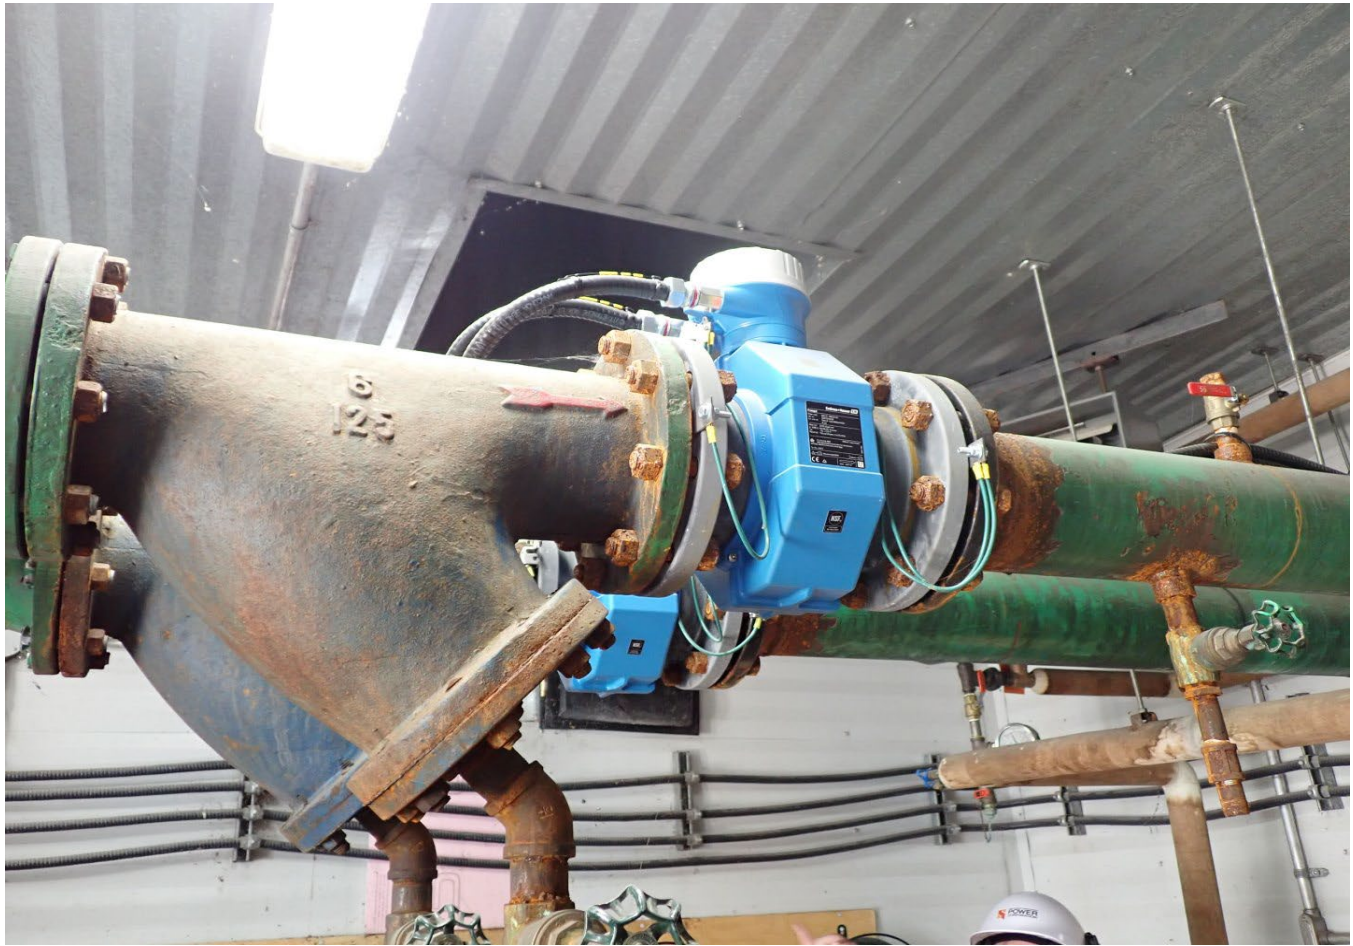
Water at the Jackfish Diesel Power Plant is used to cool the diesel generators and is used in a closed-loop system. Due to low water levels in 2023, Jackfish has been required to supply more power than average years. Northwest Territories Power Corporation (NTPC) reports water use on a monthly basis. Flow meters have been installed for all water pumps to ensure water volumes are recorded accurately (Figure 1). Reported volumes in 2023 have not exceeded the maximum water use indicated in the Licence.

Figure 1 - Example of flow meter to measure water use

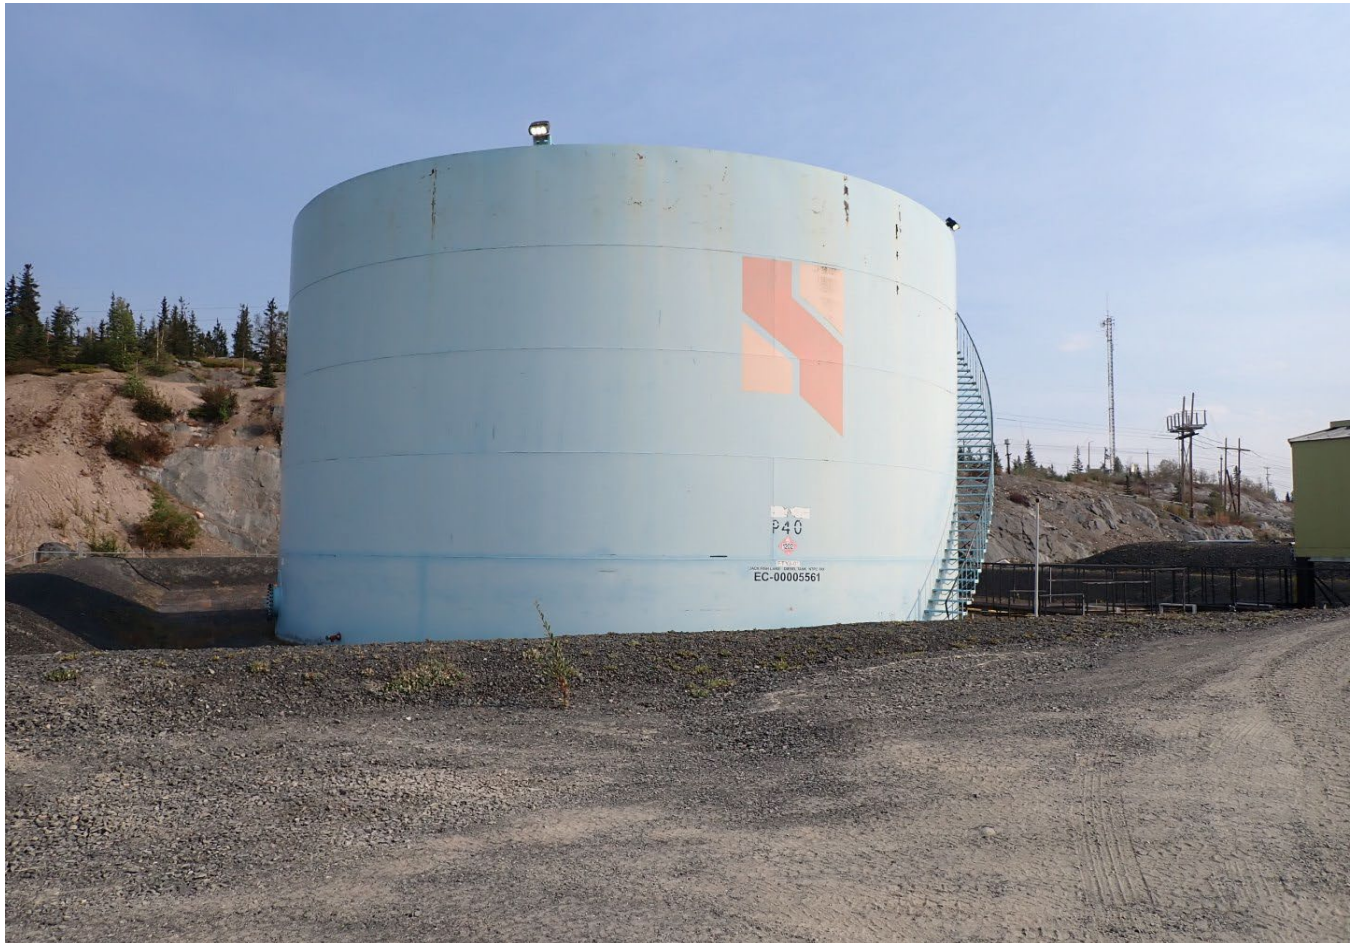
Jackfish has to store large volumes of diesel to operate the diesel generators as needed. The bulk fuel storage tank was inspected, and no concerns were noted. There was no evidence of leaks, no water within the storage berm, and appropriate spill supplies were present at refueling locations (Figure 2 & Figure 3)

Figure 2 - Bulk fuel storage tank

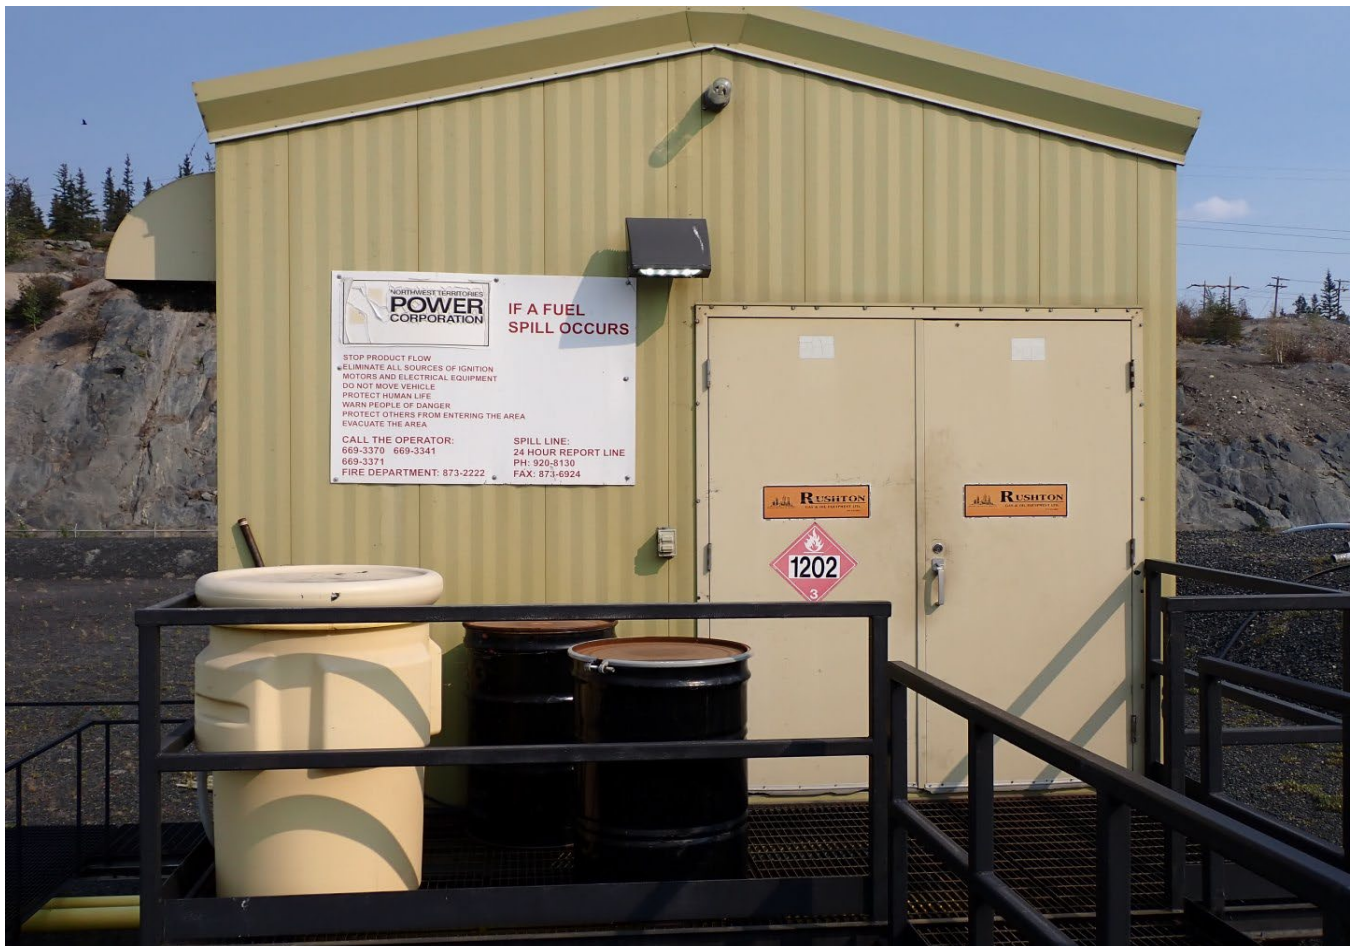
Figure 3 - Spill supplies near bulk fuel storage

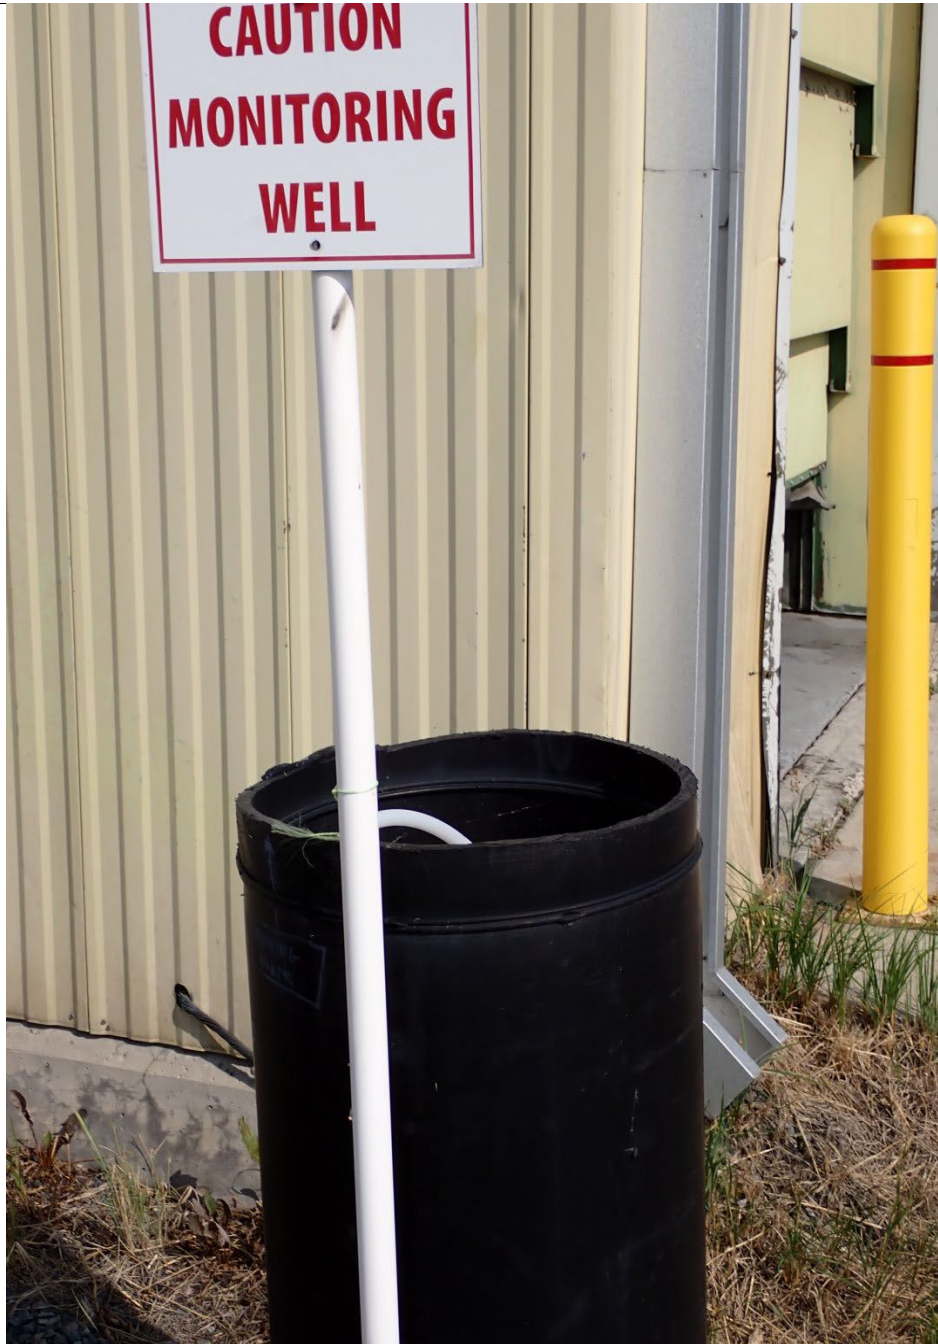
NTPC reports SNP sampling results on a monthly basis and there has not been any exceedances recorded in 2023. It is noted that there are some groundwater wells that do not have appropriate caps (Figure 4). Groundwater wells are capped to prevent any potential contaminants from entering groundwater and to ensure when the well is sampled, it is representative of conditions of the groundwater. The Inspector recommends checking all groundwater wells and ensuring each well on the property has an appropriate cap.

Figure 4 - Groundwater monitoring well without cap
