DE BEERS GROUP

December 16, 2019

Re: Snap Lake Water License Renewal (MV2019L2-0004), Land Use Permit Amendment (MV2017D0032), and Final Closure and Reclamation Plan – Response to Undertakings

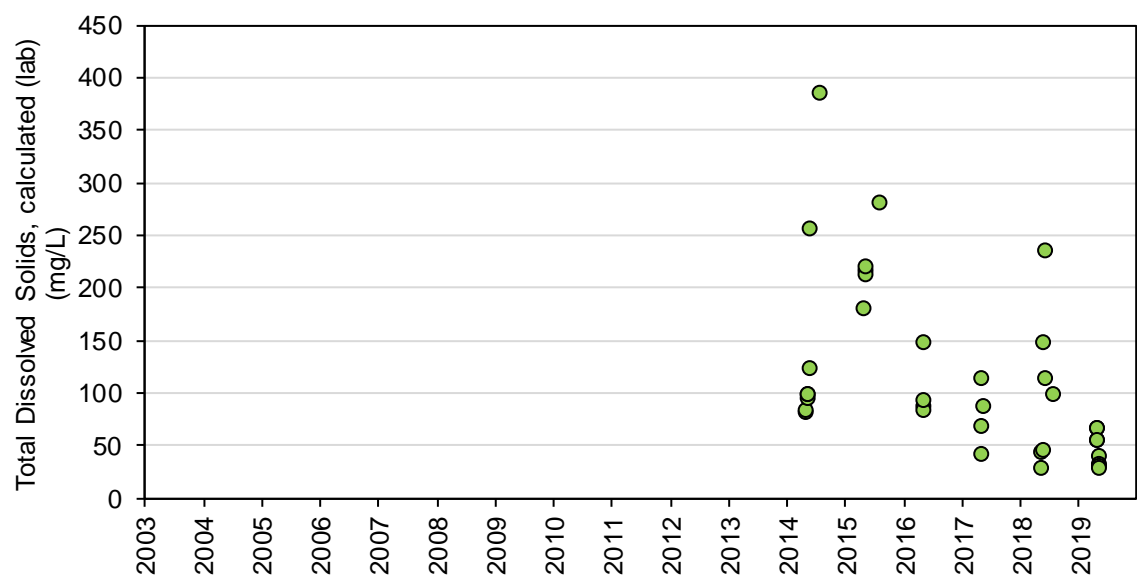
Figure 4D-1: Total Dissolved Solids, calculated (lab) Concentrations at Station SNP 02-06 during Construction, Operations, and Extended Care and Maintenance

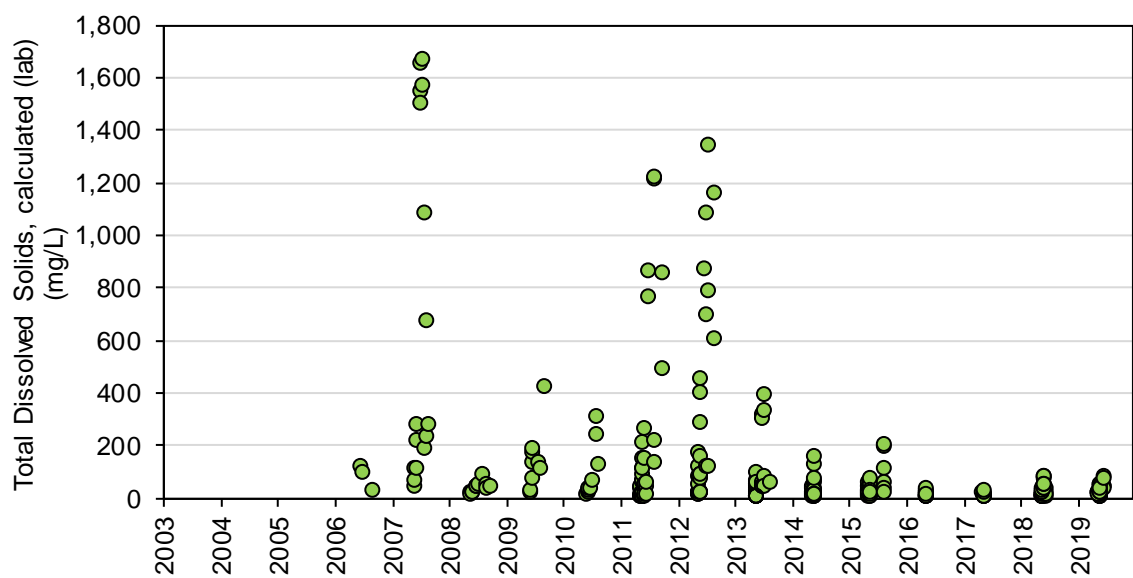
Figure 4G-1: Total Dissolved Solids, calculated (lab) Concentrations at Station SNP 02-09 during Construction, Operations, and Extended Care and Maintenance

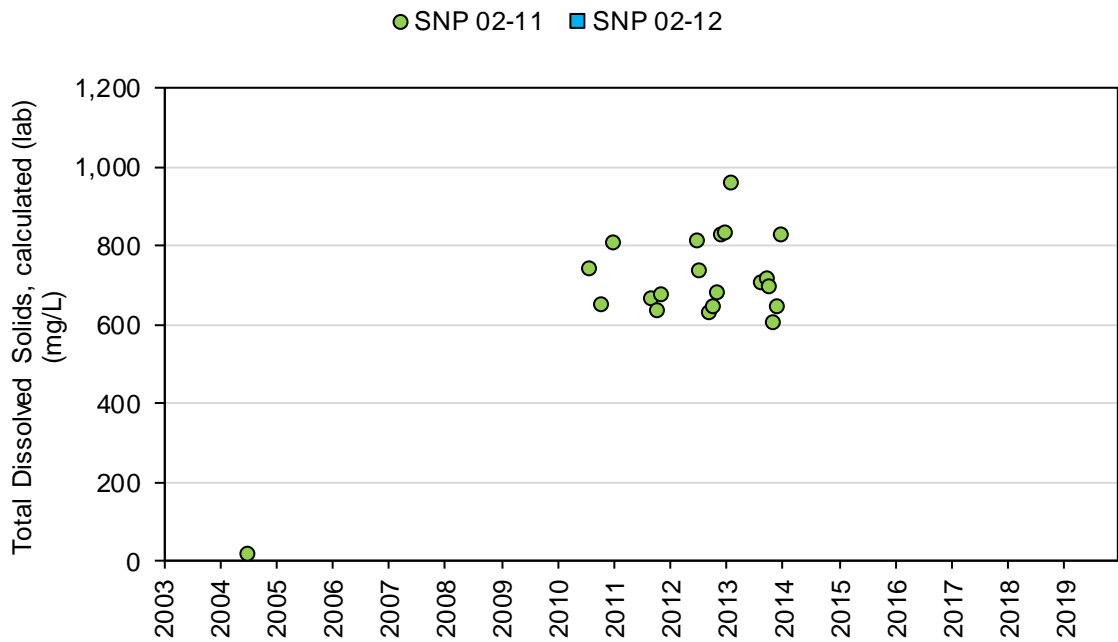
Figure 4I-1: Total Dissolved Solids, calculated (lab) Concentrations at Stations SNP 02-11 and SNP 02-12 during Construction, Operations, and Extended Care and Maintenance

Concentrations of major ions, metals and metalloids at Bog East are variable within a year, but overall are either stable over time or decreasing over time; there are no increasing trends in any parameter (De Beers 2019a). Likewise, when it is possible to sample from SNP 02-11, concentrations of major ions, metals and metalloids have been variable with no increasing trends observed (Attachment 4I).

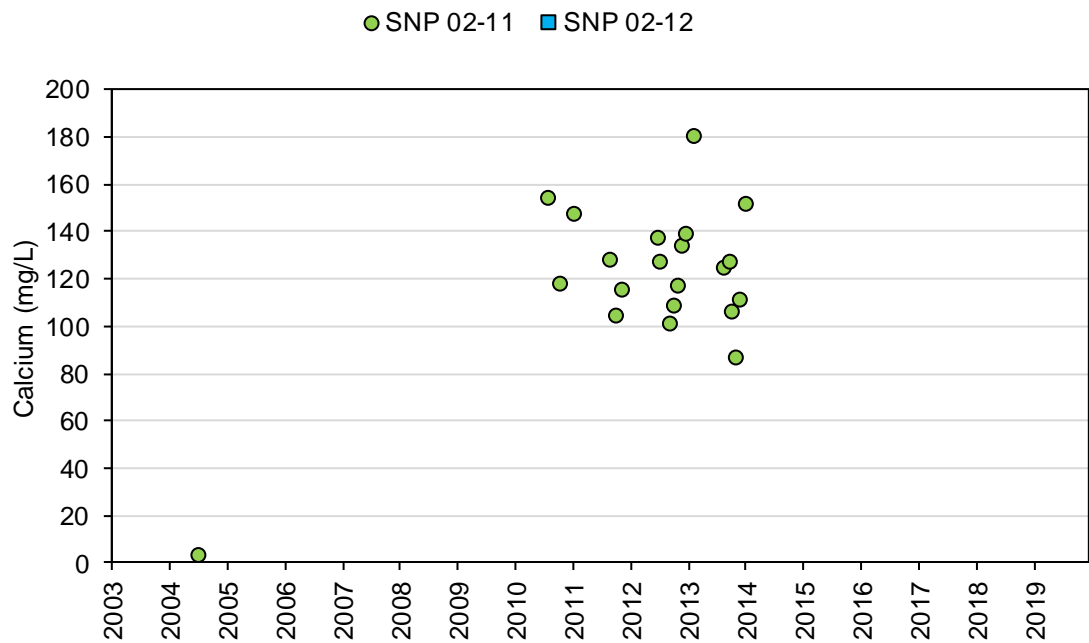
Figure 4I-2: Calcium Concentrations at Stations SNP 02-11 and SNP 02-12 during Construction, Operations, and Extended Care and Maintenance

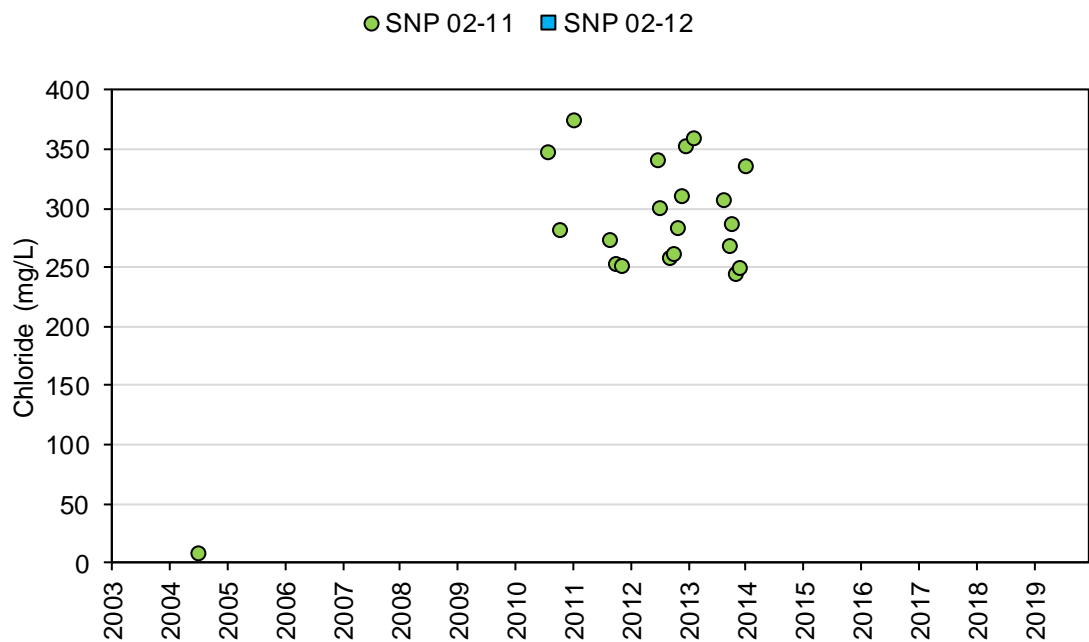
Figure 4I-3: Chloride Concentrations at Stations SNP 02-11 and SNP 02-12 during Construction, Operations, and Extended Care and Maintenance

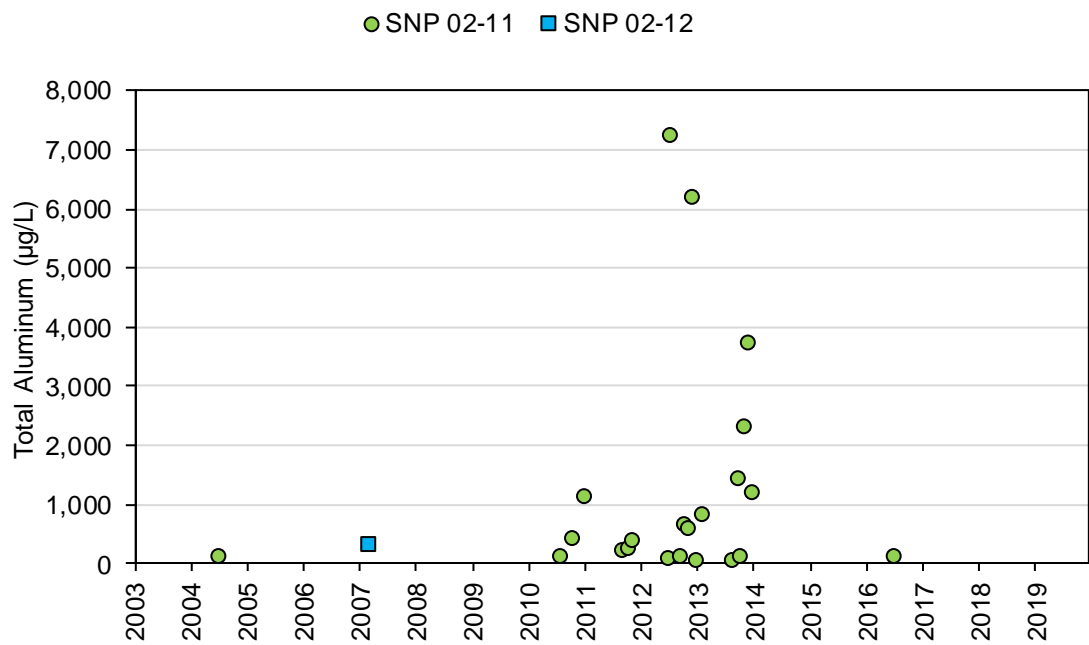
Figure 4I-13: Total Aluminum Concentrations at Stations SNP 02-11 and SNP 02-12 during Construction, Operations, and Extended Care and Maintenance

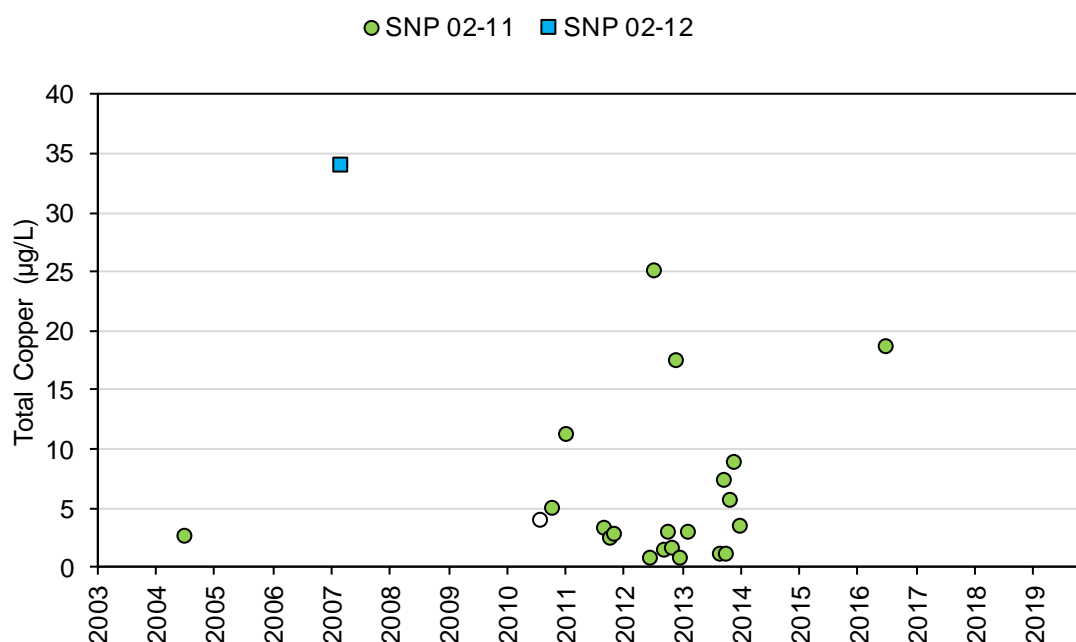
Figure 4I-24: Total Copper Concentrations at Stations SNP 02-11 and SNP 02-12 during Construction, Operations, and Extended Care and Maintenance

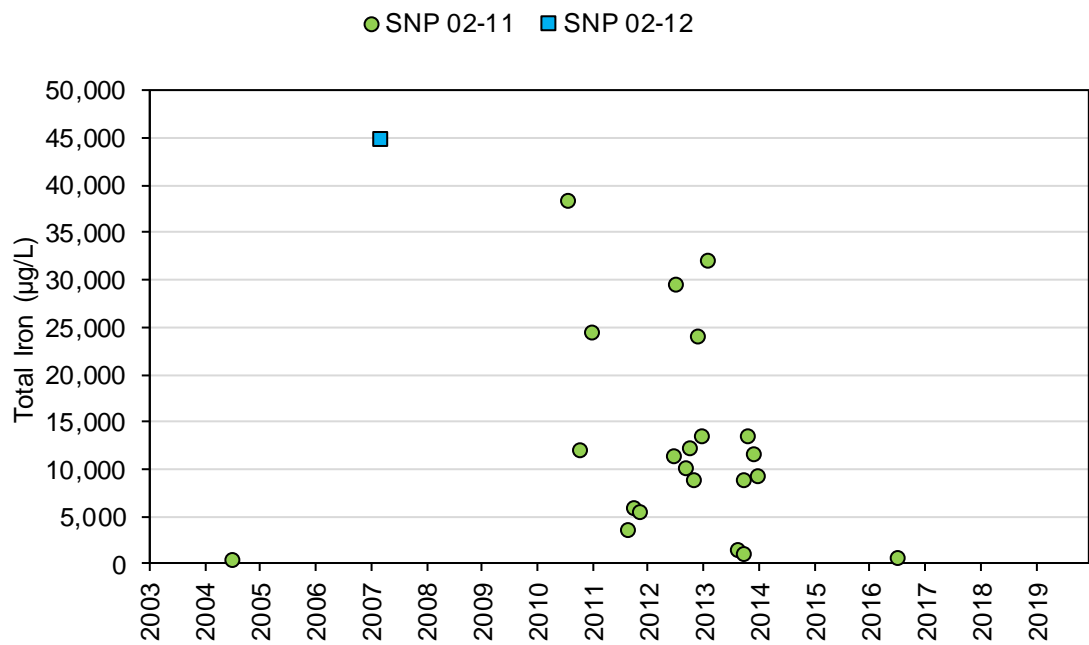
Figure 4I-25: Total Iron Concentrations at Stations SNP 02-11 and SNP 02-12 during Construction, Operations, and Extended Care and Maintenance

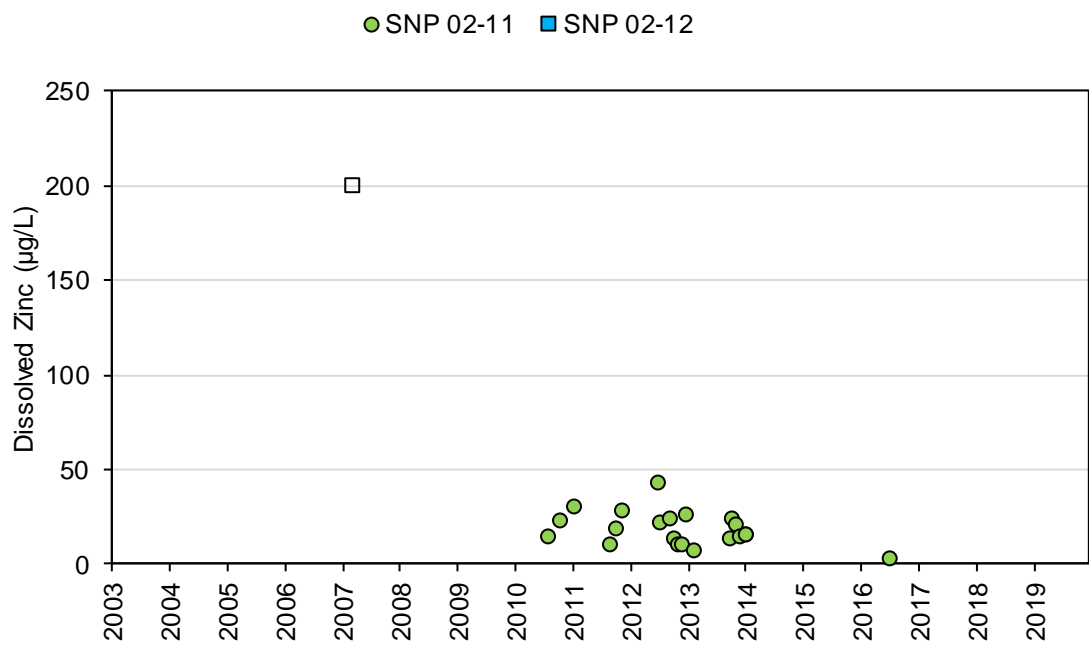
Figure 4I-68: Dissolved Zinc Concentrations at Stations SNP 02-11 and SNP 02-12 during Construction, Operations, and Extended Care and Maintenance
