# **POST-EA INFORMATION PACKAGE INCLUDING AN UPDATED PROJECT DESCRIPTION ALL SEASON ROAD TO PRAIRIE CREEK MINE**

**APPENDIX 1-11: BORROW PIT SUMARRY**

## **APPENDIX 1-12**

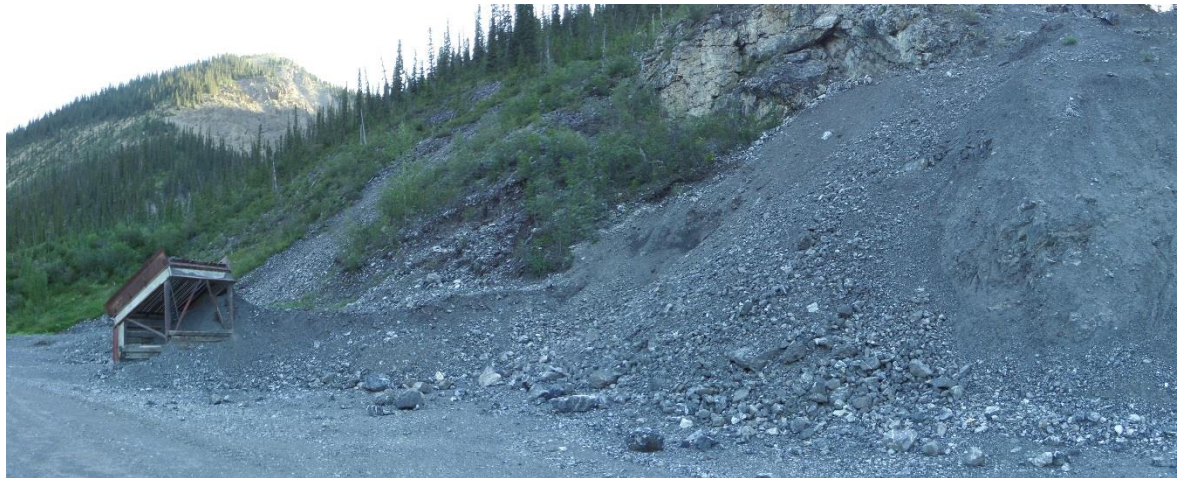
**Figure 1: BP2 materials pushed from a higher rock face for screening with a grizzly.**

The potential borrow source at BP 2 consists of crumbling bedrock that has been used in past by Canadian Zinc for miscellaneous roadway improvements. This source is identified as a calcareous mudstone that appears very competent in comparison to the previous siltstone source at 0.55 km. Based on the materials developed here to date, it appears that this rock source readily fragments under the blade of a bulldozer, although this favourable trait may decrease with bedrock depth. In past, the use of a grizzly screening unit at the site removed any oversized materials prior to loading the materials into trucks for movement. The apparent hardness and blocky fracture properties of this material may make it suitable for crushing for surfacing material, and it seems to pack into a very dense state. One limitation for a crushing operation is the proximity to Prairie Creek would constrain the amount of area for the crushing and stockpiling of any large amounts of materials.

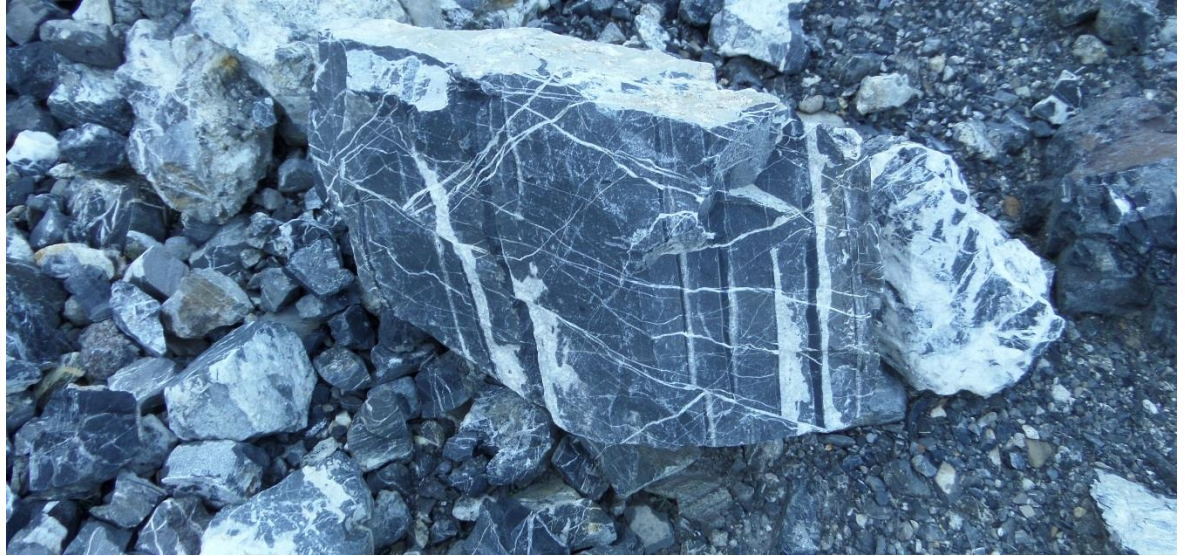
**Figure 2: Close up of the BP2 mudstone with sparry calcite cementing.**

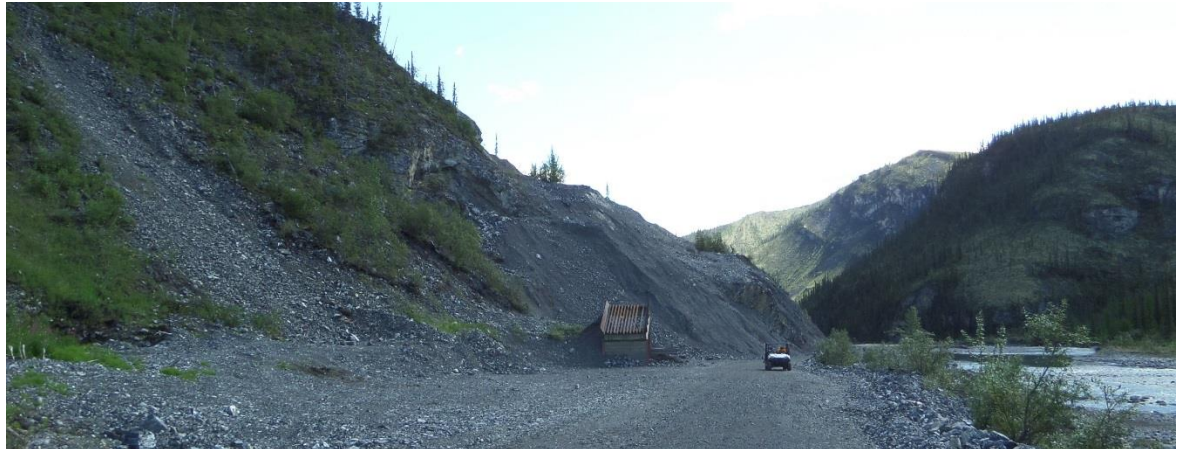
**Figure 3: BP2 viewed from the north and showing the limited processing area available.**

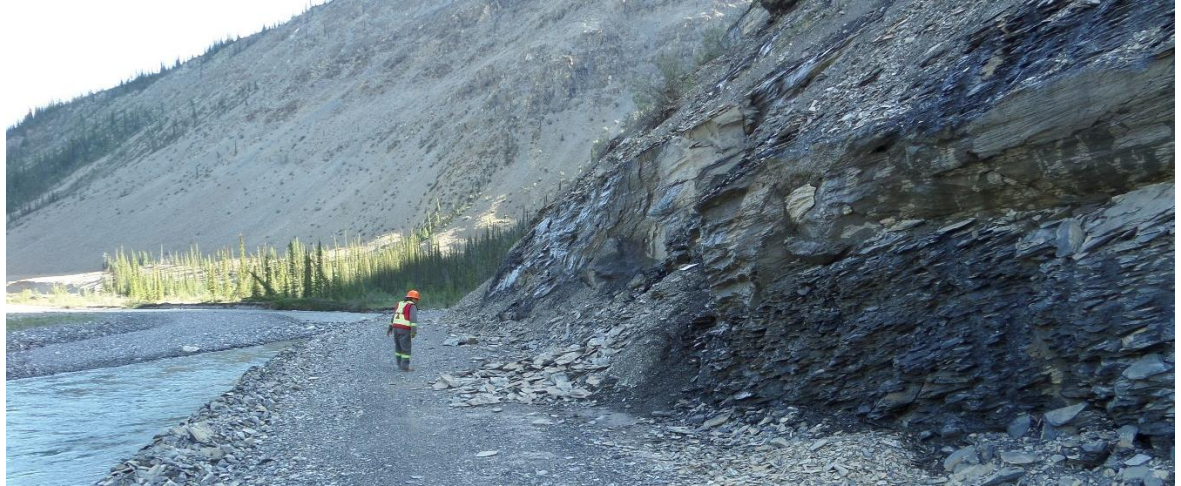
**Figure 4: The rockfall hazard at 4.01 km may generate a large quantity of waste rock that could be used to supply subgrade borrow needs elsewhere nearby.**

While the rock source at 4.01 km is not a preferred material source, there may be a large quantity of this material removed as waste rock in the building of the final road along this section. The material consists of a tall face of limestone/mudstone that may present a rockfall hazard to the present road location. In the event that this rock face has to be excavated back further, large amounts of waste rock will be generated and this material could be used to supply any anticipated borrow needs in the general area. It is anticipated that this material is more suited for subgrade construction than for surfacing material as it fractures quite easily and doesn't appear to be very durable in nature. Again, the close proximity of Prairie Creek will be a constraint to any processing or load out operations proposed here.

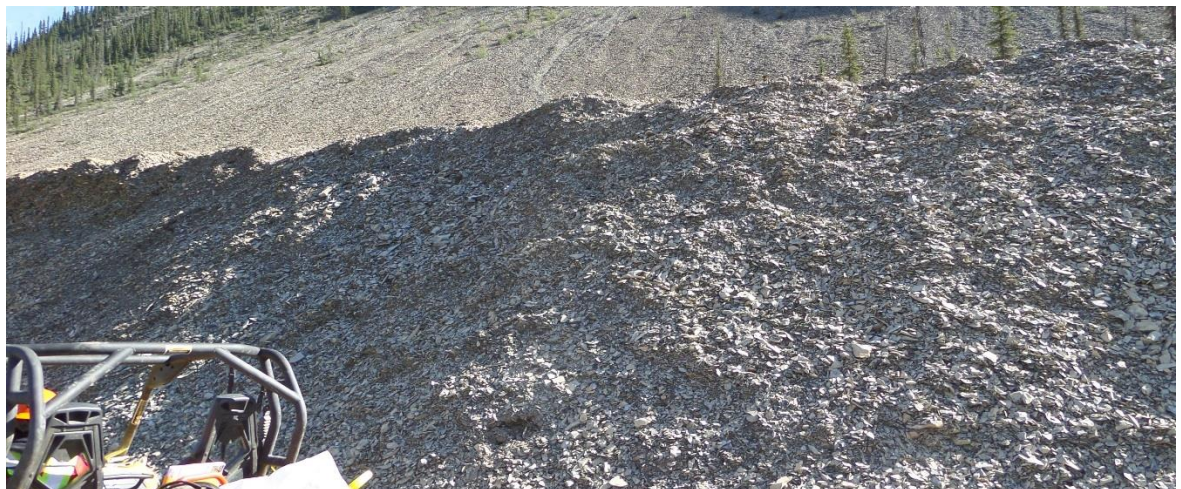
**Figure 5: The currently developed face of the colluvium talus slope at BP4B.**

Slightly further up the road route from the BP4A location is the site of a developed colluvial limestone/mudstone source that has been designated BP4B. This is basically a large talus slope that abuts to the current roadway, presenting a perfect natural source of shattered rock materials. It appears to result from the same parent rock as in BP4A, but the fragment sizes are much smaller in the colluvial slope. Again, this material seems more appropriate for subgrade construction material than for surfacing material due to its weak plane structure. In terms of ease of development for a talus source in the general area, the BP4B source is very straight forward operation – basically it appears ready to load out as it currently sits. However, if the slopes in the area of BP4A need to be trimmed back due to rockfall issues, then it makes sense to use the BP4A material for borrow instead since it will already be loaded into trucks for removal.

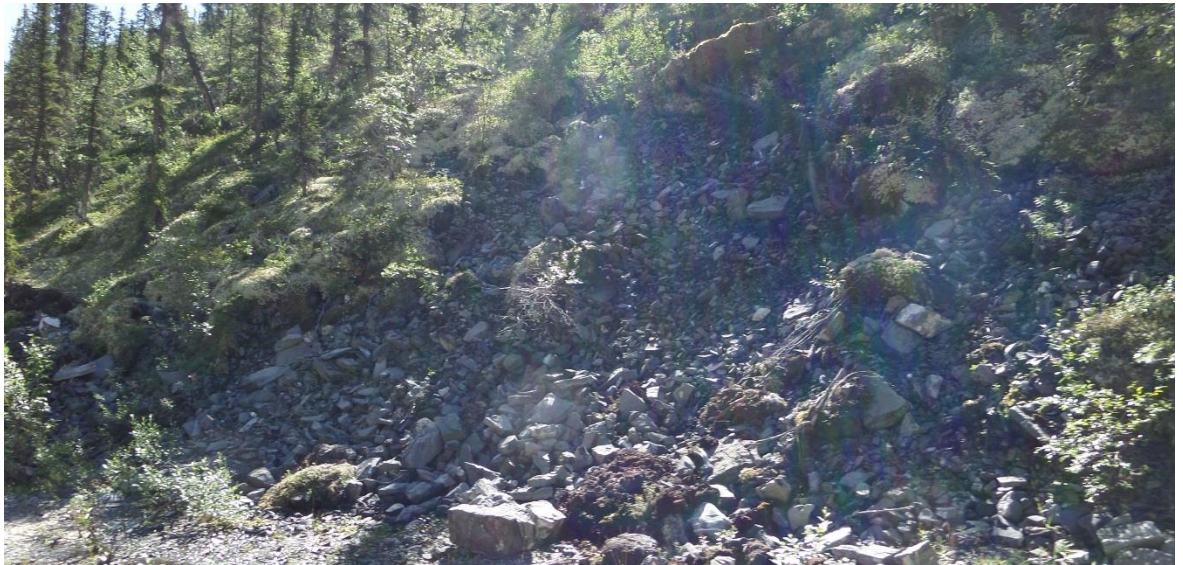
**Figure 6: BP10 material showing a wide size gradation. Also note some evidence of creep along the slope – this is assumed to be related to permafrost.**

Bp10 is a potential source of black argillite colluvium exposed in a slope alongside the roadway at 10.02 km. This material evidently extends for several hundred meters along the road here, but permafrost might be a strong possibility in the slopes as they are located on a northern aspect. Based on the material evident in the surface exposure, any permafrost in this slope may be ice poor, but it may still be a stability factor due to slow creep within the steep slope. The material in the slope does contain some competent looking large fragments that may serve as light to medium sized riprap. Riprap will be needed in this section of the road route, and along adjacent sections as well, to help manage stream flow adjacent to the roadway. This source contains some of the largest and most competent fragments noted on the western end of the road route. Planning for permafrost prior to any development is recommended.

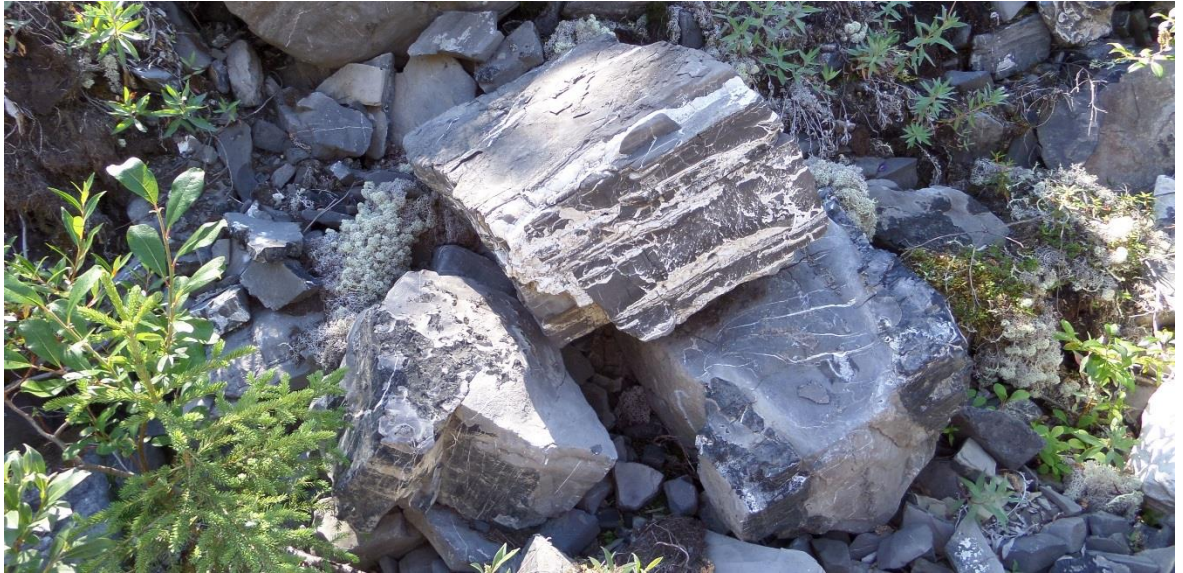
**Figure 7: Some of the potential light riprap material noted in the BP10 slope.**

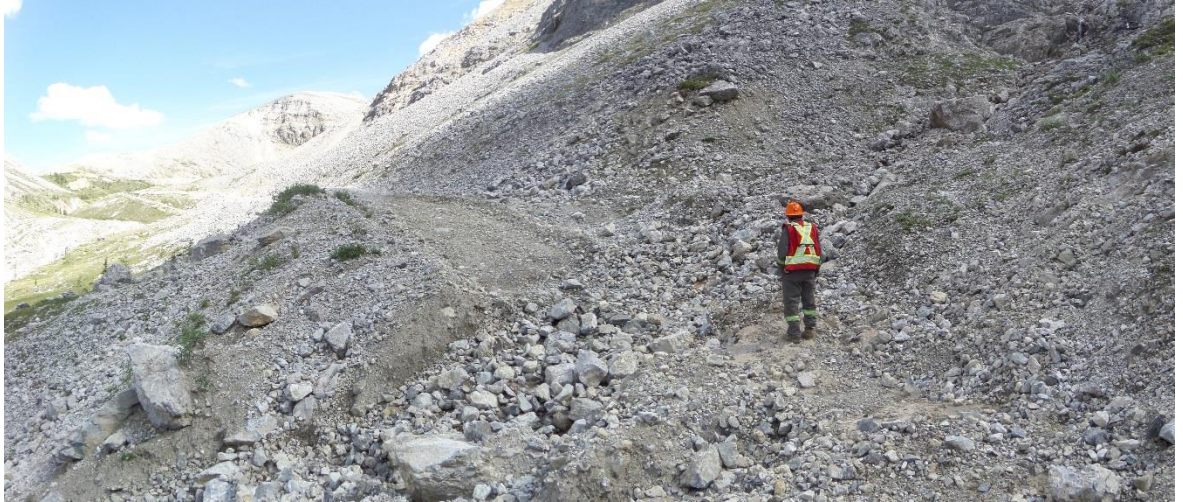
**Figure 8: The limestone talus slope at 14.88 km (BP14).**

Bp14 appears to consist primarily of a limestone talus slope along the road corridor in a high mountain pass at 14.88 km. The gradation of the material is generally toward fragments of less than 0.3m, but some occasional embedded boulders within the matrix could be used for medium to large sized riprap. This talus slope is derived from limestone bedrock, making it an ideal construction material as it poses no risk of acid drainage – it is actually an acid neutralizing material. At this location, the potential borrow pit material is best suited for either subgrade fill or riprap, as the ground is too steep to accommodate a crushing operation for road surfacing material. BP 16 may offer better opportunities for setting up a crushing plant if required. This rock would likely create a superior surfacing material for the new road as it should be quite durable in nature and pack extremely well. The light color of this rock helps reduce solar heat absorption as well, making it a preferred choice if there is a need for filling over permafrost areas to help keep the ground insulated.

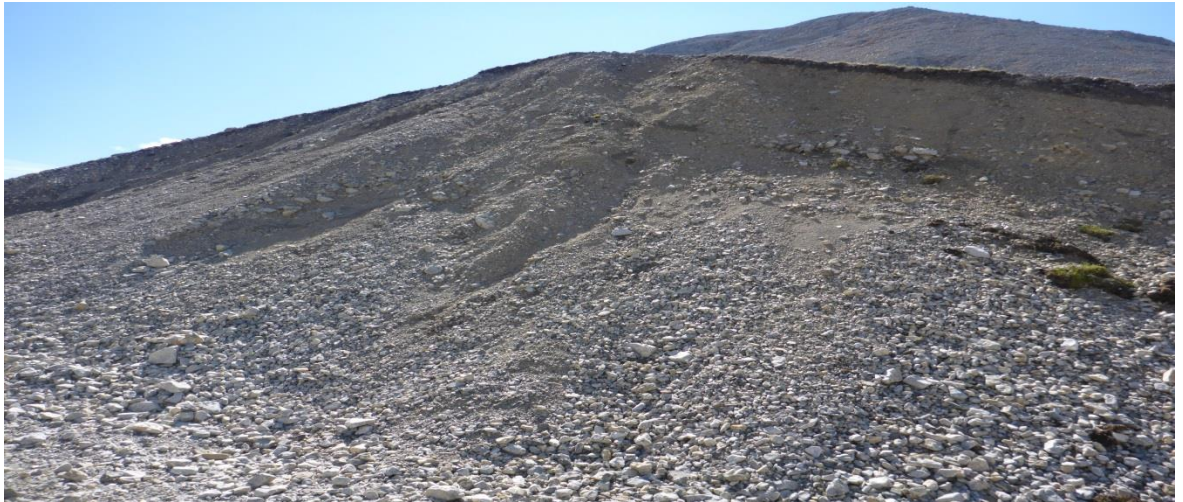
**Figure 9: Large esker like deposit of glacial-fluvial gravel at 15.8 km.**

A large esker like deposit of limestone gravel left behind from the glaciers. Appears to be a large quantity and quality should provide enough room to accommodate a crush plant but it may be tight.

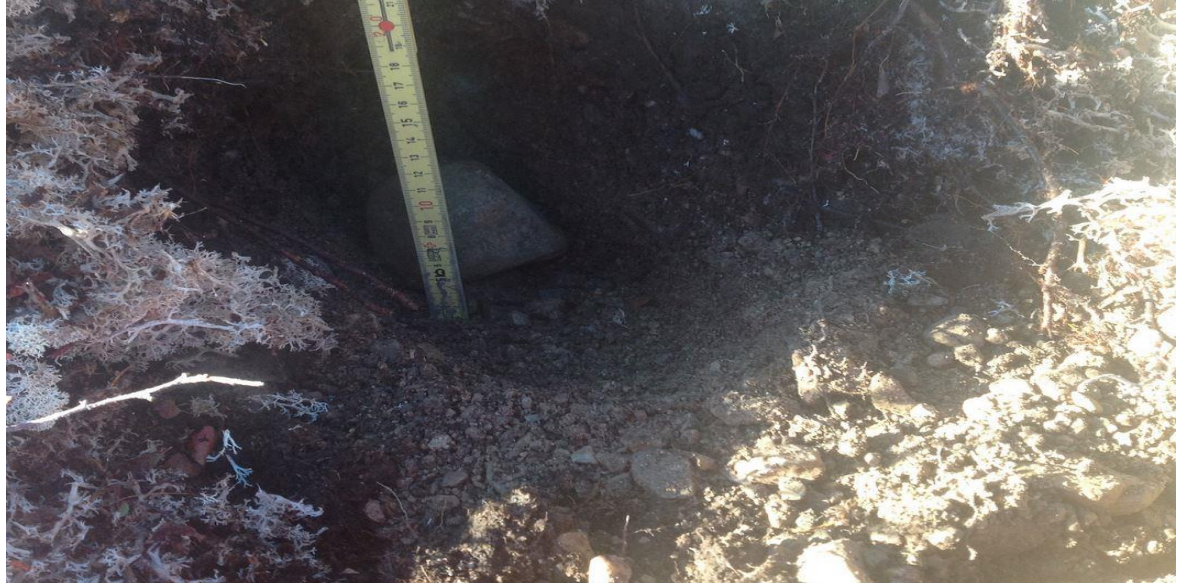
**Figure 10: Large esker like deposit of glacial-fluvial gravel at 15.8 km.**

A large esker like deposit of limestone gravel left behind from the glaciers. Appears to be a large quantity and quality. If required, should have adequate room for a crush plant.

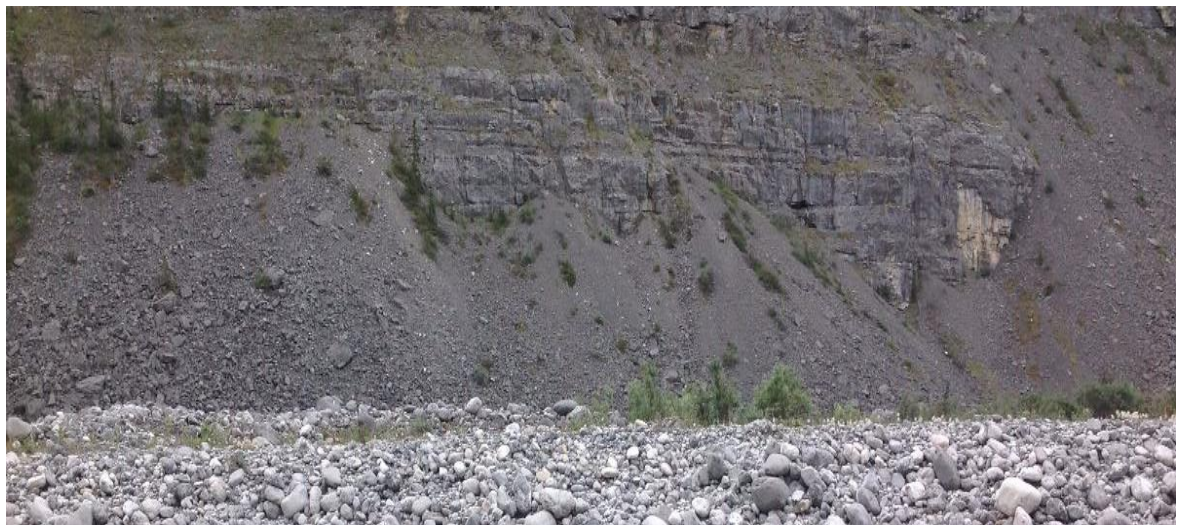
**Figure 11: Large talus rock deposits along a number of locations of the lower Sundog Creek between Km 33 to 39.**

All similar large fragmented talus rock deposit found along the lower Sundog Creek parallel to the proposed road location. Will work well for the proposed road construction approach along the lower sections of lower sundog.

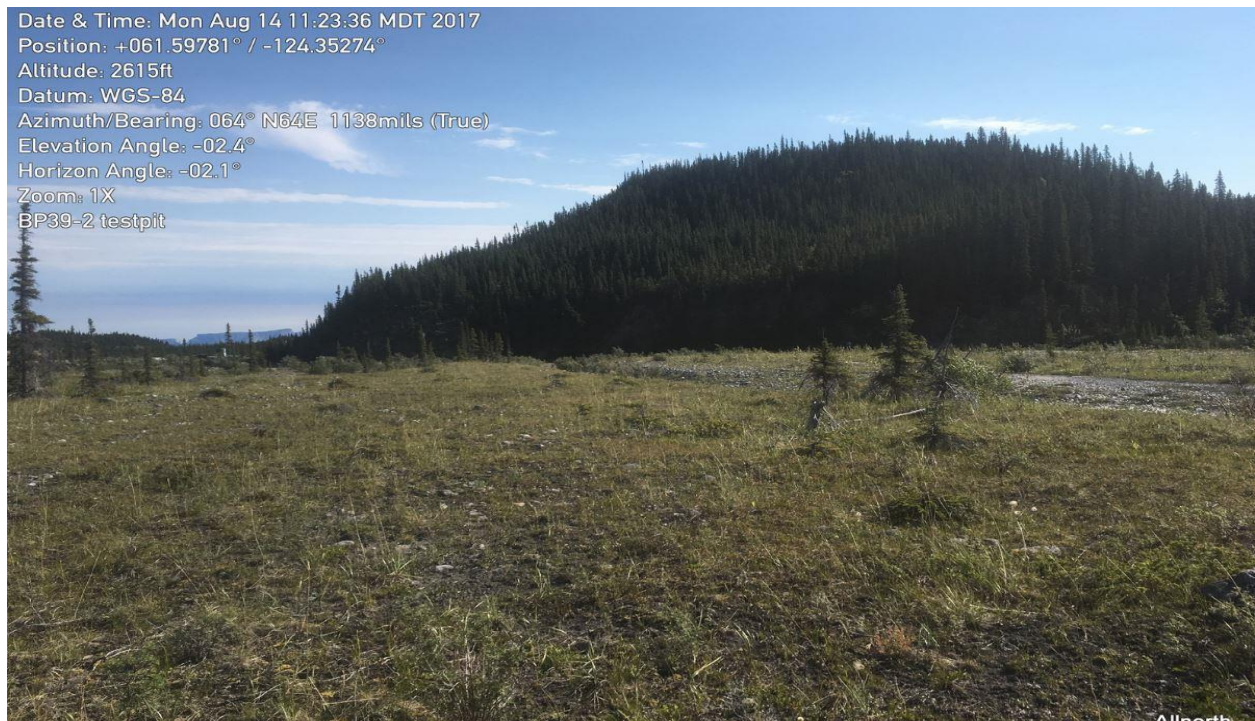
**Figure 12: View of BP 39A looking east.**

The original BP 39 (DAR 2015) has been split into two smaller borrow areas, 39A and 39B. BP 39A area was shifted to the outer extent of the original BP 39 area on a fully vegetated old alluvial floodplain along Sundog Creek. This re-defined borrow pit location offers a greater buffer distance from primary Sundog Creek channel and occupies an older portion of historic Sundog floodplain. The borrow material consists of washed carbonate materials (limestone/limy siltstone) that make for a preferable construction material. This light colored, durable, and non-acidic cobble and gravel would be a preferred material for use at many places within the project area because of its properties. It could be processed by crushing and screening into a highly durable, long-term road surfacing material for construction and maintenance purposes. The material is extremely free draining and its light color would not absorb much solar heating so it would assist in insulating fill material over permafrost zones (if required). Because it is situated on the fringe of an old alluvial wash channel, there is a good likelihood that this material is free of permafrost as well. The large flat here is also advantageous for operating a crushing plant and for stockpiling crushed materials until they can be applied to the road. Since the area may be subject to a fluctuating water table (as controlled by seepage from nearby Sundog Creek), any gravel excavation would need to be carried out during periods with a low water table.

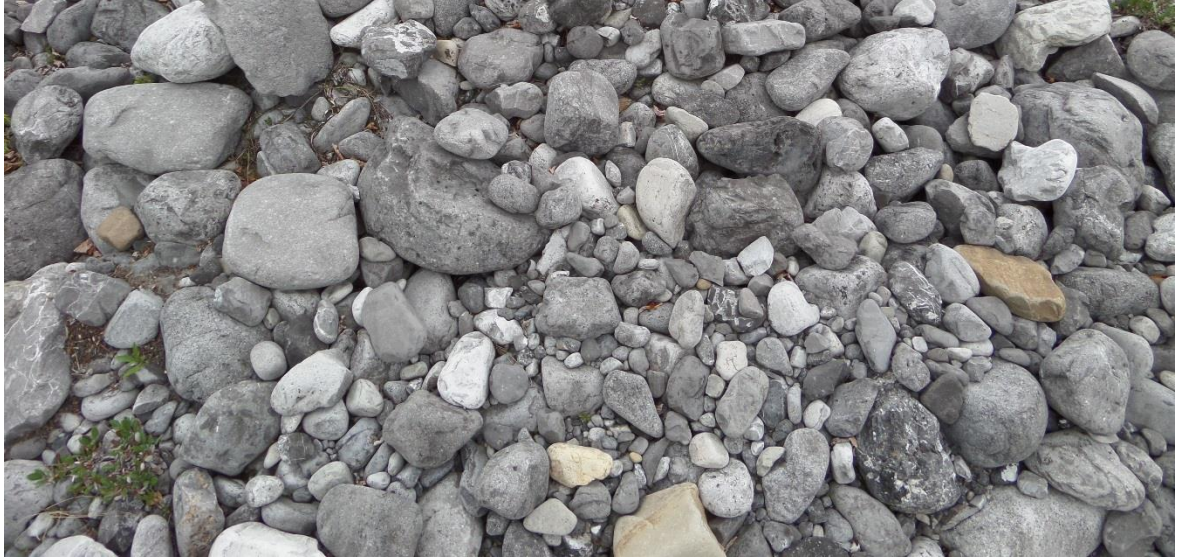
**Figure 13: Typical gravel and cobble material available at BP39A. This material consists primarily of Paleozoic carbonate rocks as evidenced by the abundance of fossilized coral fragments throughout the aggregates.**

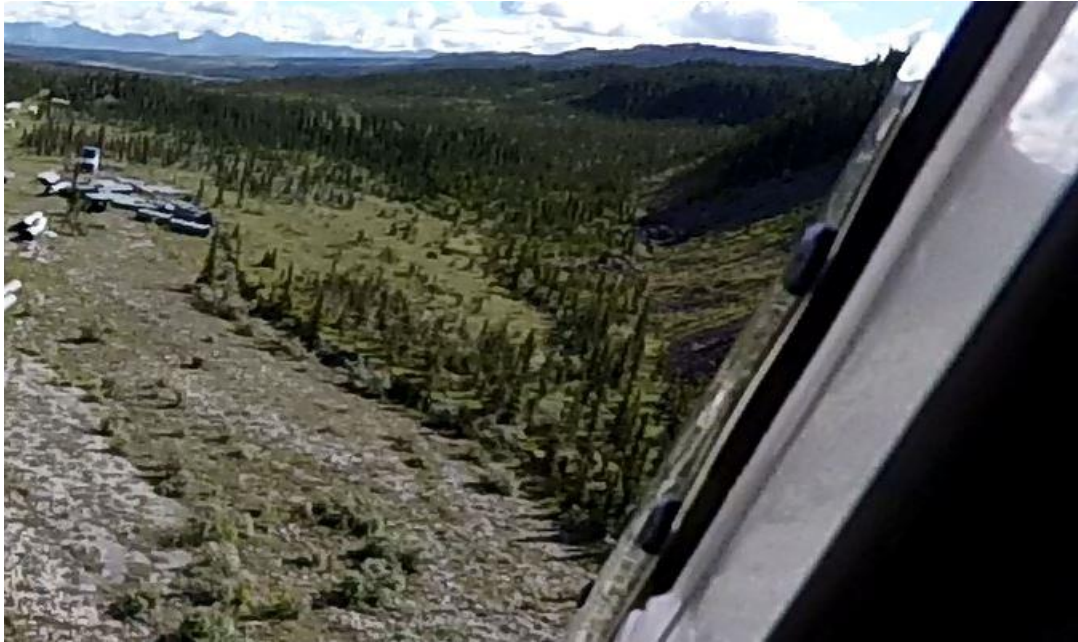
**Figure 14: View of BP 39B on right side of photo, with the original cat camp in the background.**

BP39B consists of a large talus rock face. This borrow offers a source of both colluvium and solid rock limestone for road development needs. These raw materials could be used to generate construction materials ranging from crushed surfacing materials and subgrade rock fill, to riprap for armouring. Geologically, this area consists extensively of carbonate based bedrock so all the materials available for borrow here should be acid neutralizing materials.

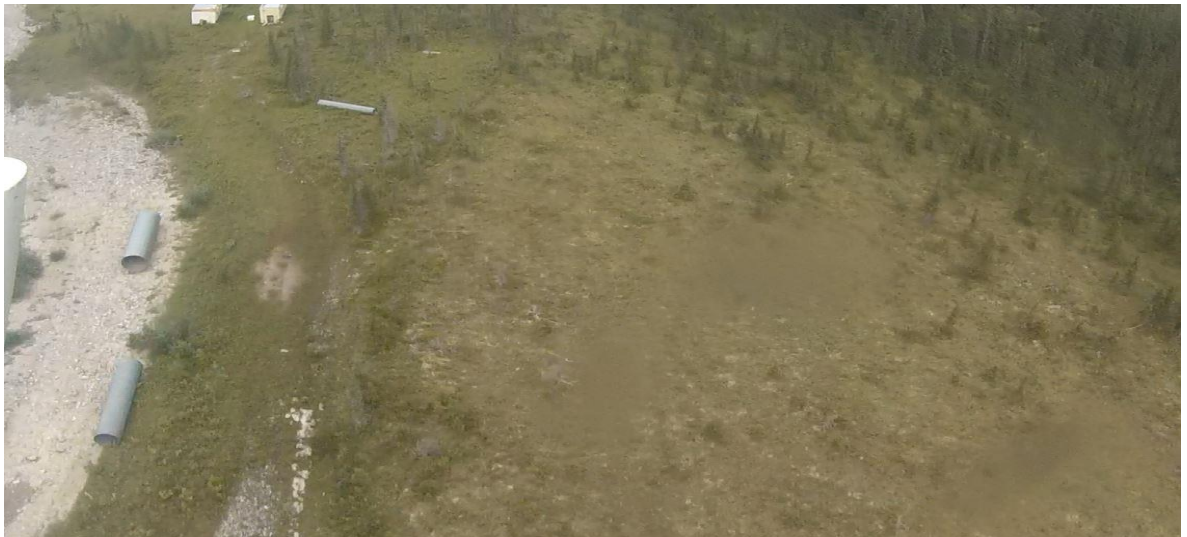
**Figure 15: Old flood plain of Sundog Creek utilized as a camp/laydown area (Cat Camp) from the 1980 winter road construction.**

Similar deposit as identified at BP 39, an old floodplain of Sundog Creek. Perhaps more attractive than BP 39 because closer proximity (1 km) to the intended destination. Expect it to be a shallow depth as to not compromise the water table. Ample room for crushing plant.

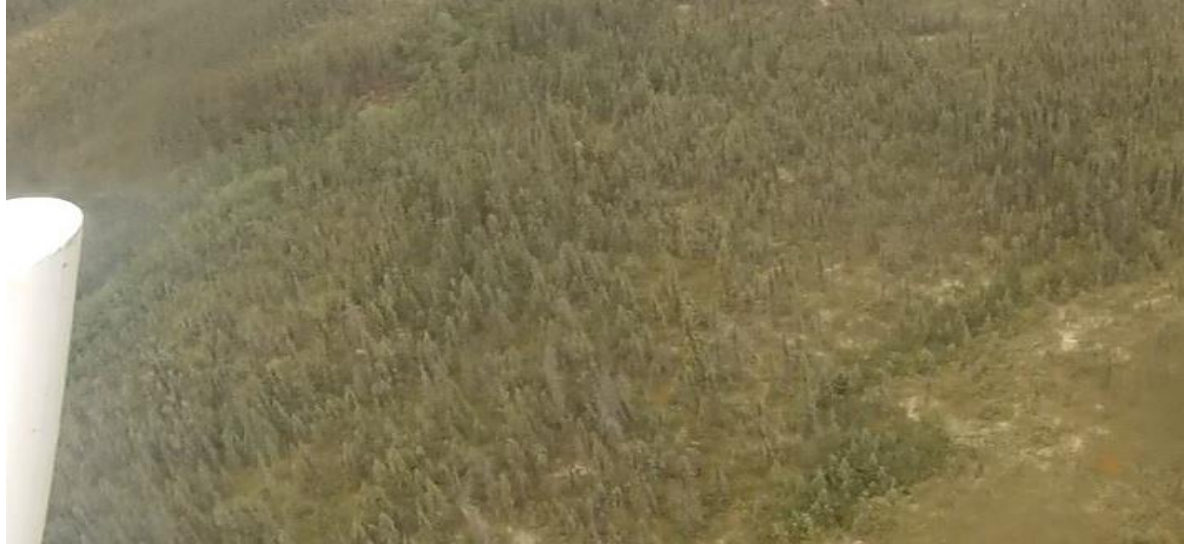
**Figure 16: An aerial view of an elevated “hump” of expected silty sand which should provide adequate base material to support overland sections.**

Not field confirmed but expecting similar material type that was consistently observed in the surrounding area. Should provide adequate base material for subgrade material for expected localized overland sections. Expect shallow pit depths of 2 m.

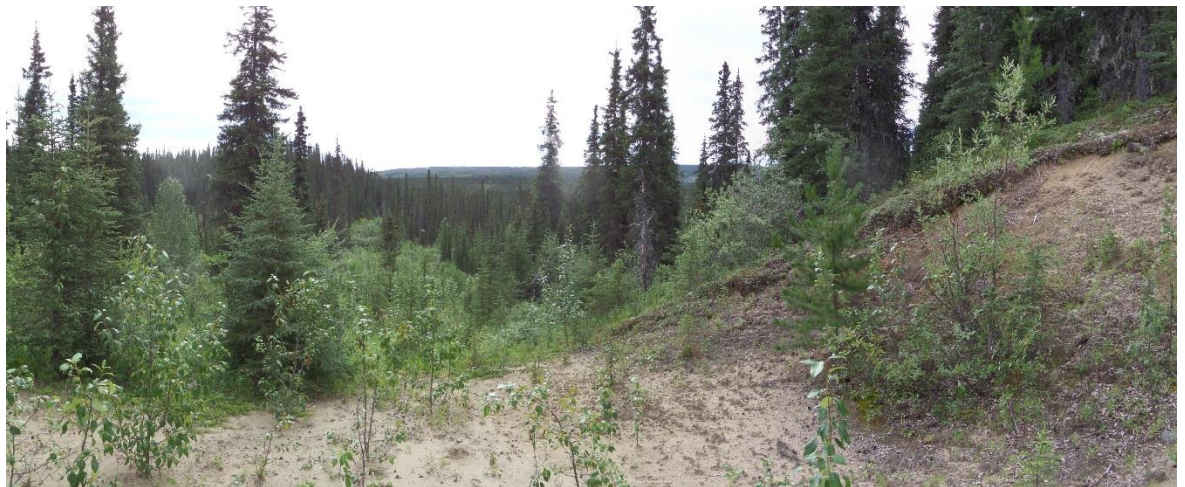
**Figure 17: View of the existing cut for the past winter road across the end of the esker at 42.6 km.**

At 43.15 km a small esker of fine sand (BP43A) is crossed by the road route. This esker runs in a westerly direction from roadway, and could be developed as a long-term source of sand for winter road sanding and for pipe bedding material during construction. During construction, this sand deposit could also be used for free draining road fill across lowlands.

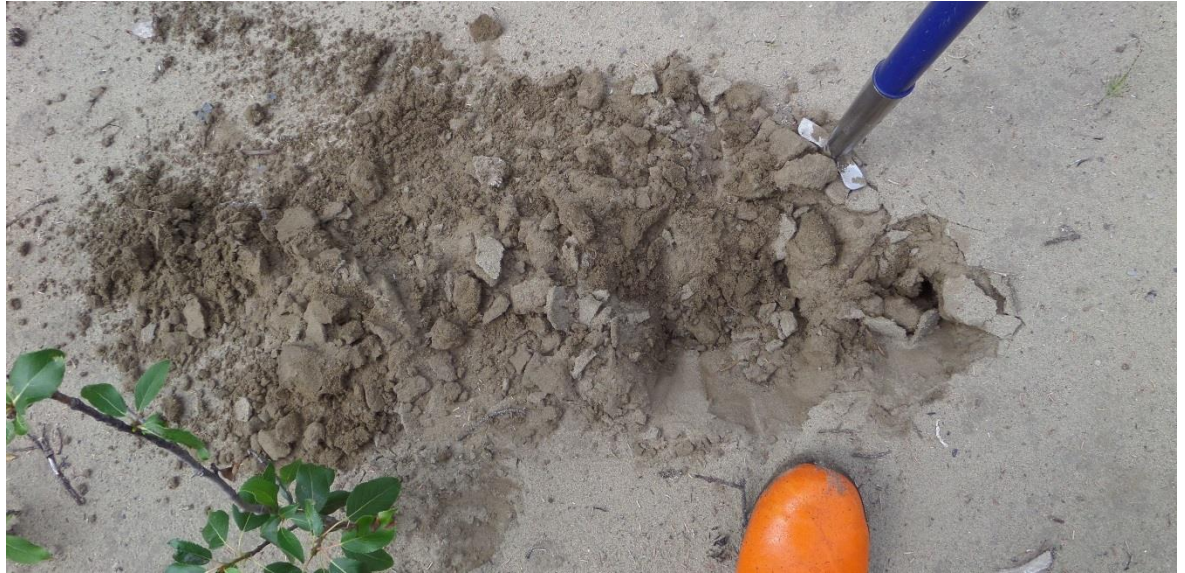
**Figure 18: Example of the fine sand in the esker source designated as BP43.**

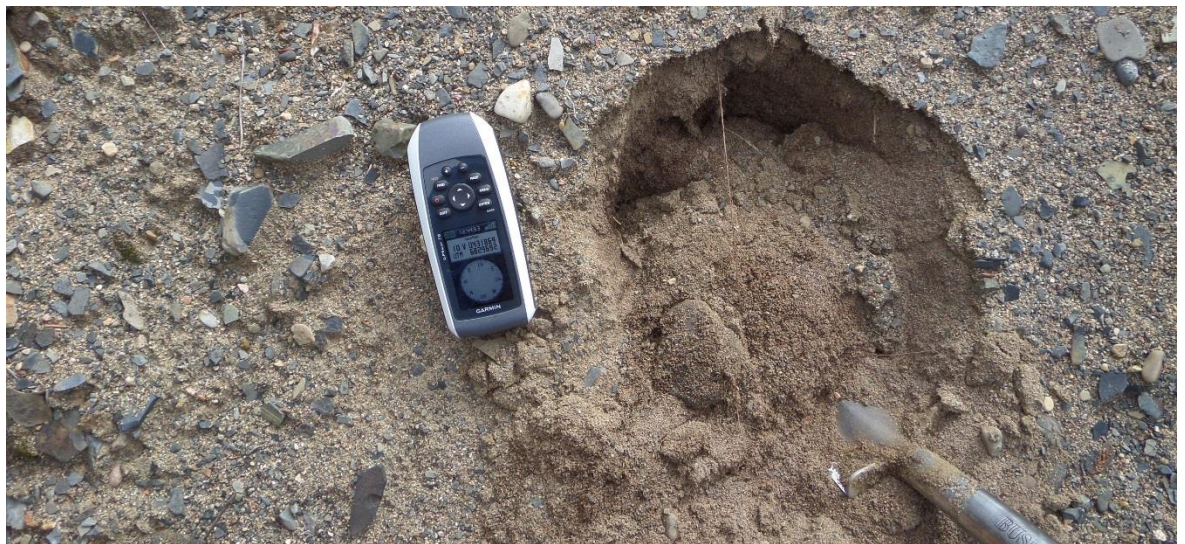
**Figure 19: View of the sand material in the original construction borrow at 43.2 km.**

BP43B is situated at 43.65 km and covers an area containing an existing borrow pit of medium sand from the original winter road construction era. While this particular area has been designated as the borrow site, the sand deposit itself runs from approximately 43.5 km to 45.75 km. As with the BP43A site, this sand has potential for pipe bedding, winter road sanding, and for subgrade fill across lowland areas. The material in BP43B grades a little coarser than the material in BP43A, so it may be a bit more appropriate for lowland fills where the pumping of groundwater into the subgrade may be a concern.

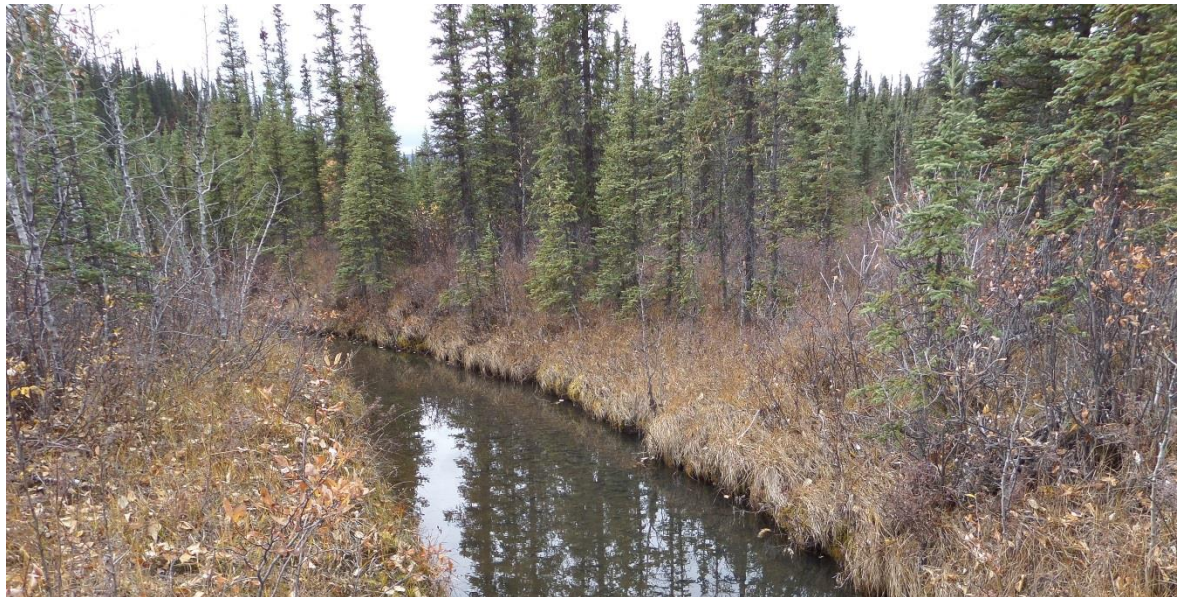
**Figure 20: The small stream that would need to be crossed to access BP47A and BP47B.**

BP47B is situated south of 46.5 km and a potential borrow source consisting of alluvial gravel deposits (carbonate based) with an exposed bedrock limestone face on west boundary. A short 400m access road with a stream crossing is required. The stream within the valley is seasonal and appears to be dry except for during the higher spring runoff periods when it briefly avulses and deposits gravels across the broader floodplain. As such, this deposit is similar to that of BP39, and the depth of excavation could be controlled by a fluctuating water table. There is also a possibility that the low level water flows are carried underground in subterranean channels within the limestone bedrock. This borrow source will be developed and operated in winter periods.

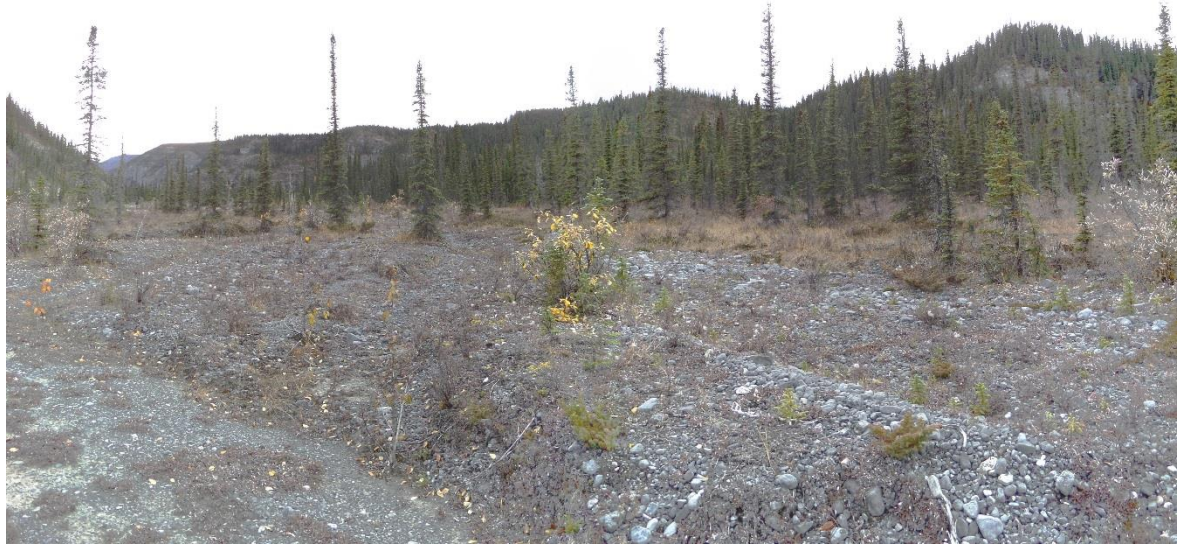
**Figure 21: View of BP47B alluvial deposit area.**

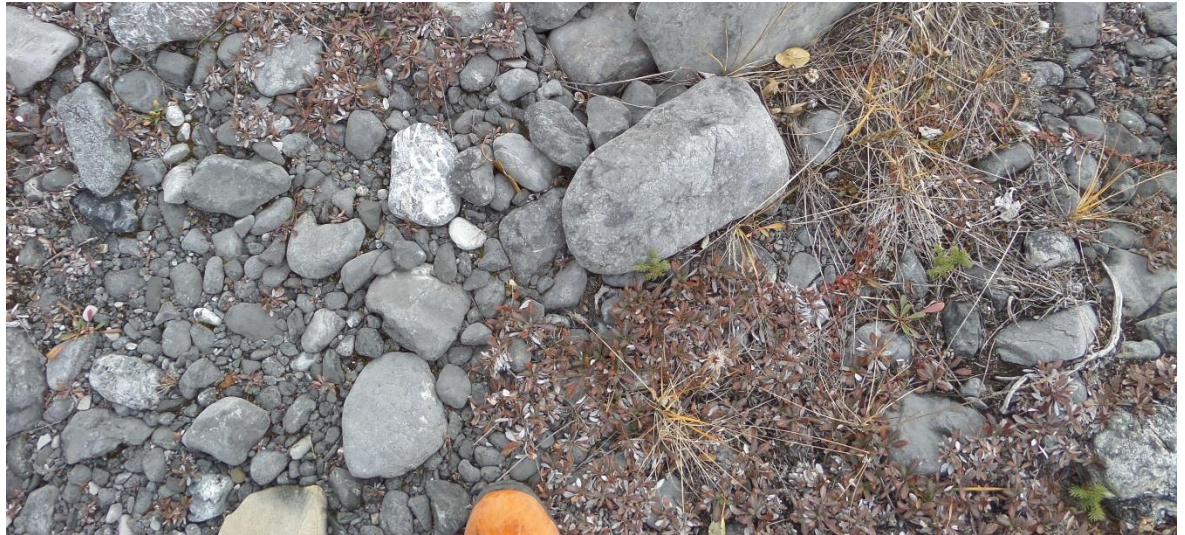
**Figure 22: Typical BP47B alluvial deposit materials derived from carbonate parent rock.**

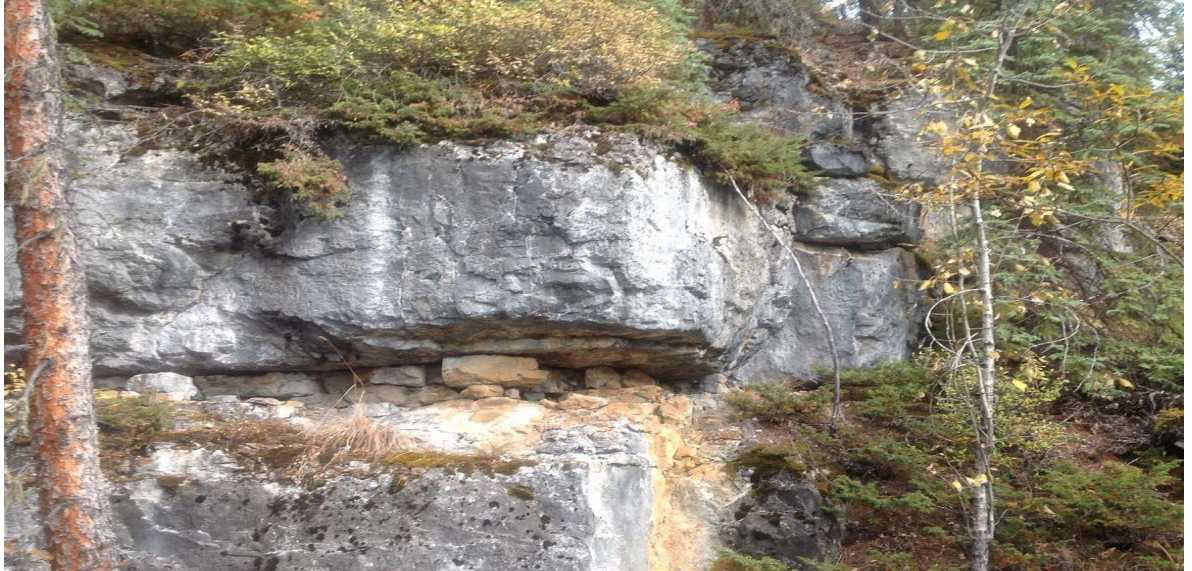
**Figure 23: Exposed rock face adjacent to the proposed road at KM 47.2.**

Assumed a similar rock formation as identified in BP 47A however is adjacent to the proposed road location so more accessible.

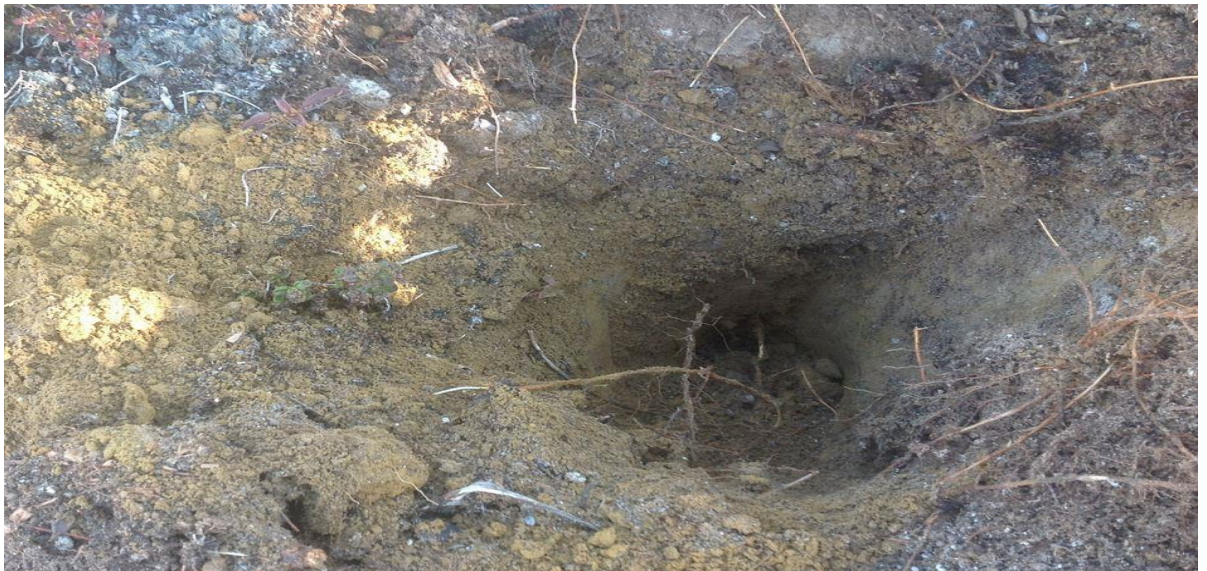
**Figure 24: An example of the fine sand material found near BP 50B.**

Could be easily expanded and would provide adequate material for localized overland sections.

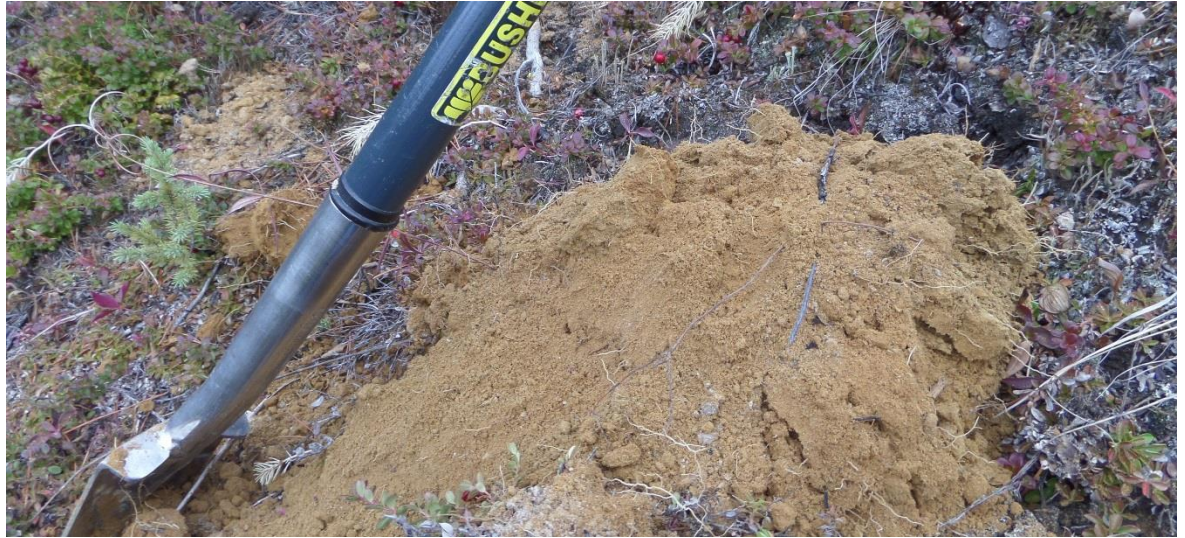
**Figure 25: The fine sand in BP50 is potential fill for crossing over nearby lowlands.**

BP50 is part of a broad area of fine sand found between 50.88 and 51.75 km that could be used for subgrade fill over the wetter lowlands in the area. These lowlands present relatively deep organics and potentially permafrost at depth. This material provides free draining

borrow, but it is also quite fine and it would have to be capped with coarser materials to protect it from potential surface erosion after construction.

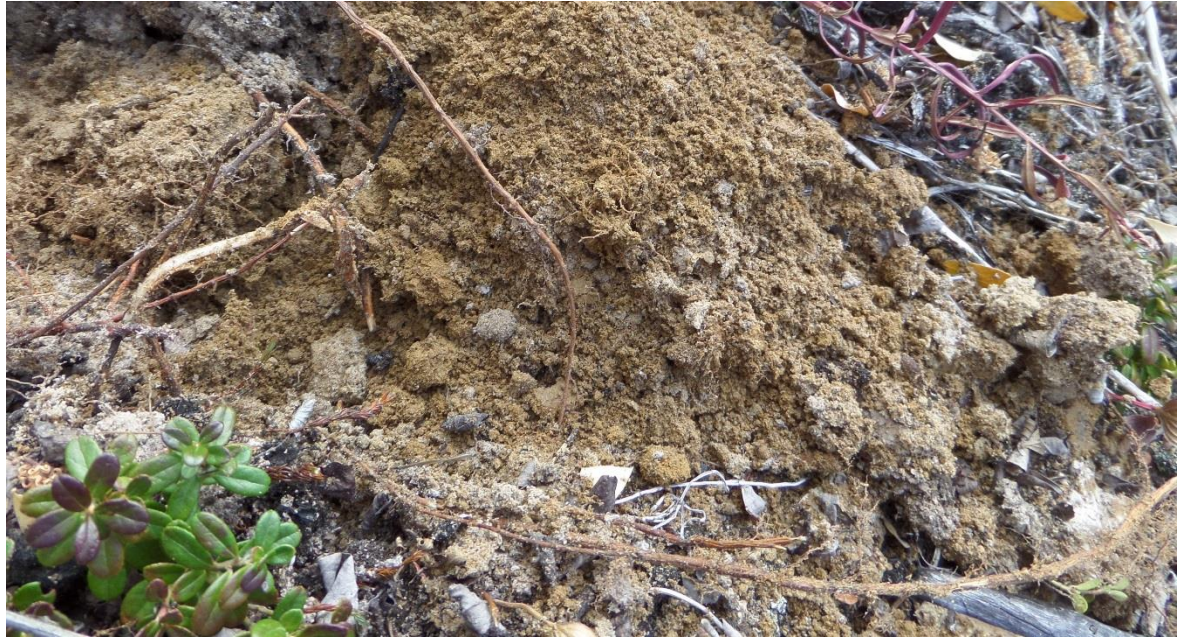
**Figure 26: The fine sand in BP51 is a potential overland subgrade borrow source.**

BP51 is part of the same broad sand deposit that BP50 is situated on, but BP51 is located strategically on the west end of a wide lowland with deep organics that the road must cross. This lowland area, possibly with permafrost under it at depth, must be crossed using overland construction techniques to build the subgrade. Overland construction involves “floating” a roadway across areas with deep organics by leaving the organics undisturbed and covering them with a thick layer of imported free-draining material taken from suitable borrow sources. BP51 would provide a suitable borrow source on the western end of the long overland section running from about 51.75 km to 52.95 km. As with BP50, this sand is quite fine and would have to be capped with coarser material to control the potential for surface erosion.

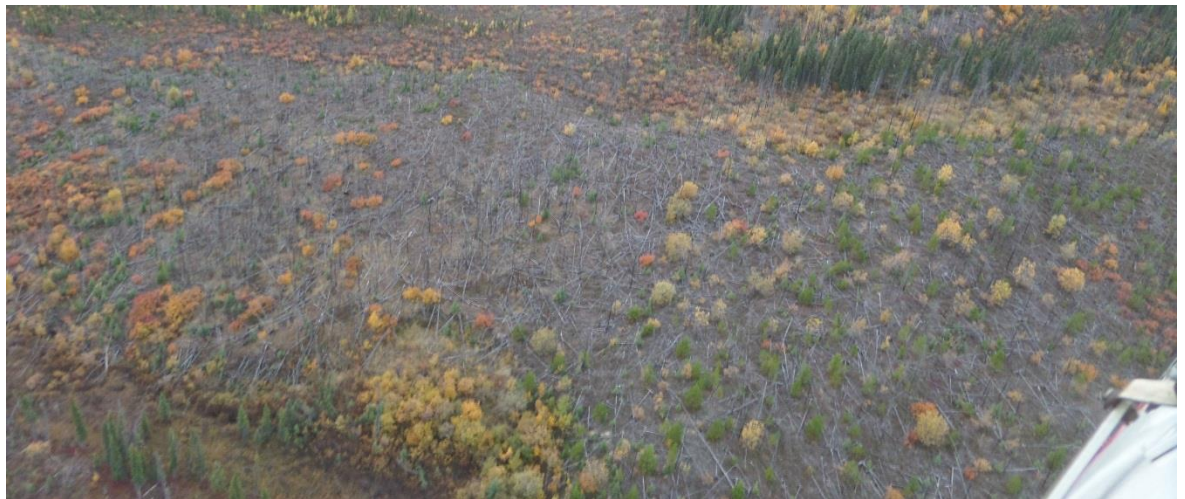
**Figure 27: Aerial view of the BP51 source area – burned area (grey) indicates the sand.**

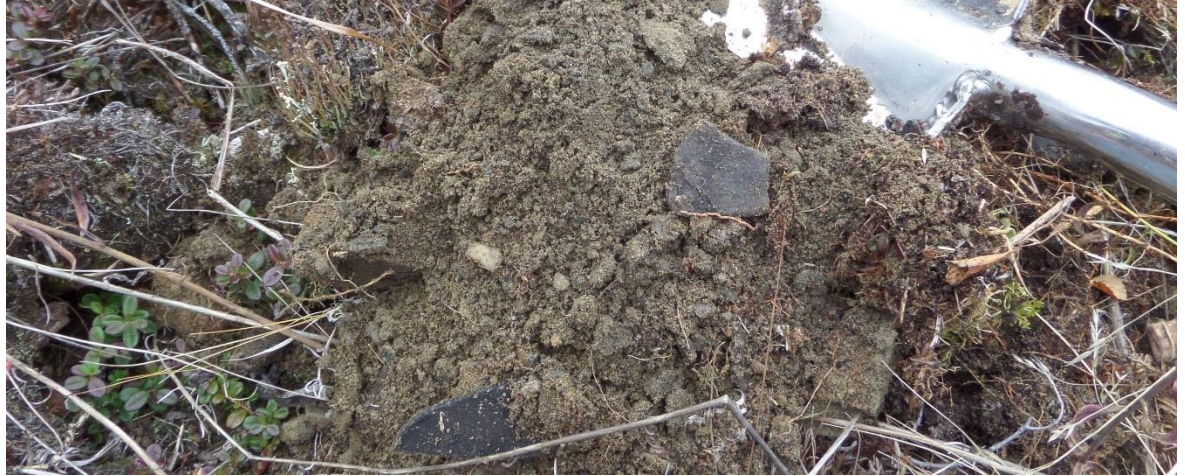
**Figure 28: Fine sand with minor gravel and shale showings in the lower bench of BP53.**

BP53 is located at 53.4 km, slightly beyond the eastern end of the wide lowland area that the road must cross between 51.75 km to 52.95 km with overland construction. BP53 is located on the nose of some benched terrain that juts out on its east side toward Poljie Creek and is bordered by an ancient paleo-channel of Poljie Creek on the north. The upper bench level consists primarily of the same fine sand as was noted in BP50 and BP51, while the lower bench has some slightly coarser sand with some minor gravel and shale fragments. All this material is free-draining and suitable for the overland fill required between 51.75 km to 52.95 km. As with the previous borrow sites in this area, this sand is quite fine and would have to

be capped with coarser material to control the potential for surface erosion. Previous subsurface geotechnical drilling at nearby Poljie Creek also indicated some gravel deposition at depth in this general area, so the lower levels of this borrow area have some limited potential for glaciofluvial gravel deposits as well.
