# **POST-EA INFORMATION PACKAGE INCLUDING AN UPDATED PROJECT DESCRIPTION ALL SEASON ROAD TO PRAIRIE CREEK MINE**

**APPENDIX 1-11: BORROW PIT SUMARRY**

## **APPENDIX 1-12**

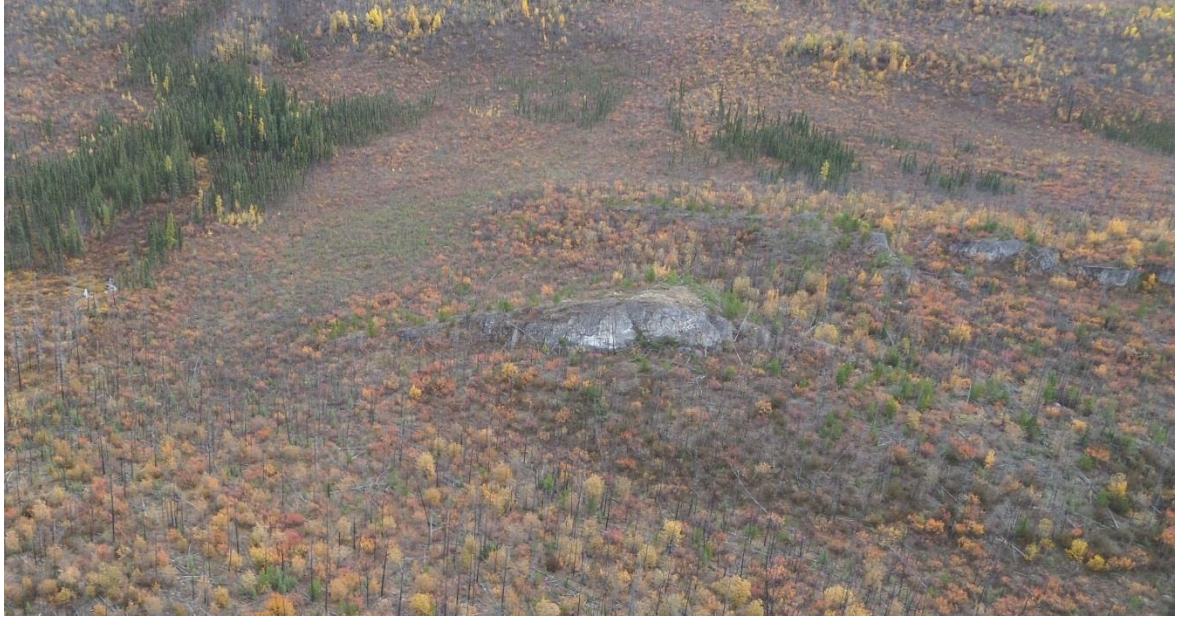
**Figure 29: Aerial view (looking east) of the carbonate rock exposures proposed for BP54.**

At 54.60 km the road route passes in close proximity to the northern end of a chain of carbonate rock protrusions along the east side of Poljie Creek. The protrusions forming BP54 consist of two low, timbered, rock outcrops on the north end of a chain of carbonate exposures that become visually impressive further south where they form karst cliffs and pinnacles overlooking Poljie Creek. While physically connected to this same chain of karst exposures, the BP54 outcrop knobs are very subdued outlying outcrops, with very little aesthetic value evident. They do however provide a good potential source of carbonate rock that could be developed into a needed source of riprap and ballast for construction within the general area. Depending on the depth of the material that can be developed here, there may be enough volume in these exposures to justify a small rock crushing operation to develop superior surfacing for the road and for the proposed airstrip nearby. This rock would also form an excellent capping material for the sand fill proposed for overland construction in the section from 51.75 km to 52.95 km to the west. It would armour the sand fill from erosion and provide a light colored reflective surface to prevent solar heat absorption into the fill should permafrost be present at depth.

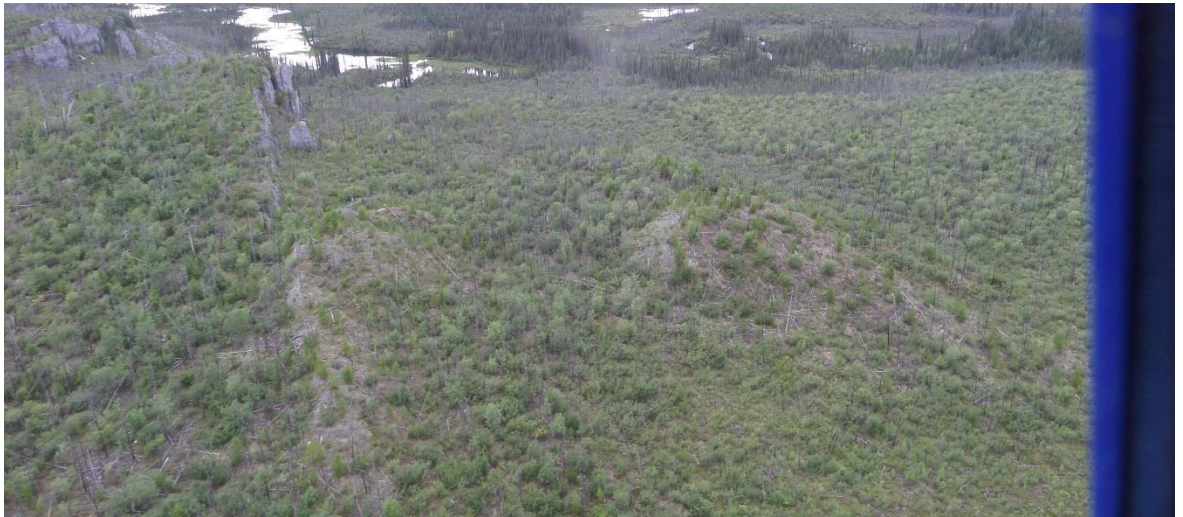
**Figure 30: Aerial view (looking southwest) of the timbered carbonate rock knobs (lower center) proposed for BP54. The more exotic karst formations (upper left) that start further south along Poljie Creek, are not part of the proposed BP54 borrow area.**

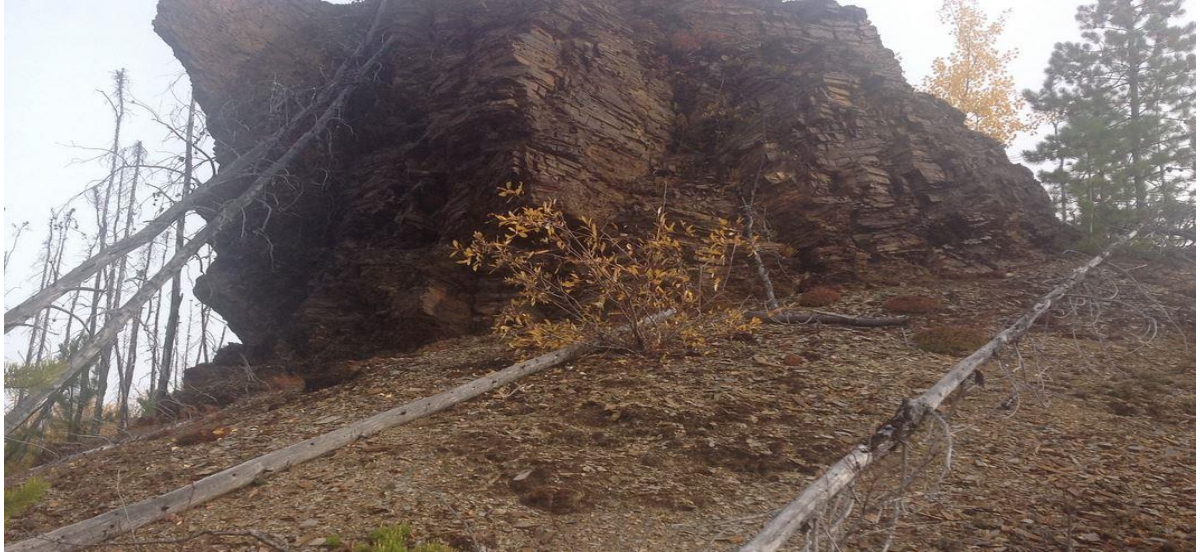
**Figure 31: The fragmented shale rock knob the road passes thru at km 55.3.**

Shale rock knobs comparable to BP 54 however the road passes thru them. Could be utilized for excellent subgrade base over overland sections and/or possibly surfacing.

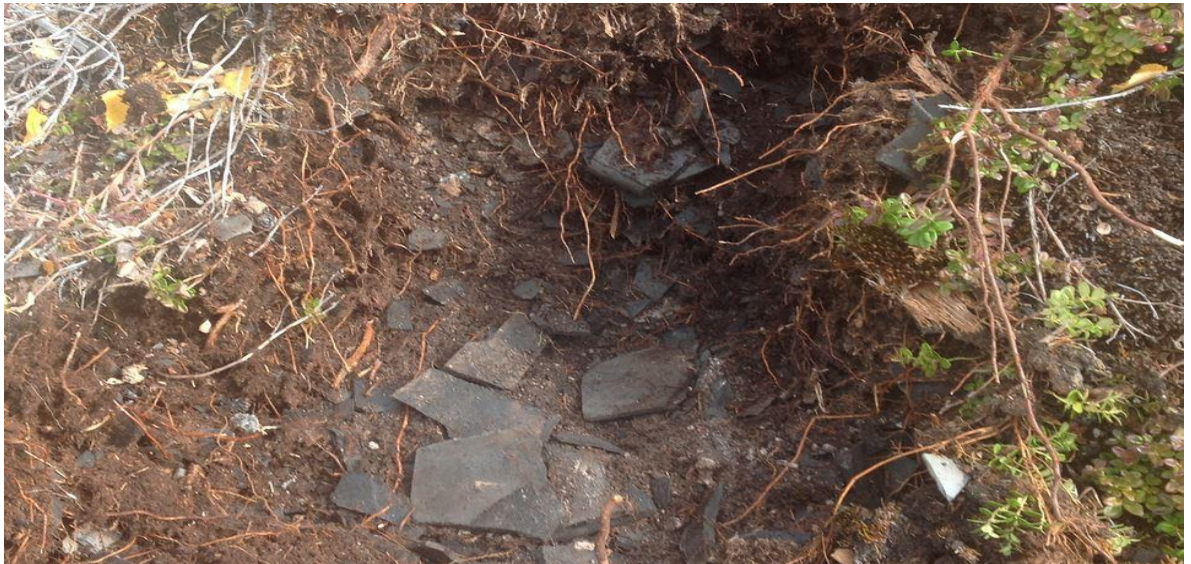
**Figure 32: A large exposed shale rock sideslope near KM 55.9.**

Exposed shale rock knob located along the upper cut-slope of the proposed road. Could provide excellent subgrade material and possibly for surfacing.

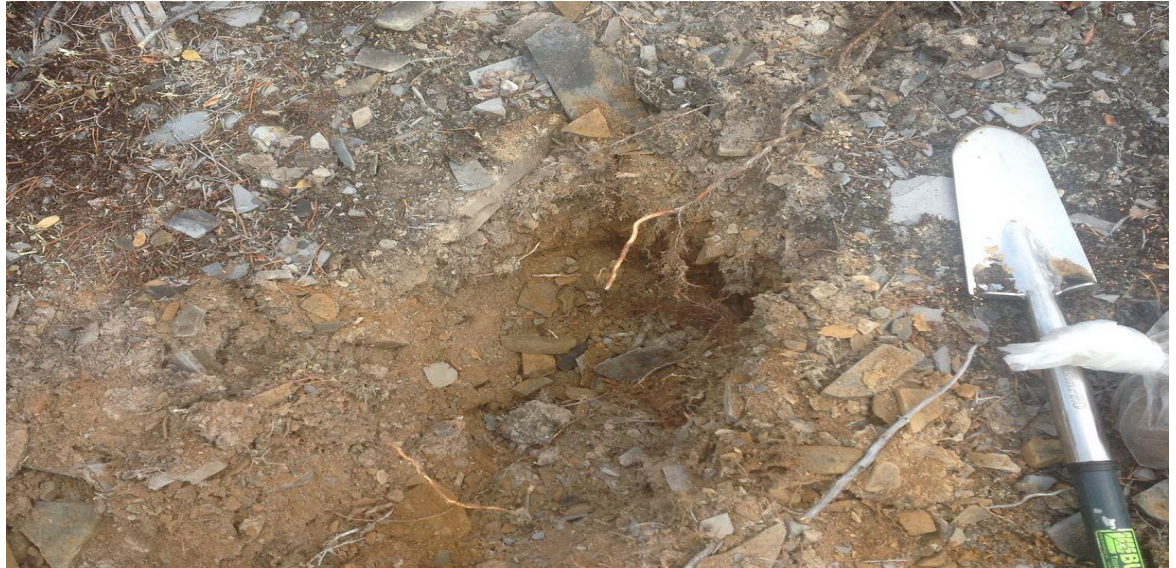
**Figure 33: An example of the shale rock found at Km 56.5.**

Exposed shale rock knob located in close proximity to road location. Could provide excellent subgrade material and possibly for surfacing.

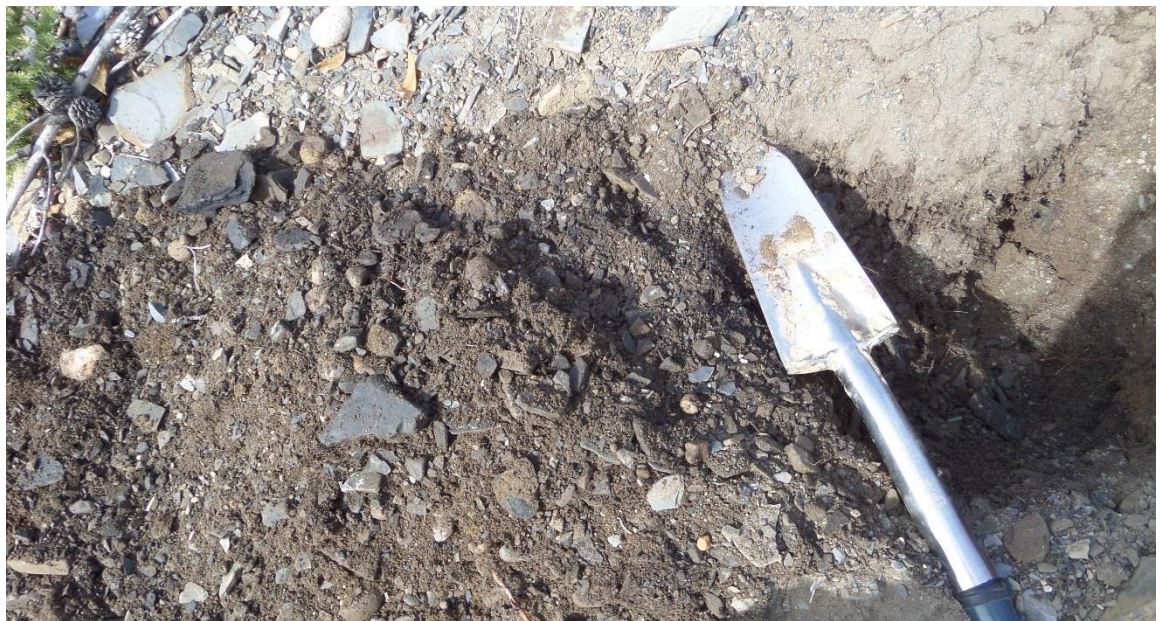
**Figure 34: Shale based sandy gravel noted along the old winter road at 59.1 km (BP59)**

BP59 consists of a shale based gravel deposit exposed in a constructed cut at 59.41 km along the old winter road. The material is fairly sandy but is still one of the better looking glaciofluvial gravel materials noted within the general area. It could be used as a lower durability pit-run gravel source, or for fill for the road or the nearby proposed airstrip. This gravelly material appears in exposures along the old winter road right up to about 59.90 km.

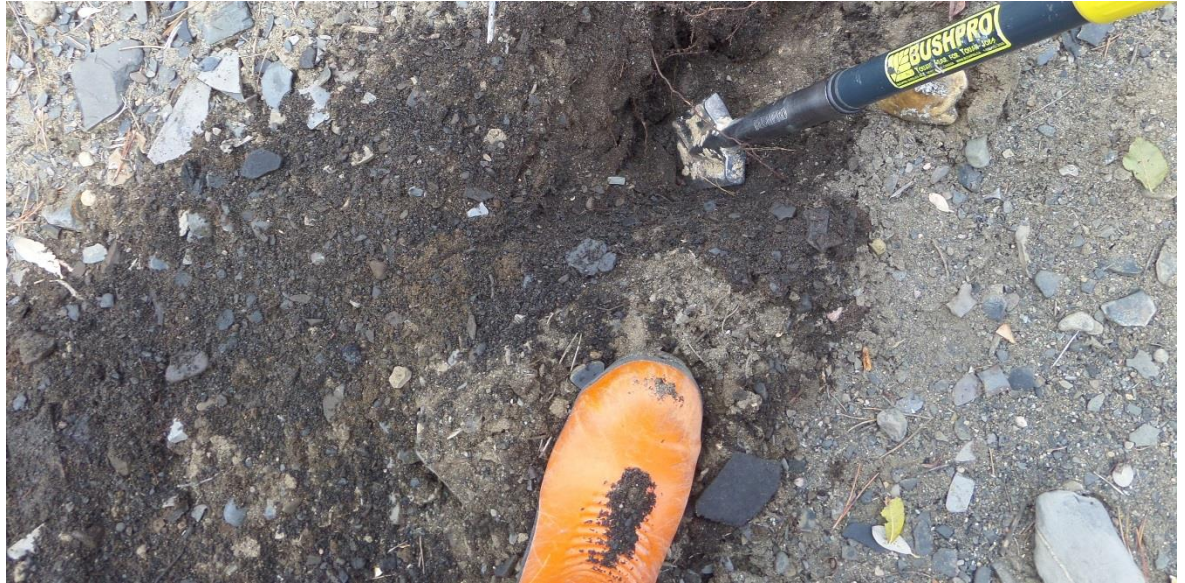
**Figure 35: Similar looking material found along winter road at 59.90 km.**

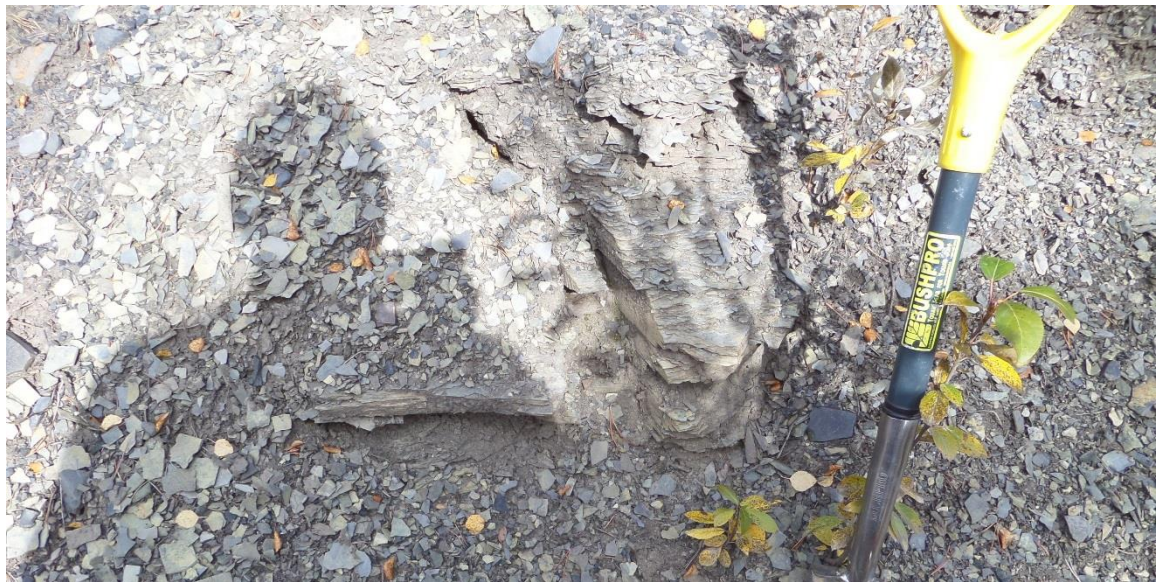
**Figure 36: Fissile siltstone exposure.**

BP61 consists of a siltstone outcrop exposed in a cut along the old winter road at 61.10 km. The material is quite fissile and likely of low durability, but is one of the best construction materials found in this section of finer grained moraine deposits with occasional seepage zones. This material can be used to firm up areas of soft ground and to repair some ditch and shoulder erosion that has occurred on a few steep grades along the old winter road west of this location.

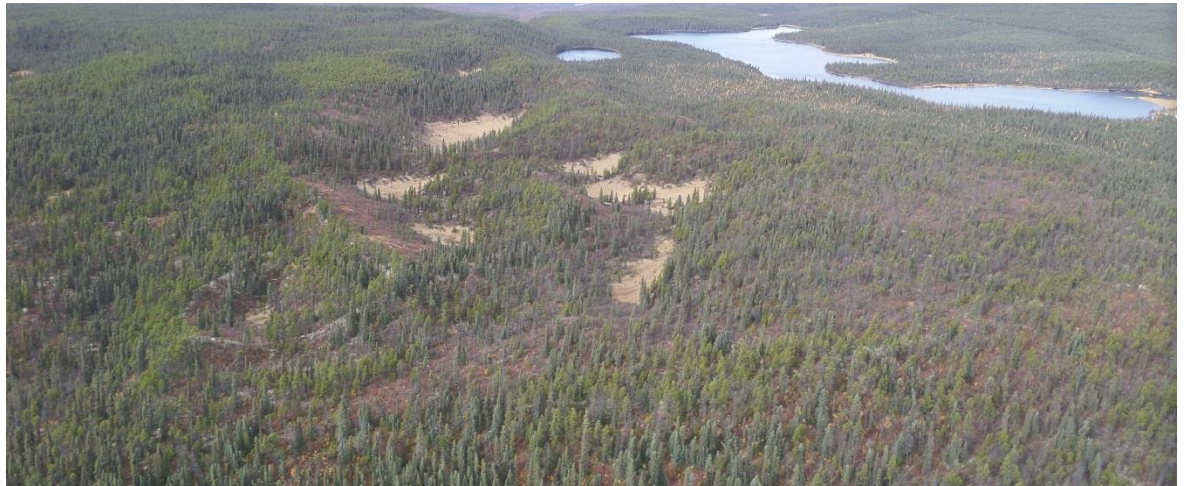
**Figure 37: Overview of major glaciofluvial deposits south of Mosquito Lake (background)**

BP64 constitutes but a small portion of a very large glaciofluvial kame/kettle deposit that is several kilometers in size and situated south of Mosquito Lake. The material contains sub-rounded sedimentary rock fragments in a matrix of silty sand that would pack well for road surfacing and may even have some natural dust control properties. The potential gravels here are quite deep and additional sampling at depth would be needed if it is necessary to confirm suitable gradation throughout. The BP64 location is situated about 400 m west of the planned road route, and has the best looking gravel from multiple sampling locations taken along the nearby esker chains. This area could be developed for gravel pit purposes with a short section of easily constructed access road across well drained soils. If however, the quantity of materials at BP65 are proven out by deeper test excavations, then it would be simpler to develop those material directly along the roadway.

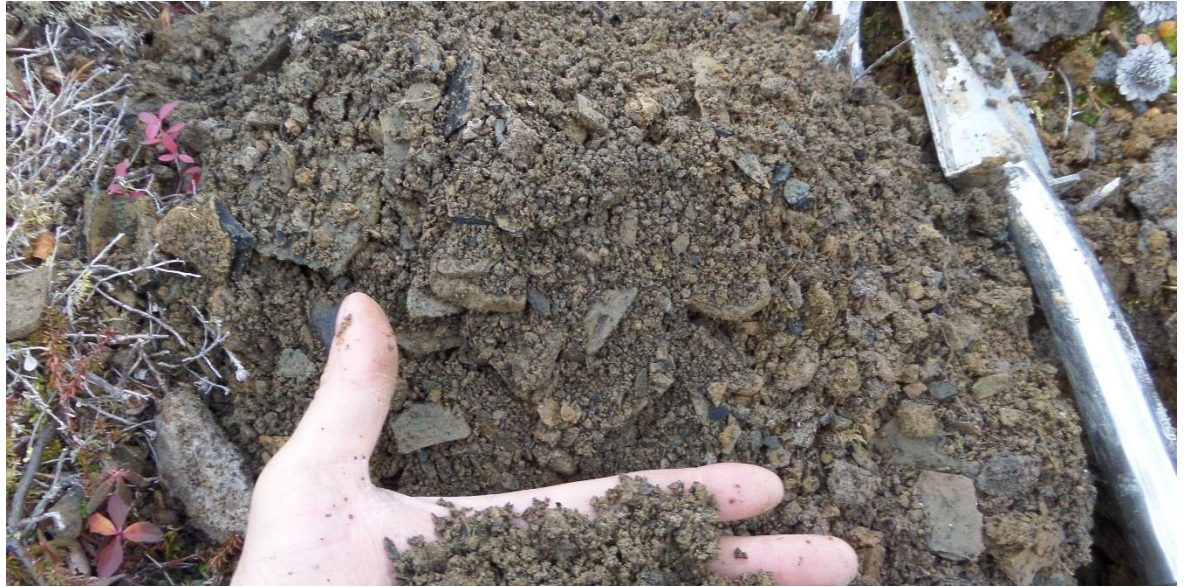
**Figure 38: Sub-rounded gravel present in the BP64 sample area**

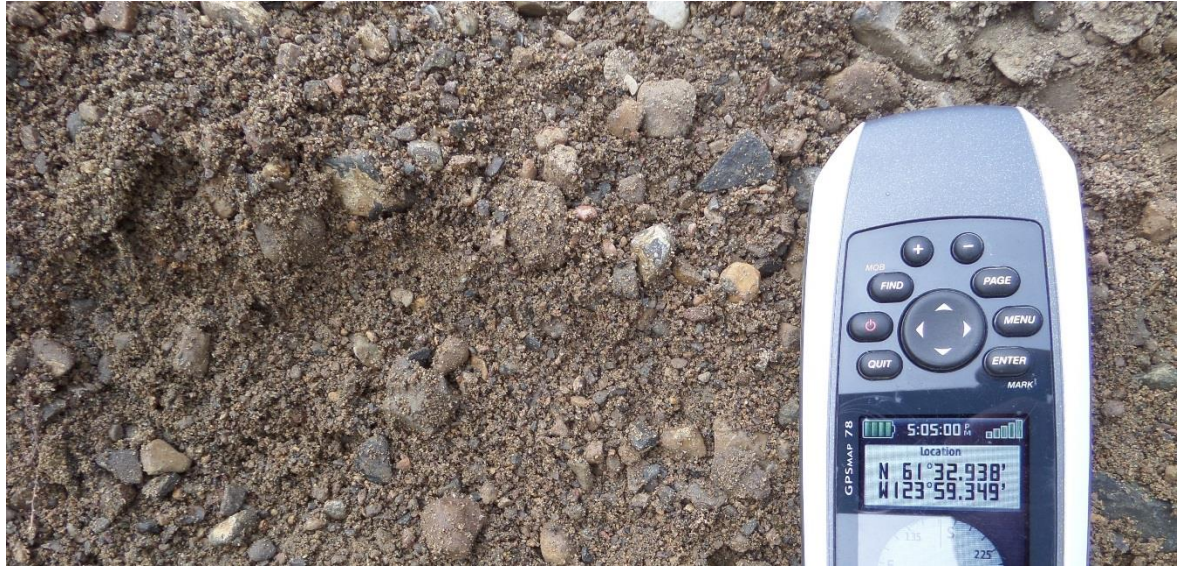
**Figure 39: Test pit with well-rounded gravel at BP65. Another test nearby revealed more angular shale gravel content, so the area is somewhat variable for gravel composition.**

BP65 also falls on the large glaciofluvial kame/kettle deposit previously noted for the BP64 site, but this borrow site falls along the existing roadway and doesn't require additional access road to develop it. BP65 appears to fall along the southern edge of the deposit area, and the depth of deposition will likely be substantially shallower in comparison to the esker deposit at BP64. As evidence of the potential for a shallow deposit here is the rock knob of primarily fissile shale that protrudes up through the area on the west side of the road. The base of this hill may contain more shale than gravel. This shale, in itself, is a potential borrow material for subgrade construction and the rock knob here appears to contain a substantial amount of it. The gravel materials sampled along the road here also appear fairly variable in composition over short distances. That, taken in combination with potentially shallow gravel deposition in this area, indicates a need for additional investigation to a greater depth to confirm materials prior to any large pit development. A low ridge formation (esker?) protruding out into the wetland on the southeast side also may contain gravels, but this formation wasn't sampled during the field reconnaissance. Should further testing in this area indicate a limited gravel volume, the use of BP64 would be the preferred alternative due to the volume available there.

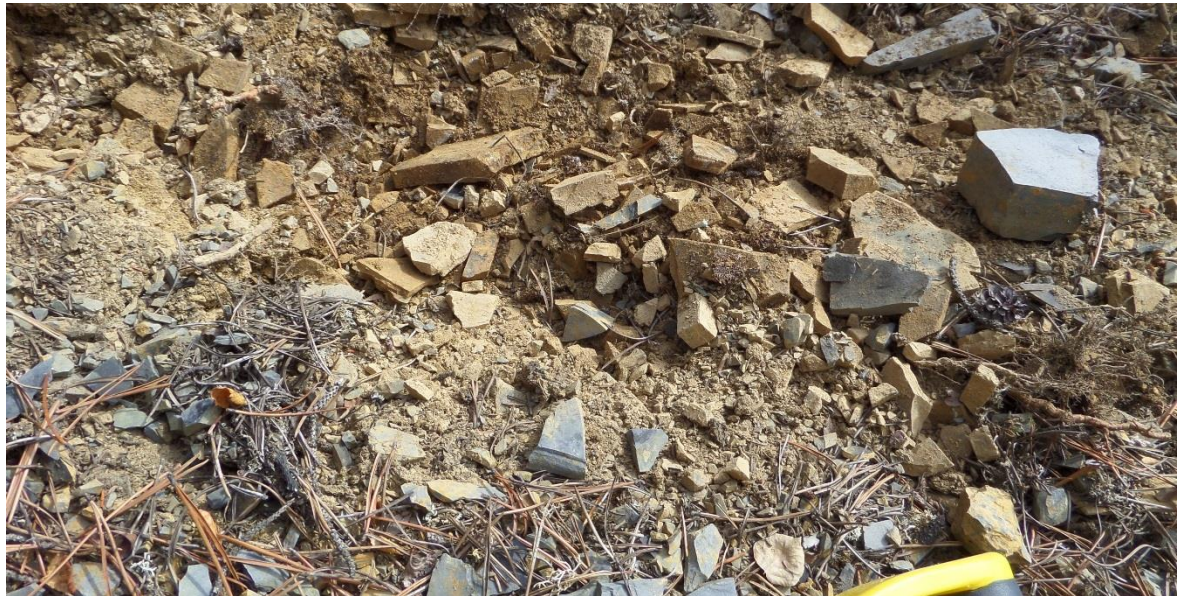
**Figure 40: Exposed face with both blocky and fine fissile shale was noted in a rock knob about 200 m southwest of BP65. This material likely extends back close to the road**

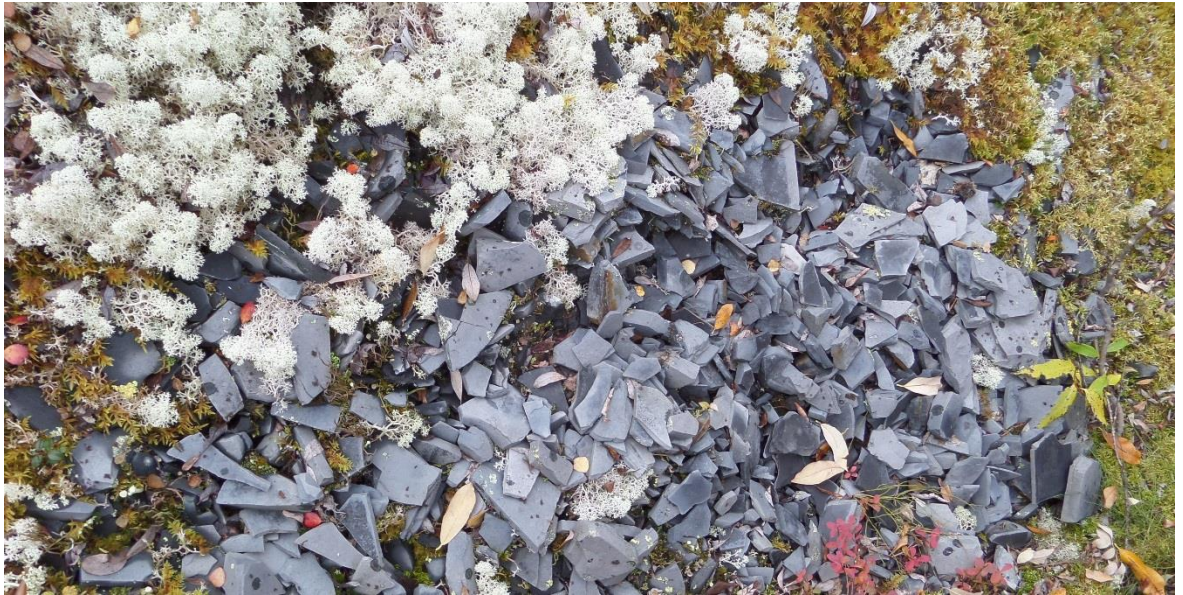
**Figure 41: Surface talus exposure of fine shale at 67.52 km (BP67).**

At 67.52 km the road route runs along the toe of a steep (70%) hillside that is covered in fine shale talus. Shale colluvium is apparent along the entire hillside above the road here up to about 67.8 km, but this location has the cleanest exposed talus material noted in the area. This material would be suitable for overland fills and for firming up areas of soft ground, but wouldn't be a very good surfacing material due to its fractures and sharp fragments. There is

also some potential for ice poor permafrost in this hillside, due to the northern aspect of this talus face, so additional investigation would be prudent before any development is carried out.

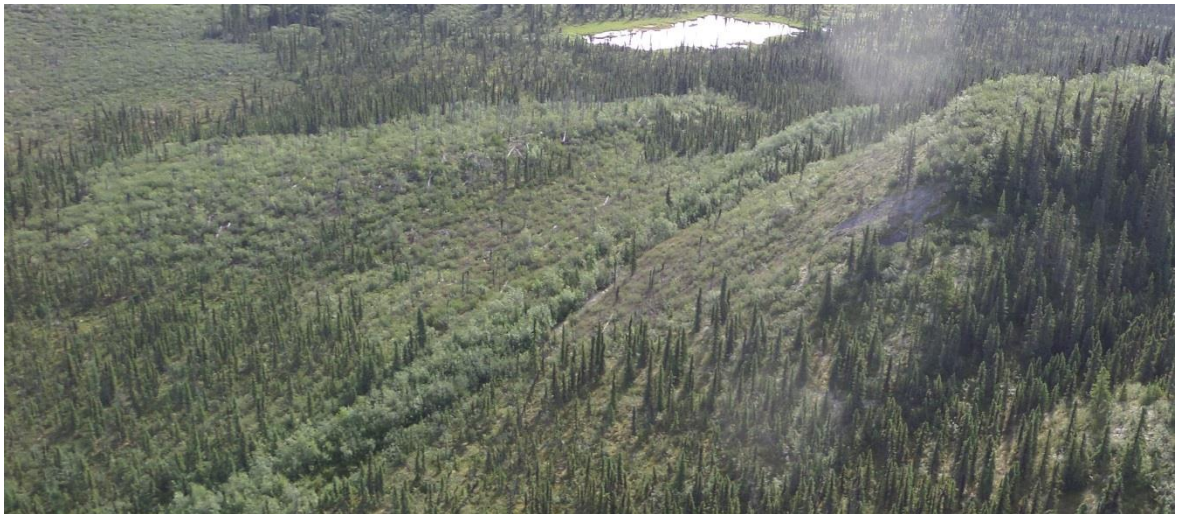
**Figure 42: BP67 talus sidehill (center right) with old road running diagonally across view.**

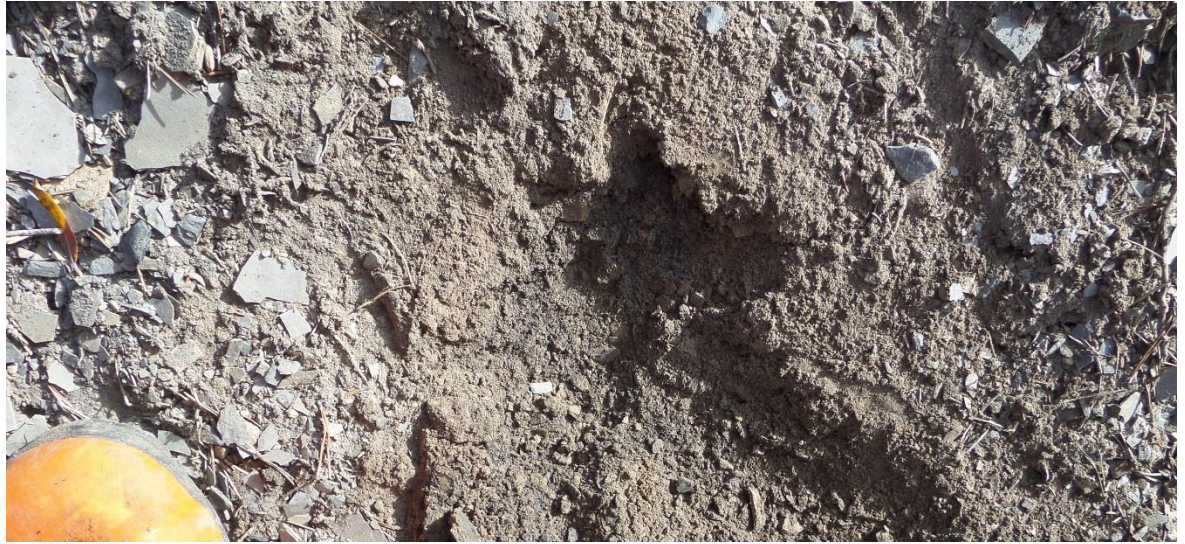
**Figure 43: Fine sand material at 70.75 km (BP70)**

The route crosses a sidehill with an old cut slope showing fine sand material intermixed with minor colluvium shale adjacent to the existing road with exposed colluvium bedrock upslope on the western portion. The sand/colluvium shale mix material (BP70) is free draining and

good for subgrade fills in overland sections. The bedrock could be ripped or blasted and utilized for armouring, subgrade fill, or crushed for surfacing.

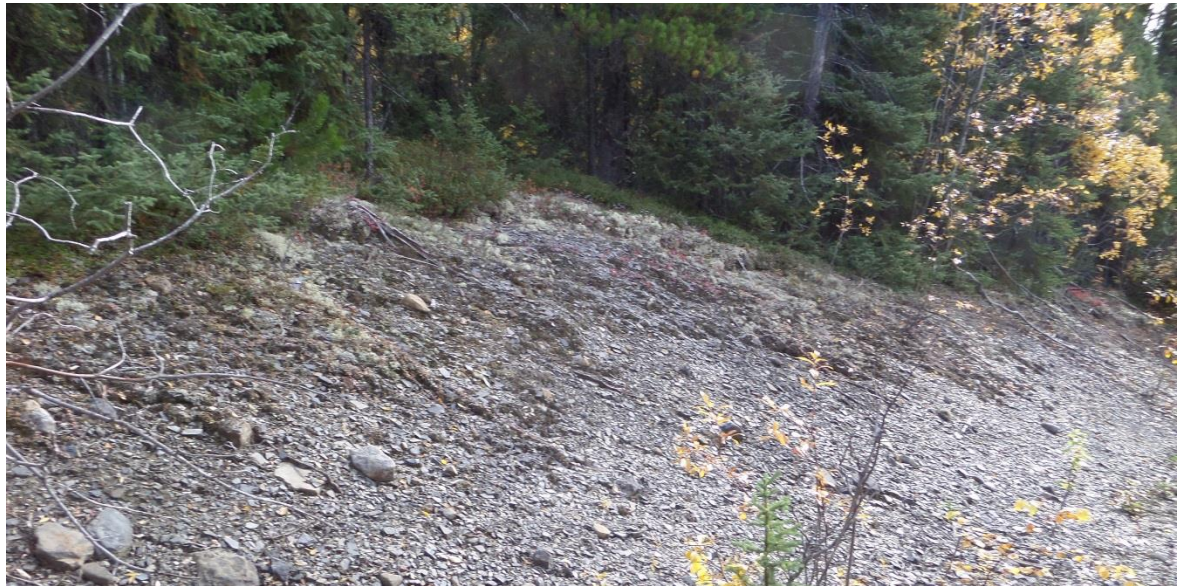
**Figure 44: The existing cut slope at BP70. The weathered face appears to be colluvium shale because of the residual fragments left in place, but the slope is in sandy materials.**

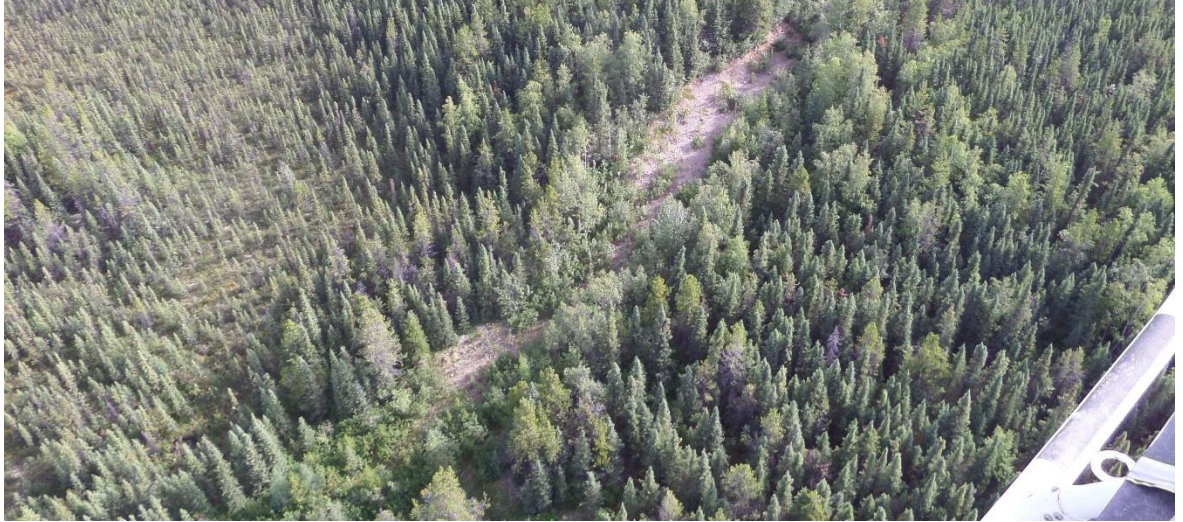
**Figure 45: Another small sand hump at 76.23 km can provide fill for a wetland crossing.**

In an almost mirror image of the BP72 situation, this small hump of sand at 76.23 km (BP76) is strategically located next to a wetland crossing that will need to be built up with fill as well. Again, the existing road footprint can be re-utilised to reduce new ground disturbance at the borrow site.

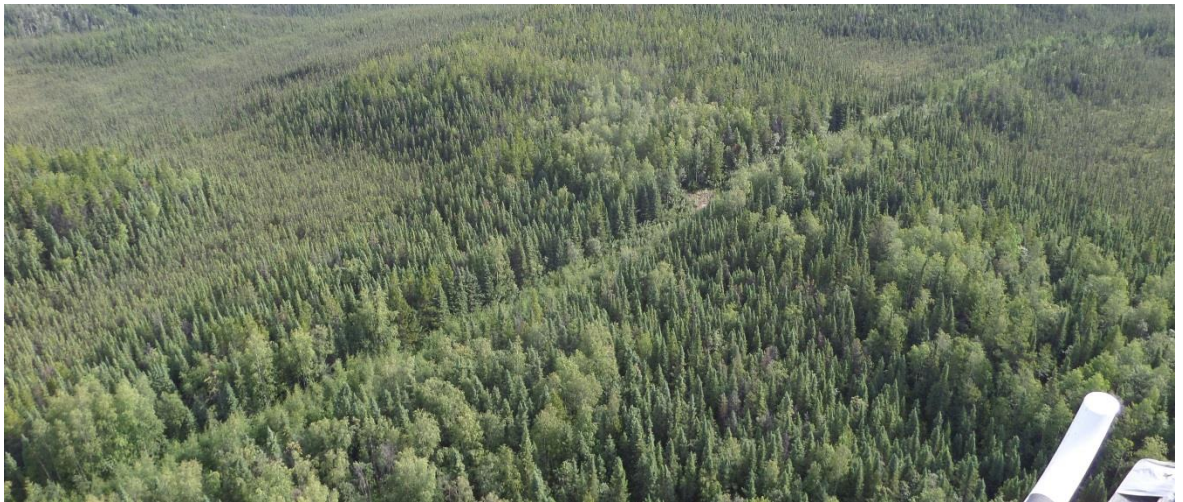
**Figure 46: A low ridge of higher sandy till (BP77A) crosses over the road route laterally at 76.7 km. This source of drier material could be used to build some of the overland fills that will be required to cross the wetland.**

Between 77 km and 78 km a broad lowland area must be crossed by the road, and additional borrow to build overland subgrade fills will be needed. This lowland area only presents a few opportunities for borrowing nearby material, and these areas consist of long low glacial deposition ridges left within the lowland margin area itself. As the existing winter road crosses these low ridges, it is advantageous to borrow the drier materials found in these areas for constructing the subgrade fills across the lowland.

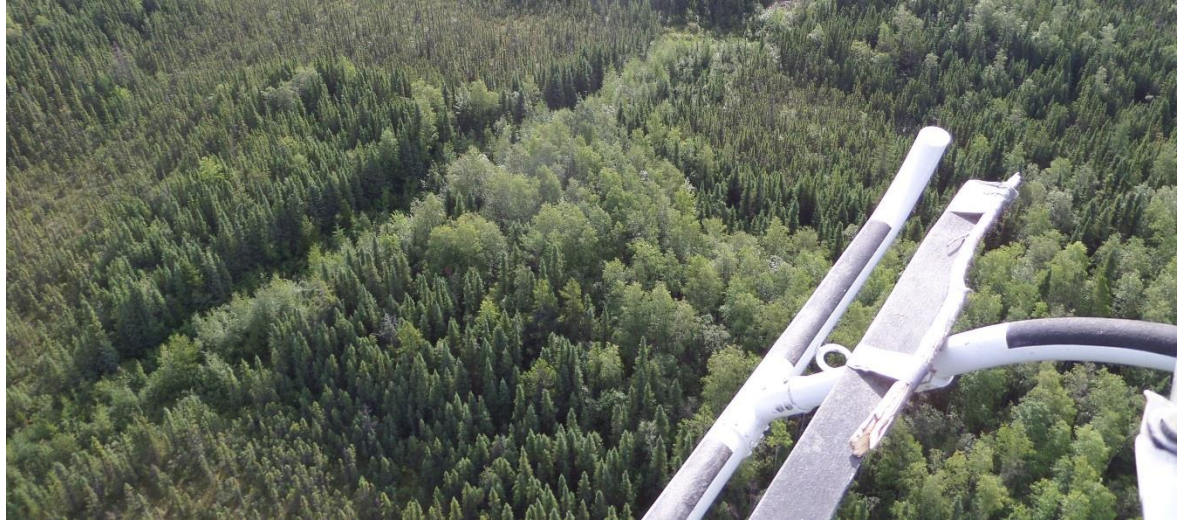
**Figure 47: A small hump of higher sandy till (BP77B) lies on the southern side of the road at 77.20 km. This source of drier material could also be used to construct some of the overland fills that will be required to cross the nearby lowland area.**

At 77.70 km, another low relief ridge of dry sandy till (BP77B) lies on the south side of the existing road. This source, in conjunction with BP77A, could be used to supply some fill for the overland subgrade crossing of the lowland to the west of this location.

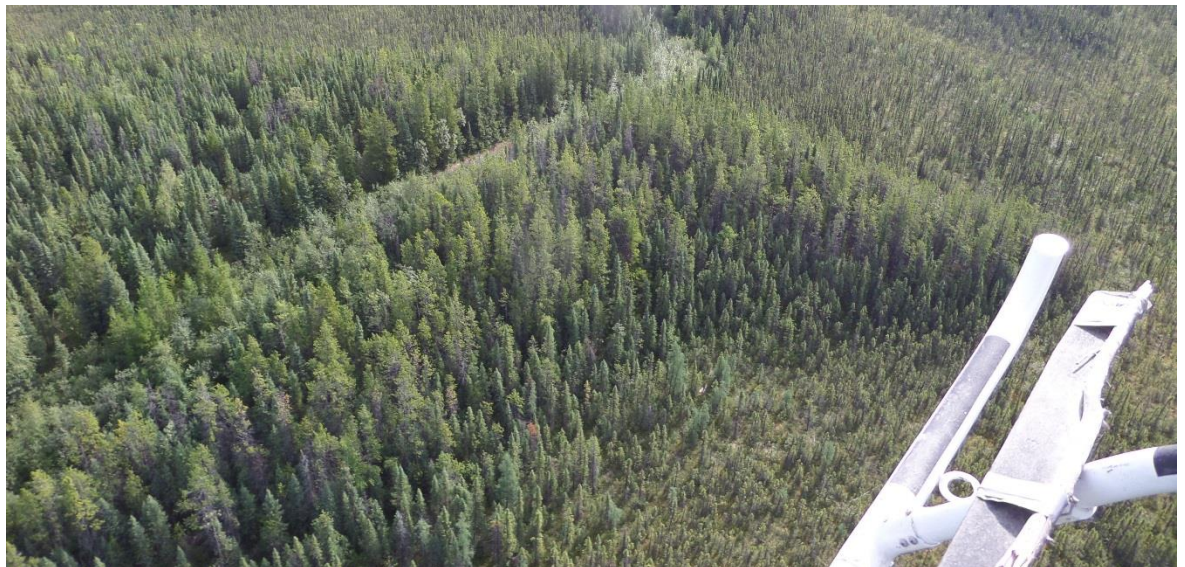
**Figure 48: A small ridge of sandy till (BP78) lies under the road route at 78.0 km. The drier material here could be used to construct adjacent overland fills.**

The nose of a ridge crossed at 78.52 km provides another source of dry sandy till (BP78) for constructing overland fills in this area of low ground.

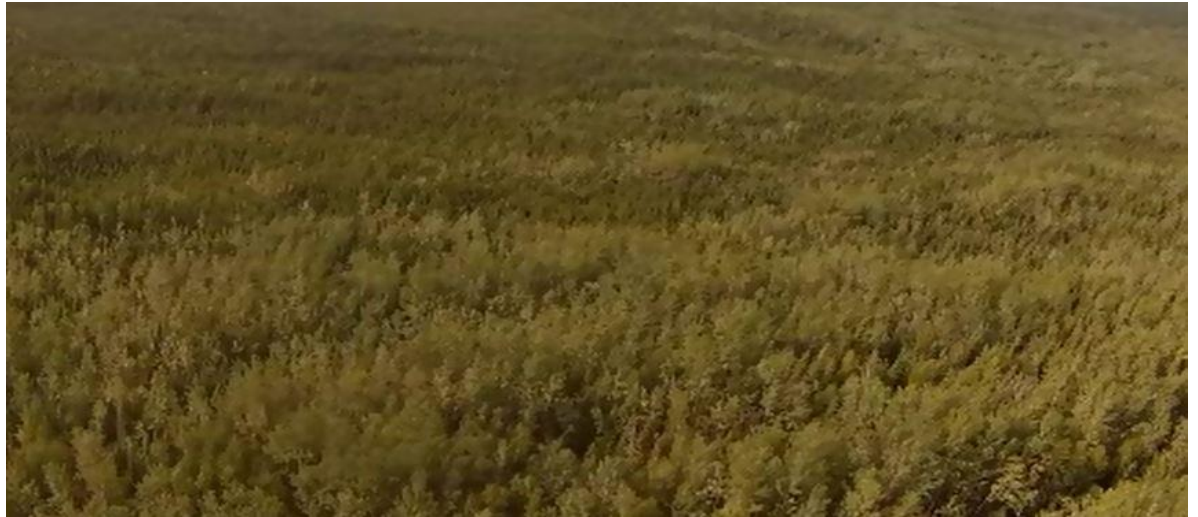
**Figure 49: The road passes through the center of this aspen patch and the borrow area parallels the road.**

Long, slender borrow area adjacent to ASR alignment. Expect clay till type material to be utilized for localized overland sections. Permafrost potential along southern boundary.

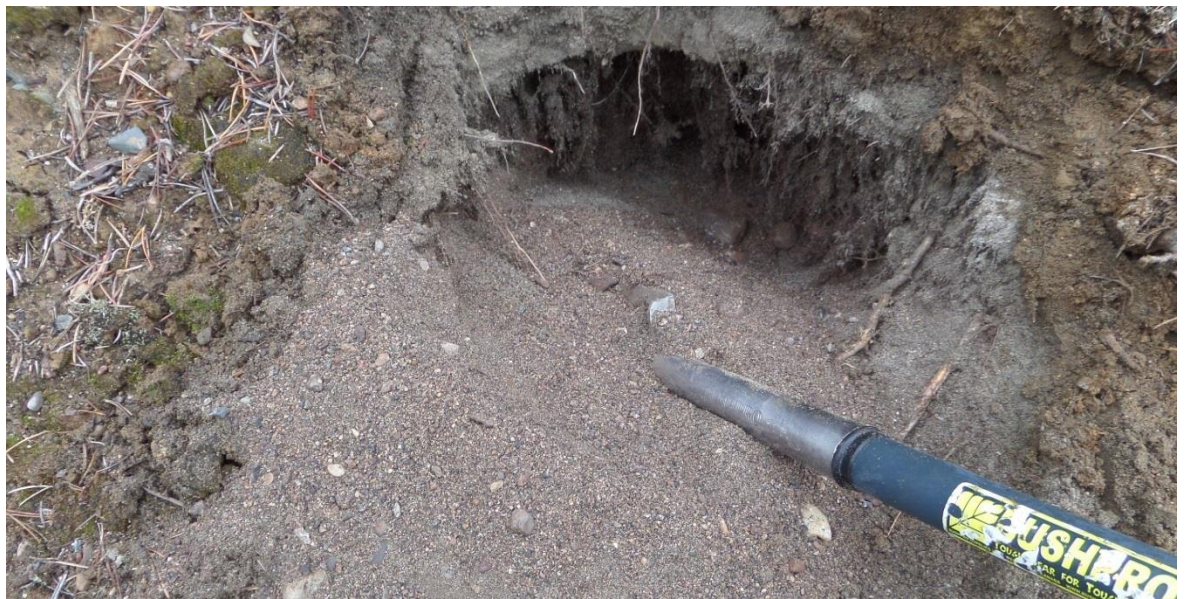
**Figure 50: Sand material found in an existing cut slope at 86.35 km. This is some of the cleanest sand noted in the area and could be used for pipe bedding and overland fills.**

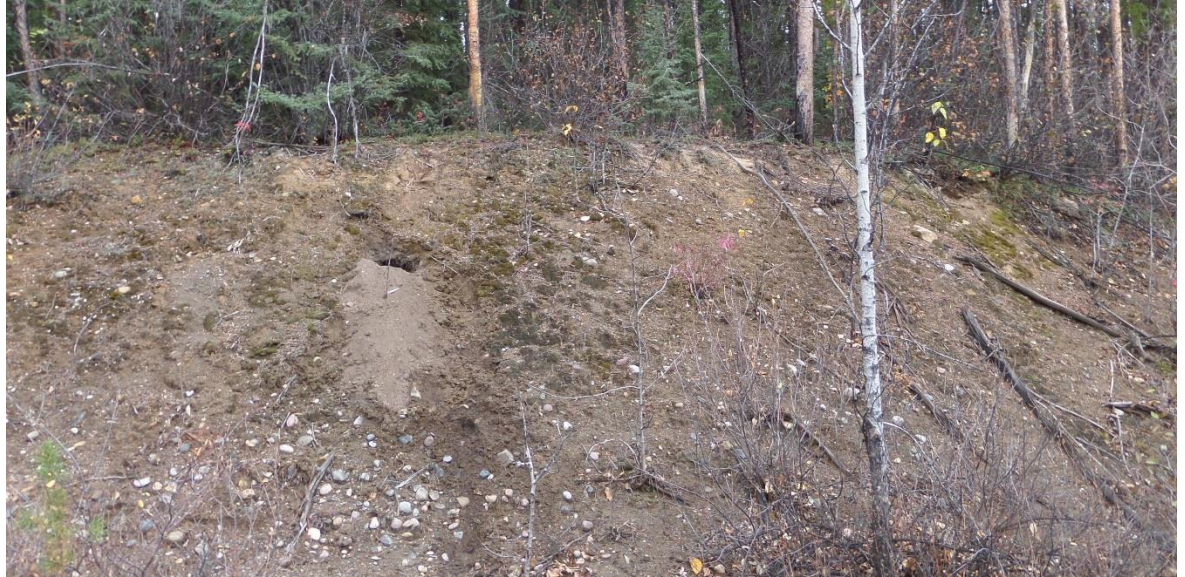
**Figure 51: Existing cut slope exposing the BP86A sand material. Large timber growing on the site indicates the area is likely permafrost free.**

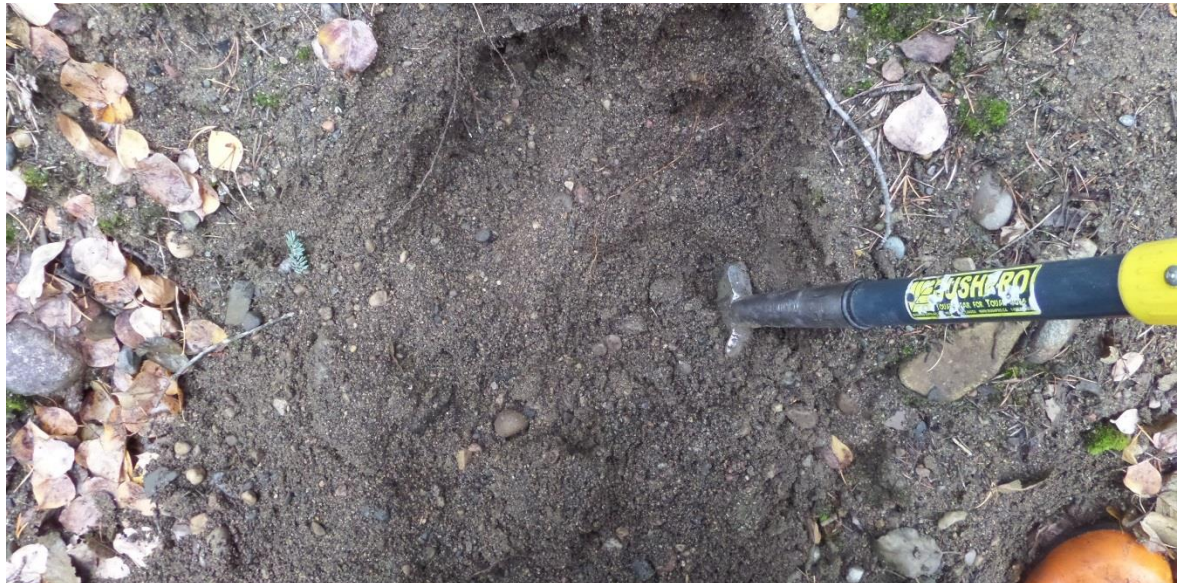
**Figure 52: Medium grain sized gravelly sand material found in an existing cut slope at 86.0 km.**

Another nearby soil exposure along an existing winter road cut face at 86.0 km (BP86B) reveals medium sized gravelly sand within the slope. This material could be utilized as road fill for construction over an adjacent lowland area, and for overland construction across other lowland sections to the northwest.

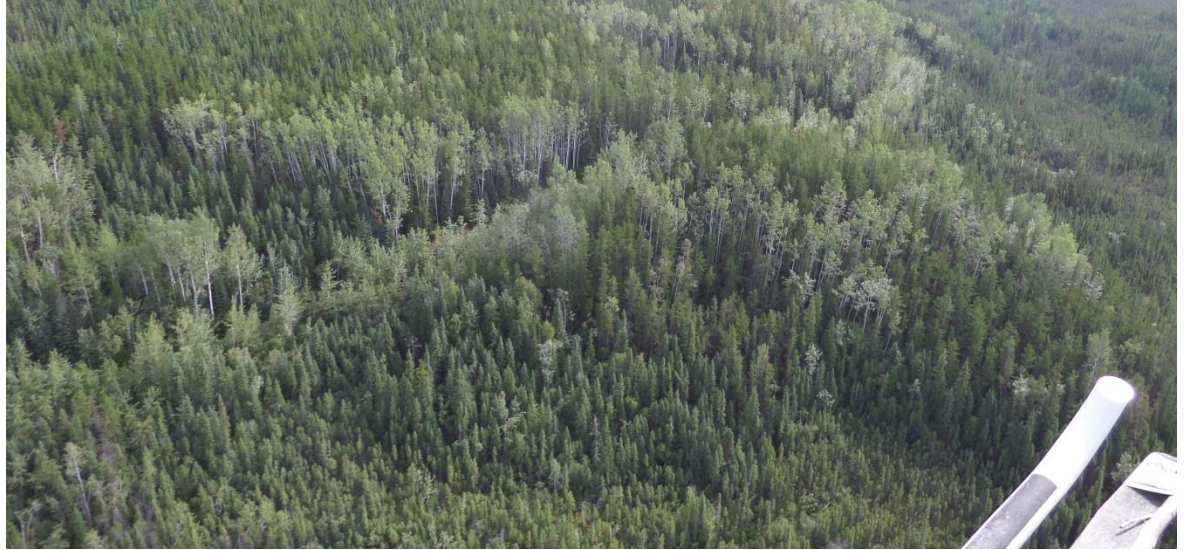
**Figure 53: Aerial view of the BP86B site (right of center) showing the ridge containing gravelly sand.**

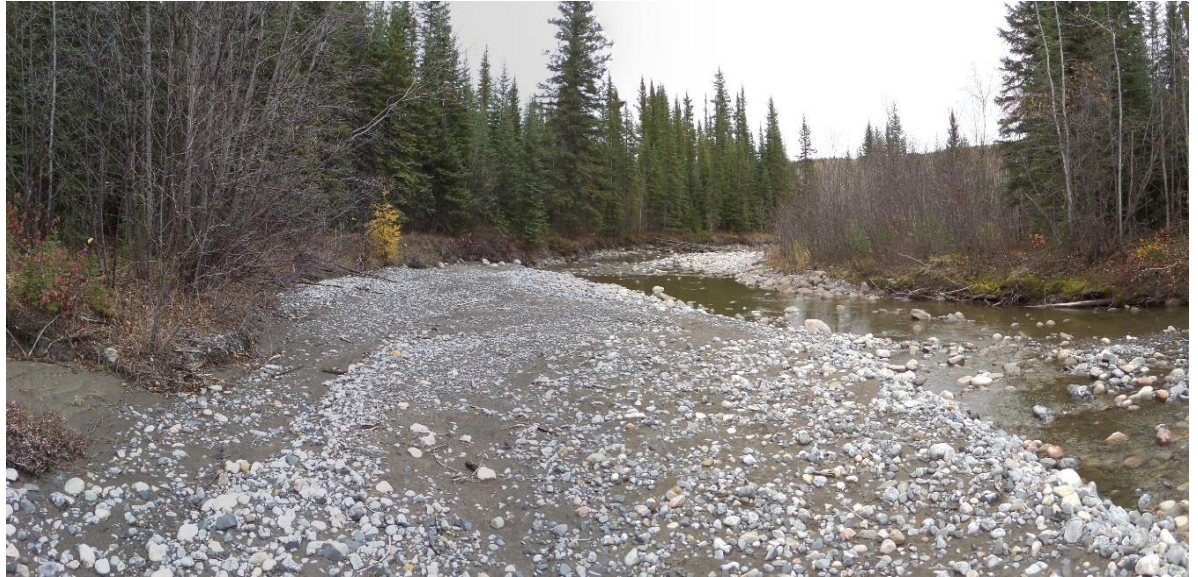
**Figure 54: The bed composition of the current day Tetcela River is assumed to be indicative of the materials that should underlie the BP87 site, which is situated well back of the river here, in the timber on the left hand side.**

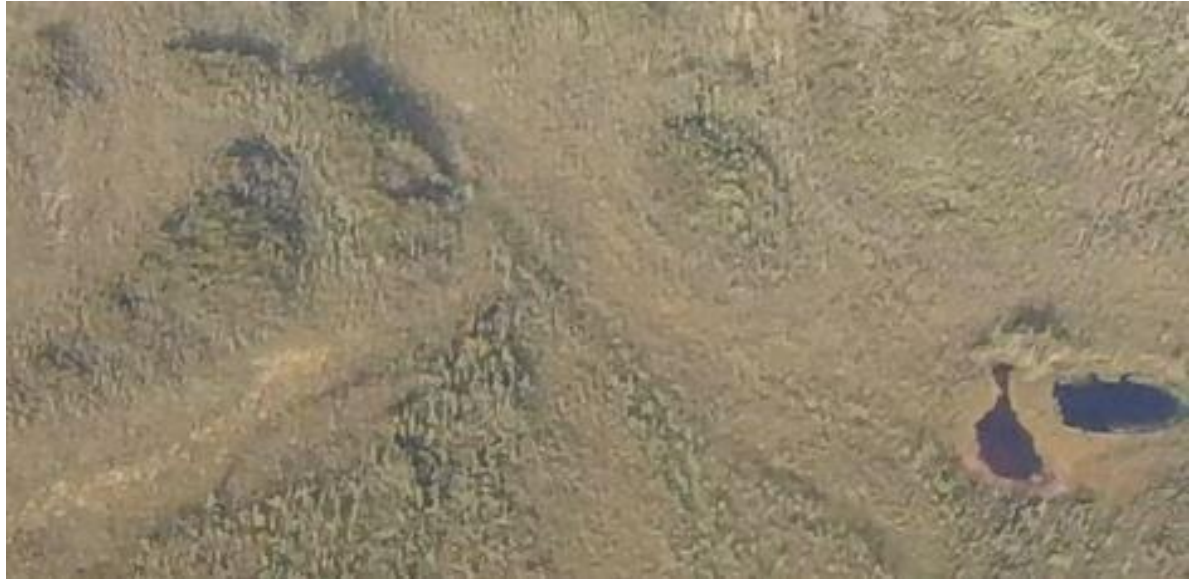
**Figure 56: Aerial view of the landscape from KP 90 to 95. Patches/islands of dry, esker type terrain covered with lodgepole pine/aspen. These humps will provide borrow material to overland the lower, depressed permafrost (likely ice-rich) sections in between.**

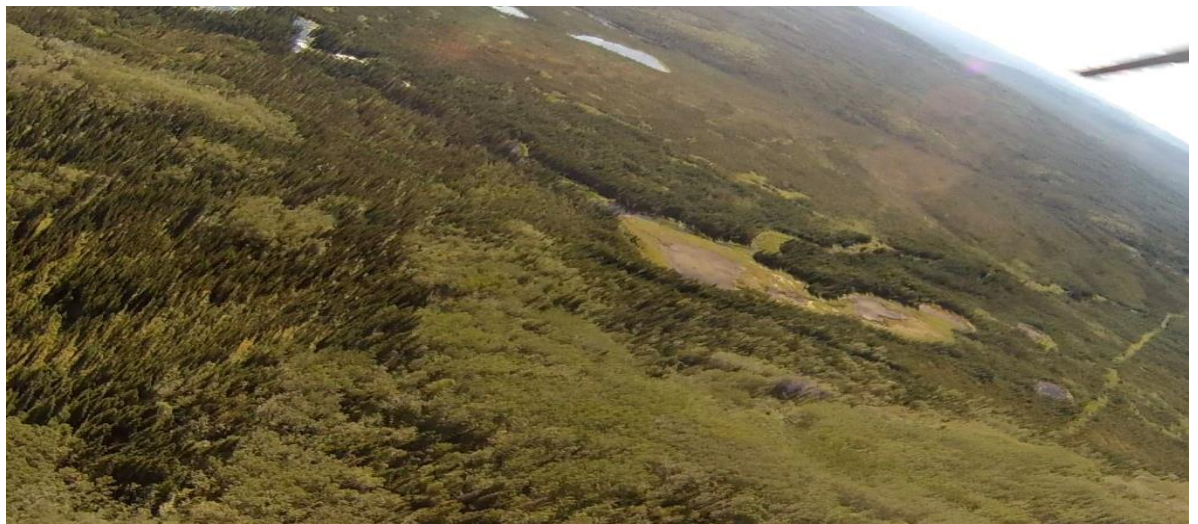
**Figure 57: Aerial view of the landscape near KP 96. Borrow to be extracted from elevated dry humps covered mainly with aspen and lodgepole pine.**

Area and volume could be easily expanded. Field investigation confirmed exposed, loose (sedimentary) rock on the surface and expected to be prevalent throughout the borrow area at depths greater than 1m surface depth. Should provide excellent borrow material for local overland subgrade material.

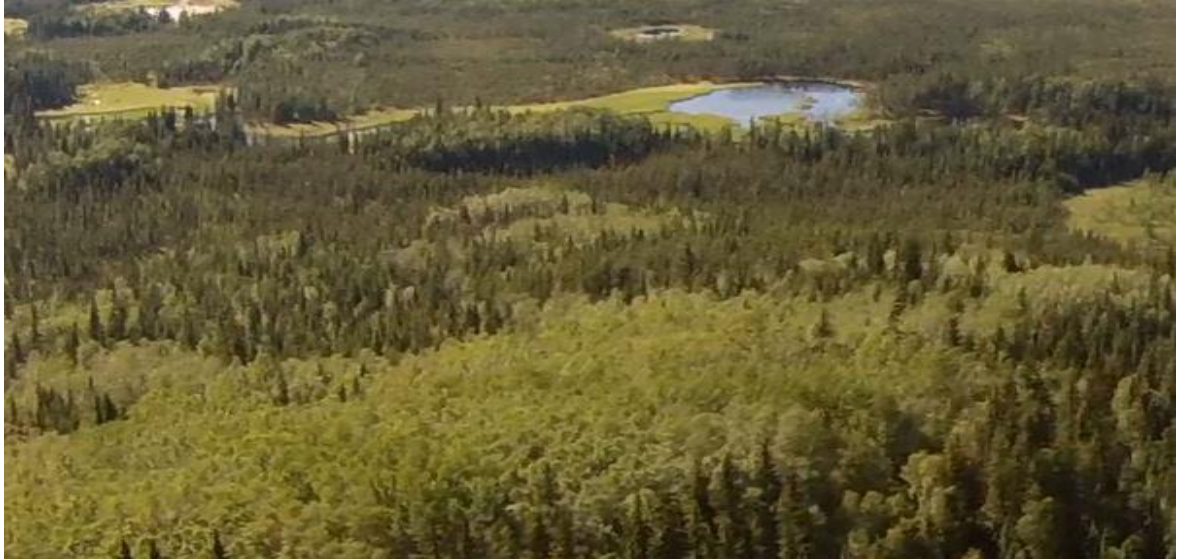
**Figure 58: Aerial view looking west at BP 97 located in middle of photo.**

Borrow volume required for localized overland sections. Area and volume could be easily expanded. Initial shovel test pit confirms silt clay material. A short access road to borrow is required.
