# **POST-EA INFORMATION PACKAGE INCLUDING AN UPDATED PROJECT DESCRIPTION ALL SEASON ROAD TO PRAIRIE CREEK MINE**

**APPENDIX 1-11: BORROW PIT SUMARRY**

## **APPENDIX 1-12**

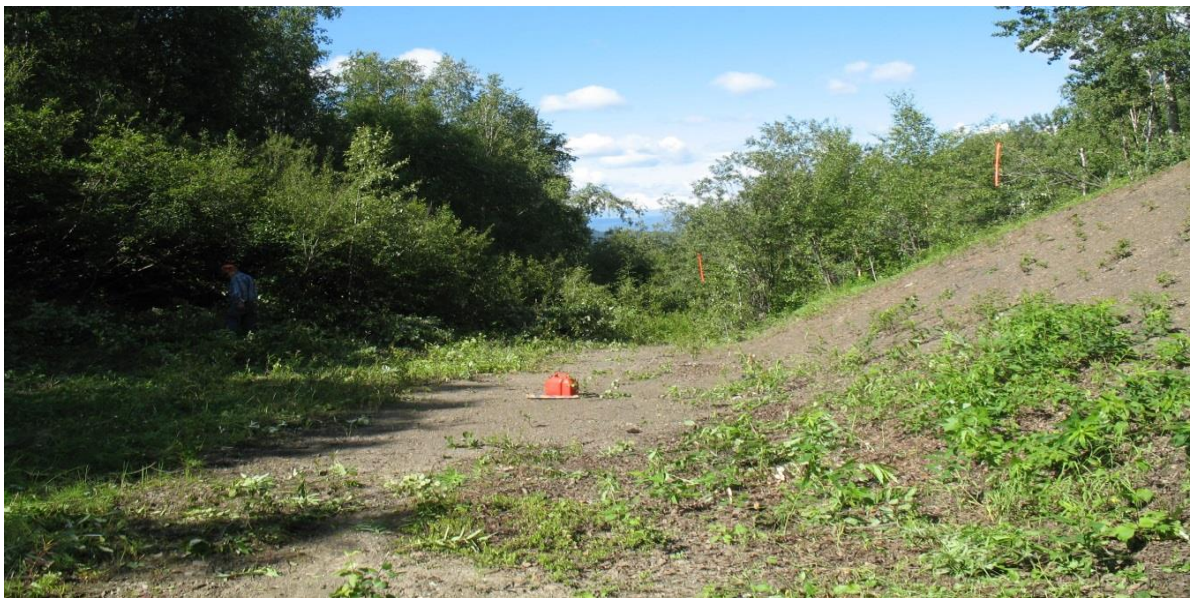
**Figure 59: Dry sand type material at Wolverine Pass.**

Borrow volume required for localized overland sections. Area and volume could be easily expanded.

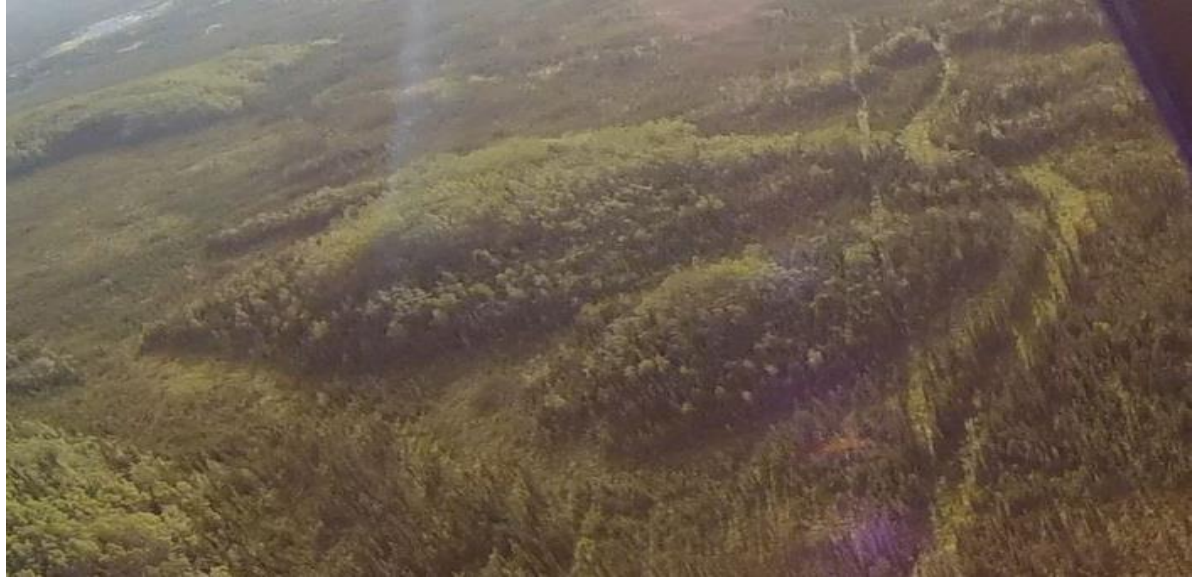
**Figure 60: Dry elevated “humps” covered with lodgepole pine and aspen should provide adequate silty clay type material for overland sections.**

Borrow volume required for localized overland sections. Requires a short 175 m access road. Area and volume could be easily expanded. Not field verified but similar material found in the surrounding area.

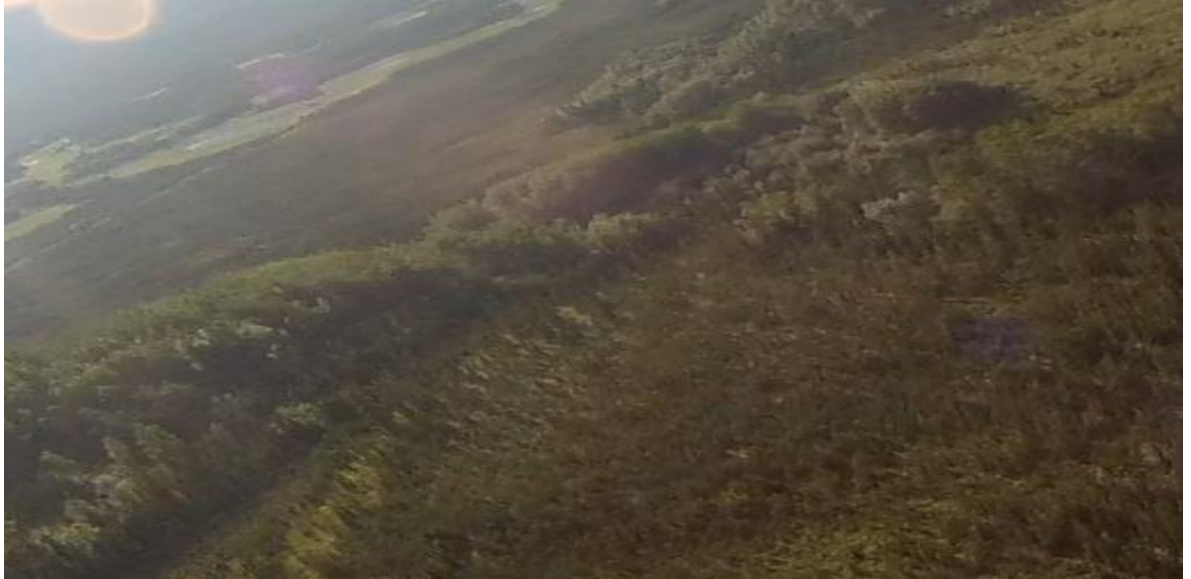
**Figure 61: BP 103 is the elevated hump with an exposed sedimentary rock/shale face on the south east side.**

Large elevated knob with potential clay till type material overlying a carbonate rock layer underneath. Short access road is required. The clay could be utilized for subgrade overland base material, the rock could be blasted/crushed and utilized for road surfacing.

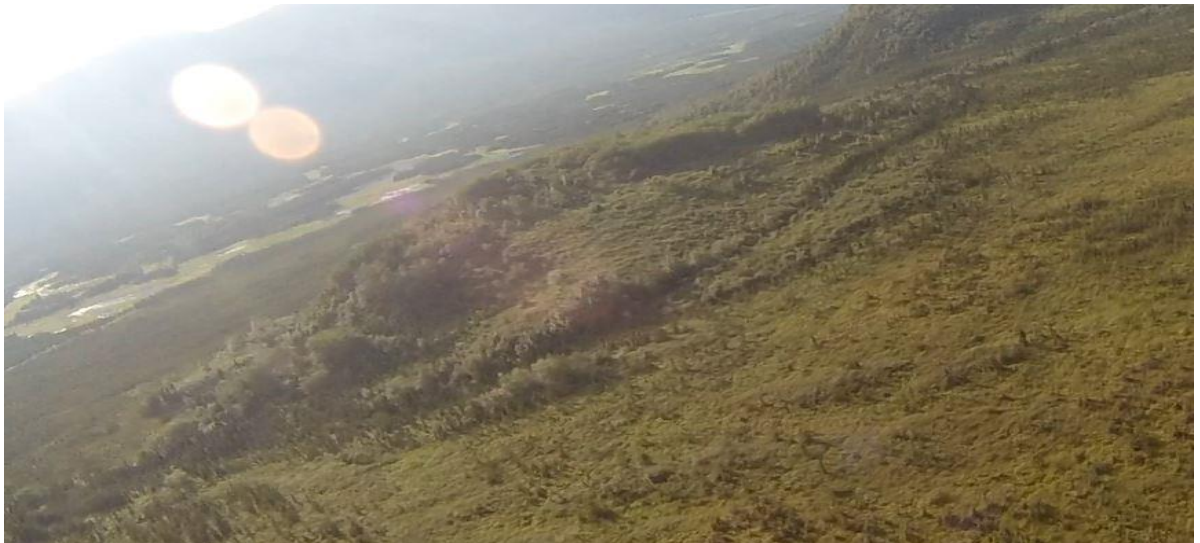
**Figure 62: Similar formation to BP 103 and expect similar soils.**

Large elevated knob with potential clay till type material overlying a sedimentary rock layer underneath. The clay could be utilized for subgrade overland base material, the rock could be ripped and would make excellent subgrade material. Future test pits will determine the precise shape and size (probably less than 2.5 ha).

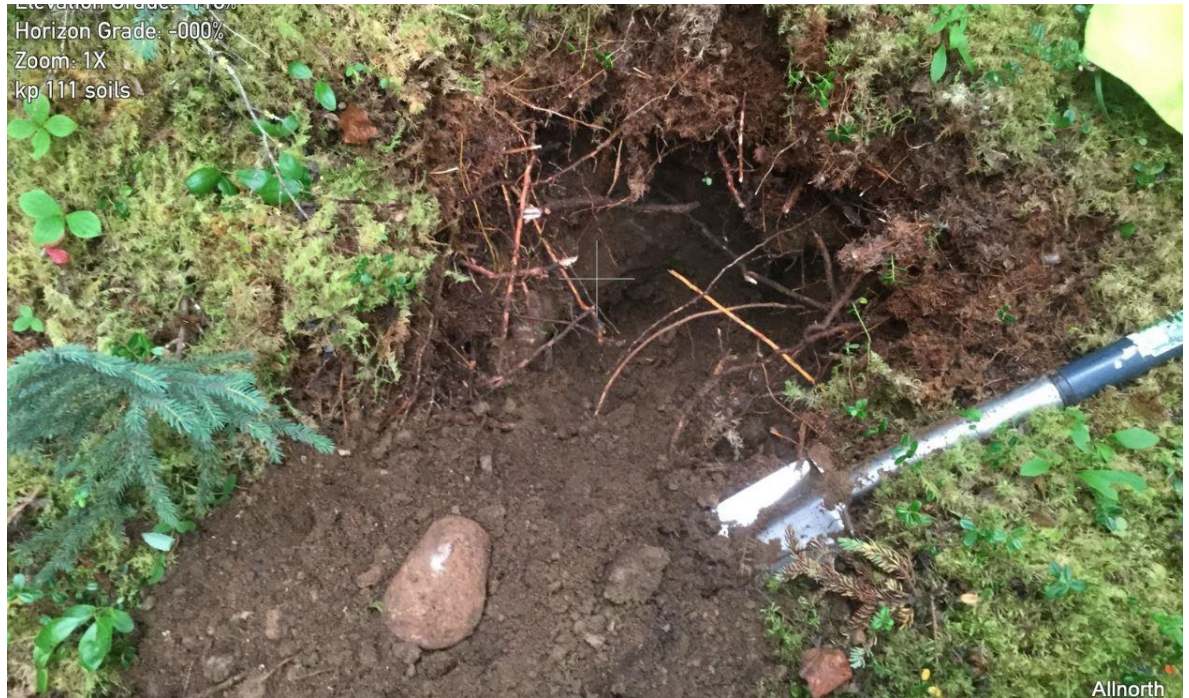
**Figure 66. A shovel test of material near BP 110 indicates excellent material for overland subgrade material.**

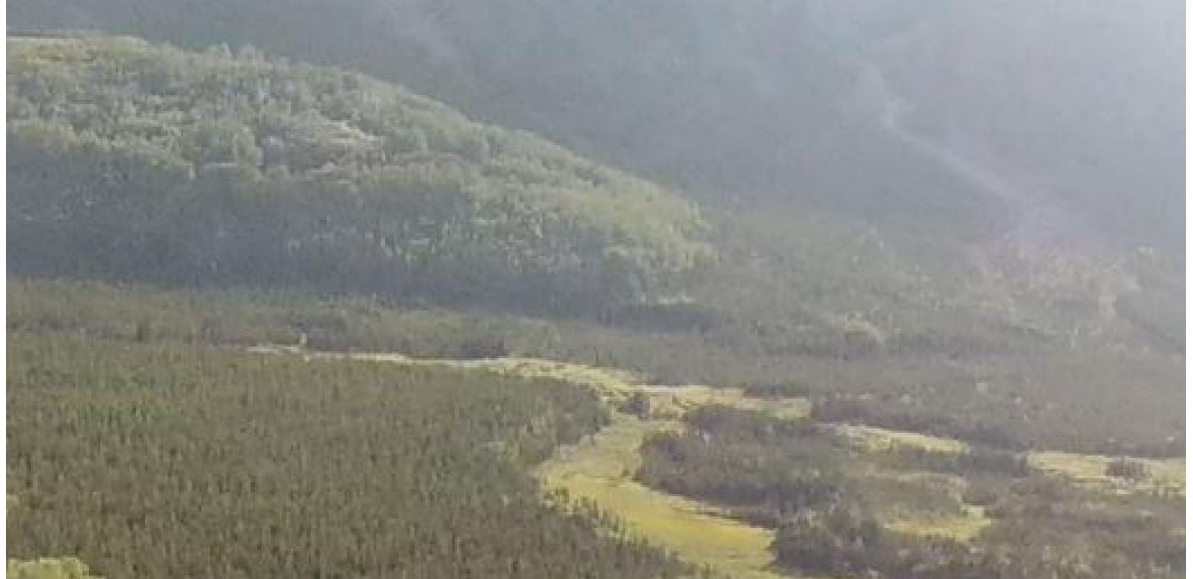
### 1.50 Km 111.6– BP 112 Alter. – Clay/Silt Till

Noticeable, large elevated ridge expected to be clay/silt/ gravel glacial till mix suitable for overland subgrade material. May encounter carbonate bedrock suitable for rock quarry and crushing underlying the till mix.

**Figure 67. The noticeable elevated knob/ridge should provide suitable subgrade borrow. The proposed ASR alignment is located at the lower base of the slope.**

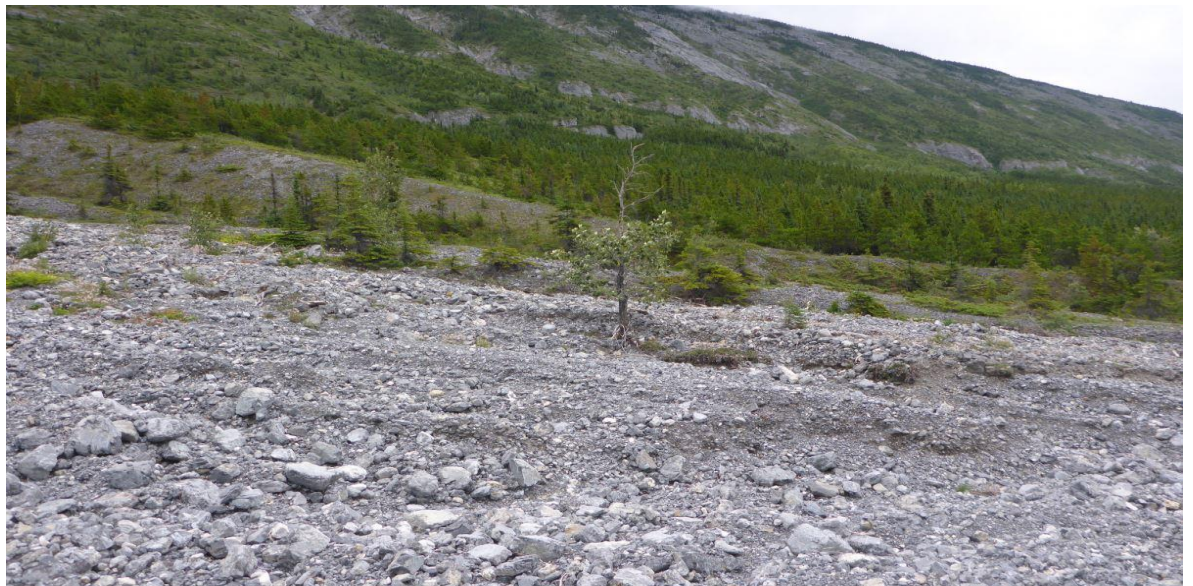
**Figure 68. Large source of quality limestone gravels and cobbles available along the proposed alternative route near KP 112. Ideal for crusher operation and a stockpile for future maintenance requirements.**

A large outwash alluvial fan originating from the nearby Franklin Mountains of the Nahanni Range located east of the defined source. As with much of the other alluvial cobble noted along the route, this source appears to originate from competent carbonate bedrock, making them an environmentally friendly and preferred construction material. Seasonal stream flows during spring thaw. Detailed design would maintain natural drainage channels.

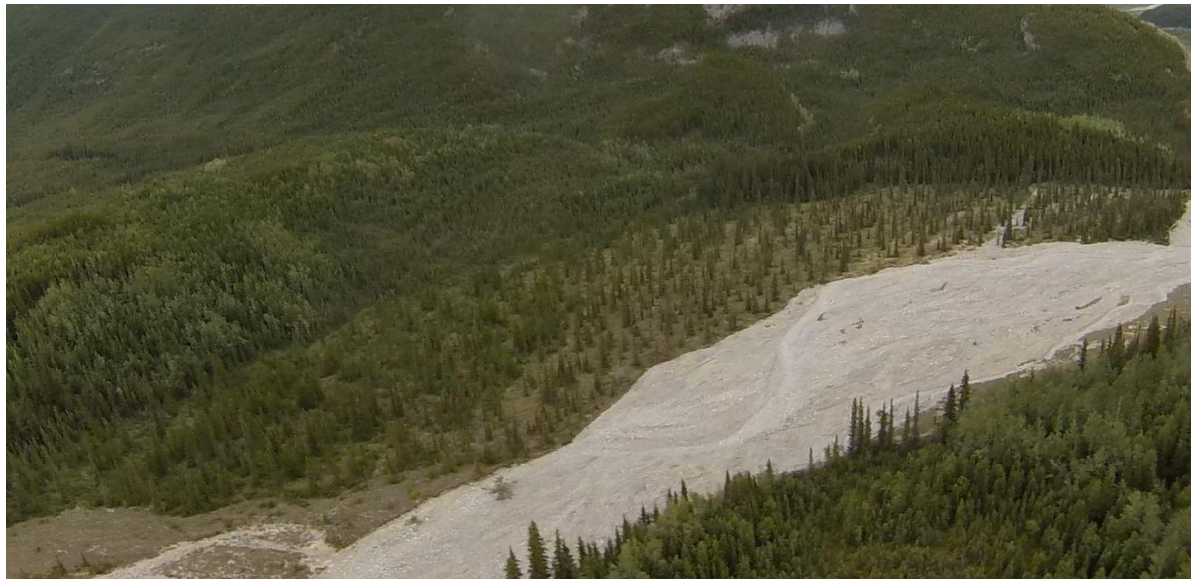
### **1.52 Km 119.1 – BP 119 Alter. – Alluvial Cobble and Gravels - Carbonates**

The material deposited at BP 112.3, 118, 119 all originate from the nearby Franklin Mountains of the Nahanni Range in the east. As with much of the other alluvial cobble noted along the route, this source appears to originate from competent carbonate bedrock, making them an environmentally friendly and preferred construction material. Seasonal stream flows during spring thaw. Detailed design would maintain natural drainage channels.

Sufficient volume and area for setting up a crushing plant and for holding stockpiled materials. This area could support aggregate material for long term road maintenance.

**Figure 69: An aerial view of BP 119, downstream from BP 118.**

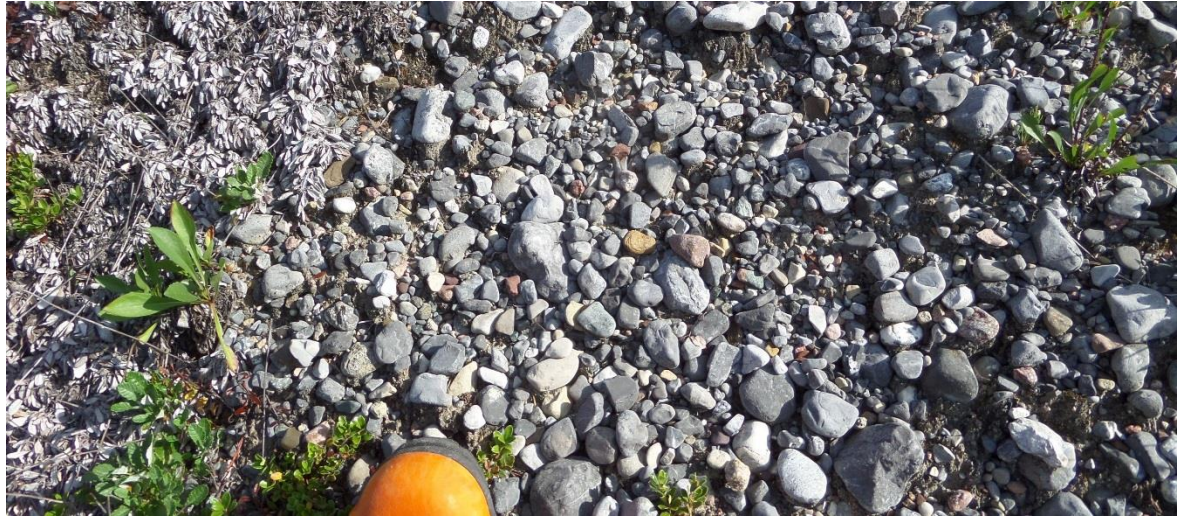
**Figure 70: Typical gravel materials found in the abandoned channel at BP123A.**

that roadway since then. The dry relict channel (BP123A) holds promise for supplying all the material required for a large crushing operation producing surfacing aggregate, as well as other products for road construction. As with much of the other alluvial cobble noted along the route, the Grainger Gap gravels appear to originate from competent carbonate bedrock, making them an environmentally friendly and preferred construction material.

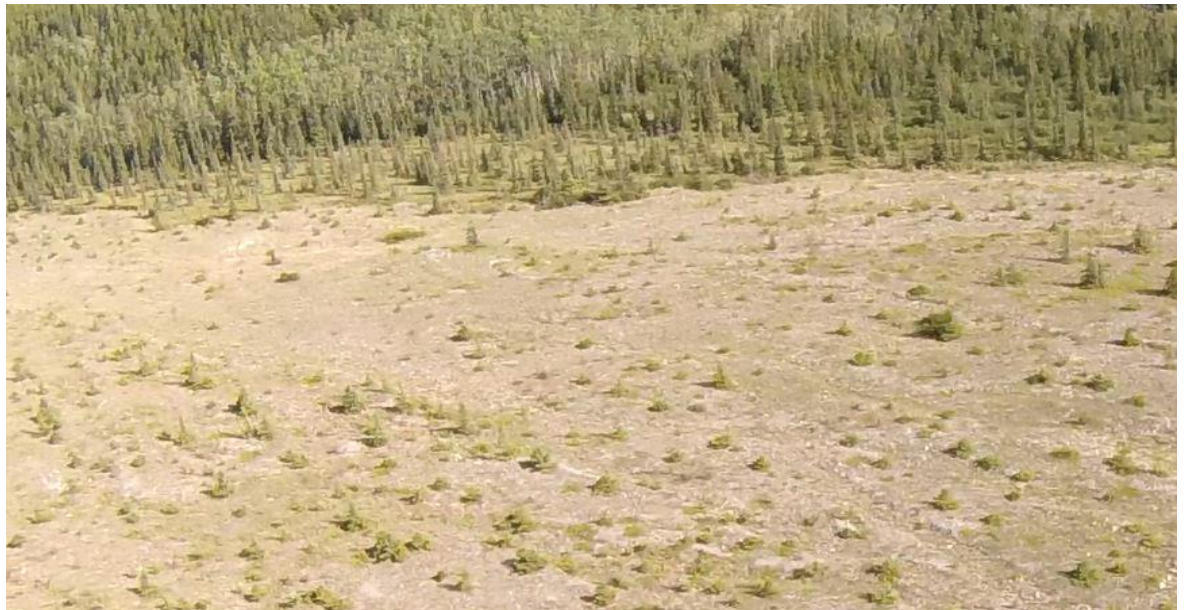
**Figure 71: Aerial view of the east end of the relict channel where BP123A is proposed. The ASR splits the borrow area, is located through the semi open forested area.**

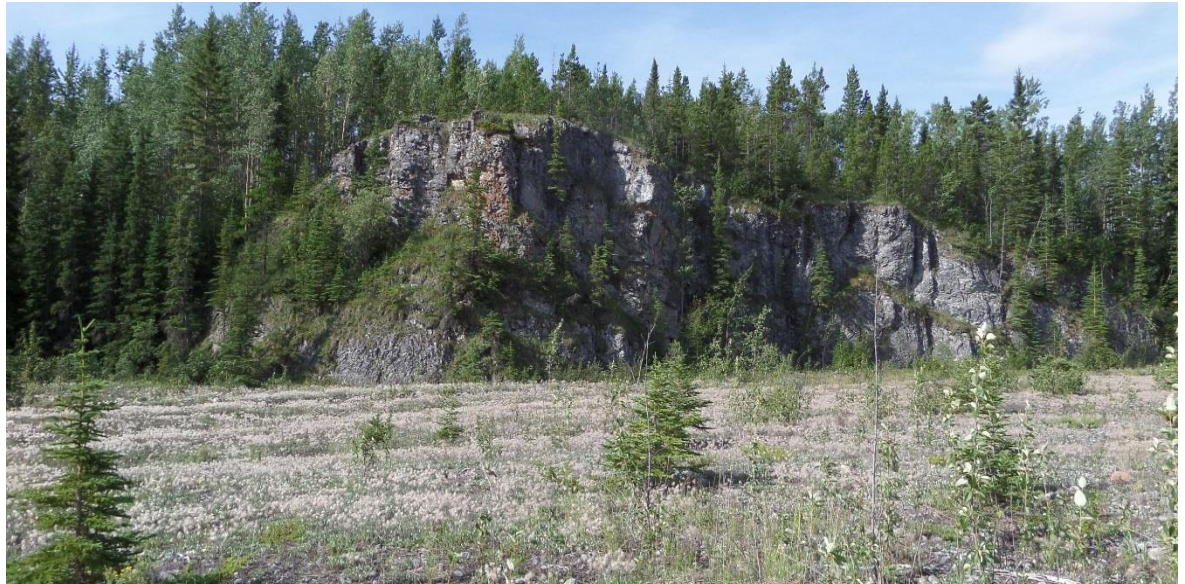
**Figure 72: View of the isolated limestone rock knob (BP123B) protruding from the BP123A relict channel plain. This knob has level access on all sides of it making it a very simple location to develop for a source of blasted rock.**

Directly adjacent to the relict avulsion channel at BP123A, is a limestone bedrock knob that juts up about 10 m in height from the alluvial plain. This rock knob is readily accessible from flat ground on all sides, making it a simple candidate for developing a blasted rock source in this area. While the eroded rock surface is fairly fractured, there is potential for producing larger shot rock and riprap from interior sections of the rock knob via controlled blasting. The limestone rock would be an environmentally friendly material for stream crossing works.

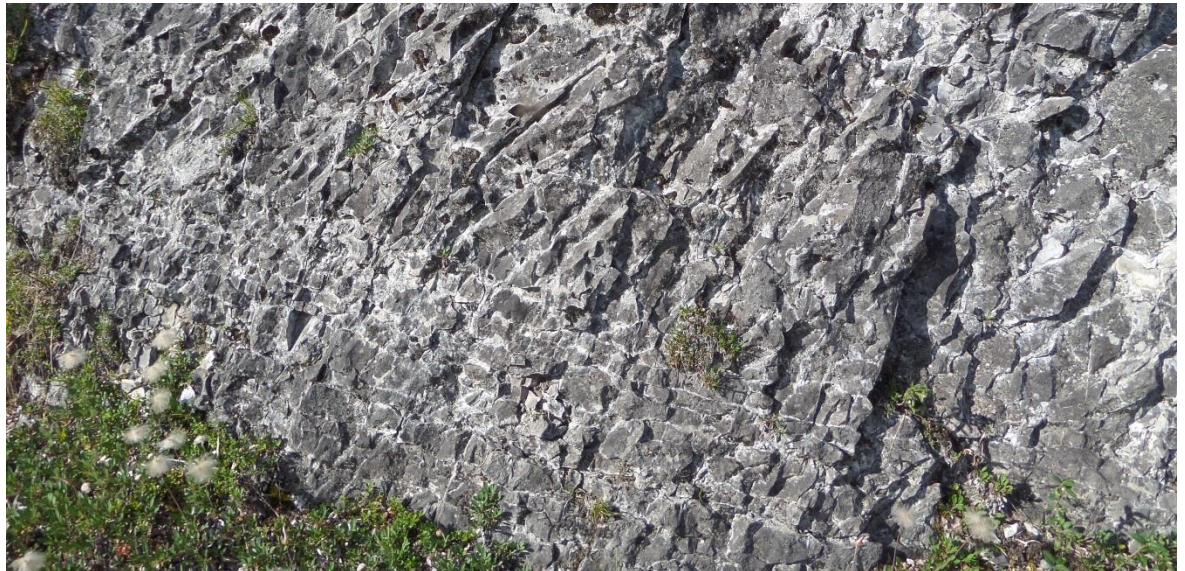
**Figure 73: Closer view of the limestone bedrock available in BP123B.**

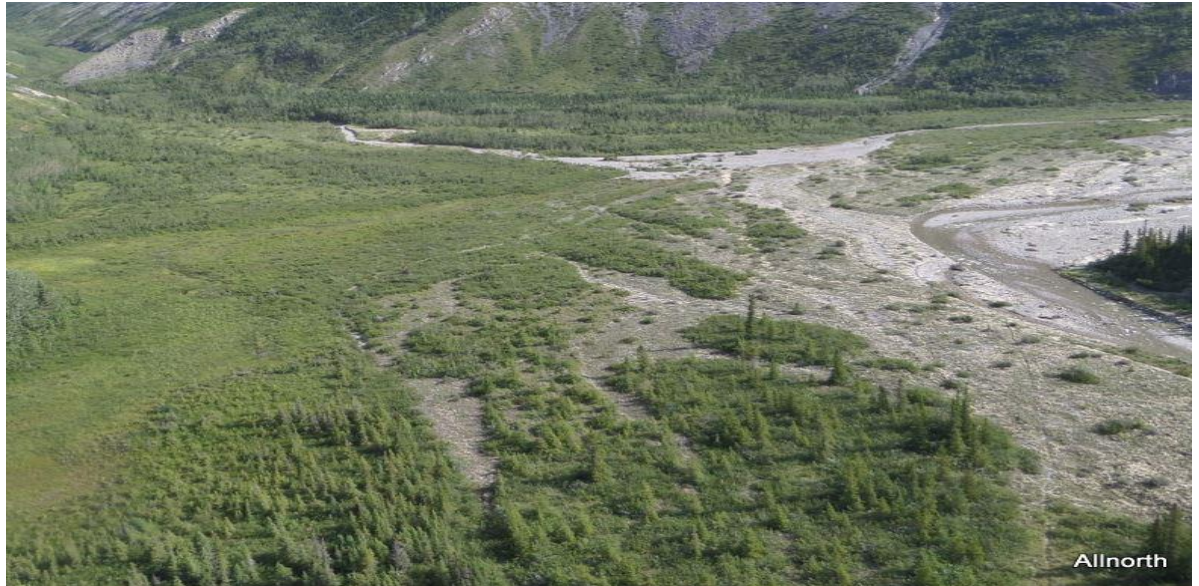
Similar material type as BP 123, BP 118, BP 119, part of the old floodplain of the Grainger River. Preferred location vs. BP 123A because closer proximity to surfacing requirements between KP 125 to 132.

**Figure 74: Another aerial view of the large deposit of gravels and cobbles, this one at KP 124.**

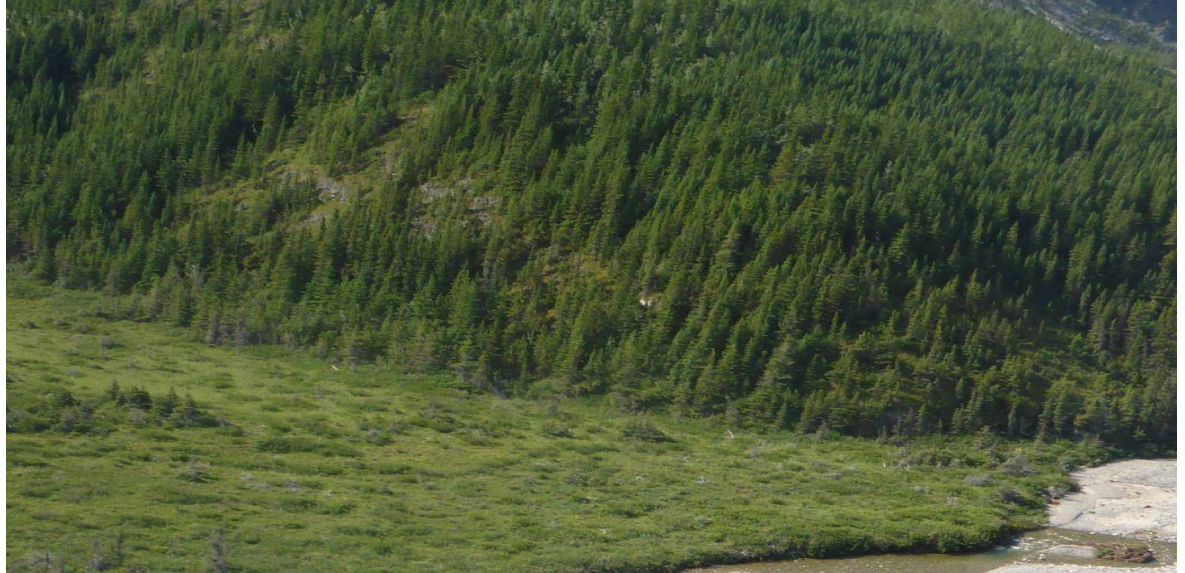
**Figure 75: A view of the exposed rock face of BP 125A. The proposed road is located on the right side of photo at the base of the slope on the historic flood plain of Grainger River.**

An exposed outcrop of limestone bedrock with talus at the base (125B) would make an excellent rock quarry. The northern tip of BP 125A is in close proximity to the proposed road while BP 125B requires a short 400m access road but offers loose talus rock deposit at the base of the face. Both pits would provide excellent base material for overland construction from KP 124.8 to 127.2.

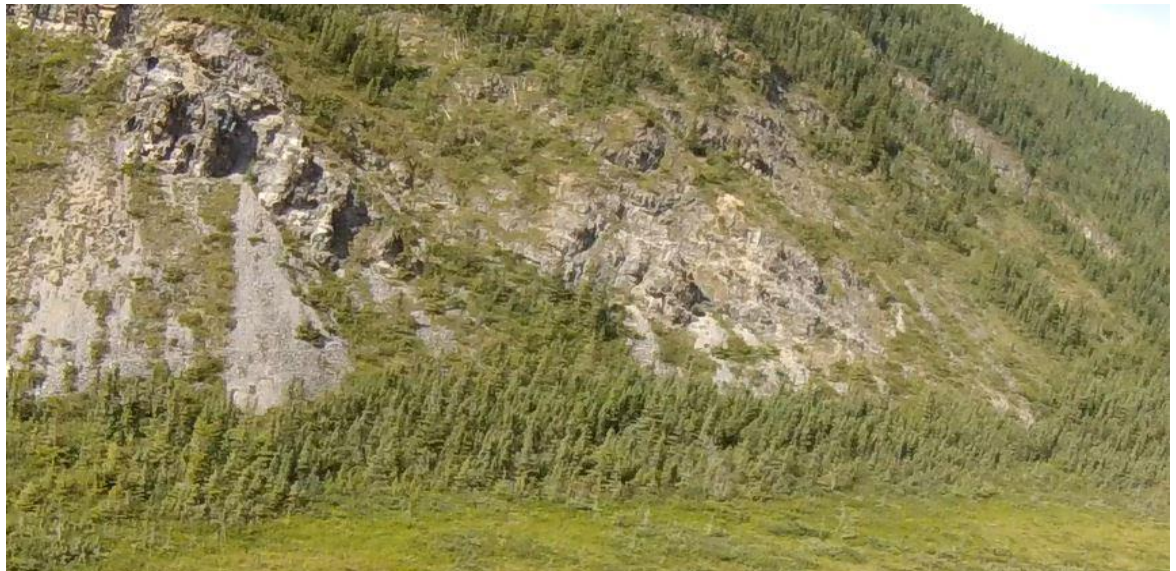
**Figure 76: At view of BP 125B with exposed bedrock and talus rock deposit at the base.**

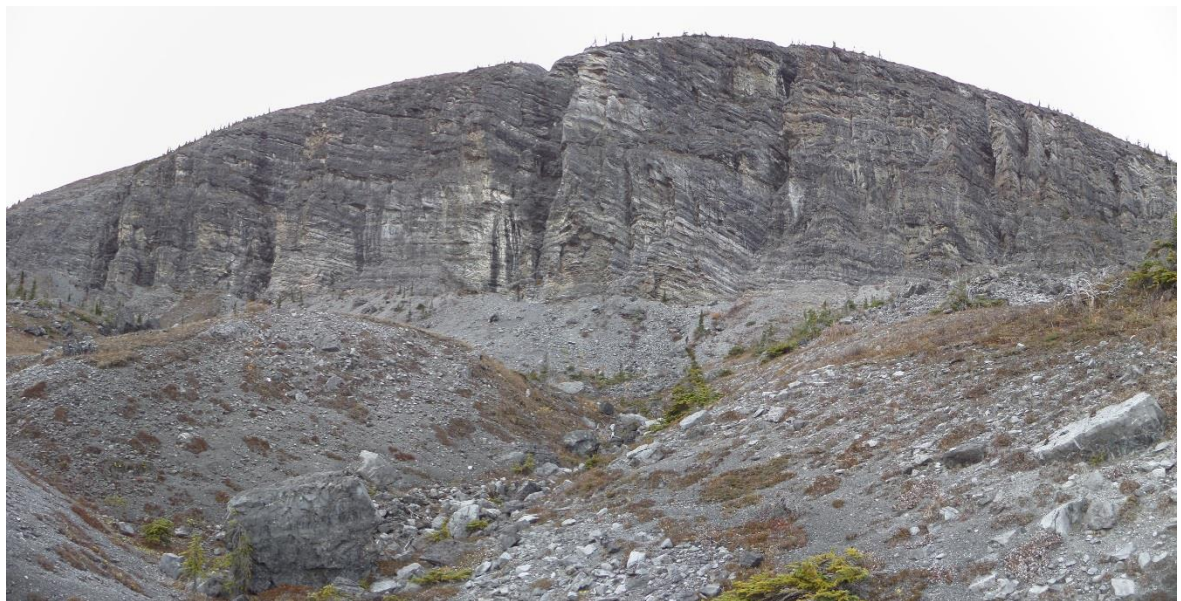
What appears to be a large limestone rockslide above the road at 126.40 km presents an opportunity to access naturally broken rock in a wide range of sizes, varying from large riprap down to fine rubble. The toe of this slide is about 250 m above the road, and it extends another 500 m uphill toward the originating bedrock cliffs. There is an extensive supply of broken rock in this formation, and it doesn't require expensive blasting to produce it – just

When viewed in the field, this formation has all the appearances of a run-out zone from a large past rockslide, but when viewed on satellite photos the toe of the slide seems to have some appearance of “flowing” material. This raised the question of whether this rubble formation is actually a rockslide deposit or a rock covered glacial remnant, and a subsequent field inspection of the surface debris failed to provide a clear answer to that question. It would be necessary to conduct some subsurface excavation to determine if there is ice present in, or under the rubble. If the formation is the remnant of a glacier, the lower toe of the formation may still provide ample thawed rubble material that has resulted from past ice retreat from subsequent melting.

**Figure 77: View of the top end of rubble source and the near vertical limestone cliff it originated from.**

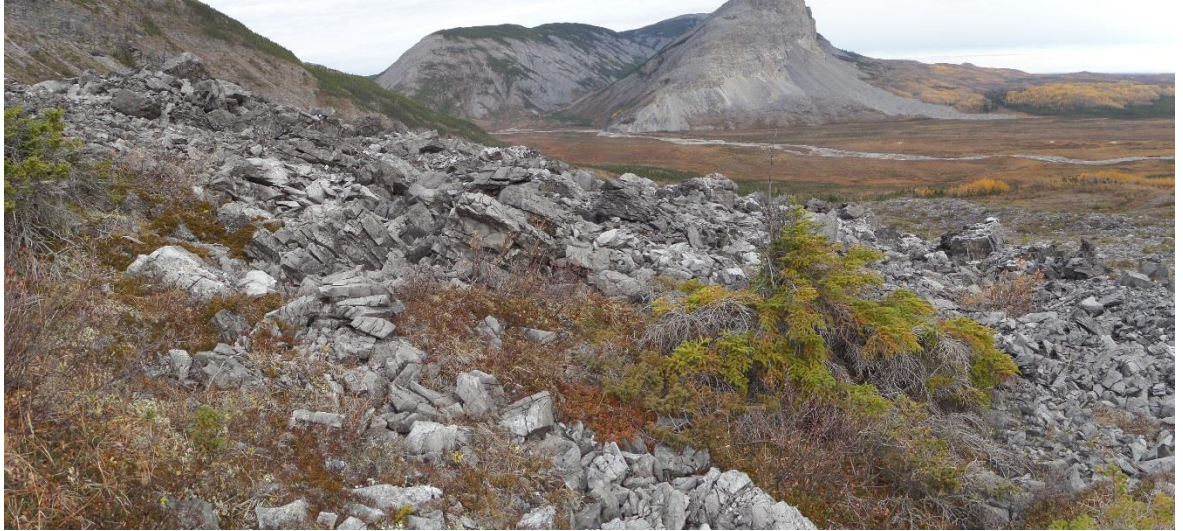
If the formation is just rockslide debris, there is potential to save the substantial costs of drilling and blasting nearby bedrock to generate riprap sources for the many stream crossings within economic haul range. The finer rubble would also be ideal for subgrade construction across the many lowland areas nearby, especially over areas of permafrost due to its light, solar reflecting color. If, during the construction of the new winter road, there is an opportunity to probe this location, it would provide a definitive answer as to the material core properties of this formation, and indicate its suitability for providing construction materials.

**Figure 78: Limestone colluvium rock gradation available at the middle of the rubble slope.**

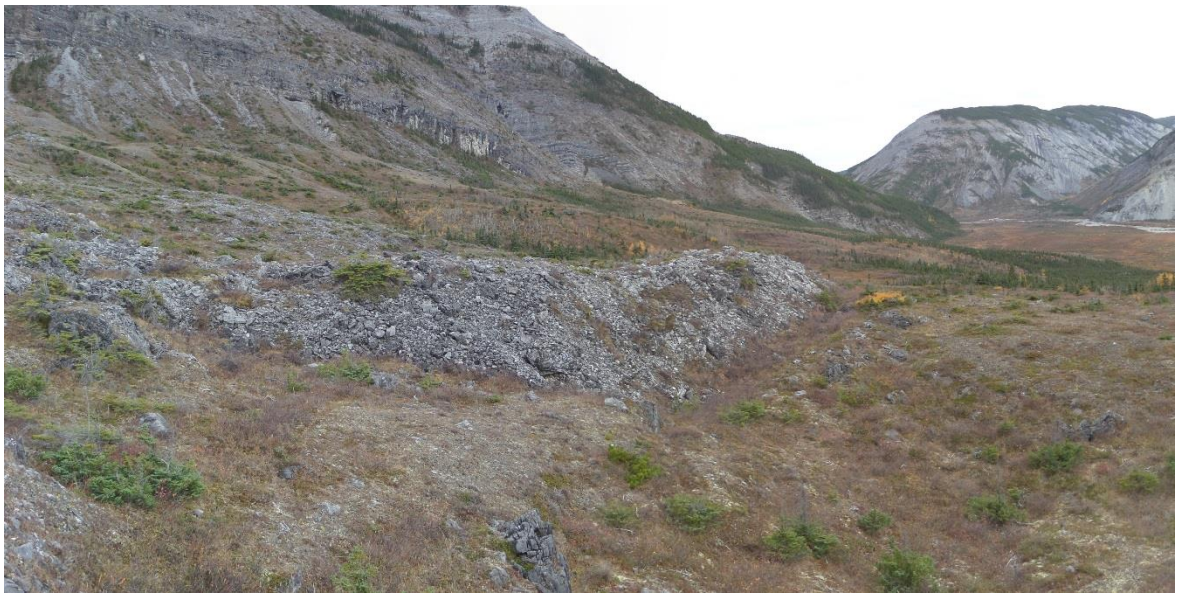
**Figure 79: Finer material evident at the toe of the rubble slope. If the rubble pile is a rock glacier, this portion may be ice free now, as it is at the terminal end of the debris field.**

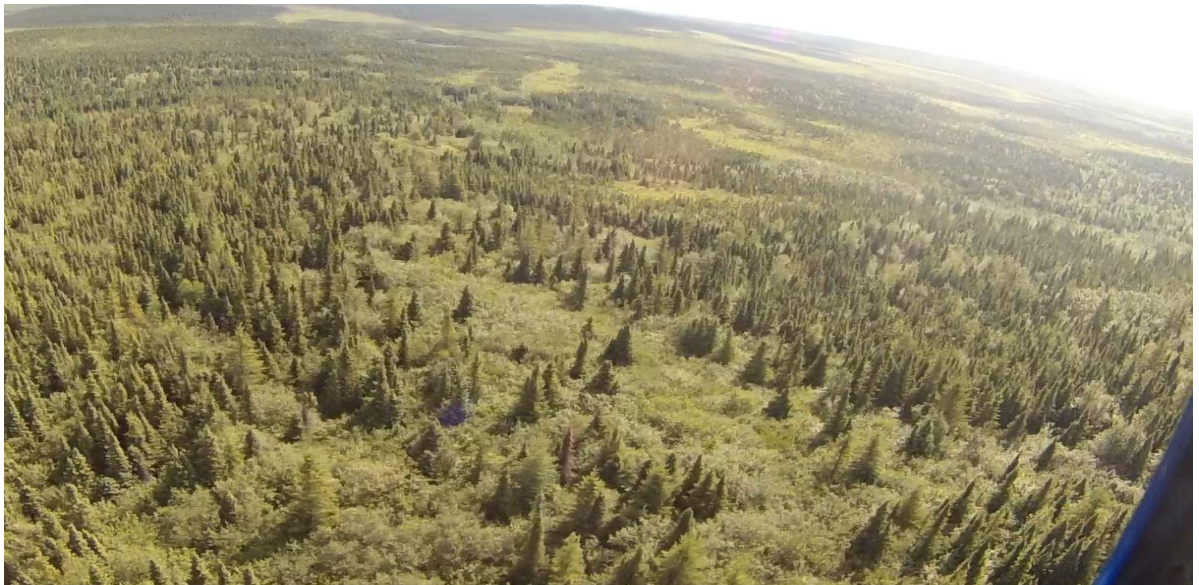
### **1.59 Km 129.2 – BP 132 – Clay/Silt Till**

Clay till borrow material for subgrade overland construction. Expect permafrost around the perimeter.

**Figure 81. View of the vegetation cover at BP 132.**

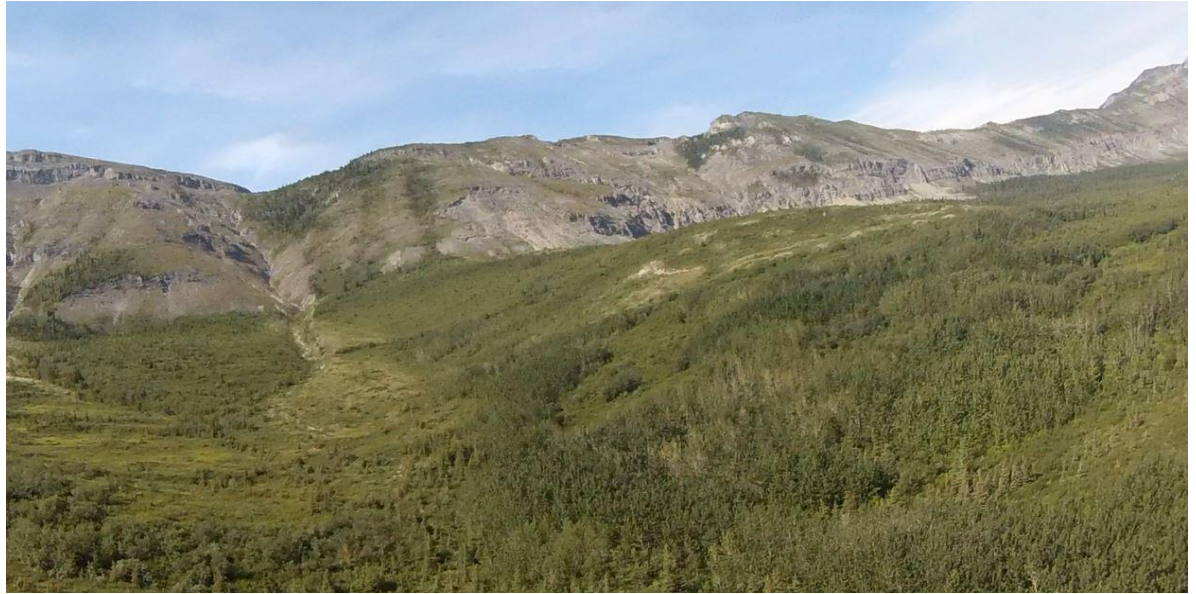
**Figure 82 View looking west from the proposed road location. Limited alluvial gravels located in bottom of draw and exposed outcrops of limestone bedrock upper portions. Side slopes (on the lower right) could provide suitable clay/silt/sand till borrow material for subgrade construction.**

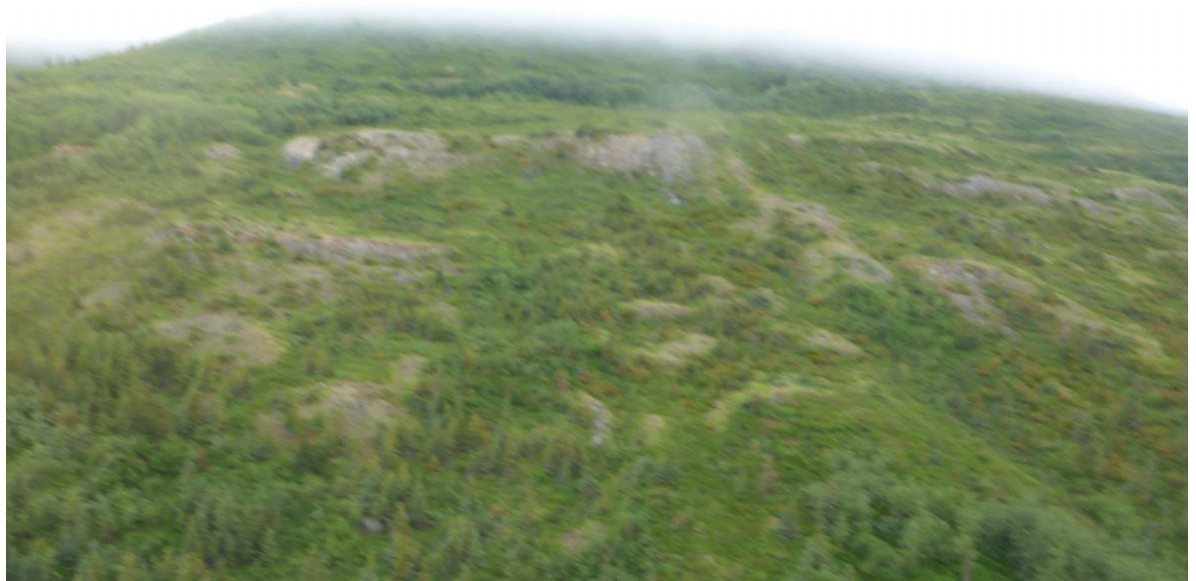
### **1.61 Km-134.90 BP 138 – Exposed Limestone / Carbonate Bedrock**

BP 138 contains exposed limestone rock outcrops which could be blasted and crushed for surfacing material. Requires a 1.2 km access road.

**Figure 83. A view of the exposed limestone rock outcrops.**

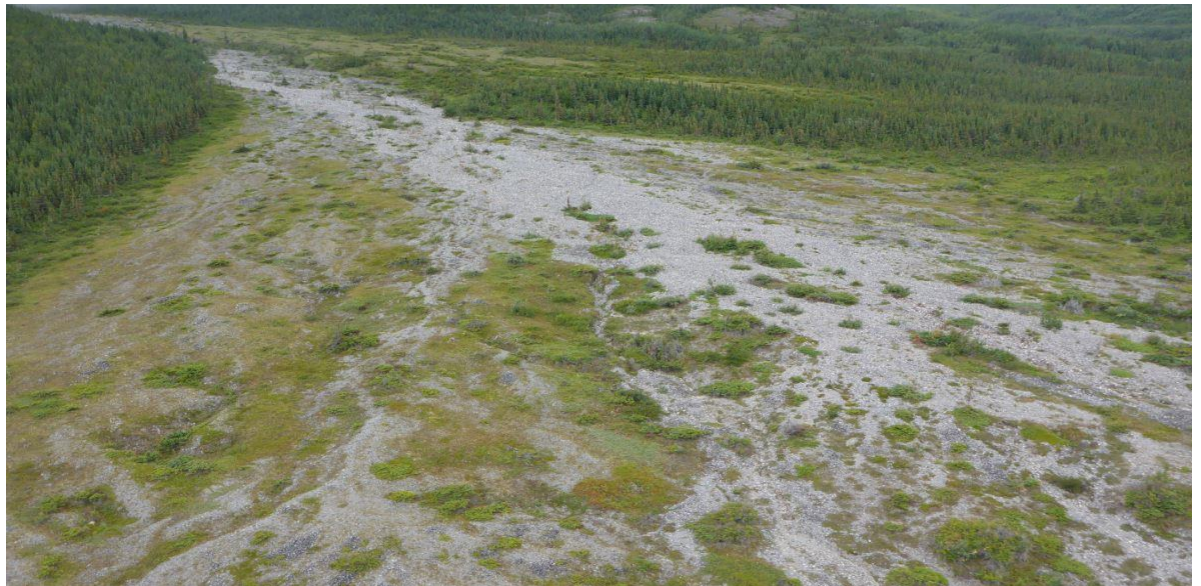
## **1.62 Km 136.50 – BP 139 - Alluvial Cobble and Gravels - Carbonates**

A large alluvial fan deposit originating from the nearby Nahanni Range in the west. As with much of the other alluvial cobble noted along the route, this source appears to originate from competent carbonate bedrock, making them an environmentally friendly and preferred construction material. Seasonal stream flows during spring thaw. Detailed design would maintain natural drainage channels.

Sufficient volume and area for setting up a crushing plant and for holding stockpiled materials. This area could support aggregate material for long term road maintenance. Requires 2.0 km access road.

**Figure 84. An aerial view of the vast alluvial fan deposit at BP 139.**

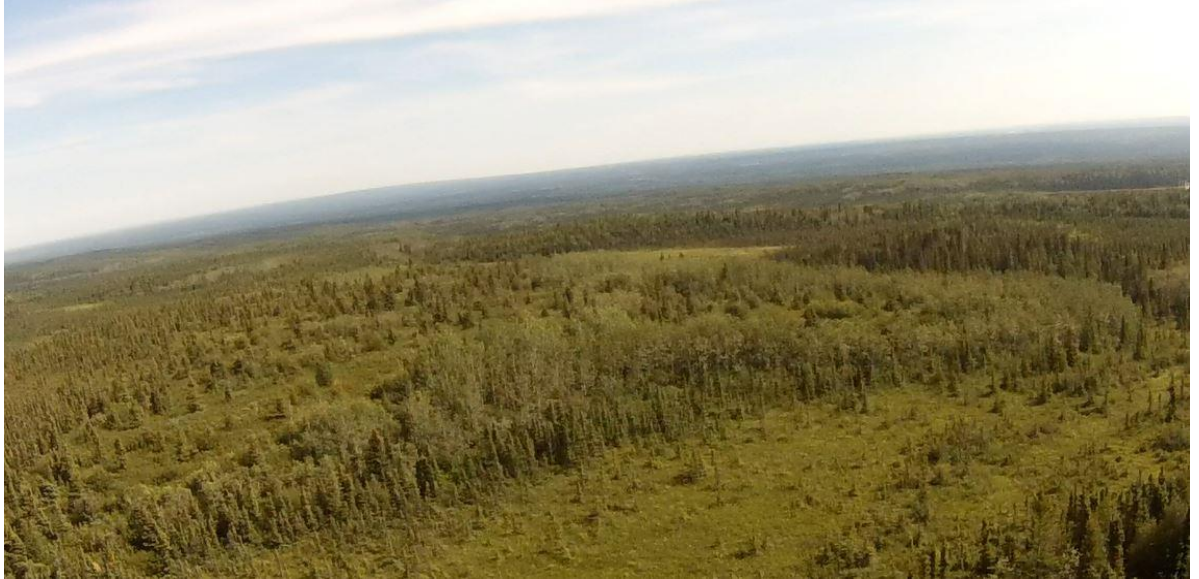
## **1.63 Km 136.90 – BP 140 – Clay/Silt Till**

Back-up clay/silt/sand till borrow material for subgrade overland construction. Potential permafrost surrounding perimeter.

**Figure 85. A raised knob vegetated with mature aspen/cottonwood could provide suitable backup borrow material for subgrade construction.**

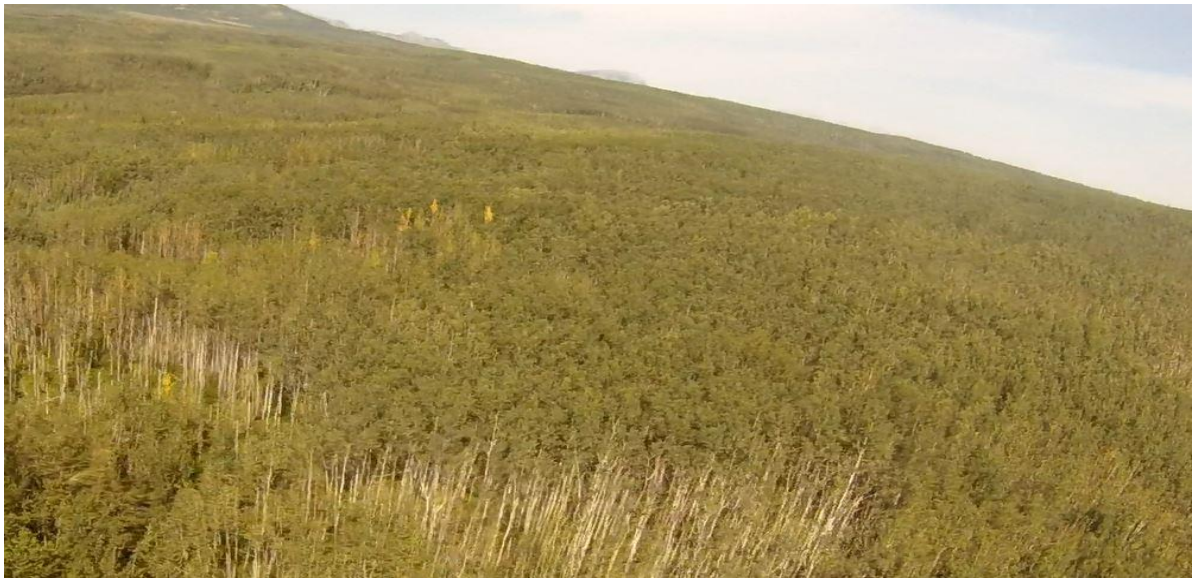
#### **1.64 Km 140.5 – BP 143 – Clay/Silt Till**

Back-up clay/silt/sand till borrow material for subgrade overland construction.

**Figure 86. Mature aspen covers the proposed backup borrow material at BP 143.**

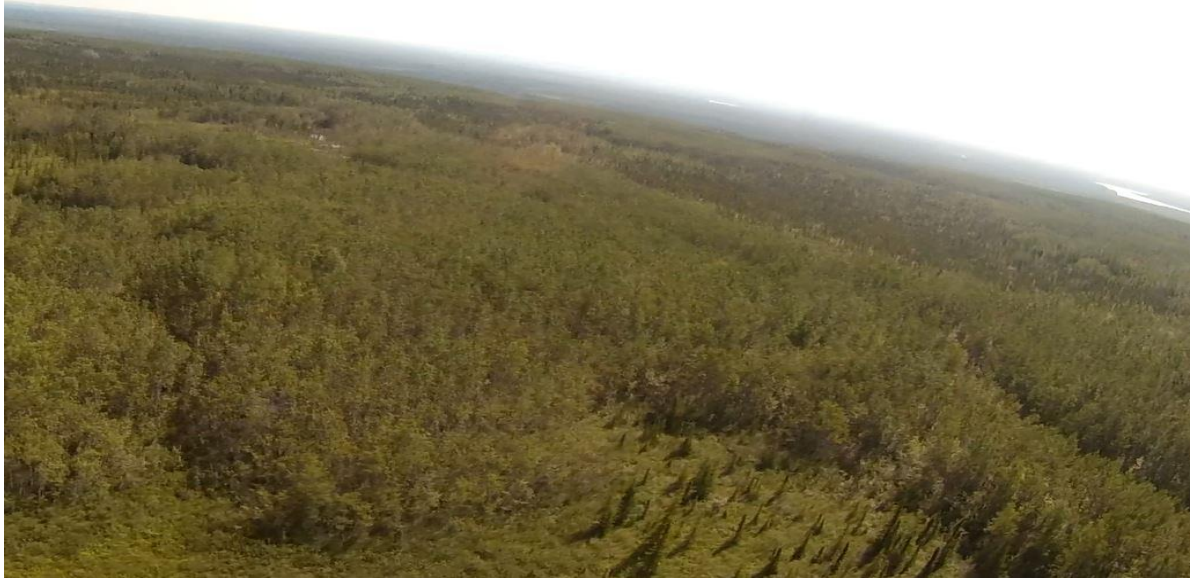
**Figure 87. A view of BP 146.**

Back-up clay/silt/sand till borrow material for subgrade overland construction.

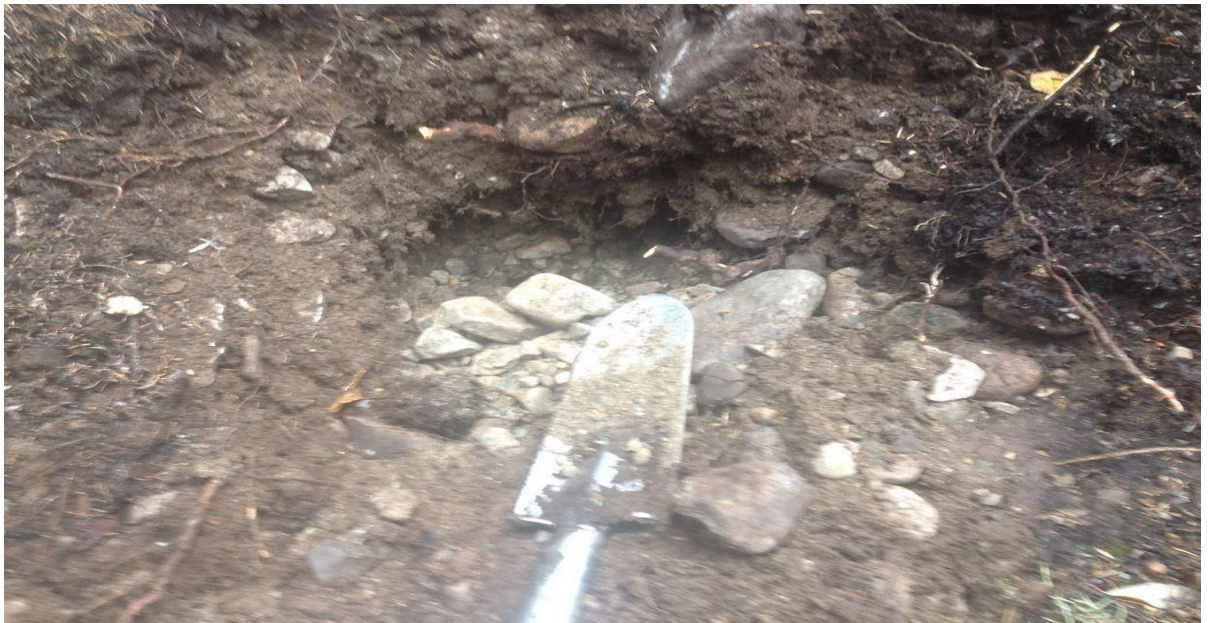
Must confirm depth and area but expect shallow source (2m deep) spread over a large fan. Some short access road(s) may be required to develop. A significant size (4m wide) seasonal stream divides the two defined patches. Probably requires crushing.

**Figure 88: One example of the gravel type material at BP 151.**

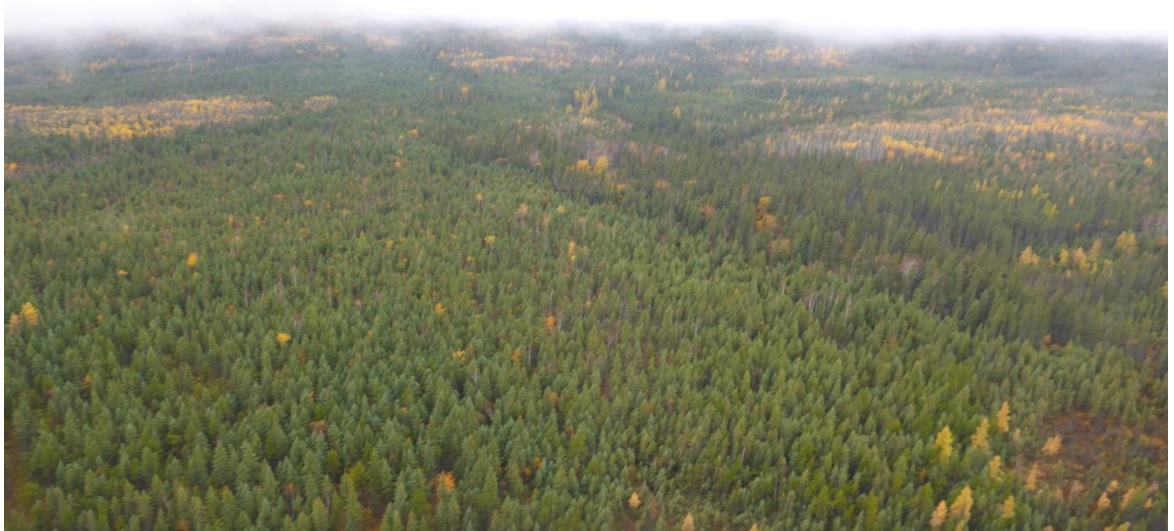
**Figure 89: An aerial view of the large fan at BP 151, KP 151.5.**

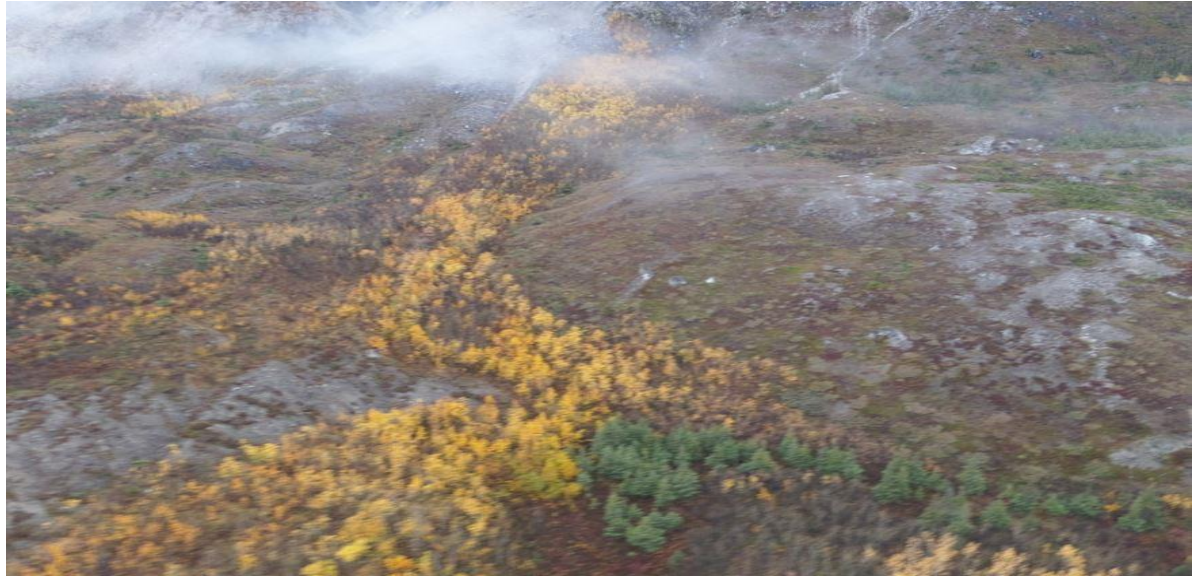
### **1.68 Km 154.50 – BP 158 - Limestone/Carbonate Talus Bedrock**

Excellent source of mixed talus rubble at the base of limestone/carbonate rock face/bedrock. A very strategic aggregate source to supply surfacing requirements and rip rap from KP 155 to 184. Assumes will be extracted by ripping and blasting quarry. Requires a 1.5 km access road.

**Figure 91: An aerial view of large deposit of talus rock at BP 158.**
