# **POST-EA INFORMATION PACKAGE INCLUDING AN UPDATED PROJECT DESCRIPTION ALL SEASON ROAD TO PRAIRIE CREEK MINE**

**APPENDIX 1-11: BORROW PIT SUMARRY**

## **APPENDIX 1-12**

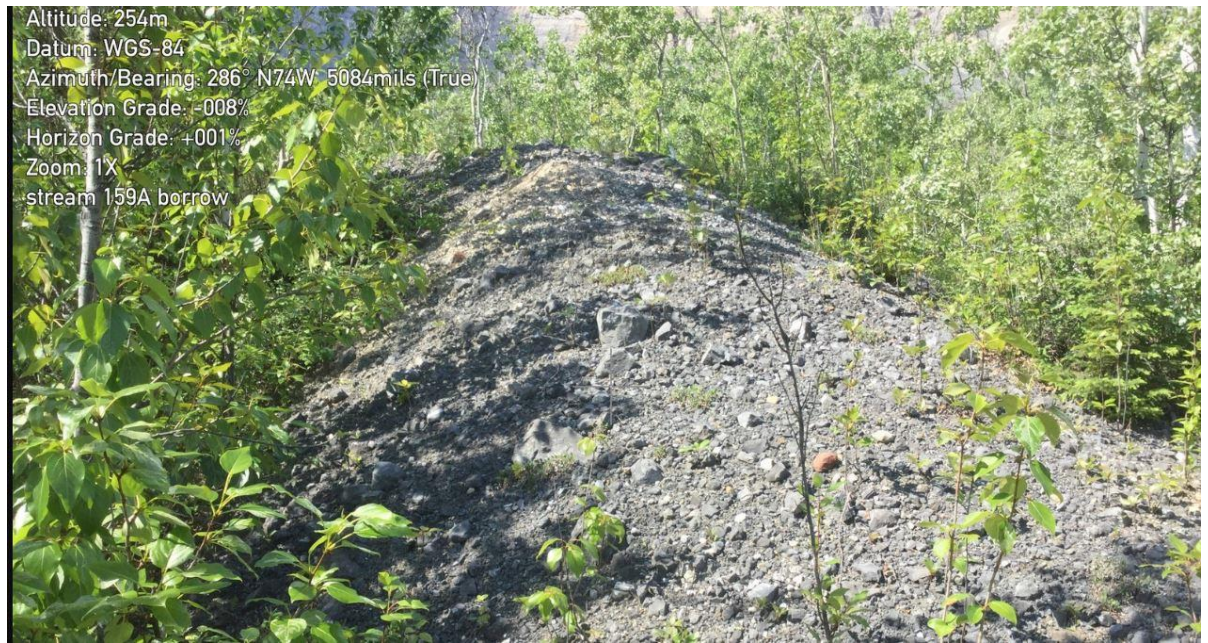
### **1.69 Km 155.0 – BP 159A – Rock Debris Deposit**

Similar type of material as BP 158 but more of a deposit mix of limestone based rocks, gravel, , not likely requiring blasting to extract material.. A detailed investigation to determine the potential and extent of the deposit must be completed. This source would be strategic location to serve aggregate requirements on both the north side and especially the south side of the Liard River where gravel sources are difficult to find.

**Figure 92: An example of material deposit at BP 159A.**

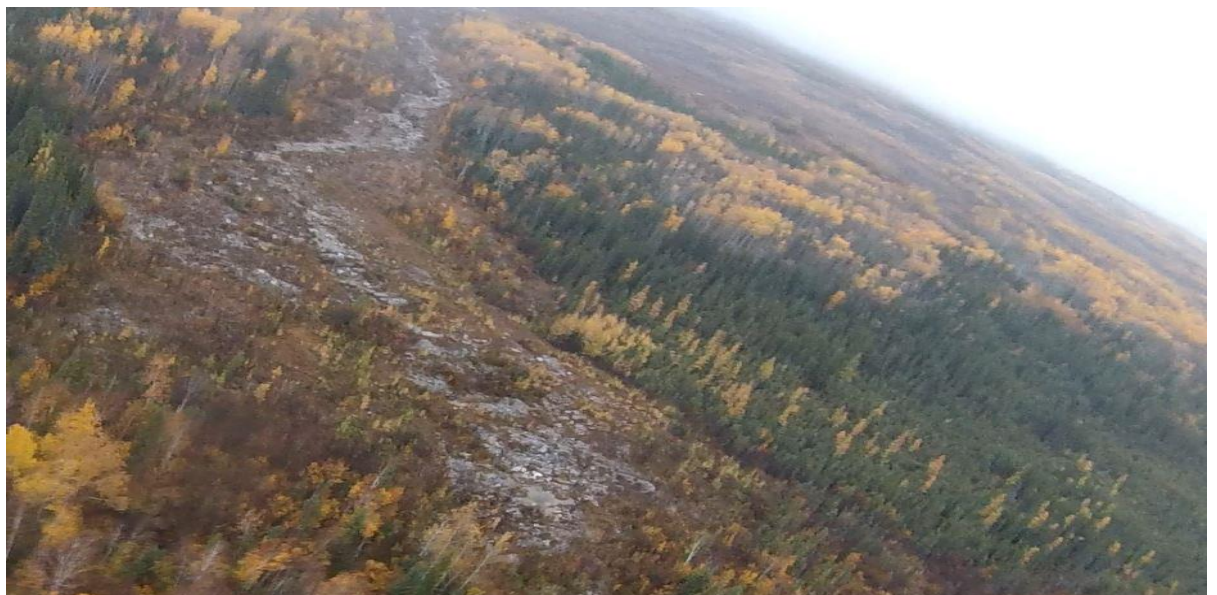
On the north side of the proposed Liard River landing/crossing exists a large debris/fan of rubble mix of limestone based rocks, gravel, mixed with clay. A detailed investigation to determine the potential and extent of the deposit must be completed. Likely not a large source of material, but close proximity to ASR works makes it attractive.

**Figure 93: An aerial view of the potential aggregate source just above the proposed north landing on the Liard River.**

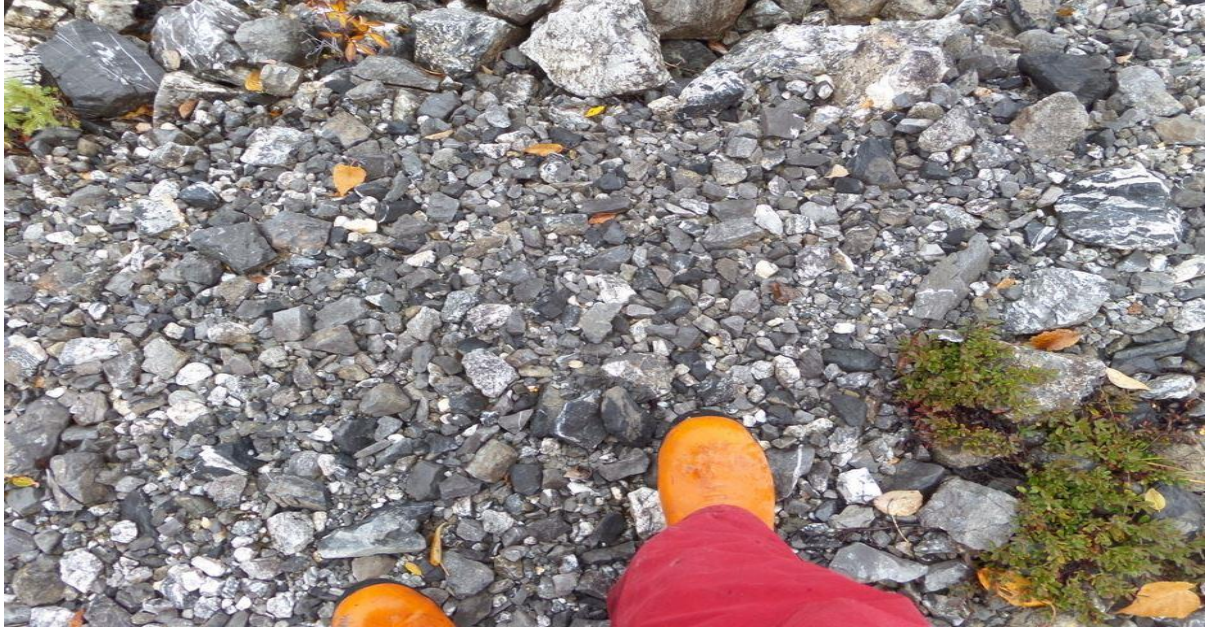
**Figure 94: On the surface, the material looks attractive but only additional investigation will determine the true potential of the source.**
