**Re: Land Use Permit MV2019X0008
Miscellaneous
Prosperous Lake Territorial Park, NT**

ENVIRONMENTAL INSPECTION REPORT

Location(s) Inspected:	Boat ramp installation in the Prosperous Lake Territorial Park.
------------------------	---

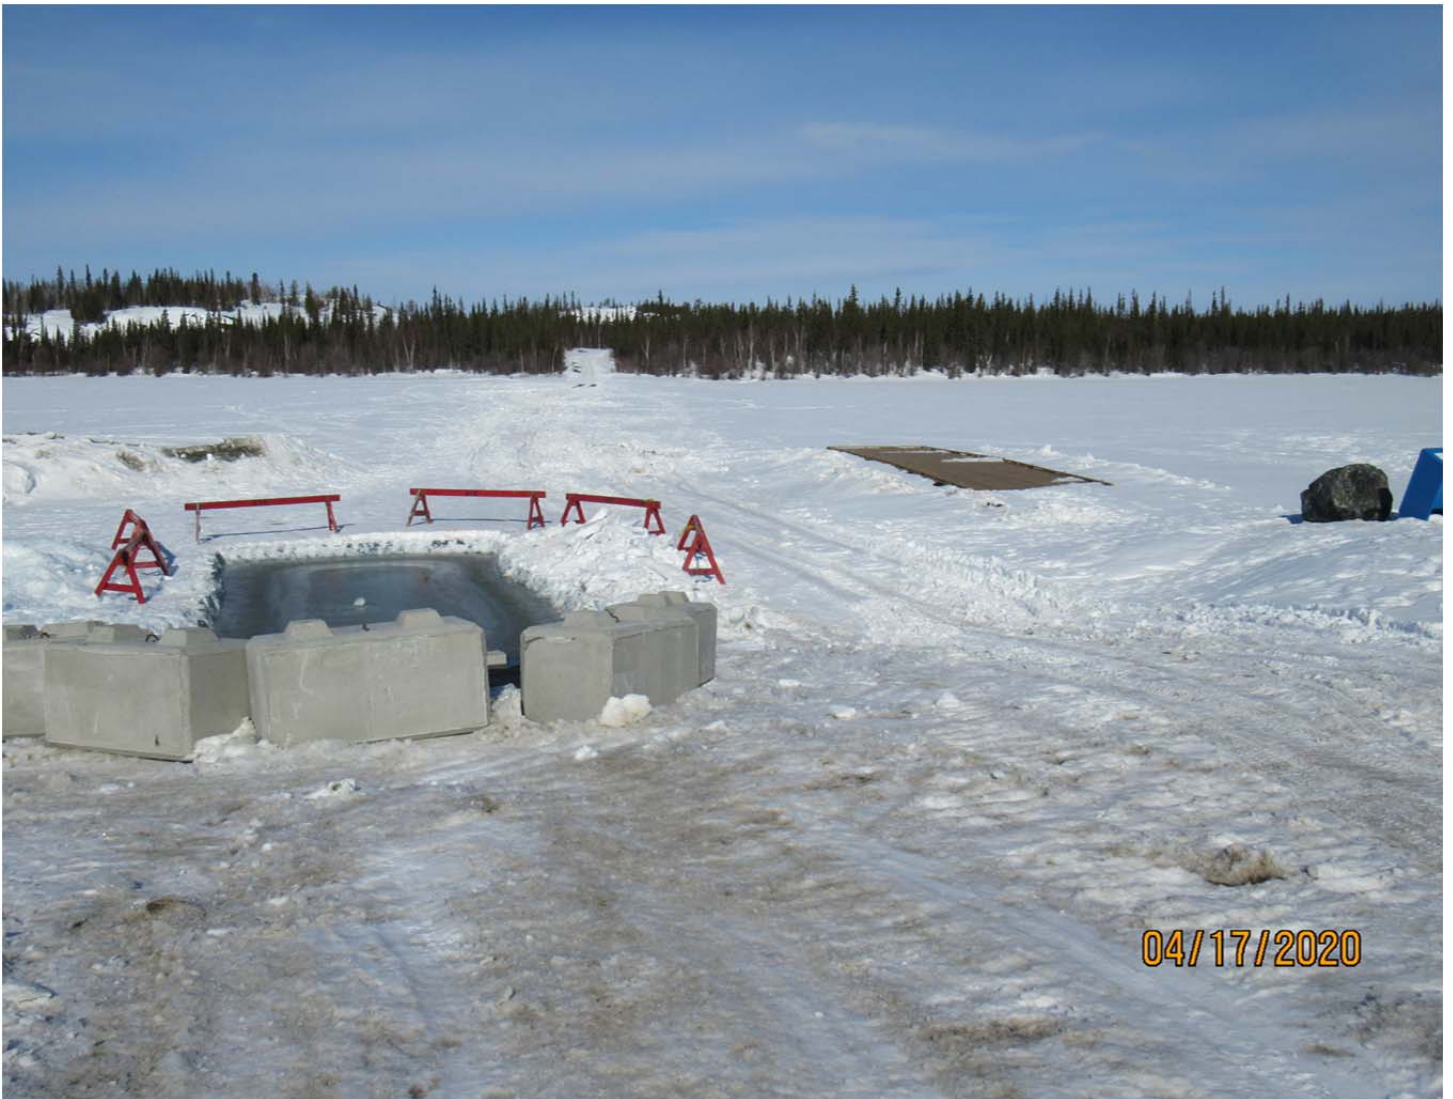
All aspects of operations were discussed with Mr. Houghton and as seen in Photo #1 & #2, the placement of the geotextile fabric and concrete boat ramp was complete. The Inspector was informed that all work was completed in the "dry" and the water that can be viewed in the photographs seeped into the work site after placement of the boat ramp. Inspectors are pleased to report that the water viewed had no suspended sediments (TSS) and turbidity didn't appear to be a concern from a water quality perspective.

Photo #1 - MV2019X0008 - GNWT-ITI - Prosperous Lake Territorial Park
Looking west at the newly installed boat ramp and existing infrastructure at the Prosperous Boat Launch.

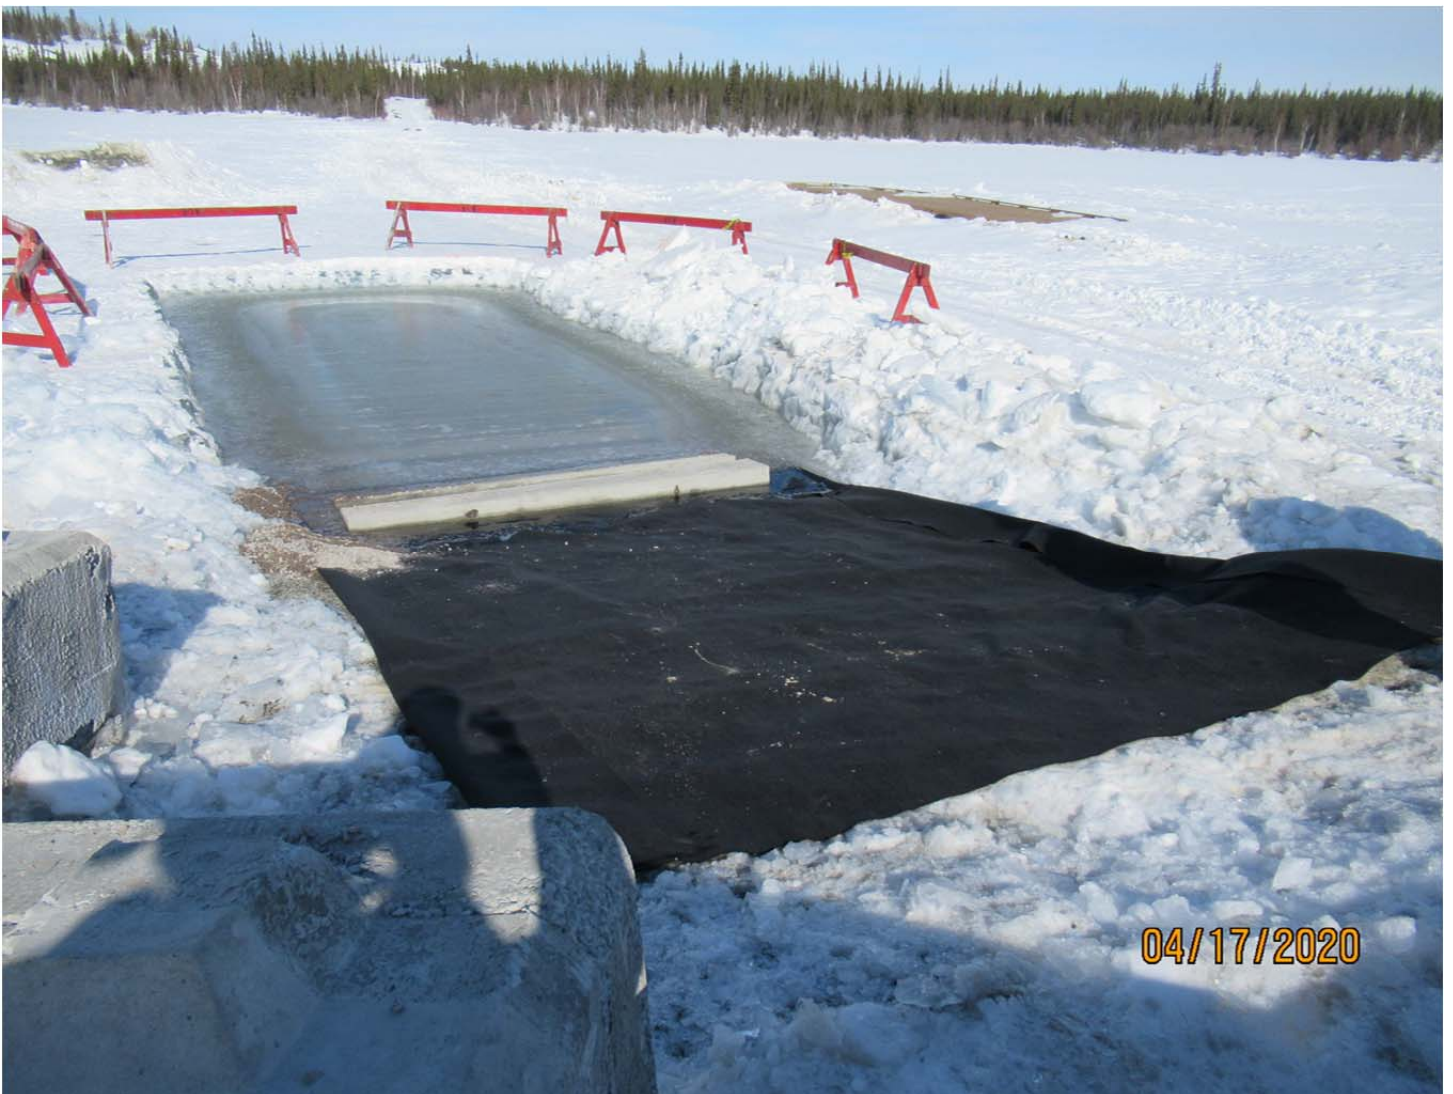
Photo #2 - MV2019X0008 - GNWT-ITI - Prosperous Lake Territorial Park
Geotextile fabric and concrete boat ramps have been installed south of the existing ramp & dock.

With the exposed geotextile fabric, the Inspector discussed covering this material with Mr. Houghton and was informed that this work will be completed in open water season with adherence to all requirements of Water Licence MV2019L8-0005. The Inspector posed the question on whether or not the stockpile of granular material viewed in Photo #4 would be utilized since it is ¾" minus crush.

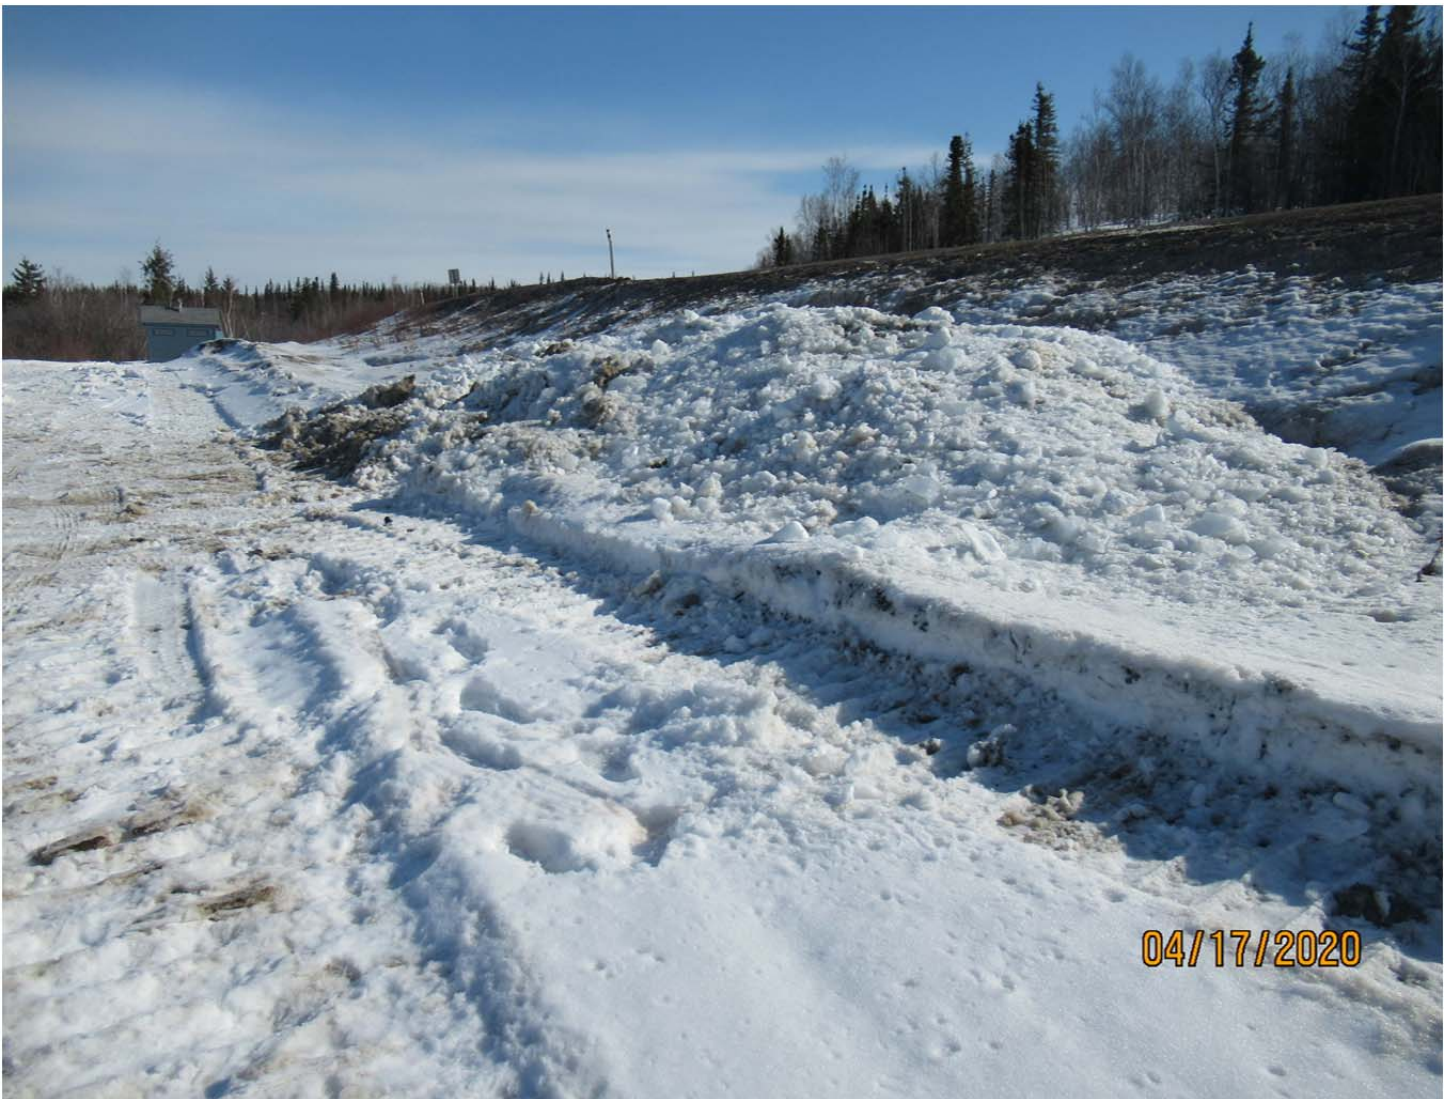
The excavation of the ice for the placement of the boat ramp was discussed with Mr. Houghton and the Inspector was informed that during the excavation lake bottom sediments were left in place to minimize the potential for an environmental concern to arise. Also, excavated ice was trammed with a loader to the east side of the parking lot (Photo #3) for disposal to reduce flows or potential sedimentation concerns from arising during the spring melt.

Photo #3 - MV2019X0008 - GNWT-ITI - Prosperous Lake Territorial Park
Excavated ice was trammed with a loader from the work site to the east side of the parking lot.

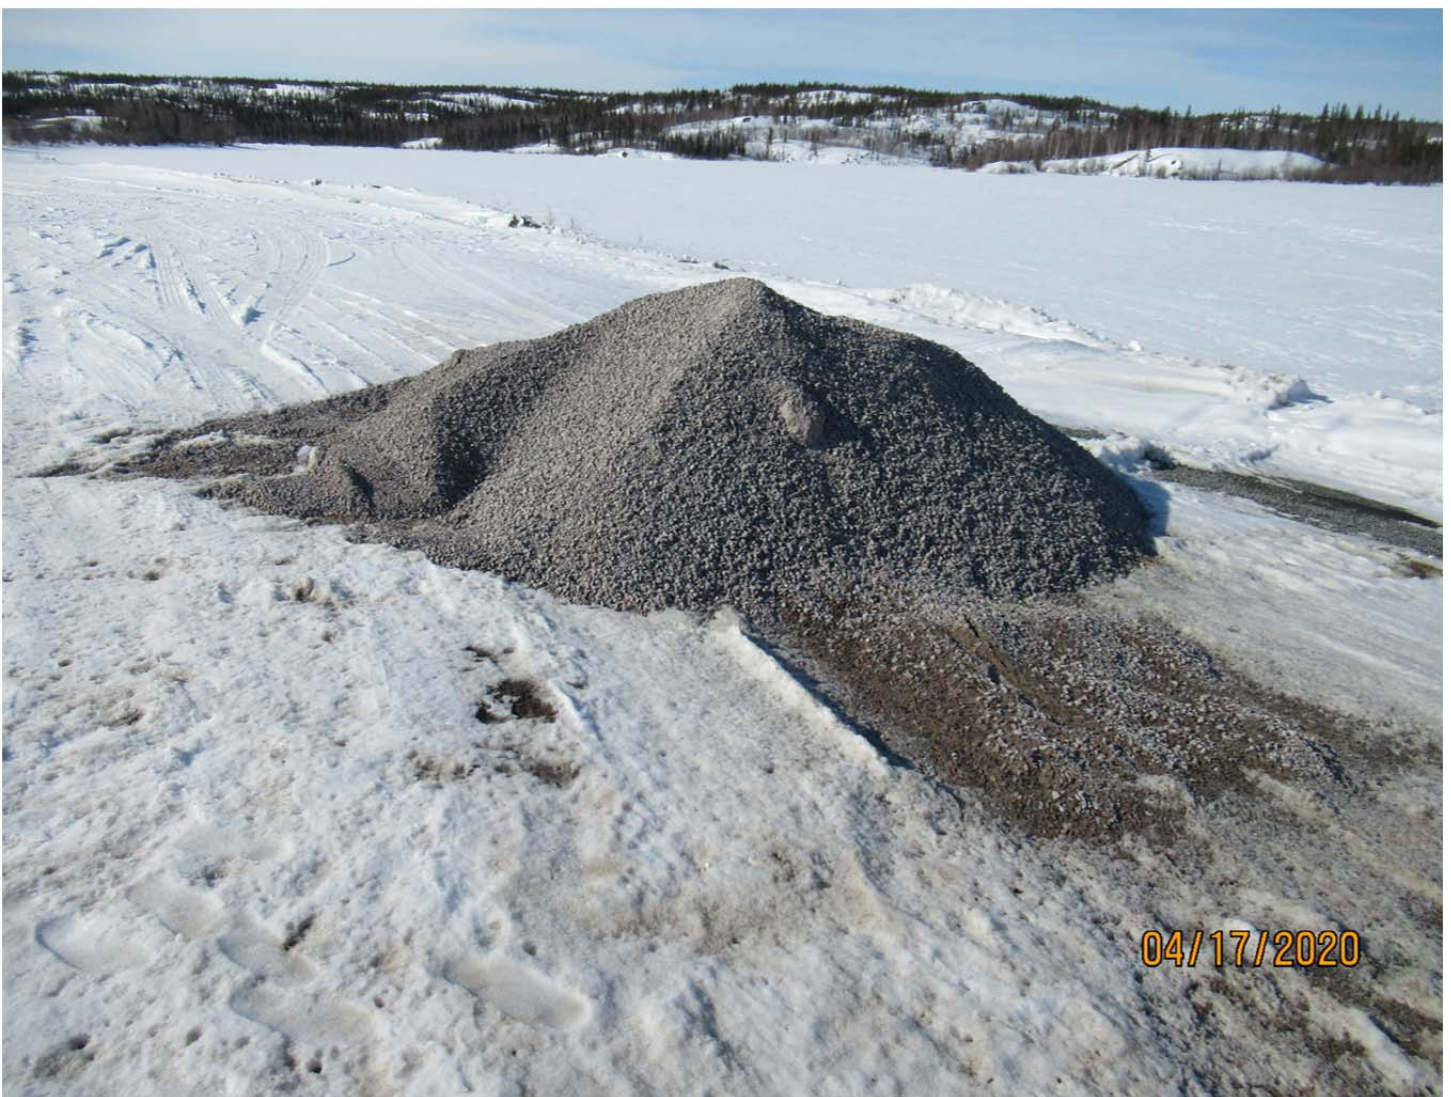
Photo #4 - MV2019X0008 - GNWT-ITI - Prosperous Lake Territorial Park
A stockpile of 20 mm blend remains on site.

Since the stockpiled material contains fines, the Inspector has requested that ¾" clean crush be utilized for placement on top of the geotextile fabric since it will reduce the likelihood of a large sediment plume from occurring. Mr. Houghton confirmed that this product is available and will be used. This cooperation to comply with the request of an Inspector is appreciated.
