File Number MV2019X0027
Type of Operation MISC.
Location KM 6 Camp and Fuel Storage Area

ENVIRONMENTAL INSPECTION REPORT

Permittee:	Yukon Gov. Dept. of Highways and Public Works	Permit Expiry Date:	August 30, 2025
Land Use Permit No.	MV2019X0027	Previous Inspection:	July 18, 2023
Quarrying Permit No.		Inspection Date:	August 09, 2023
Contractor:		Subcontractor:	
Location(s) Inspected:	KM 6 Camp and Fuel Storage Area		
Current Stage of Operation:	On-going		
Program Modifications Approved:

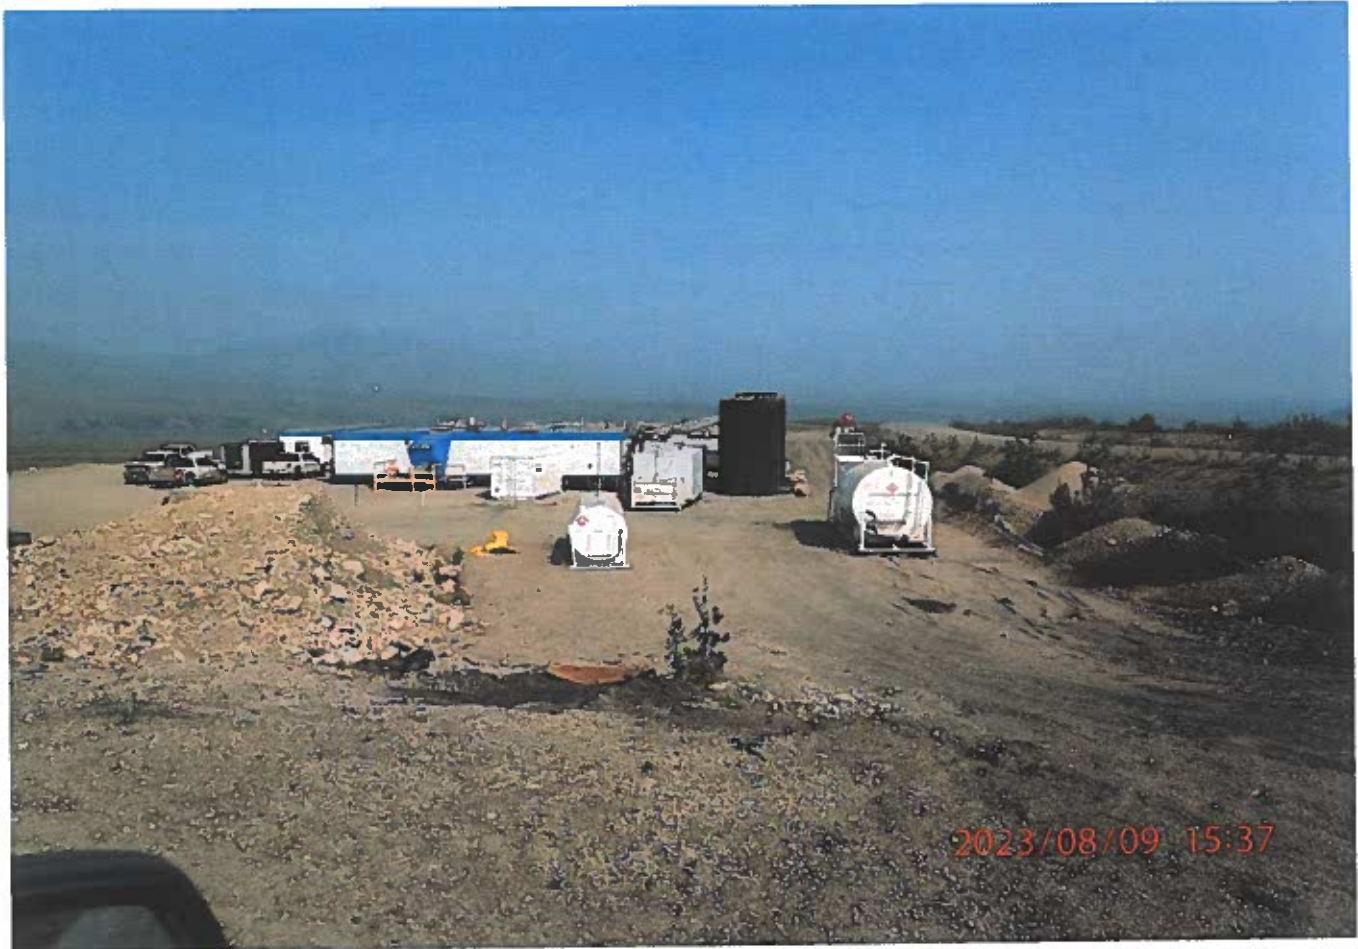
Figure 1

During the inspection there were a few concerns regarding the fuel and waste fuel management. Near the south side of the camp site there were two big petroleum storage tanks, one of them with a capacity exceeding 34,000 liters that did not have the pump handles secured and did not have a secondary spill containment tray for re-fueling equipment (see figure 2). The other concern was regarding waste oil near the west edge of the camp site that did not have any secondary spill containment (see figure 3). The Inspector notified Gary from Rohl (the contractor) prior to leaving and the issues were taken care of immediately.

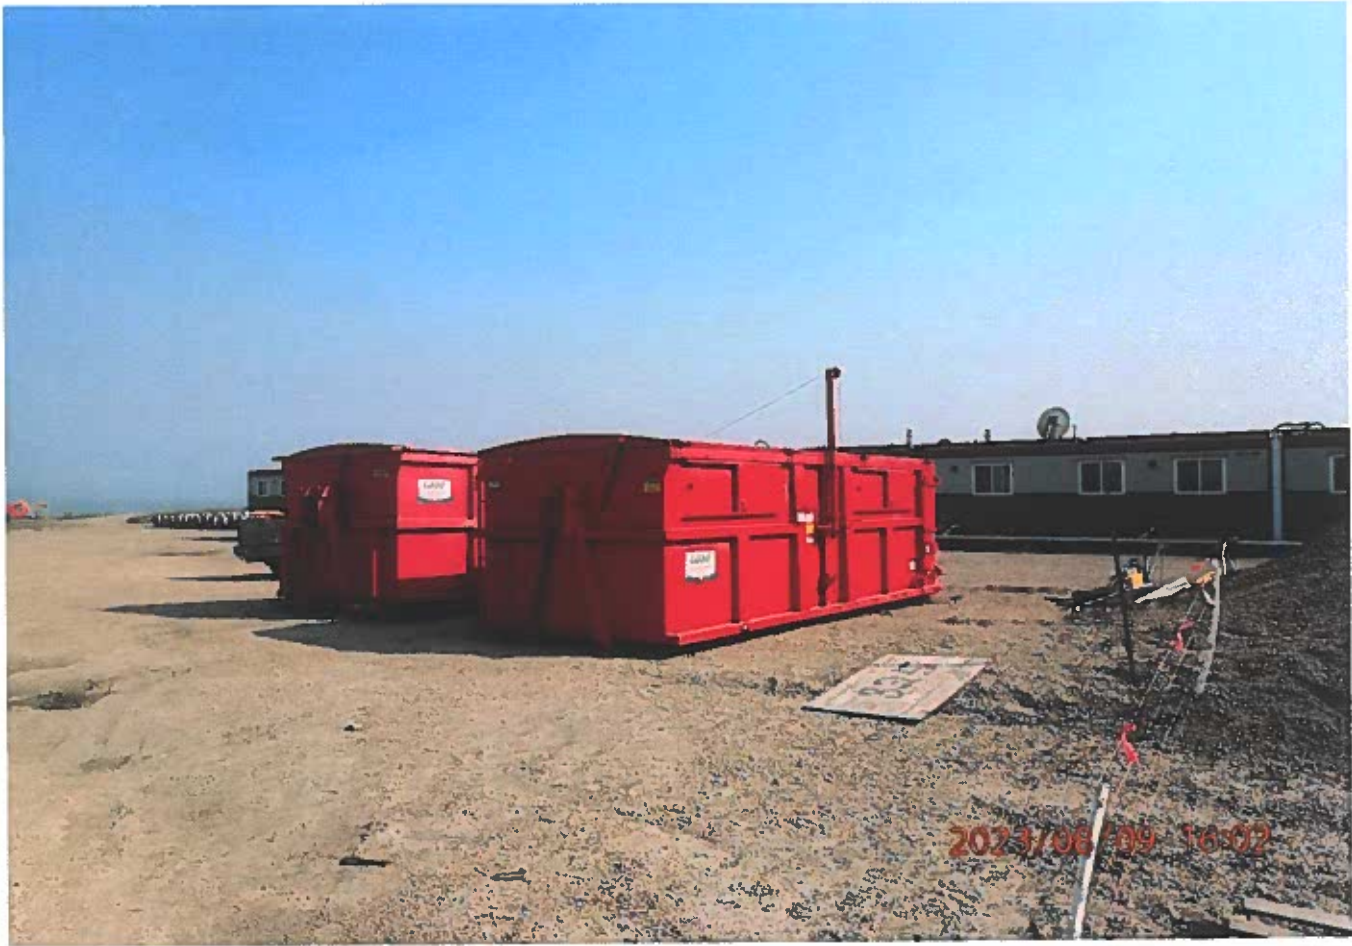
Figure 5

The rest of the operation was clean and organized with Rohl managing the solid waste quite well with two large bins (see figure 5) and a burner for combustibles (see figure 6).
