Closure and Reclamation Plan

Liard West, Northwest Territories

February 2024

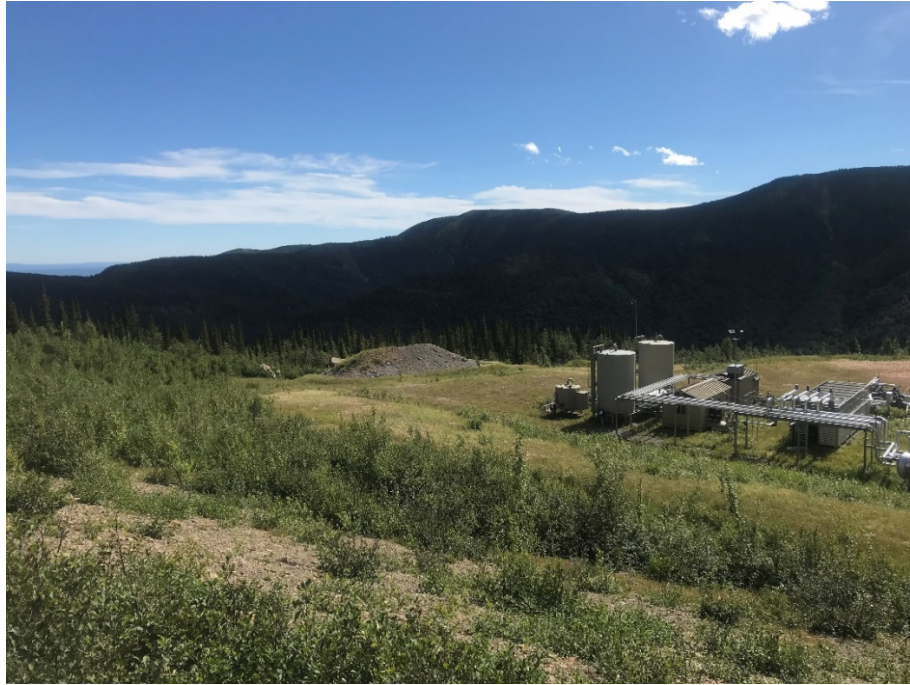
PHOTOGRAPH 1: Overview of M-25 site, facing northwest. Two above ground storage tanks can be seen near the west side of the site. A stockpile is located near the west boundary of the site (2022).

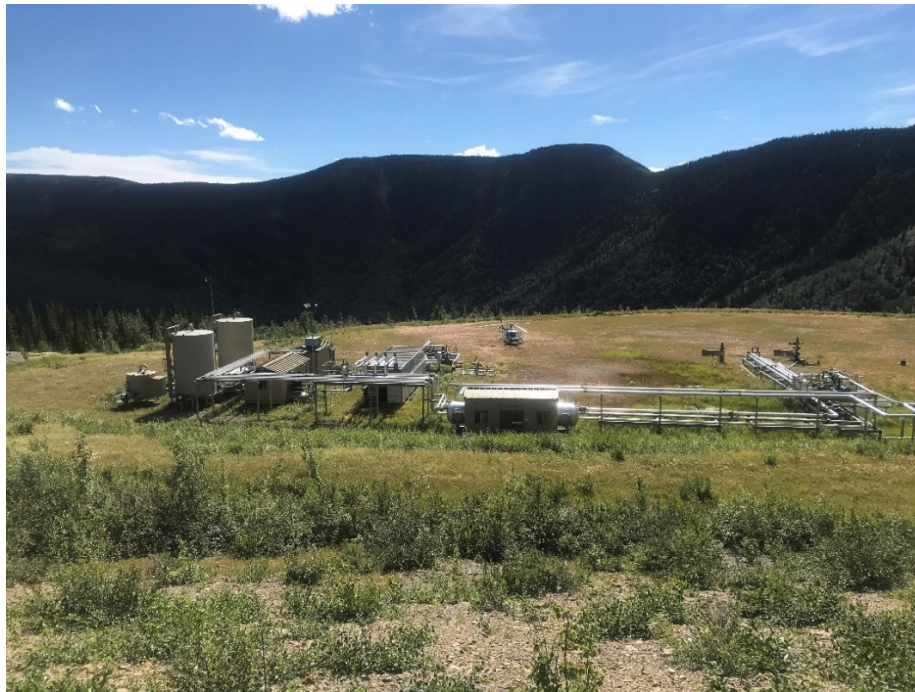
PHOTOGRAPH 2: Overview of the M-25 site, facing north. Two above ground storage tanks are visible on the west side of the facilities. Wellheads M-25 and 2/M-25 can be seen in the center of the site (2022).

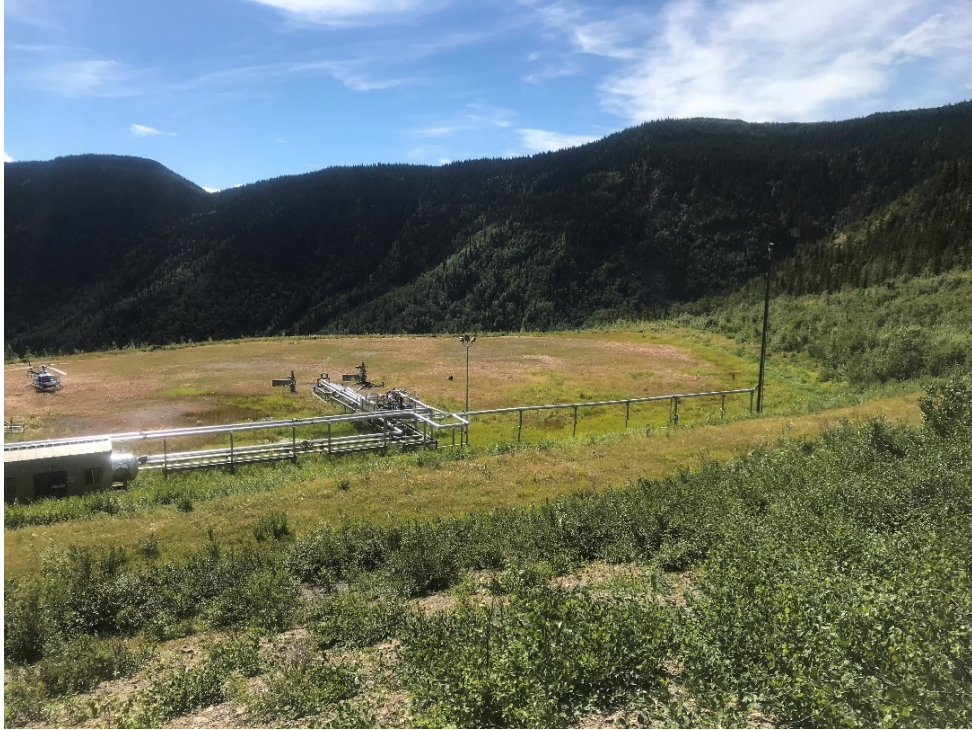
PHOTOGRAPH 3: Overview of M-25 site, facing northeast. Wellheads M-25 and 2/M-25 can be seen in center of the site. A flare stack is visible on the east side of the site (2022).

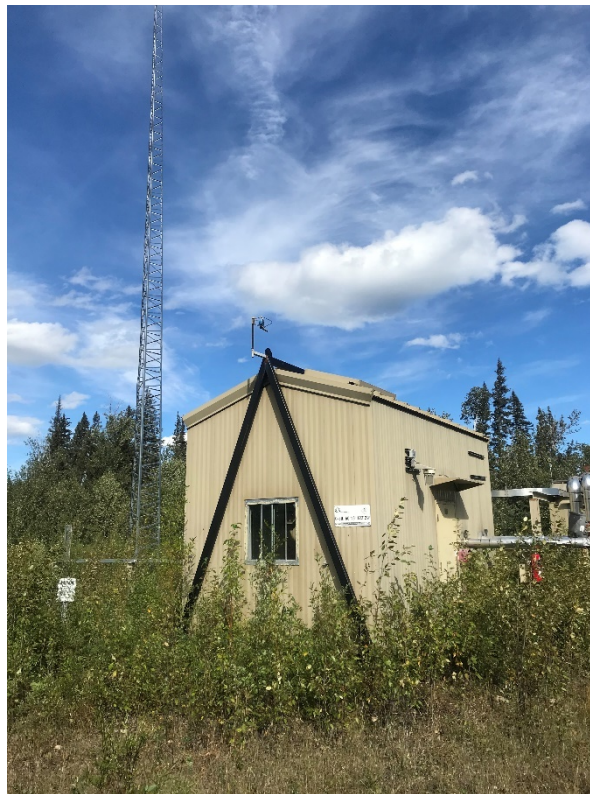
PHOTOGRAPH 8: Radio tower and facility housing the O-80 wellhead, facing east (2022).

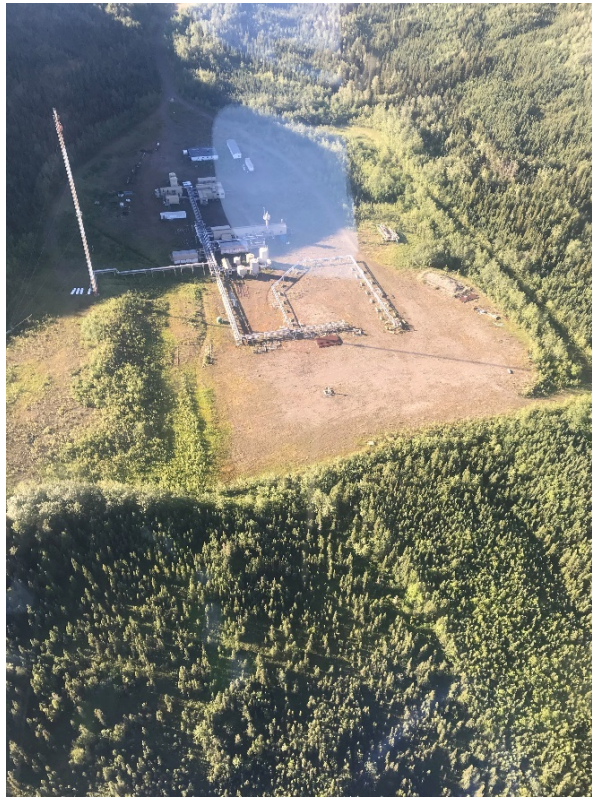
PHOTOGRAPH 11: Aerial overview of K-29 site, facing south. Site access can be seen on the south side of the site (2022).

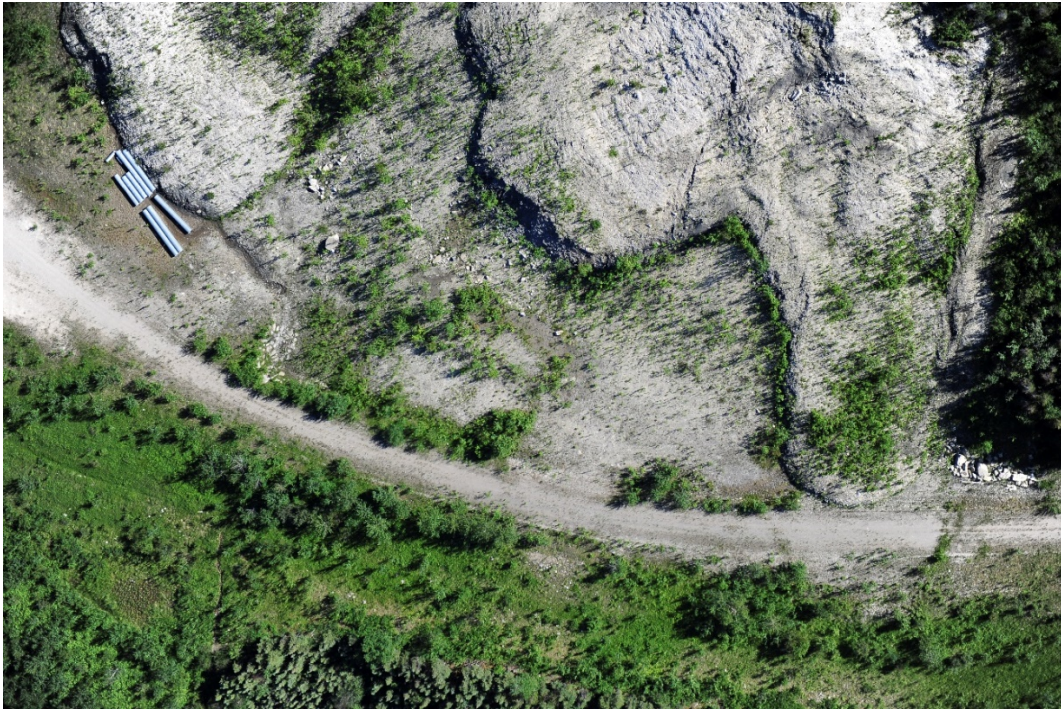
PHOTOGRAPH 13: Aerial image of culverts being stored adjacent to access road to site K-29 (July 11, 2017).

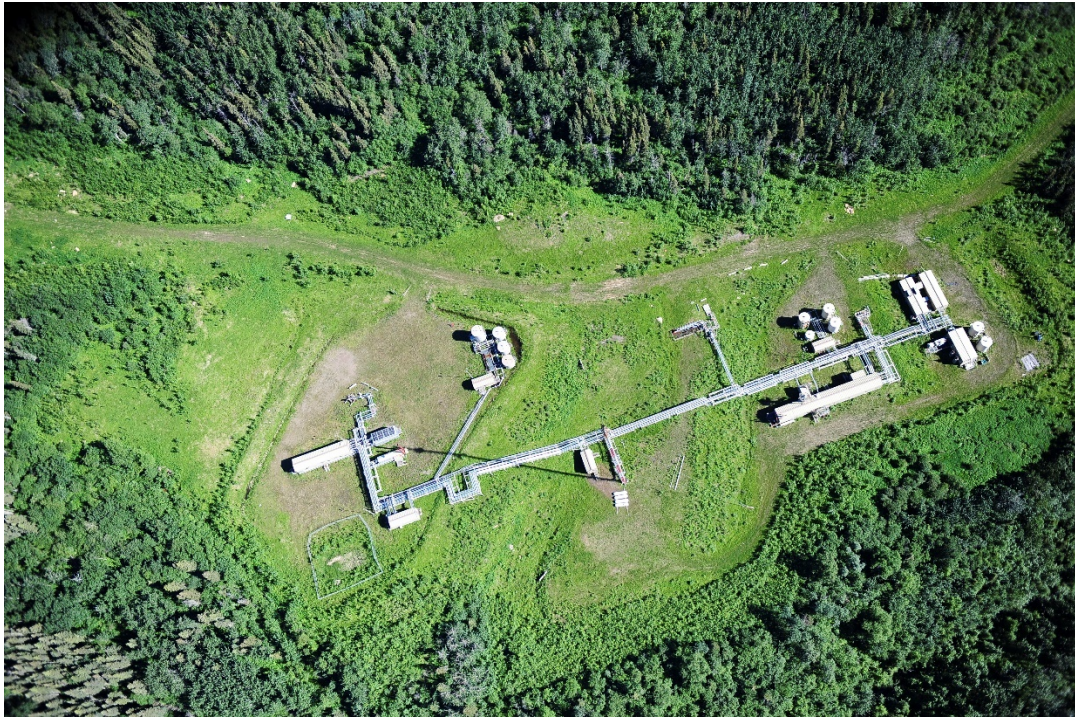
PHOTOGRAPH 17: Aerial overview of F-25 site and access running east west along the north side of the site, facing northeast (July 11, 2017).

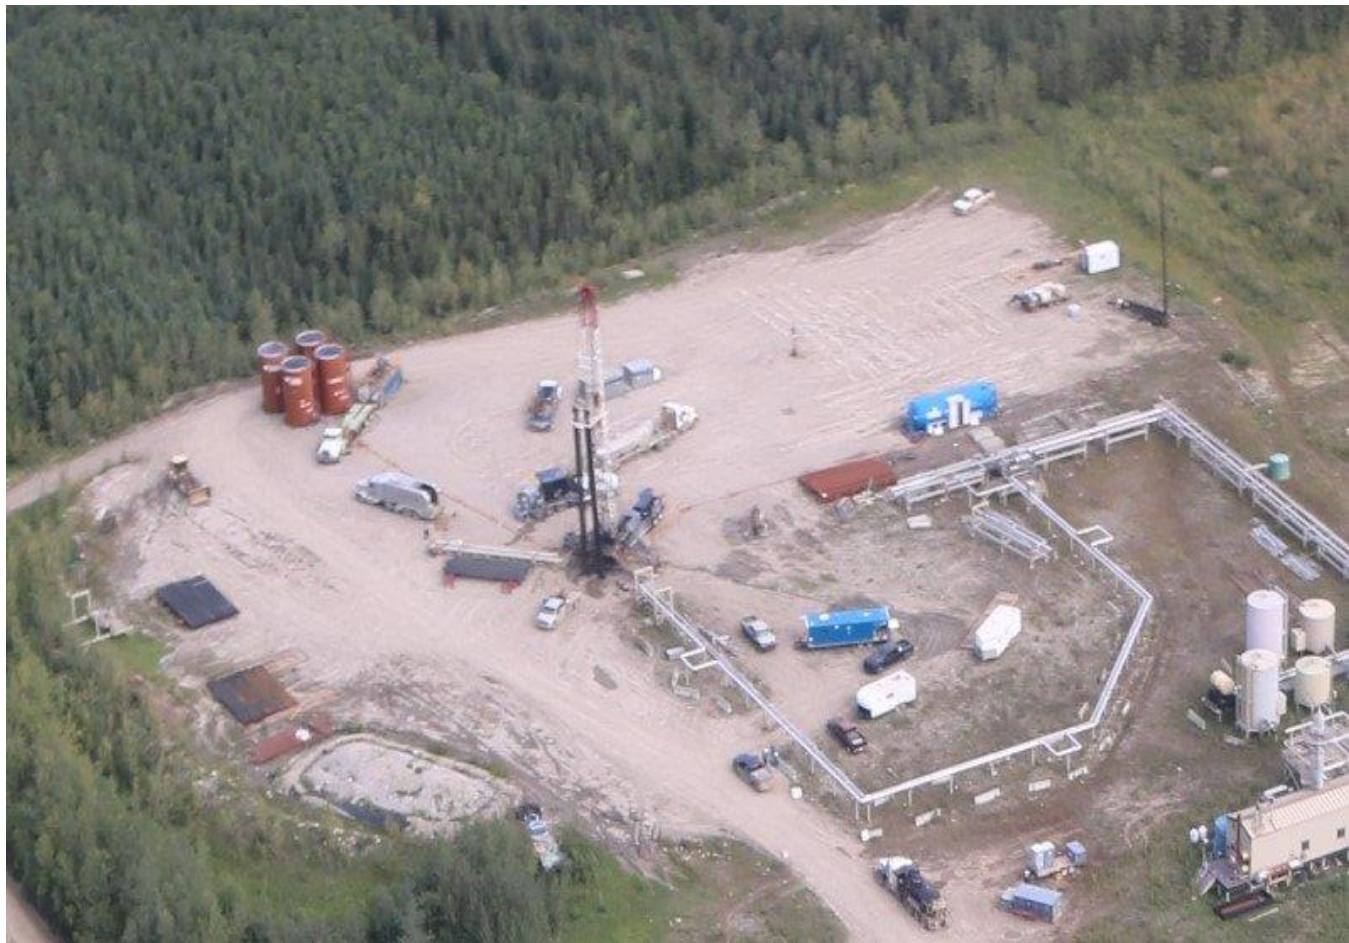
K-29: There were personnel on site at the time of the inspection. The rig was set up, a flare stack, tanks, numerous vehicles, a loader and portable office trailers. All infrastructure appeared to be in good condition and there were still miscellaneous materials on site. No erosion was observed at the time of the inspection.

Figure 2
K-29 rig set up

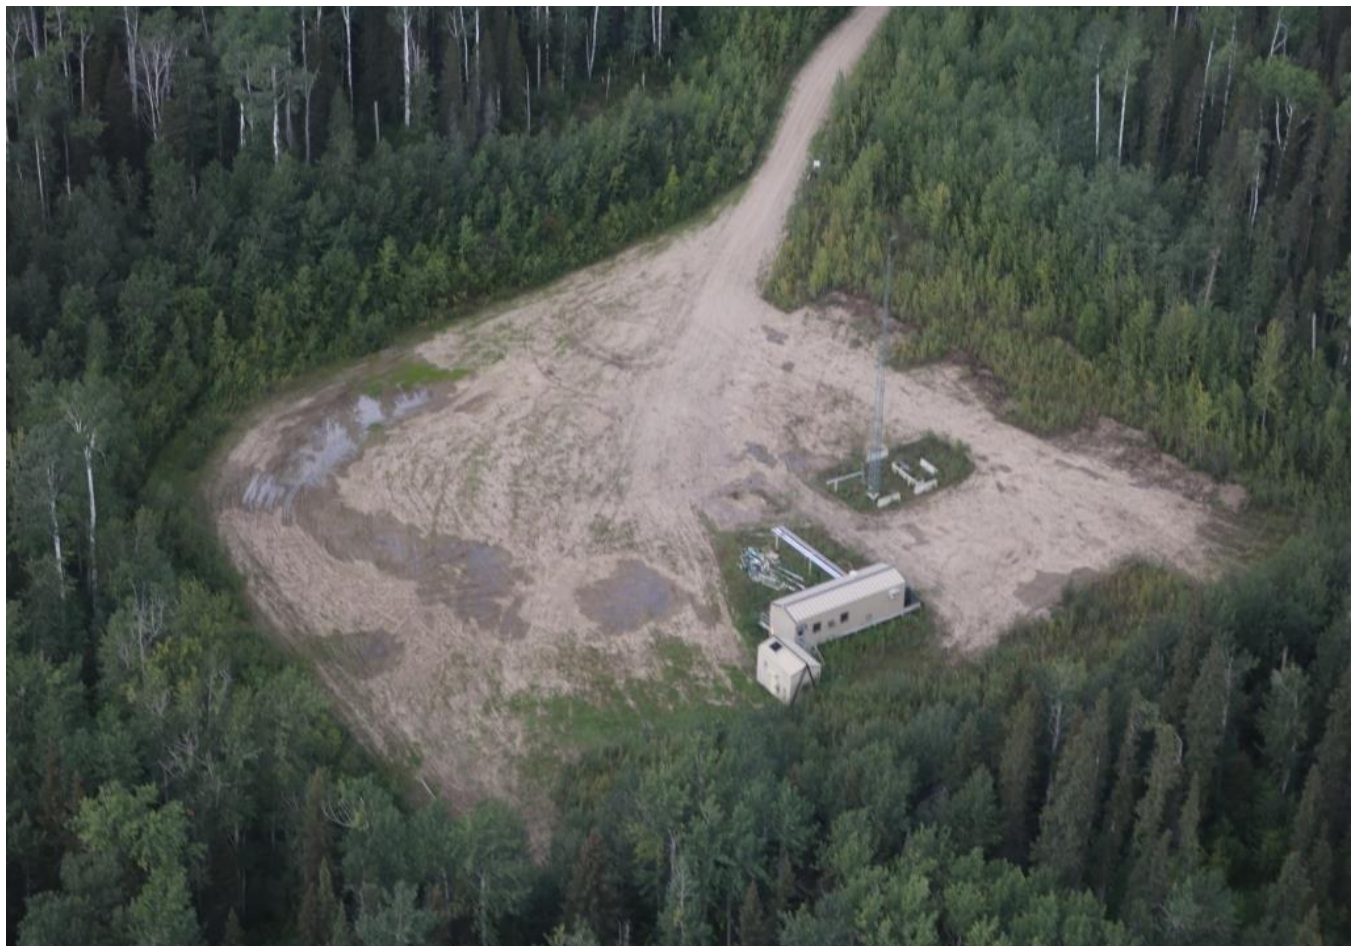
O-80: There were no personnel on site at the time of the inspection. The wellhead was still present. Infrastructure appeared to be in a good condition. There was a pile of materials and debris that should be properly disposed of.

Figure 3
O-80- note debris pile

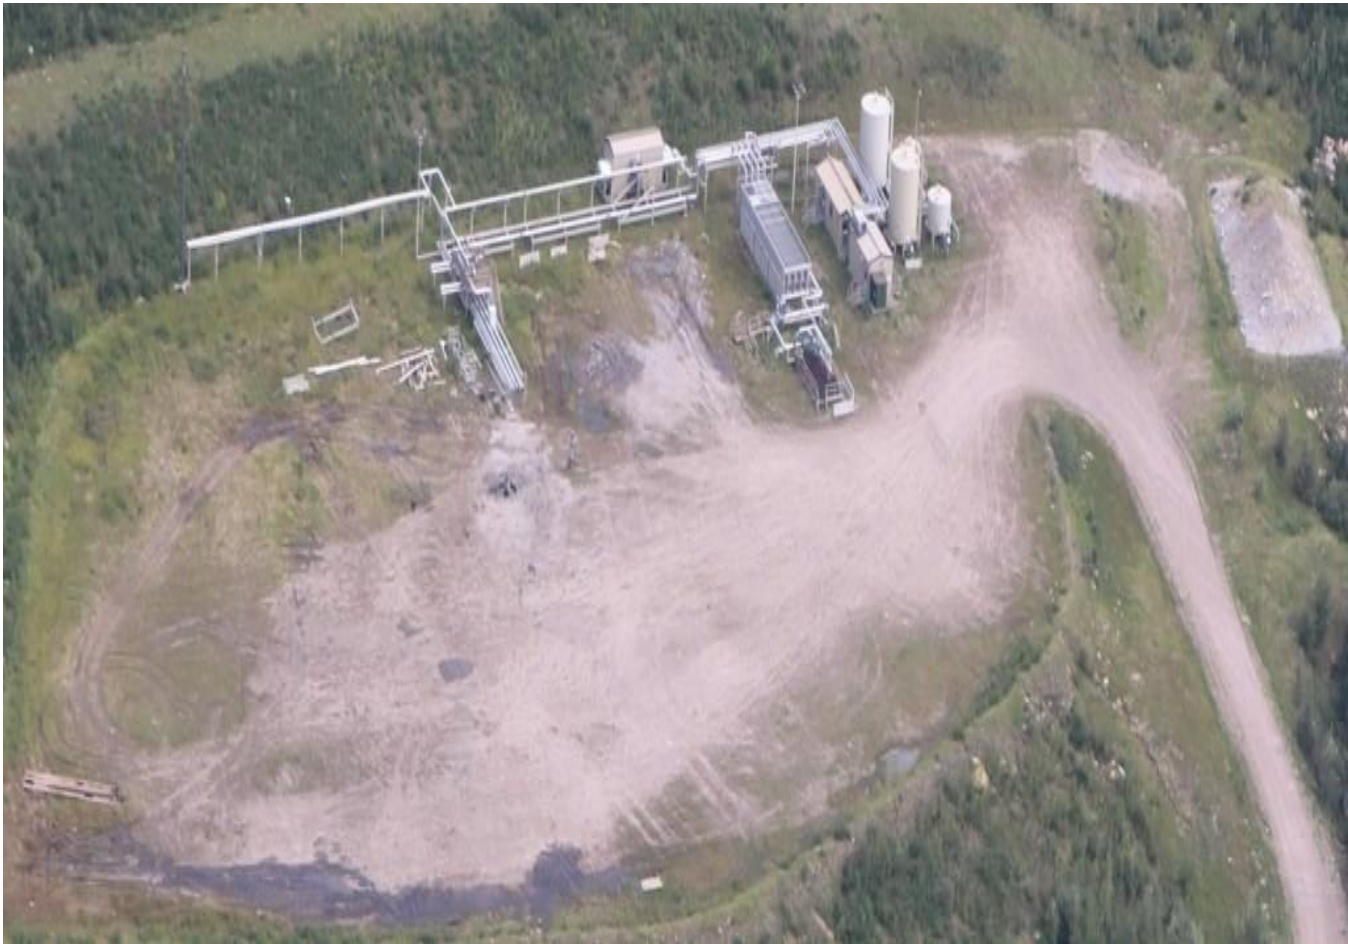
M-25: There were no personnel on site at the time of the inspection. The wellheads were still present. Infrastructure appeared to be in a good condition. There was a pile of materials and debris that should be properly disposed of.

Figure 6
M-25- note debris pile

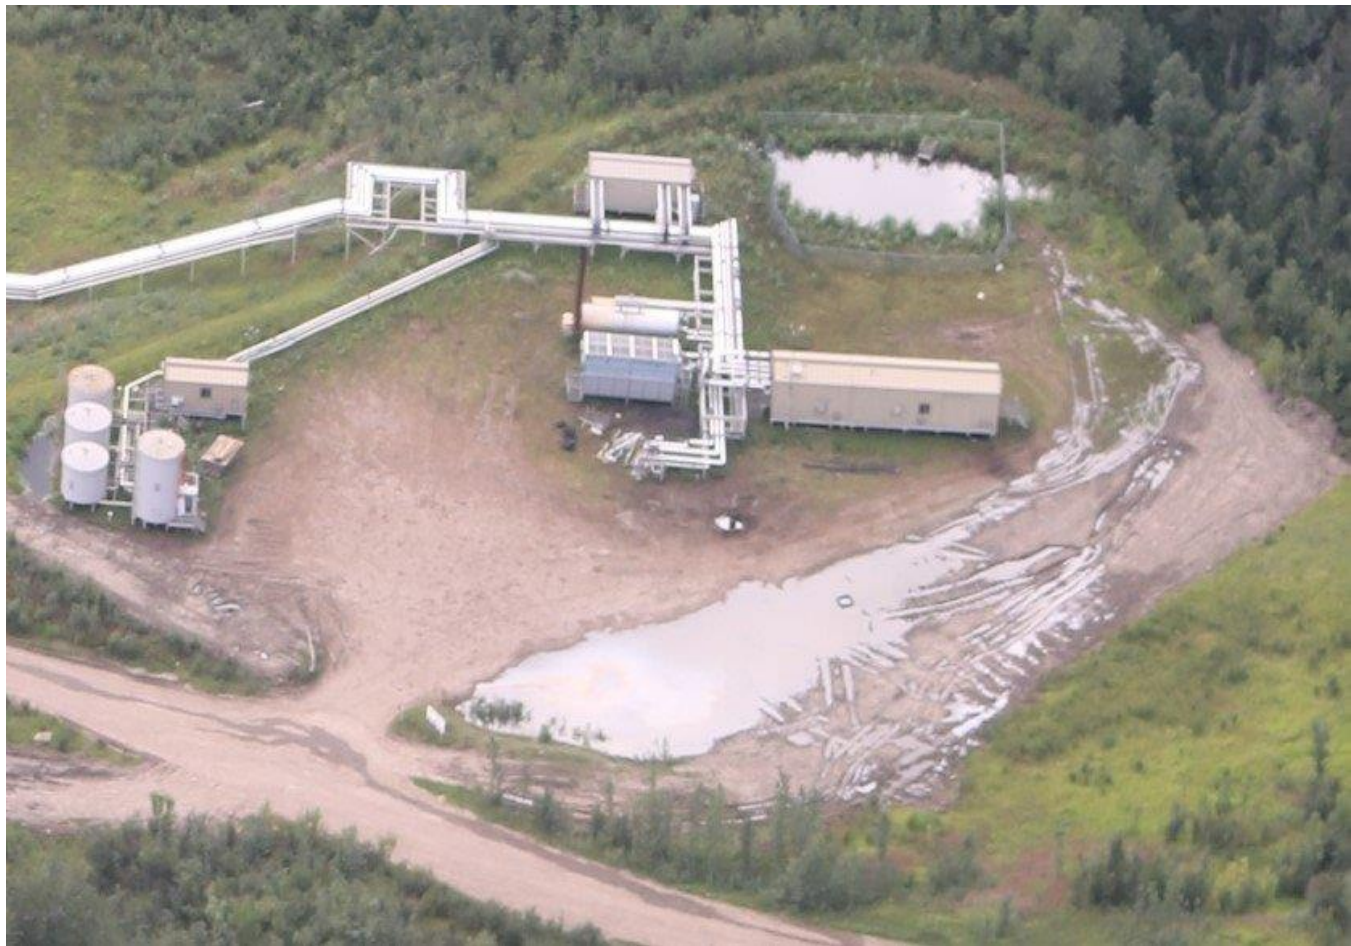
F-25/F-25A: There were no personnel on site at the time of the inspection. The wellhead was still present. Infrastructure appeared to be in a good condition. The fenced off sump was overflowing. No erosion was observed.

Figure 8
F-25/F-25A- note sump overflowing
