File Number	MV2020L2-0002
Type of Operation	CLASS B – Mining and Milling
Location	Discovery Lake, NT

An inspection of the above noted operation was conducted on July 5th, 2024, by Water Resource Officers Meaghan MacIntyre-Newell and Nahum Lee. Enclosed is a copy of the Water Use Inspection Report.

WATER USE INSPECTION REPORT

LICENCE #:	MV2022L2-0002	EXPIRY DATE:	October 15 th , 2027
LICENCEE:	Sixty North Gold Mining Ltd.	PREVIOUS INSPECTION:	March 5 th , 2024
COMPANY REP:	Dave R. Webb	INSPECTION DATE:	July 5 th , 2024

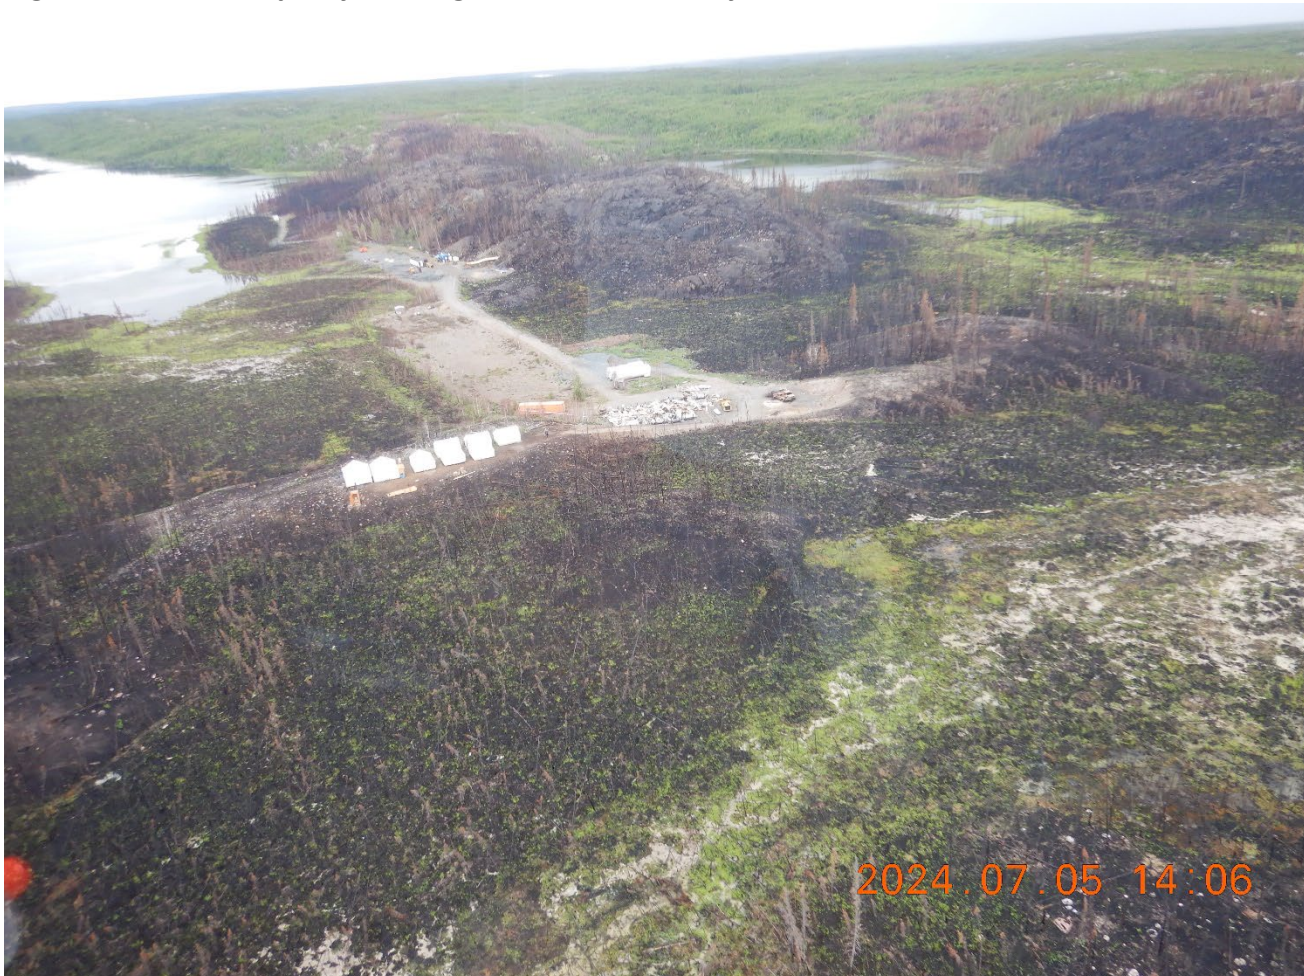
Figure 1 – Mon Property looking towards Discovery Lake.

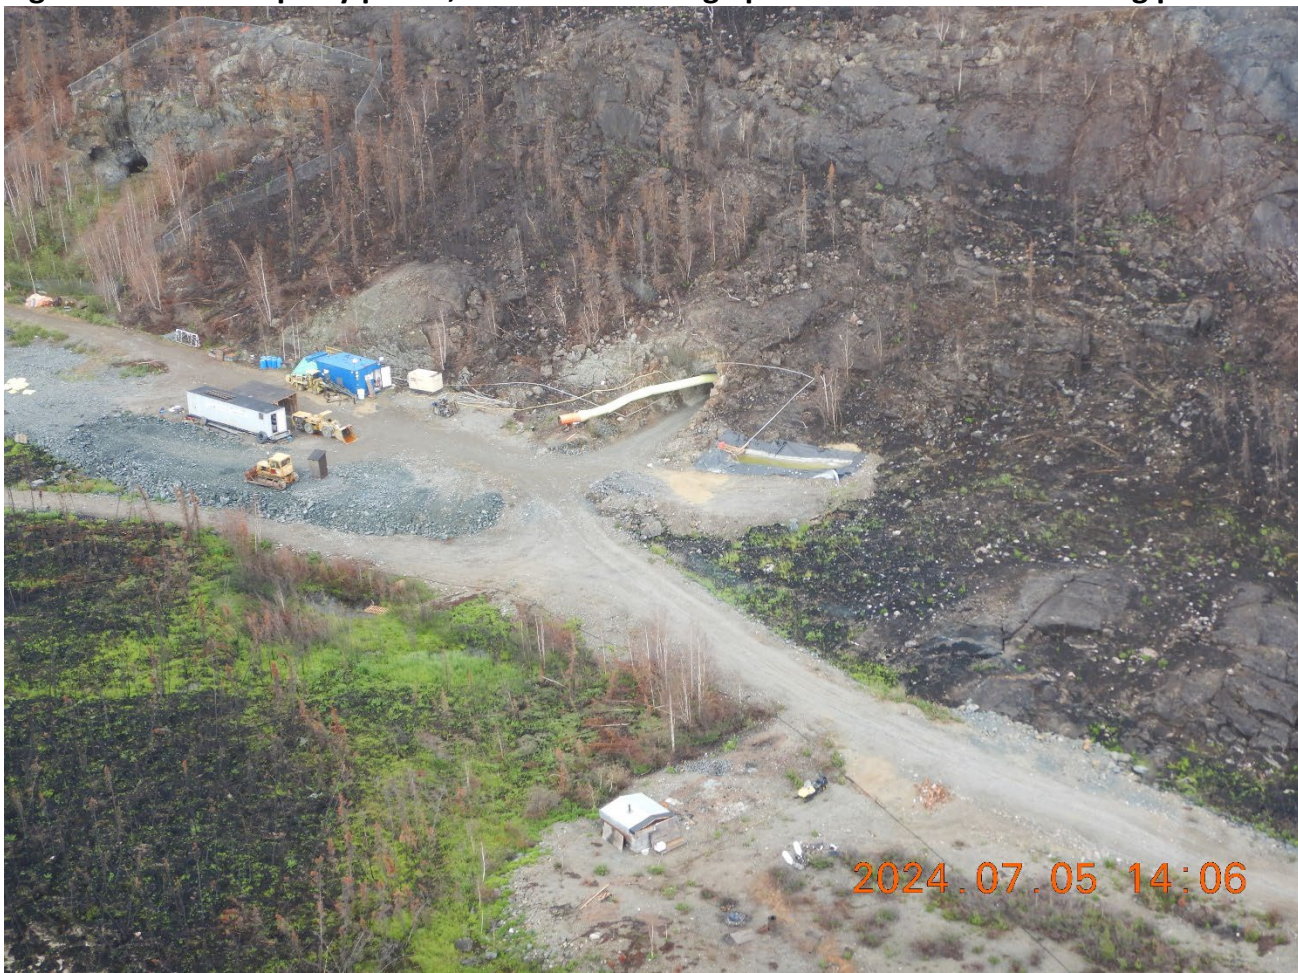
Personnel on site have indicated that there is very little water in the underground workings and that managing this aspect of the program has been relatively easy thus far. Water from the underground is being pumped, to surface and into a settling pond adjacent the underground portal opening. There has been no discharge from the mine water collection sump thus far. The licensee must adhere to the Licence Surveillance Network Program and Part F, Condition 21 and ensure the proper sampling of the mine water settling pond prior to any discharge occurring.

Figure 2 – Mon Property portal, waste rock storage pile and mine water settling pond.

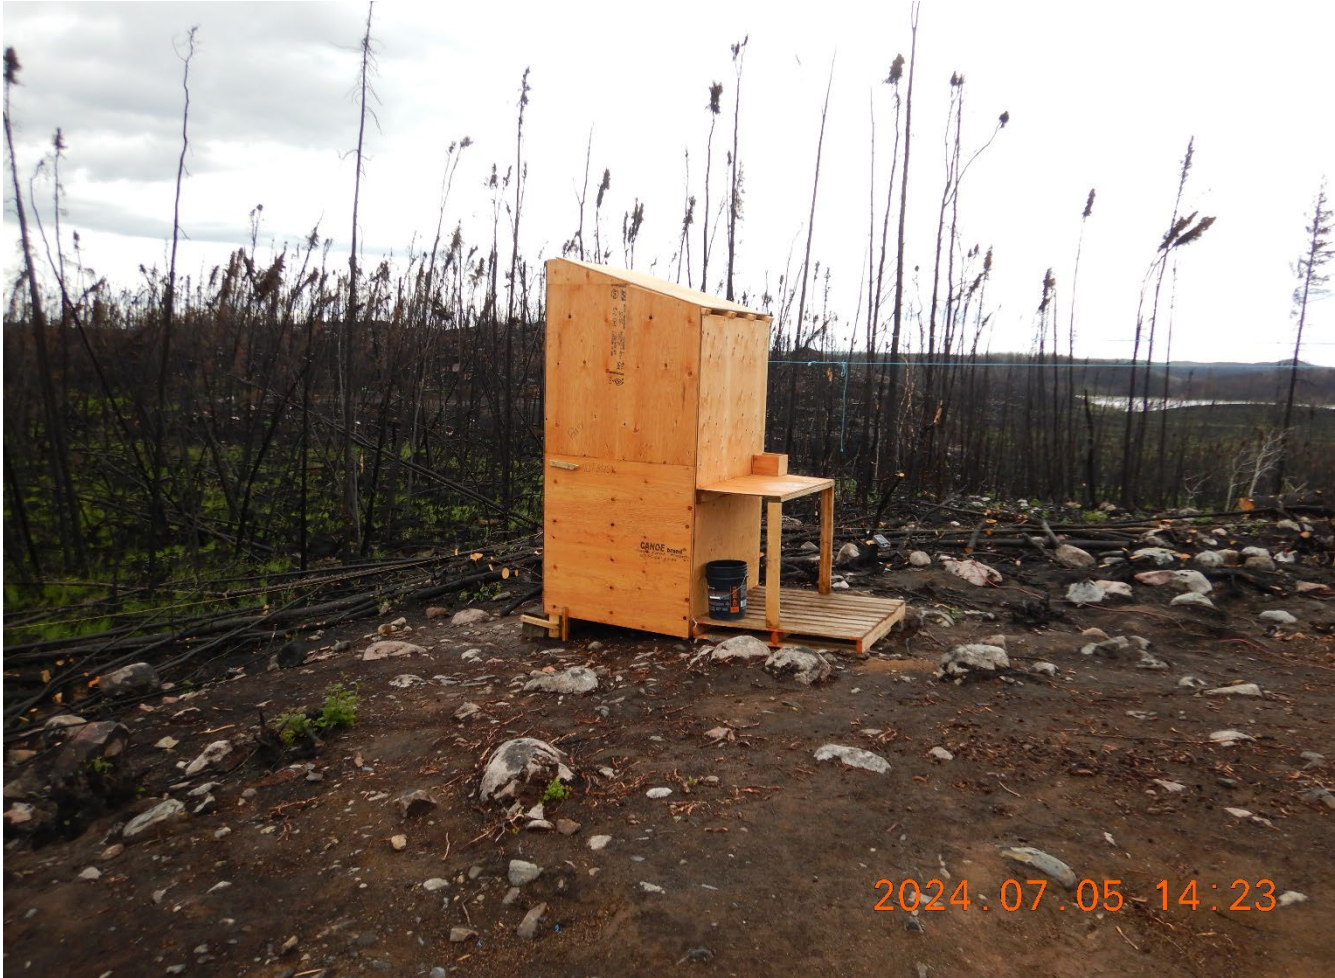
As a result of last year’s fires, the old camp was burned and therefore sewage from the camp is temporarily being placed in a pit for burial. Grey water from the dry and kitchen are being passively discharged from those camp buildings for overland treatment. Once the washroom facilities are replumbed, all sewage and greywater must report to the sewage treatment plant for treatment. Until such time, the current method of sewage and greywater disposal is acceptable.

Figure 3 – Pit Privy for sewage disposal.

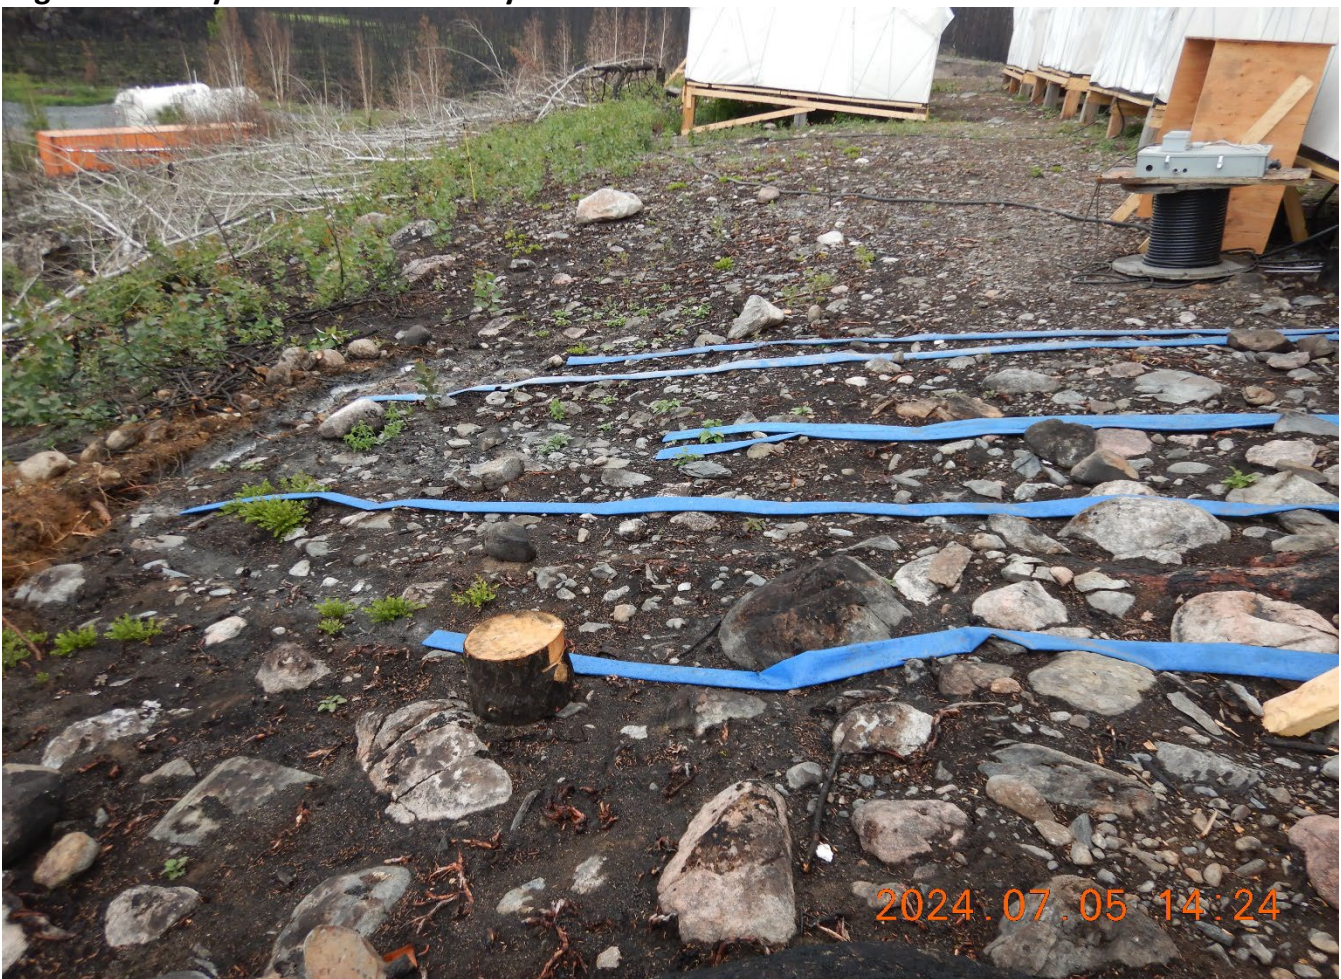
Figure 4 – Greywater lines from dry and kitchen.

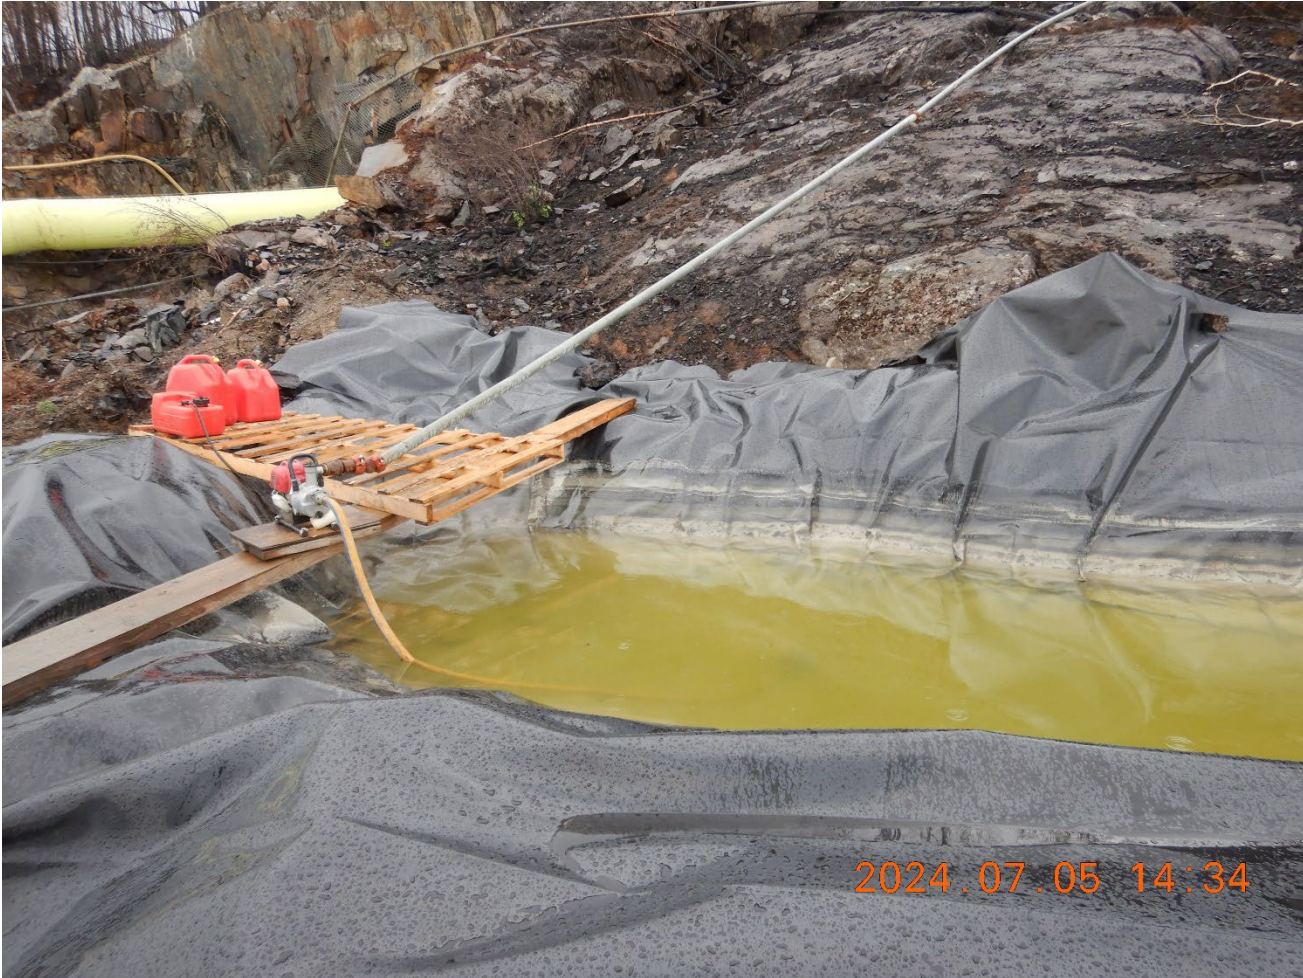
Figure 5 – Mine water settling pond (SNP-8).

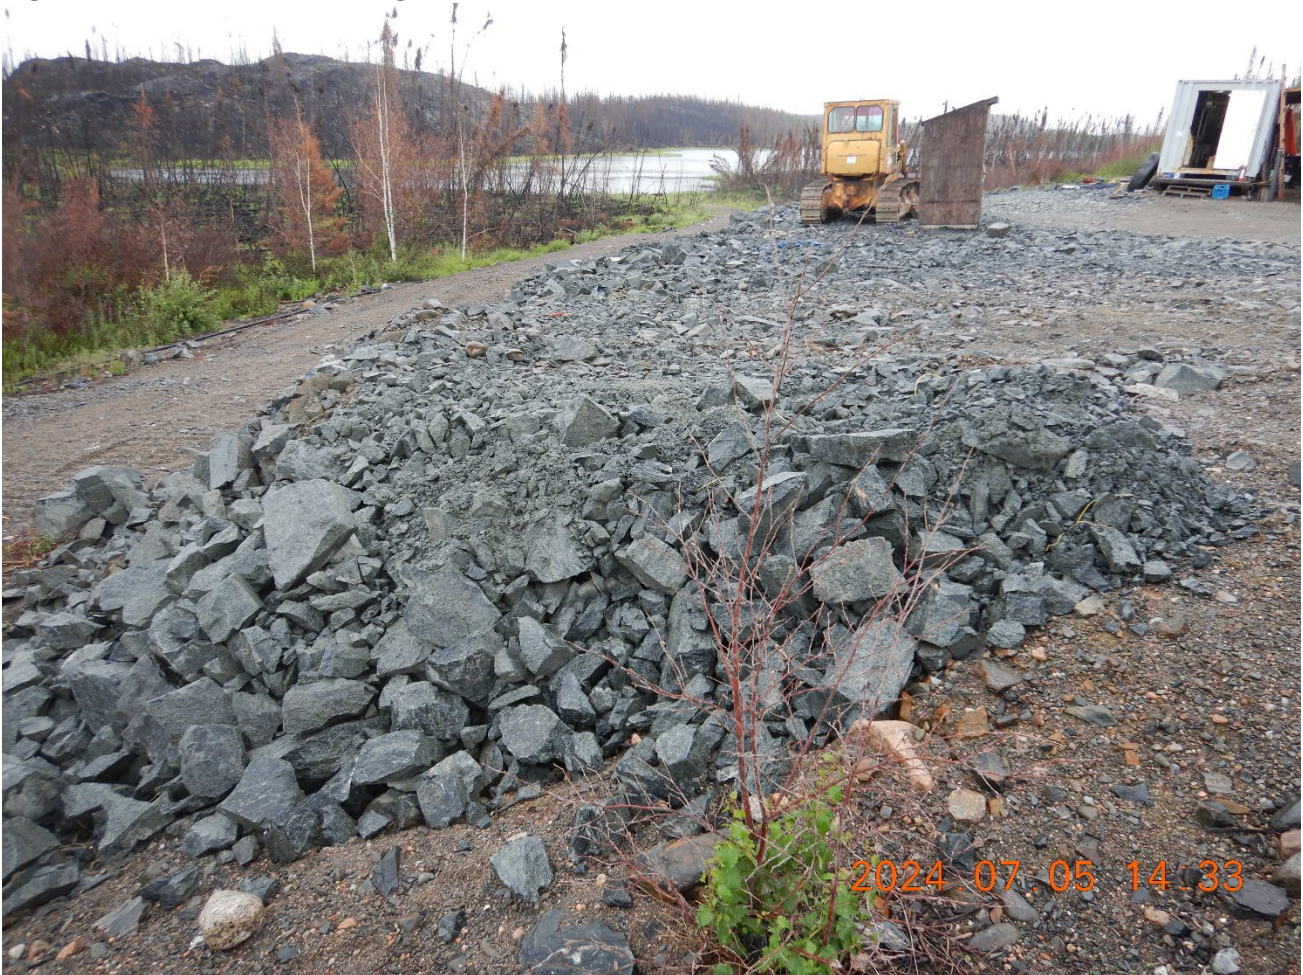
Bulk sampling is occurring underground which will involve the extraction of waste (country) rock from the underground for stockpile as well as the extraction of mineralized materials (the potential ore) for sampling/grading. Waste rock is being stored outside the existing portal currently and storage will progress towards the temporary camp upstream of the historic tailings facility along the road systems identified in the project description.

Figure 6 – Waste rock storage.

The licensee must adhere to the approved Geochemical Characterization Plan and waste rock and mineralized material must be sampled for acid rock drainage potential.

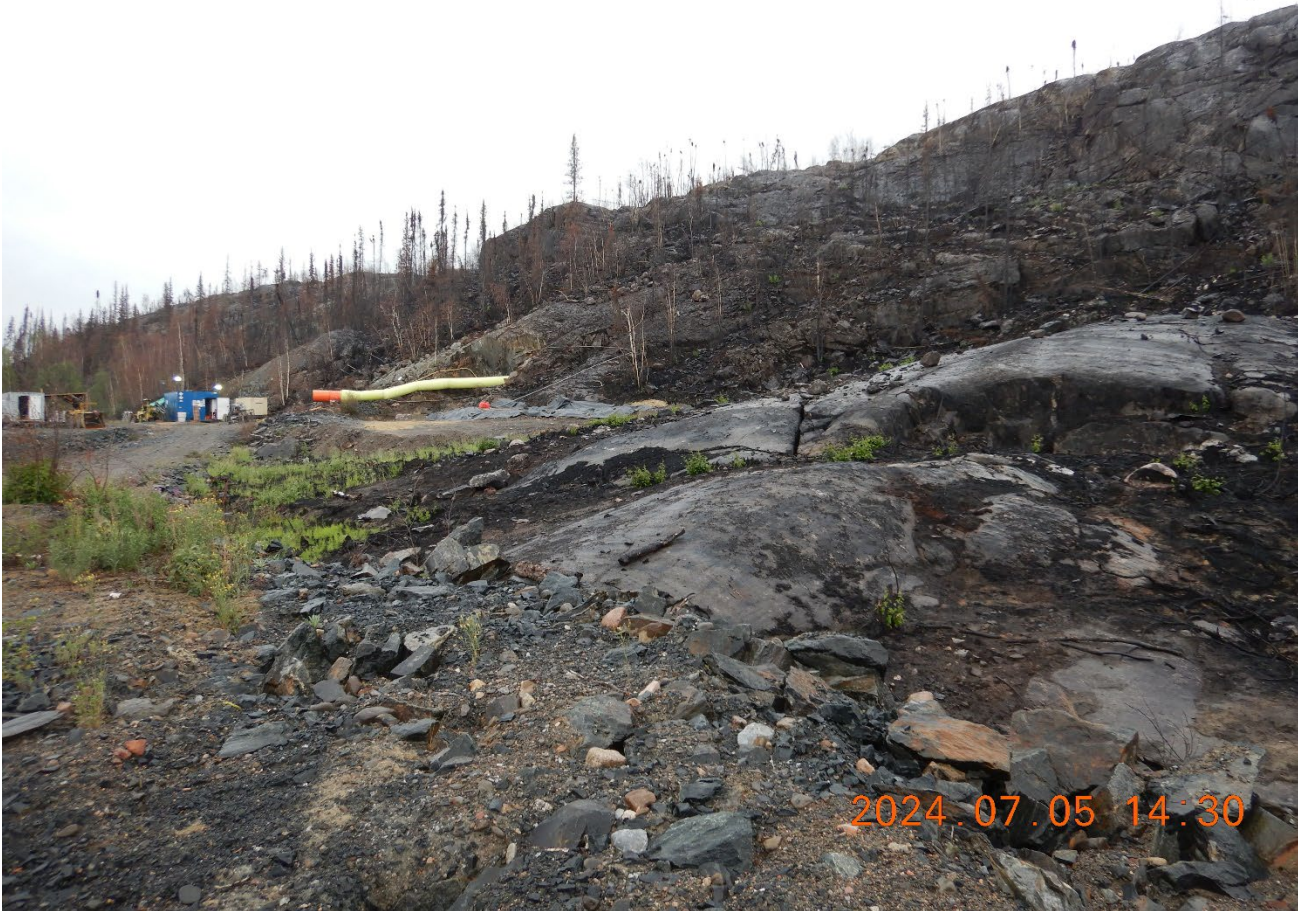
Mineralized materials will be placed along the outcrop just outside the portal where samples will be collected and sent out for analysis. This storage location is close to the approved mill site to reduce the distance it will have to be moved for processing during future operations given favorable sample results are received.

Figure 7 – Future mill site and area where mineralized material will be stored pending sample results.

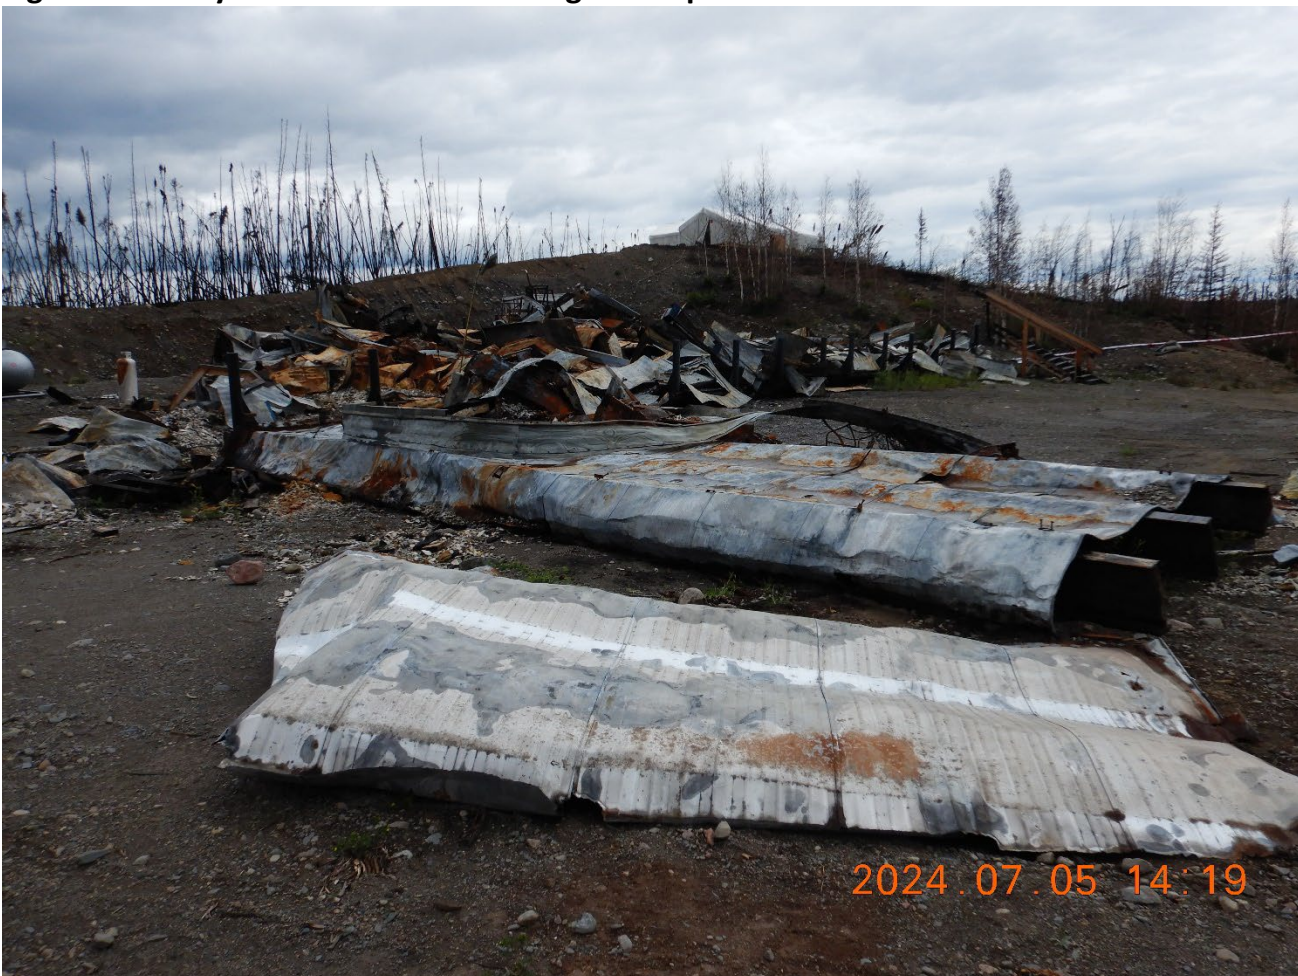
Most solid waste will be removed from site for proper disposal. Any clean wooden material and cardboard can be burned onsite. No concerns were noted with waste disposal methods during the inspection. Many buildings and pieces of equipment were impacted by the 2023 forest fires and during the season, waste related to the forest fires will be consolidated and properly stored for removal on the winter road.

Figure 8 – Bulky waste from fired damaged camp stored for removal.

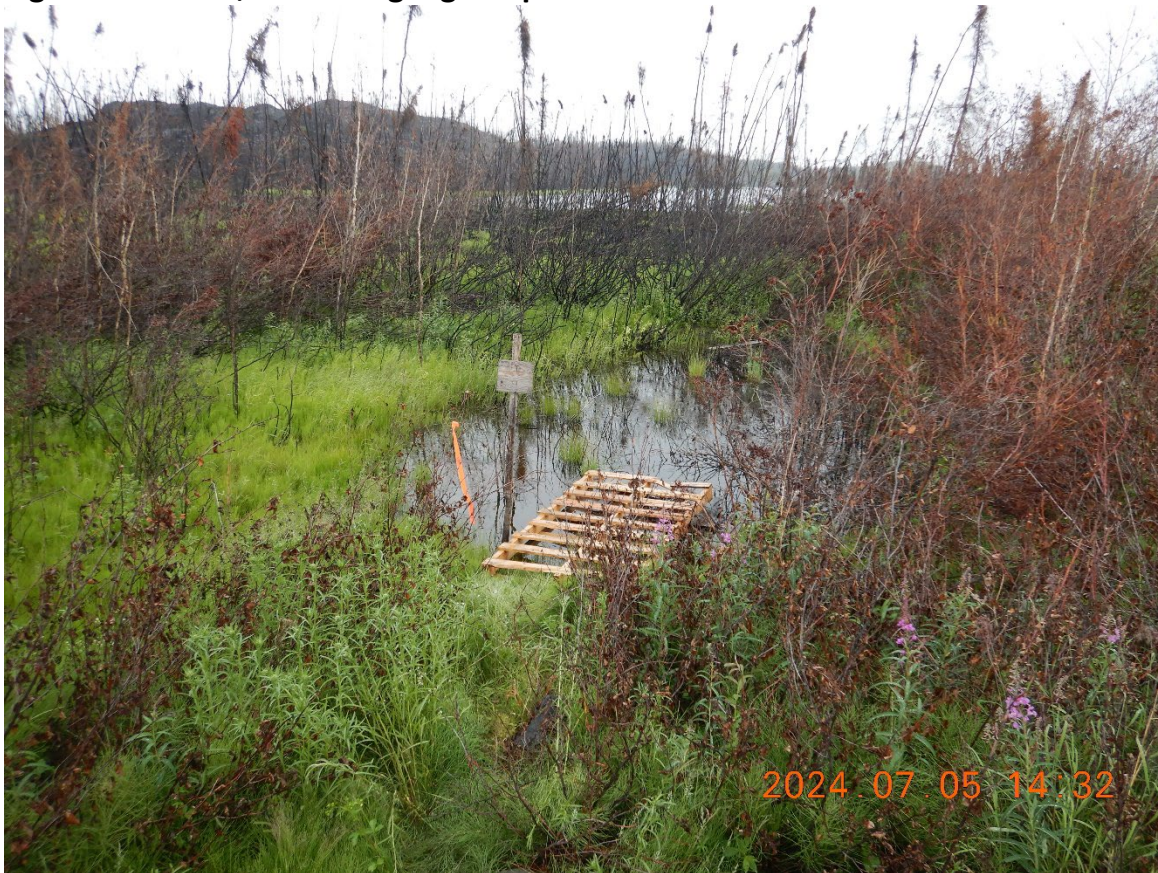
Figure 9 – SNP-9, Clearer signage required.

SNP reporting has not been consistent. Please ensure reports are submitted monthly to an Inspector and the Board. Please ensure signage is placed at all active SNP Stations as the season progresses.

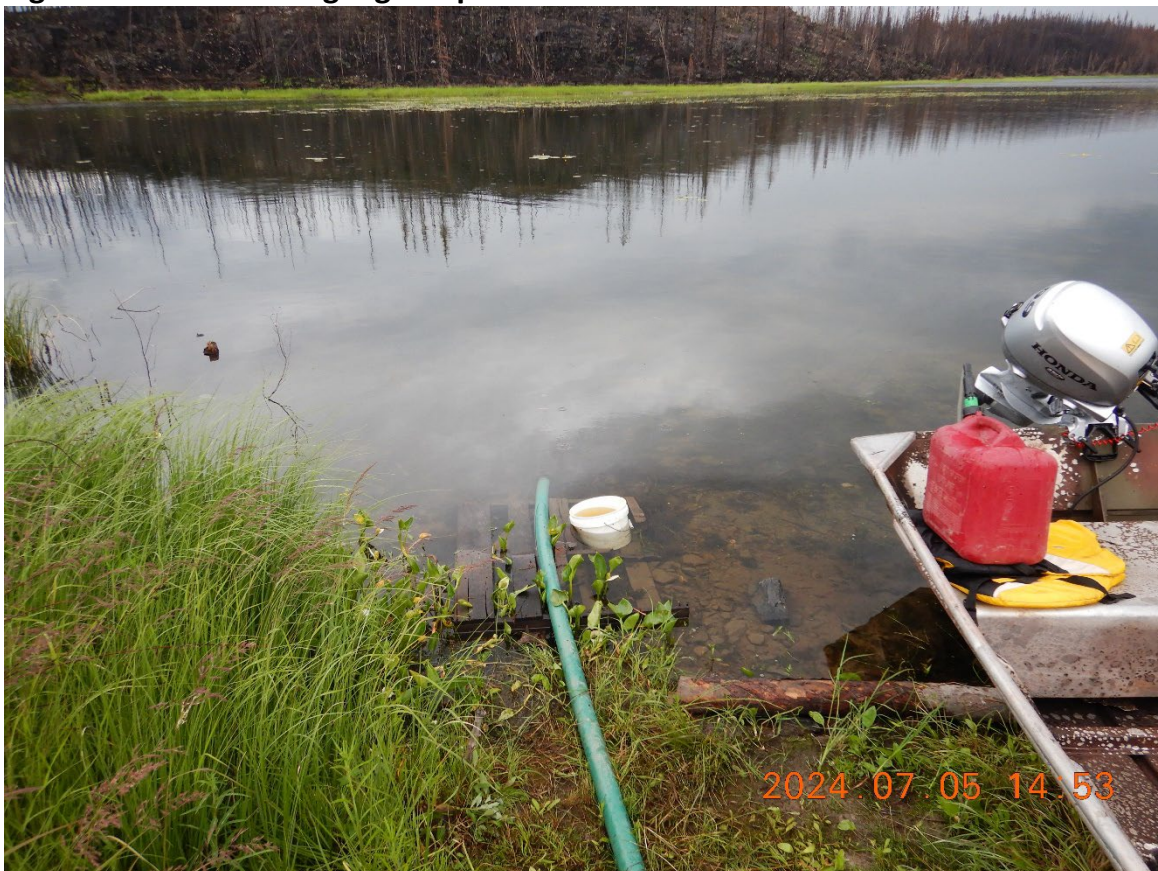
Figure 10 – SNP-11. Signage required.
