File Number	MV2020L2-0002
Type of Operation	CLASS B – Mining and Milling
Location	Discovery Lake, NT

An inspection of the above noted operation was conducted on September 19, 2024 by Water Resource Officer Nahum Lee. Enclosed is a copy of the Water Use Inspection Report.

WATER USE INSPECTION REPORT

LICENCE #:	MV2022L2-0002	EXPIRY DATE:	October 15th, 2027
LICENCEE:	Sixty North Gold Mining Ltd.	PREVIOUS INSPECTION:	July 5th, 2024
COMPANY REP:	Dave R. Webb	INSPECTION DATE:	September 19th, 2024

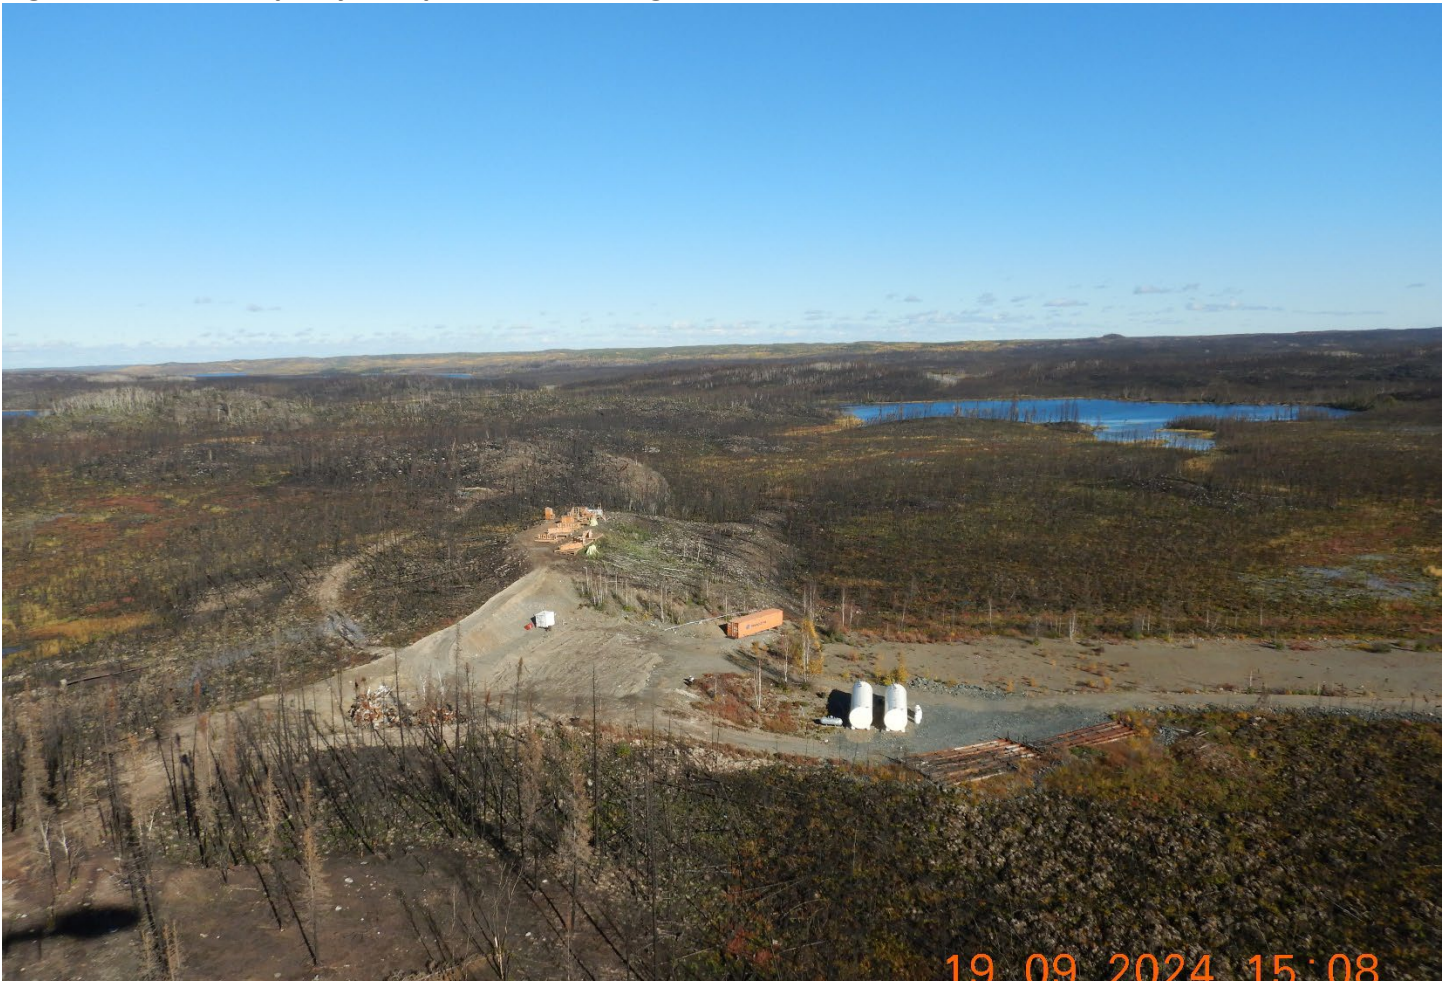
Figure 1 – Mon Property Camp and fuel storage.

The camp and fuel storage area are shown from the air (Photo 1). Discovery Lake as seen in Photo 2, supplies the water for use at the dry and the kitchen. No concerns were identified with the freshwater intake system as the camp was closed for freeze up. The August SNP report indicated that 91m³ of freshwater were used during the summer program.

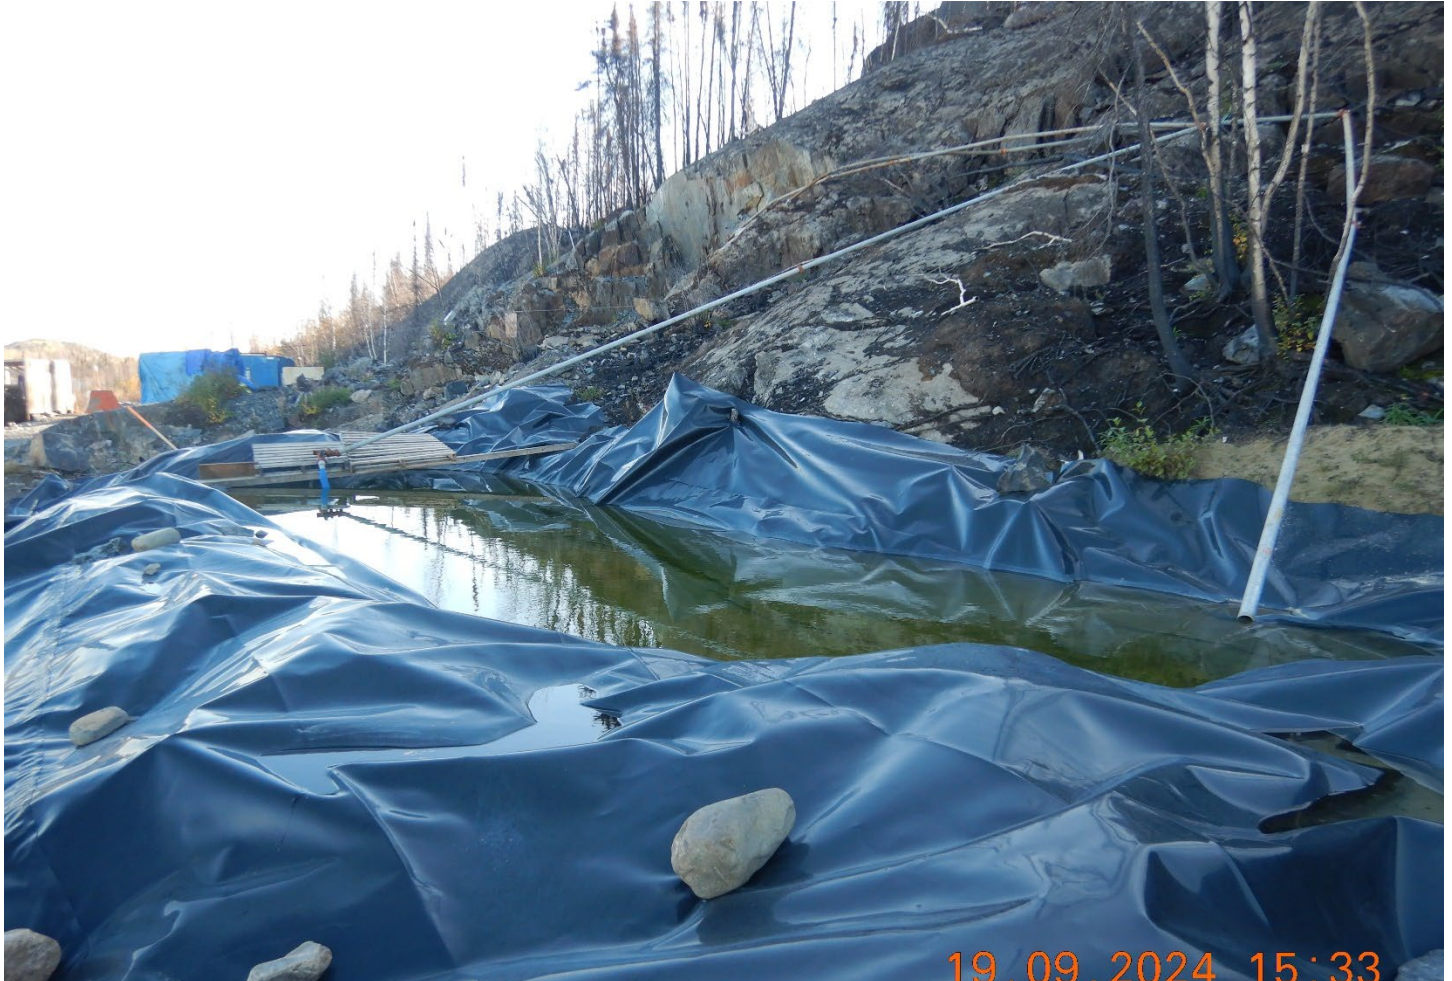
Figure 3 – Mine water settling pond.

The settling pond was nearing capacity at the time of discharge (Photo 3).

Given the very low volume of water in the settling pond and the fact that there is not currently a discharge, the Inspector sees no immediate threat to the environment. The settling pond does, however, appear to be reaching it's capacity.

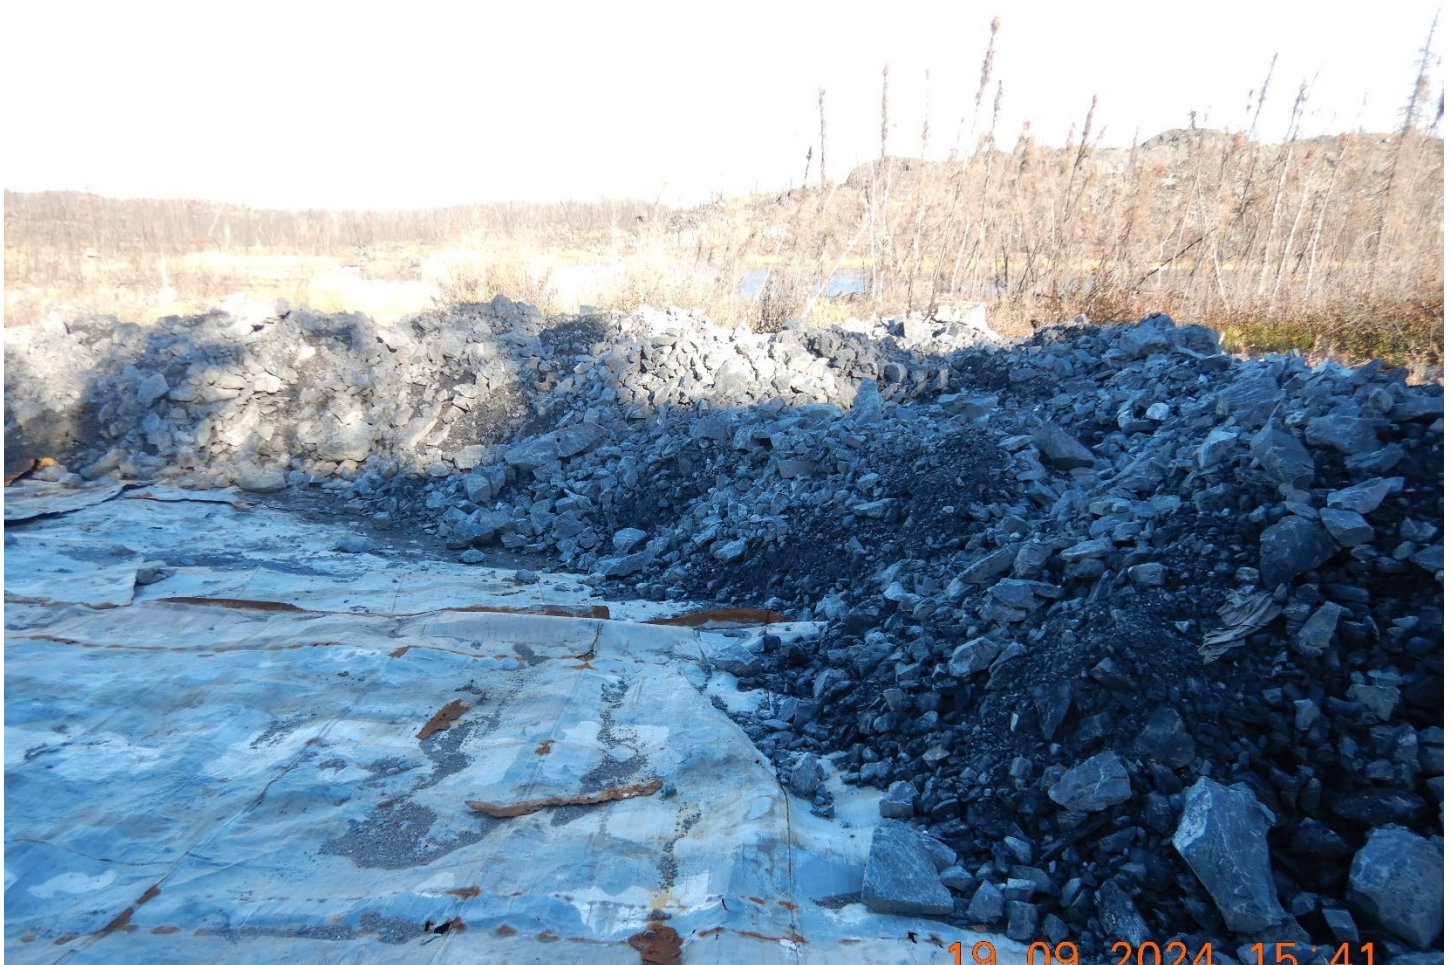
Figure 4 – Mineralized materials stored on repurposed tin from burned camp trailers.

Some potentially mineralized material has been stored on top of tin siding from the old burnt camp. The tin was used to segregate potential ore from waste country rock (Photo 4).

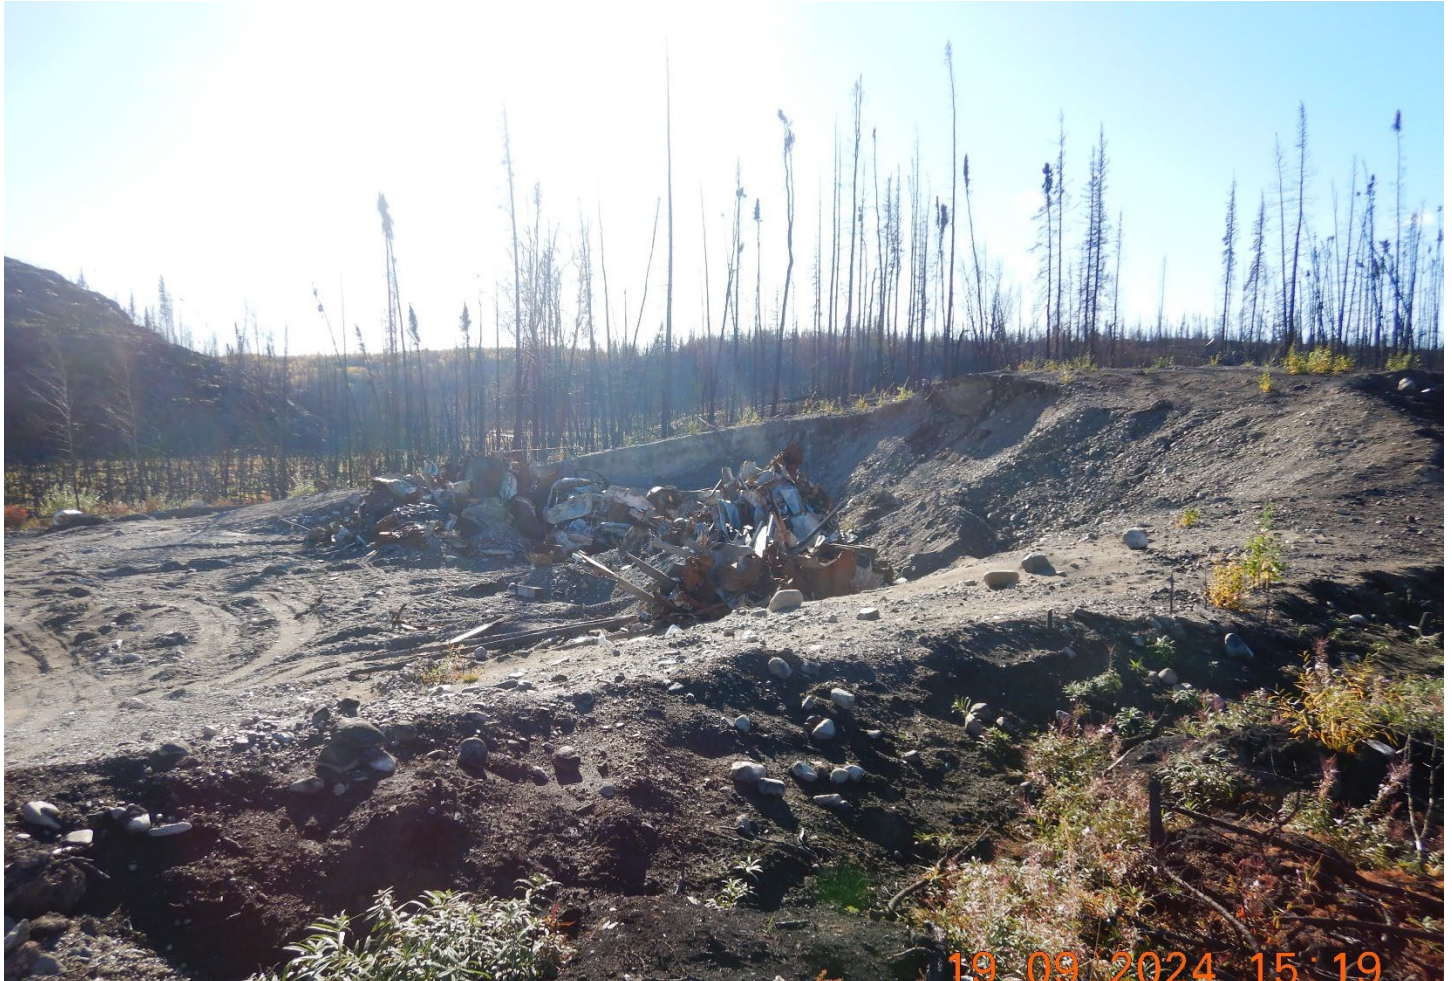
Figure 5 – Waste from burned camp is stored for off-site disposal during winter road.

Most solid waste will be removed from site for proper disposal. Any clean wooden material and cardboard can be burned onsite. No concerns were noted with waste disposal methods during the inspection. Waste materials from the fire have been sorted and segregated for removal from site. They are currently stockpiled in the quarry (Photo 5&6).
