**Re: Westcoast Energy Inc. (Westcoast)
Pointed Mountain Pipeline Abandonment Project (Project)
Water Licence MV2023L1-0013 (Licence)
Part I: Closure and Reclamation, Condition 1
Closure and Reclamation Plan**

**Pointed Mountain Pipeline Abandonment
Closure and Reclamation Plan**

Phase I Environmental Site Assessment

Remedial Action Plan
PM-1 Site, Kilometre Post 0.0, Northwest Territories

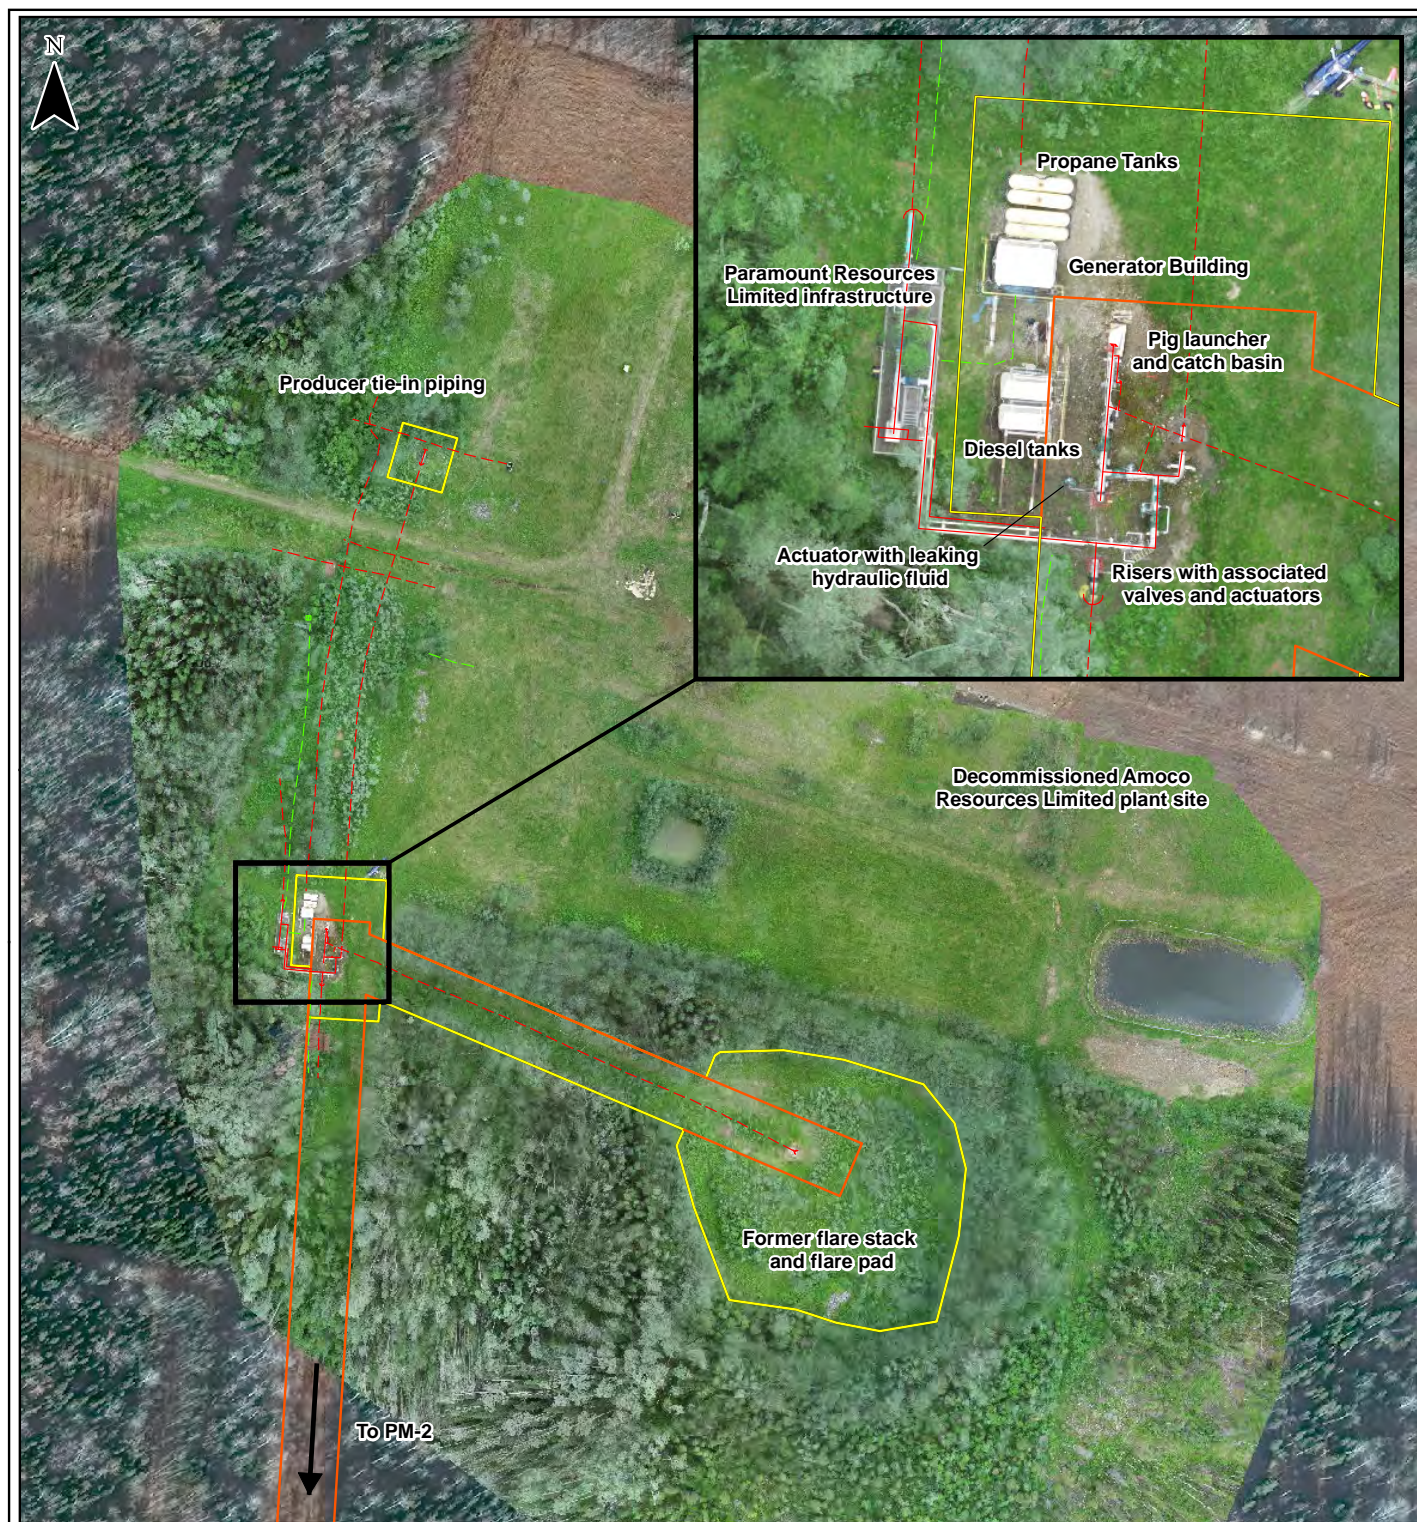
FIGURE 2.2-1

- Underground Pipeline
- Above Ground Pipeline
- Above Ground Power
- Underground Power
- Westcoast Pipeline Right-of-Way
- Westcoast Site Boundary

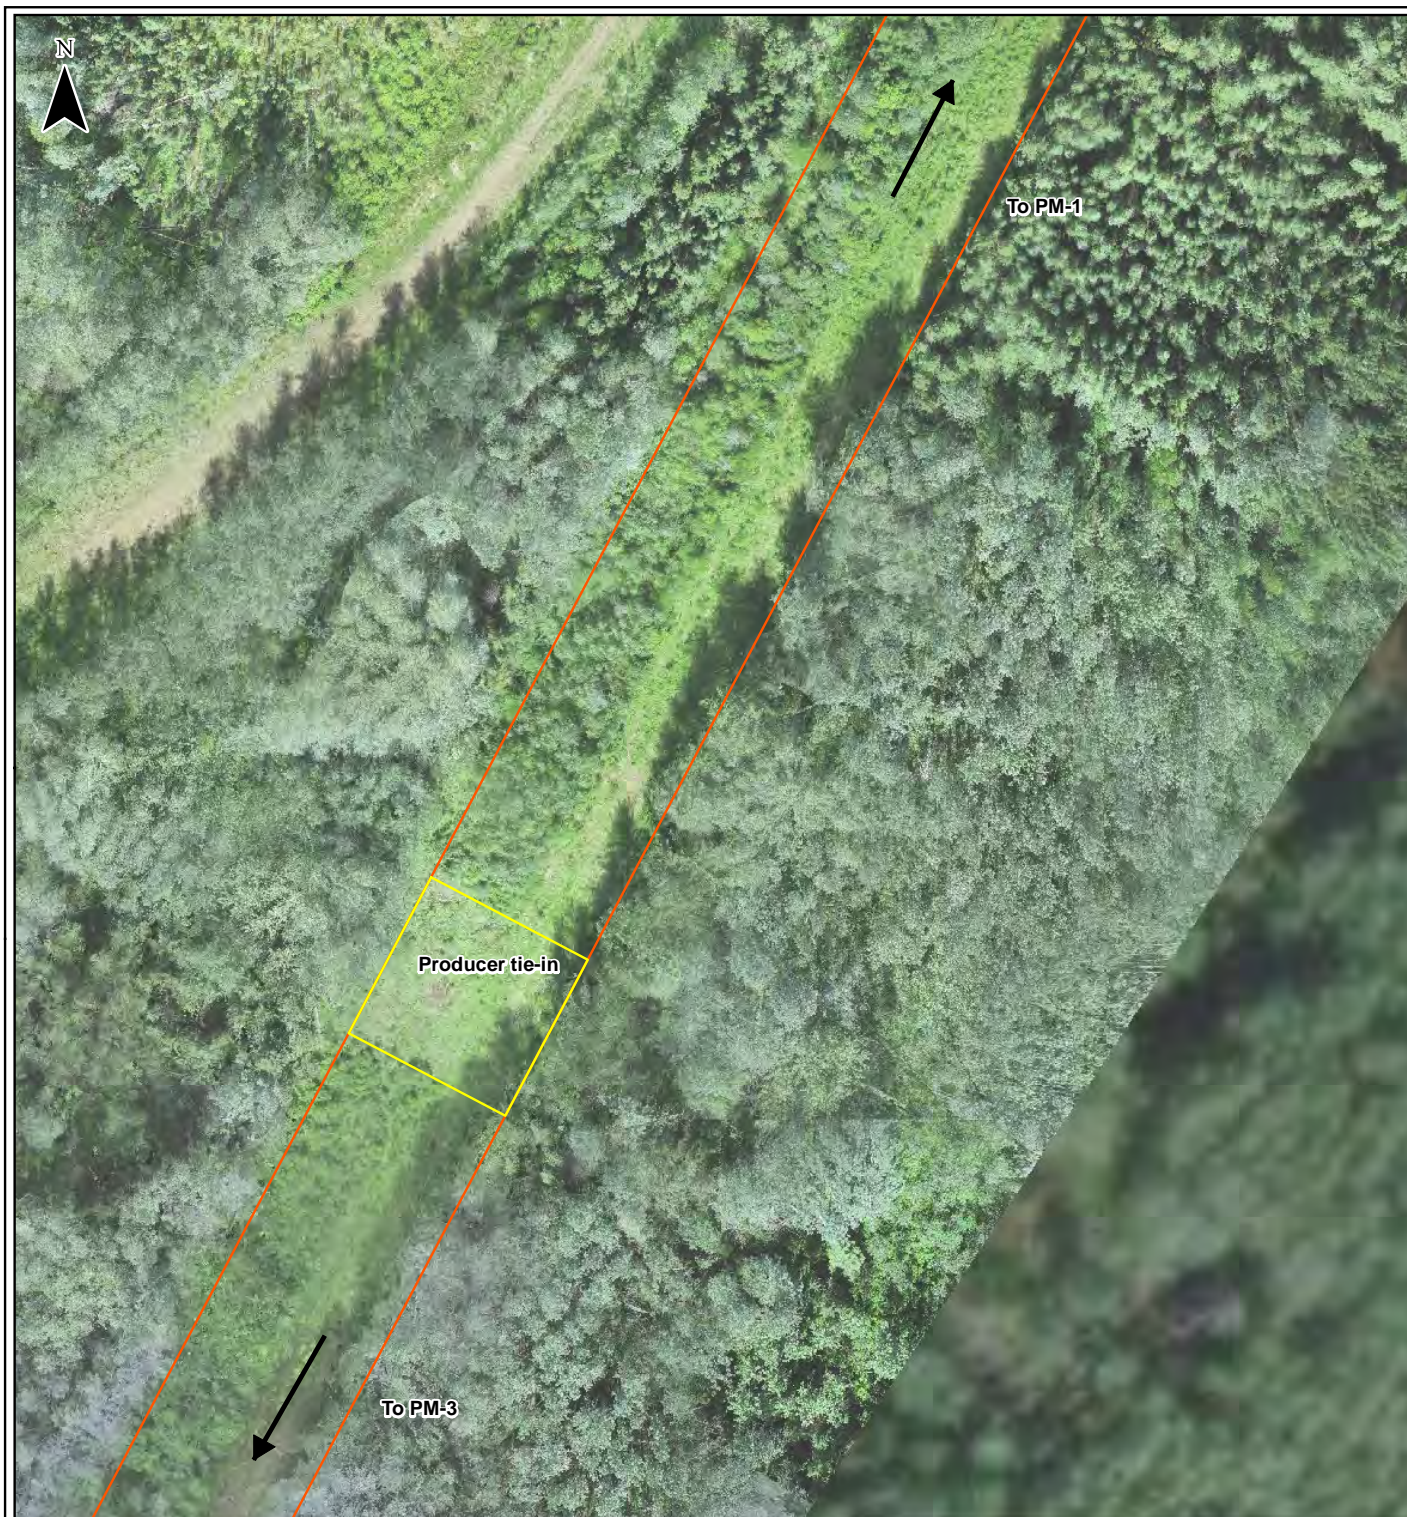
FIGURE 2.2-2

**PM-2 SITE OVERVIEW
PHASE I ENVIRONMENTAL SITE ASSESSMENT**

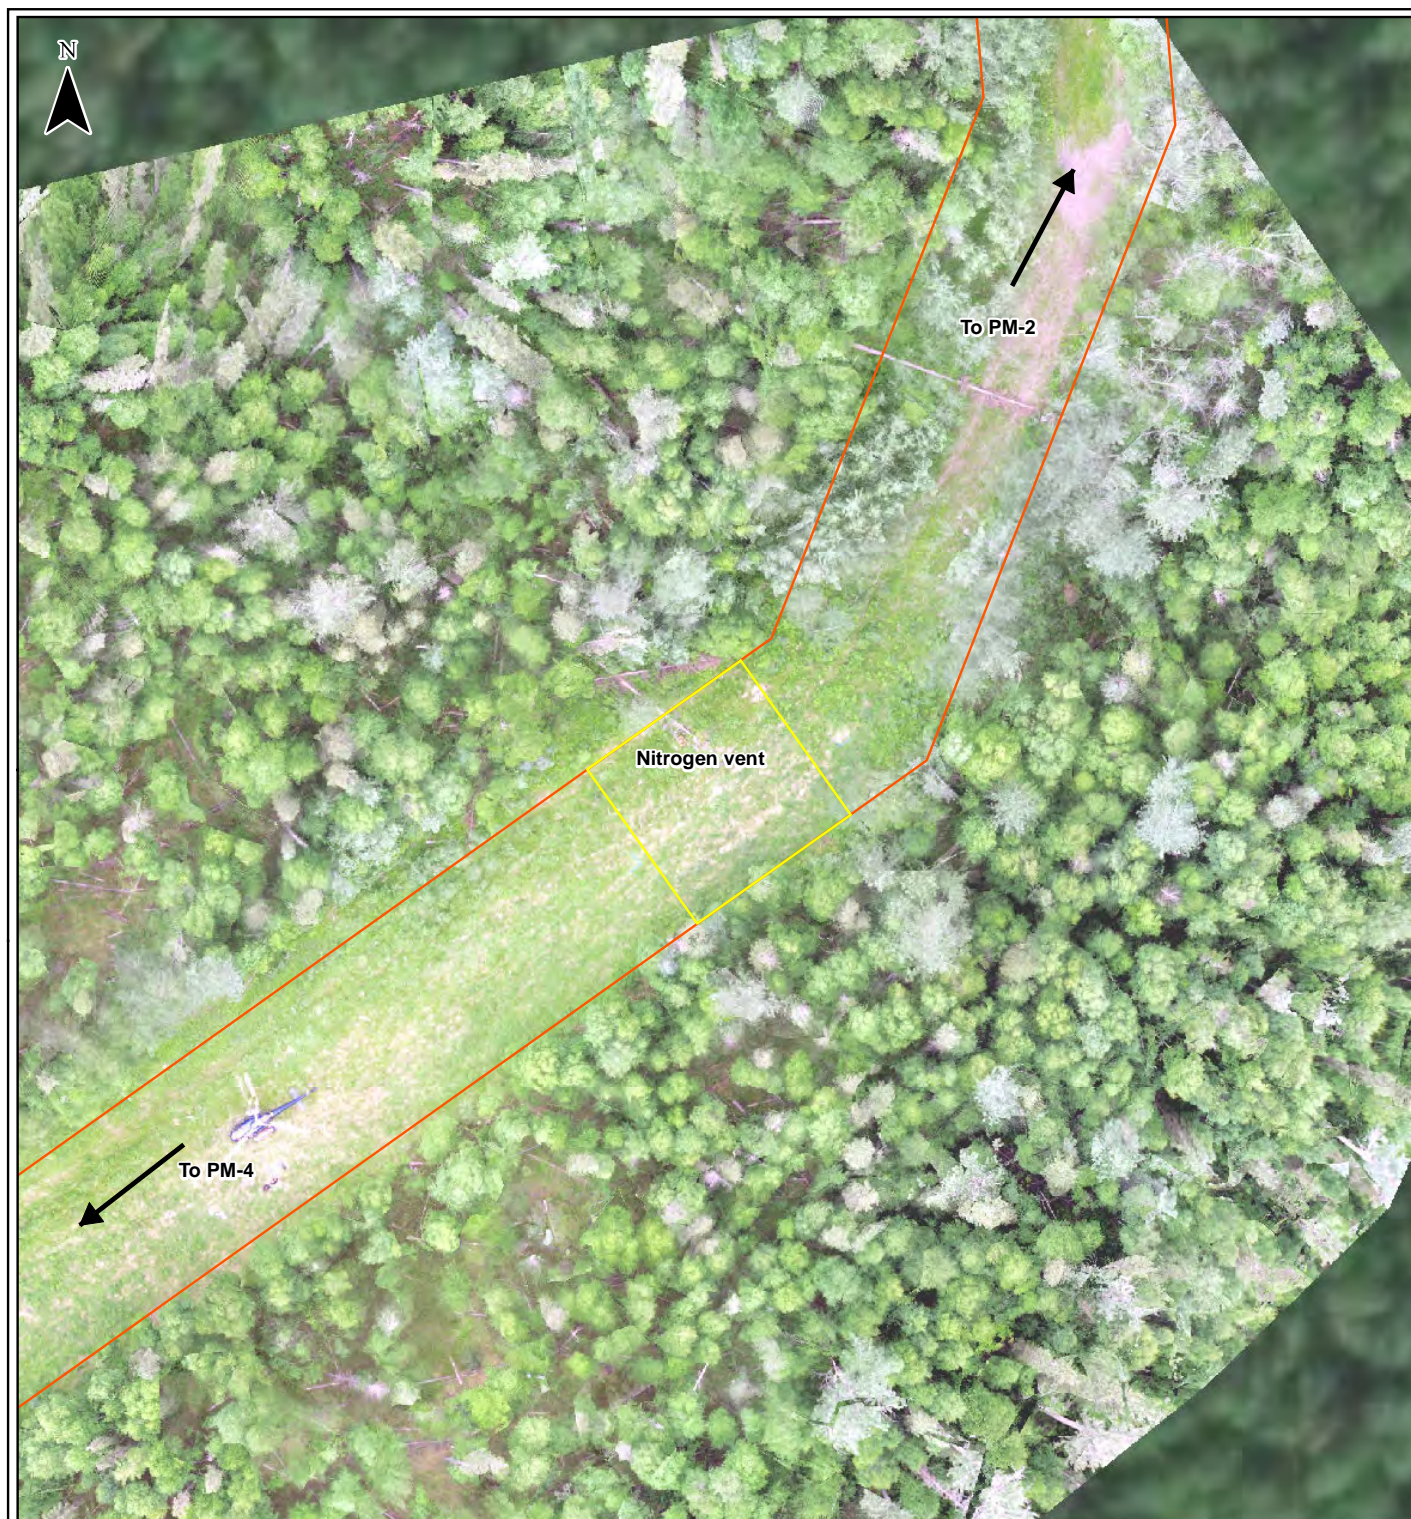
FIGURE 2.2-3

PM-3 SITE OVERVIEW
PHASE I ENVIRONMENTAL SITE ASSESSMENT

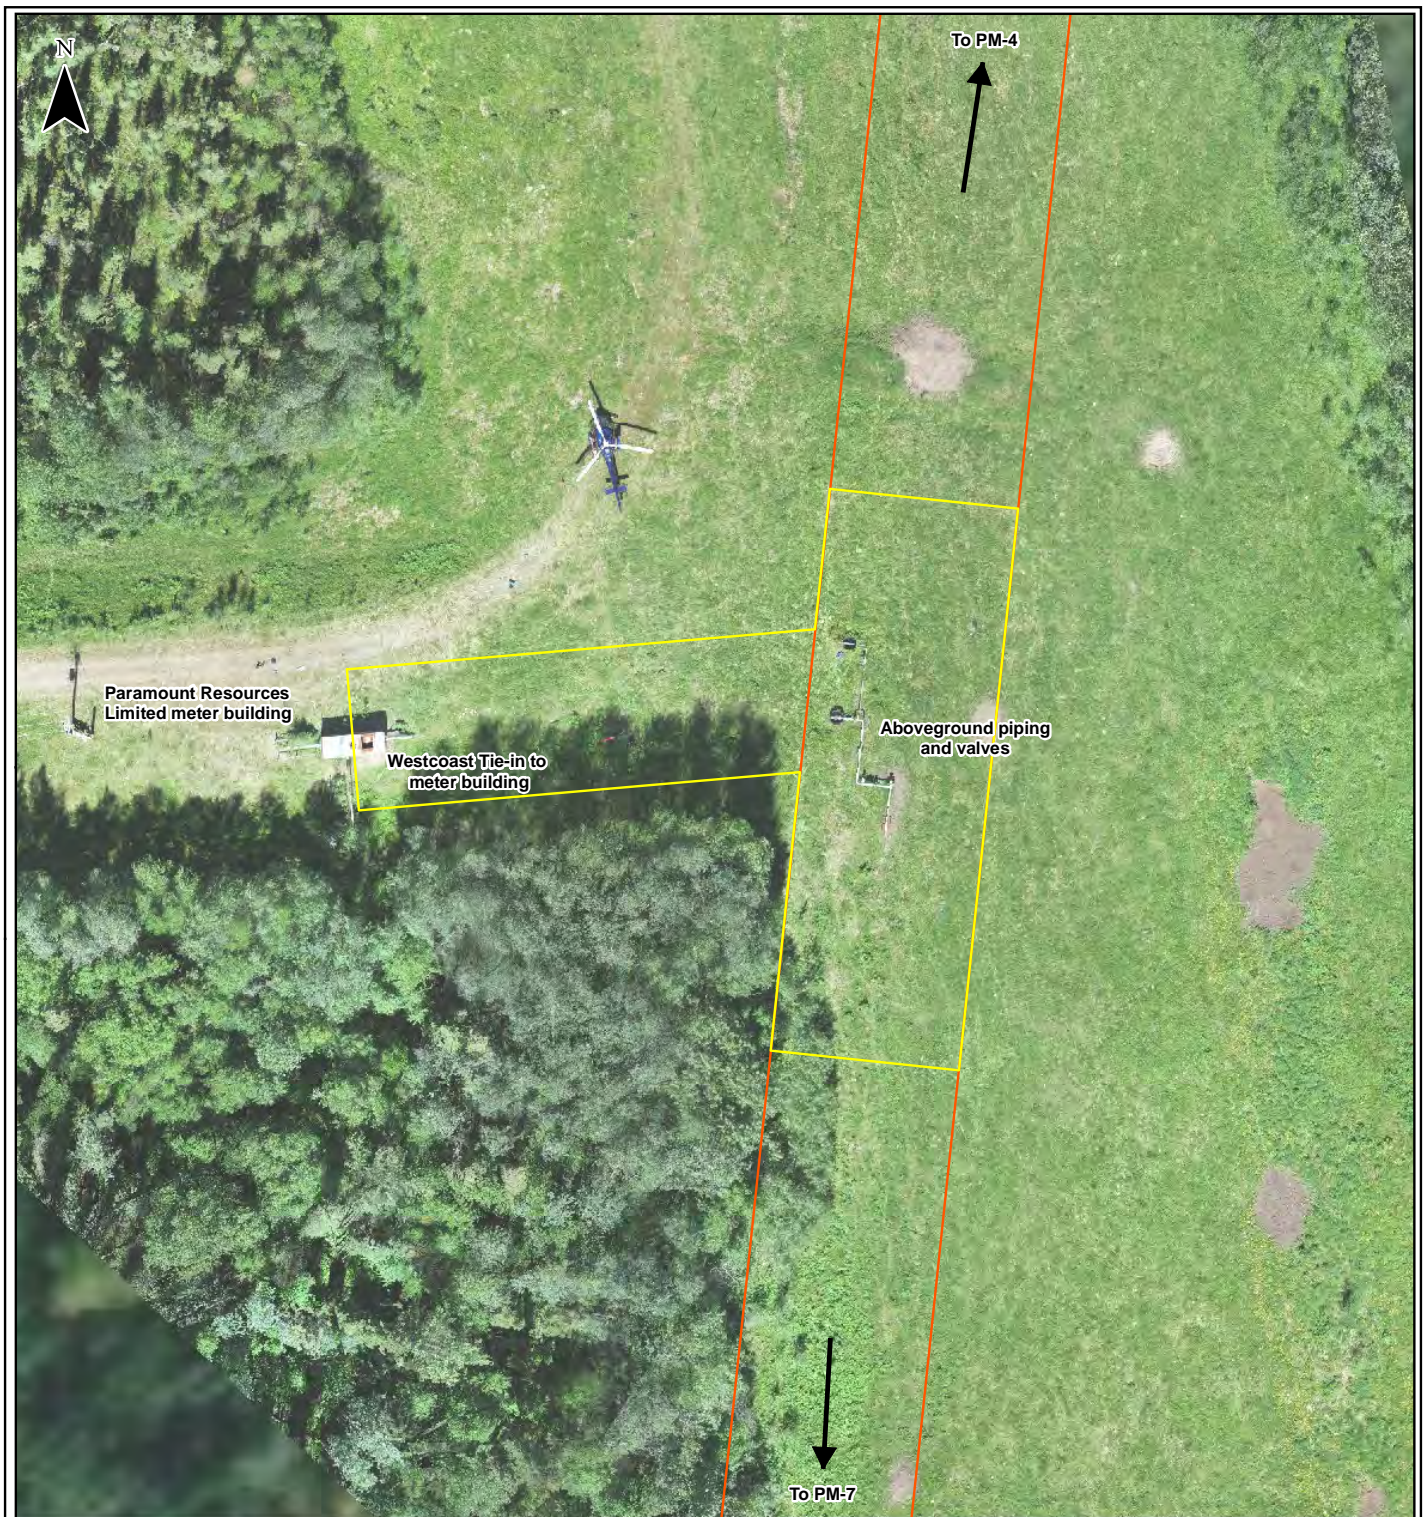
FIGURE 2.2-5

PM-6 SITE OVERVIEW
PHASE I ENVIRONMENTAL SITE ASSESSMENT

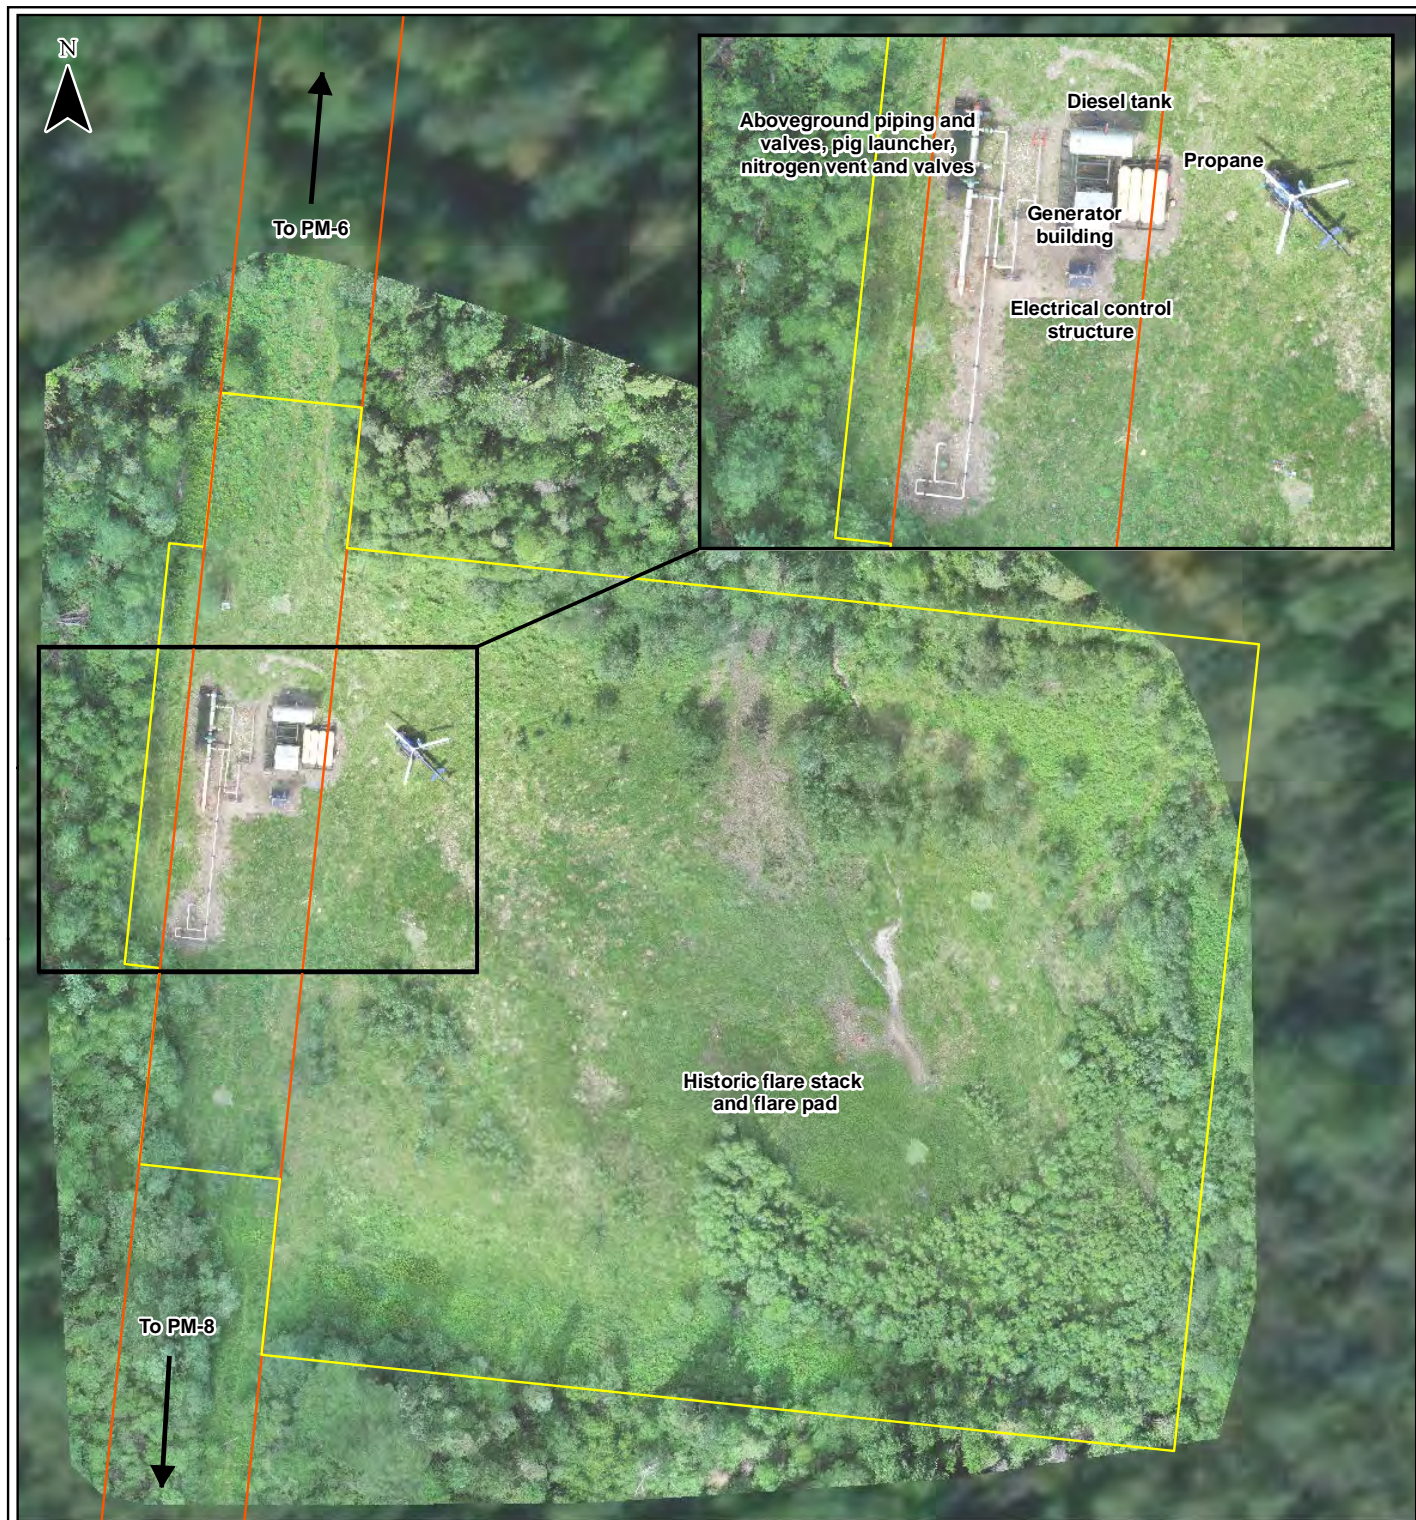
FIGURE 2.2-6

PM-7 SITE OVERVIEW
PHASE I ENVIRONMENTAL SITE ASSESSMENT

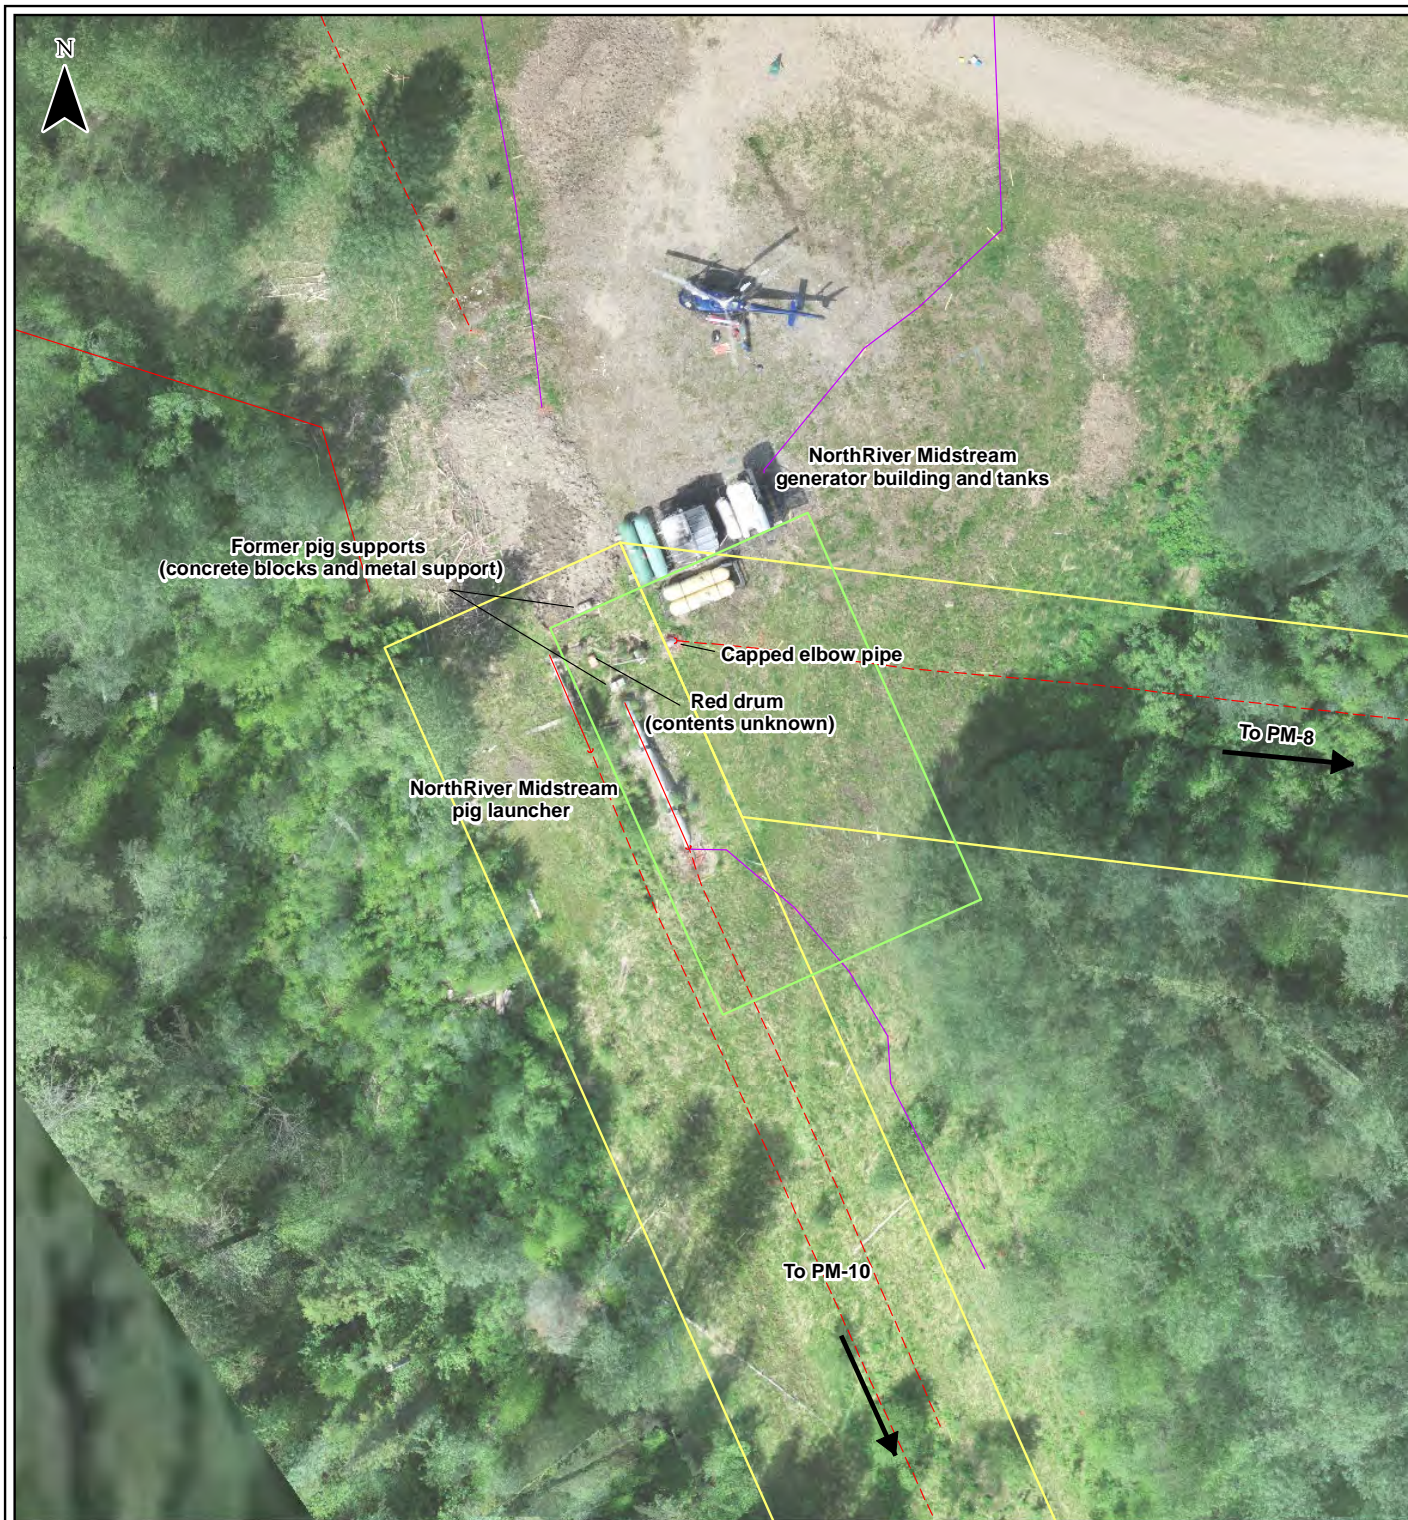
<p>— Above Ground Pipeline</p> <p>— Underground Pipeline</p> <p>— Above Ground Communications</p> <p>— Westcoast Pipeline Right-of-Way</p> <p>— Westcoast Site Boundary</p>		<p>FIGURE 2.2-8</p> <p>PM-9 SITE OVERVIEW</p> <p>PHASE I ENVIRONMENTAL SITE ASSESSMENT</p> <p>WESTCOAST ENERGY INC.</p> <p>POINTED MOUNTAIN PIPELINE</p> <p>ABANDONMENT PROJECT</p>	
<p>ENBRIDGE</p> <p>NAD 1983 UTM Zone 10N</p> <p>Satellite Imagery: Source: Esri, Maxar, GeoEye, Earthstar Geographics, CNES/Airbus DS, USDA, USGS, AeroGRID, IGN, and the GIS User Community;</p> <p>Roads: NRCan 2014-2015; Railway: NRCan 2012.</p>		<p>SCALE: 1:500</p> <p>0 5 10</p> <p>Metres</p> <p>(All Locations Approximate)</p>	
<p>Jacobs</p> <p>Although there is no reason to believe that there are any errors associated with the data used to generate this product or in the product itself, users of these data are advised that errors in the data may be present.</p>		<p>November 2021</p>	<p>CE810600</p>

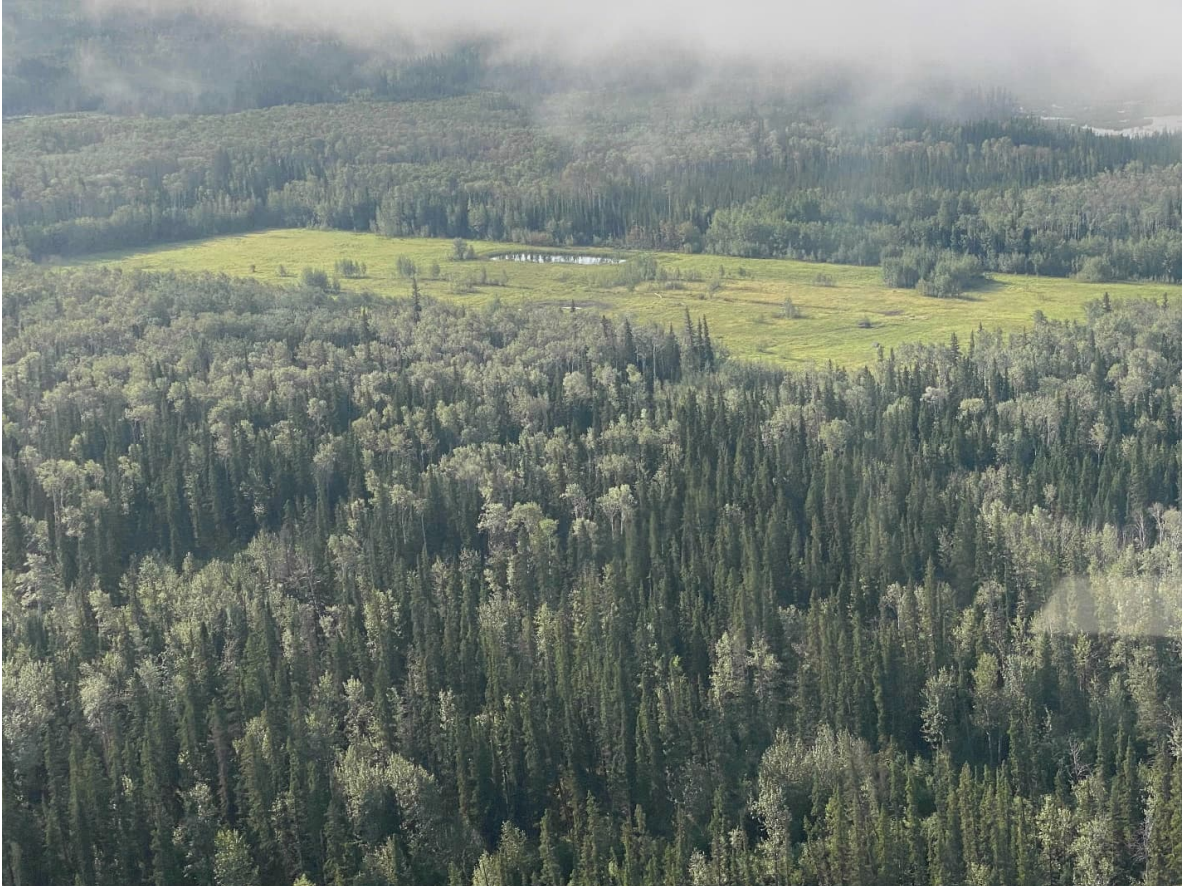
Photograph 1: Aerial view of former Amoco Gas Plant site north of the PM-1 aboveground infrastructure, facing southeast.

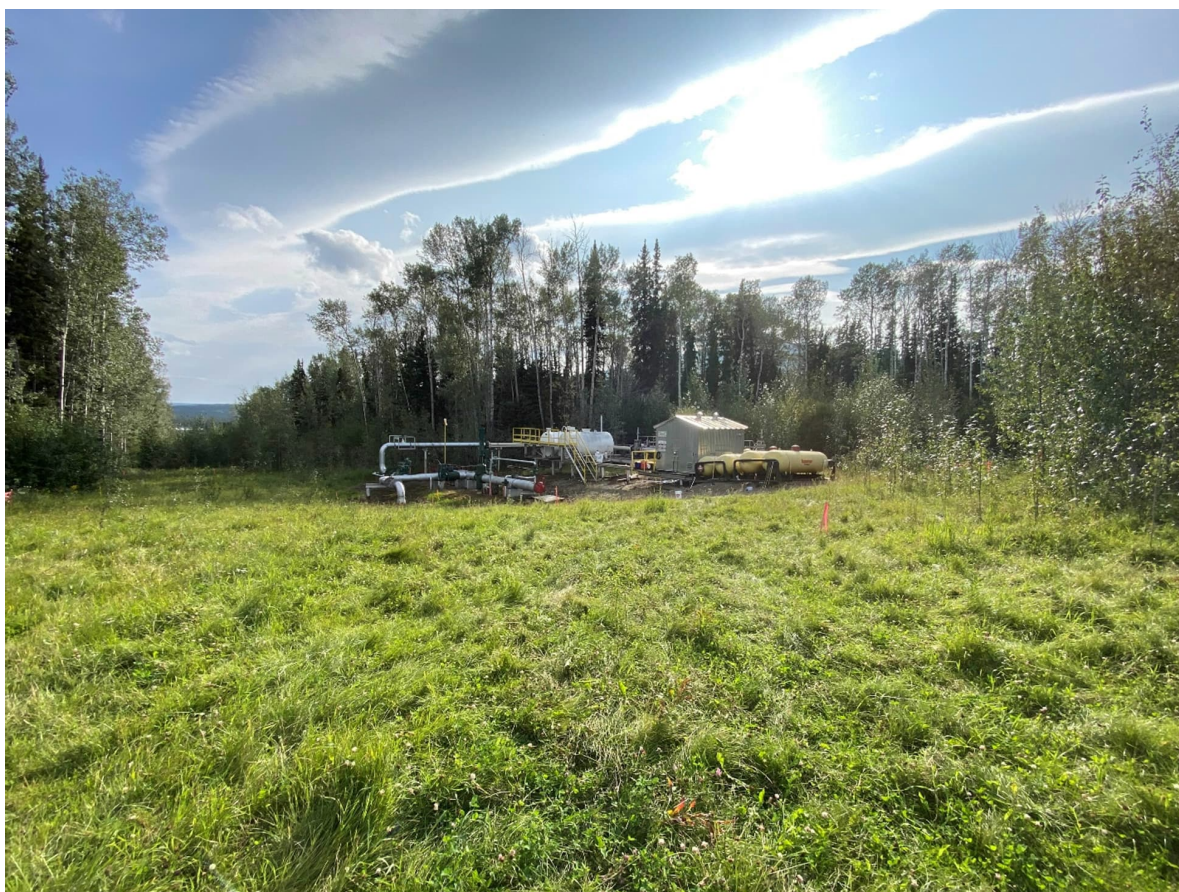
Photograph 2: Facing southwest towards aboveground infrastructure at PM-1.

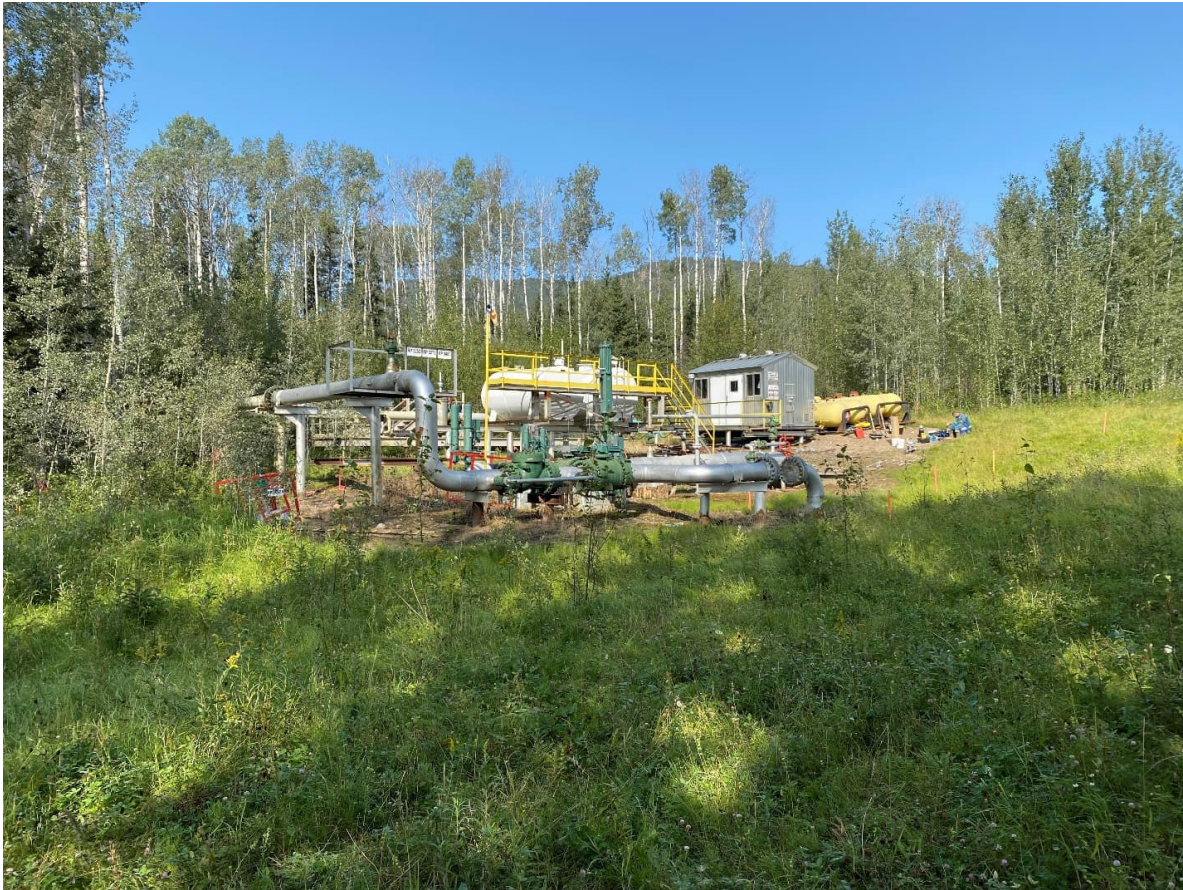
Photograph 3: Facing northwest towards aboveground infrastructure at PM-1. Tall riser on the left side of the photograph owned by Paramount Resources Ltd.

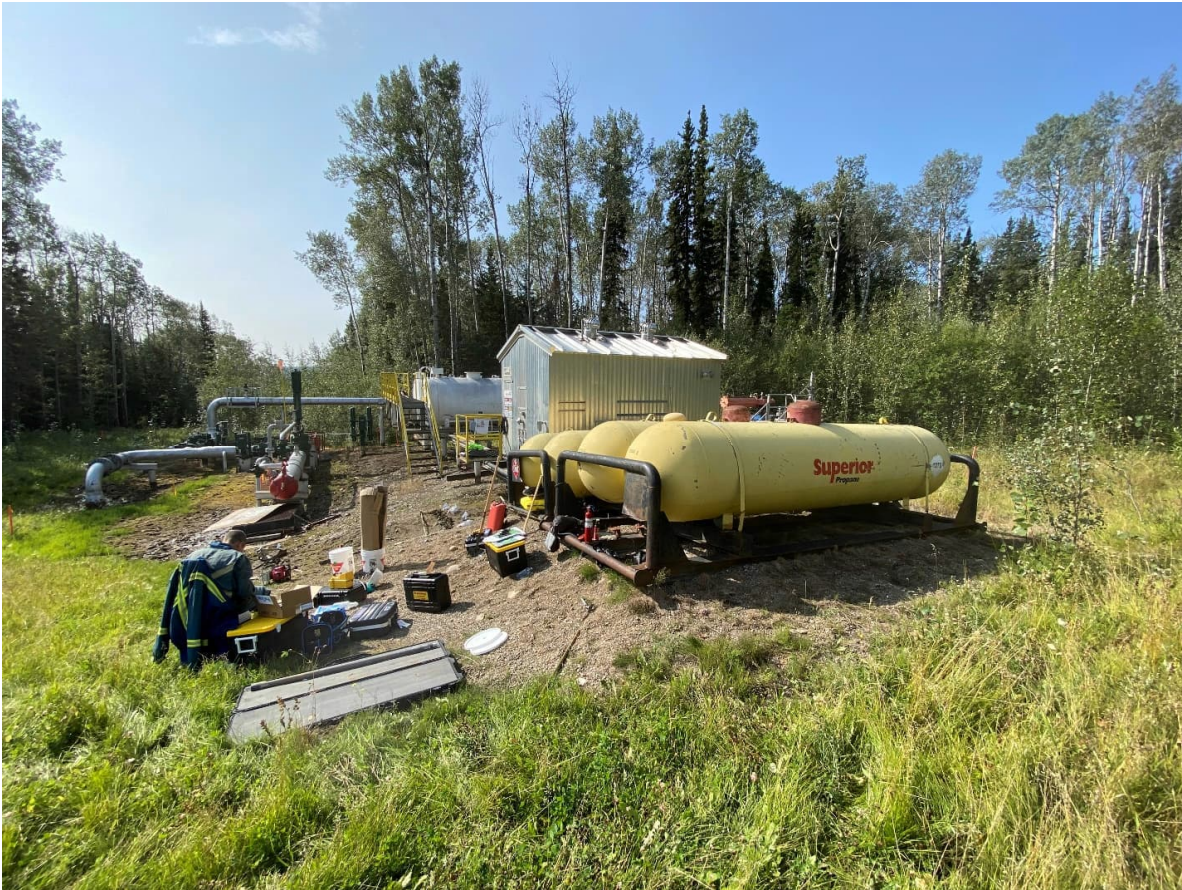
Photograph 4: Facing south towards aboveground infrastructure at PM-1. Tall riser in the background is owned by Paramount Resources Ltd.

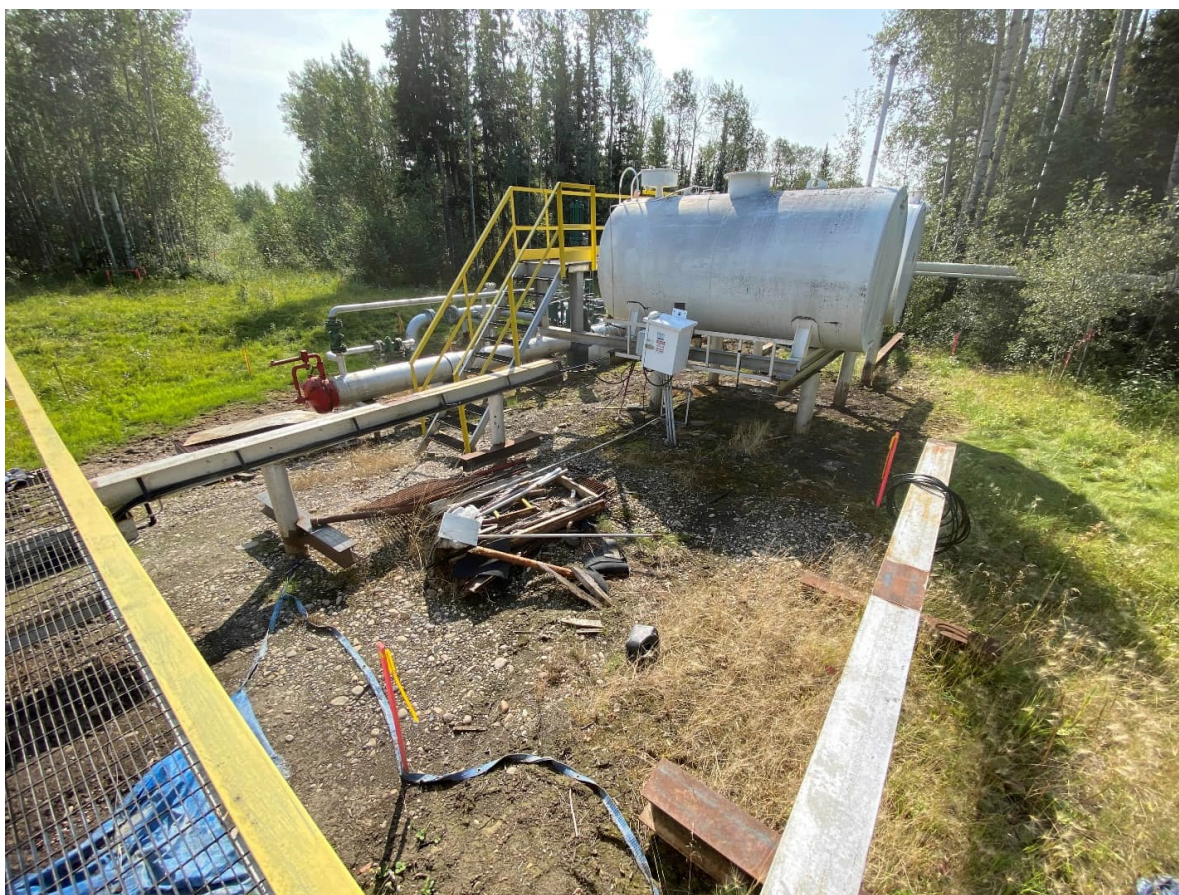
Photograph 5: Facing southeast towards diesel aboveground storage tanks on platforms.

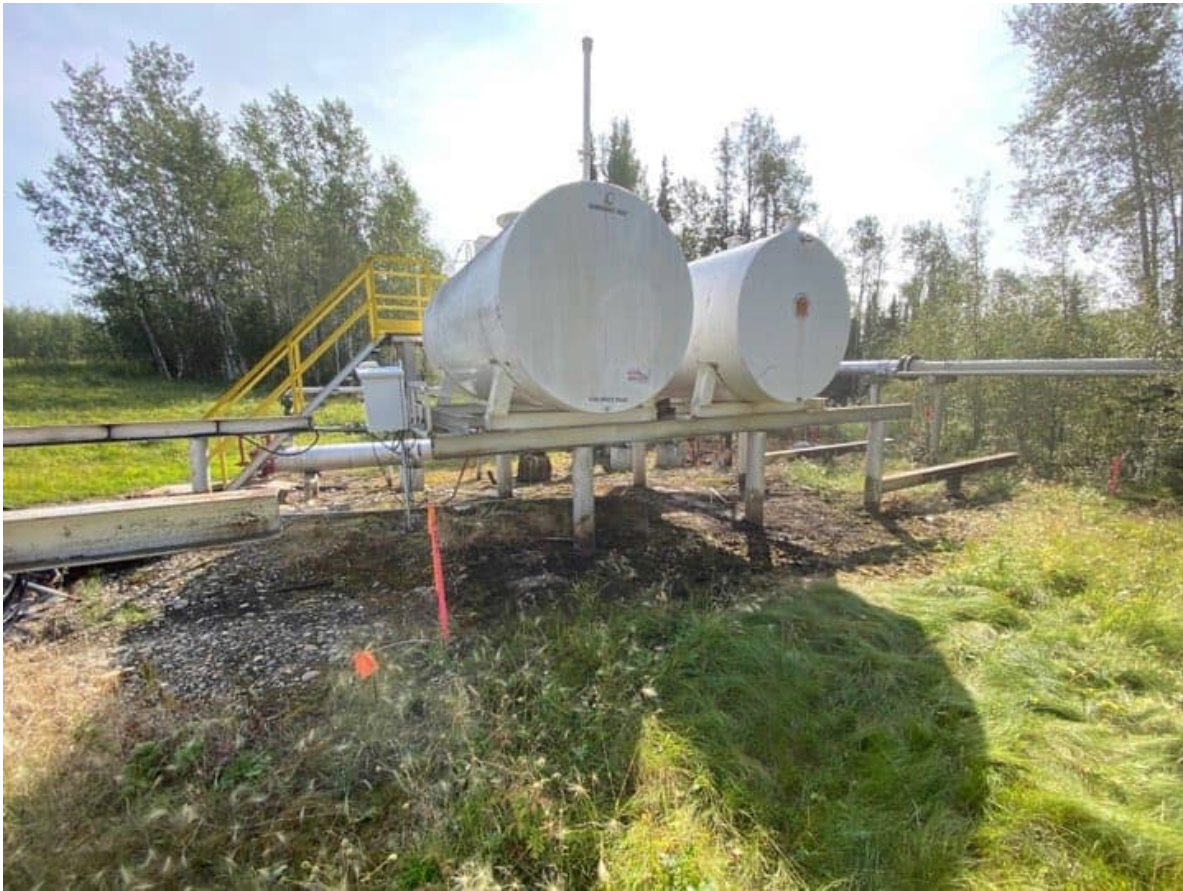
Photograph 6: Elevated diesel aboveground storage tanks. Facing southeast. Tall riser on the right side of the photograph owned by Paramount Resources Ltd.
