**FINAL REPORT: LONG-TERM
MONITORING (YEAR 1) –
GORDON LAKE GROUP OF
SITES**

Prepared for:
Public Services and Procurement
Canada on behalf of
Crown-Indigenous Relations and
Northern Affairs Canada

Prepared by:
Stantec Consulting Ltd.
40 Highfield Park Drive, Suite 102
Dartmouth, NS B3A 0A3

March 31, 2020

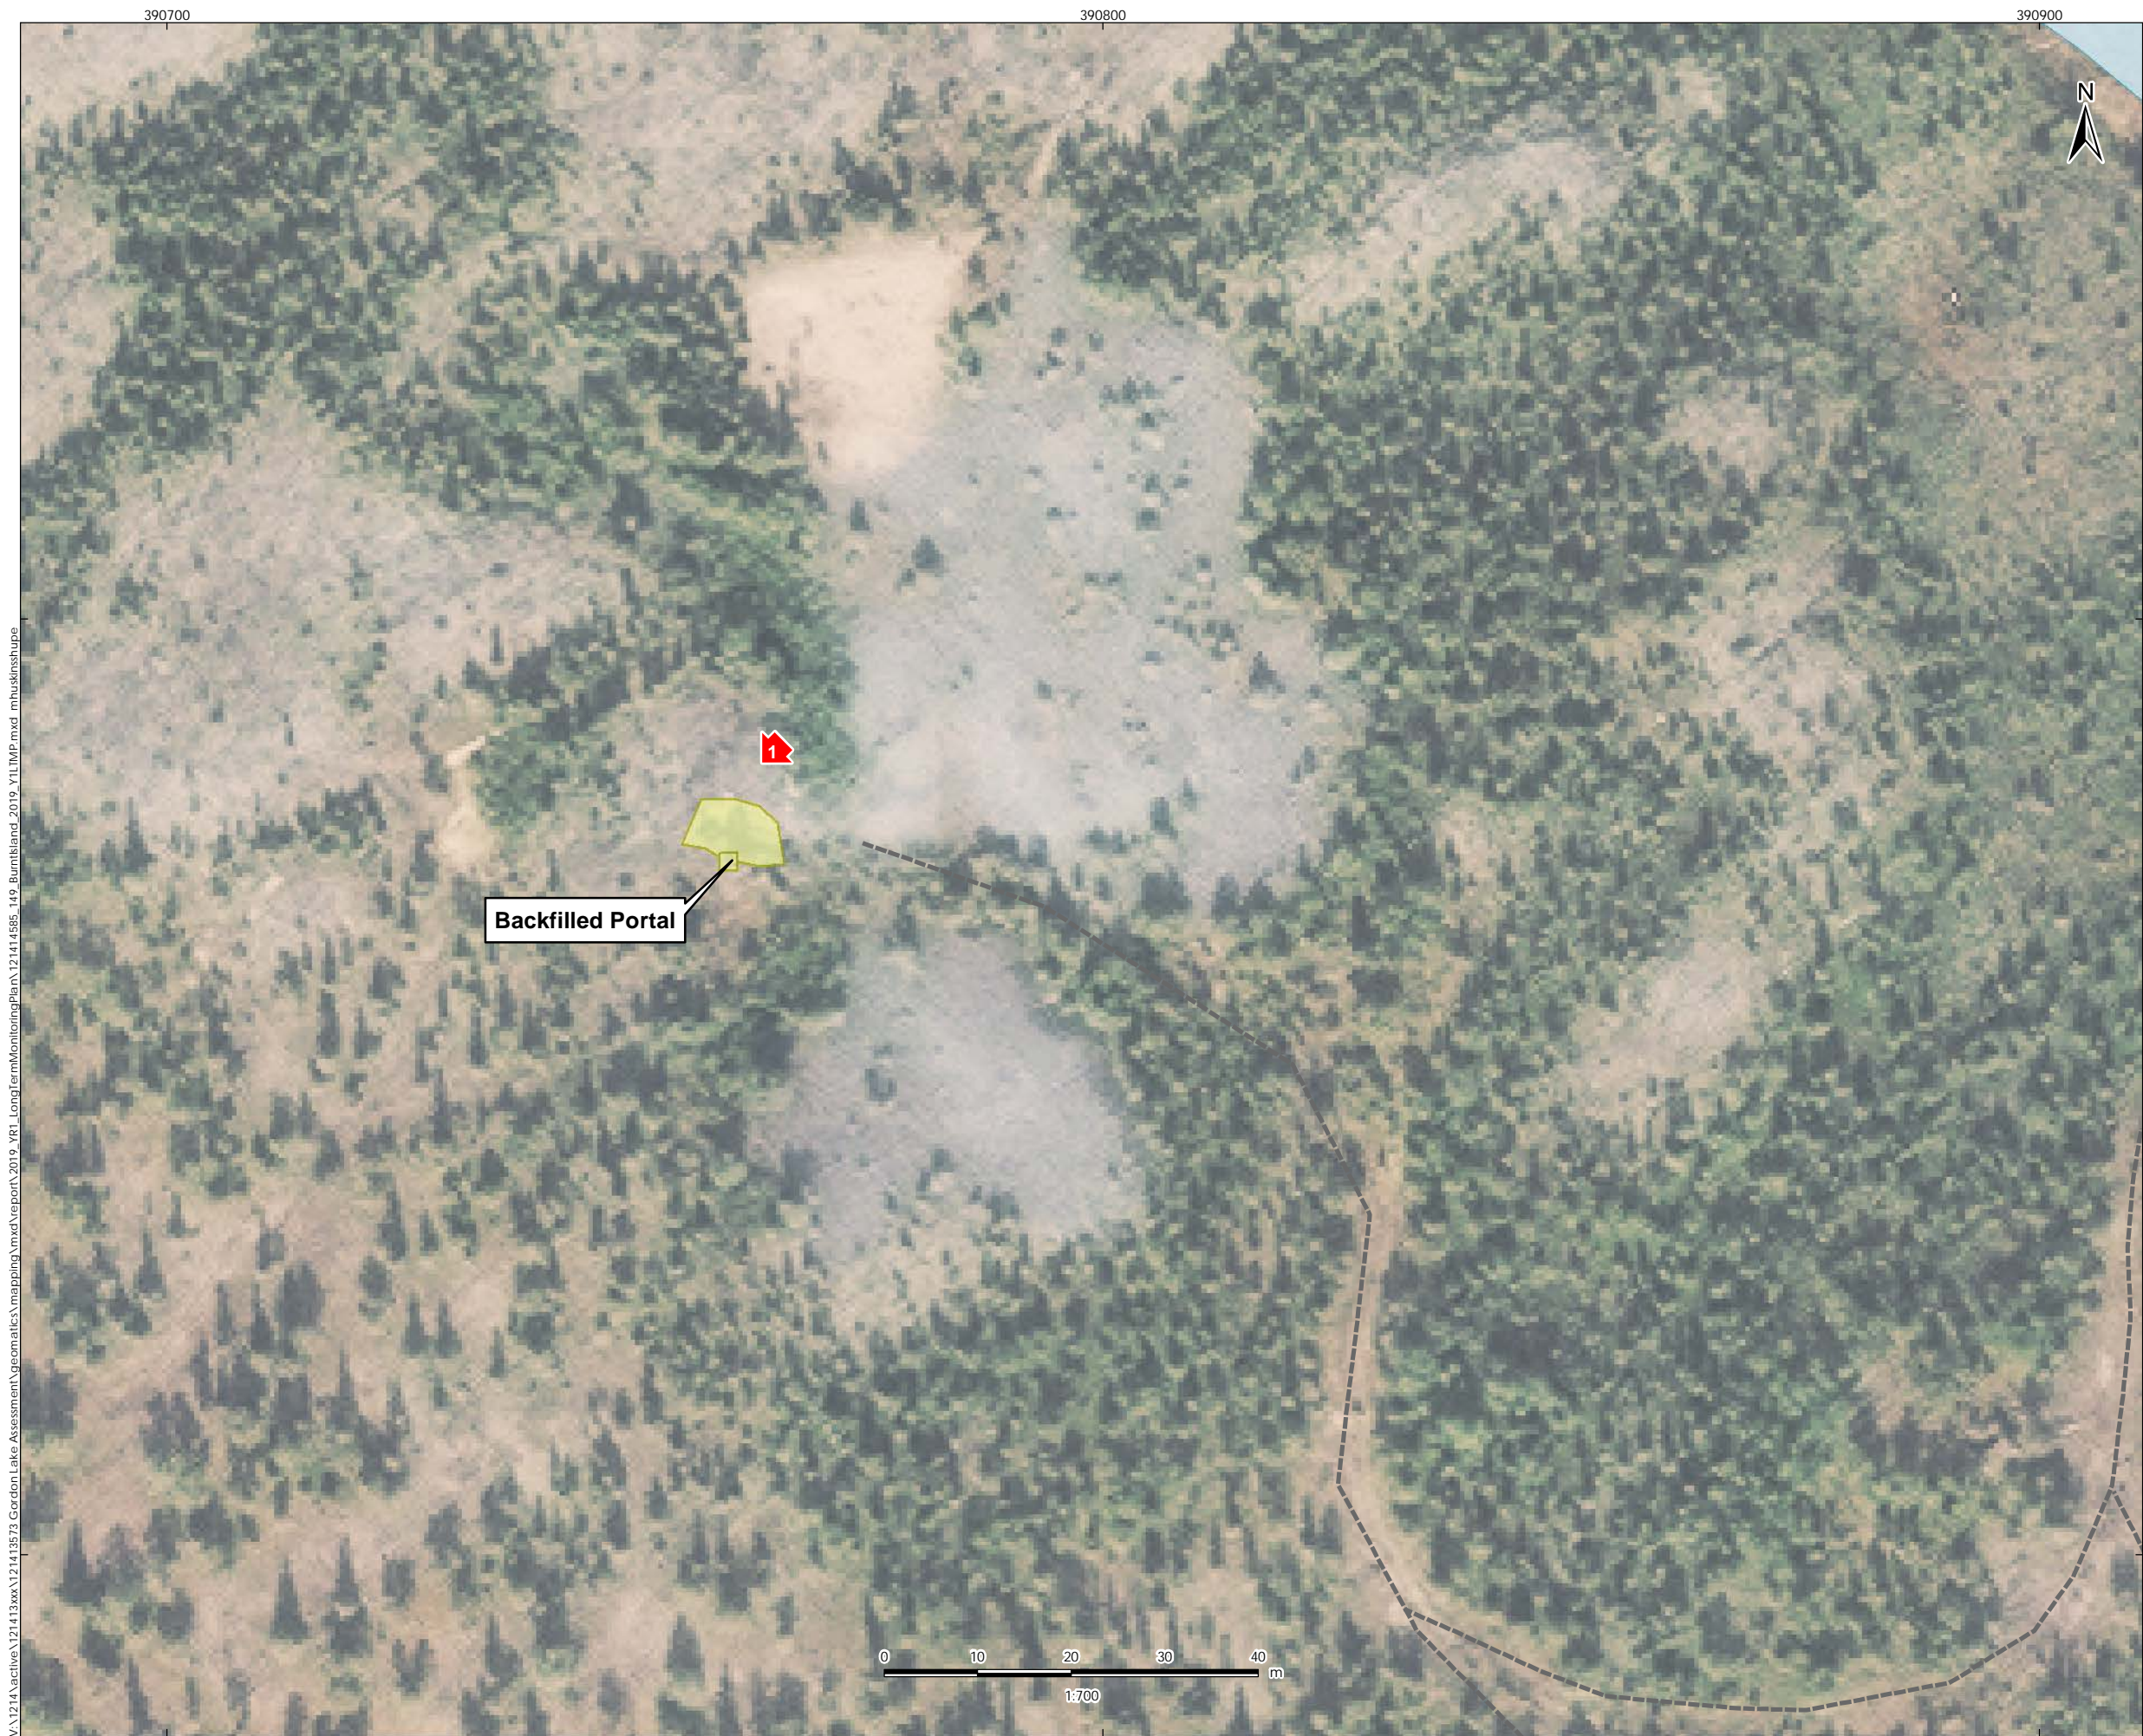
Figure No.
A1.3

Title
Burnt Island - Shaft Area
Summary of Long Term Monitoring
Components

Burnt Island	Mine Openings	Mine Shaft	A1.3	Physical	Verify the backfill material is stable with no significant resulting erosion or settlement. Verify the structural stability of the mine opening cap.	Major subsidence (<0.5m) of backfill is observed and/or structural concerns (e.g. deformation, cracking, etc.).	Investigation to identify cause and/or safety concerns. Completing repairs as needed.	Quinquennially	Years 1 and 5	Frost-free periods	Exit criteria are not applicable for mine openings unless otherwise authorized by authorities having jurisdiction.
Burnt Island	Waste Rock	BUR_WR_01	A1.5	Chemical	Verify no visual signs of ARD down-gradient of remaining impacts.	Down-gradient environment indicates signs of ARD (e.g. new loss of vegetation, stressed vegetation, discoloration, etc.).	Sampling of down-gradient soil and surface water for metals. Trouble-shooting potential sources and addressing waste rock if needed.	Quinquennially	Years 1 and 5	Summer	Future exit criteria as well as triggers for action/monitoring frequency will based on long-term results of monitoring.

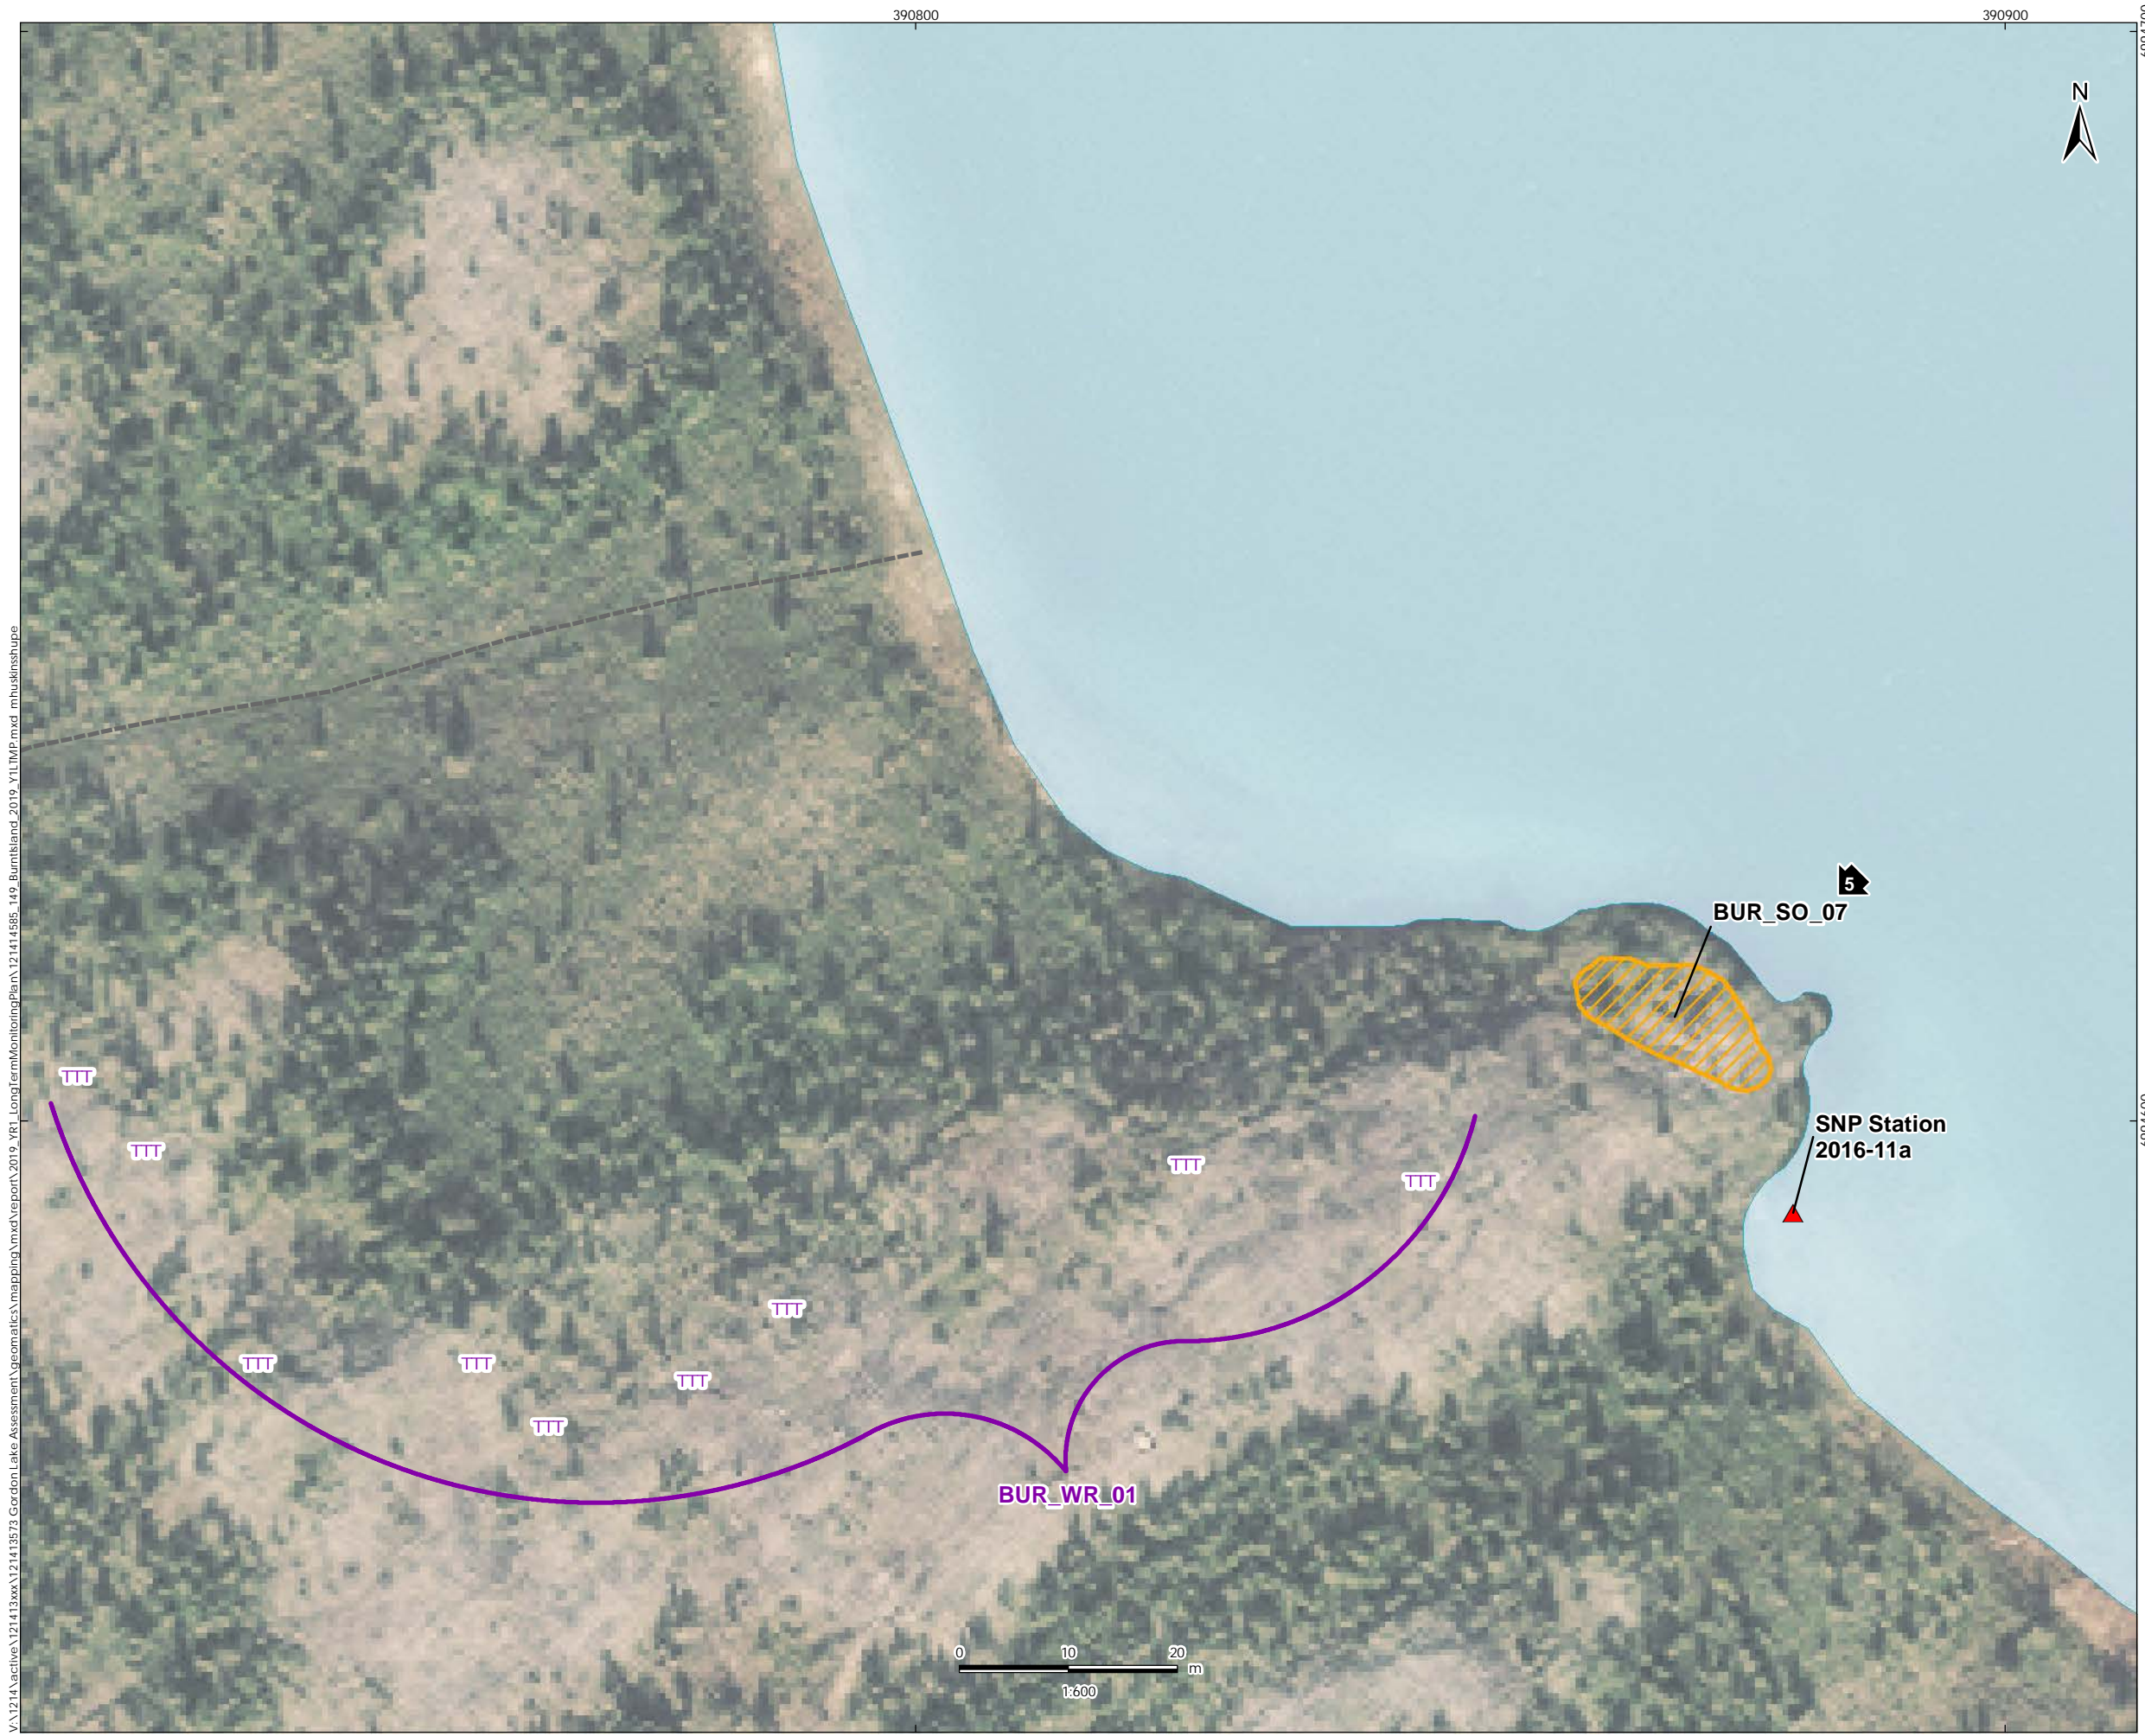
Figure No.
A1.4

Title
Burnt Island - Waste Rock Area
Summary of Long Term Monitoring
Components

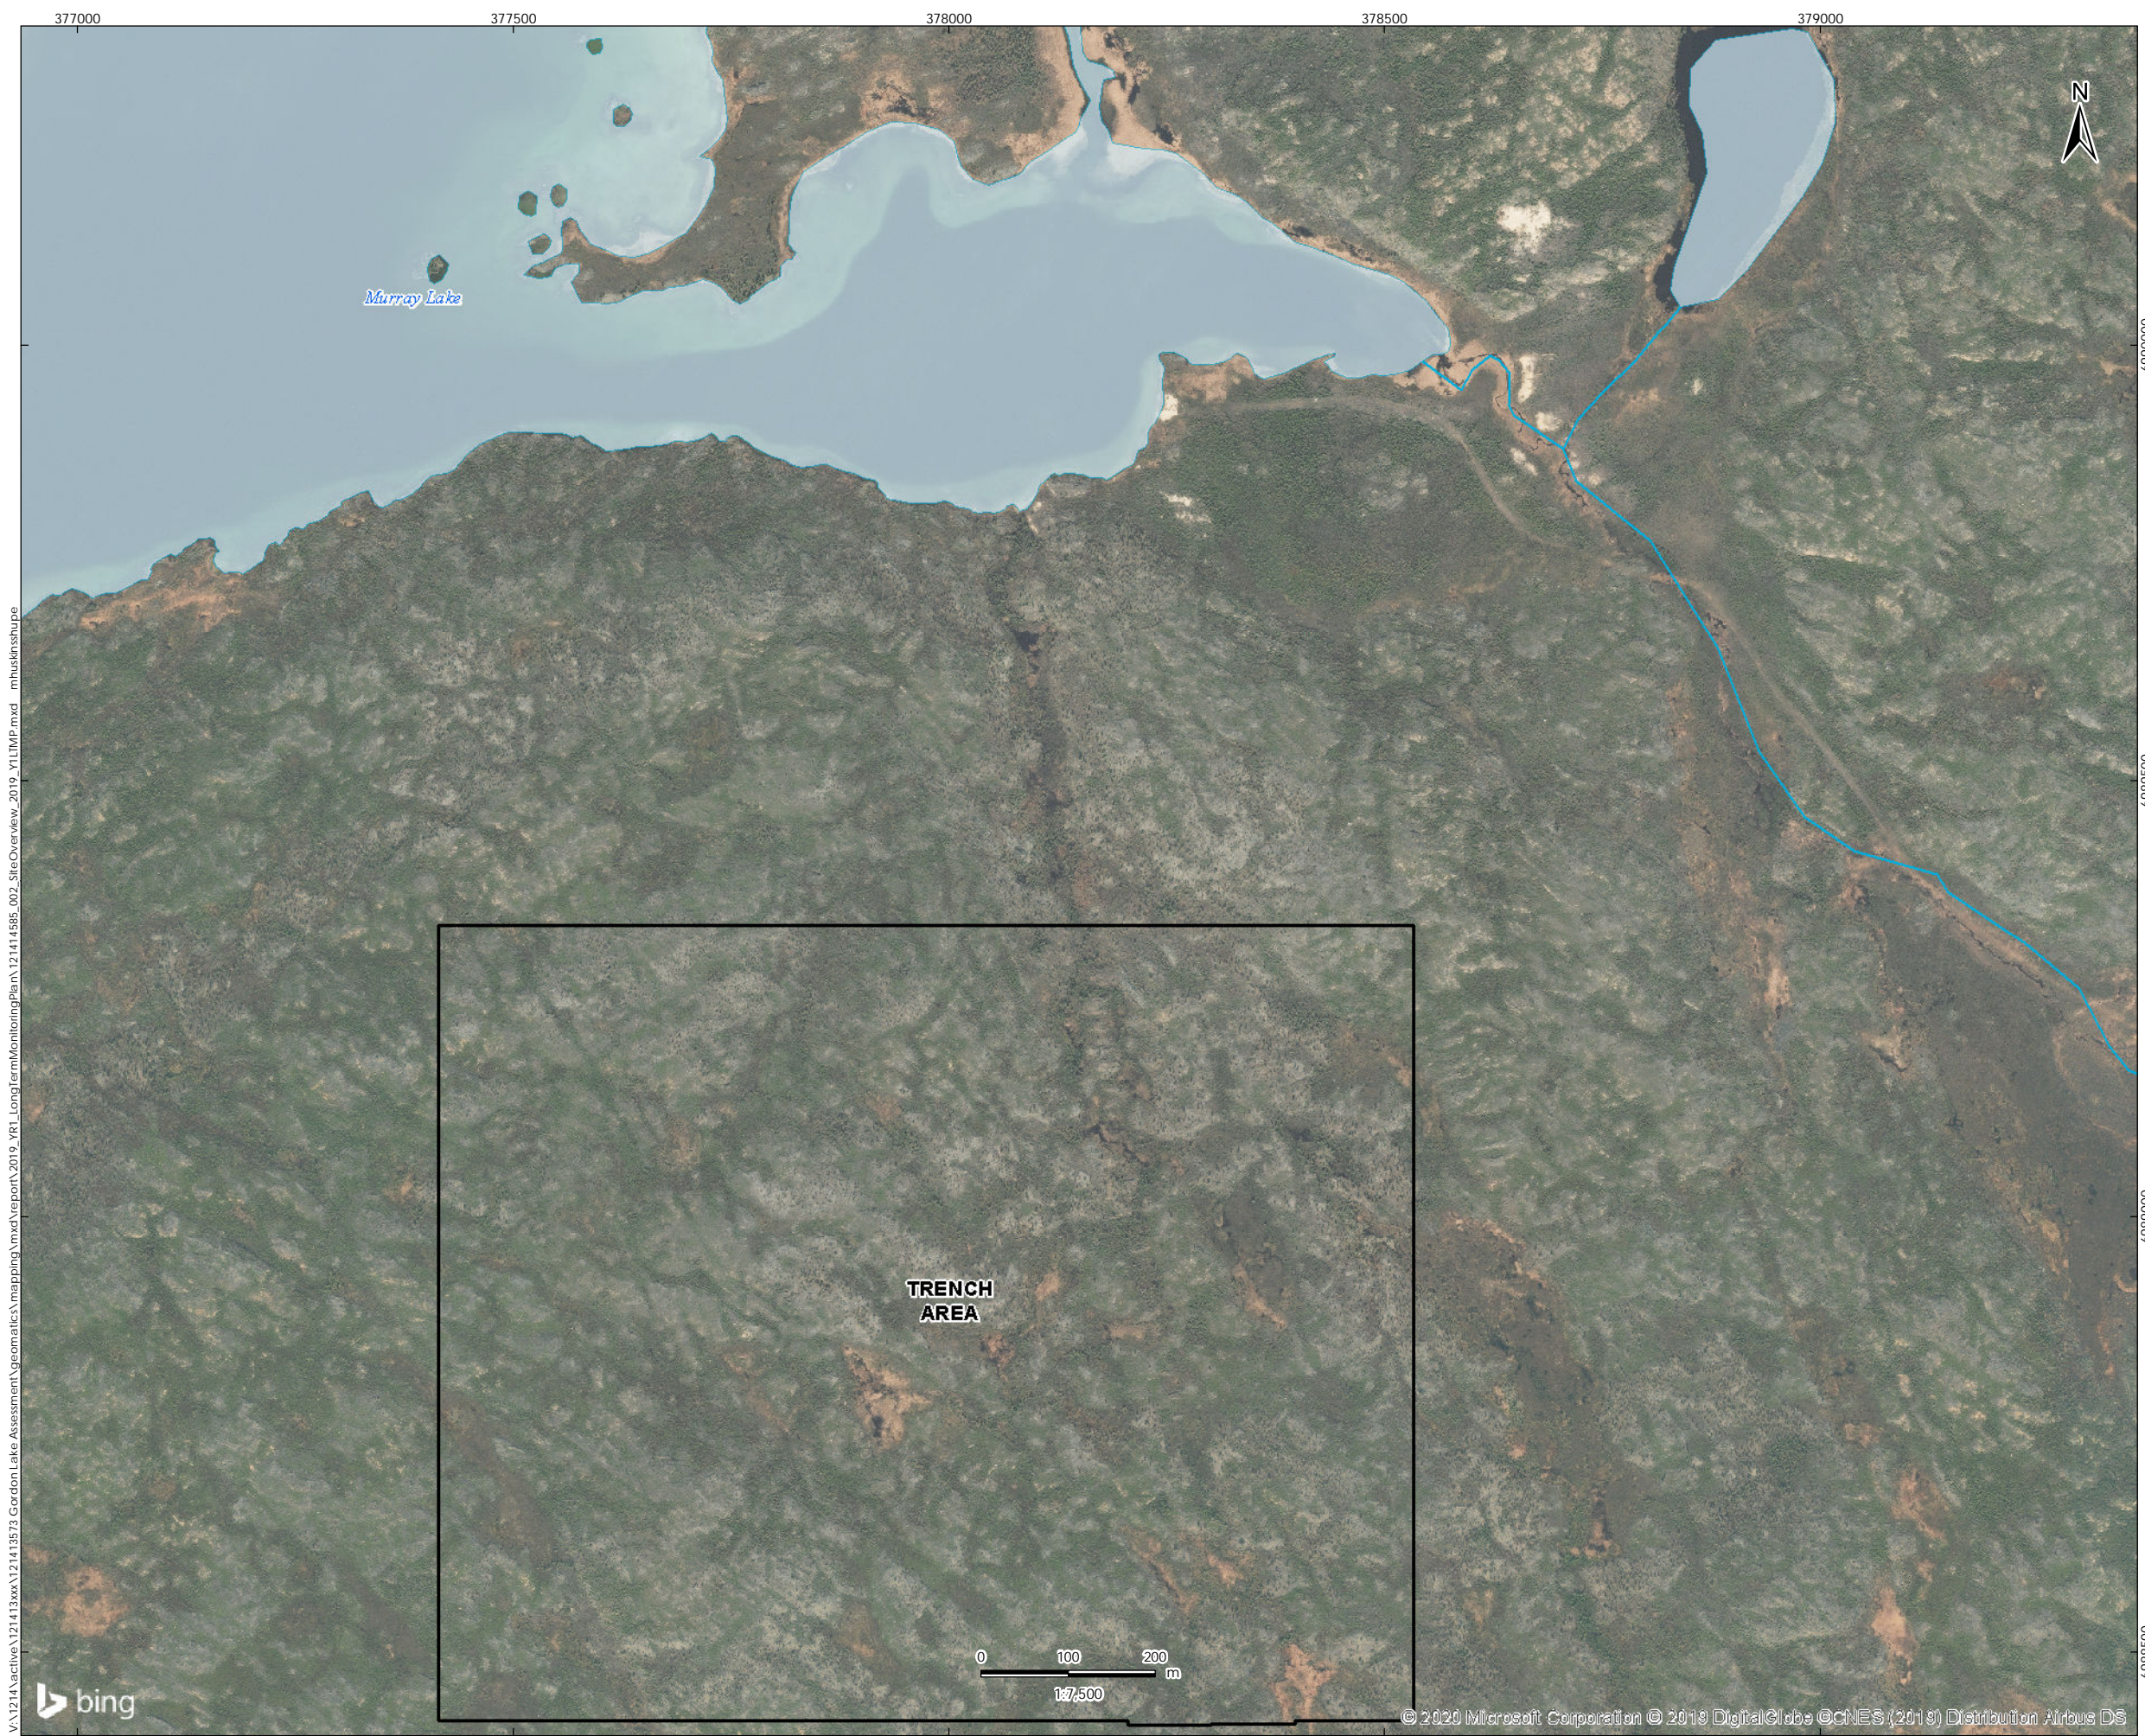
Figure No.
A4.3

Title
Kidney Pond - Portal Area
Summary of Long-Term Monitoring
Components

Kidney Pond	Co-Mingled Impacted Soil	KID_SO_07	A4.3	Erosion	Verify excavation backfill material is stable with no significant resulting erosion or washout into down-gradient water. Visually monitor vegetative health to confirm stable or increasing growth.	Erosion/washout concerns in nearby water and/or rills >10cm. Vegetative health observed to be decreasing (and potential erosion concerns as detailed above).	Reviewing SNP surface water results (SNP Station 2016-11 especially for TSS) and increasing frequency and/or adjusting sampling locations if needed. Trouble-shooting of source and sediment/erosion control measures as needed. May consider revegetation or ways to increase vegetative health for the purpose of erosion control.	Biennially	Years 1, 3 and 5	Frost-free periods	Absence of major erosion concerns over three consecutive monitoring events.

Kidney Pond	PHC Impacted Soil	KID_SO_10	A4.3	Erosion	Verify excavation backfill material is stable with no significant resulting erosion or washout into down-gradient water. Visually monitor vegetative health to confirm stable or increasing growth.	Erosion/washout concerns in nearby water and/or rills >10cm. Vegetative health observed to be decreasing (and potential erosion concerns as detailed above).	Reviewing SNP surface water results (SNP Station 2016-11 especially for TSS) and increasing frequency and/or adjusting sampling locations if needed. Trouble-shooting of source and sediment/erosion control measures as needed. May consider revegetation or ways to increase vegetative health for the purpose of erosion control.	Biennially	Years 1, 3 and 5	Frost-free periods	Absence of major erosion concerns over three consecutive monitoring events.
Kidney Pond	Waste Rock	KID_WR_01	A4.3	Erosion	Verify excavation backfill and large area of regraded material is stable with no significant resulting erosion or washout, especially into down-gradient water. Visually monitor vegetative health to confirm stable or increasing growth.	Erosion/washout concerns in nearby water and/or rills >10cm. Vegetative health observed to be decreasing (and potential erosion concerns as detailed above).	Reviewing SNP surface water results (SNP Station 2016-11 especially for TSS) and increasing frequency and/or adjusting sampling locations if needed. Trouble-shooting of source and sediment/erosion control measures as needed. May consider revegetation or ways to increase vegetative health for the purpose of erosion control.	Biennially	Years 1, 3 and 5	Frost-free periods	Future exit criteria as well as triggers for action/monitoring frequency will be based on long-term results of monitoring..

Kidney Pond	Mine Openings	Portal	A4.3	Physical	Verify backfill material is stable with no significant resulting erosion or settlement.	Major subsidence (<0.5m) of backfill is observed and/or structural concerns (e.g. deformation, cracking, etc.).	Investigation to identify cause and/or safety concerns. Completing repairs as needed.	Quinquennially	Years 1 and 5	Frost-free periods	Exit criteria are not applicable for mine openings unless otherwise authorized by authorities having jurisdiction.
Kidney Pond	Waste Rock	KID_WR_03	A4.3	Chemical	Verify no visual signs of ARD down-gradient of remaining impacts.	Down-gradient environment indicates signs of ARD (e.g. new loss of vegetation, stressed vegetation, discoloration, etc.).	Sampling of down-gradient soil and surface water for metals. Trouble-shooting potential sources and addressing waste rock if needed.	Quinquennially	Years 1 and 5	Summer	Future exit criteria as well as triggers for action/monitoring frequency will be based on long-term results of monitoring.

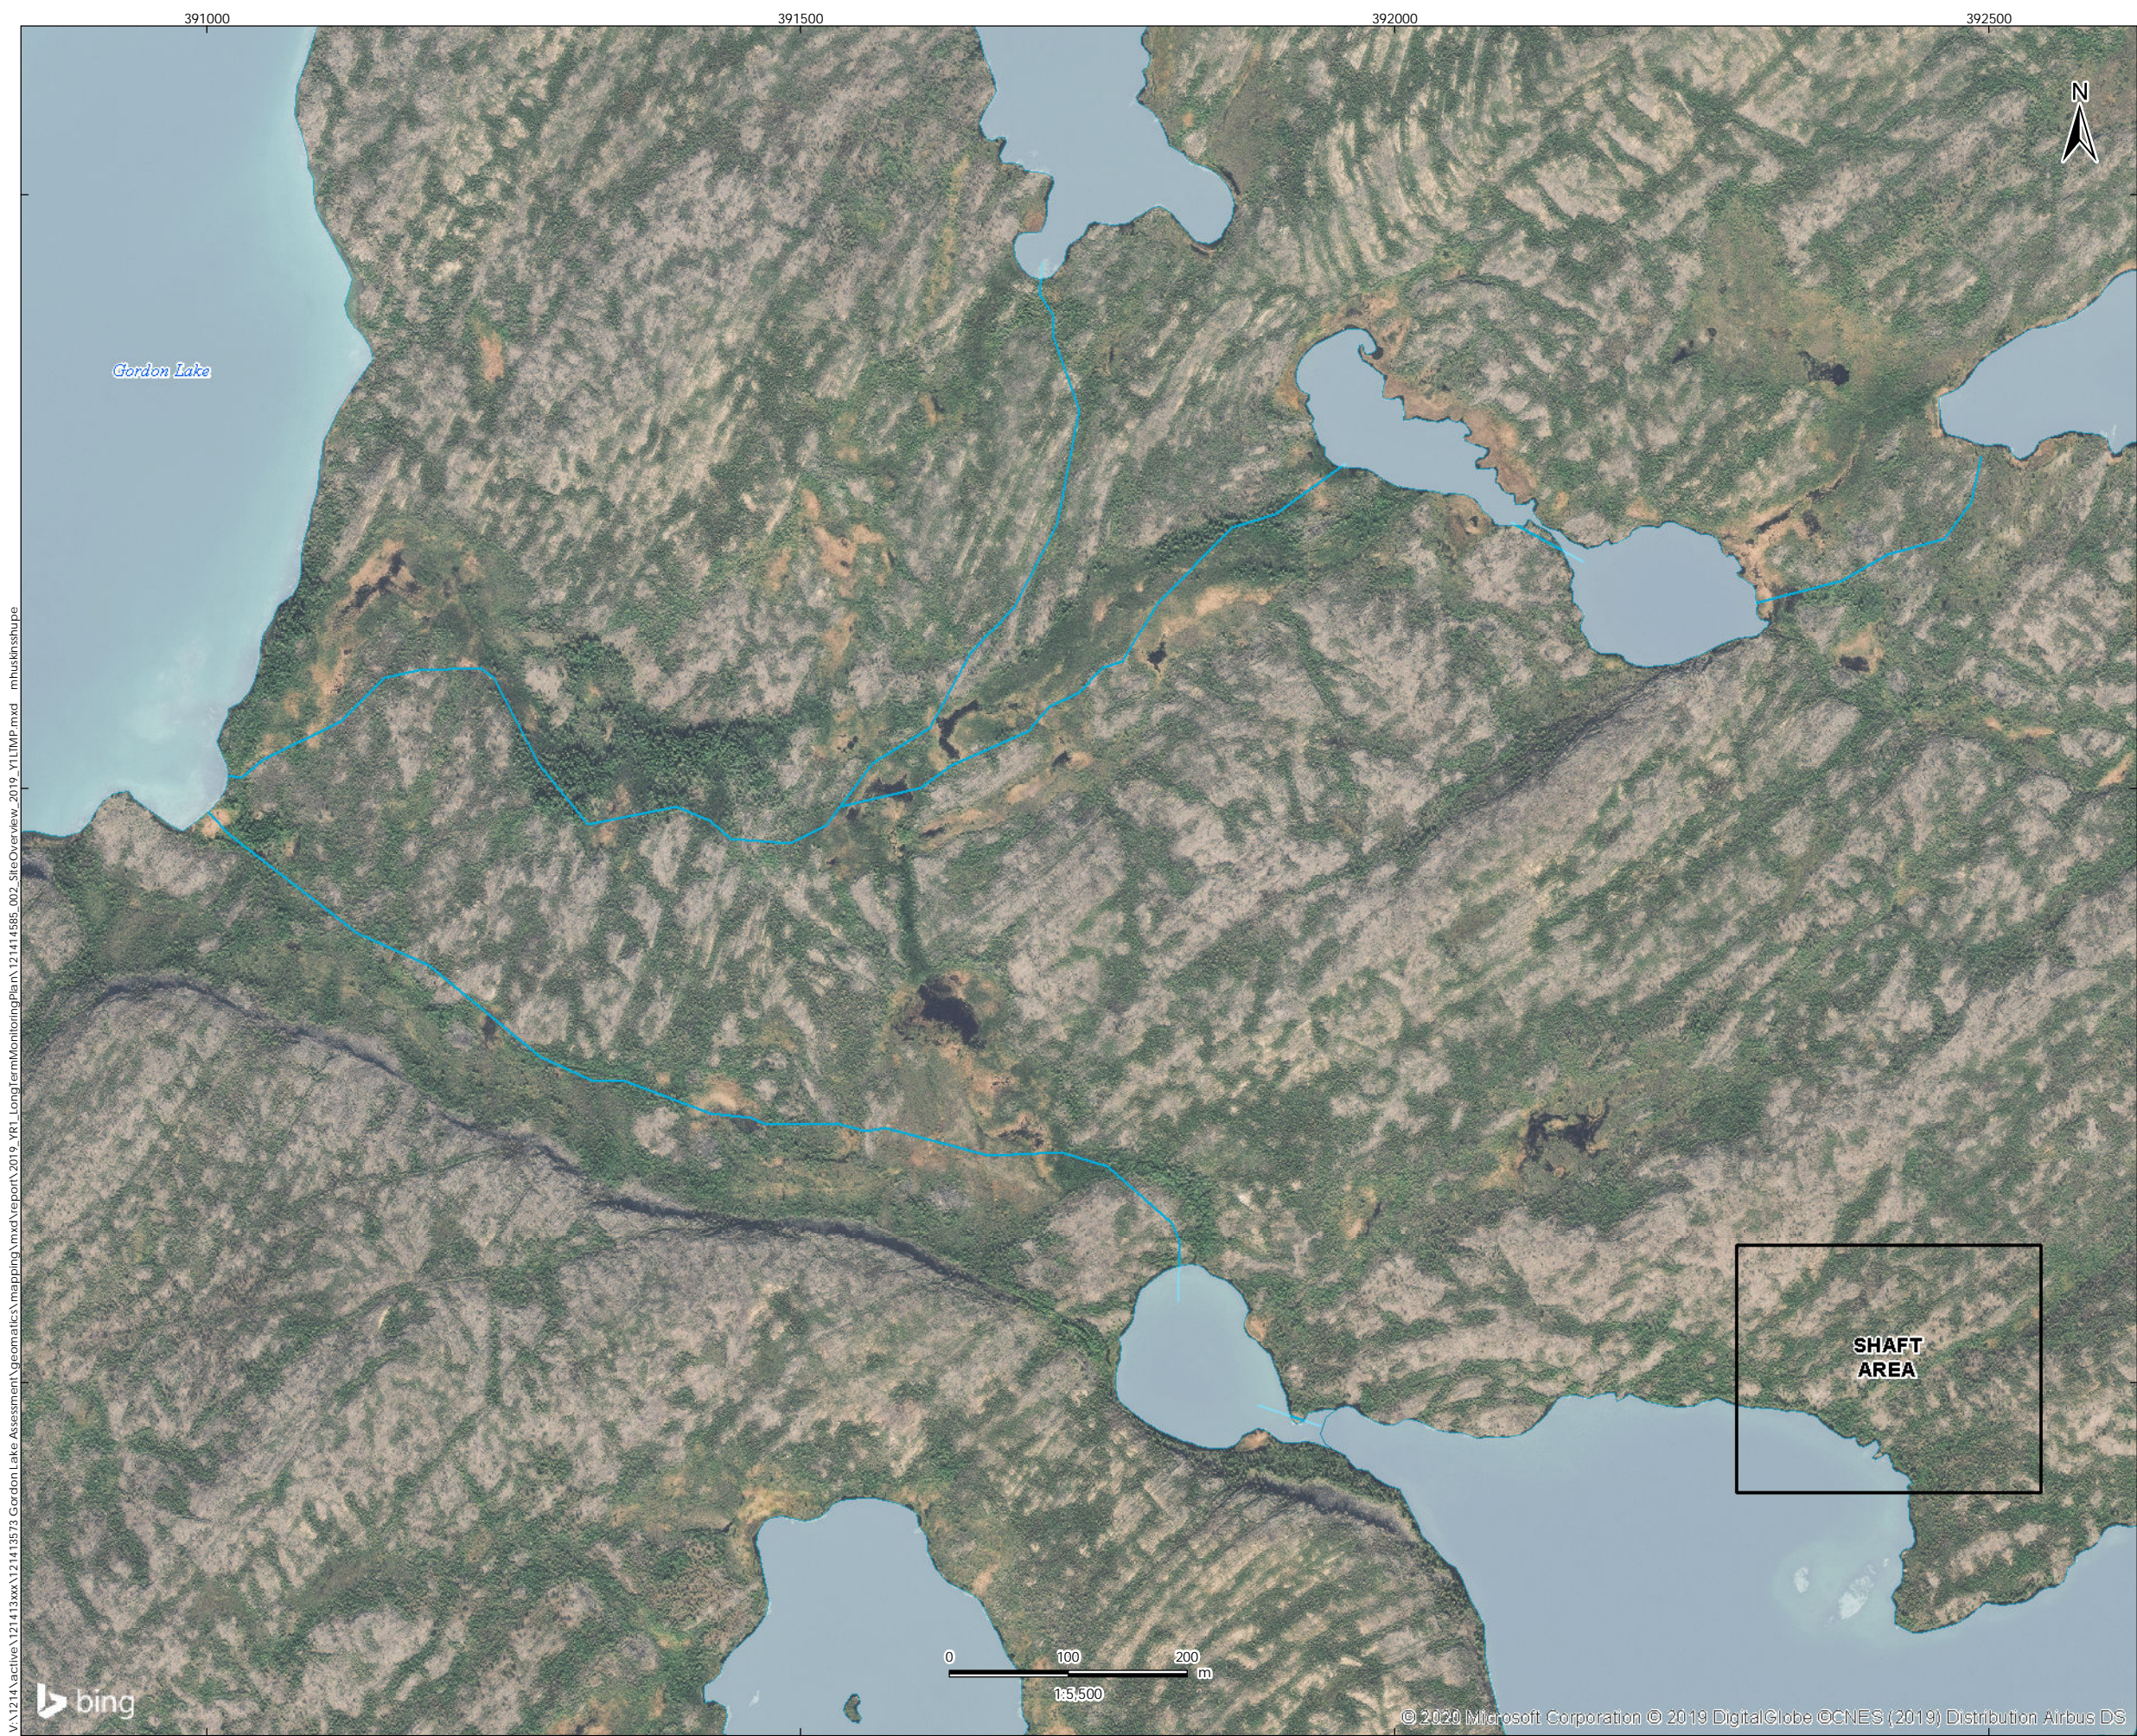
Figure No.
A5.2

Title
Murray Lake - Trench Area
Summary of Long-Term Monitoring
Components

Murray Lake	Mine Openings	Deep Trench/Shaft	A5.2	Physical	Verify backfill material is stable with no significant resulting erosion or settlement.	Major subsidence (<0.5m) of backfill is observed and/or structural concerns (e.g. deformation, cracking, etc.).	Investigation to identify cause and/or safety concerns. Completing repairs as needed.	Quinquennially	Years 1 and 5	Frost-free periods	Exit criteria are not applicable for mine openings unless otherwise authorized by authorities having jurisdiction.
Murray Lake	Waste Rock	MUR_WR_01	A5.2	Chemical	Verify no visual signs of ARD down-gradient of remaining impacts.	Down-gradient environment indicates signs of ARD (e.g. new loss of vegetation, stressed vegetation, discoloration, etc.).	Sampling of down-gradient soil and surface water for metals. Trouble-shooting potential sources and addressing waste rock if needed.	Quinquennially	Years 1 and 5	Summer	Future exit criteria as well as triggers for action/monitoring frequency will be based on long-term results of monitoring.

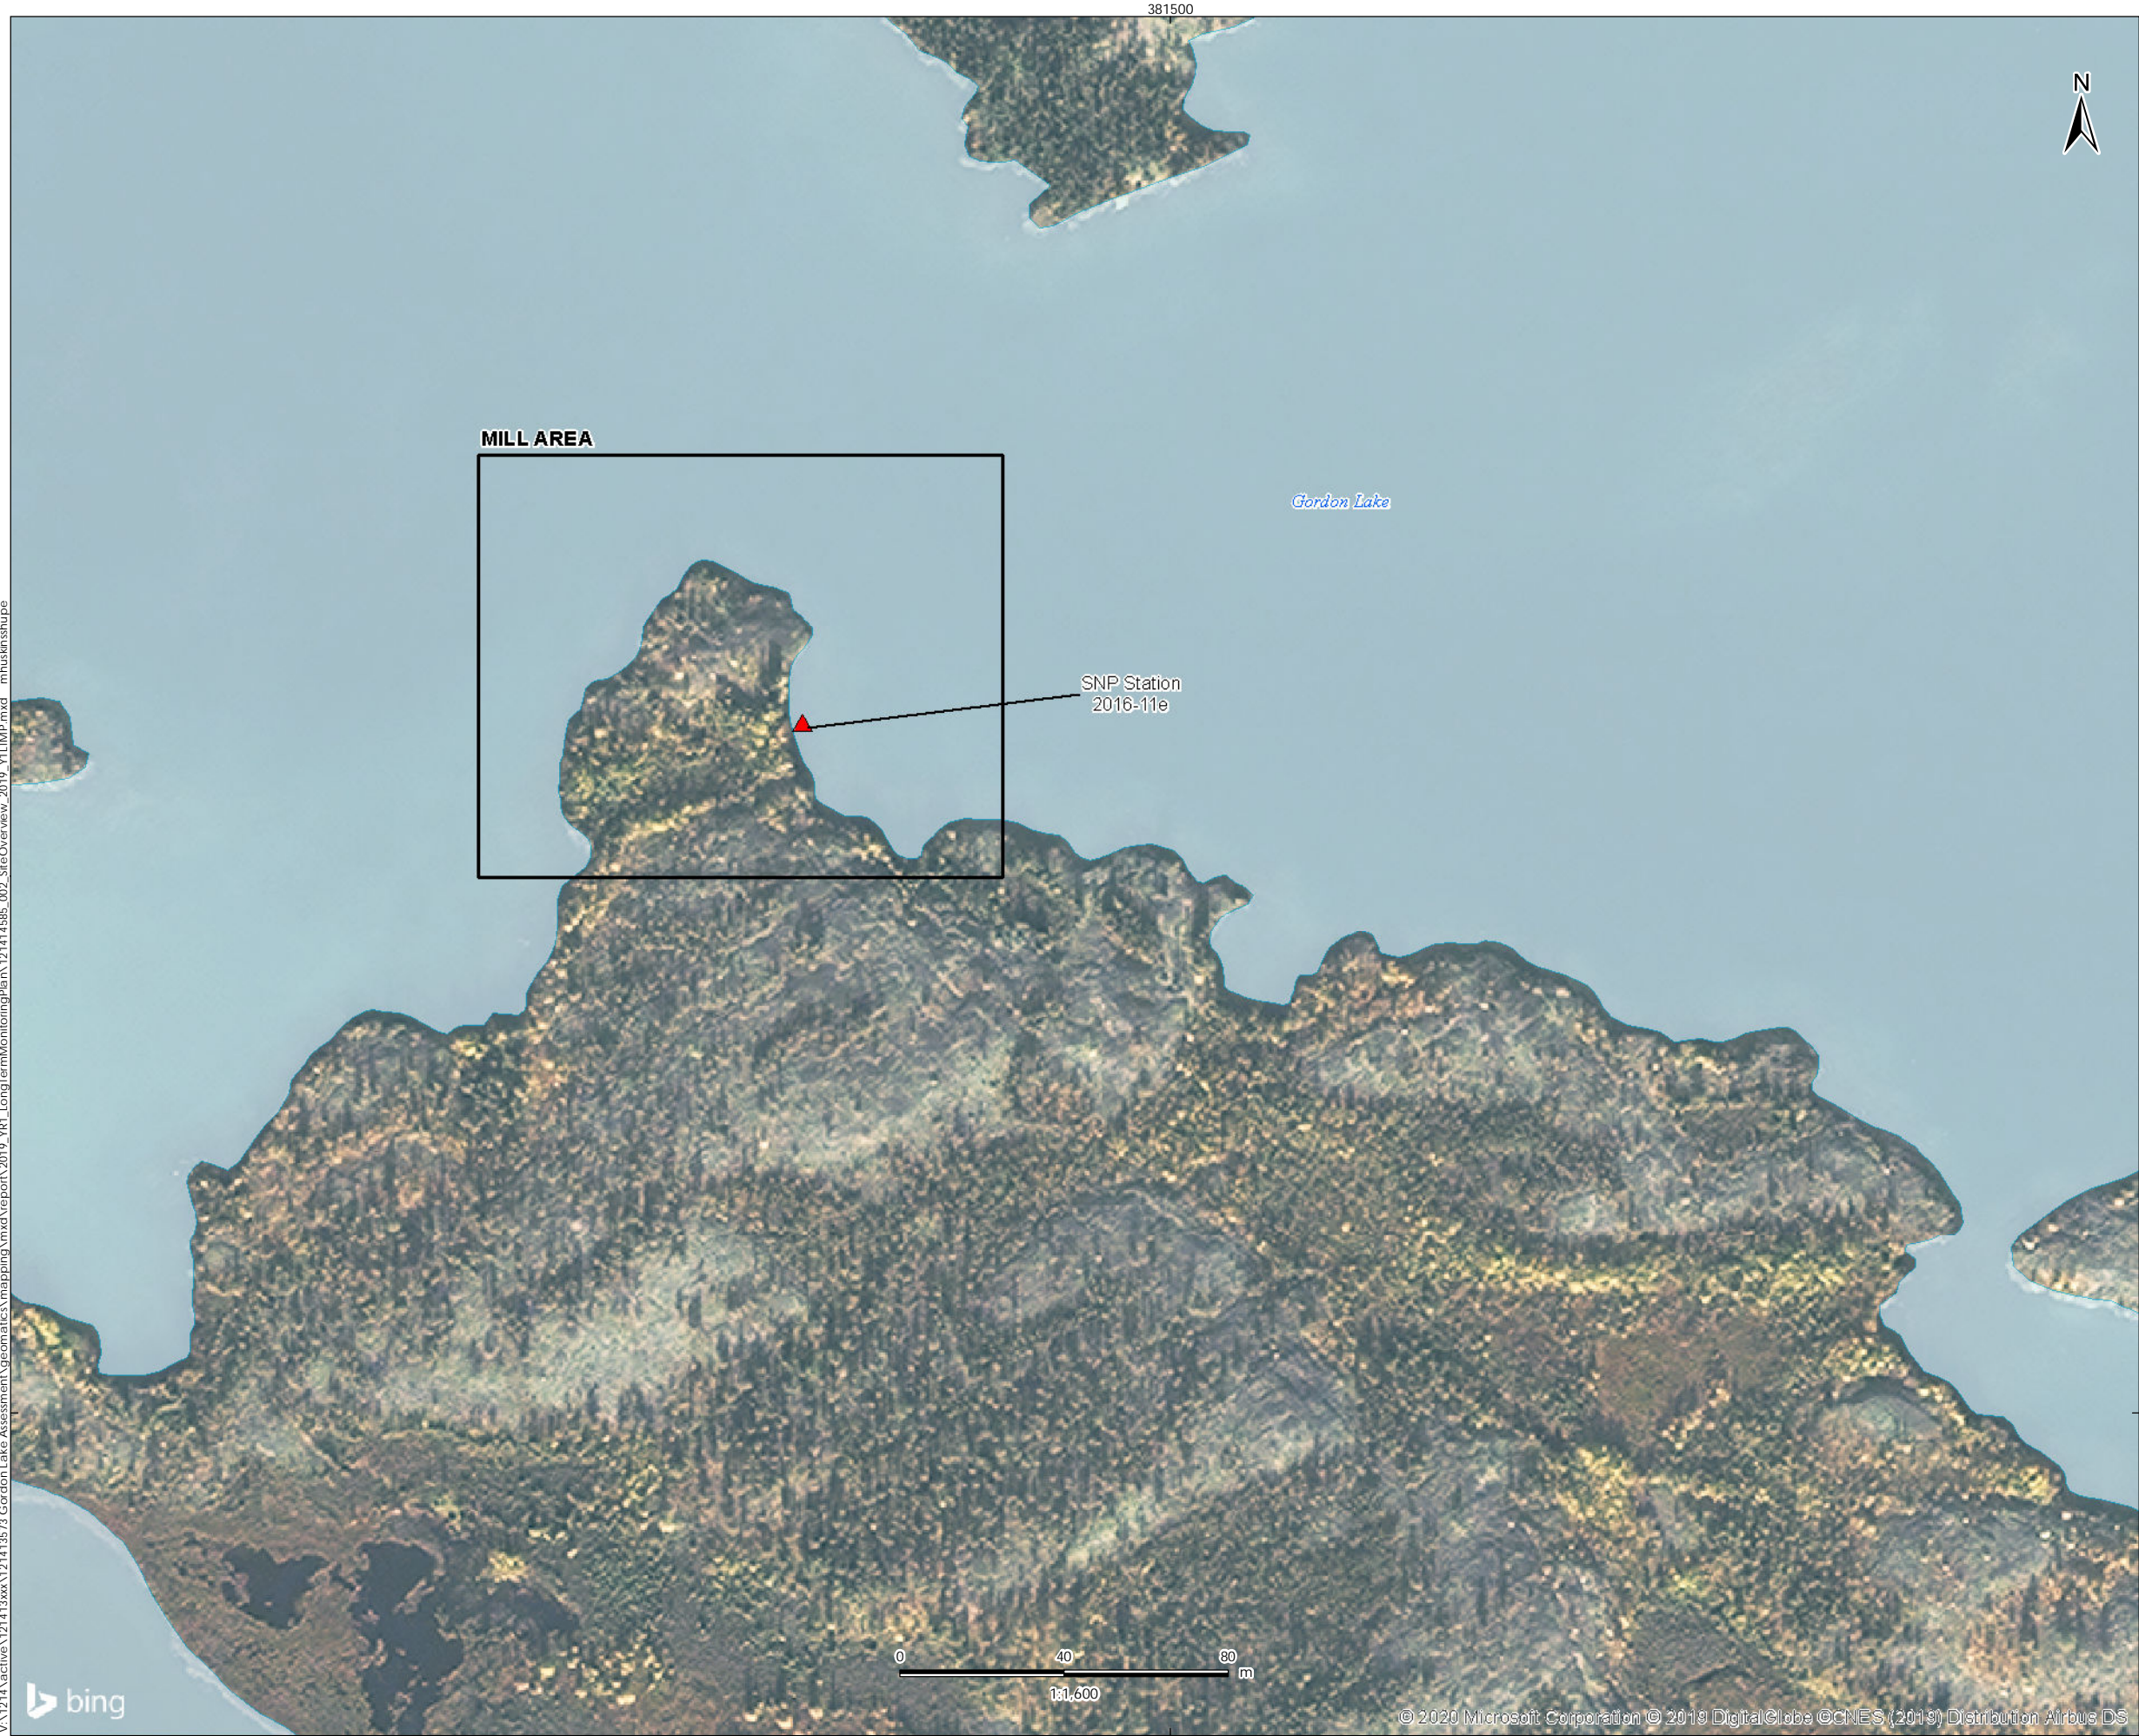
Figure No.
A6.2

Title
Storm Property - Shaft Area
Summary of Long-Term Monitoring
Components

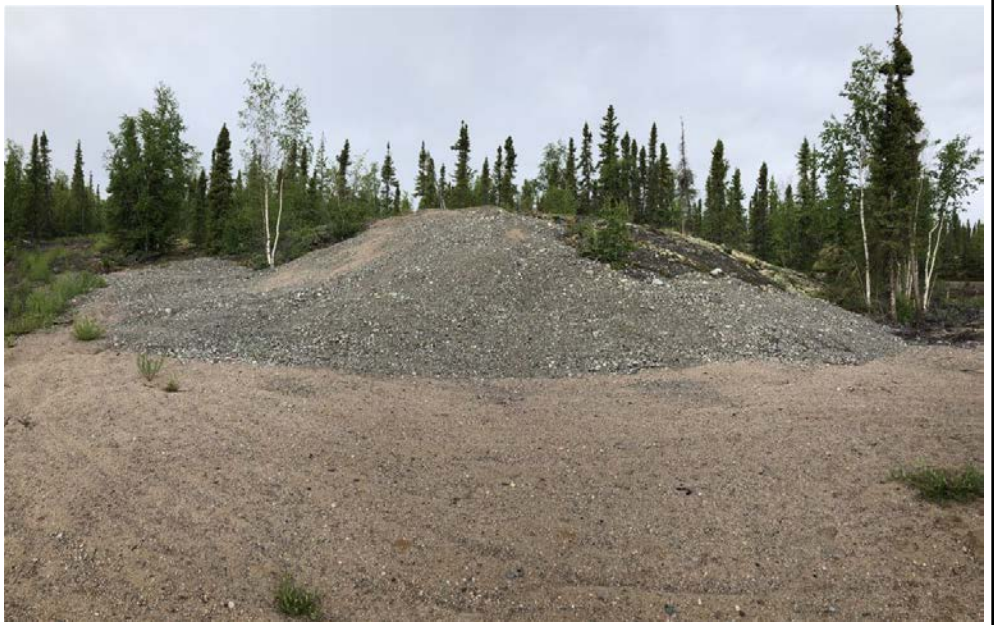
Client:	Public Services and Procurement Canada	Project:	121414585
Site Name:	Gordon Lake Group of Sites	Site Location:	Burnt Island
Photograph ID: BUR-1

Photo Location: Burnt Island Portal			
Direction: Looking southwest			
Survey Date: 7/10/2019			
Comments: Viewpoint 1 (Figure A1.4, Appendix A)			
Photograph ID: BUR-2

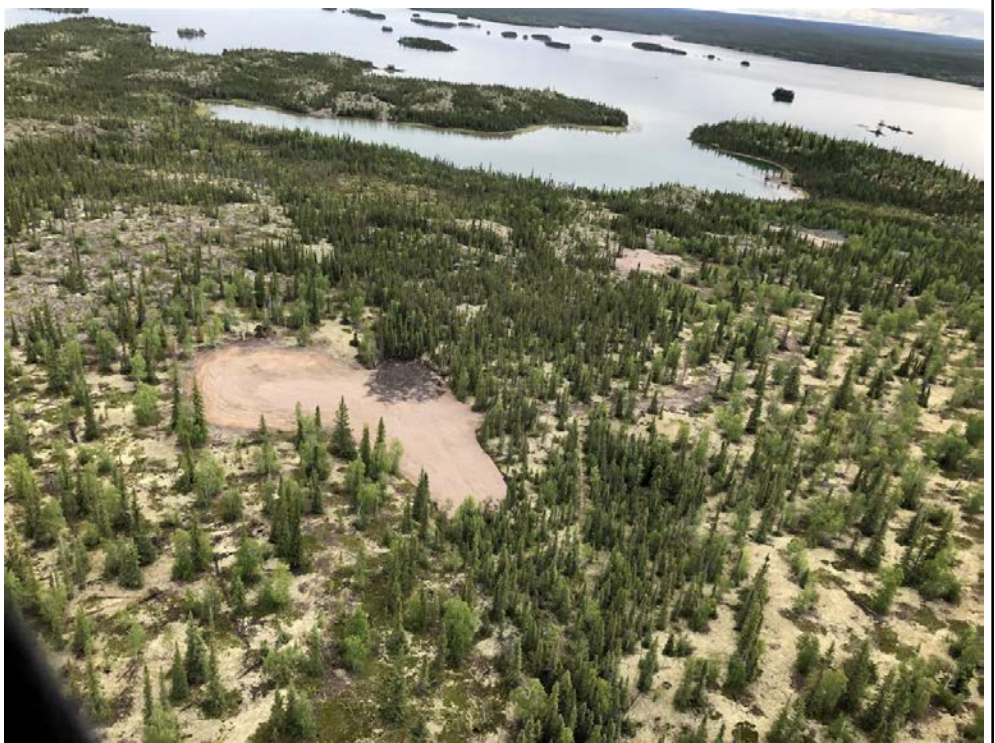
Photo Location: Burnt Island Tailings Area			
Direction: Aerial view looking northeast			
Survey Date: 7/10/2019			
Comments: Aerial Viewpoint 2 (Figure A1.2, Appendix A)

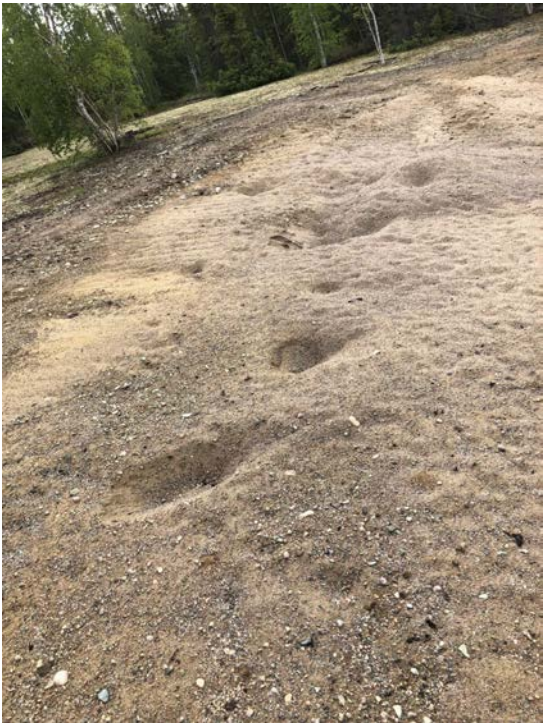
Client:	Public Services and Procurement Canada	Project:	121414585
Site Name:	Gordon Lake Group of Sites	Site Location:	Burnt Island
Photograph ID: BUR-5

Photo Location: Burnt Island Tailings Area			
Direction: Looking north towards northwest end of GD-45 borrow source.			
Survey Date: 7/10/2019			
Comments: Minor settled area			
Photograph ID: BUR-6

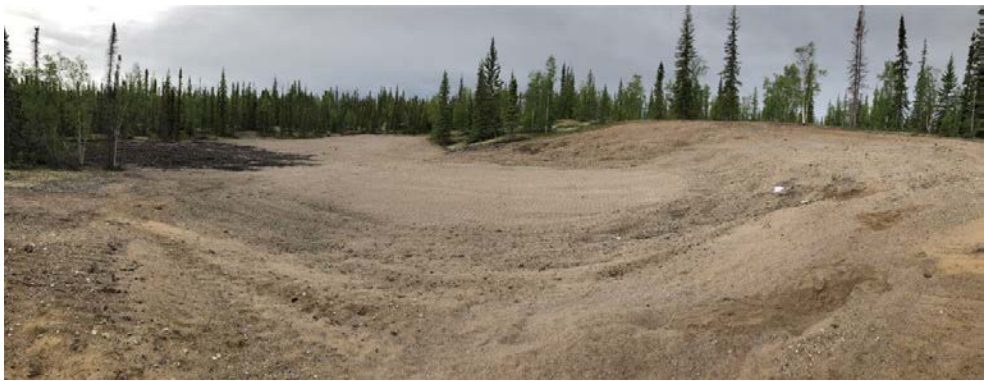
Photo Location: Burnt Island Tailings Area			
Direction: Looking southwest across tailings cover.			
Survey Date: 7/10/2019			
Comments: Viewpoint 3 (Figure A1.2, Appendix A). Slash placed on the left and GD-45 borrow source on the right.
