**FINAL REPORT: LONG-TERM
MONITORING (YEAR 1) –
GORDON LAKE GROUP OF
SITES**

Prepared for:
Public Services and Procurement
Canada on behalf of
Crown-Indigenous Relations and
Northern Affairs Canada

Prepared by:
Stantec Consulting Ltd.
40 Highfield Park Drive, Suite 102
Dartmouth, NS B3A 0A3

March 31, 2020

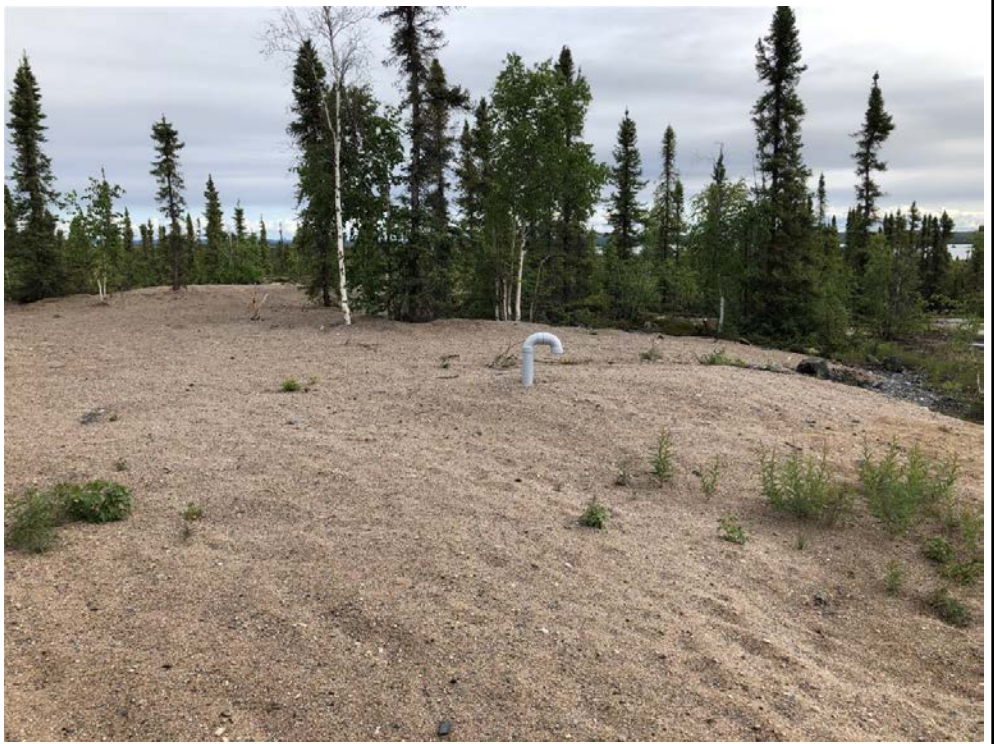
Client:	Public Services and Procurement Canada	Project:	121414585
Site Name:	Gordon Lake Group of Sites	Site Location:	Burnt Island
Photograph ID: BUR-7

Photo Location: Burnt Island Mine Shaft			
Direction: Looking northwest			
Survey Date: 7/10/2019			
Comments: Viewpoint 4 (Figure A1.3, Appendix A)			
Photograph ID: BUR-8

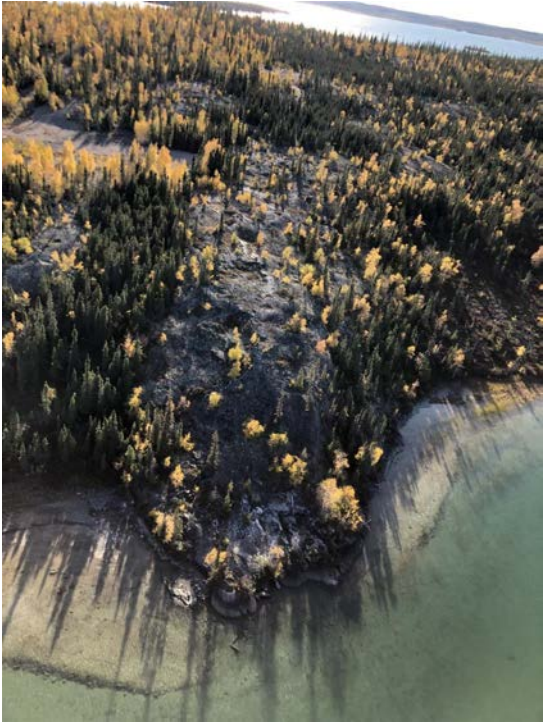
Photo Location: Burnt Island BUR_WR_01			
Direction: Aerial view looking west			
Survey Date: 9/11/2019			
Comments: Aerial Viewpoint 5 (Figure A1.5, Appendix A)

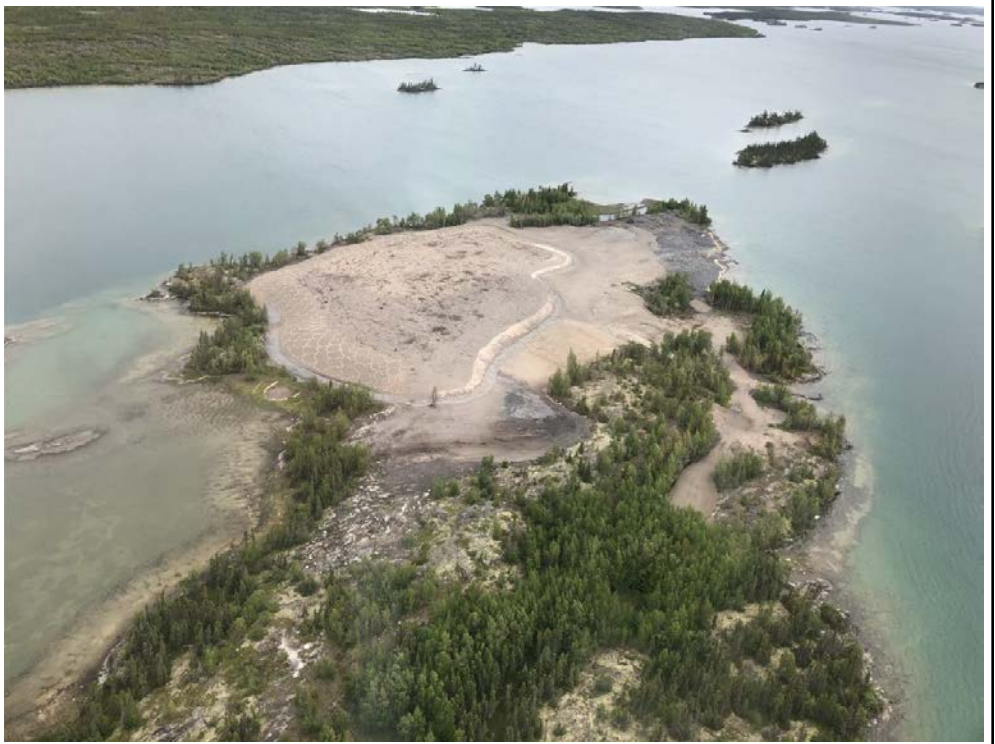
Client:	Public Services and Procurement Canada	Project:	121414585
Site Name:	Gordon Lake Group of Sites	Site Location:	Camlaren
Photograph ID: CAM-1

Photo Location: Camlaren Mine Area			
Direction: Aerial view looking south			
Survey Date: 7/10/2019			
Comments: Aerial Viewpoint 8 (Figure A2.3, Appendix A)			
Photograph ID: CAM-2

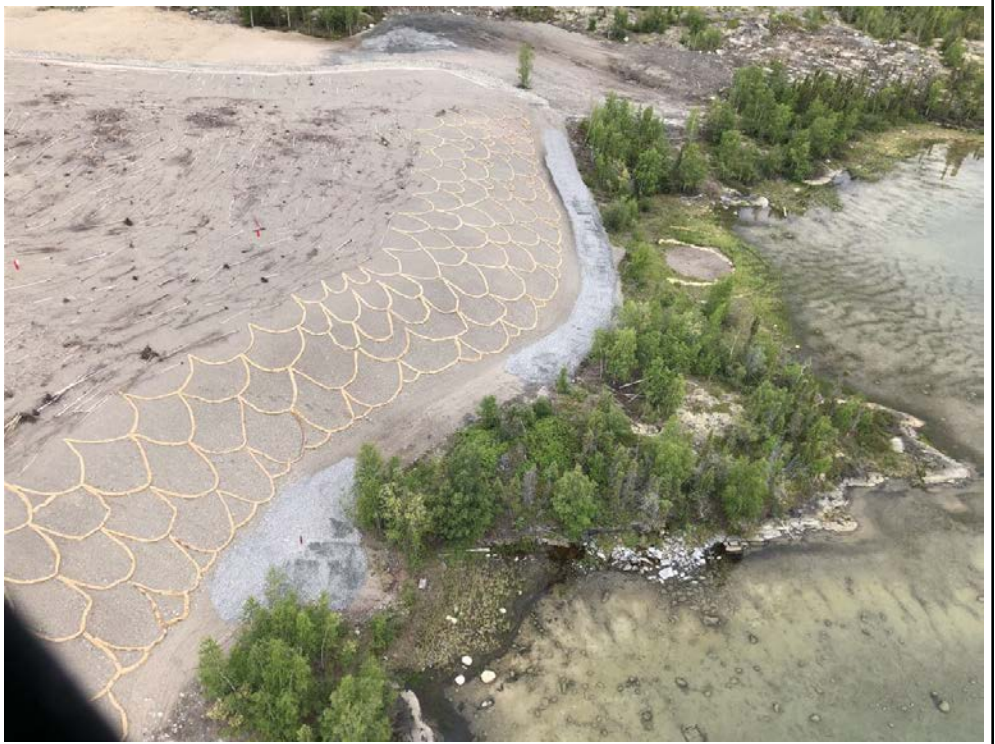
Photo Location: Camlaren Mine Area North			
Direction: Aerial view looking southwest			
Survey Date: 7/10/2019			
Comments: Aerial Viewpoint 12 (Figure A2.3, Appendix A). View of CAM_SO_20.			
Photograph ID: CAM-6

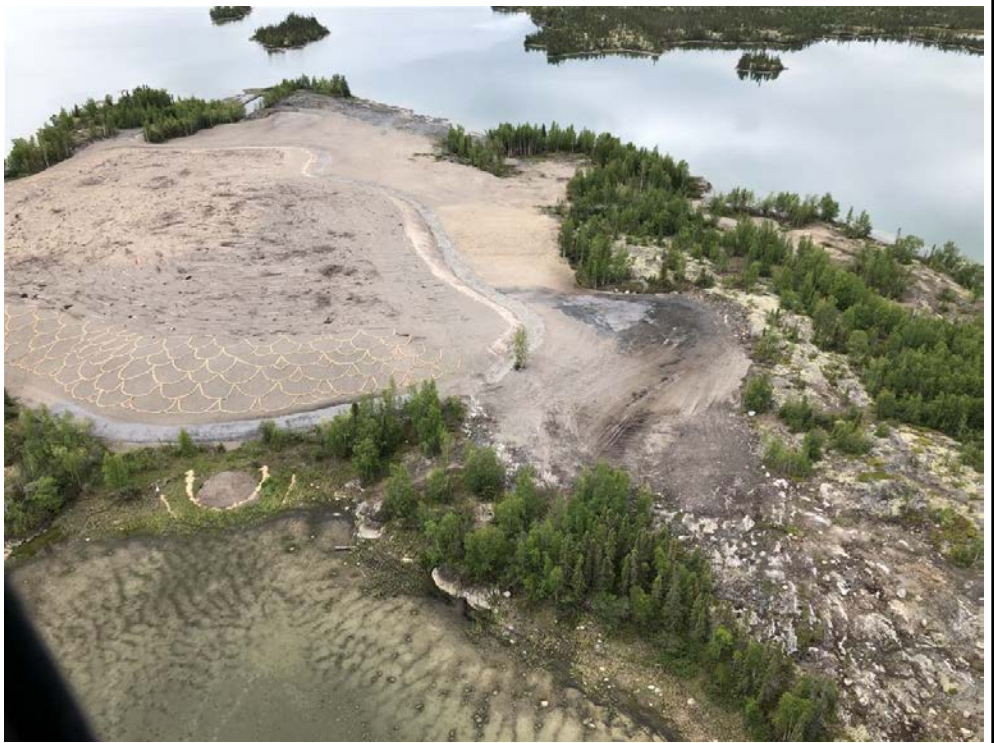
Photo Location: Camlaren Mine Area			
Direction: Aerial view looking southwest			
Survey Date: 7/10/2019			
Comments: Aerial Viewpoint 13 (Figure A2.3, Appendix A). View of CAM_SO_20, CAM_SO_04, CAM_SO_05, CAM_SO_06, CAM_SO_07, CAM_SO_08, CAM_SO_18 and CAM_SO_19.

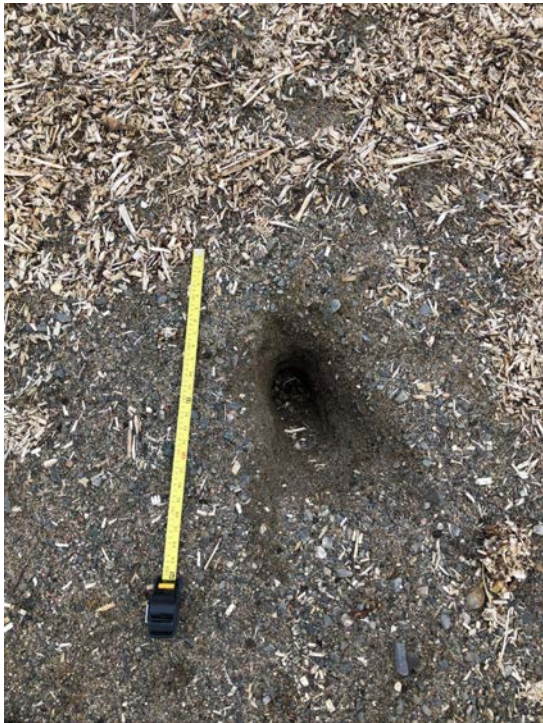
Photo Location: TSCA			
Direction:			
Survey Date: 7/10/2019			
Comments: Animal burrow on south slope of TSCA 0.4m deep

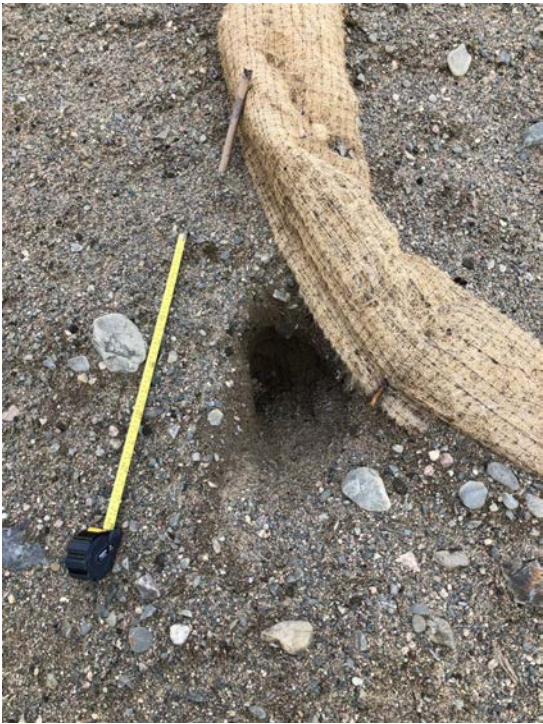
Photo Location: TSCA			
Direction:			
Survey Date: 7/10/2019			
Comments: Animal burrow on southeast slope of TSCA 0.4m deep			
Photograph ID: TSCA-4

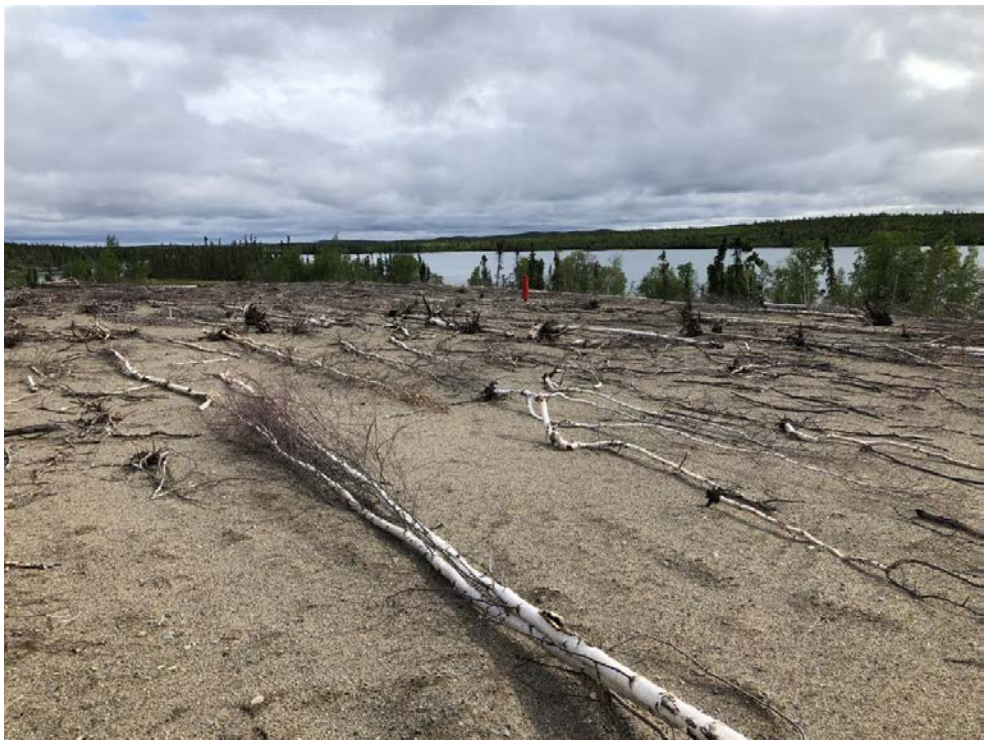
Photo Location: TSCA			
Direction: looking northeast			
Survey Date: 7/10/2019			
Comments: Top cover of TSCA with VB2 in the background. Viewpoint 2 (Figure 2.2, Appendix A)

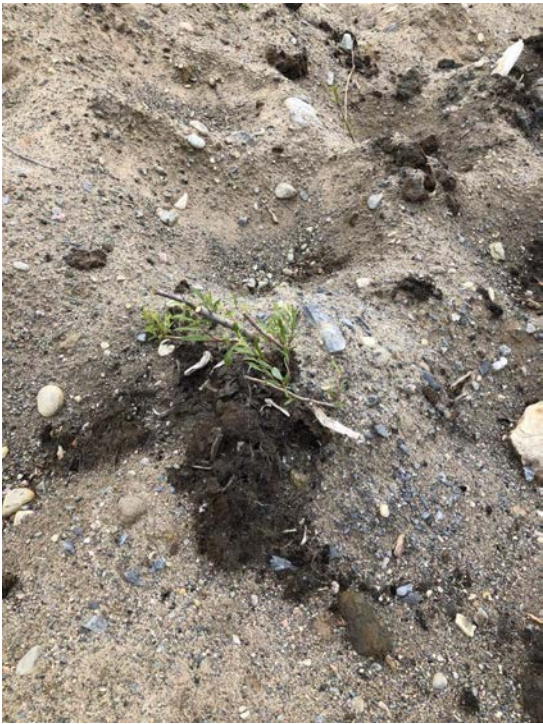
Client:	Public Services and Procurement Canada	Project:	121414585
Site Name:	Gordon Lake Group of Sites	Site Location:	Zenith Island
Photograph ID: ZEN-1

Photo Location: Zenith Island			
Direction:			
Survey Date: 7/10/2019			
Comments: Vegetation growth observed at willow stems planted at CAM_SO_23			
Photograph ID: ZEN-2

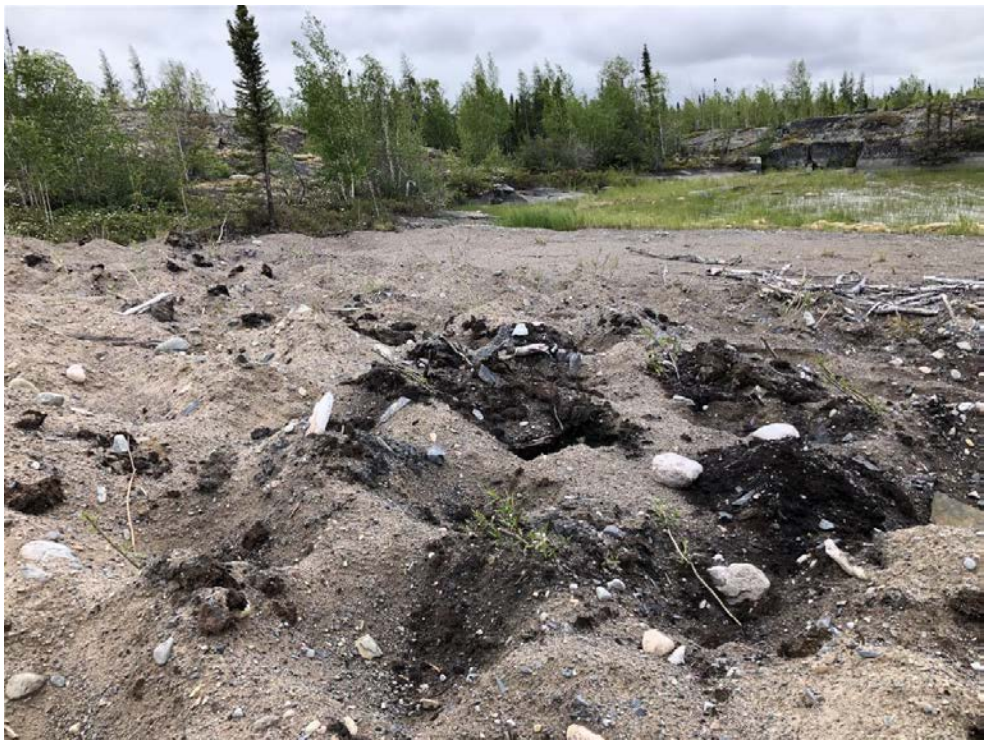
Photo Location: Zenith Island			
Direction: Looking west			
Survey Date: 7/10/2019			
Comments: Rough and loose at CAM_SO_23 with willow stem growth. Viewpoint 1 (Figure A2.4, Appendix A)

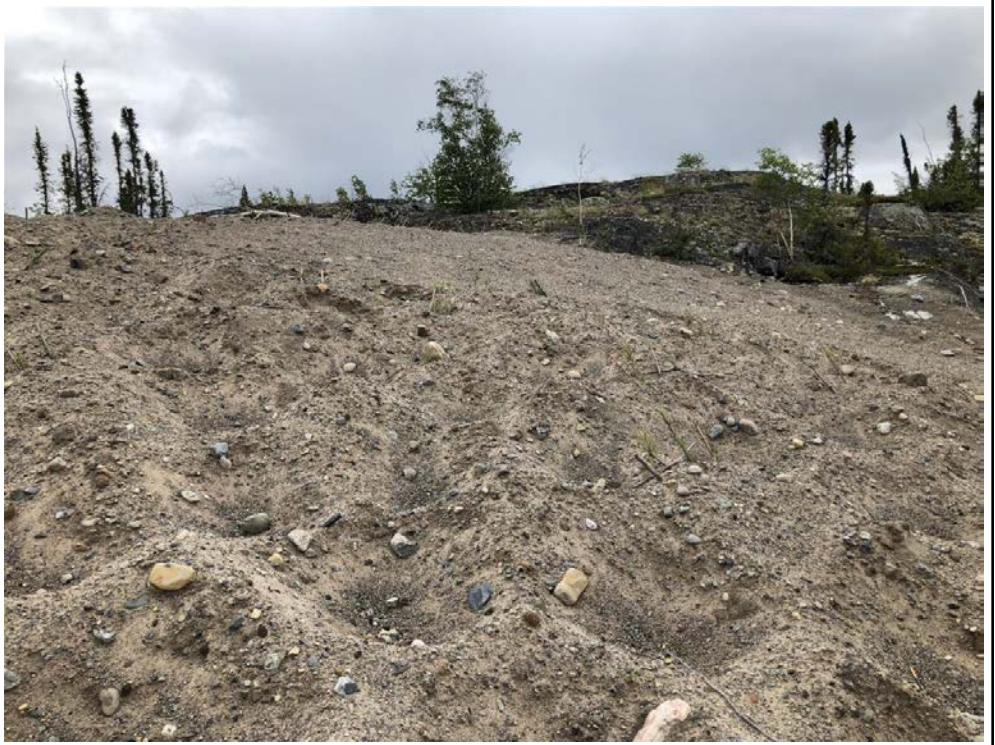
Client:	Public Services and Procurement Canda	Project:	121414585
Site Name:	Gordon Lake Group of Sites	Site Location:	Zenith Island
Photograph ID: ZEN-3

Photo Location: Zenith Island			
Direction: Looking south			
Survey Date: 7/10/2019			
Comments: Rough and loose at CAM_SO_23 with willow stem growth. Viewpoint 2 (Figure A2.4, Appendix A)

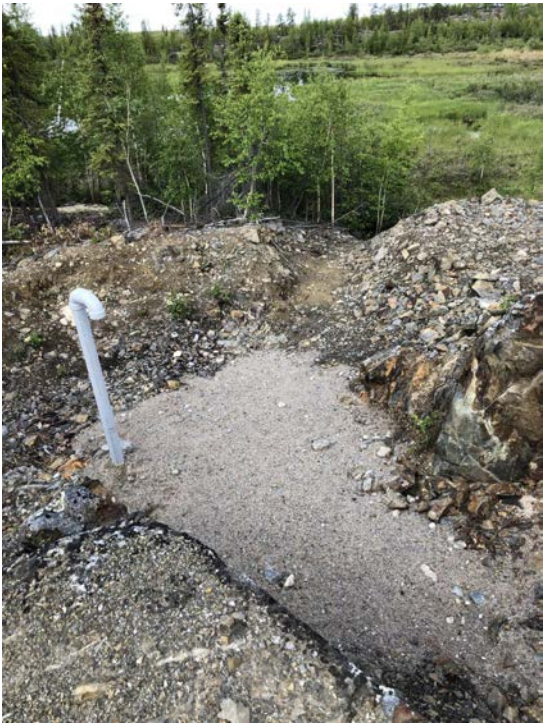
Client:	Public Services and Procurement Canada	Project:	121414585
Site Name:	Gordon Lake Group of Sites	Site Location:	Goodrock
Photograph ID: GOO-1

Photo Location: Goodrock North Mine Shaft			
Direction: Looking southeast			
Survey Date: 7/8/2019			
Comments: Viewpoint 1 (Figure A3.3, Appendix A)			
Photograph ID: GOO-2

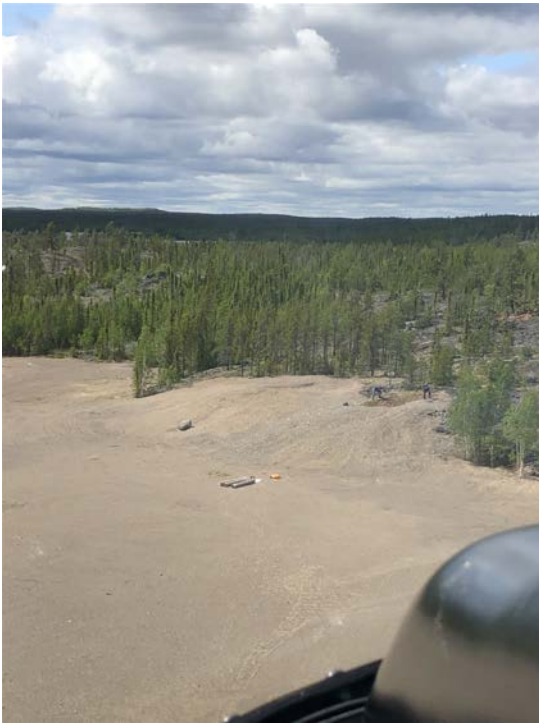
Photo Location: Kidney Pond Portal			
Direction: Looking northwest			
Survey Date: 7/10/2019			
Comments: Aerial view of Kidney Pond portal during manual backfilling of cover slump. Aerial Viewpoint 1 (Figure A4.3, Appendix A)			
Photograph ID: KID-2

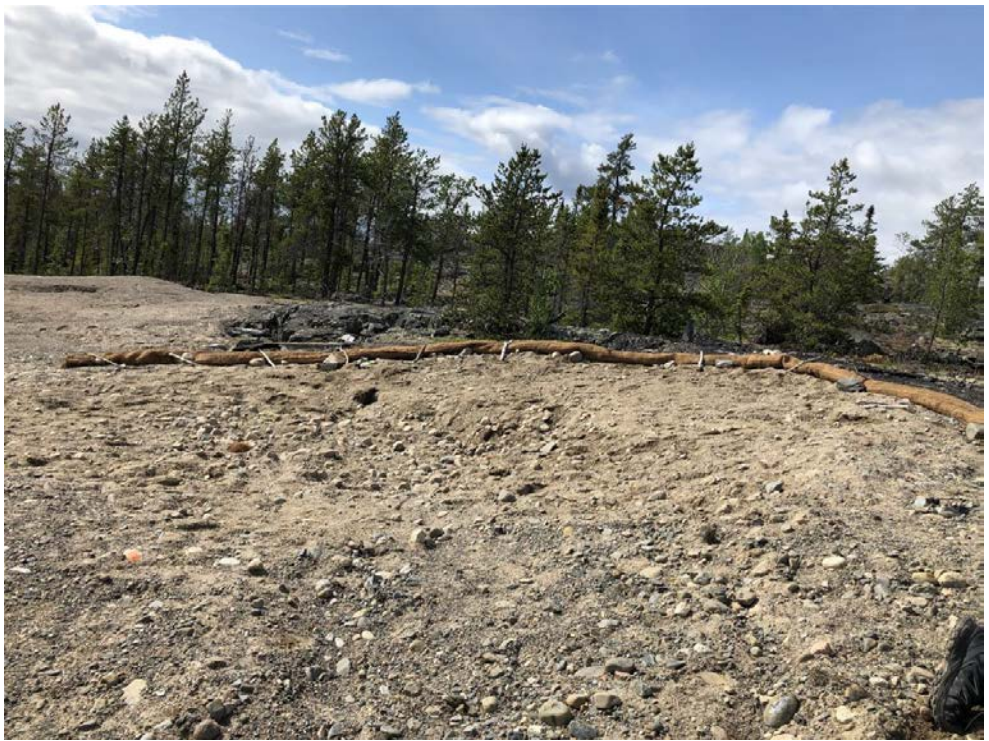
Photo Location: Kidney Pond			
Direction: Looking northwest			
Survey Date: 7/9/2019			
Comments: Coconut mat installed for erosion control at Kidney Pond Portal.

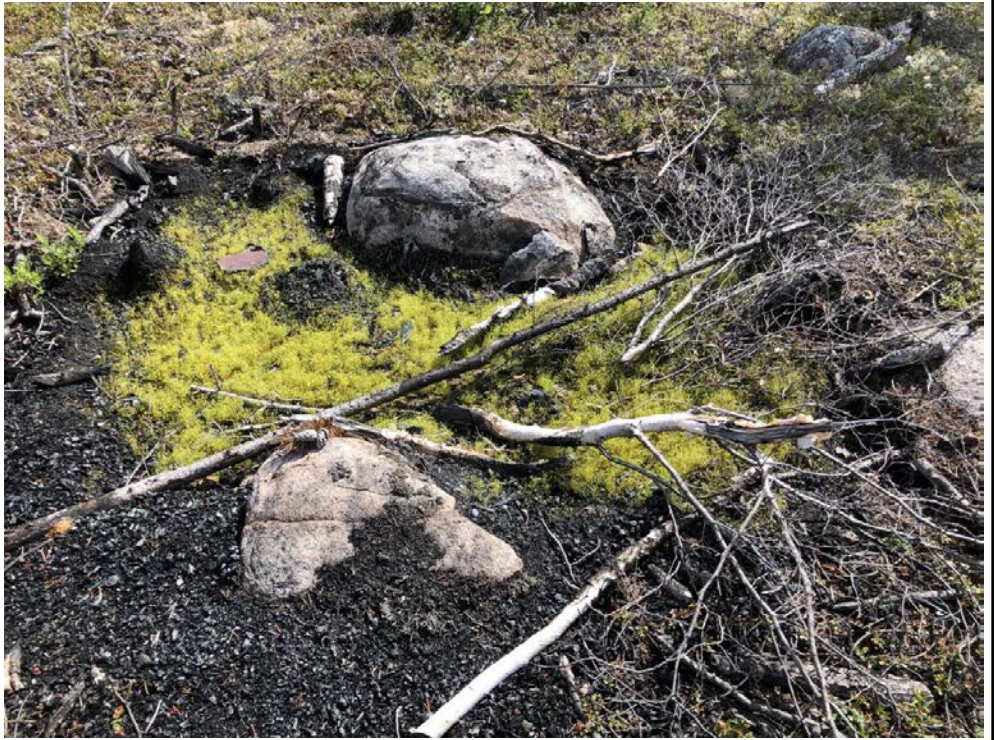
Photo Location: Kidney Pond			
Direction:			
Survey Date: 7/9/2019			
Comments: Natural vegetation regrowth at camp site near KID_WR_01			
Photograph ID: KID-4

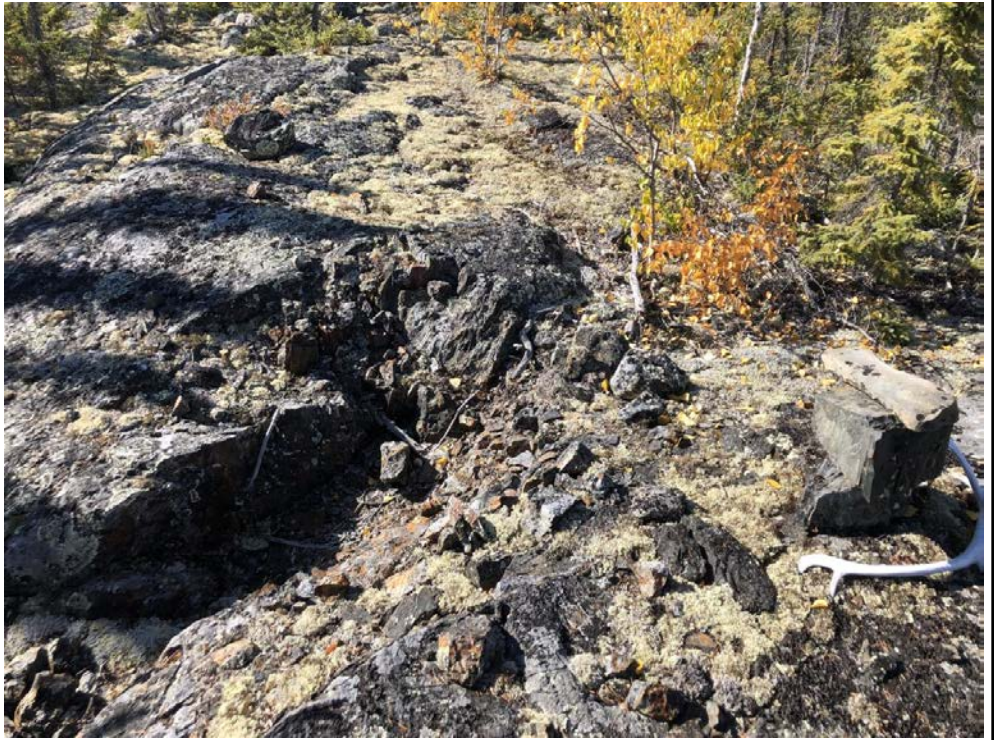
Photo Location: Kidney Exploration Camp			
Direction:			
Survey Date: 9/11/2019			
Comments: KID_WR_04 trench near KID_SO_06			
Photograph ID: KID-6

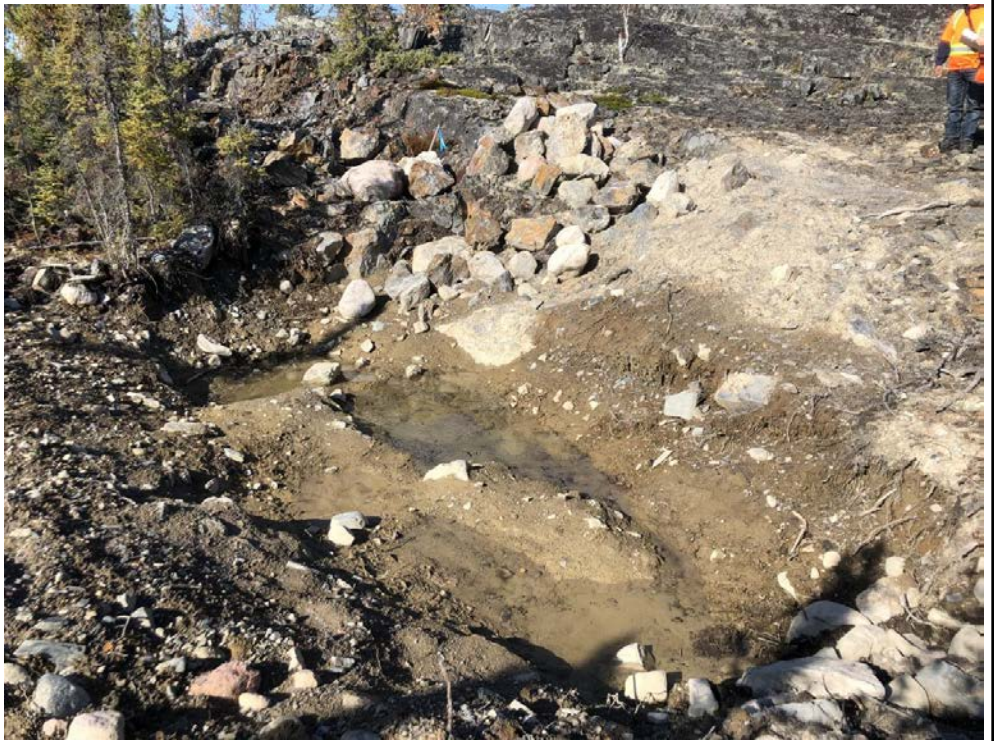
Photo Location: Kidney Exploration Camp			
Direction: Looking northwest			
Survey Date: 9/11/2019			
Comments: KID_WR_04 near KID_SO_06

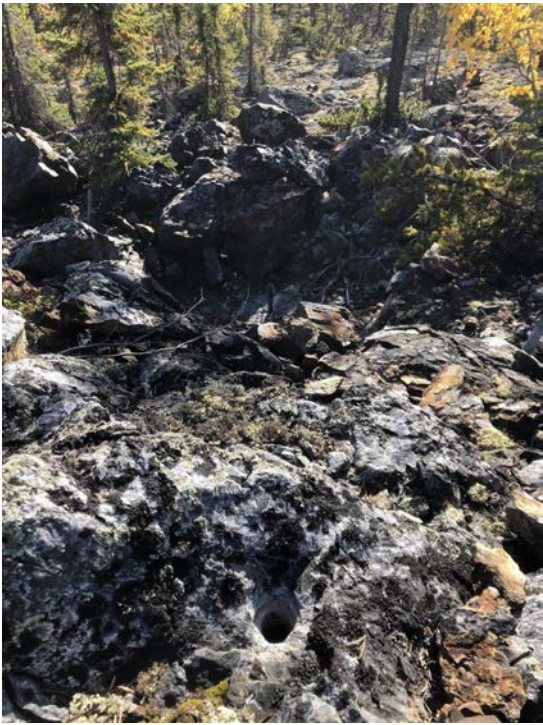
Photo Location: Kidney Exploration Camp			
Direction:			
Survey Date: 9/11/2019			
Comments: KID_WR_04 trench and drill hole.

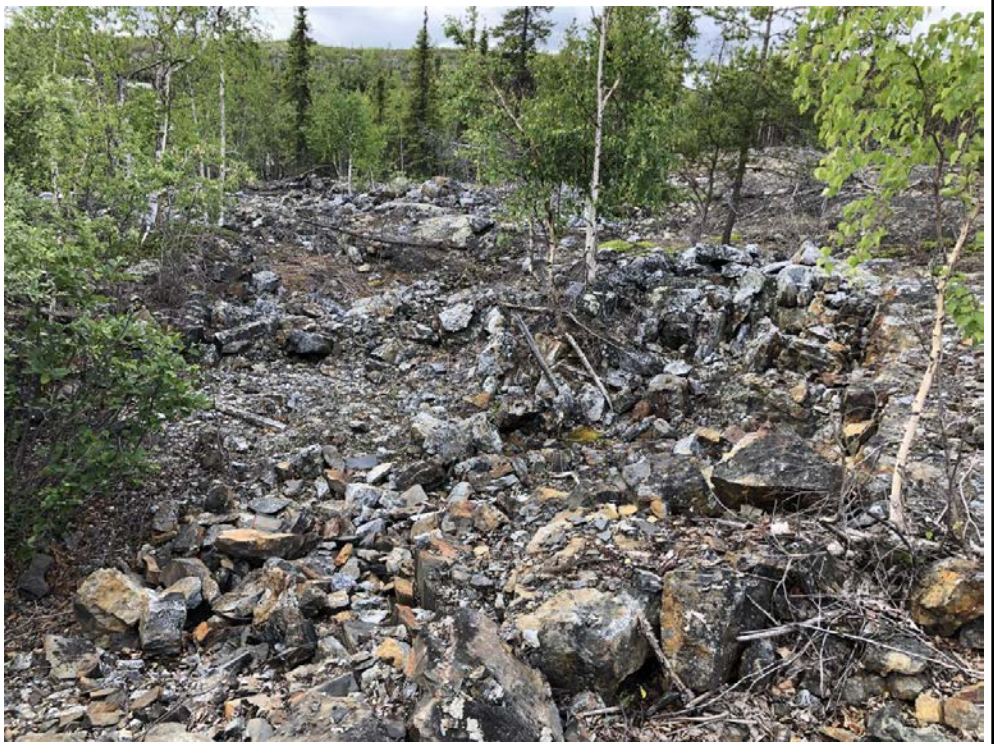
Photo Location: Storm Moderate Risk Waste Rock STO_WR_02			
Direction: looking east			
Survey Date: 7/10/2019			
Comments: Viewpoint 6 (Figure A6.2, Appendix A)			
Photograph ID: STO-6

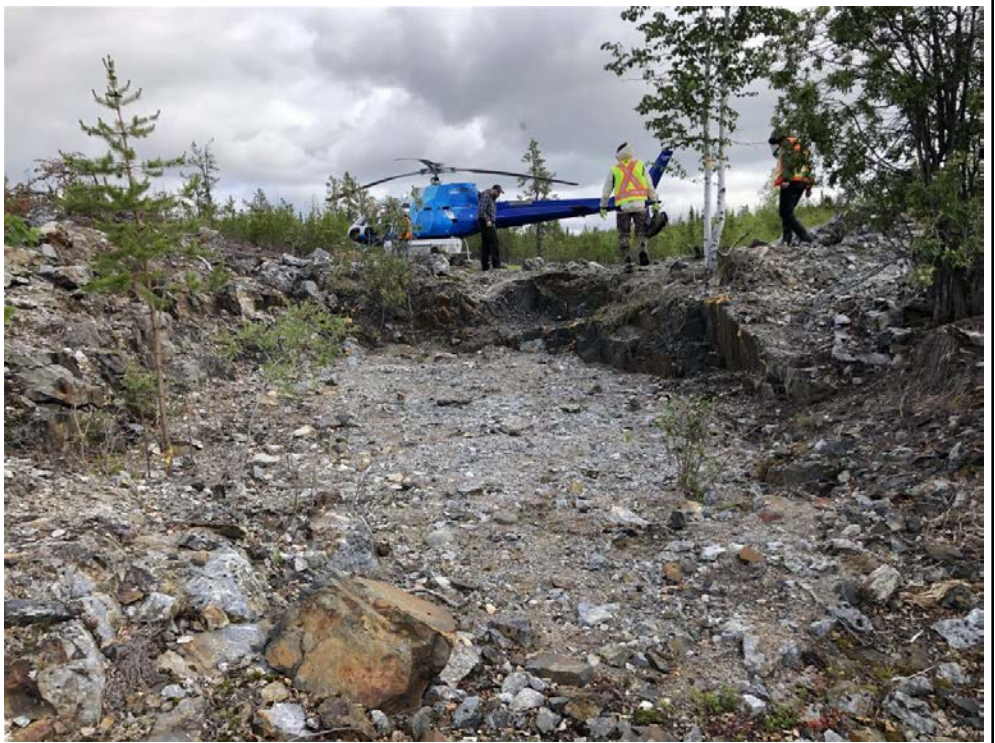
Photo Location: Storm North Mine Shaft			
Direction: looking northeast			
Survey Date: 7/10/2019			
Comments: Viewpoint 5 (Figure A6.2, Appendix A)

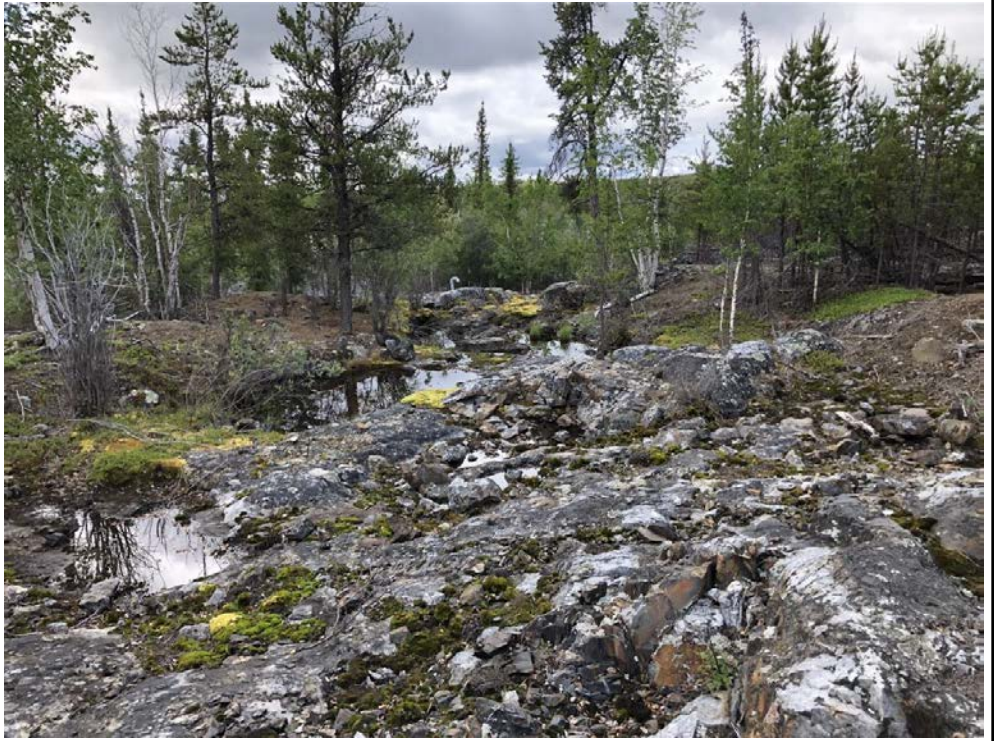
Client:	Public Services and Procurement Canda	Project:	121414585
Site Name:	Gordon Lake Group of Sites	Site Location:	Storm Property
Photograph ID: STO-7

Photo Location: Storm Moderate Risk Waste Rock STO_WR_01			
Direction: looking southeast			
Survey Date: 7/10/2019			
Comments: Viewpoint 4 (Figure A6.2, Appendix A)

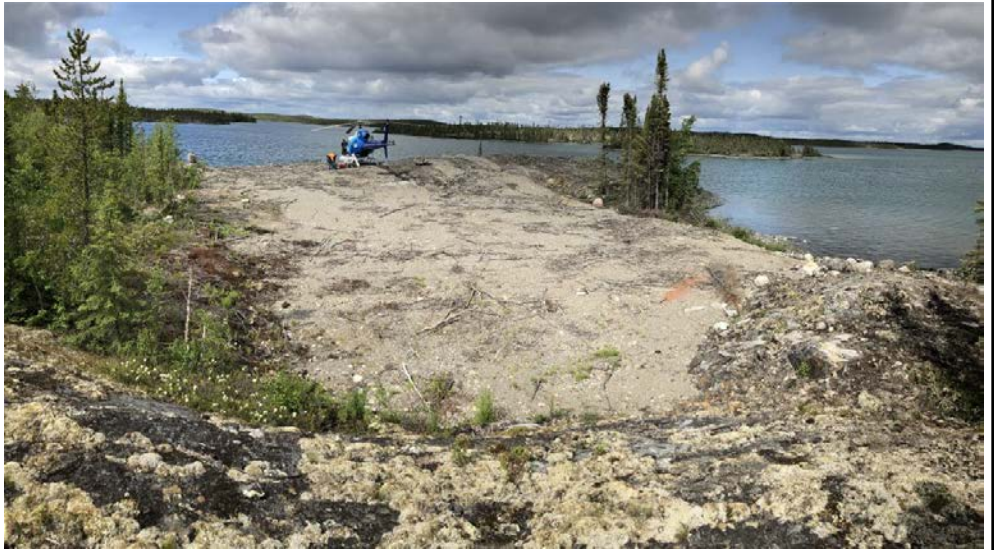
Client:	Public Services and Procurement Canada	Project:	121414585
Site Name:	Gordon Lake Group of Sites	Site Location:	Treacy
Photograph ID: TRE-1

Photo Location: Treacy Mill Area			
Direction: Looking north			
Survey Date: 7/10/2019			
Comments: View of mainly TRE_SO_01. Viewpoint 1 (Figure A7.2, Appendix A)			
Photograph ID: TRE-2

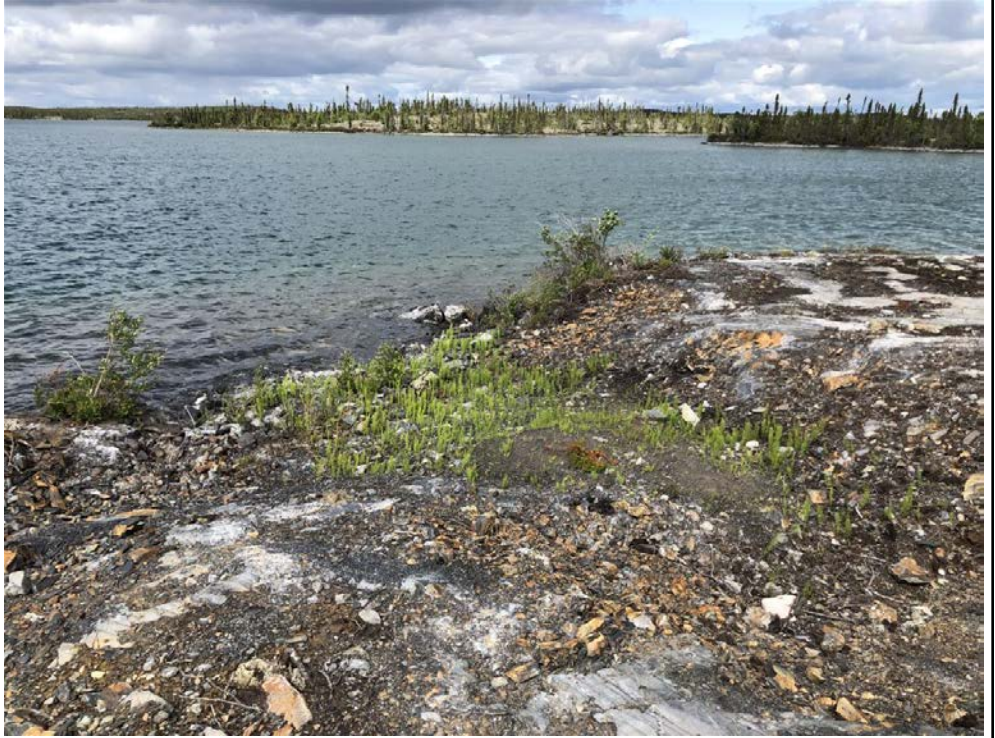
Photo Location: Treacy Mill Area Vegetation			
Direction: Looking north			
Survey Date: 7/10/2019			
Comments: Natural germination of horsetail. Viewpoint 2 (Figure A7.2, Appendix A)

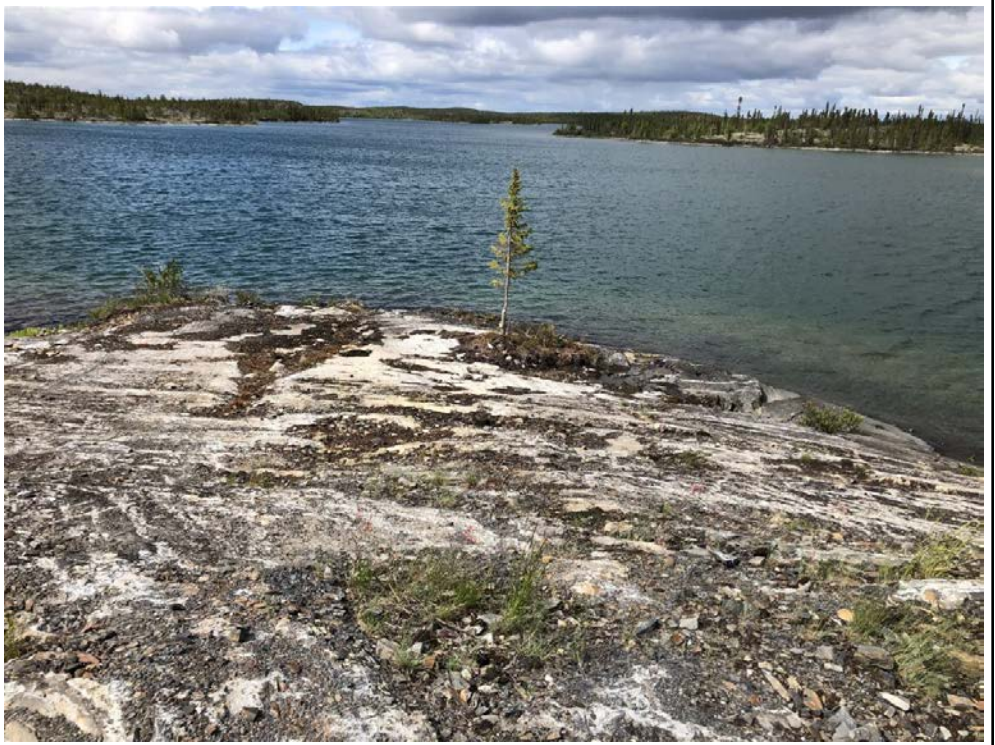
Client:	Public Services and Procurement Canada	Project:	121414585
Site Name:	Gordon Lake Group of Sites	Site Location:	Treacy
Photograph ID: TRE-3

Photo Location: Treacy Mill Area Vegetation			
Direction: Looking west			
Survey Date: 7/10/2019			
Comments: Grass growth from 2018 revegetation efforts. Viewpoint 3 (Figure A7.2, Appendix A)

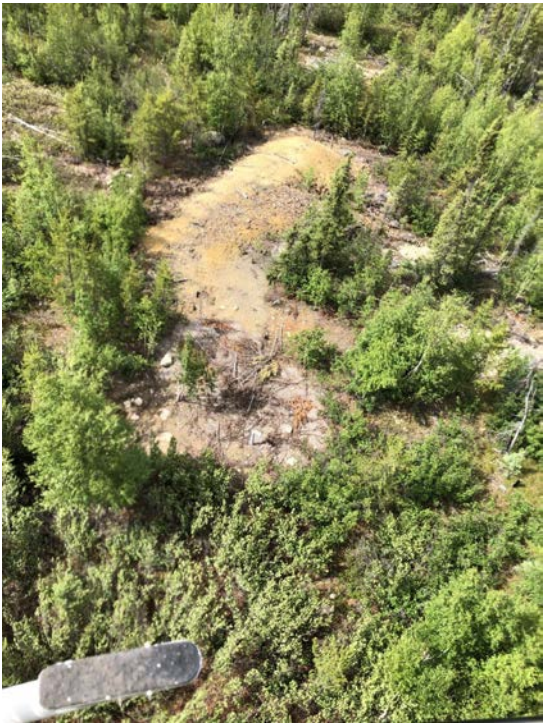
Client:	Public Services and Procurement Canda	Project:	121414585
Site Name:	Gordon Lake Group of Sites	Site Location:	Try Me
Photograph ID: TRY-1

Photo Location: Try Me Mine Shaft			
Direction: Aerial view looking northwest			
Survey Date: 7/10/2019			
Comments: Aerial Viewpoint 1 (Figure A8.2, Appendix A)

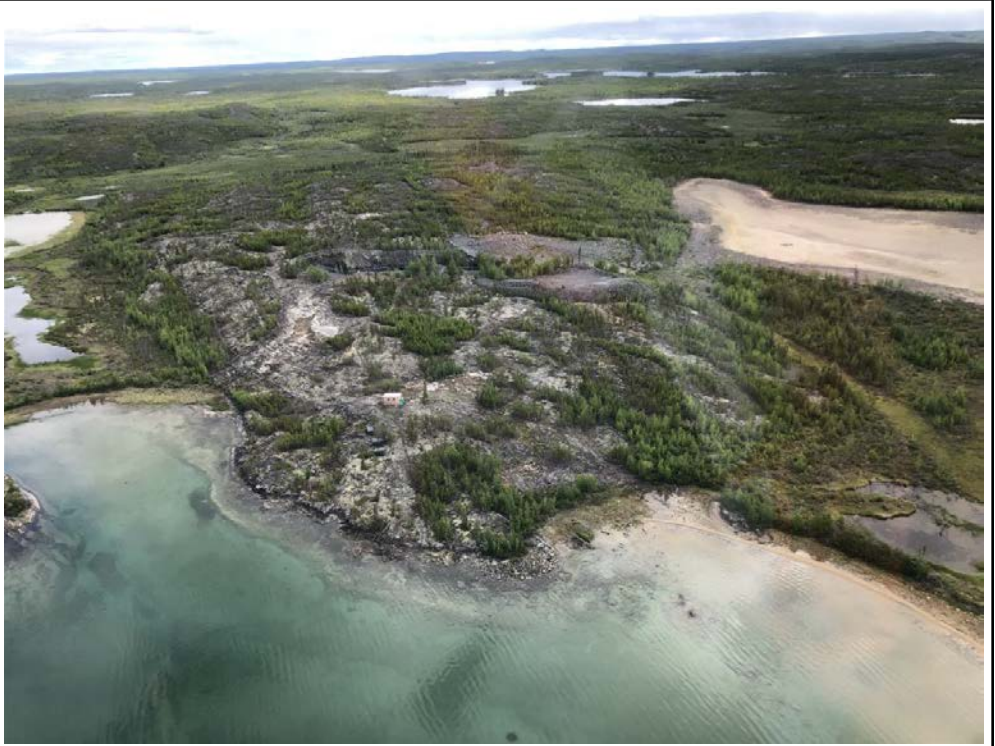
Client:	Public Services and Procurement Canada	Project:	121414585
Site Name:	Gordon Lake Group of Sites	Site Location:	West Bay
Photograph ID: WES-1

Photo Location: West Bay			
Direction: Looking northeast			
Survey Date: 7/10/2019			
Comments: View of emergency shelter, open pit and GD-37 in the right background. Aerial Viewpoint 1 (Figure 9.2, Appendix A)			
Photograph ID: WES-2

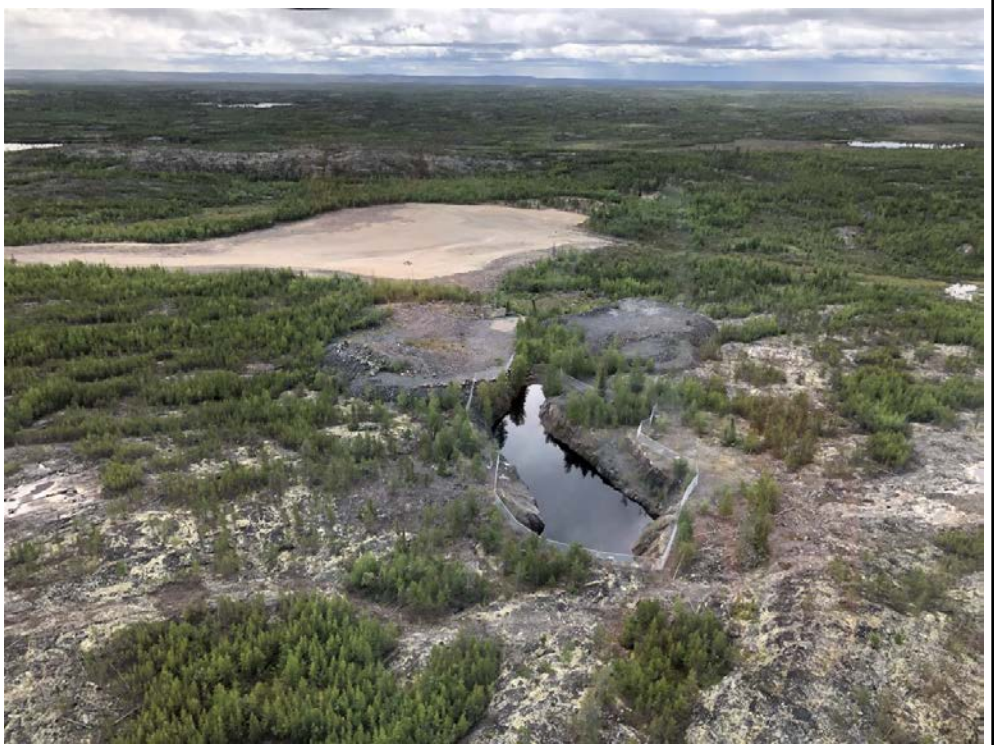
Photo Location: West Bay			
Direction: Looking south			
Survey Date: 7/10/2019			
Comments: View of open pit, WES_WR_01, WES_WR_02 and GD-37 in the background. Aerial Viewpoint 2 (Figure 9.2, Appendix A)

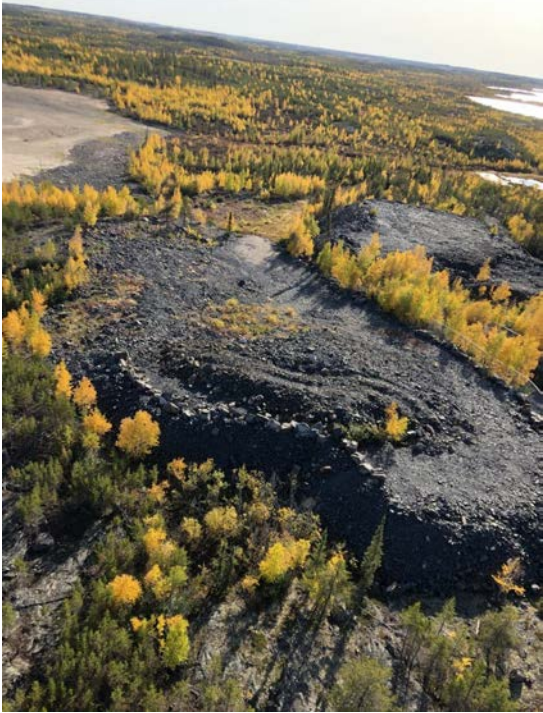
Client:	Public Services and Procurement Canada	Project:	121414585
Site Name:	Gordon Lake Group of Sites	Site Location:	West Bay
Photograph ID: WES-3

Photo Location: West Bay			
Direction: Looking southwest			
Survey Date: 9/11/2019			
Comments: View of mainly WES_WR_01. Aerial Viewpoint 3 (Figure 9.2, Appendix A)			
Photograph ID: WES-4

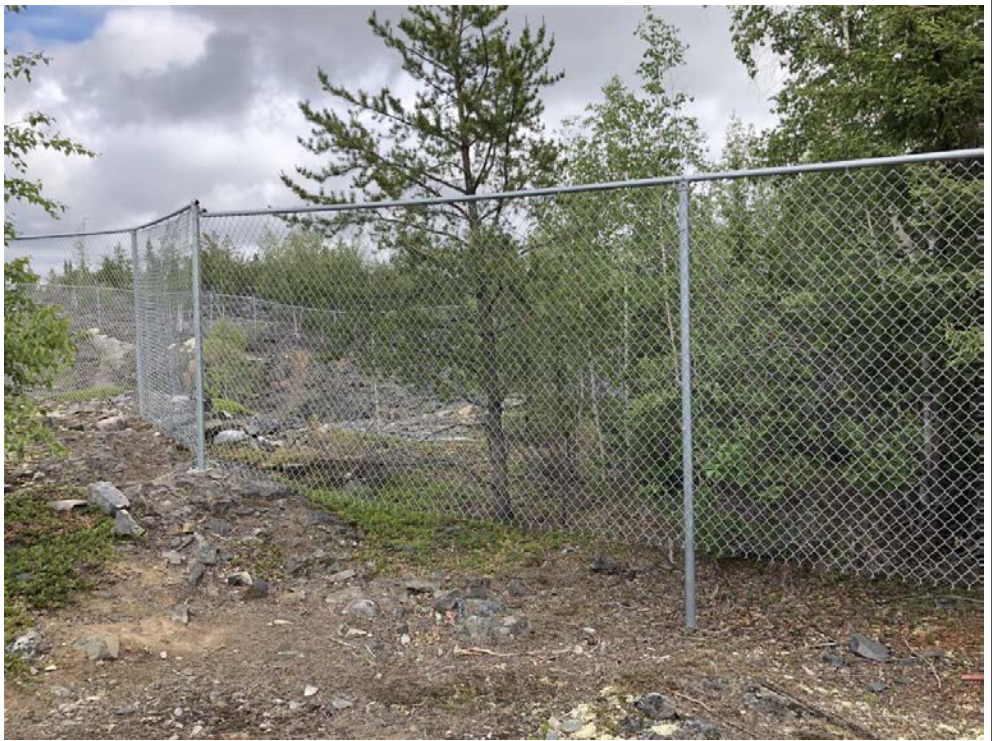
Photo Location: West Bay Open Pit Barrier			
Direction:			
Survey Date: 7/10/2019			
Comments: Example of spacing between bottom of fence barrier and ground surface.

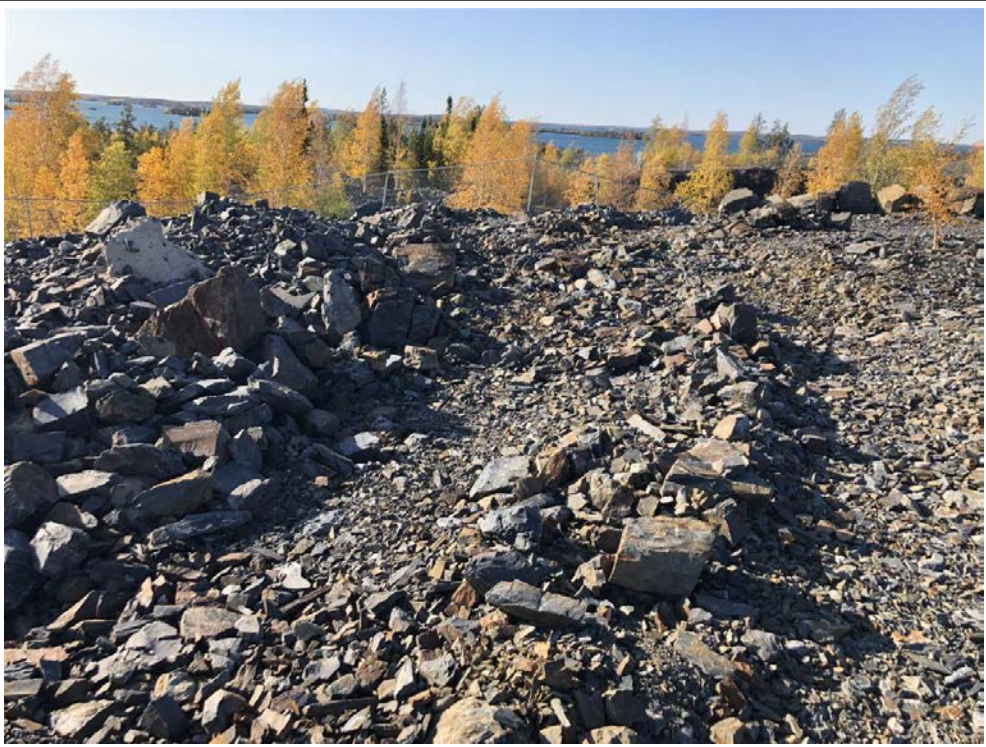
Client:	Public Services and Procurement Canda	Project:	121414585
Site Name:	Gordon Lake Group of Sites	Site Location:	West Bay
Photograph ID: WES-5

Photo Location: West Bay Moderate Risk Waste Rock			
Direction: Looking north west			
Survey Date: 9/11/2019			
Comments: View of WES_WR_01. Viewpoint 4 (Figure 9.2, Appendix A)
