Highway 1 Jean Marie River Bridge Replacement Northwest Territories Geotechnical Investigation

JEAN MARIE RIVER BRIDGE GEOTECHNICAL INVESTIGATION

22-062

MARCH 2023

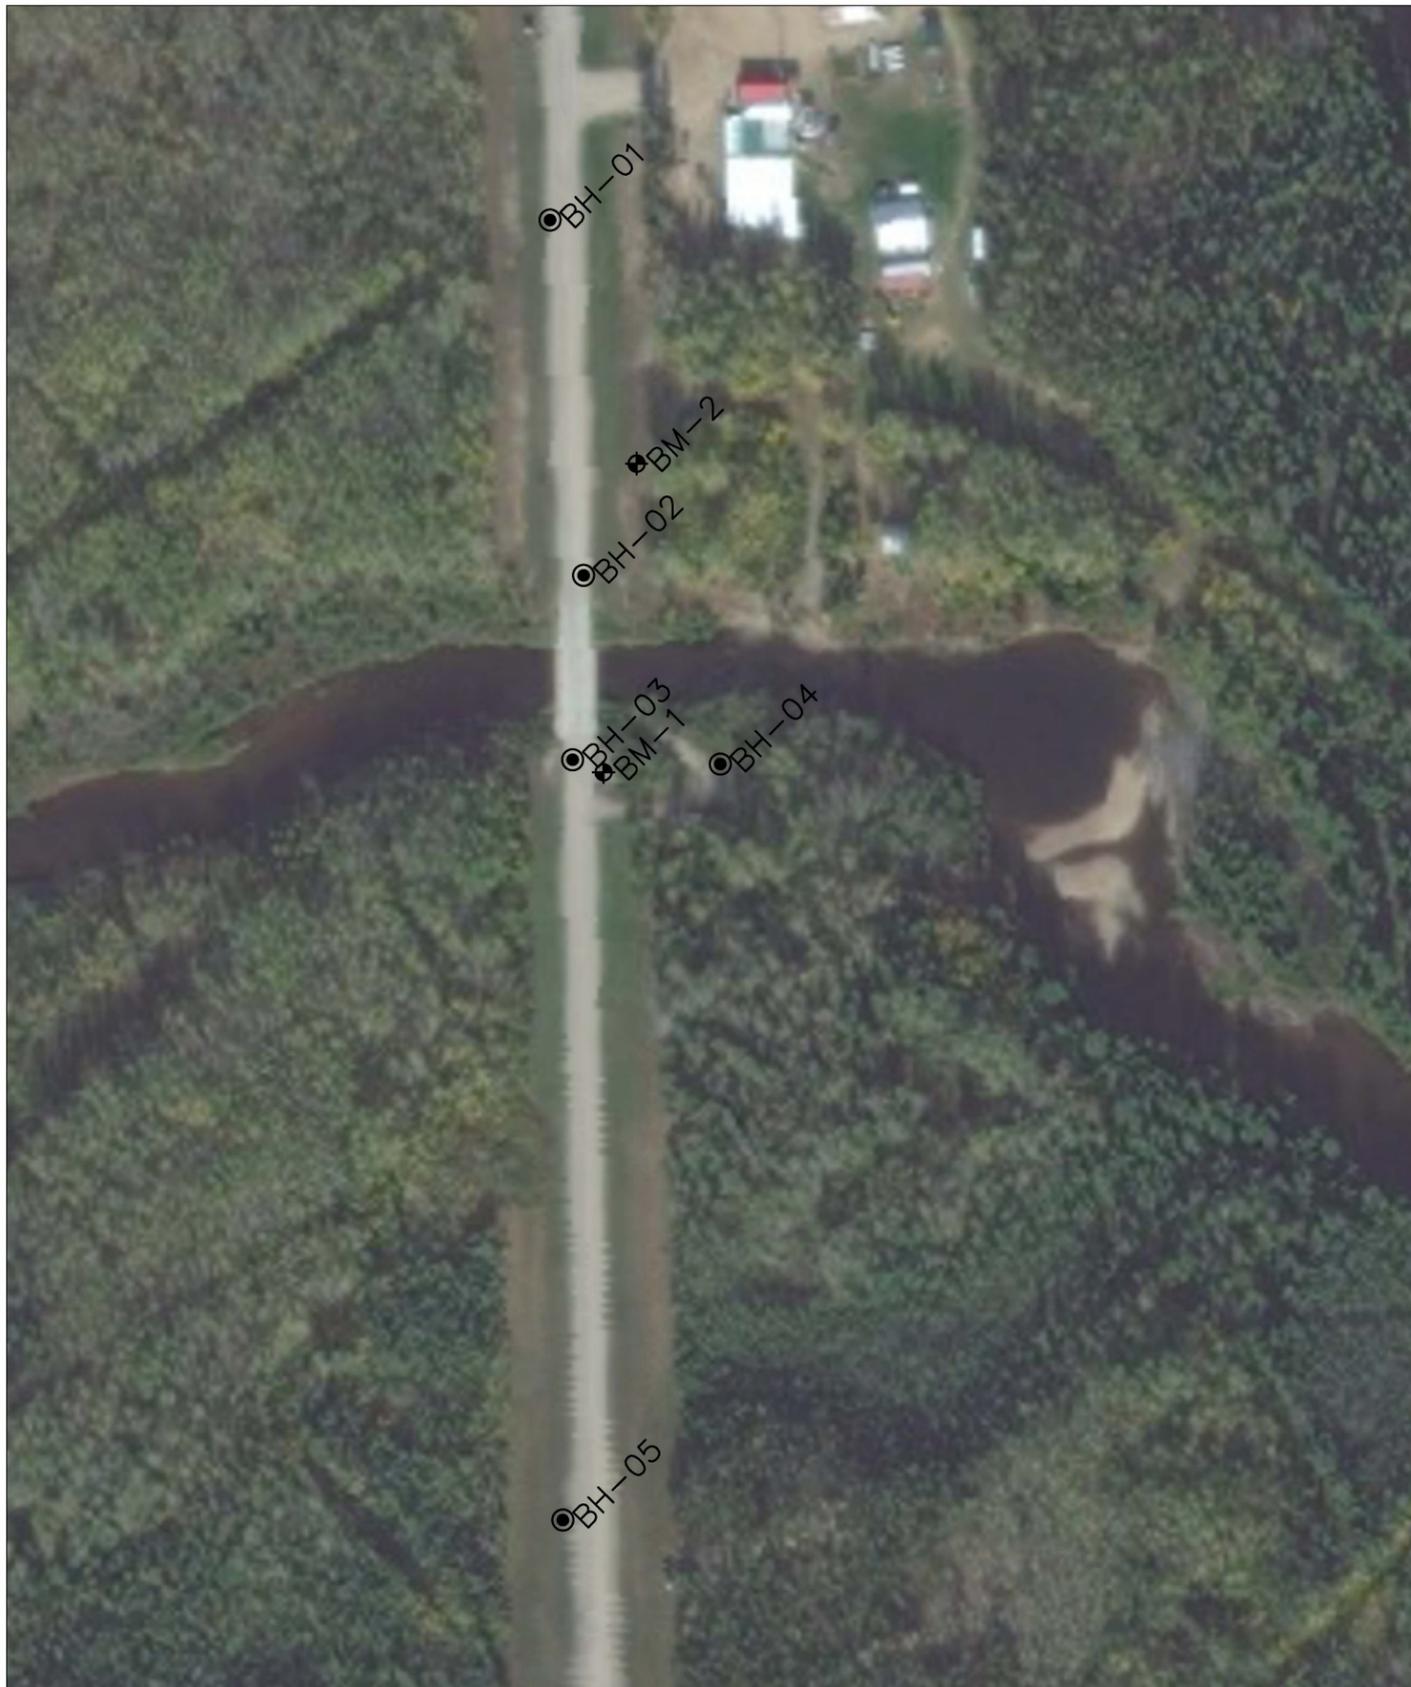
Legend	
◆	Benchmark
●	Borehole

Point Table				
Point #	Elevation	Northing	Easting	Description
1	206.55	6813590.94	593981.66	BM-1
2	208.56	6813676.41	593990.85	BM-2
101	207.60	6813743.86	593966.79	BH-01
102	206.72	6813645.50	593976.10	BH-02
103	206.73	6813594.42	593973.07	BH-03
104	203.24	6813593.24	594014.07	BH-04
105	205.76	6813383.88	593970.35	BH-05

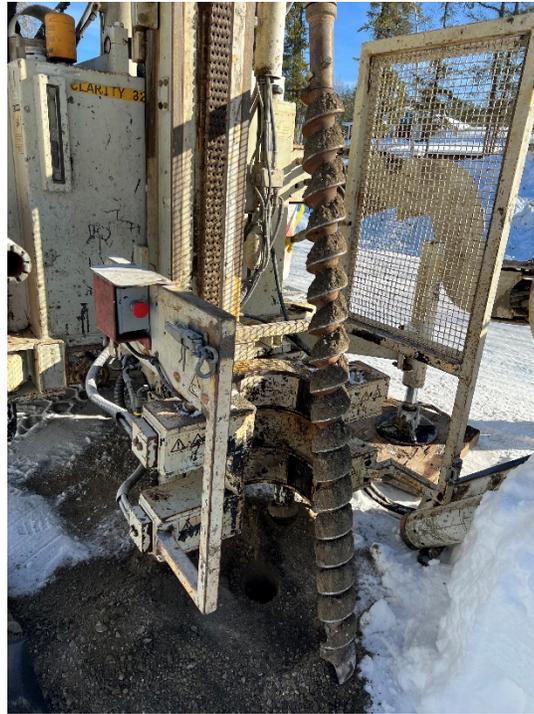
Figure 1: BH-01 (0 – 1.5mbgs)

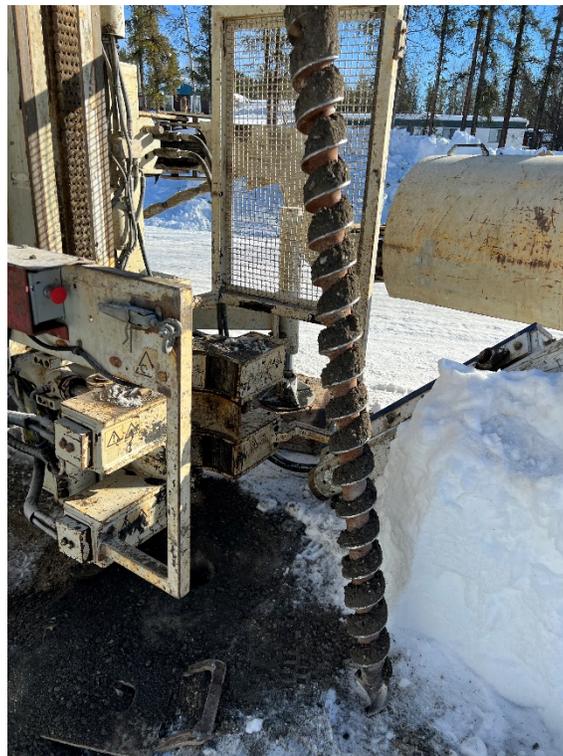
Figure 2: BH-01 (1.5 - 3.0mbgs)

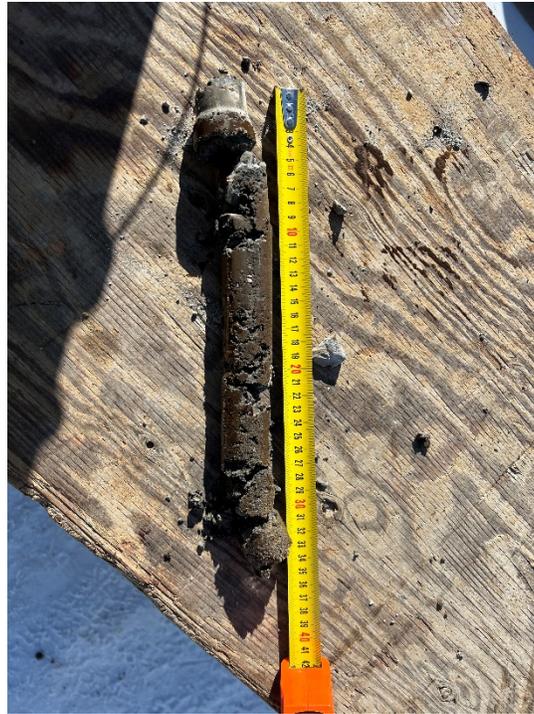
Figure 3: BH-01 SPT Recovery at 3.0mbgs

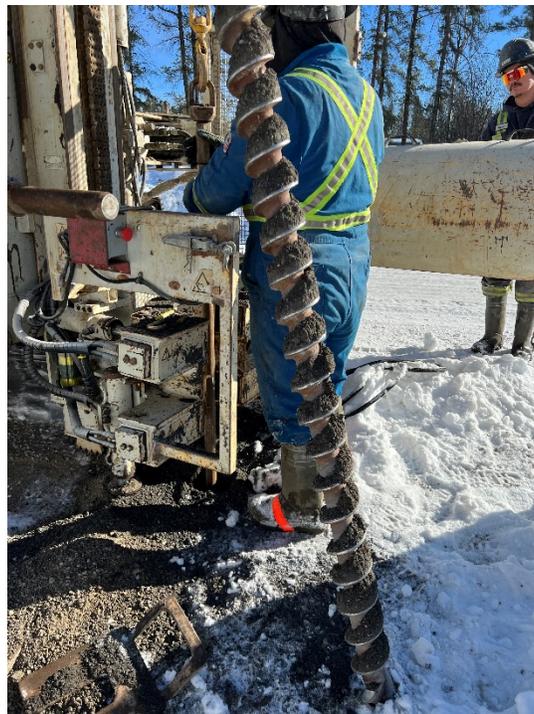
Figure 4: BH-01 (3.0 - 4.5mbgs)

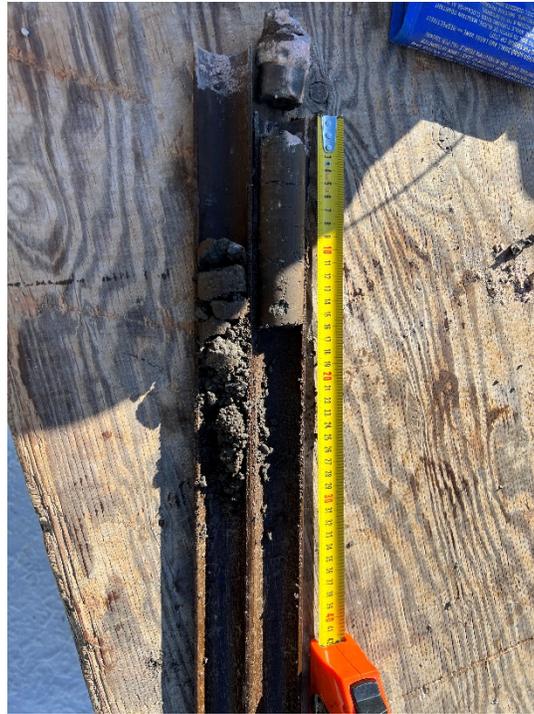
Figure 5: BH-01 SPT Recovery at 4.5mbgs

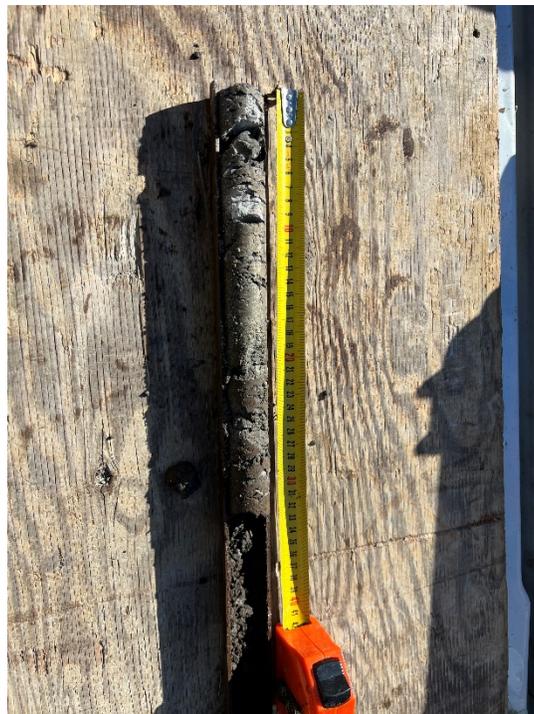
Figure 6: BH-01 SPT Recovery at 5.2mbgs

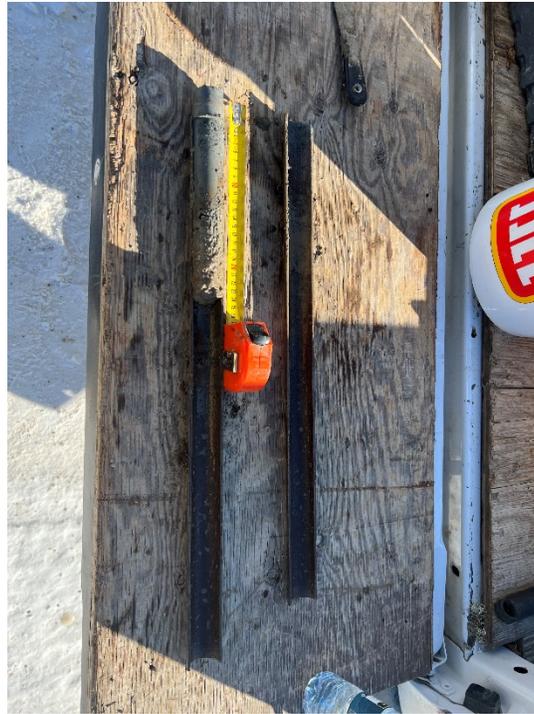
Figure 9: BH-02 SPT Recovery at 4.5mbgs

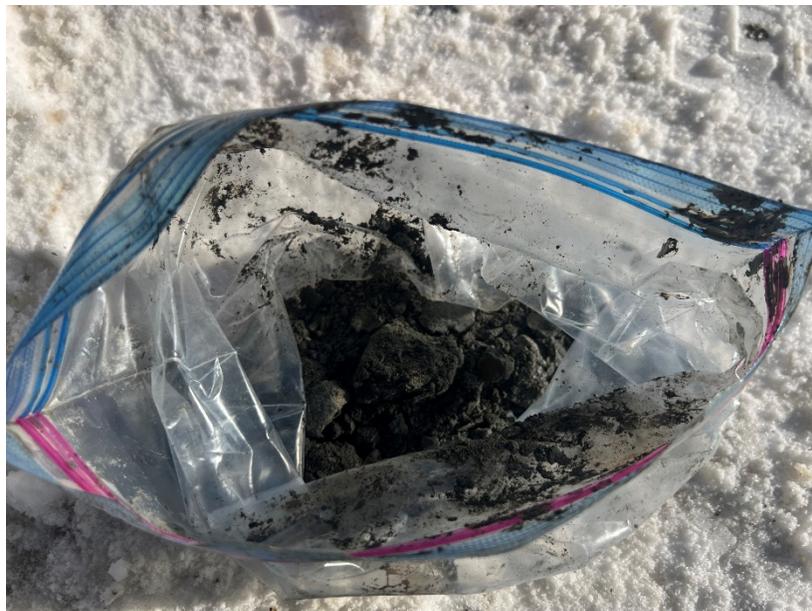
Figure 10: BH-02 SPT Recovery at 6.0mbgs

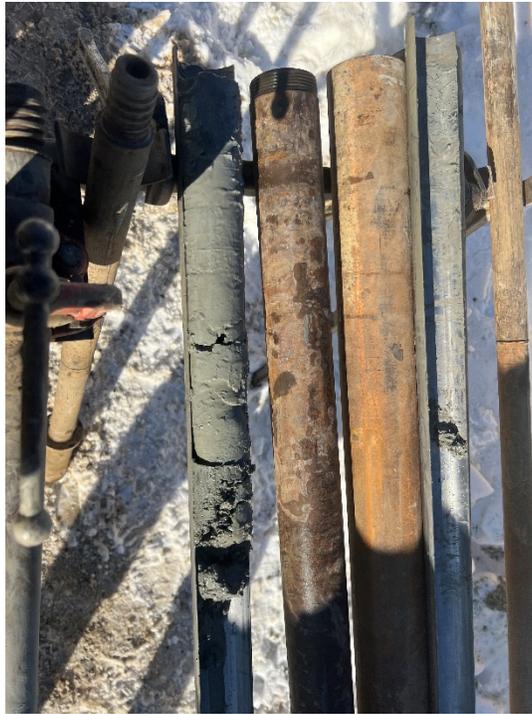
Figure 11: BH-02 Core Recovery 6.0 – 6.5mbgs

Borehole 2 was advanced using a tricone drill bit due to hard drilling conditions as a result of seasonal frost. Drill casing was installed to prevent sloughing of material for more accurate SPT results. The hole was advanced to 6.0mbgs using the tricone bit until bedrock was encountered where the drilling method was switched to rock coring until a completion depth of 11.2mbgs.

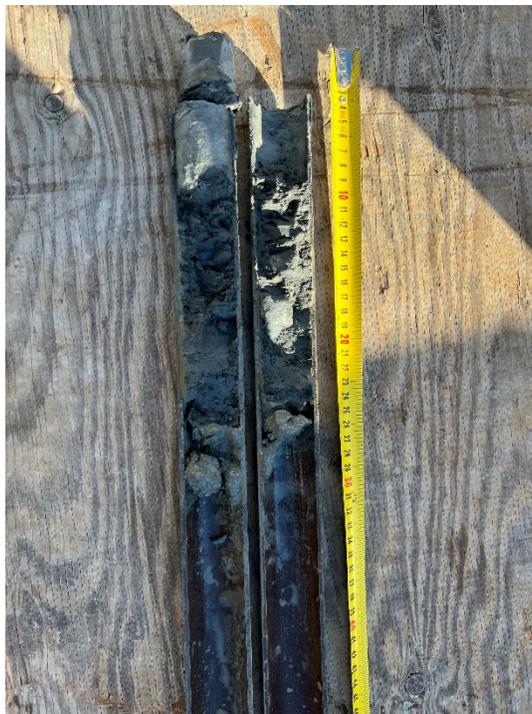
Figure 12: BH-02 SPT Recovery at 6.7mbgs

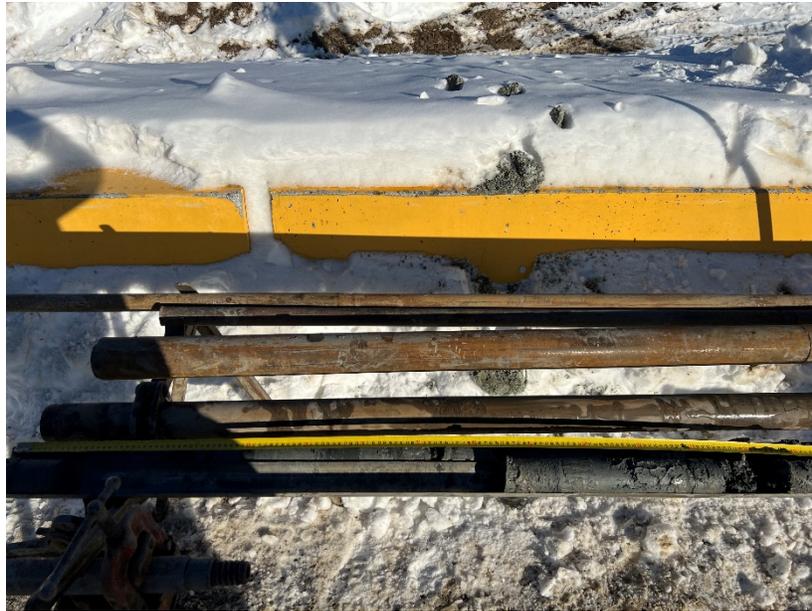
Figure 13: BH-02 Core Recovery 7.2 - 8.2mbgs

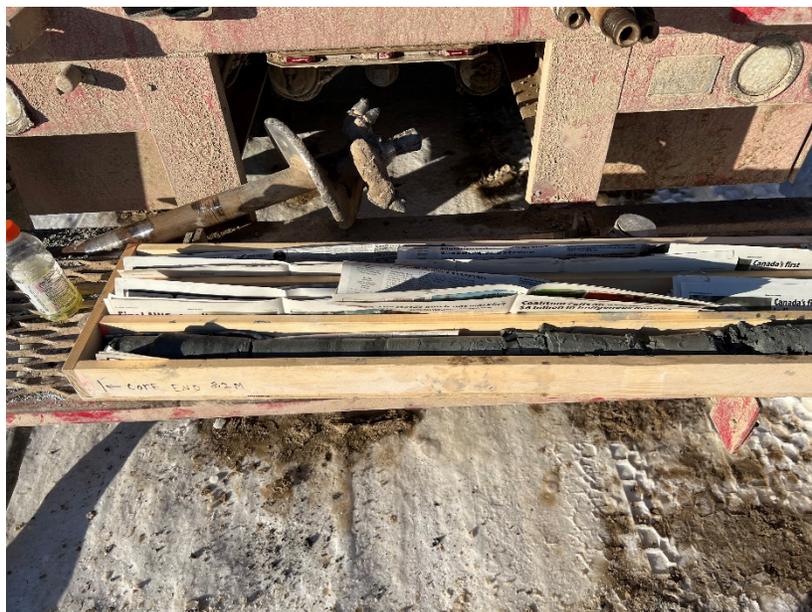
Figure 14: BH-02 Core Recovery 7.2 - 8.2mbgs

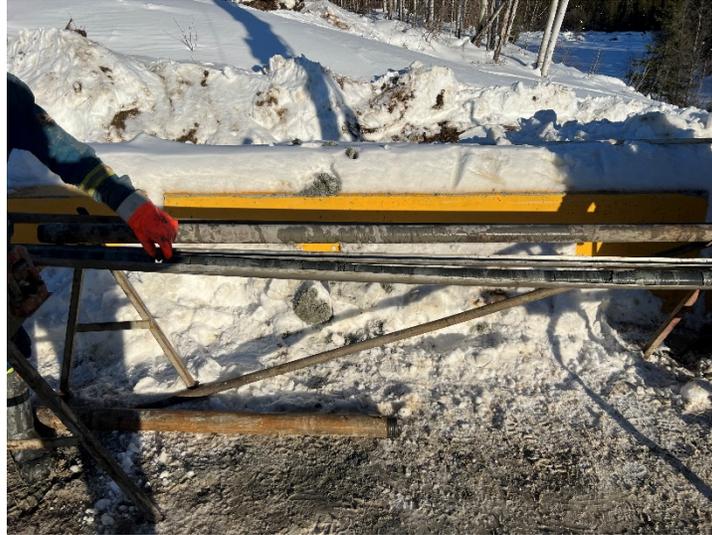
Figure 15: BH-02 Core Recovery 7.2 – 11.2mbgs

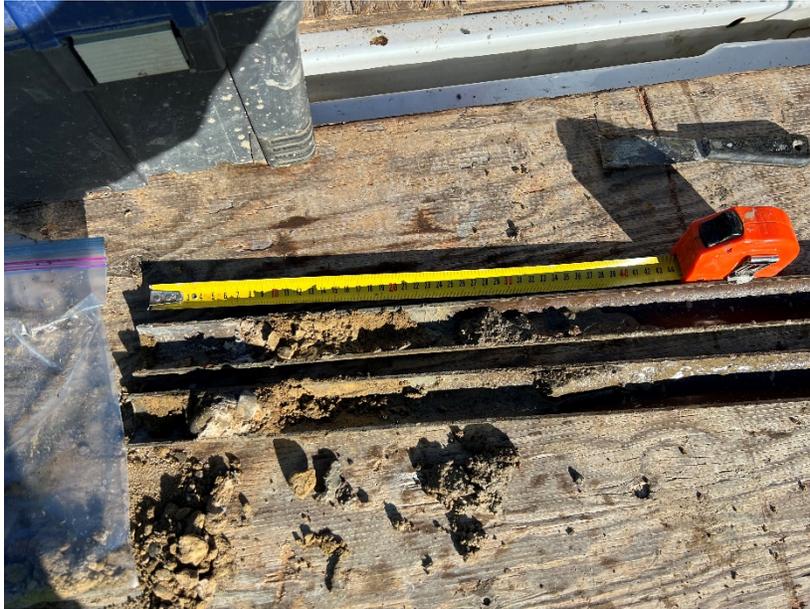
Figure 17: BH-03 SPT Recovery at 3.0mbgs

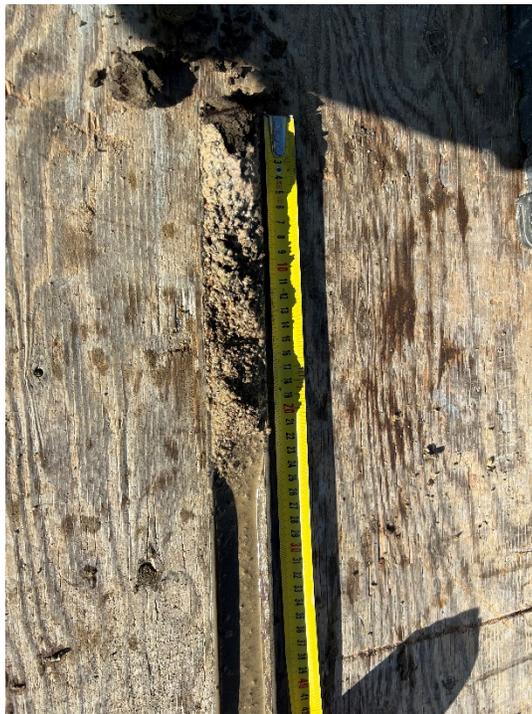
Figure 18: BH-03 SPT Recovery at 4.5mbgs

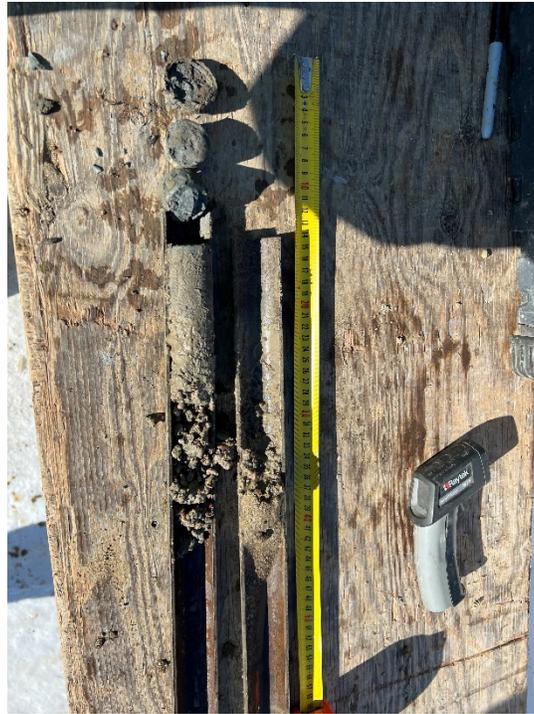
Figure 19: BH-03 SPT Recovery at 7.5mbgs

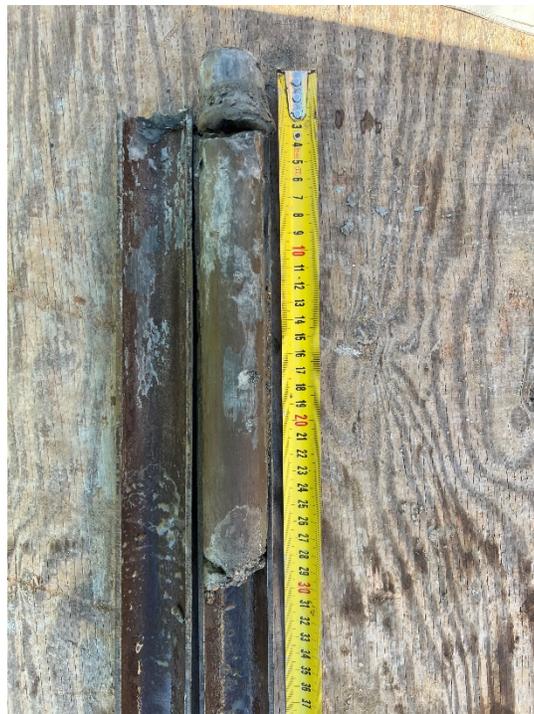
Figure 20: BH-03 SPT Recovery at 9.7mbgs

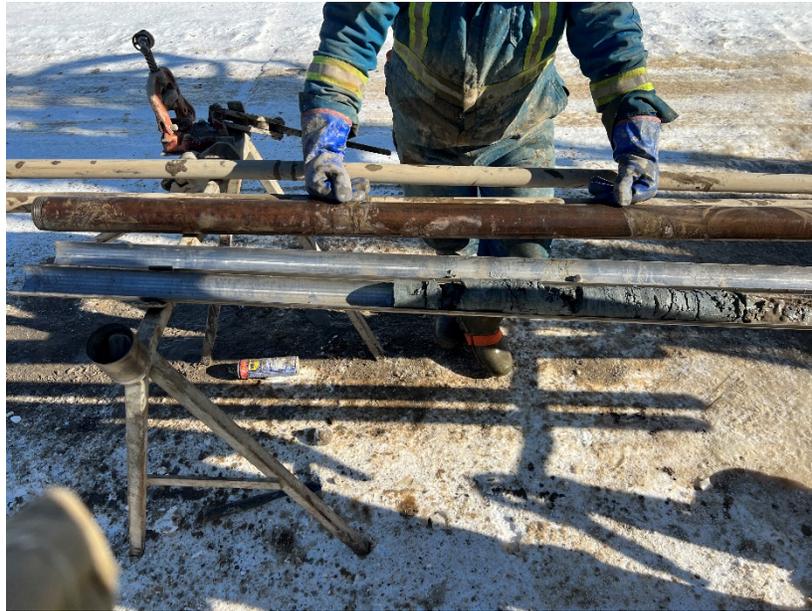
Figure 21: BH-03 Core Recovery

Borehole 3 was advanced using a tricone drill bit due to hard drilling conditions as a result of seasonal frost. Drill casing was installed to prevent sloughing of material for more accurate SPT results. The hole was advanced to 7.5mbgs using the tricone bit until bedrock was encountered where the drilling method was switched to rock coring until a completion depth of 12.7mbgs.

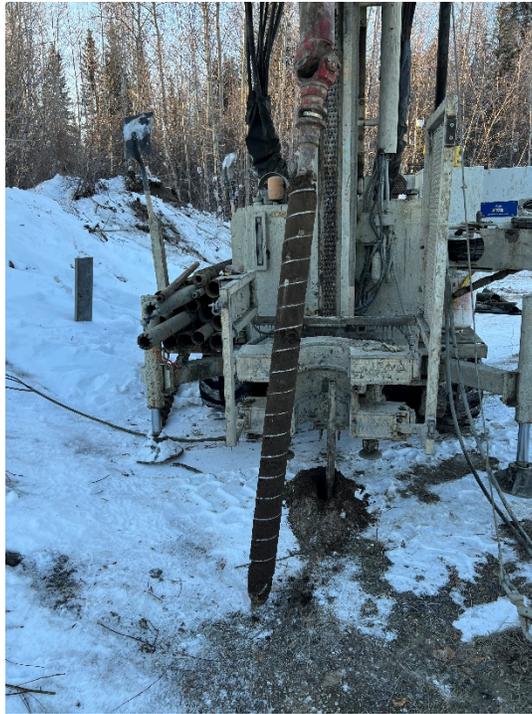
Figure 23: BH-04 (0 – 1.5mbgs)

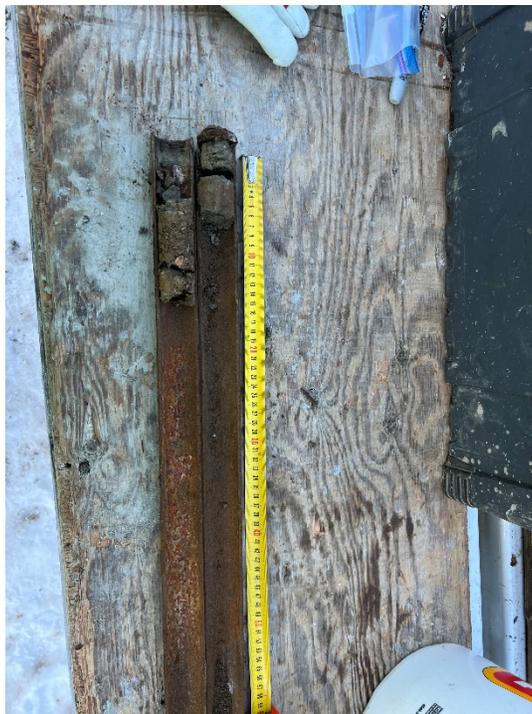
Figure 24: BH-04 SPT Recovery at 1.5mbgs

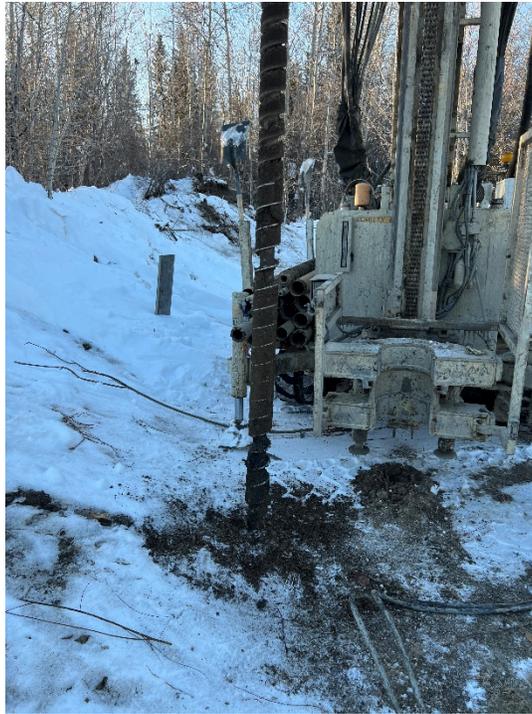
Figure 25: BH-04 (1.5 – 3.0mbgs)

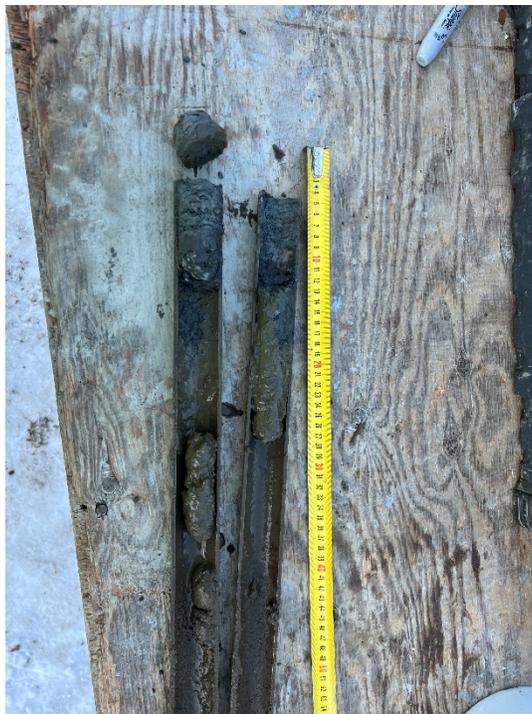
Figure 26: BH -04 SPT Recovery at 3.0mbgs

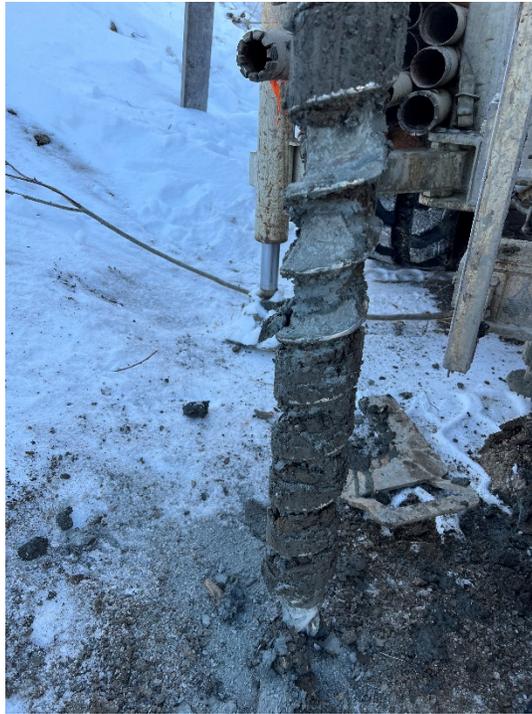
Figure 27: BH-04 (3.0 - 4.5mbgs)

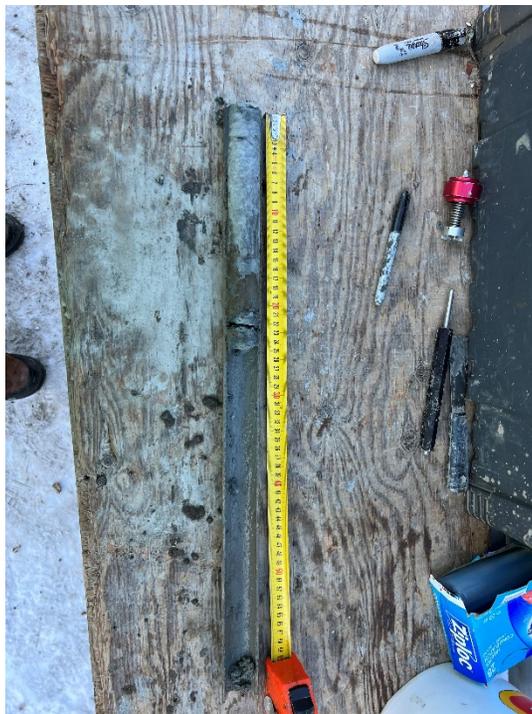
Figure 28: BH-04 SPT Recovery at 4.5mbgs

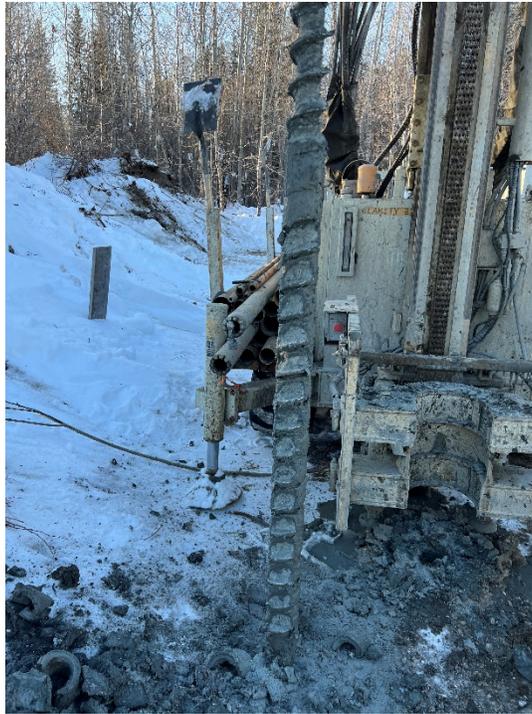
Figure 29: BH-04 (4.5 – 6.0mbgs)

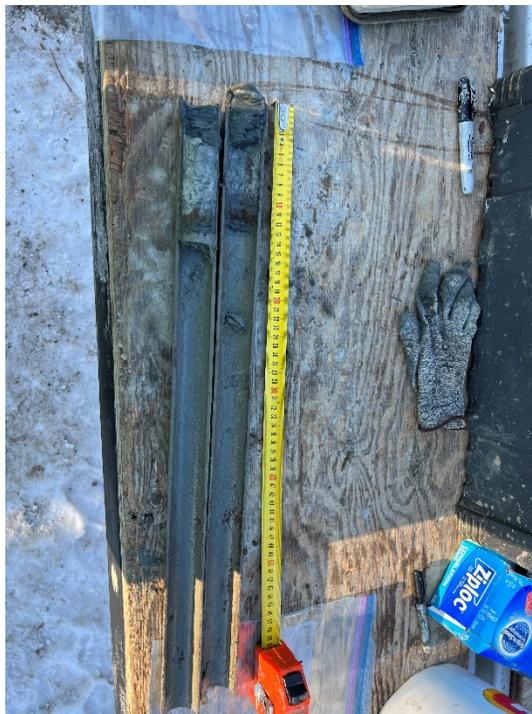
Figure 30: BH-04 SPT Recovery at 6.0mbgs

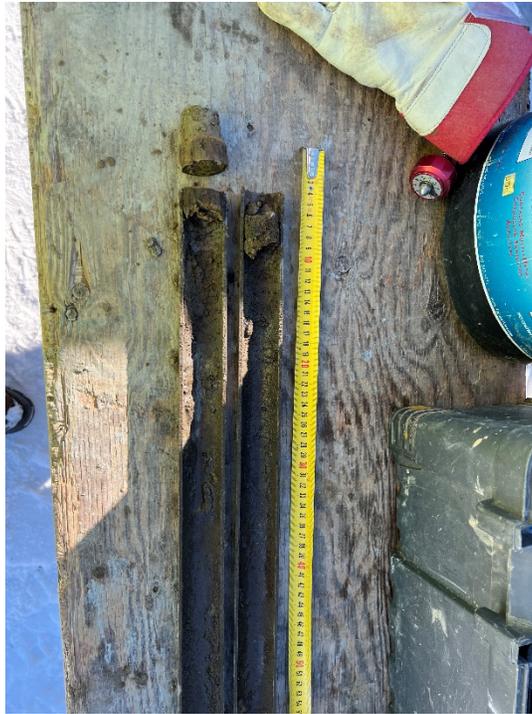
Figure 33: BH-05 SPT Recovery at 1.5mbgs

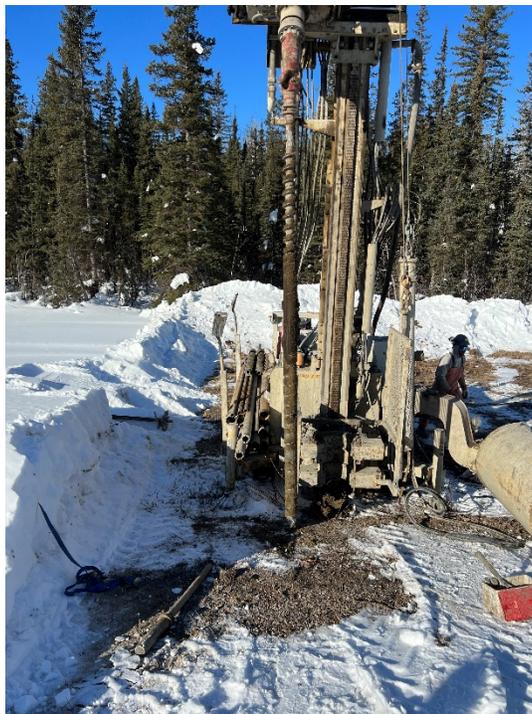
Figure 34: BH-05 (1.5 - 3.0mbgs)

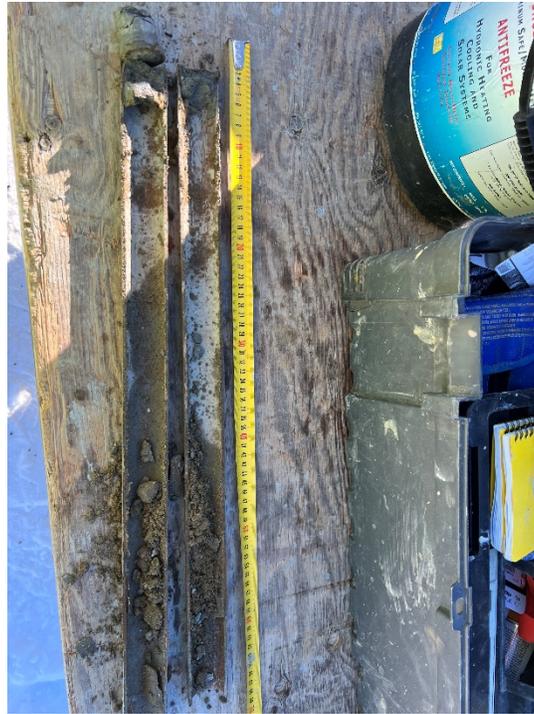
Figure 35: BH-05 SPT Recovery at 3.0mbgs

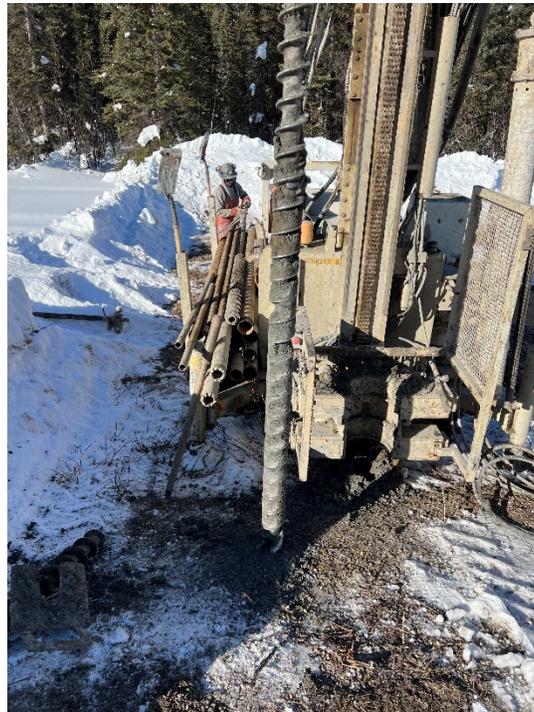
Figure 36: BH-05 (3.0 - 4.5mbgs)

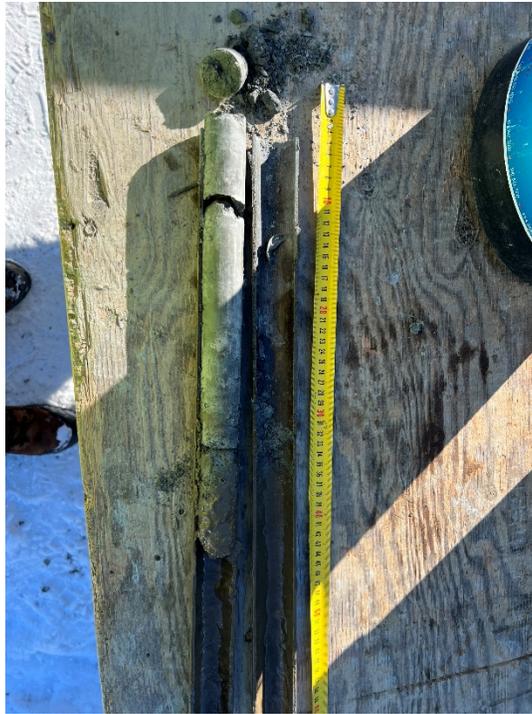
Figure 37: BH-05 SPT Recovery at 4.5mbgs

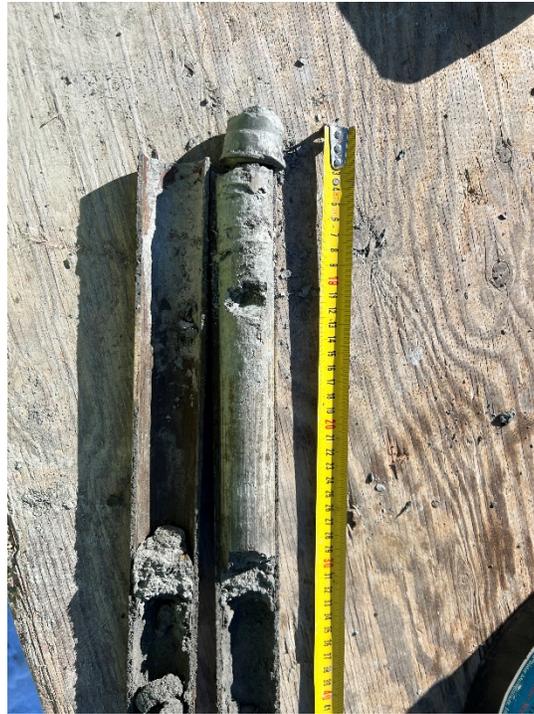
Figure 41: BH-05 SPT Recovery at 7.5mbgs

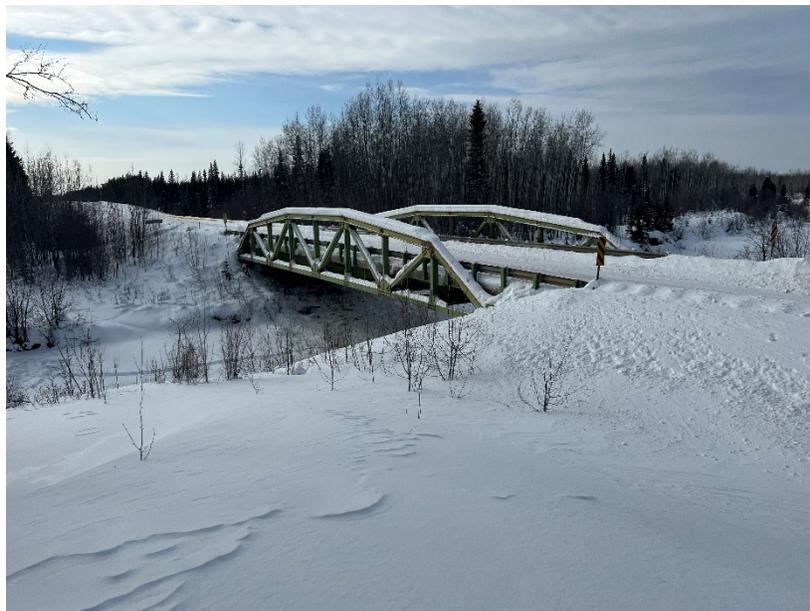
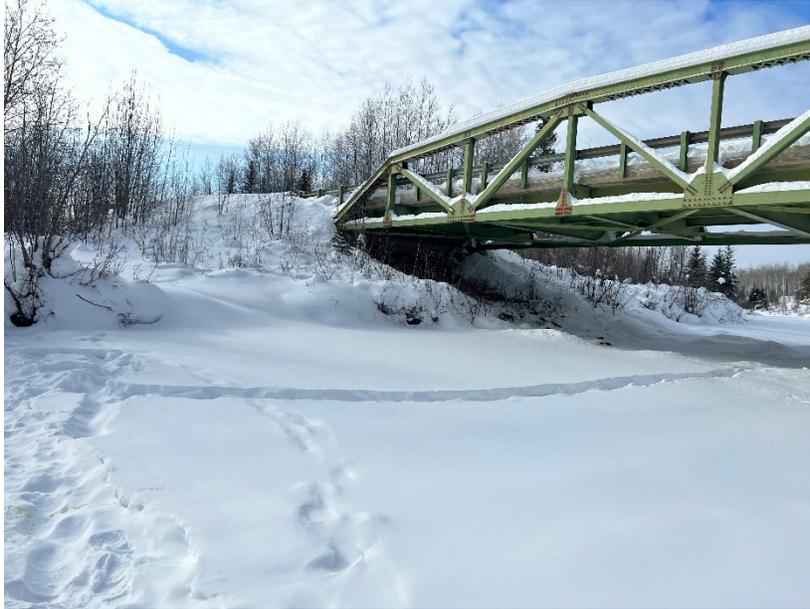
Figure 42: Existing Structure

Figure 43: Existing Structure

The existing structure is a single-span half-through pony truss bridge over the Jean Marie River, originally constructed in 1969. Based on the structural analysis for the pony truss system, the superstructure has been deemed to have insufficient capacity for CL625 and CL800 Loads. It has been evaluated to be more beneficial to replace the structure vs strengthening the existing structure. (GNWT RFP Architectural and Engineering Services)

The current structure spans approximately 40m and is supported by driven wooden piles located under concrete abutments at either end. Maskwa's understanding is that the replacement structure is to consist of a single span similar to the existing bridge, with abutments located in similar locations to that of the current structure.

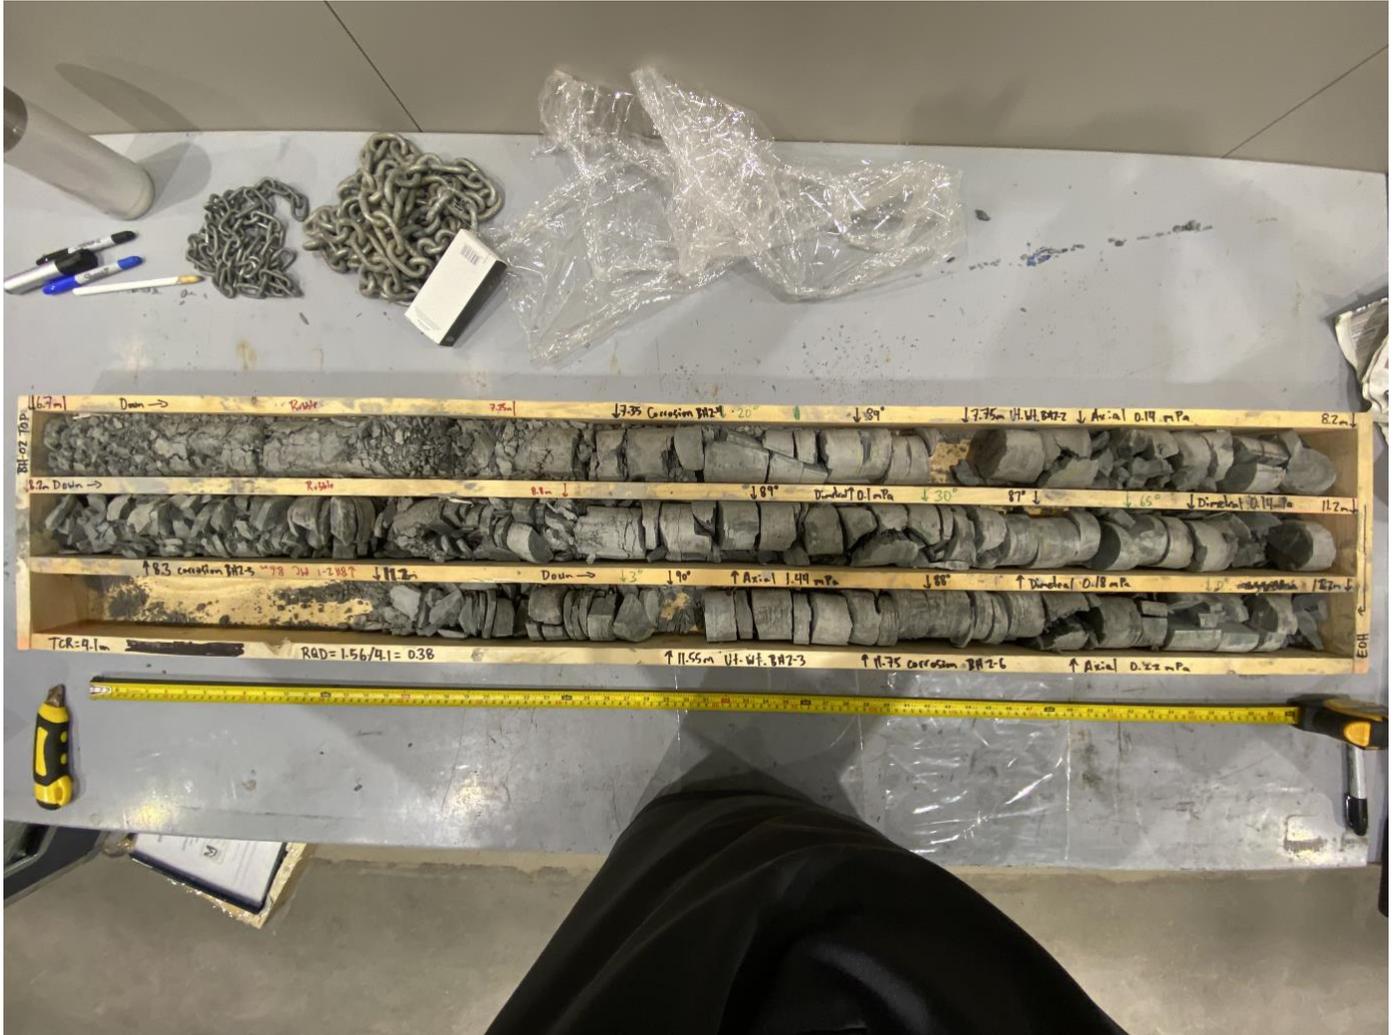
Photograph 1: BH-02

Maskwa Engineering Ltd. – Borehole 2 (BH-02)

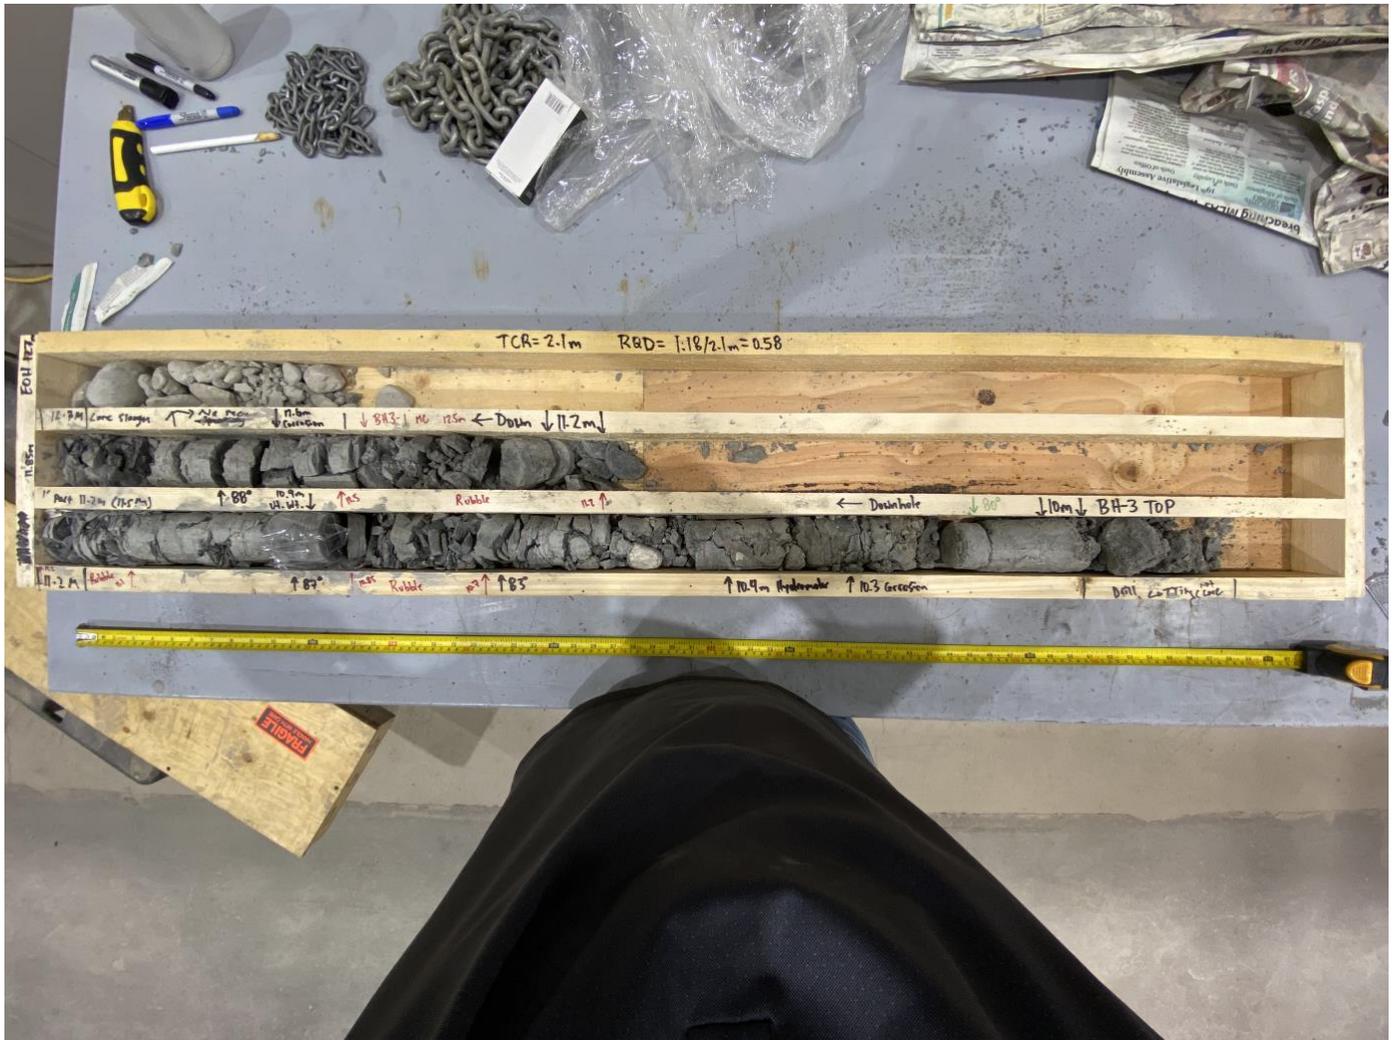
Photograph 2: BH-03

Maskwa Engineering Ltd. – Borehole 3 (BH-03)

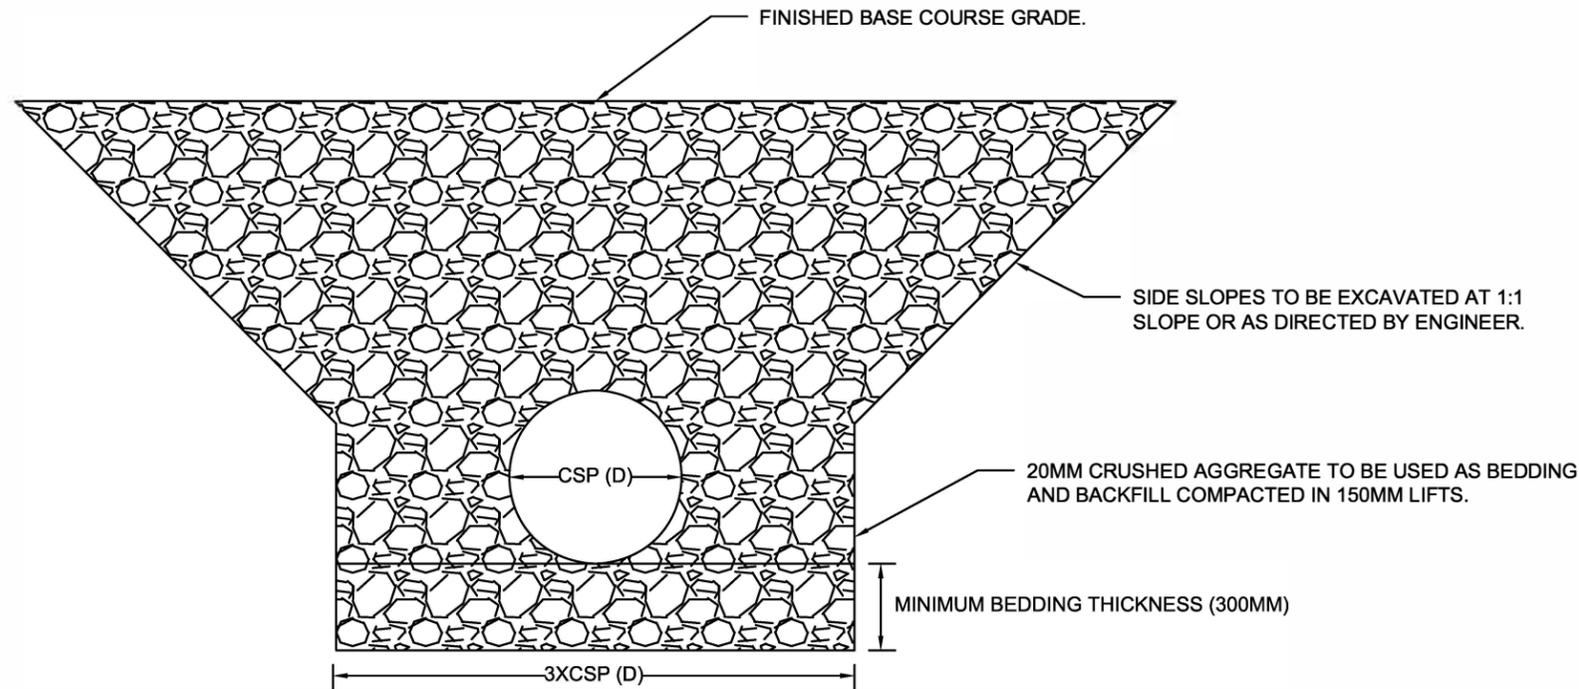
- CSP (D) = CORRUGATED STEEL PIPE DIAMETER.
- AN ENGINEER MUST INSPECT THE THE EXCAVATION PRIOR TO BACKFILL.
- A WOVEN GEOTEXTILE SHALL BE USED AT THE BASE OF THE EXCAVATION.
- CSP BEDDING TO BE AT 100% OF MAXIMUM DRY DENSITY ACCORDING TO ASTM D698 STANDARD PROCTOR VALUE PRIOR TO INSTALLATION.
- FILL MUST BE BROUGHT UP SIMULTANEOUSLY ON EITHER SIDE OF THE CSP IN MAXIMUM LIFTS OF 150MM COMPACTED TO 100% OF THE STANDARD PROCTOR VALUE.
- 300MM THICK ROCK APRON TO BE PLACED ON NON WOVEN GEOTEXTILE FILTER FABRIC ON EITHER END OF CSP AS EROSION CONTROL.
- ROCK APRON TO FOLLOW ROCK RIPRAP CLASS 1.
- THIS DRAWING IS INTENDED TO DEATIL THE FILL REQUIRMENTS FOR THE ACCESS ROAD CULVERT REPLACEMENTS.

Project No.: 0000005729	DRAWING TITLE: CULVERT REPLACEMENT DETAIL	CLIENT: GNWT	SCALE: NTS	DRAWN BY: CJC		
	Dwg No.: 1	PROJECT: JEAN MARIE RIVER BRIDGE REPLACEMENT ENGINEERING SERVICES			MASKWA JOB No.: 22-062	CHECKED BY: BJ
	Revision					DATE: JULY 2023
No.	Date	Description	Chkd

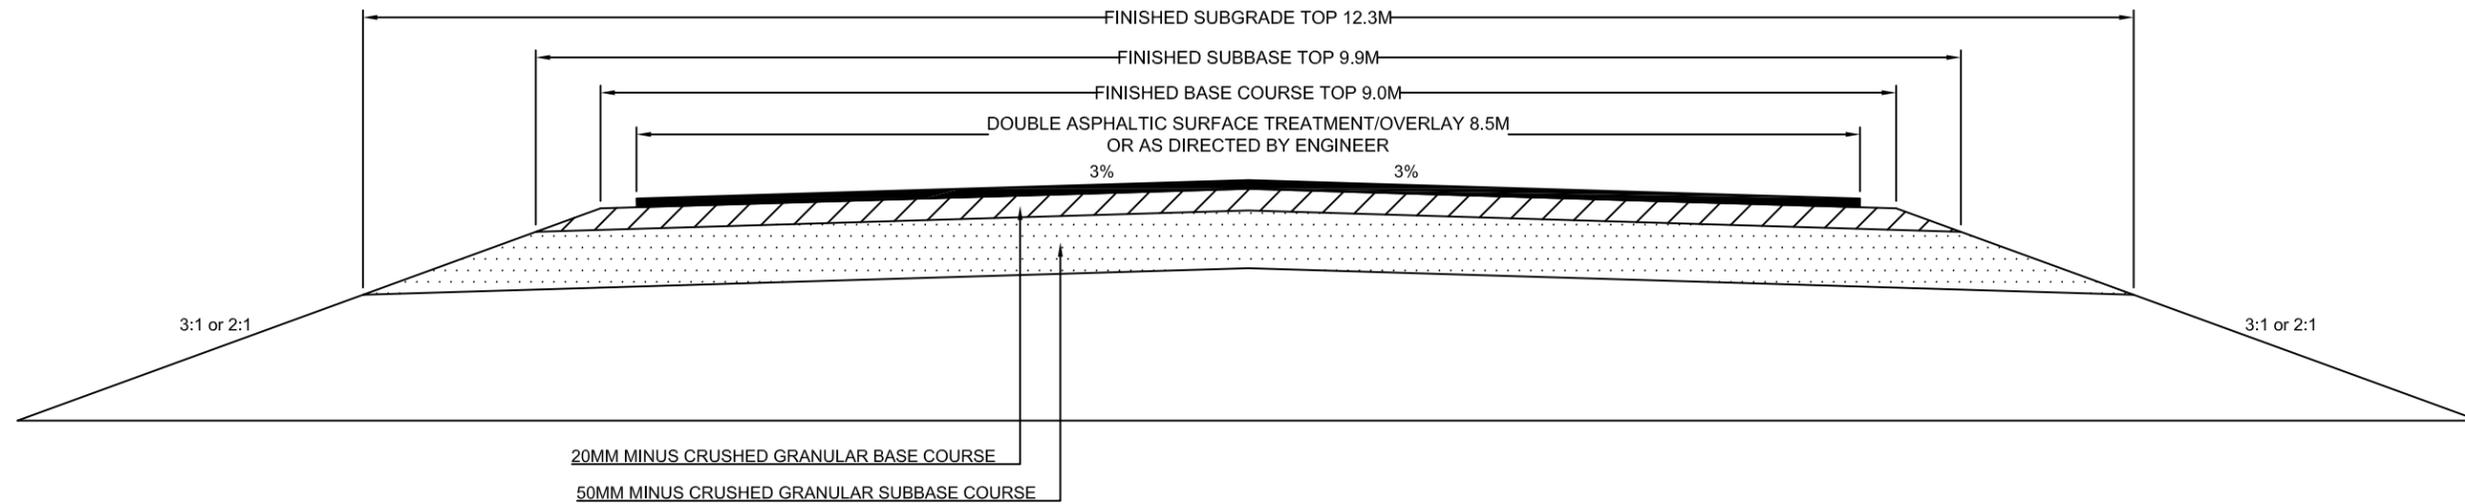
- WIDTH OF MATERIALS AND ROAD ARE LEFT TO THE DISCRETION OF THE PROJECT TRANSPORTATION ENGINEER AND MAY VARY FROM THIS DRAWING.

The embankment reconstruction of the bridge approaches shall conform to typical road embankment benching and compaction methods so that uniform compaction is achieved in each layer of the road. The following features are recommended for the construction of the new embankment:

- Base to be 300mm thick (20mm minus).
- Chip seal to be 32mm thick, each layer to be 16mm thick (Based on Maximum Particle Size).
- The minimum Head Slope to the river is to be 1.75:1 with a Woven Geotextile pinned to the embankment Head Slope as per the manufacturer's recommendations.
