N1L4-0150 - weir breach repair - access to Snare Forks Channel

#### Re: Snare Forks Channel Access Permit Request

Snare Forks Freeboard Dyke 1 Breach June 15, 2006

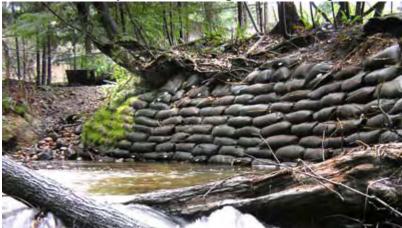
Exhibit 3: Example of an Ecological Retaining Wall

This technology uses interlocked soil bags to form a retaining wall to promote slope stability. The ecological retaining walls provide a vegetated face for slopes and walls to aid in erosion control, slope repair, bank protection and earth retention applications. Some of the ecological retaining wall manufacturers claim that their systems offer the strength of stone and concrete while maintaining a natural looking feature. The soil bags can be seeded or planted to re-vegetate the bank. Refer to Exhibit 3 for an example of an ecological retaining wall.

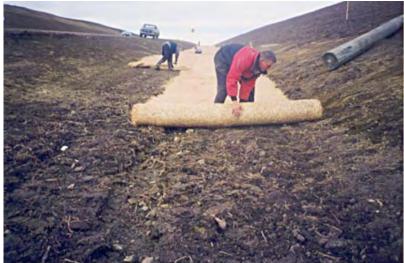
**Exhibit 5: Example of Erosion Control Mats**

Erosion control mats (ECMs) are a temporary degradable rolled erosion control product composed of processed natural or polymer fibres mechanically, structurally or chemically bound together to form a continuous mat to provide erosion control and facilitate vegetation establishment. They are stapled onto the ground over an area that has been or will later be seeded and fertilized. As the vegetation grows through the ECM, the ECM provides erosion protection, a microclimate for seed germination, and protection of the immature plants from mechanical damage. Refer to Exhibit 5 for an example of erosion control mats.

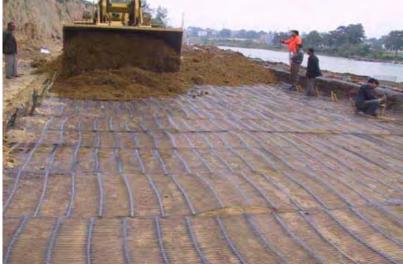
### Exhibit 6: Example of a Geogrid

Geogrids are meshes usually made of a regular pattern of fairly rigid, plastic tensile bars. These meshes are typically used to strengthen fill materials in geotechnical applications. The bars are oriented in one principle strength direction. Geogrids interlock with the soil and have excellent long term creep strength. Their tensile strength can prevent or decrease the degree of differential settlement in some applications by transmitting the load over a broader area of soil, thereby diminishing the vertical stress in the soil. The strength of a geogrid allows positive reinforcement of embankments and retaining walls. Refer to Exhibit 6 for an example of a geogrid.

Geogrids are typically installed horizontally between layers of fill material to reduce the likelihood of sloughing. Advantages

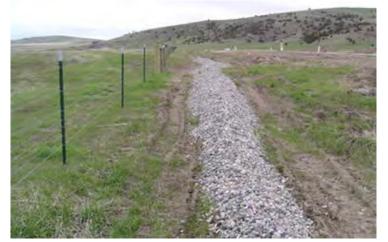
Exhibit 9: Example of a Filter Berm (geotextile fabric not visible)

The filter berms are constructed of a geotextile material surrounded by burlap sand bags and drainage rock that spans the width of the drainage channel. The edges of the filter berms can be comprised of check dam materials. The filter berm is constructed in the overflow drainage channel of the check dam. While the check dam may clog with sediment, the filter berm requires regular maintenance to clean or replace the geotextile material to continue filtering out suspended sediments.

Additional filter material in the form of filter socks (which consist of granular material or mulch wrapped in filter cloth) can be added to this section if overflows are frequent. Refer to Exhibit 9 for an example of a filter berm.

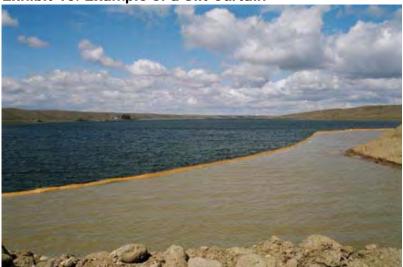
Exhibit 10: Example of a Silt Curtain

The floating silt curtains are comprised of a geotextile material that is suspended from a float that is strung across the channel in a series of baffles to catch sediment and reduce the water flow.

A baffle is typically configured by securing a silt curtain on one bank, extending it to a point that is about 2/3 to 3/4 the width of the water channel and then anchoring another line to the opposite bank. This process is repeated from the opposite bank, just up or downstream of the other curtain, to form one baffle to slow the flow rate and promote sediment filtering. Refer to Exhibit 10 for an example of a silt curtain.

Silt curtains provide an effective and price sensitive system for isolating silt in an aquatic ecosystem. The orientation of the silt curtains can be used to direct flow away from vulnerable portions of bank that are more likely to be eroded.

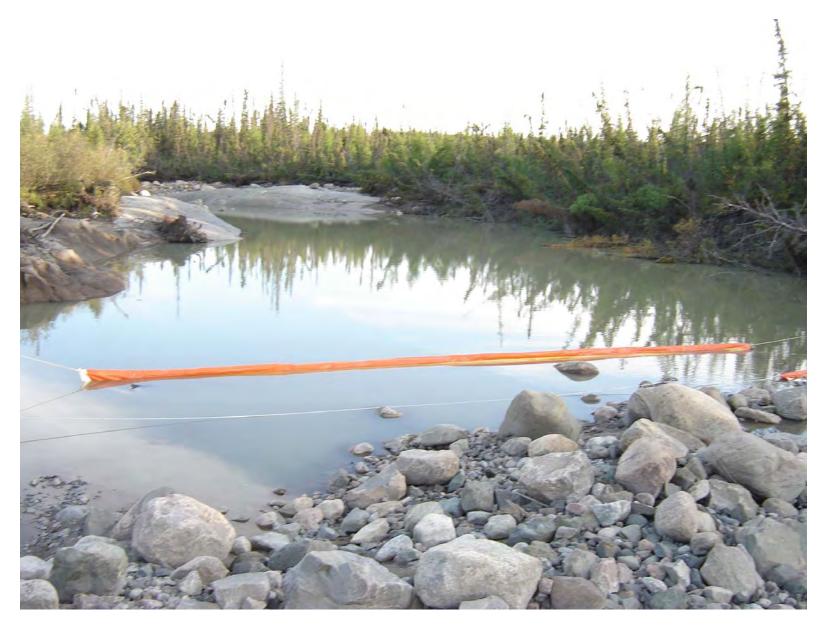
Photograph 2: View of Upper Reach from Silt Curtain #1

- At the midpoint of the upper reach a gravel bar had formed due to the breach that was directing water towards the west bank through a narrow side-channel. This caused erosion of the exposed bank and the mobilization of sediment to areas downstream of this location. Rocks were relocated by hand from the center of the gravel bar to the opening of the side-channel to prevent flow along the exposed bank and to allow for increased flow towards the center of the main channel. A rock berm was added at the downstream side of the gravel bar to redirect flow away from the edge of the downstream silt curtain, to prevent overflow during periods of heavy runoff, and to encourage ponding and settling of suspended sediment on the upstream side of the silt curtains at this location. The water now flows among the rocks on the central portion of the channel at this location and there is no fast moving water in the upper reach of the Snare Forks Channel in contact with the banks. This measure eliminates one of the main sources of sedimentation in the upper reach (see photos 1, 2).

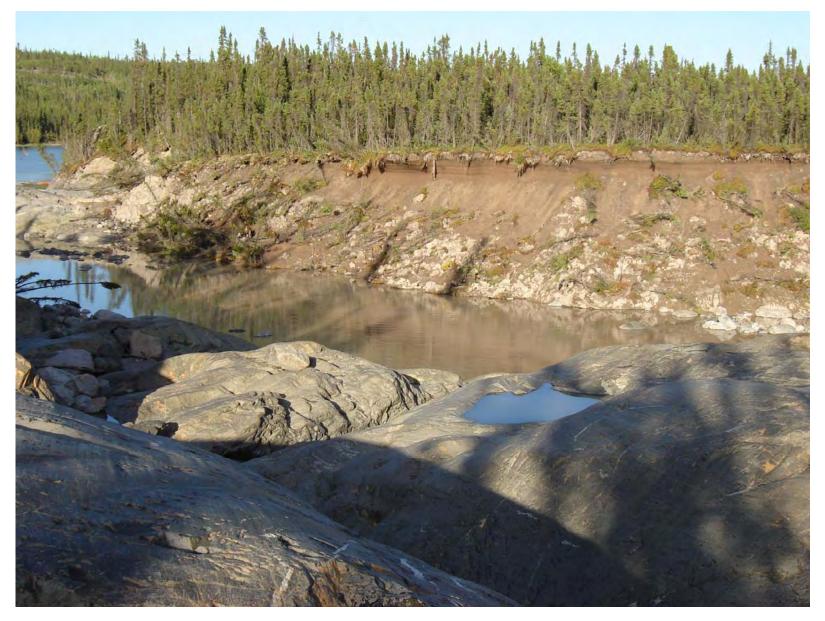
Photograph 4: View into Lower Reach from Rock Cascade

- Silt fencing was installed along the stable, exposed banks in both the upper and lower reaches of the channel from Dyke 1 to Strutt Lake. Fencing is held in place by 3 foot wooden stakes and was installed by digging a trench and anchoring the bottom edge of the geotextile fabric within the trench with native soil. The silt fencing is designed and was installed in such a manner as to intercept small land slide or sloughing events and to reduce surface runoff. Accessible exposed banks within the upper reach were lined with silt fencing. The area opposite the rock cascade was lined with silt fencing and the remainder of the accessible and stable slopes within the lower reach were also lined with silt fencing. The gravel bar at the outfall to Strutt Lake was lined with silt fencing to help reduce/contain sediment inputs from wave action and surface runoff at this location (see photos 3 7).

- Erosion control matting was installed on relatively flat areas consisting of exposed silt and mud to help mitigate erosion of these areas and act to reduce sediment laden inputs of surface runoff. The biodegradable mats are constructed of a fine coconut weave and are proven to be effective in this application. These were installed in suitable locations within both the upper and lower reaches of the channel (see photos 3 7).

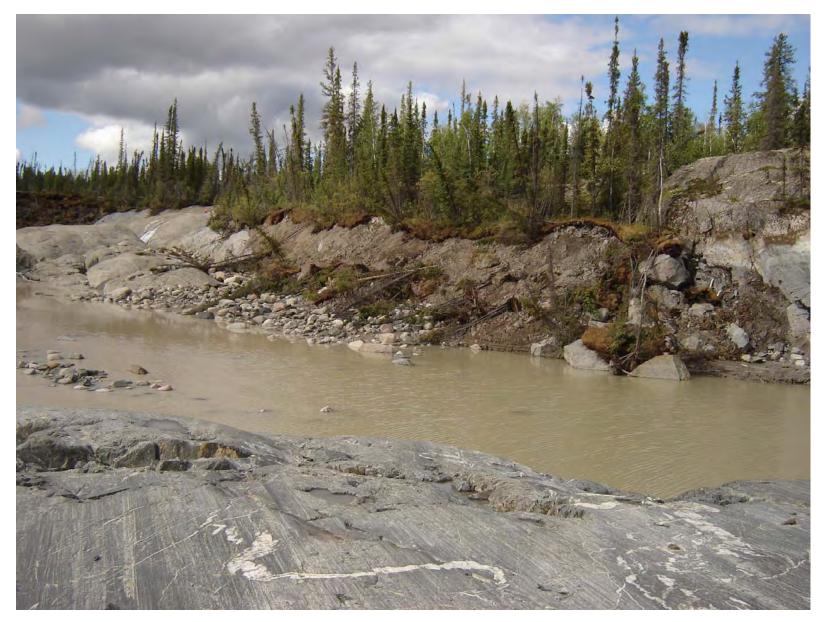
**Photograph 5: View of Lower Reach and Rock Cascade**

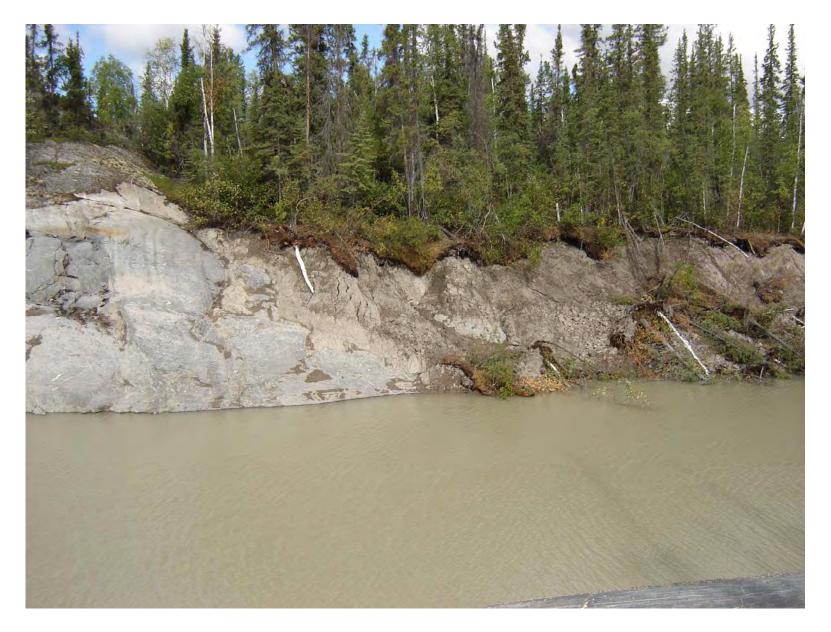
Photograph 6: View of Lower Reach

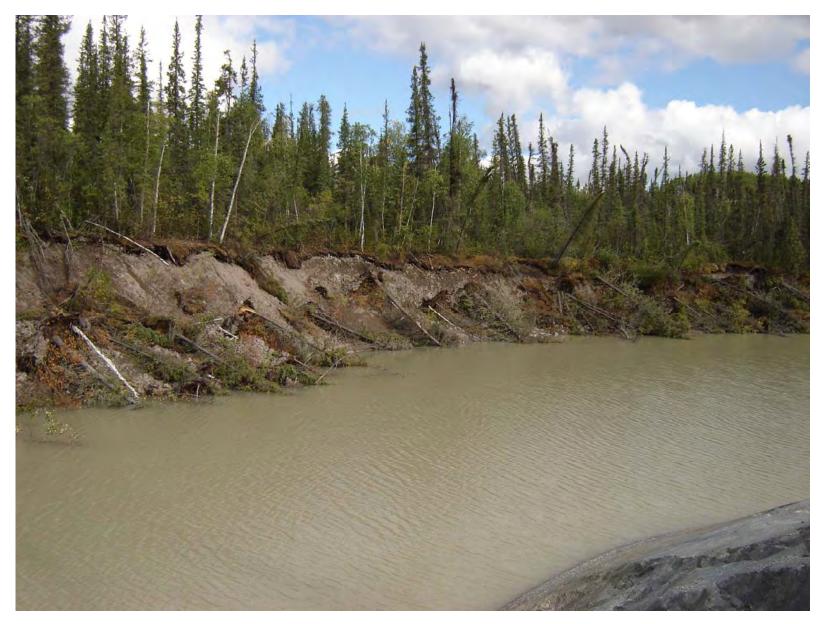
Photograph 7: View of Lower Reach

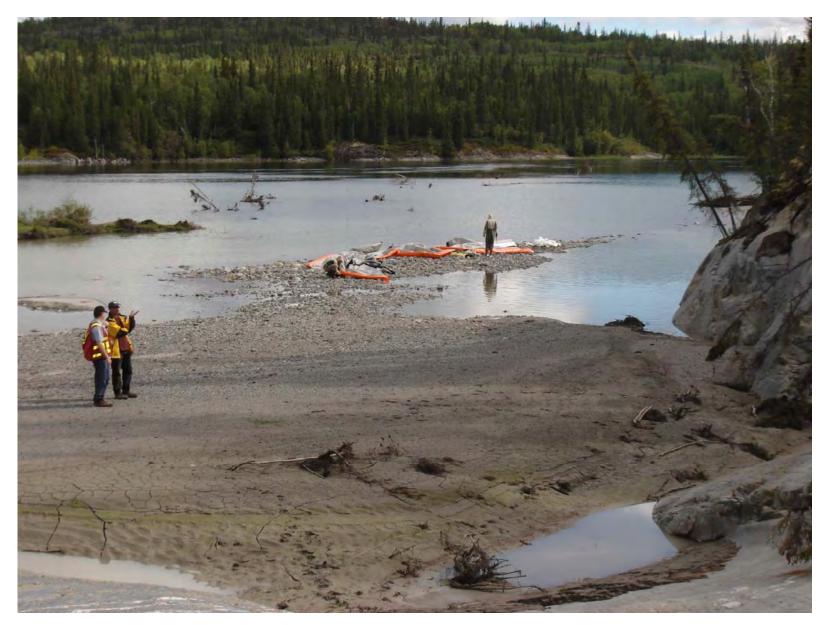
Photograph 9: Channel mouth, view towards Strutt Lake

- velocity of water within the lower reach, to encourage settling, and to allow for limited filtration of the water through the curtains. It is anticipated that the water level in the lower reach will fluctuate with the level of Strutt Lake by up to 1 meter, and this has been provided for through the installation of silt curtains with depth enough to deal with the maximum depth of the channel (see photos 8, 9).

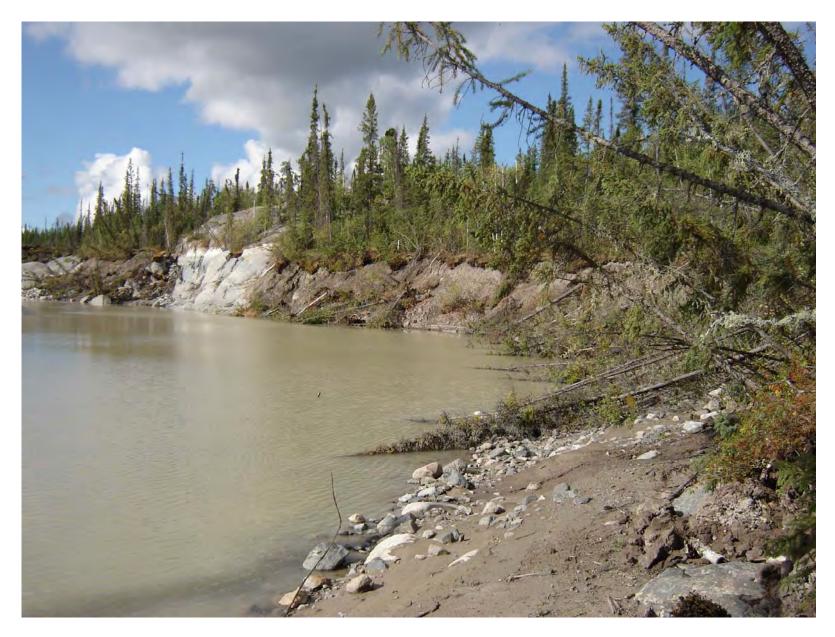
**Photograph 10: View of Lower Reach from Strutt Lake**

- Two filter berms were constructed near the base of the rock cascade to filter or help retain sediment laden groundwater that has collected in the area opposite the rock cascade and is discharging to the main channel near the bottom of the falls. The upstream berm (Filter Berm 1) was constructed by digging a trench perpendicular to the flow, anchoring a silt curtain within the trench, and supporting and anchoring the back-side of the curtain with a rock berm. The groundwater flowing from this area appears to pond in front of this berm. A second berm (Filter Berm 2) was constructed downstream of the first using sand bags filled with a mixture of sand, gravel and smaller crushed rock. These sand bags were placed within the channel in an attempt to slow the flow and encourage filtration of the runoff through the sand bags and settlement of suspended sediment upstream of the berm (see photos 10, 11).

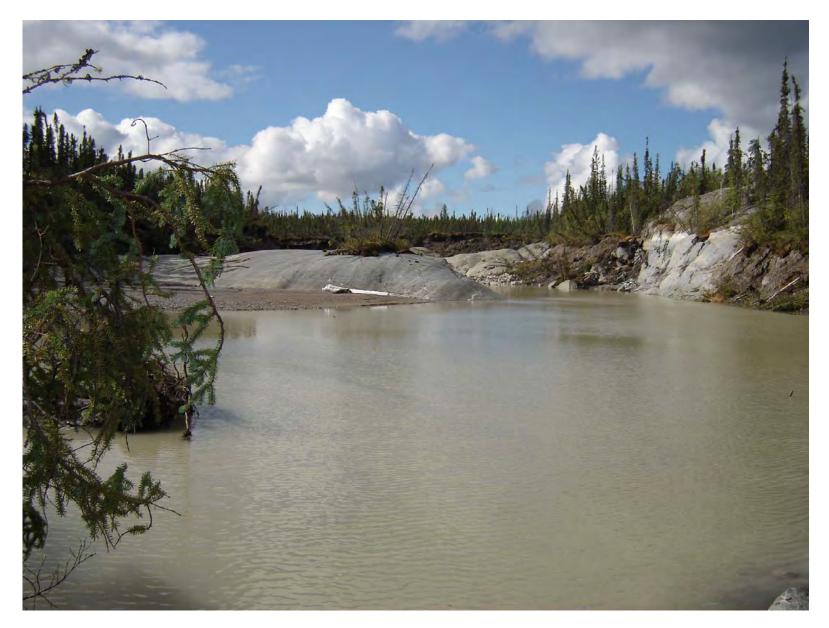
**Photograph 11: View into Lower Reach from Strutt Lake**

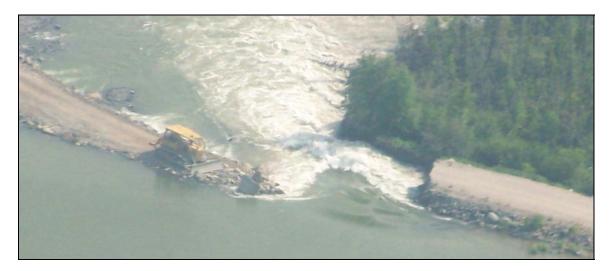
Figure 3 - Snare Forks Breach June 27, 2006

- The breach is officially closed at 11:00.
- The flow through the dyke is estimated to be 10 m3/s.
- Equipment operators begin placing finer material on the upstream edge of the dyke to reduce the flow of water through the larger rocks of the dyke.
- The low section on the east side of Dyke 2 is topped up.

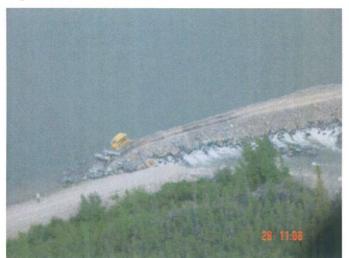
Figure 3: Breach closure

11:00 am breach closed. Vehicles safely crossed the weir and crews began raising the level of the weir. Some water still flowed through the rocks that make up the dyke but operational efforts turned to sealing the upstream surface. Granular material required for this sealing will be taken from the pits near the Snare Forks reservoir.
