Norman Wells Operations Annual Flowline Integrity and Break-Up Report

March 2023

Norman Wells Bathymetric Survey

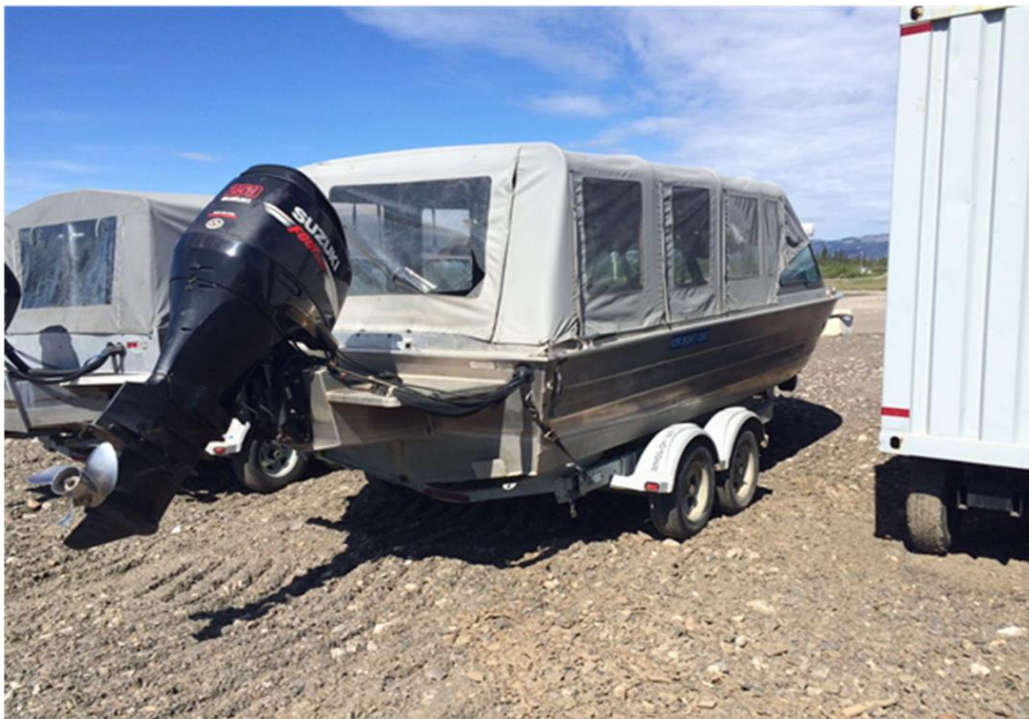
Figure 2.6.1.1

The survey launches and boat captains for this project were supplied by Imperial Oil Resources. The primary launch (Boat 1 – Figure 2.6.1.1) is a 7.3 m. aluminum vessel equipped with a 250 hp, 4 stroke Suzuki motor. The motor was equipped with a propeller.
