## ***Great Bear Lake Sites – 2017 Annual Water Licence Report (Licence #S17L8-002)***

**Prepared for: Sahtu Land and Water Board**

**Date: March 29, 2018**

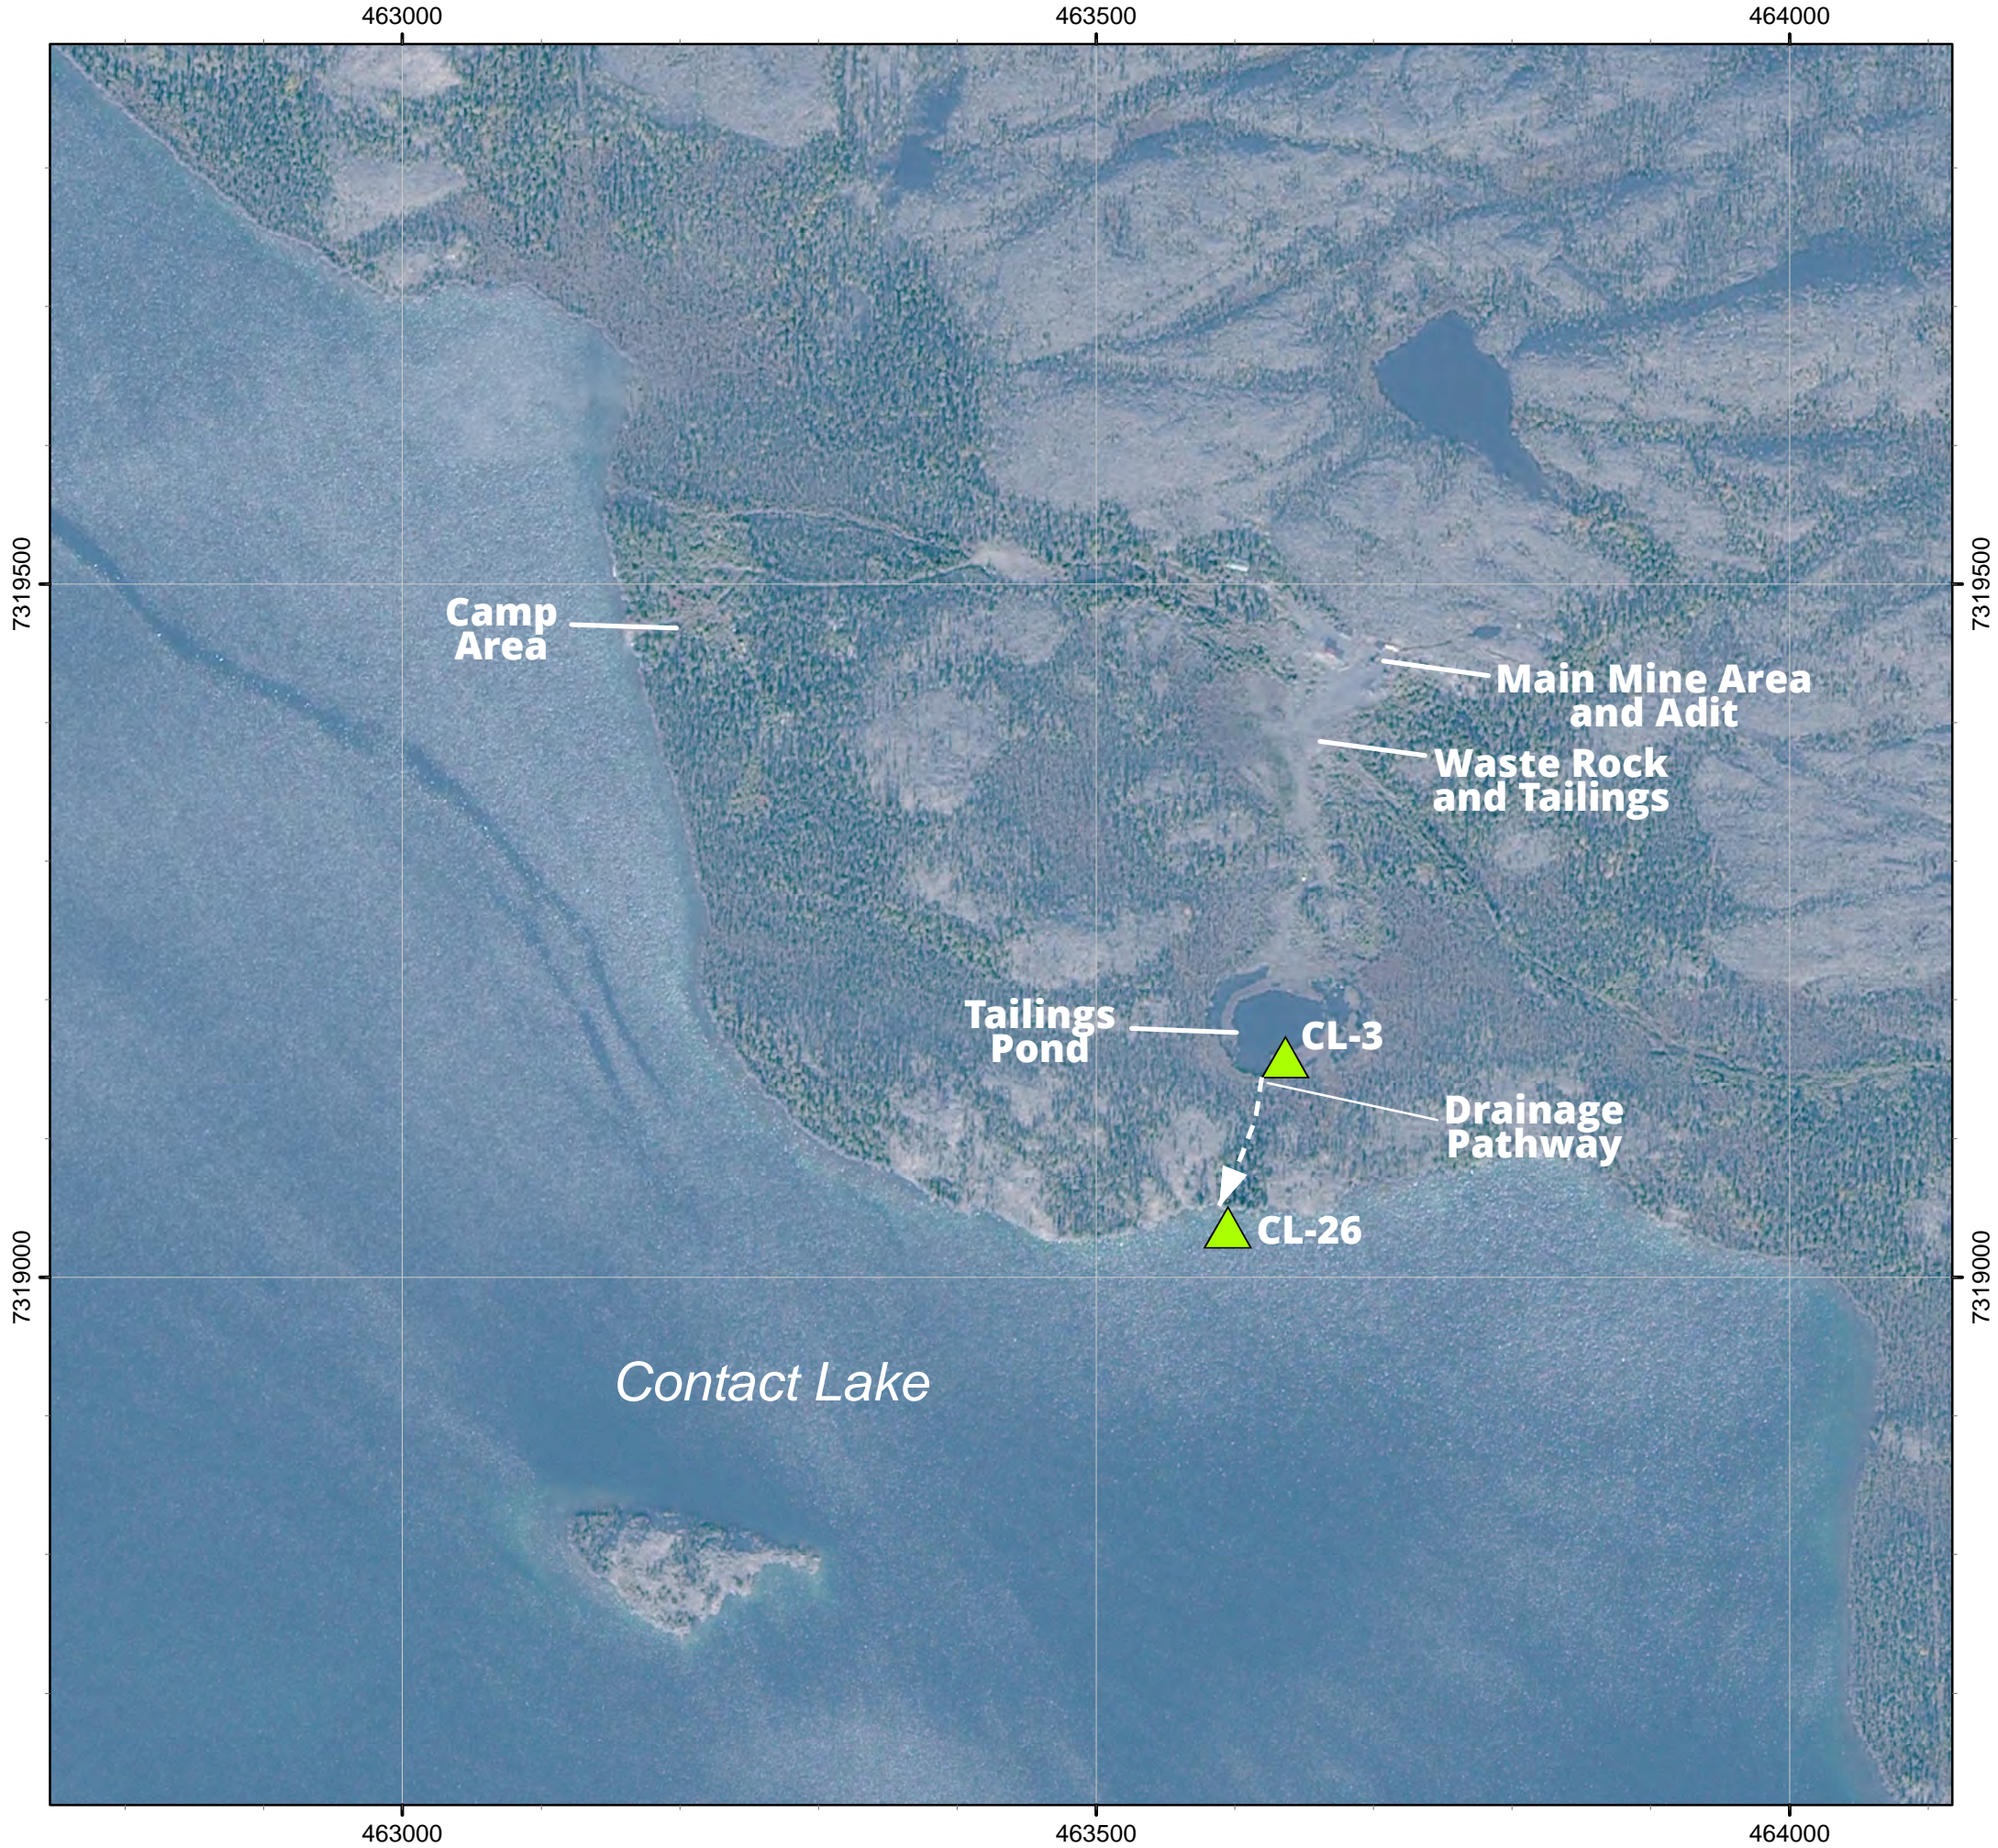
**Figure 4: Great Bear Lake  
Contact Lake Mine SNP Stations**  
Contaminated Sites and Remediation Division

Station Name	SNP Number	Latitude <sup>A</sup>	Longitude <sup>A</sup>
CL-3	S17L8-002 (12G)	65° 59' 27.18" N	117° 48' 3.00" W
CL-26	S17L8-002 (13H)	65° 59' 23.21" N	117° 48' 6.16"W

- Water Licence Description: Tailings Pond – Corresponding with established station CL-3
- Water Licence Location: Contact Lake Mine
- 2017 Sampling Rationale: Sampled once in 2017 (September) and SNP data provided in Appendix 1, Table A2. Complete dataset provided in Appendix C – 2017 Water Quality Monitoring Report.
- EQC Evaluation: No EQC for this station.
