## ***Great Bear Lake Sites – 2019 Annual Water Licence Report (Licence #S17L8-002)***

**Prepared for: Sahtu Land and Water Board**

**Date: March 31, 2020**

## *2019 Water Quality Monitoring Report*

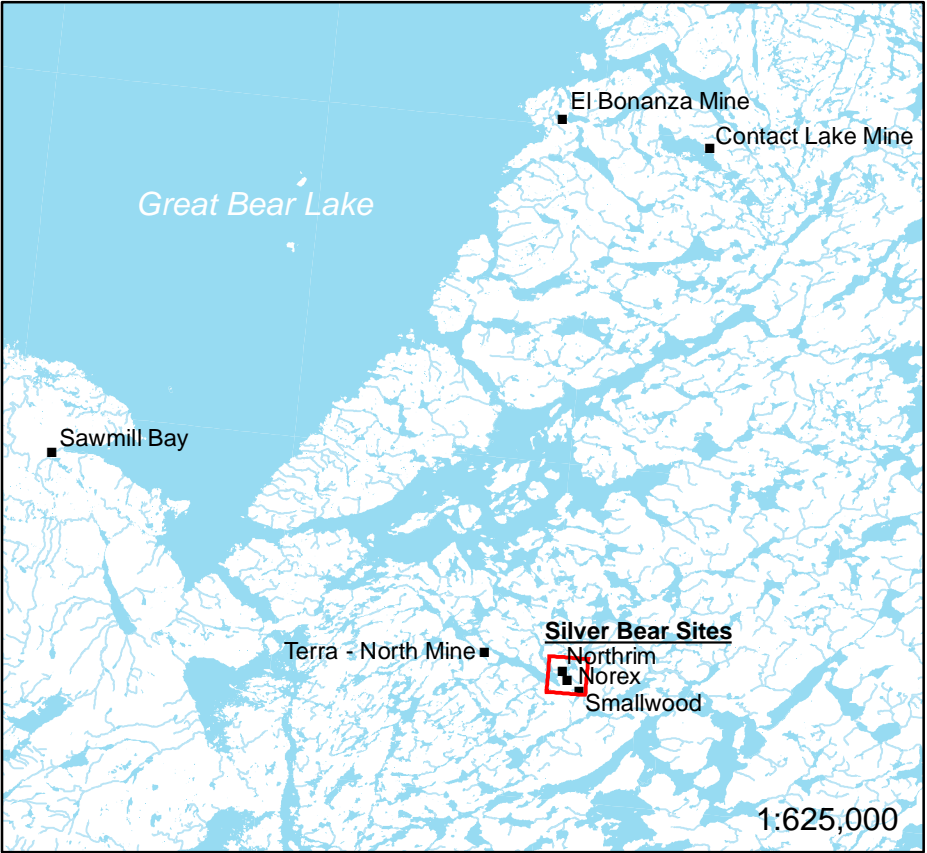
**Figure 3: Great Bear Lake**  
**Northrim & Norex Mine SNP Stations**  
Contaminated Sites and Remediation Division

Station Name	SNP Number	Latitude <sup>A</sup>	Longitude <sup>A</sup>
NO-7	S17L8-002 (8C)	65° 35' 51.25" N	117° 59' 3.80" W
NO-6	S17L8-002 (9D)	65° 35' 43.84" N	117° 58' 52.18" W
NX-3	S17L8-002 (10E)	65° 35' 22.20" N	117° 58' 6.00" W
NX-12	S17L8-002 (11F)	65° 35' 41.50" N	117° 58' 25.54" W

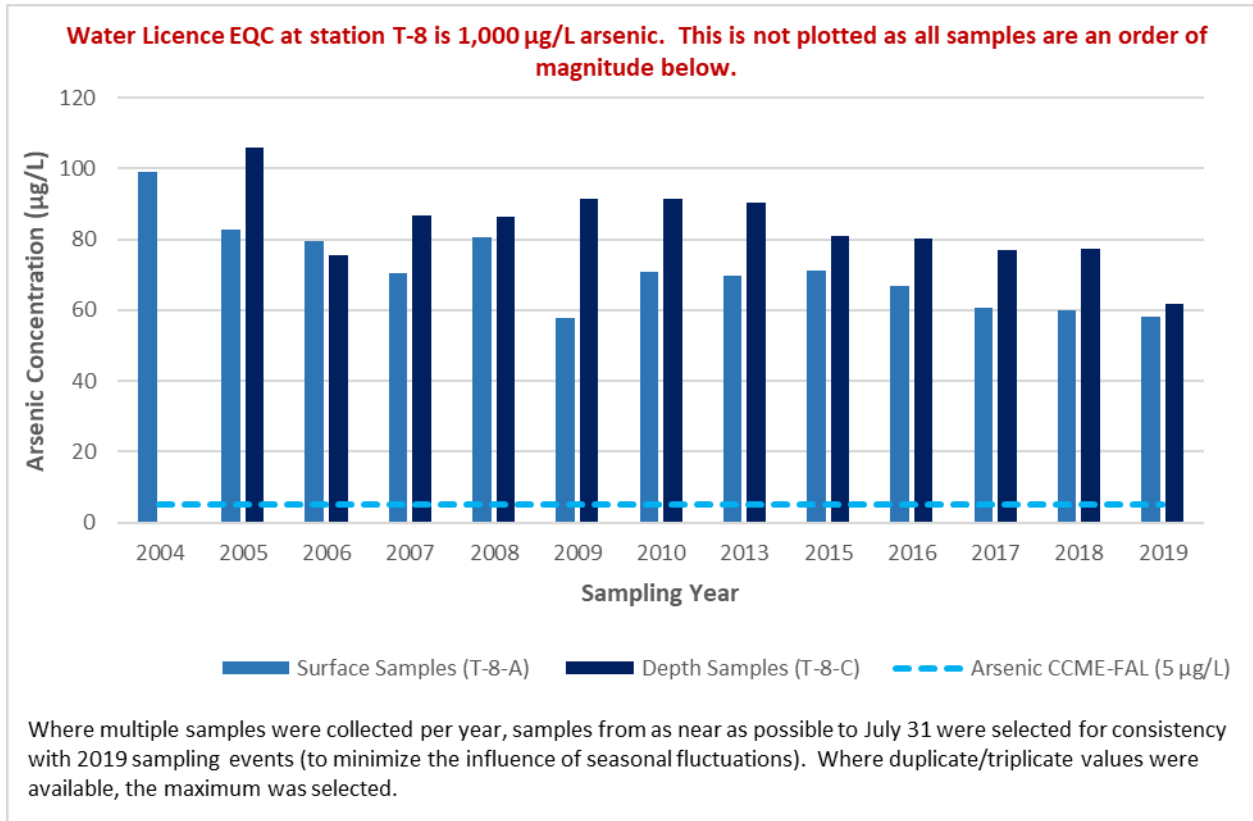
**Figure 1 Arsenic Concentrations in Ho Hum TCA (T-8)**

The 2019 samples from the Ho Hum TCA station T-8 exceeded arsenic and copper CCME-FAL guidelines at all depths sampled. No other metal parameters exceeded these guideline values. Multi-year plots have been provided below for surface and depth samples at station T-8, for both arsenic (Figure 1) and for copper (Figure 2).

Samples at station T-8 were collected at 1m, 5m and 13m depths, consistent with previous monitoring events. Arsenic concentrations were 58 µg/L, 58 µg/L and 61.9 µg/L respectively. As evidenced in Figure 1, arsenic concentrations at station T-8 were well below the Water

Licence EQC (1,000 µg/L), though above the CCME-FAL (5 µg/L). Depth samples (approximately 10-13 m below surface) are in all years higher in arsenic concentration than the corresponding surface sample. A general decrease in arsenic concentration is shown since sampling began at the station in 2004. As was documented in previous years, arsenic is found to be largely in the dissolved phase (Appendix B, Table B-2).

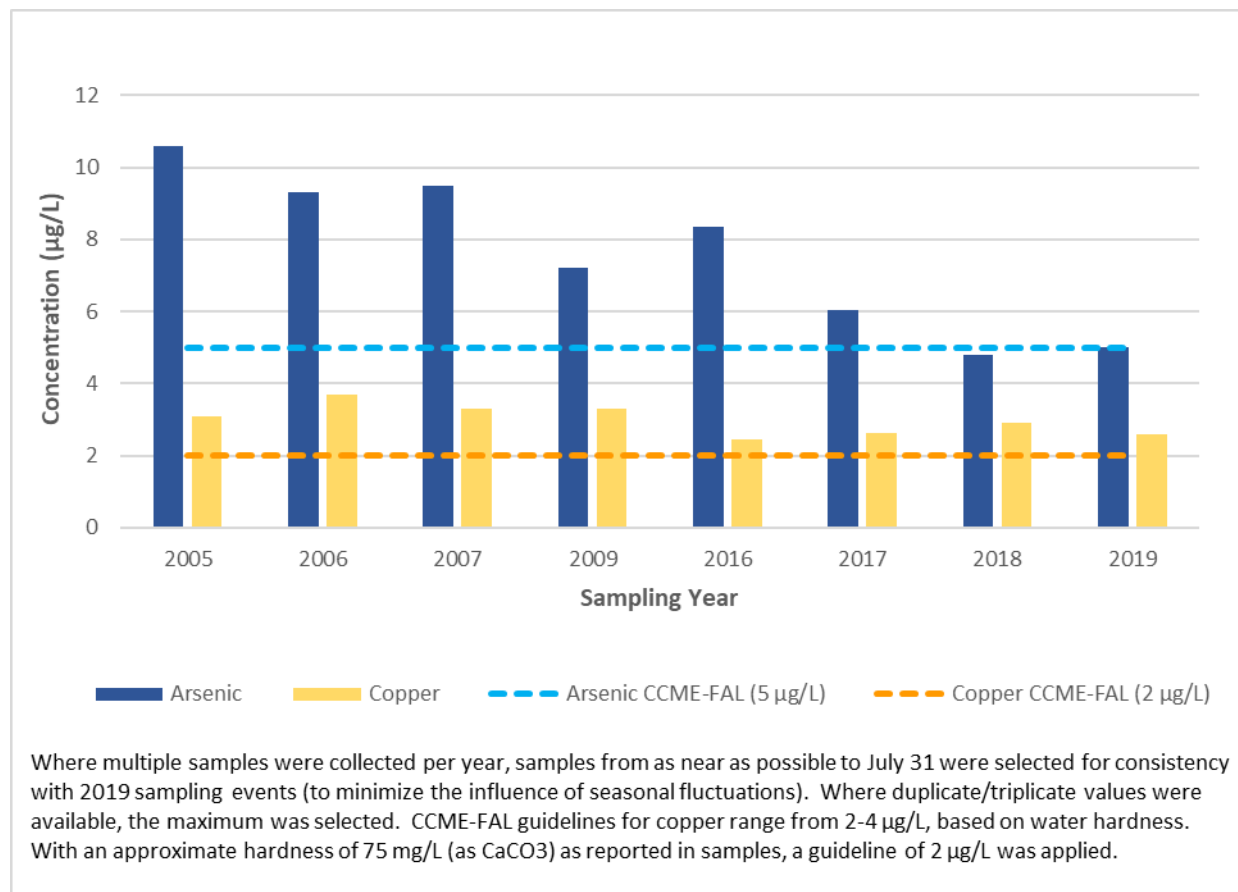
**Figure 3 Copper and Arsenic Concentrations in Hermandy Lake (NO-7)**

Copper concentrations in sample NO-7 (2.6 µg/L) from Hermandy Lake exceeded the CCME-FAL guideline for copper (2 µg/L), and arsenic concentrations (5 µg/L) equalled the CCME-FAL guideline. While the 2019 copper concentrations were similar to 2018, arsenic was slightly higher (CIRNAC-CARD 2019). To evaluate copper and arsenic trends, 2019 concentrations were plotted with the multi-year dataset (Figure 3). As demonstrated, both the 2019 arsenic and copper concentrations are within the range of normal from data collected at station NO-7.

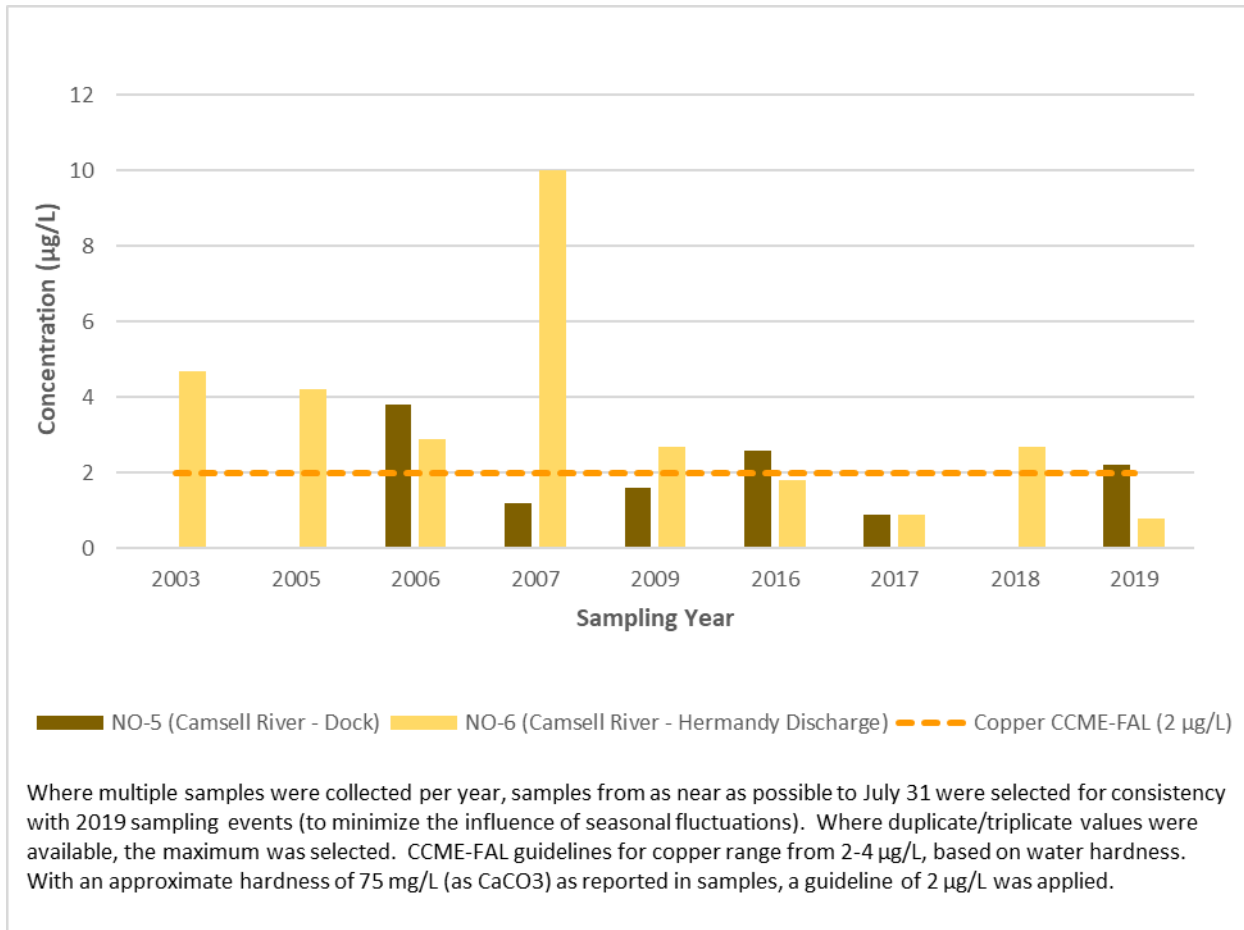
**Figure 4** Copper Concentrations in the Camsell River at Northrim Mine (NO-5, NO-6)

Three stations were assessed in the Camsell River at Northrim Mine. Station NO-6 (Hermandy Lake discharge point) as part of the routine PRMP, and responsive monitoring stations NO-5 (at the Camsell River dock) and NO-27 (mid-stream and downstream of Northrim Mine). All metal concentrations at the downstream station NO-27 were below CCME-FAL guidelines. While arsenic concentrations were equal to the CCME-FAL guideline of 5 µg/L in Hermandy Lake station NO-7, all arsenic concentrations in the Camsell River stations were below the CCME-FAL guideline. The 2018 copper concentrations at station NO-6 (2.69 µg/L) marginally

exceeded the copper guideline (2 µg/L); however, 2019 results (0.8 µg/L) were well below. In contrast, Responsive Monitoring station NO-5 was slightly elevated above the guideline (2.2 µg/L). The multi-year plot of copper concentrations at stations NO-5 and NO-6 are provided in Figure 4 below, which documents that 2019 findings are consistent with the historic dataset. As with other samples, copper was found to be primarily in the dissolved phase (Appendix B, Table B-2).

Increasing water levels observed during 2018 and 2019 sampling events have resulted in forced collection of the shoreline samples landward and away from the active flow of the Camsell River. This may be a potential cause of the elevated copper concentrations when compared with 2017 results. The 2017 sampling activities were conducted in September, during which water levels are commonly lower.

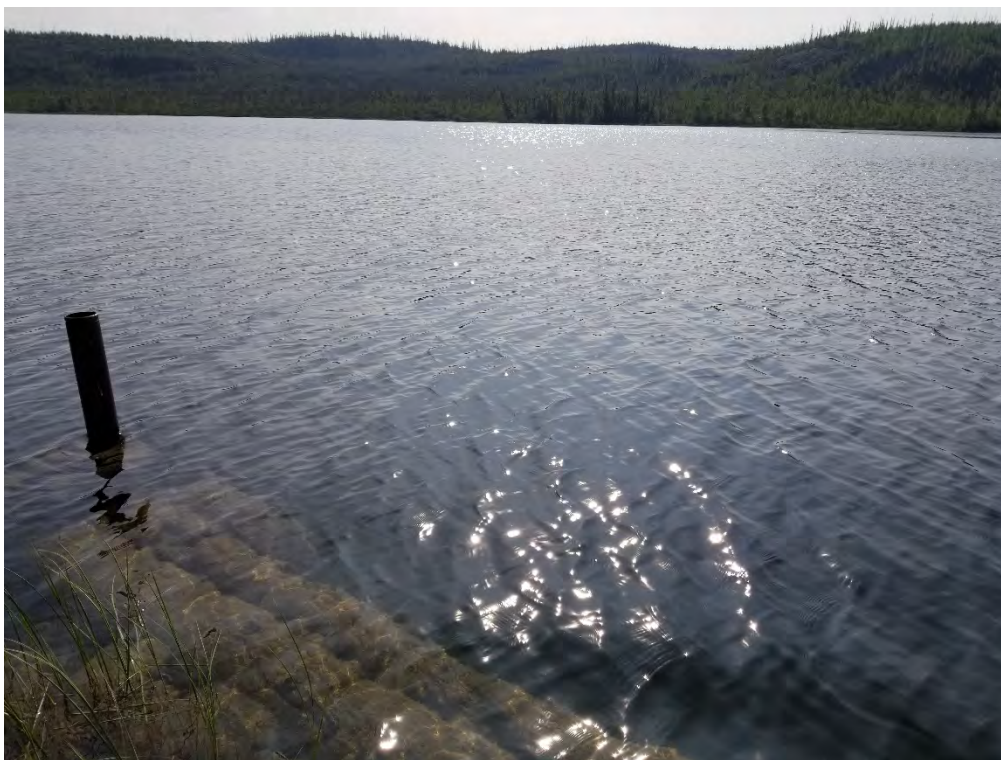
**Photo 7 Northrim Mine - Station NO-5:** Camsell River, at dock

During the 2019 field campaign the Camsell River water levels were significantly higher and topped the dock wall at the Northrim Mine. These water levels were higher than were observed in both 2017 (INAC-CARD 2018a) and 2018 (CIRNAC-CARD 2019).

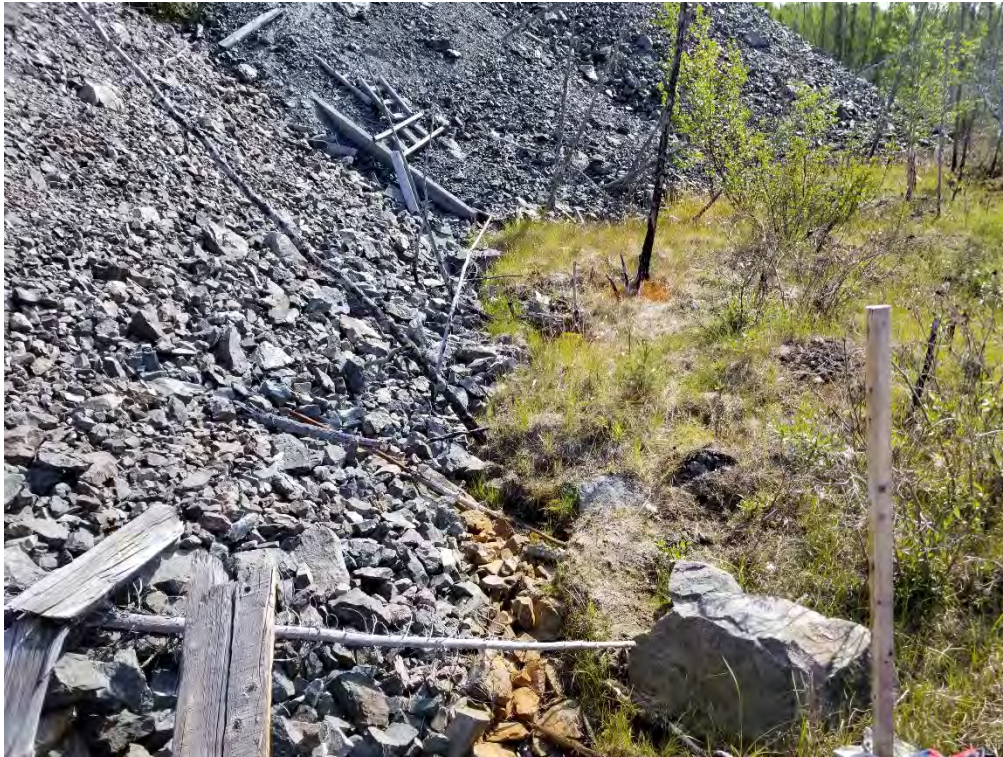
**Photo 9 Norex Mine – Station NX-3:** West seep of waste rock pile

Seepages emerging from the Norex Mine waste rock pile have been routinely monitored since 2002. The majority of seepage occurs on the northeast side of the pile and was found to have elevated levels of arsenic, cadmium, copper, lead and zinc. The source of most of this water is drainage from the main portal, which enters the waste rock pile soon after it emerges from the mine. From June through August 2006, the volume of mine drainage was estimated to vary from 30 to 60 litres per minute, with the lower flow rate occurring later in the year. Significant geochemical changes are reported as the adit water flows through the waste rock pile. Iron, manganese and arsenic concentrations reduce, while concentrations of zinc and to a lesser extent copper, cobalt and lead, increase. The concentration of these metals was found not to have a material effect on the downstream Camsell River (SENES/SRK 2008).
