Report: 2010 Completion Report for Great Bear Lake Sites – Phase I Remediation

Great Bear Lake Sites - Phase I Remediation

Sawmill Bay, Contact Lake,
El Bonanza, Bonanza, NWT

Indian and Northern Affairs
Canada

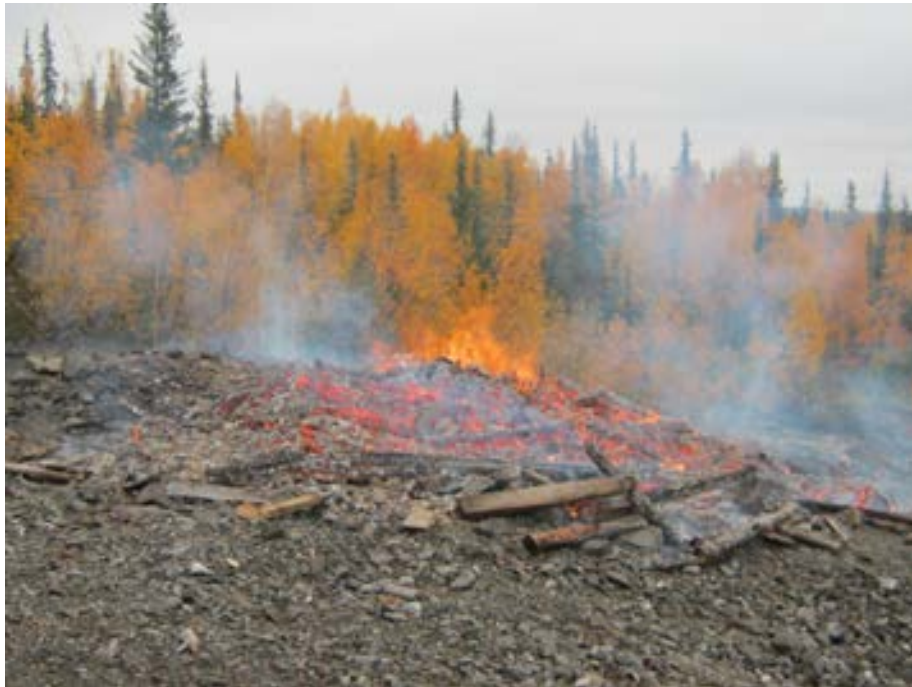
Photo 5: Window sills and door frames removed from Cabin 1, Contact Lake ↑

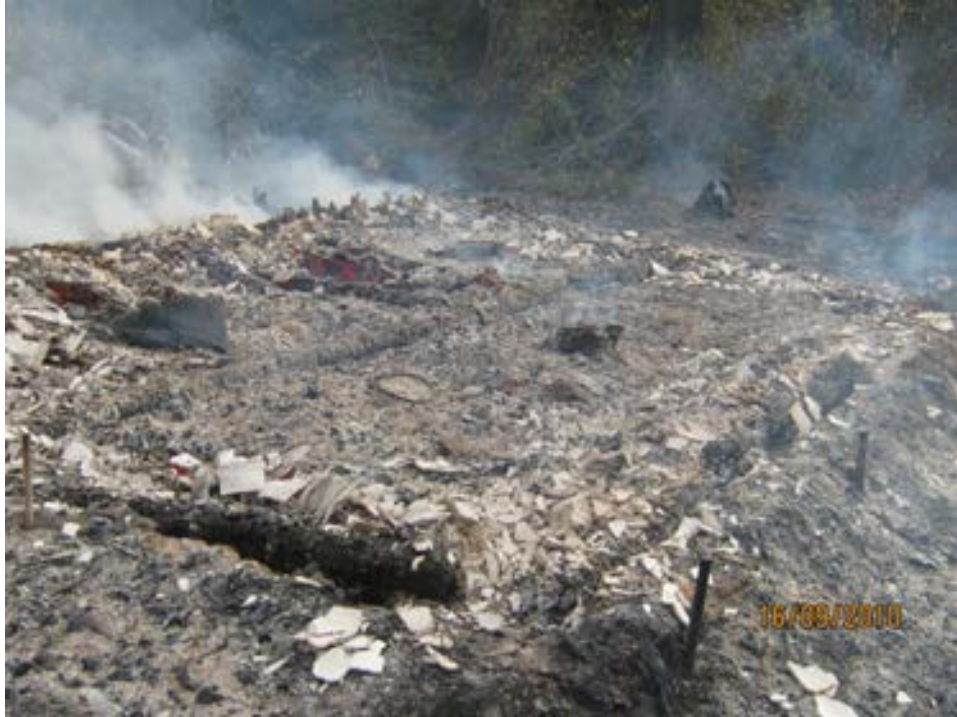
Photo 6: Contact Lake controlled burn ↑

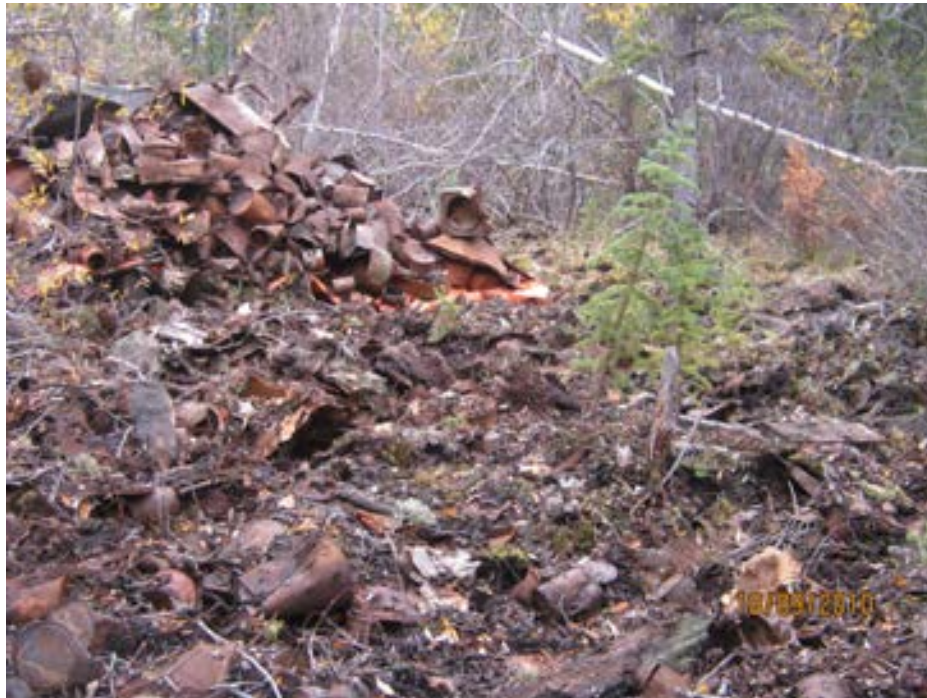
Photo 7: Typical burn nearing the conclusion, Contact Lake ↑

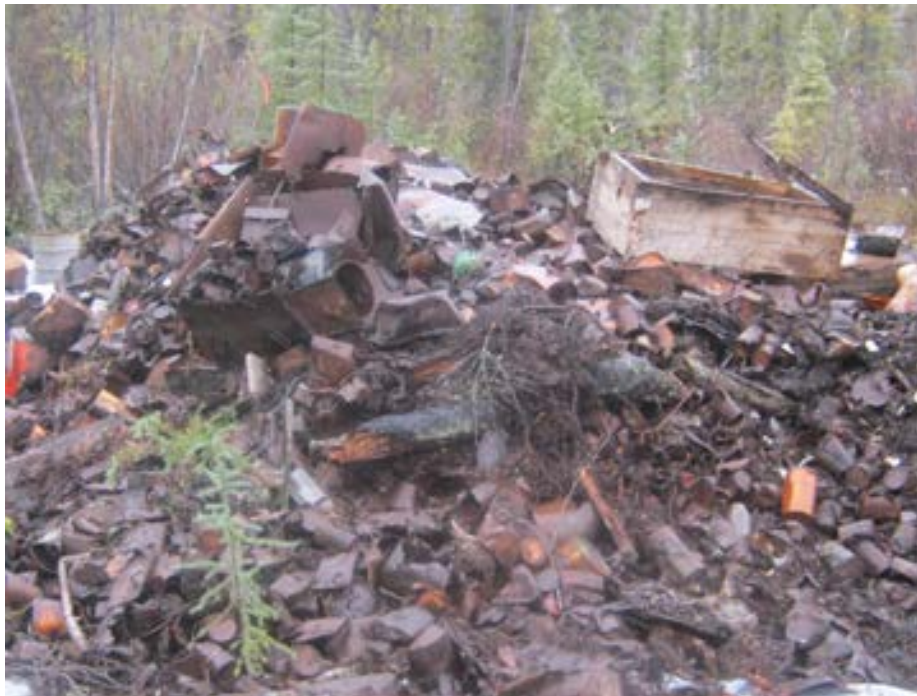
Photo 9: CL-DA-1, surface debris removal in progress ↑

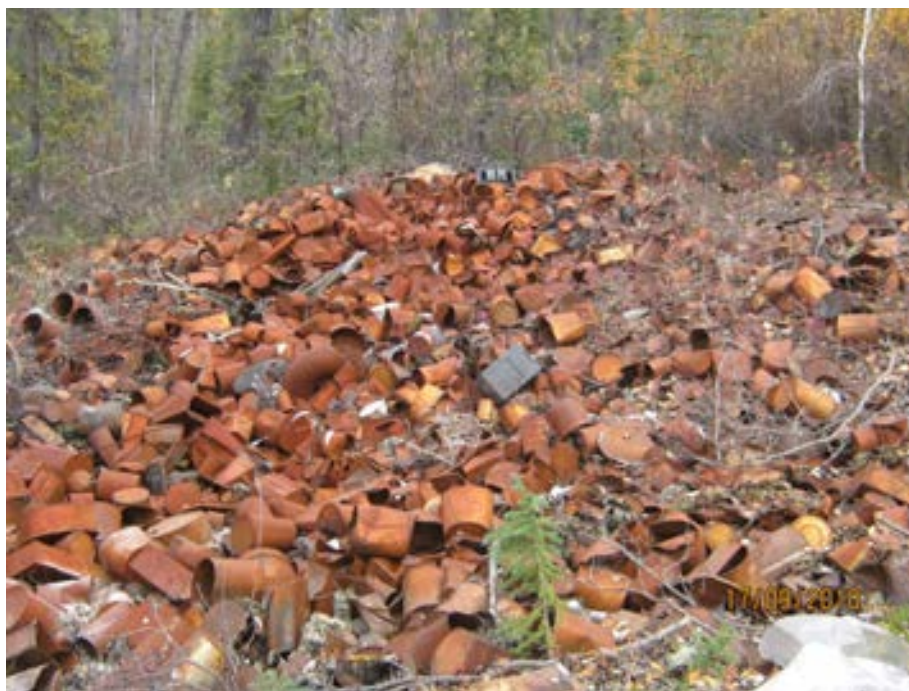
Photo 10: Non-hazardous debris stockpile (NHDS) adjacent to CL-DA-1 ↑

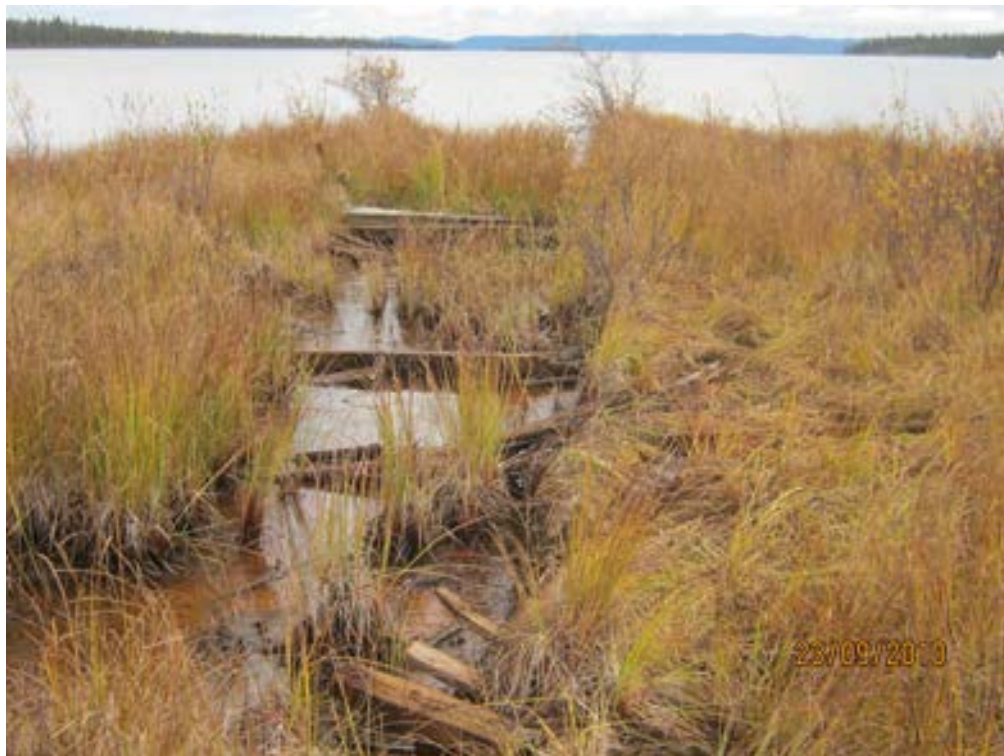
Photo 41: Pipe extending into the lake at SA-DA-19, Sawmill Bay ↑

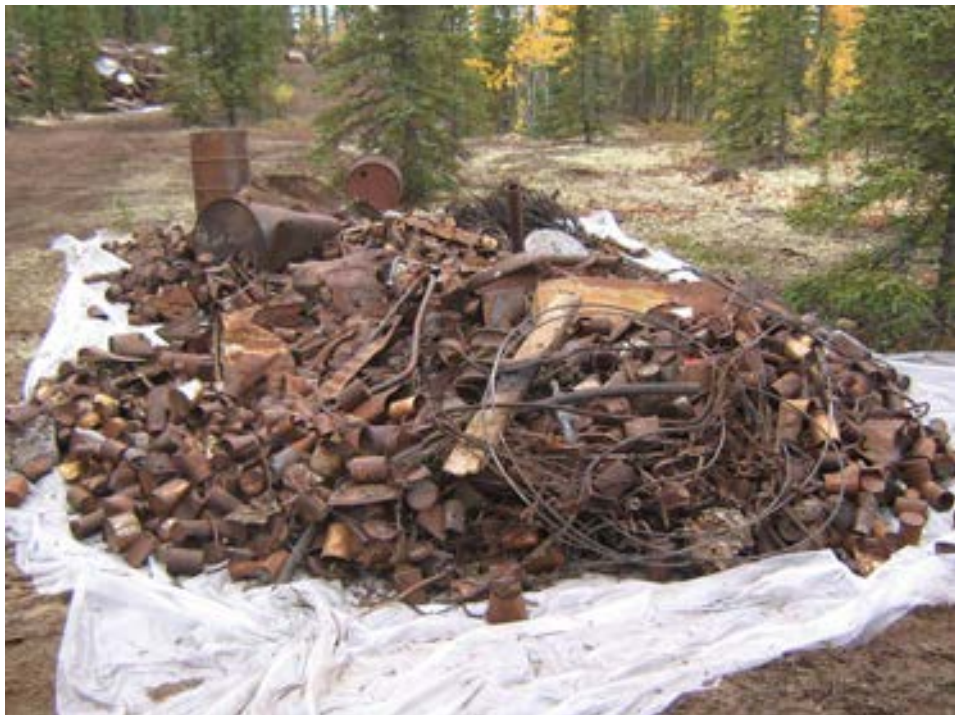
Photo 51: Sawmill Bay, non-hazardous debris stockpile, SB-NHDS-1 ↑

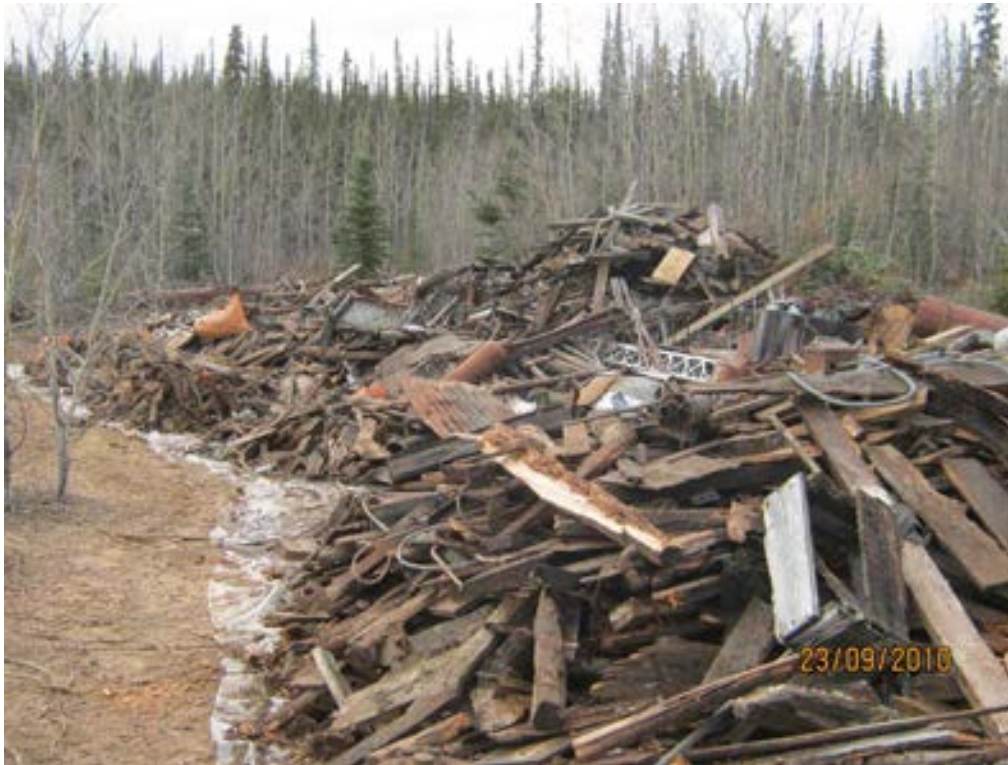
Photo 52: Sawmill Bay, non-hazardous debris stockpile, SB-NHDS-2, near the dock area ↑

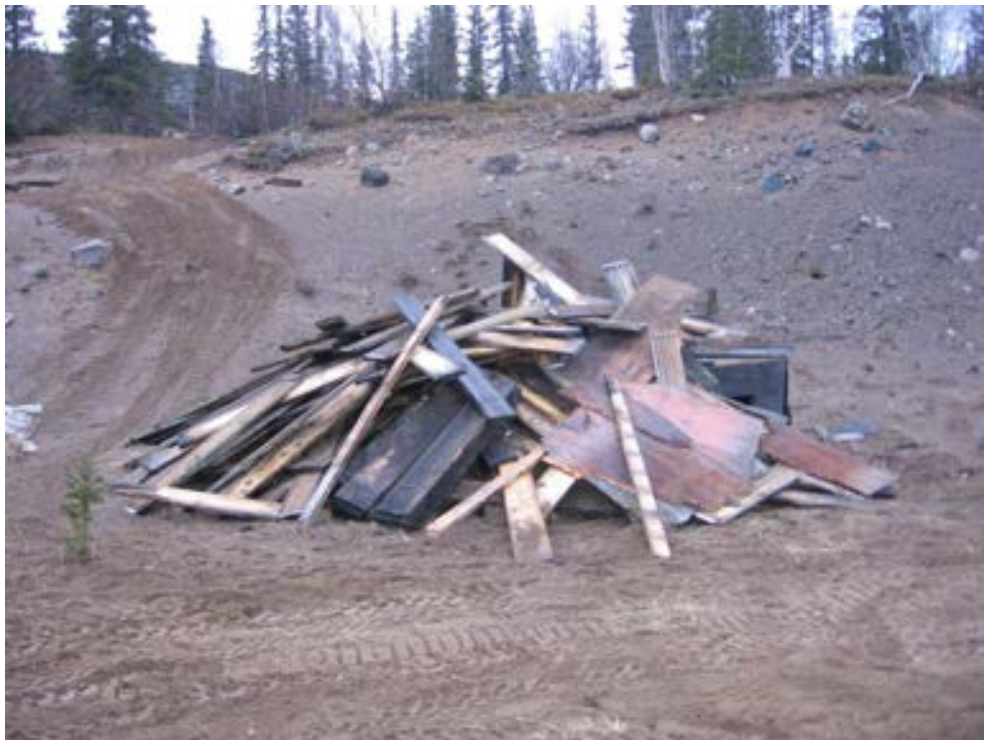
Photo 23: EB-DA-4 before debris removal ↑

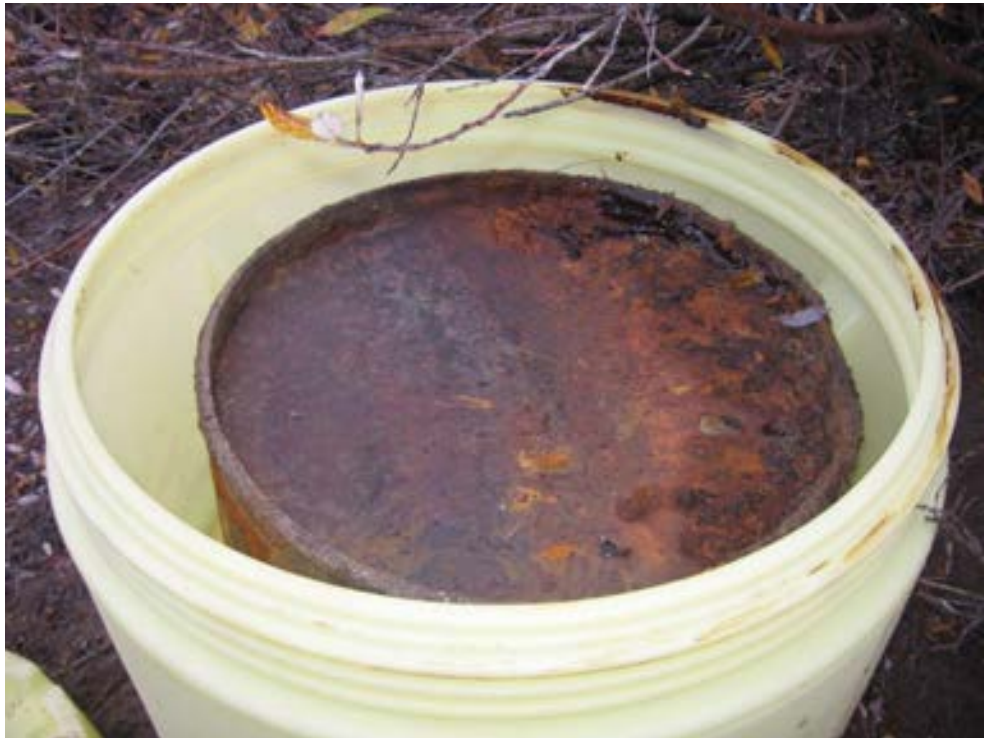
Photo 27: Drum stockpile near NHDS 2 ↑

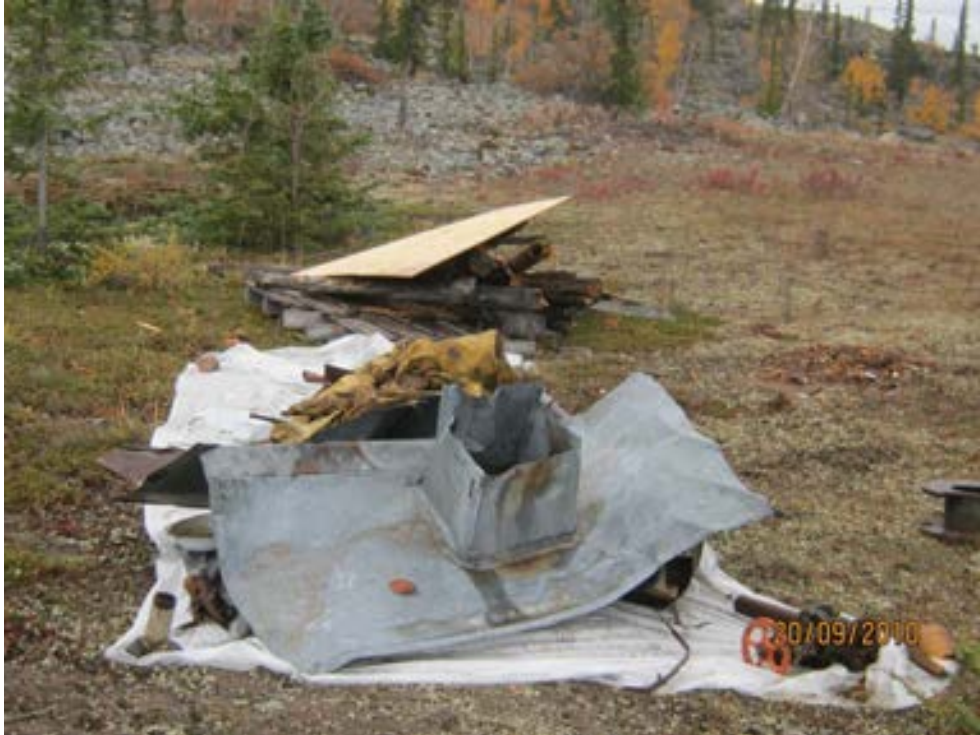
Photo 35: El Bonanza airstrip tanks EC00000950-3 and 4 ↑

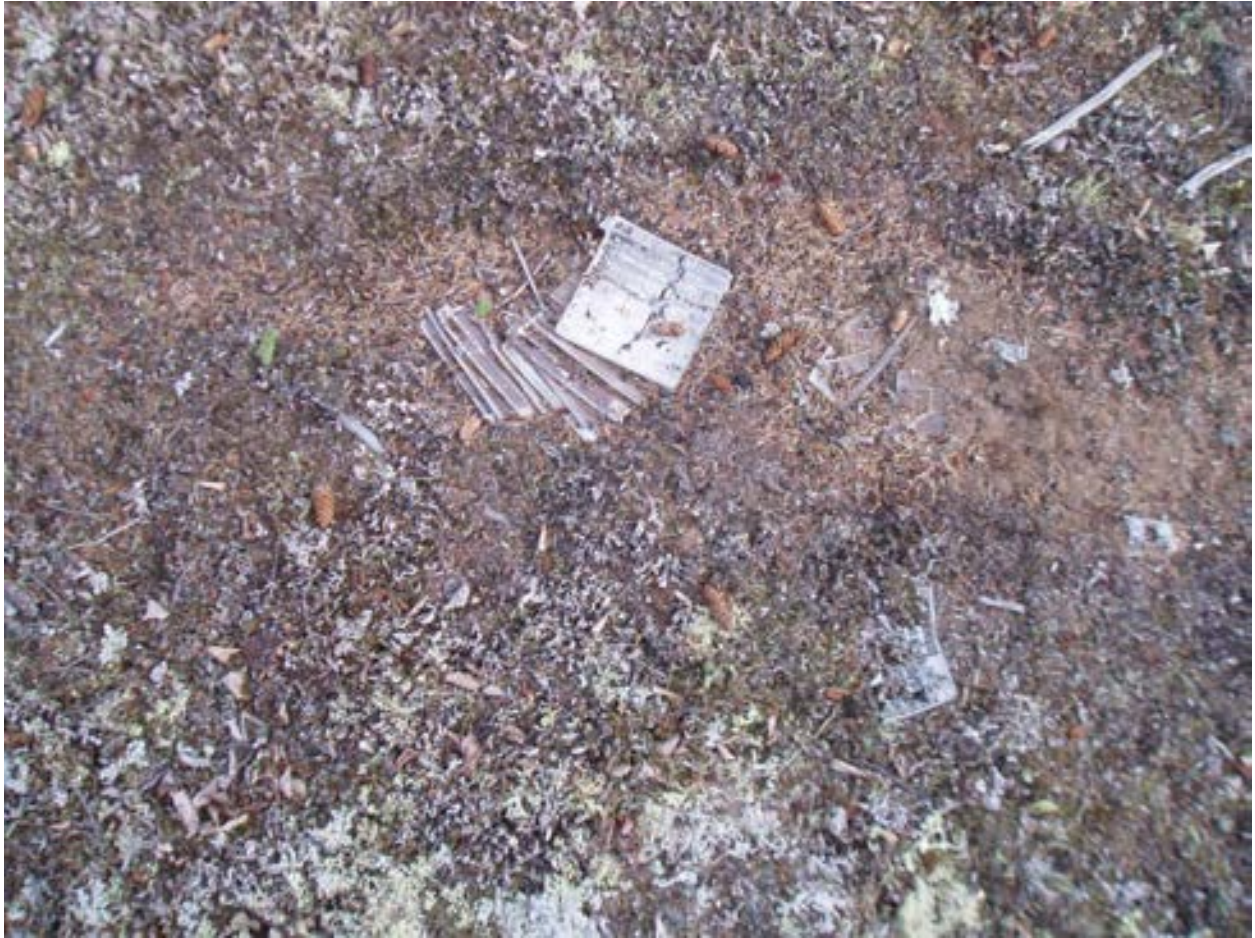
Broken battery found near to main drum cache on the south side of the bay.

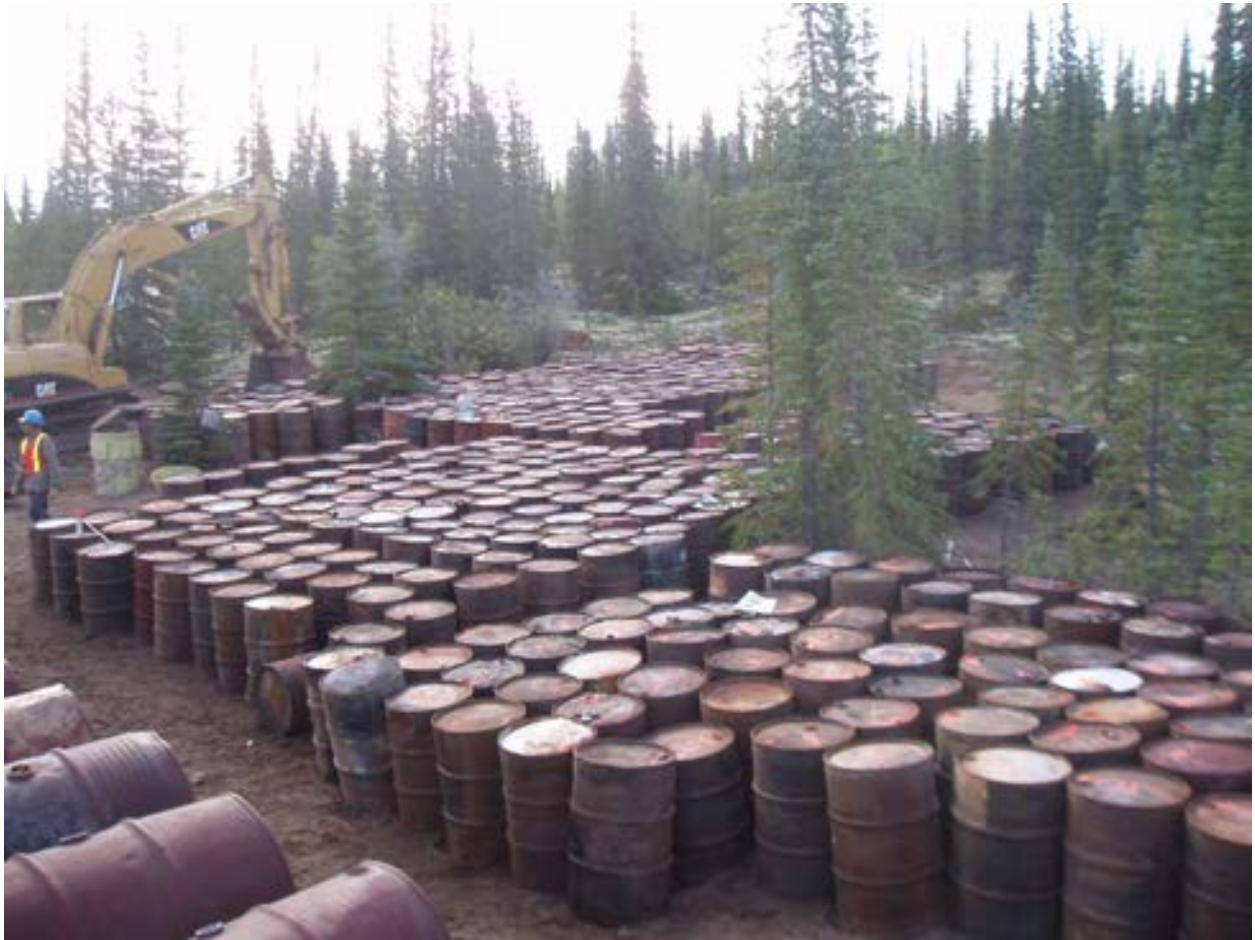
The stock pile of drums containing liquid and or sludge.

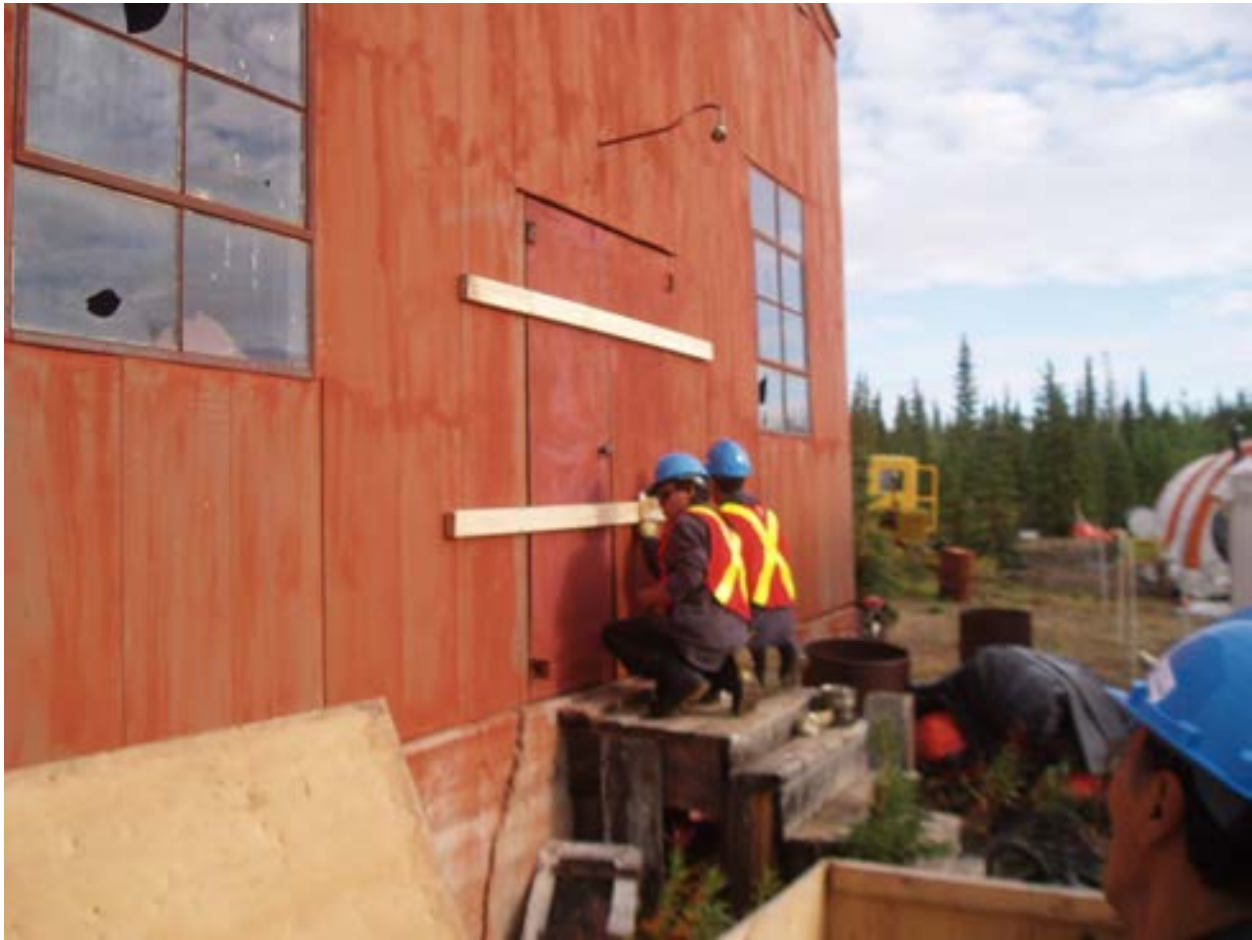
Closure of the main door of the Power House, the door is also latched on the inside. The two doors at the north side are sealed in the same fashion.

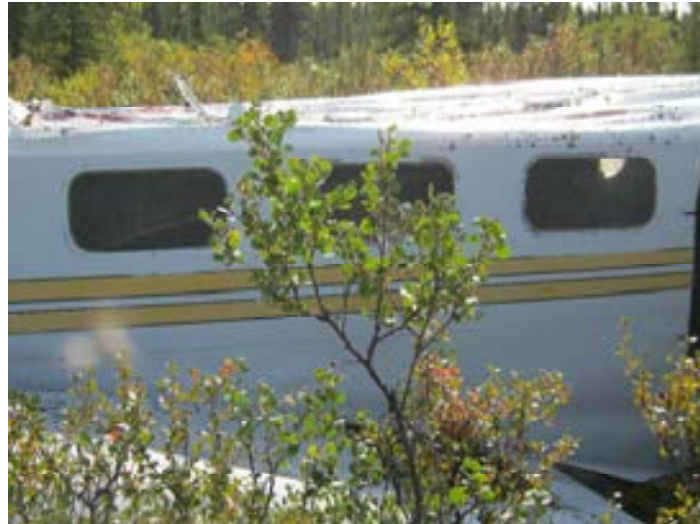
The plane fuselage is in the contract to remove. There is suspected asbestos containing material around the fuel line.

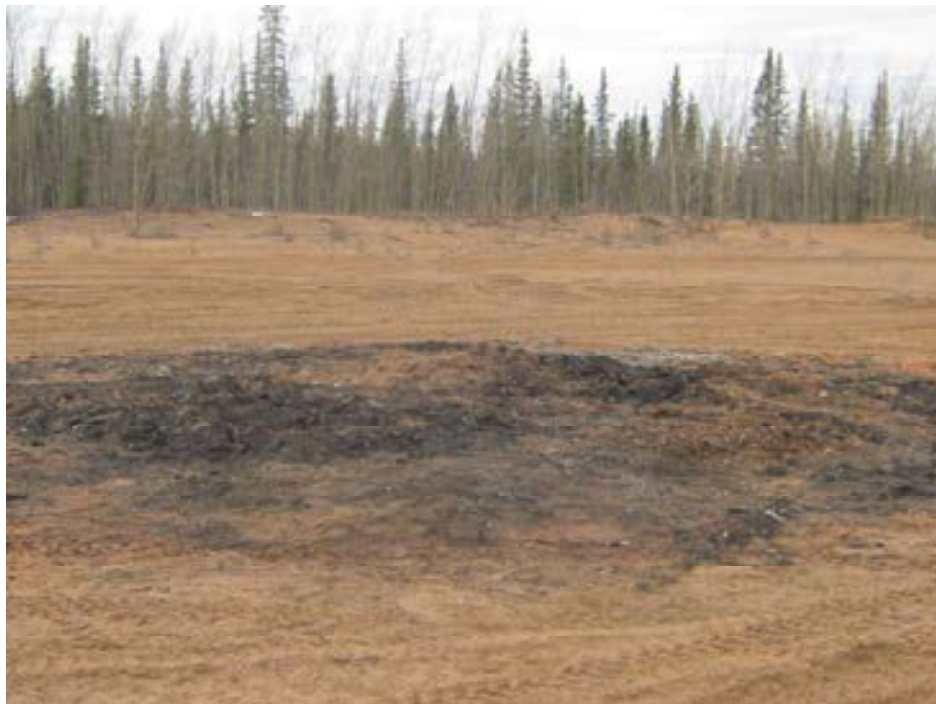
Airstrip Burn location, sample SB-AA

Burn Location	Sample Identity	Exceedances
Airstrip	SB-AA	Lead, zinc
Camp Gully	SB-CGA	Boron, hexavalent chromium, antimony, barium, copper, lead, zinc

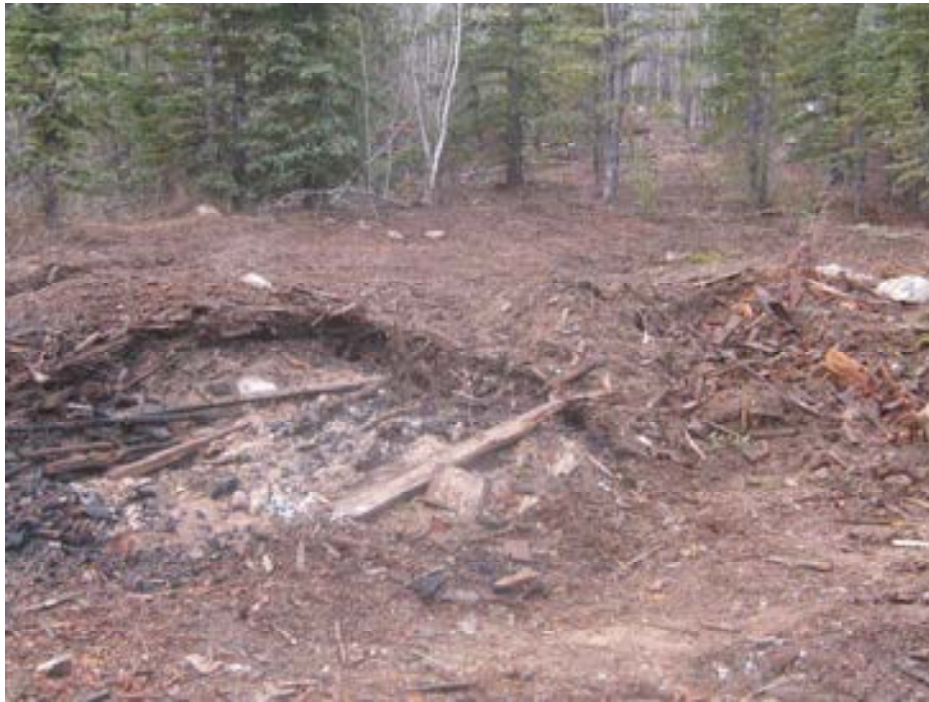
Camp Gully Burn, sample SB-CGA

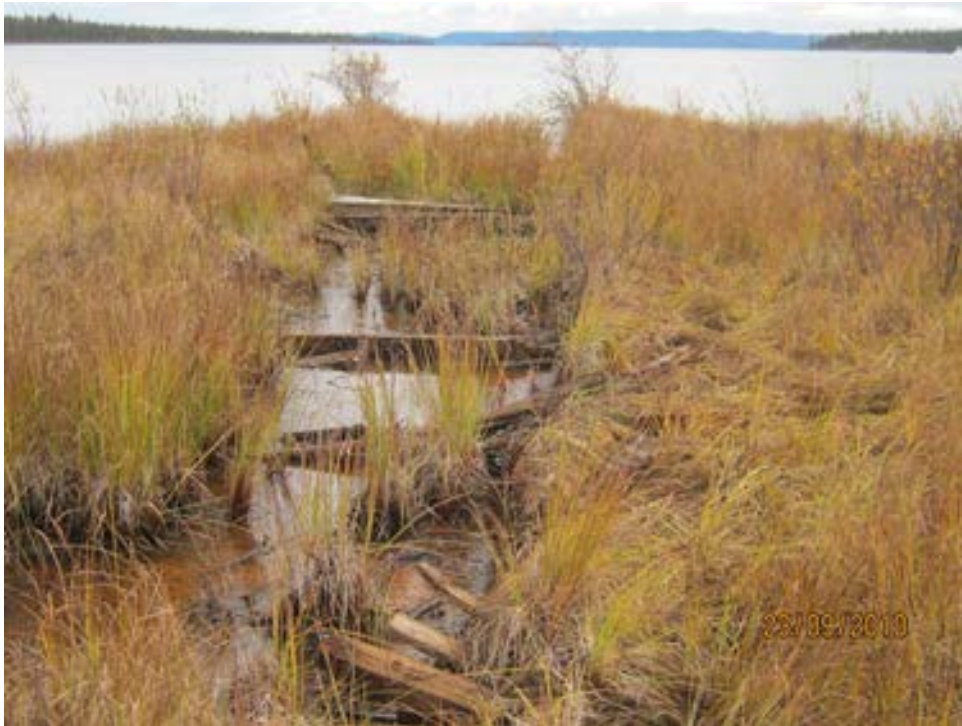
SA-DA-19, loose wooden debris collected, dock remains

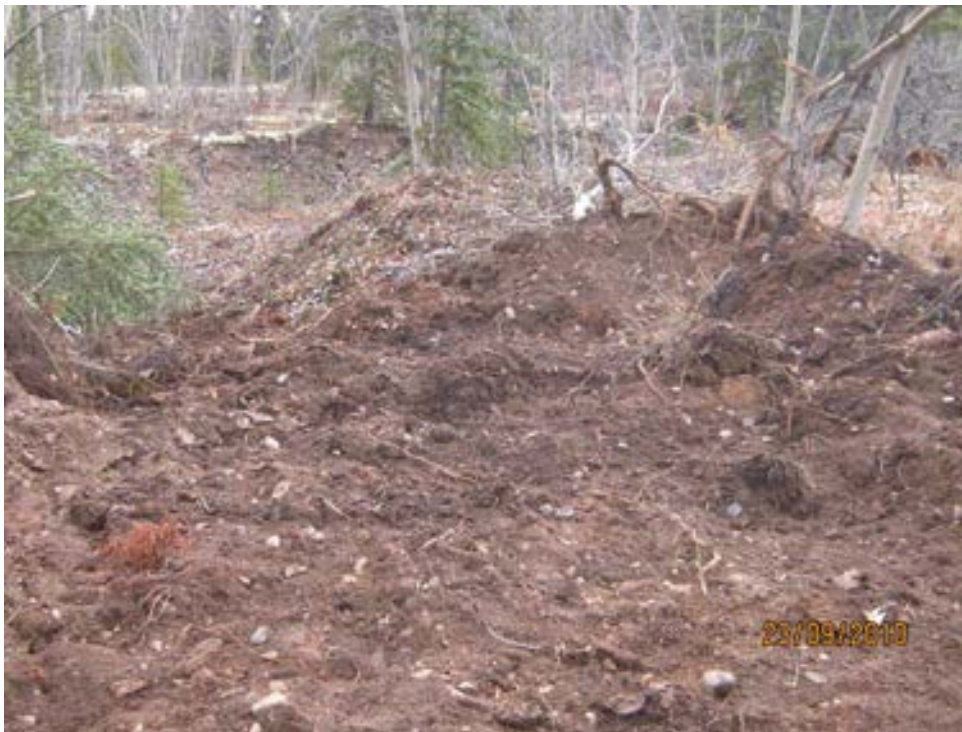
SA-DA-23 after surface debris collection

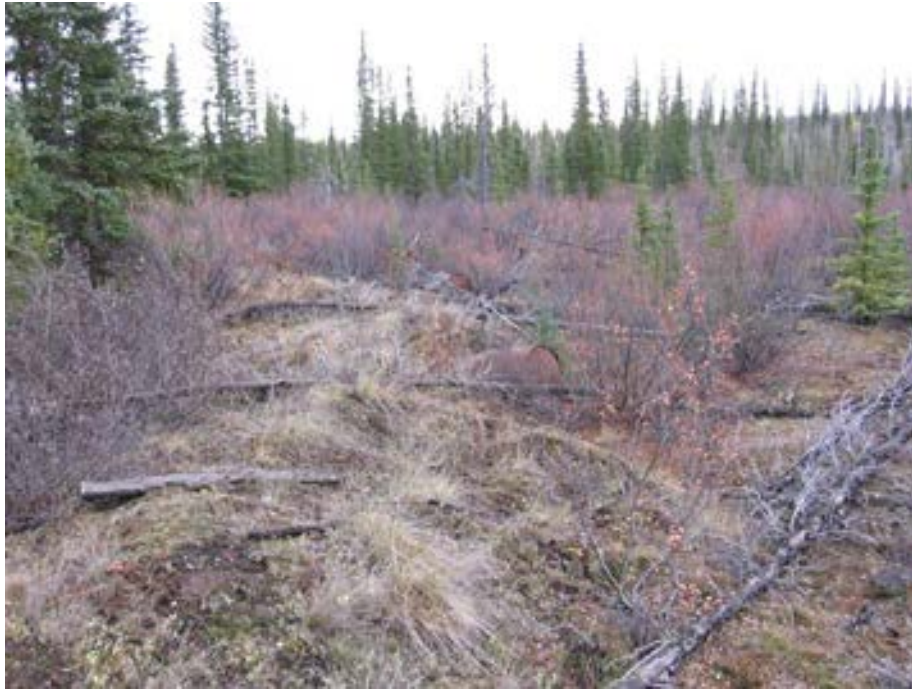
Drums found at SA-DA-7 were removed

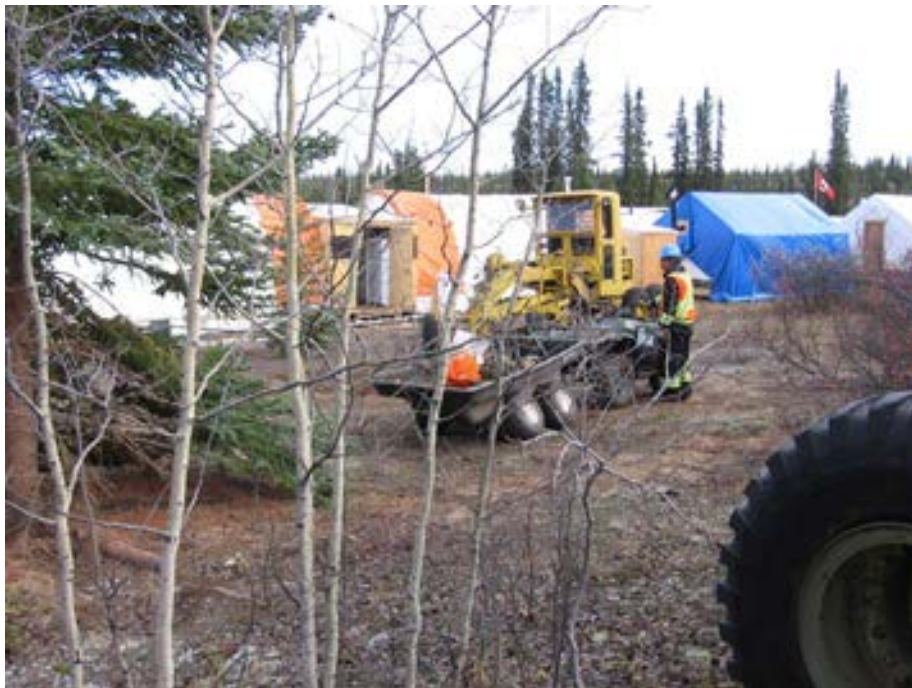
Debris removal at SA-DA-12

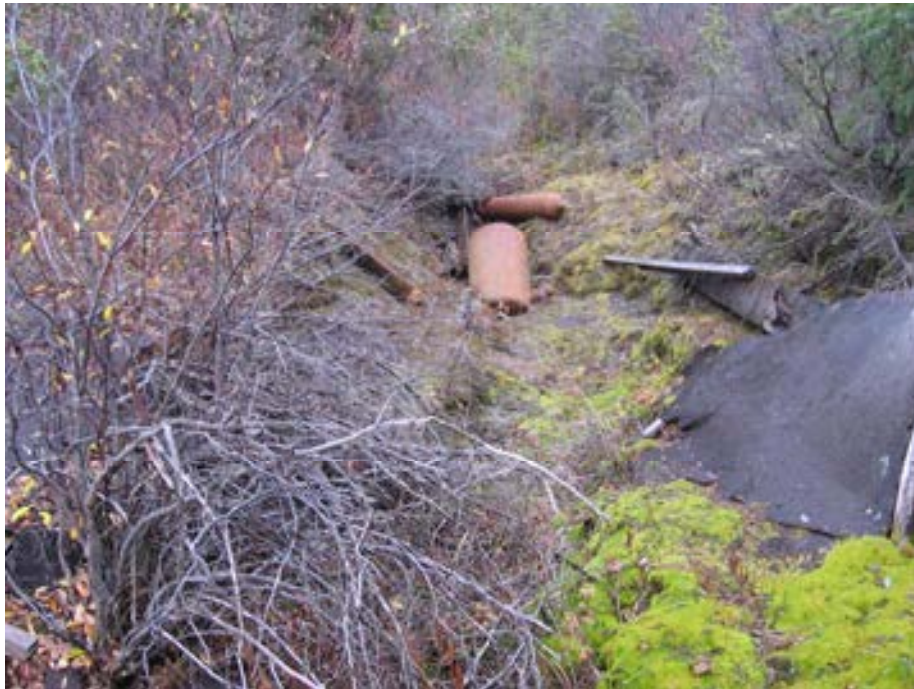
Additional debris found at SA-DA-12

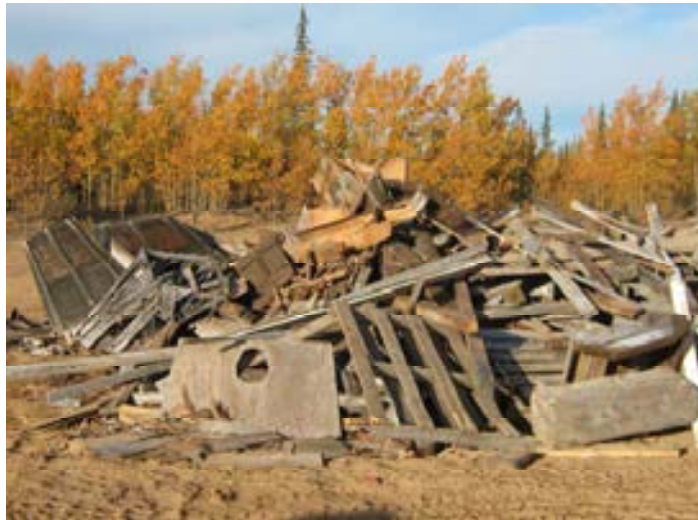
Burnable wood pile. Measurement to be calculated prior to burning

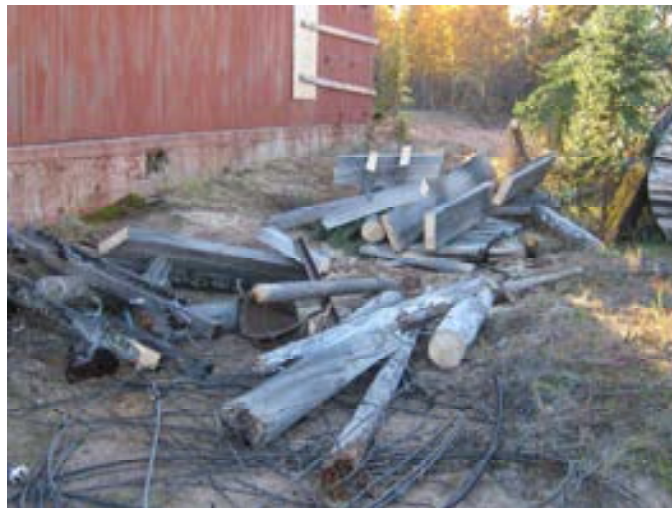
Debris adjacent to the power house. Chainsaw used to facilitate hauling.

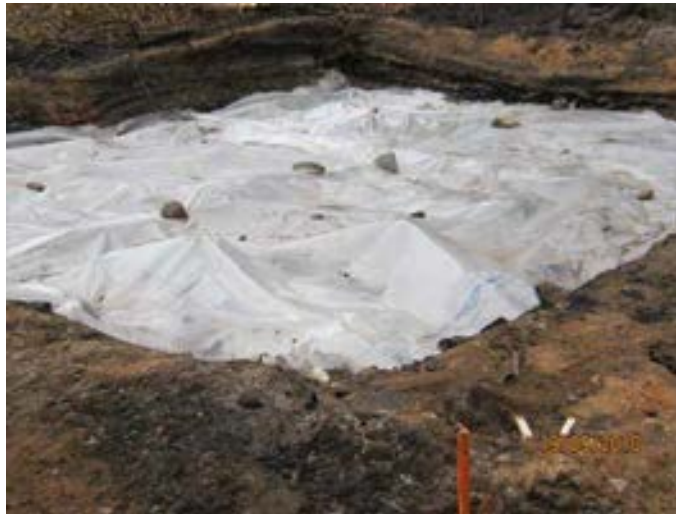
Poly liner above ash

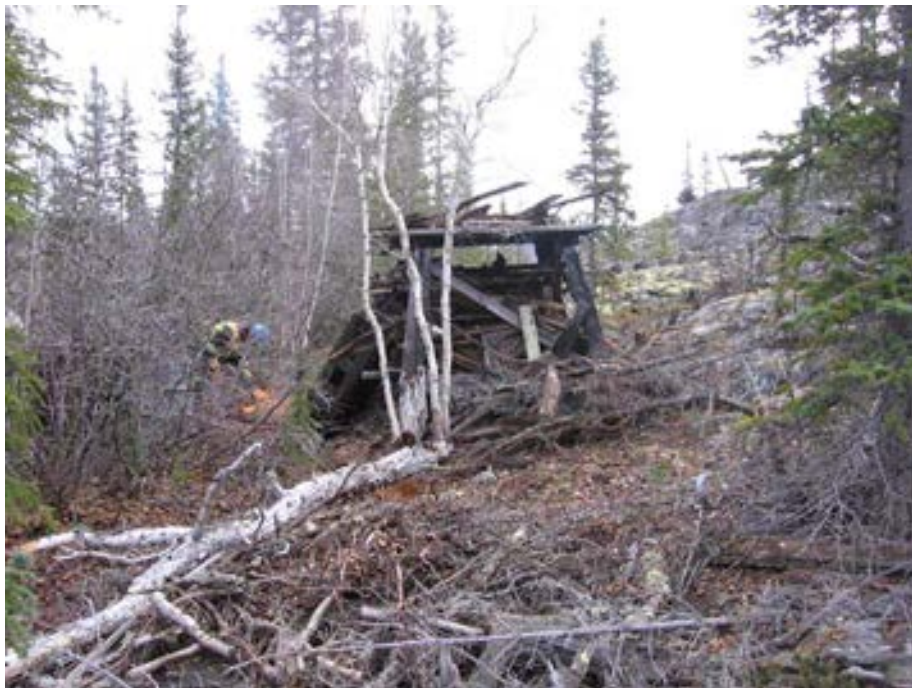
Burn pile at Bonanza's old fuel cache site

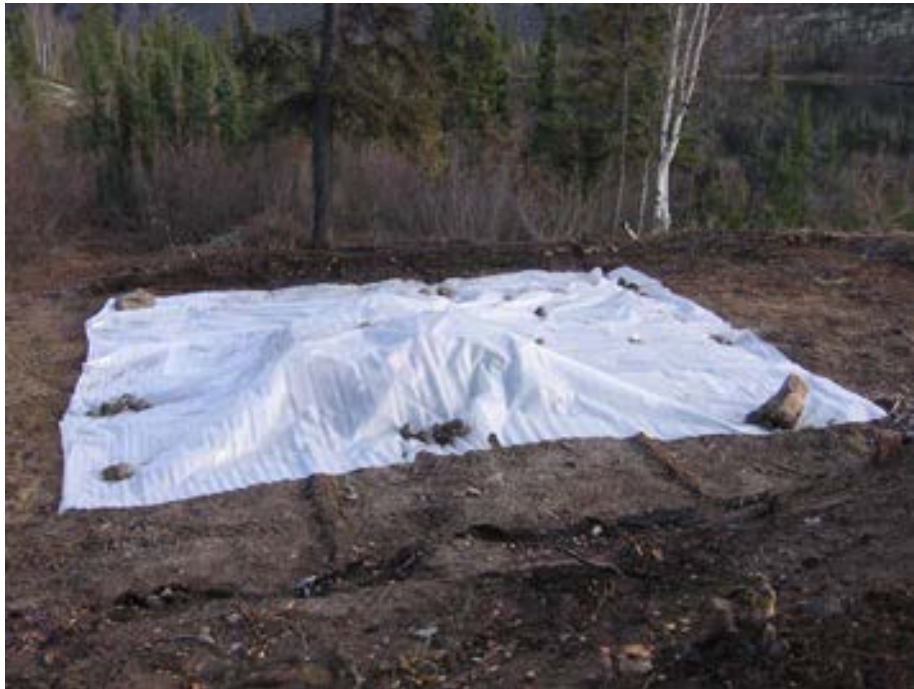
Ash pile raked and covered at old Building 13 at El Bonanza

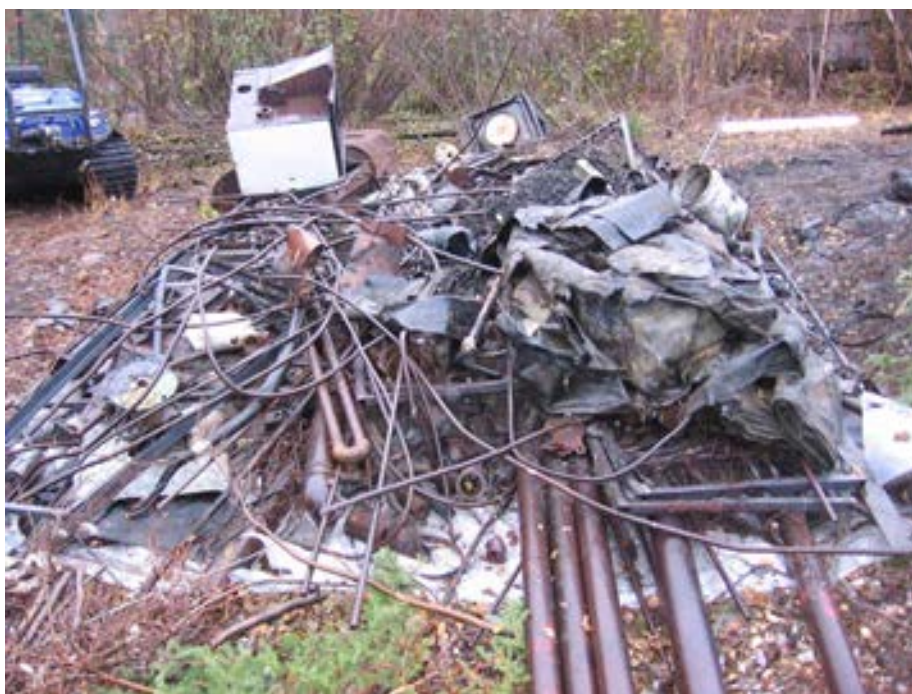
Non-hazardous debris pile at EB-DA-2

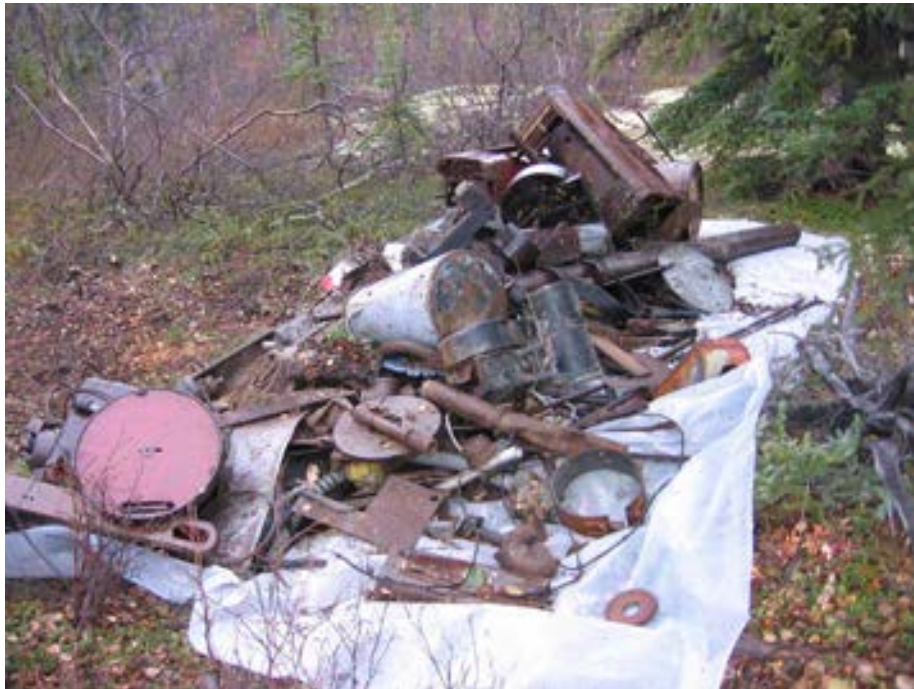
Non-hazardous debris pile at EB-DA-3

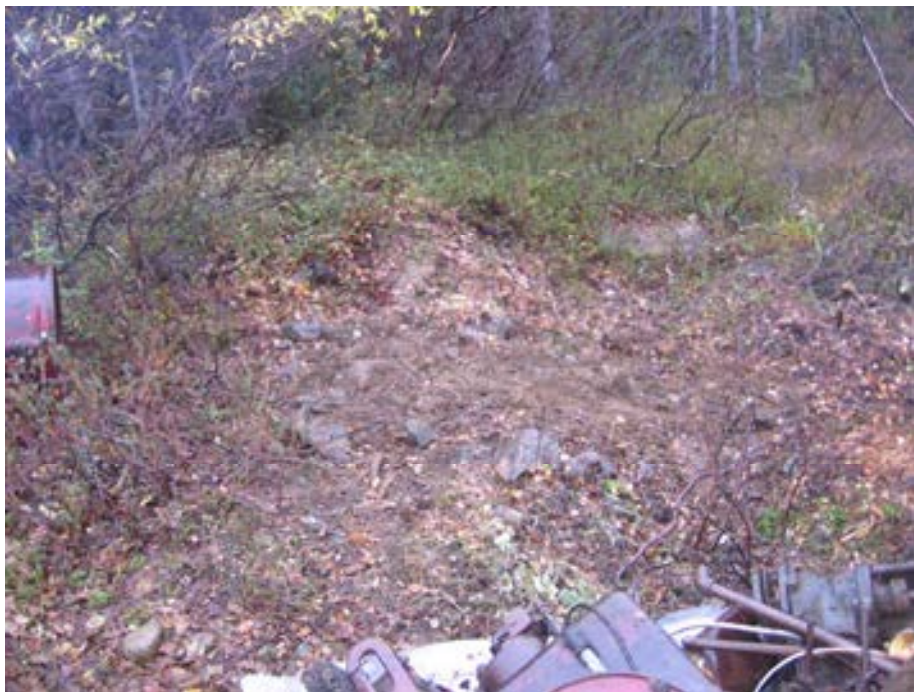
Clean debris area at EB-DA-3

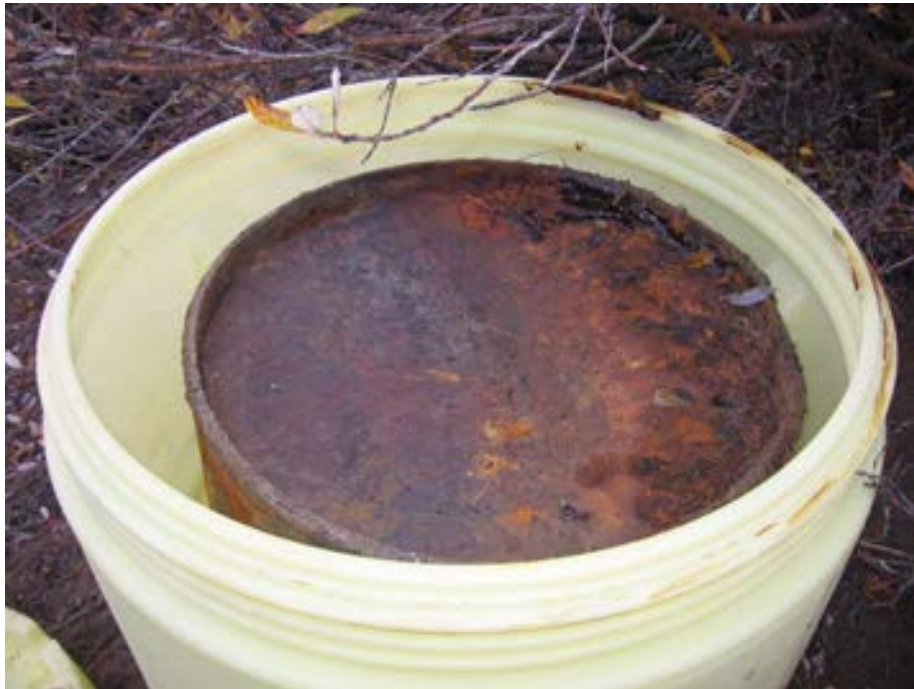
Leaking barrel placed in overpack

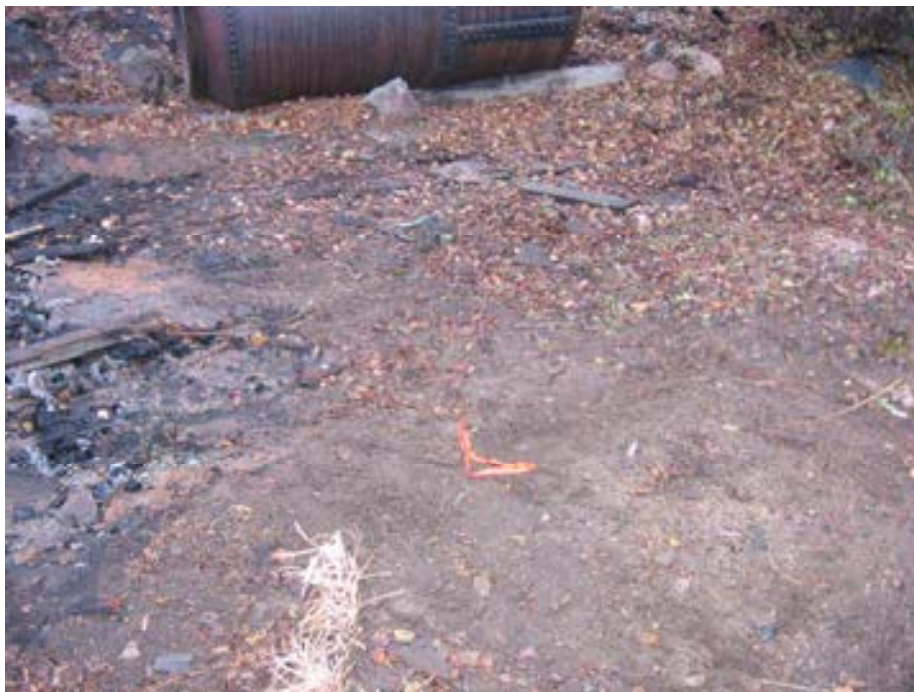
Pin marking location of PCB transformer

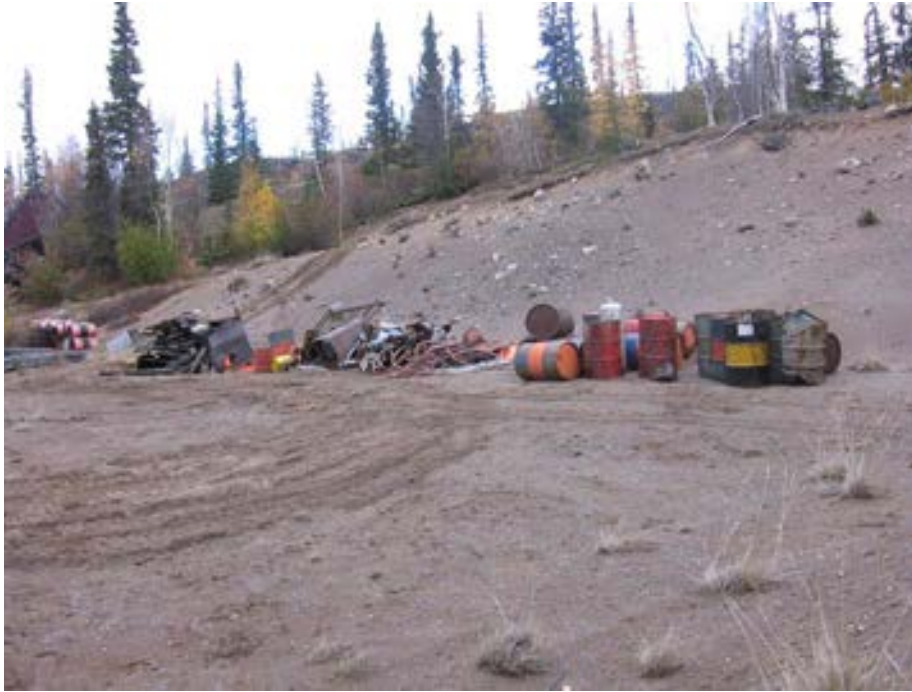
Non hazardous debris and drums at EB-DA-4
