Report: 2010 Completion Report for Great Bear Lake Sites – Phase I Remediation

Great Bear Lake Sites - Phase I Remediation

Sawmill Bay, Contact Lake,
El Bonanza, Bonanza, NWT

Indian and Northern Affairs
Canada

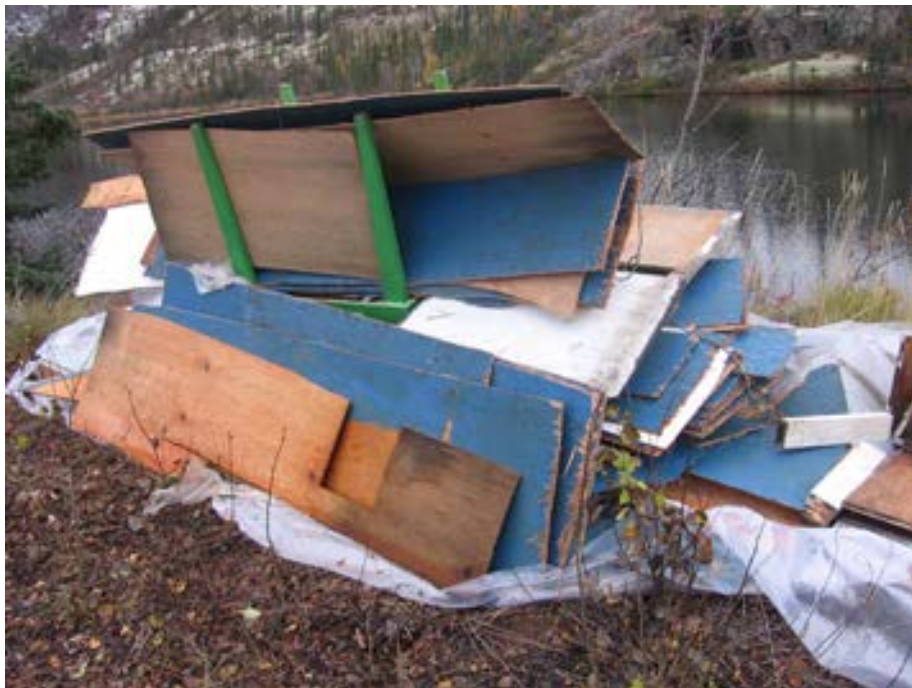
Hazardous debris pile near building 13

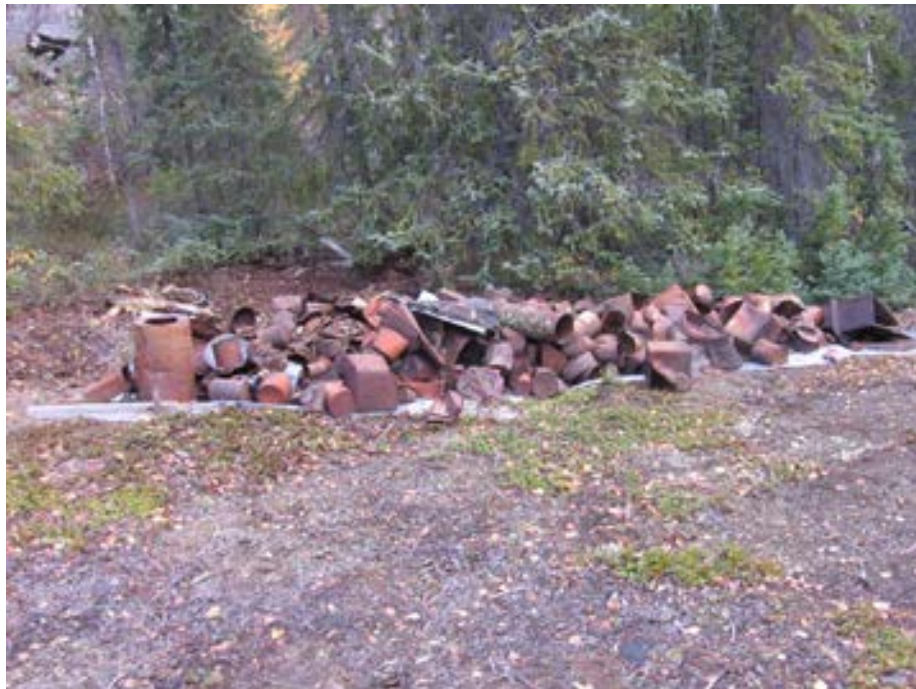
Non-hazardous debris stockpile near Building 1 at Bonanza

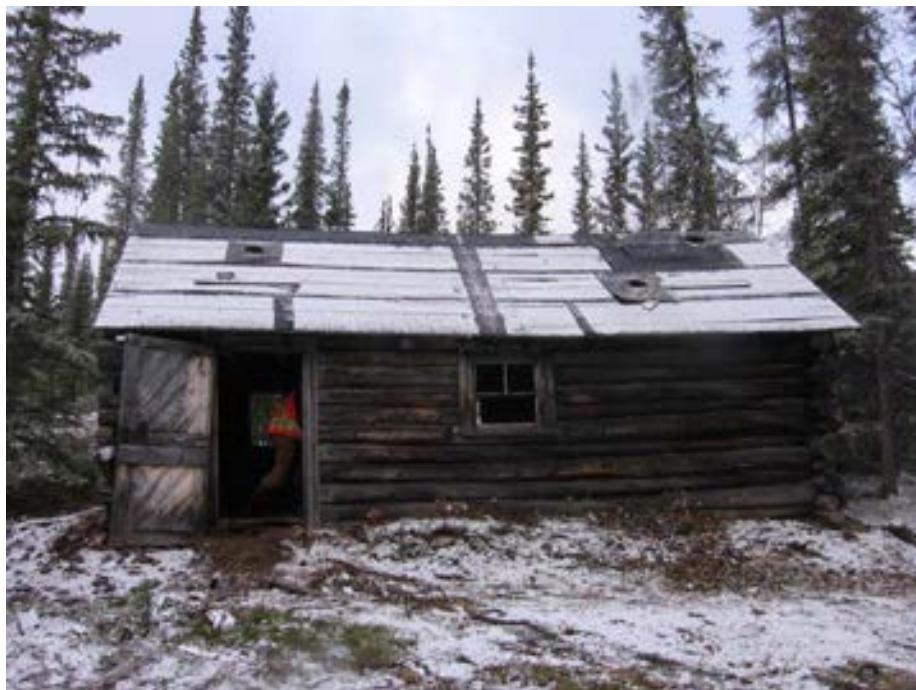
Building #1 at Bonanza prior to burning

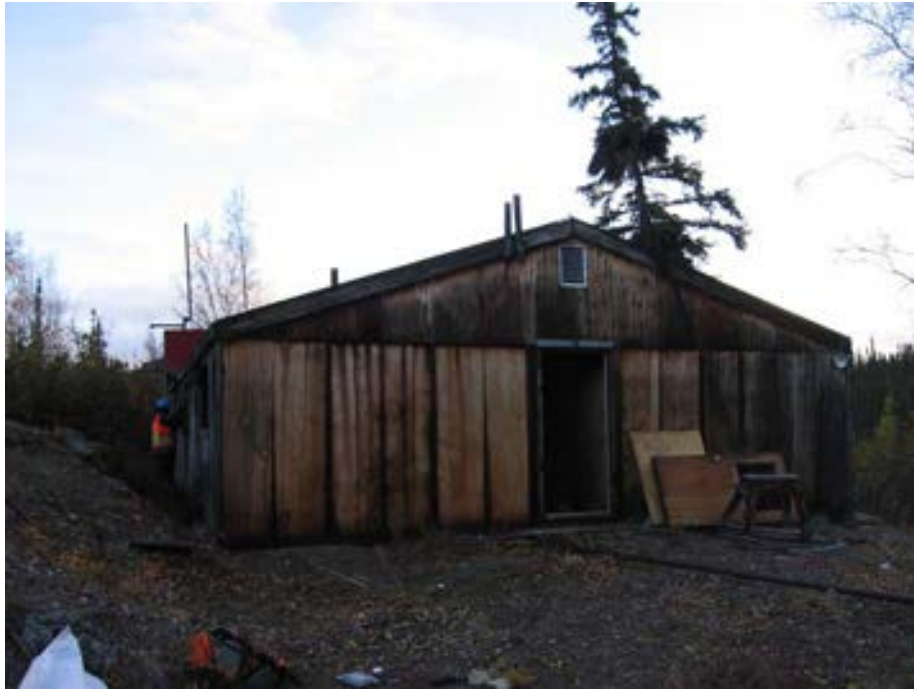
Building 13 prior to burning

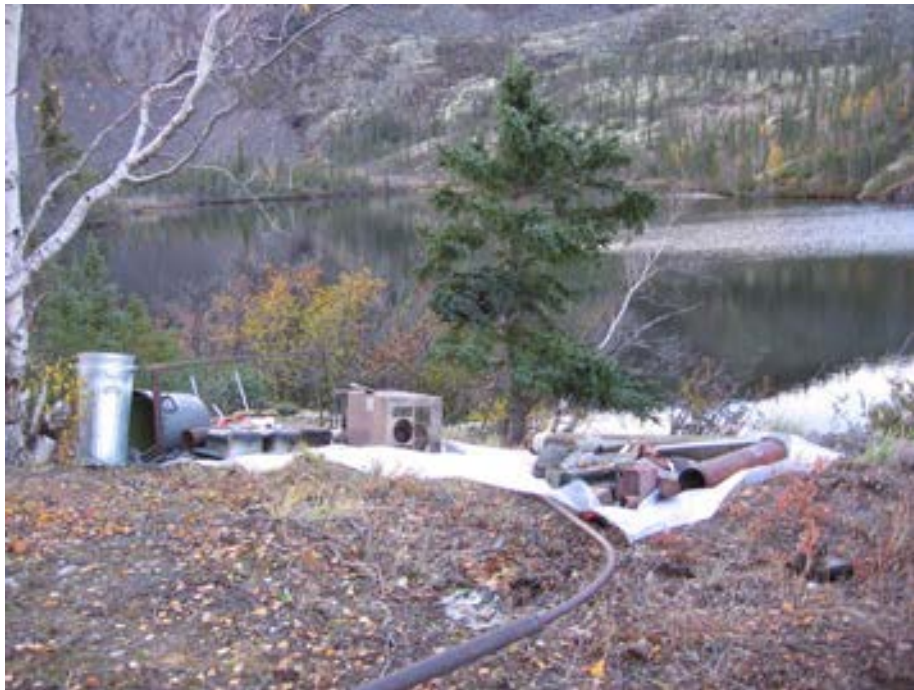
Hazardous debris pile near building 13

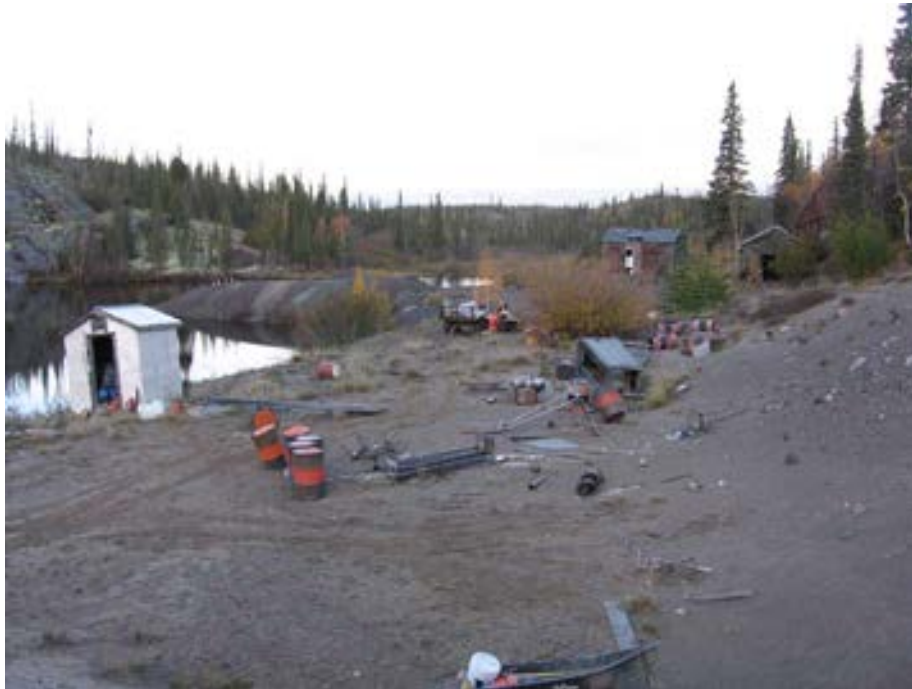
EB-DA-4 prior to debris removal
