File Number S18L3-003
Type of Operation CLASS B – MUNICIPAL Water Licence
Location Mackenzie River

WATER USE INSPECTION REPORT

LICENCE #:	S18L3-003	EXPIRY DATE:	November 18, 2028
LICENCEE:	Town of Norman Wells	PREVIOUS INSPECTION:	June 01, 2023
COMPANY REP:	Cathy Clarke, SAO	INSPECTION DATE:	May 24, 2024

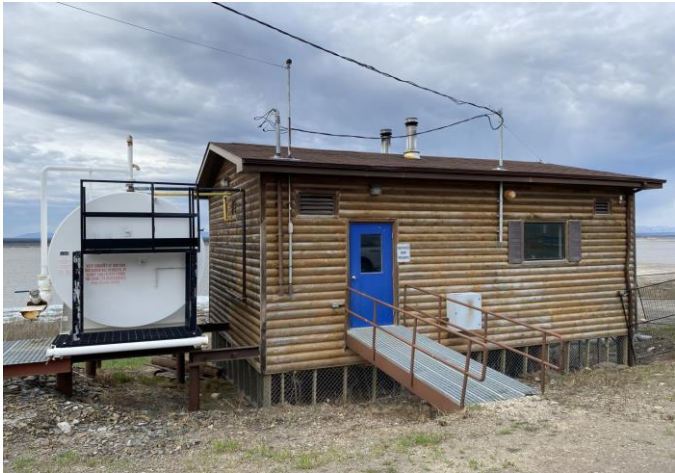
1. Water Intake and Pump Station:
 - Located at the Norman Wells dock, above where water is pumped from the Mackenzie River.
 - During the visit, the area was covered in river ice (May 2024).

- The pump station has a generator with secondary containment.
 - In winter, water from the pump station is heated and returned to the river to prevent pump lines from freezing. Glycol is used for this purpose.

Figure 1
Water intake pump house, generator near Mackenzie River Town of Norman Wells main dock

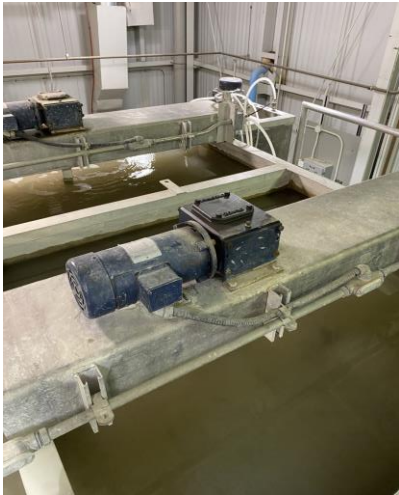
2. Water Treatment Plant:
 - Receives water from the pump house for treatment.
 - Treatment involves several steps:
 - Aluminum Sulfate and polymer are added to clump particles together, allowing them to settle at the bottom of the settling pool. This is necessary because Mackenzie River water has higher turbidity compared to lake water.

Figure 2
Water Settling area in the Water Treatment Plant

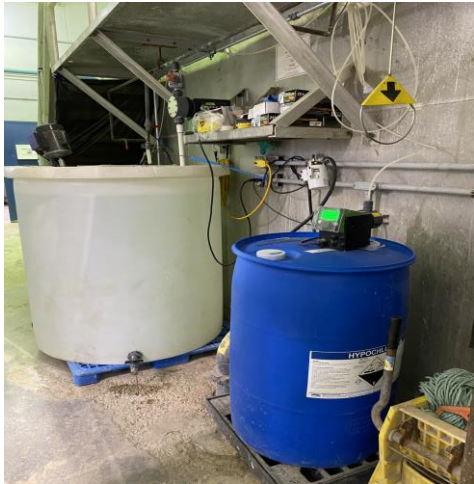
Figure 3
Flocculant mixing station

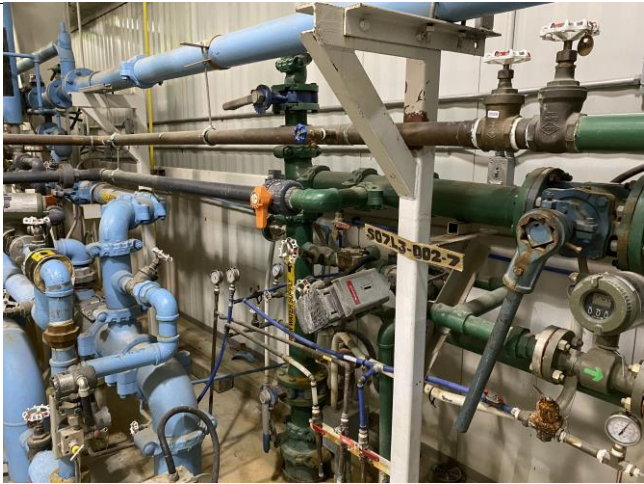
- pH adjusters like soda ash are added, especially during the spring melt when water acidity fluctuates. This helps stabilize the pH level.
 - Chlorine is added to disinfect the water. After chlorination, the water is filtered before distribution.

- There is a laboratory on-site for testing water quality.

Figure 4
Water Treatment facility, SNP sampling

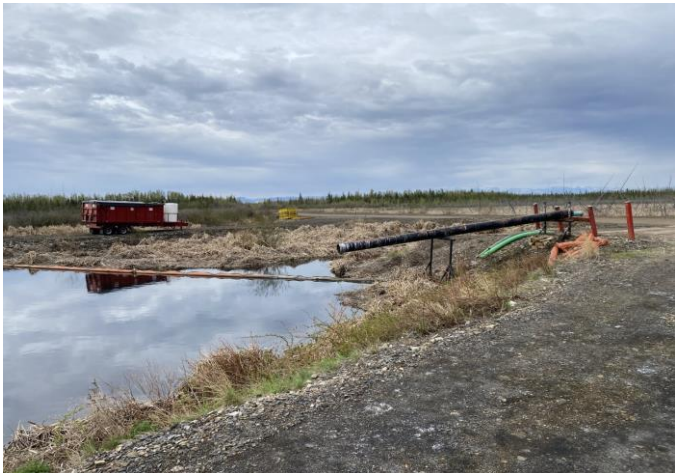
4. Sewage Lagoon Overview:
- WRO Officer Erin Goose and Hugo Pabke visited the sewage lagoon site.
 - The overall status of the sewage lagoon was good with no issues reported.
5. Use of Enzyme Bio Clear:
- Enzyme bio clear is being used in the first two cells of the lagoon.
 - Its purpose is to accelerate the decomposition of organic material.
 - The bio clear is effective, as evidenced by the presence of bubbles in the holding cell. This indicates active decomposition.
6. Lagoon Operation:
- The lagoon operates with a system where sewage is initially treated in the first two cells with bio clear.
 - After initial treatment, the contents are released into a larger pond where natural decomposition processes further break down the waste.

Figure 5
Pump out at Town Sewage Lagoon

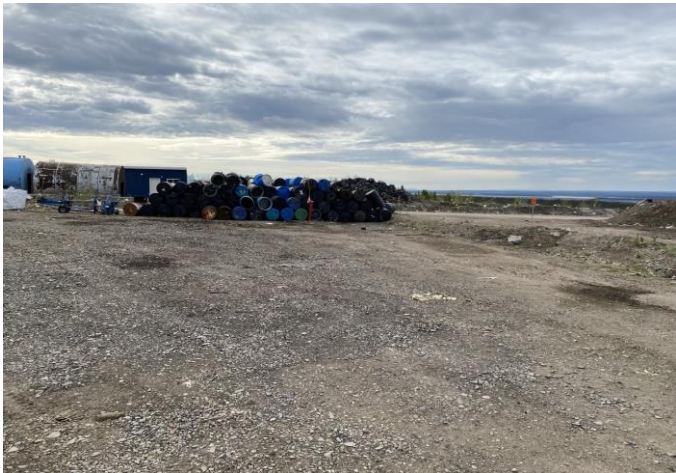
2. Waste Disposal Practices:
 - Burning of waste is not conducted at the Solid Waste Facility.
 - Hazardous waste area has been recently emptied and the waste has been sent south for disposal.

- There is ongoing testing and analysis of ground material in the hazardous waste site to assess contamination levels.
3. Infrastructure and Expansion:

Figure 6
Hazardous Waste area
