**Reference: 2023 Environmental Site Monitoring Report: Nogha K-14 Wellsite Area and Sump Area**

The Nogha K-14 Wellsite Area and Sump Area (collectively called the Site) are located in the Sahtu Settlement Area (SSA), Northwest Territories (NT), approximately 147 kilometres (km) north of Norman Wells (Attachment A: Figure A.1). The Wellsite Area is 1.4 hectares (ha) and contains a wellhead. The Sump Area is 0.15 ha and contains a drilling sump. (Attachment A: Figure A.2 and Figure A.3). Photos of the Site are provided in Attachment B as Photo B.1 to Photo B.23.

## 1 Key Findings and Recommendations

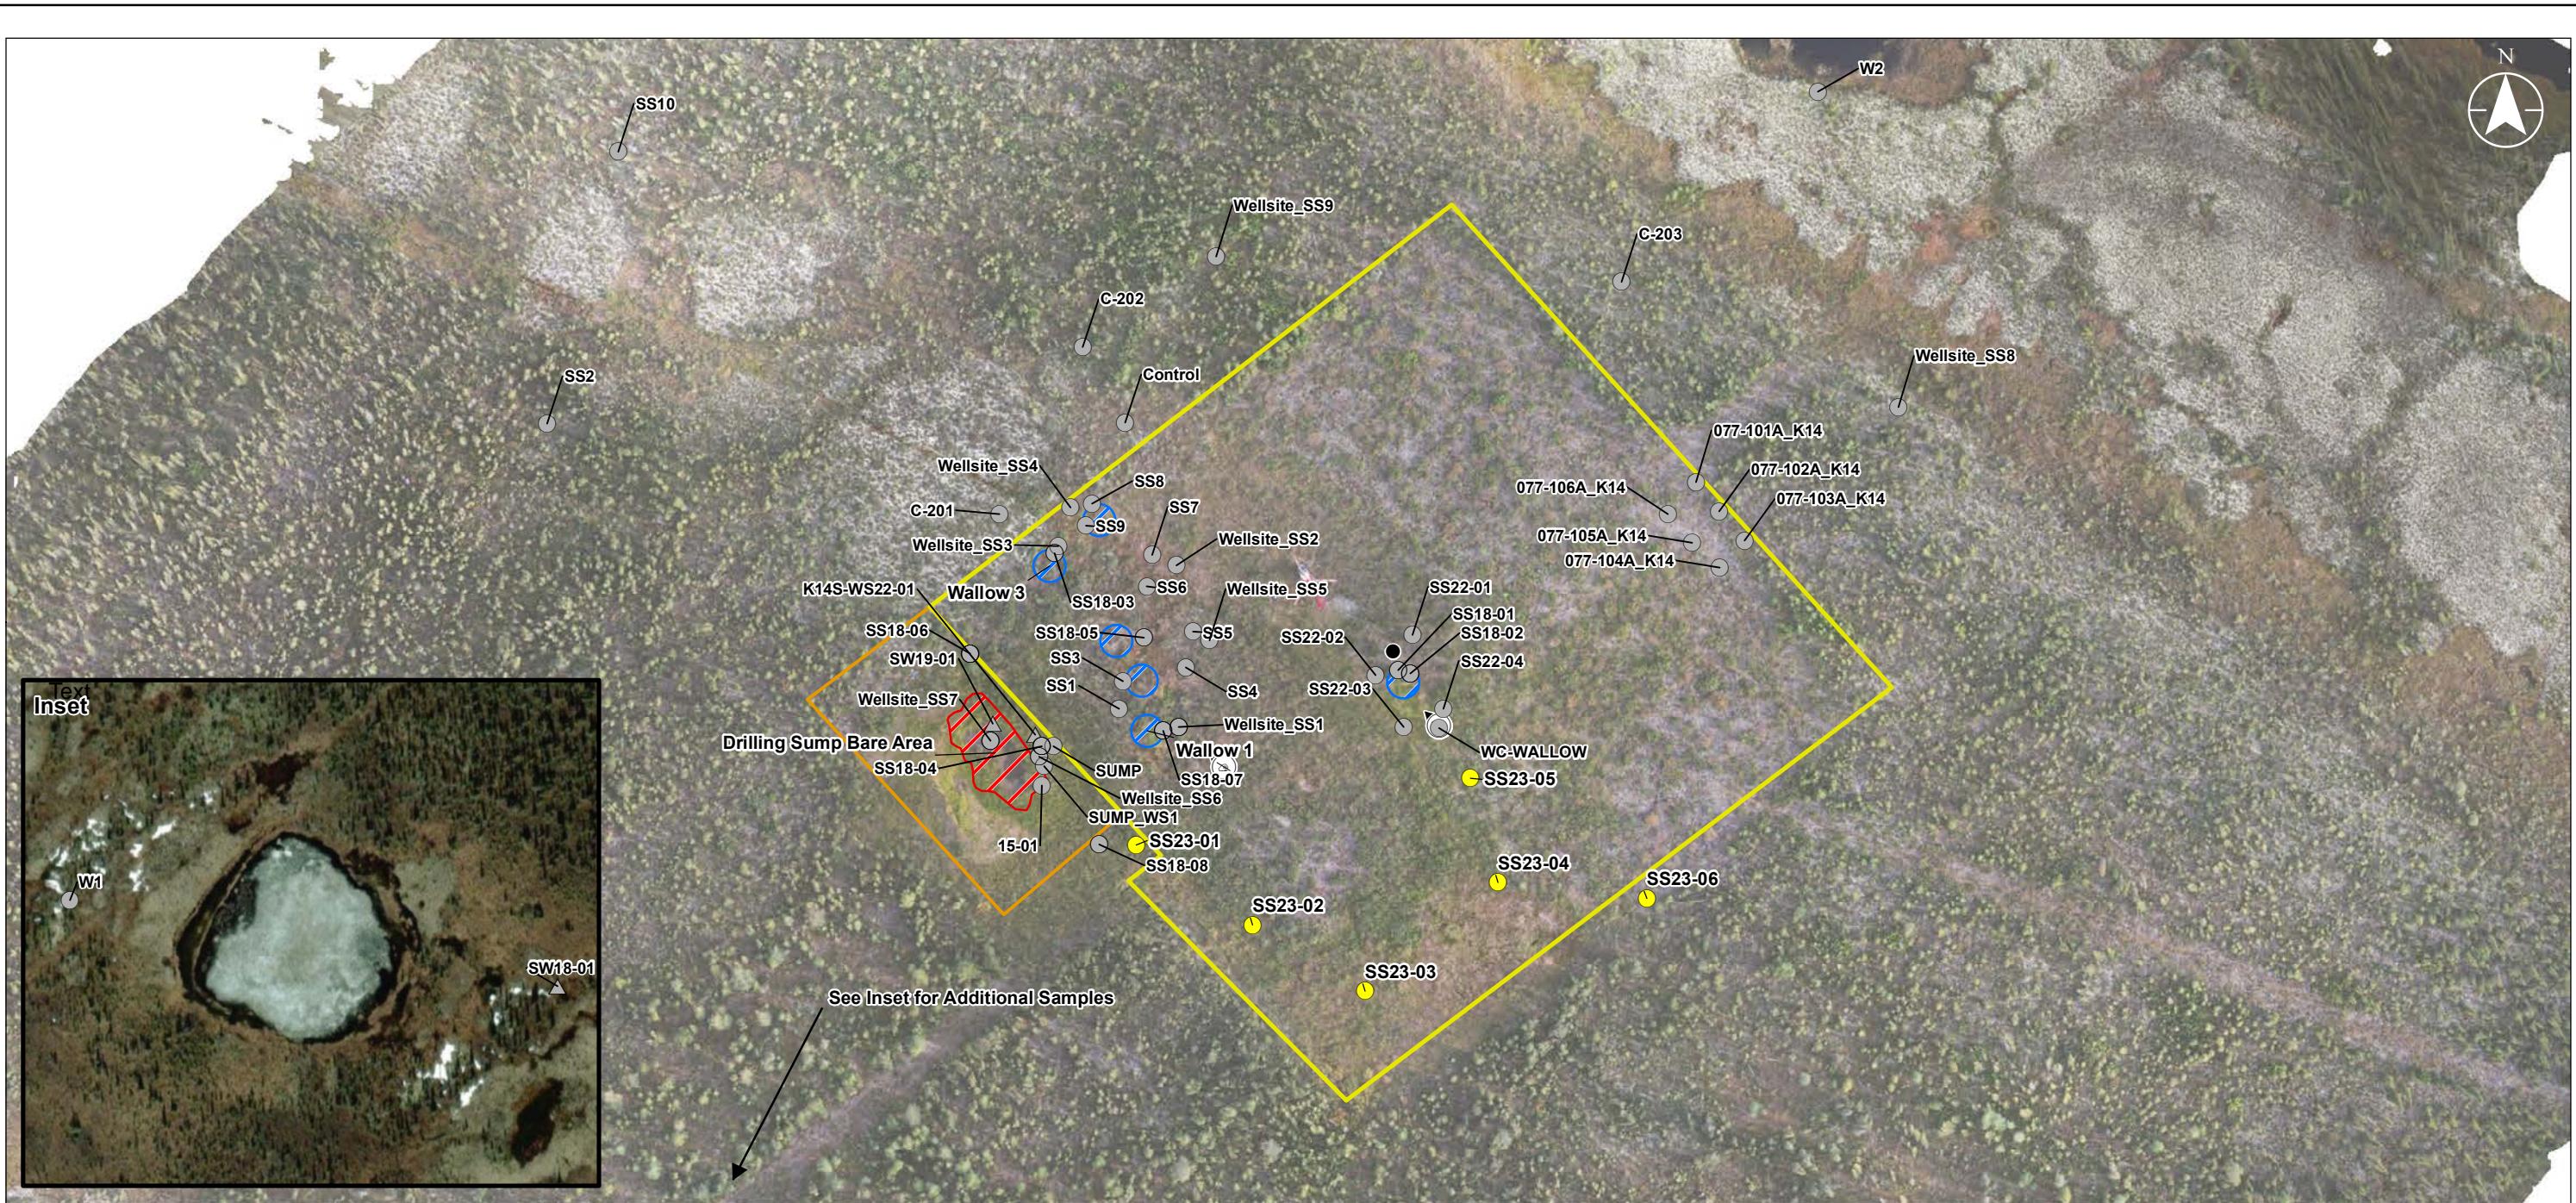
## **ogha K-14 Wellsite Area and Sump Area Soil and Water Sample Locations**

- 2023 Soil Sample
  - Historical Soil Sample
  - ▲ Historical Water Sample
  - Camera
  - Wellhead
  - Further Treatment Required
  - Sump Area
  - Wallow
  - Wellsite Area

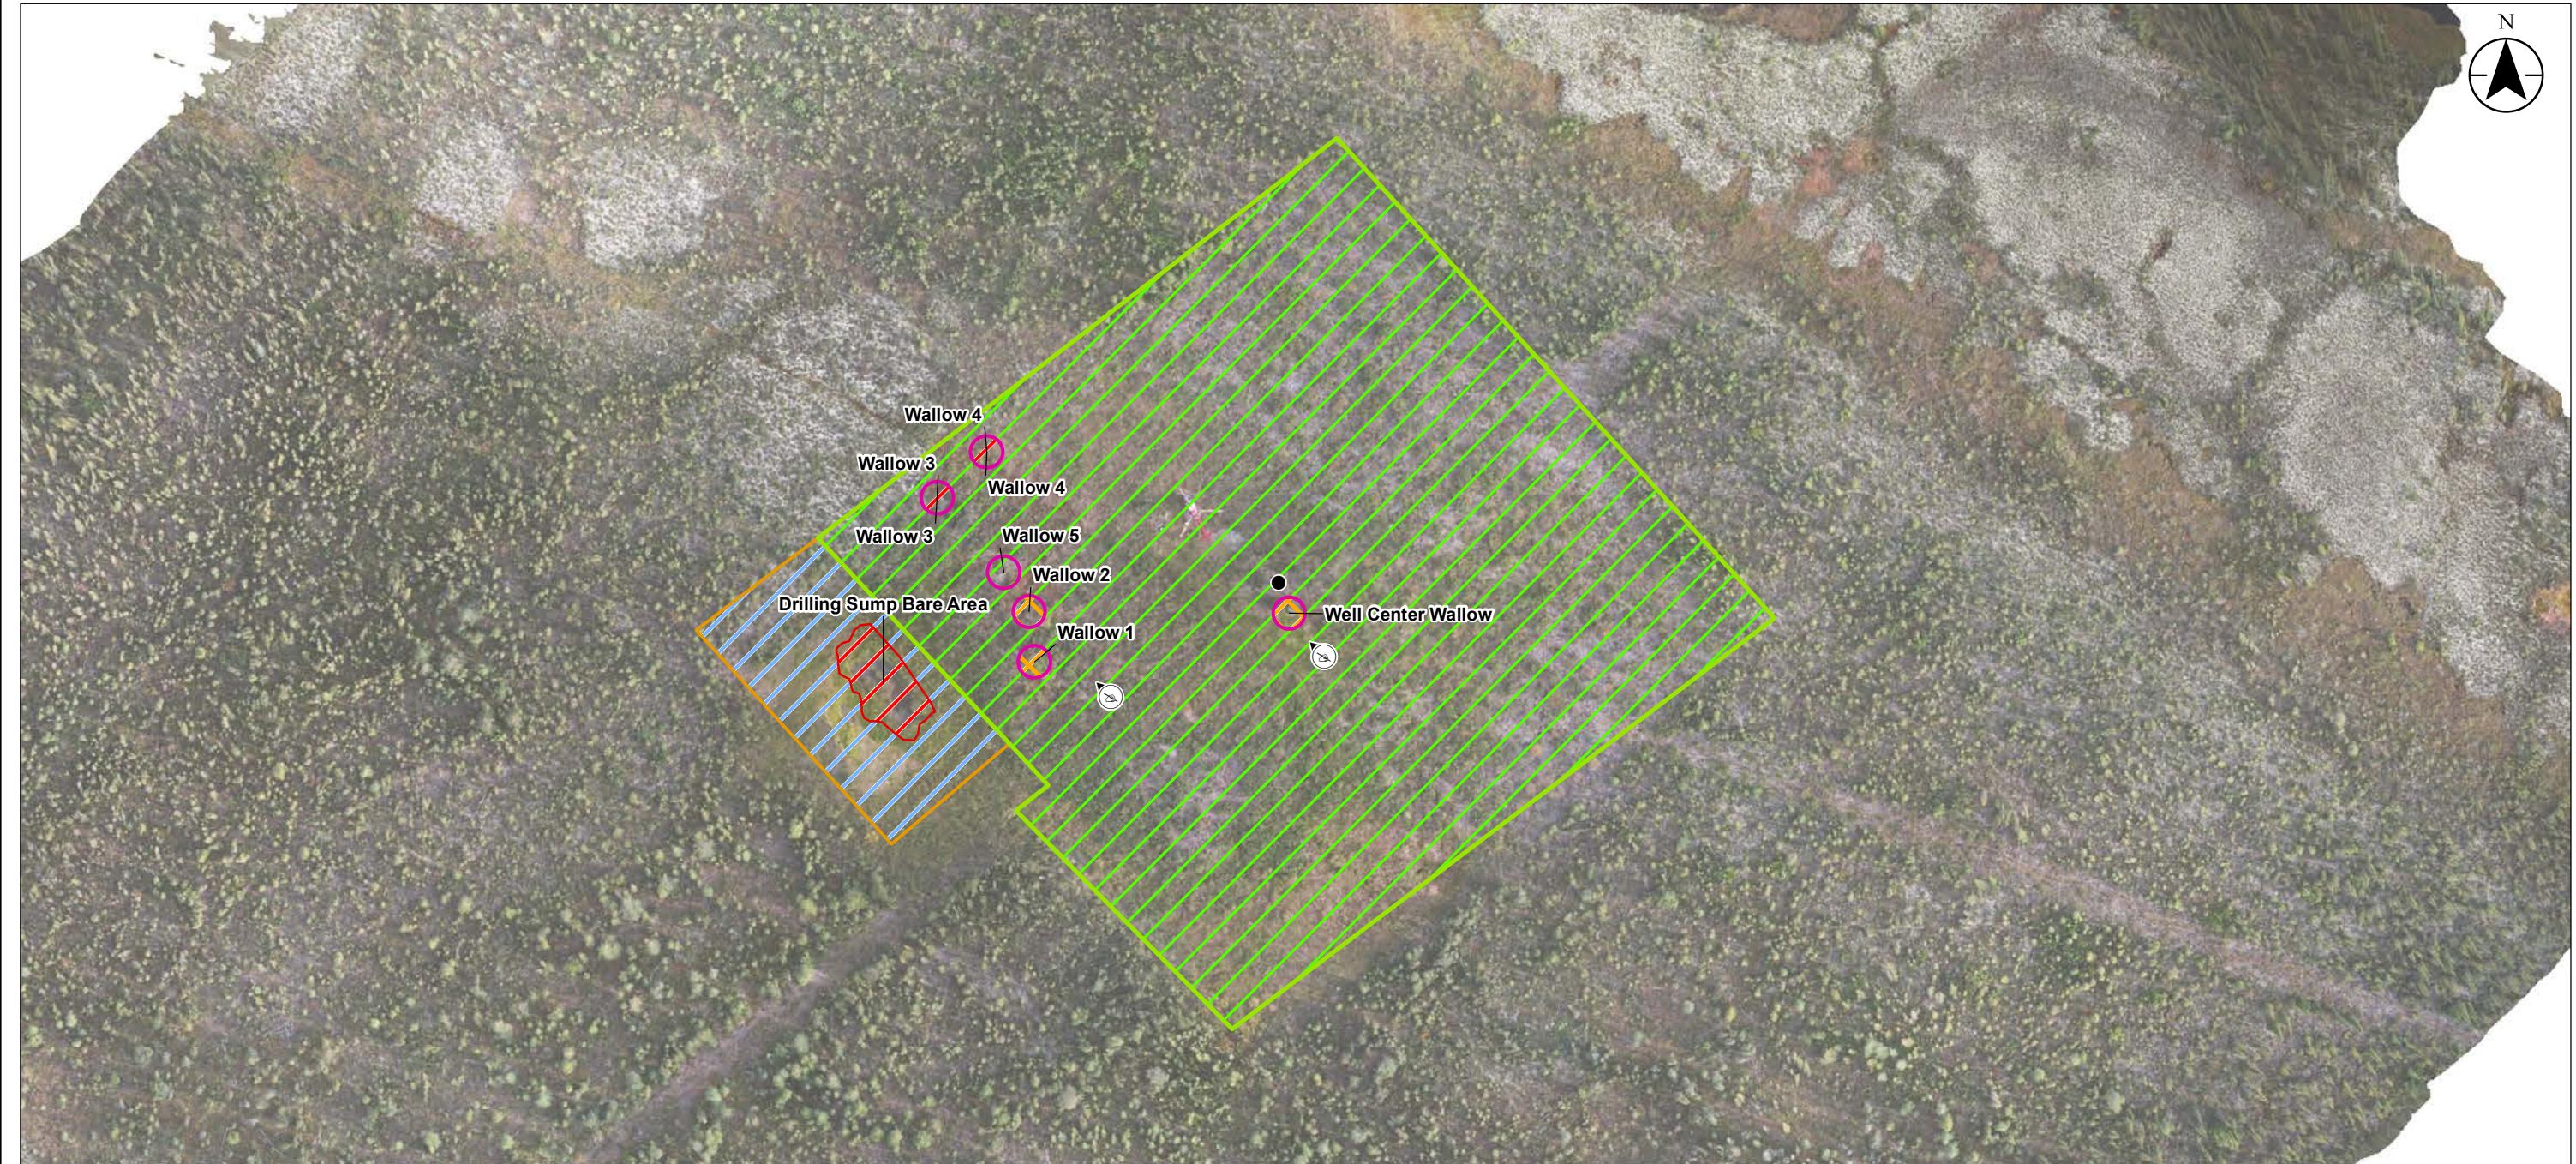
- Camera
- Wellhead
- Further Treatment Required
- Natural revegetation with native tree, shrub and forb species that meets land use permit requirements
- Revegetation with seeded agronomic and native grass species that meets land use permit requirements
- Sump Area
- Wallow
- Wellsite Area

Parameters	Monitoring Observations and Results	Soil and Water Analytical Results (if exceedances)	Future Recommended Work
Vegetation	<p><b>Wellsite Area</b> (Attachment A: Figure A.3):</p> <ul style="list-style-type: none"> <li>• Wellsite Area had naturally revegetated with trees, shrubs, and forbs (Attachment B: Photo B.12 to Photo B.15).</li> <li>• Vegetation cover in the majority of the Wellsite Area met land use permit requirements for &gt;70% vegetation cover, and in healthy condition, including the WC Wallow and Wallows 1, 2 and 5.</li> <li>• The WC Wallow and Wallows 1 to 5 underwent reclamation treatments in 2019 to increase vegetation cover. Vegetation has re-established in the WC Wallow and Wallows 1, 2, and 5. Wallows 3 and 4 were not assessed during the 2023 site visit.</li> </ul> <p><b>Well Centre Wallow:</b></p> <ul style="list-style-type: none"> <li>• Vegetation was well established in the area. Total vegetation cover was approximately 80% to 85%, consisting of 70% to 75% cover for seeded native grasses and 10% for naturally established forbs and shrubs (Attachment B: Photo B.16).</li> <li>• Vegetation cover met permit requirements (i.e., &gt;70% cover and healthy condition).</li> <li>• Vegetation did not appear to be grazed (0% of plants grazed) and ground did not appear impacted by ungulate hoof traffic.</li> </ul> <p><b>Wallow 1:</b></p> <ul style="list-style-type: none"> <li>• Vegetation was well established in the area. Total vegetation cover was approximately 80% to 85%, consisting of 75% to 80% cover for seeded native grasses and 5% for naturally established shrubs and forbs (Attachment B: Photo B.17).</li> <li>• Vegetation cover met permit requirements (i.e., &gt;70% cover and healthy condition).</li> <li>• Vegetation did not appear to be grazed (0% of plants grazed) and ground did not appear impacted by ungulate hoof traffic.</li> </ul>	<ul style="list-style-type: none"> <li>• Not applicable for this parameter.</li> </ul>	<p><b>Wellsite Area:</b></p> <ul style="list-style-type: none"> <li>• Carry out reconnaissance level vegetation monitoring in the Wellsite Area, including the WC Wallow and Wallows 1 to 5.</li> <li>• Carry out detailed vegetation monitoring at the proposed standing water and soil sampling locations.</li> <li>• Reconnaissance level monitoring for invasive plants whenever a site visit is carried out, particularly at the wallows.</li> <li>– Carry out invasive plant/weed control treatments if infestations reach a density that prohibits vegetation establishment and growth, including pulling plants, storing in garbage bags, and disposing off-site at an approved facility.</li> </ul> <p><b>Sump Area:</b></p> <ul style="list-style-type: none"> <li>• Carry out reconnaissance level vegetation monitoring on the overall Sump Area, including the Drilling Sump Bare Area.</li> <li>• Carry out detailed vegetation monitoring at the proposed standing water and soil sampling locations.</li> </ul>

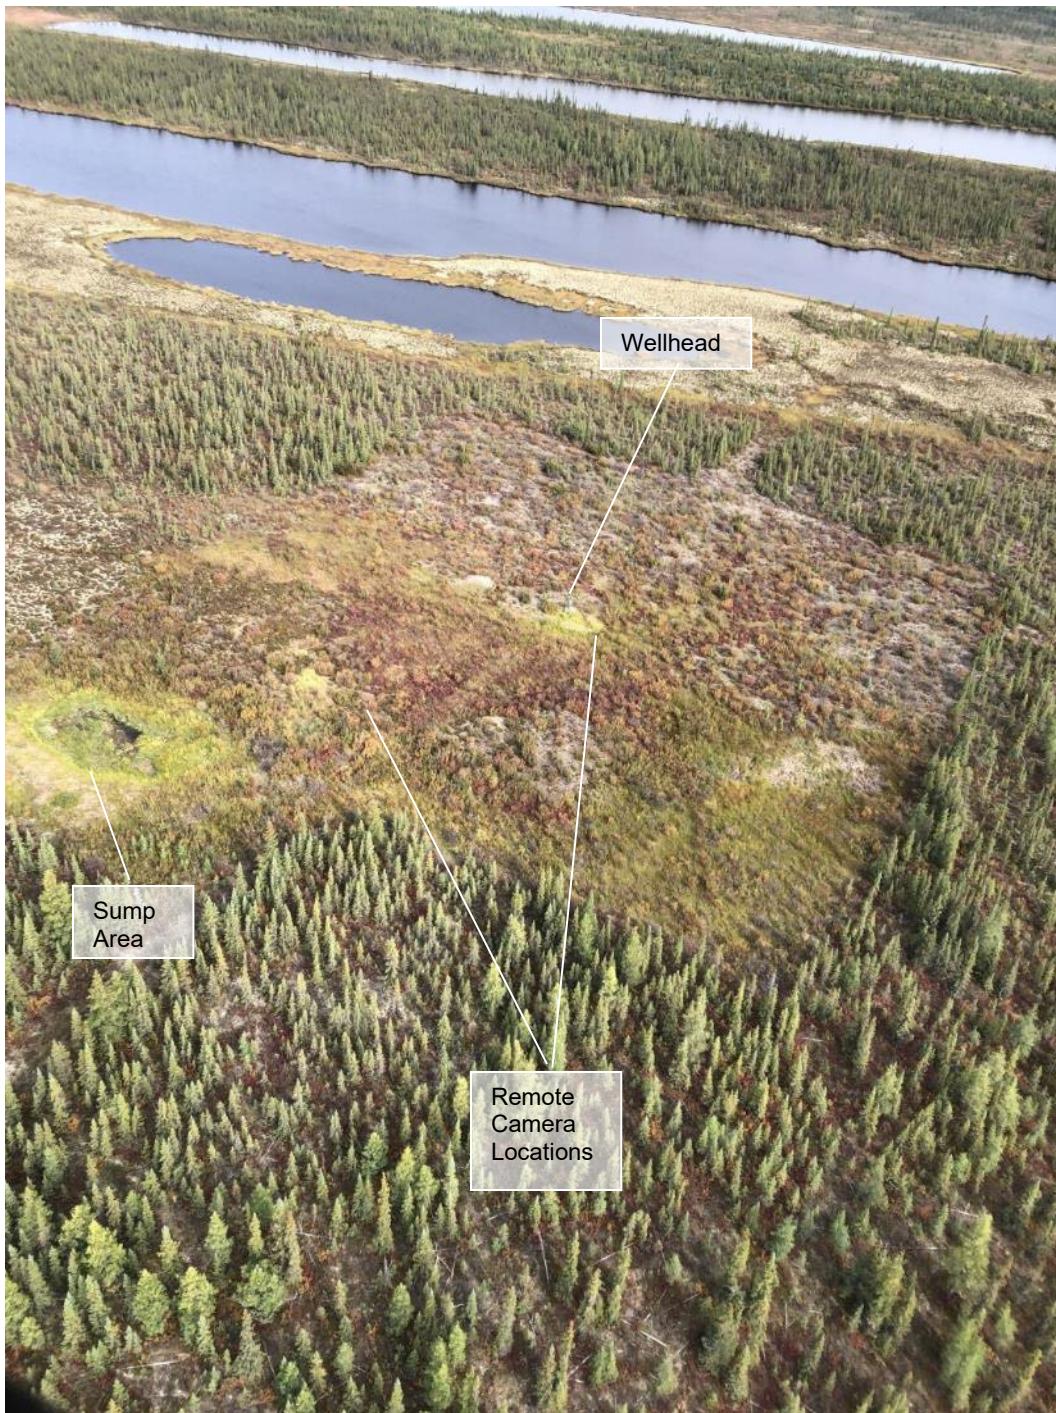
**Photo B.1      K-14 Wellsite Area and Sump Area: Overview**

Note: North facing aerial view showing the Wellsite Area, Sump Area, Wellhead, and Remote Camera Locations (August 30, 2023).

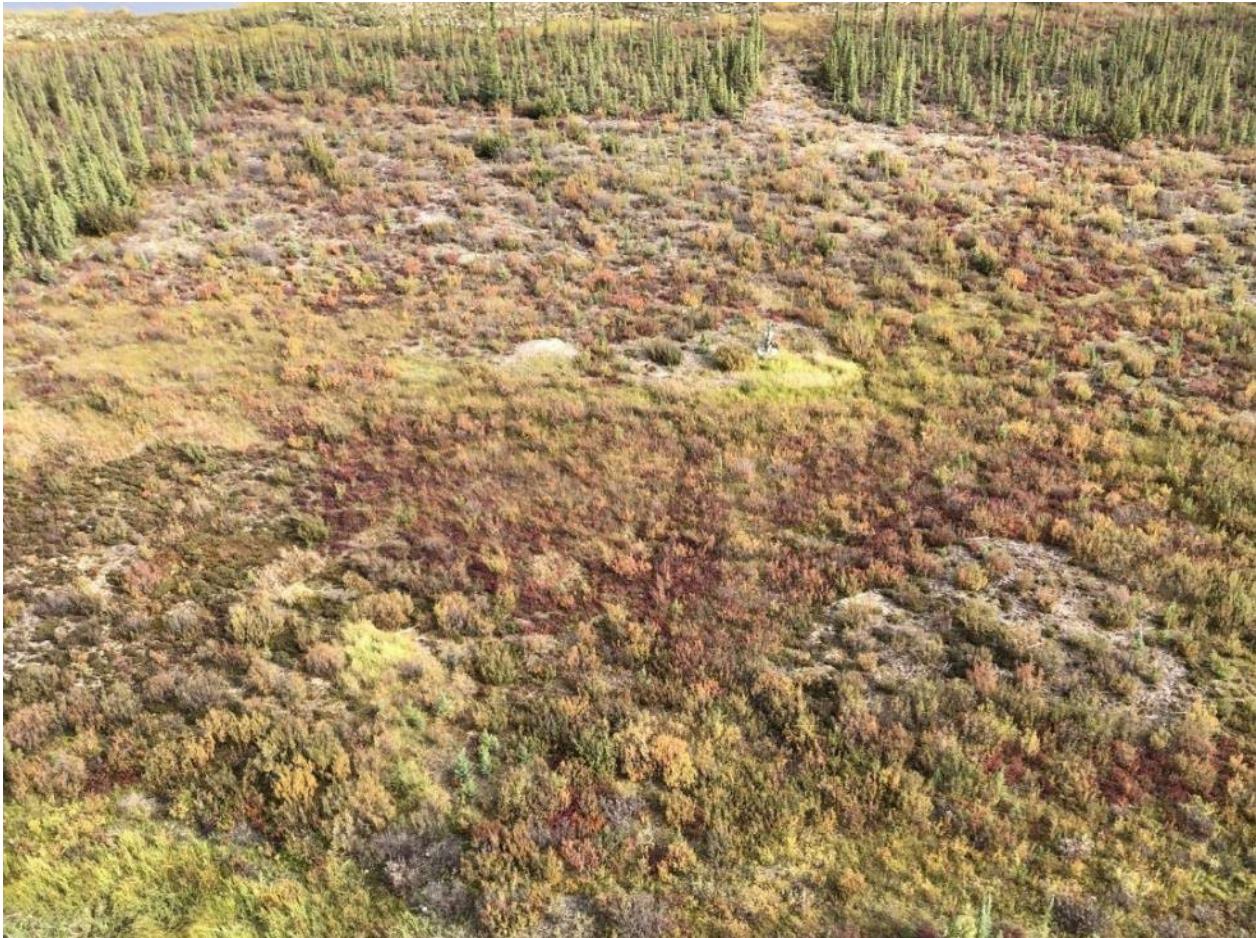
**Photo B.2      K-14 Wellsite Area and Sump Area: Wellsite Area Close-up View**

Note: Northeast facing aerial view of the Wellsite Area showing typical ground and vegetation cover conditions (August 30, 2023).

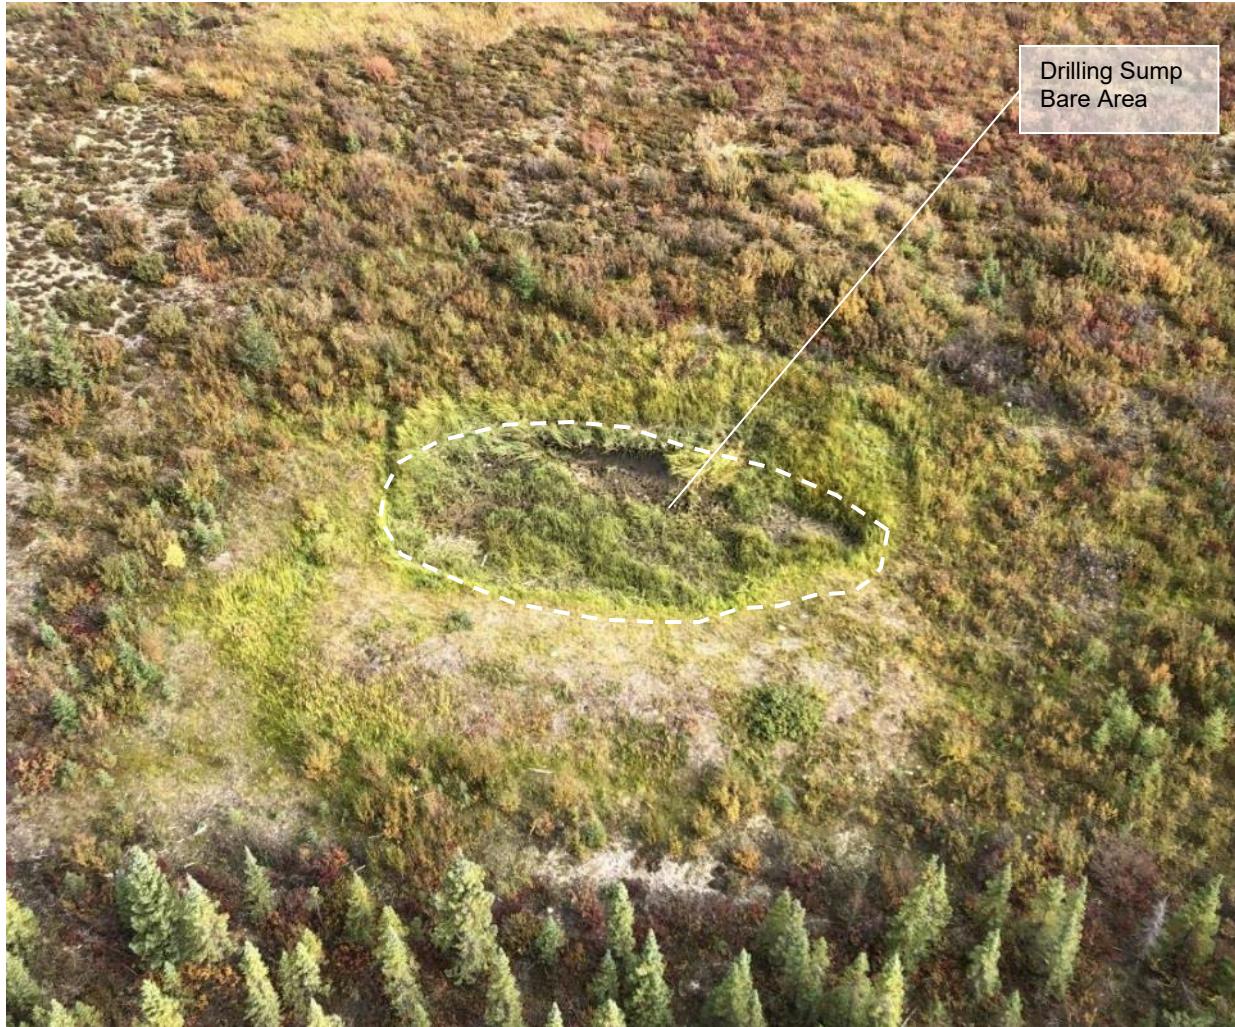
**Photo B.3 K-14 Wellsite Area and Sump Area: Sump Area Close-up View**

Note: Northeast facing aerial view of the Sump Area showing the location of the Drilling Sump Bare Area, sump surface conditions, and vegetation cover conditions (August 30, 2023).

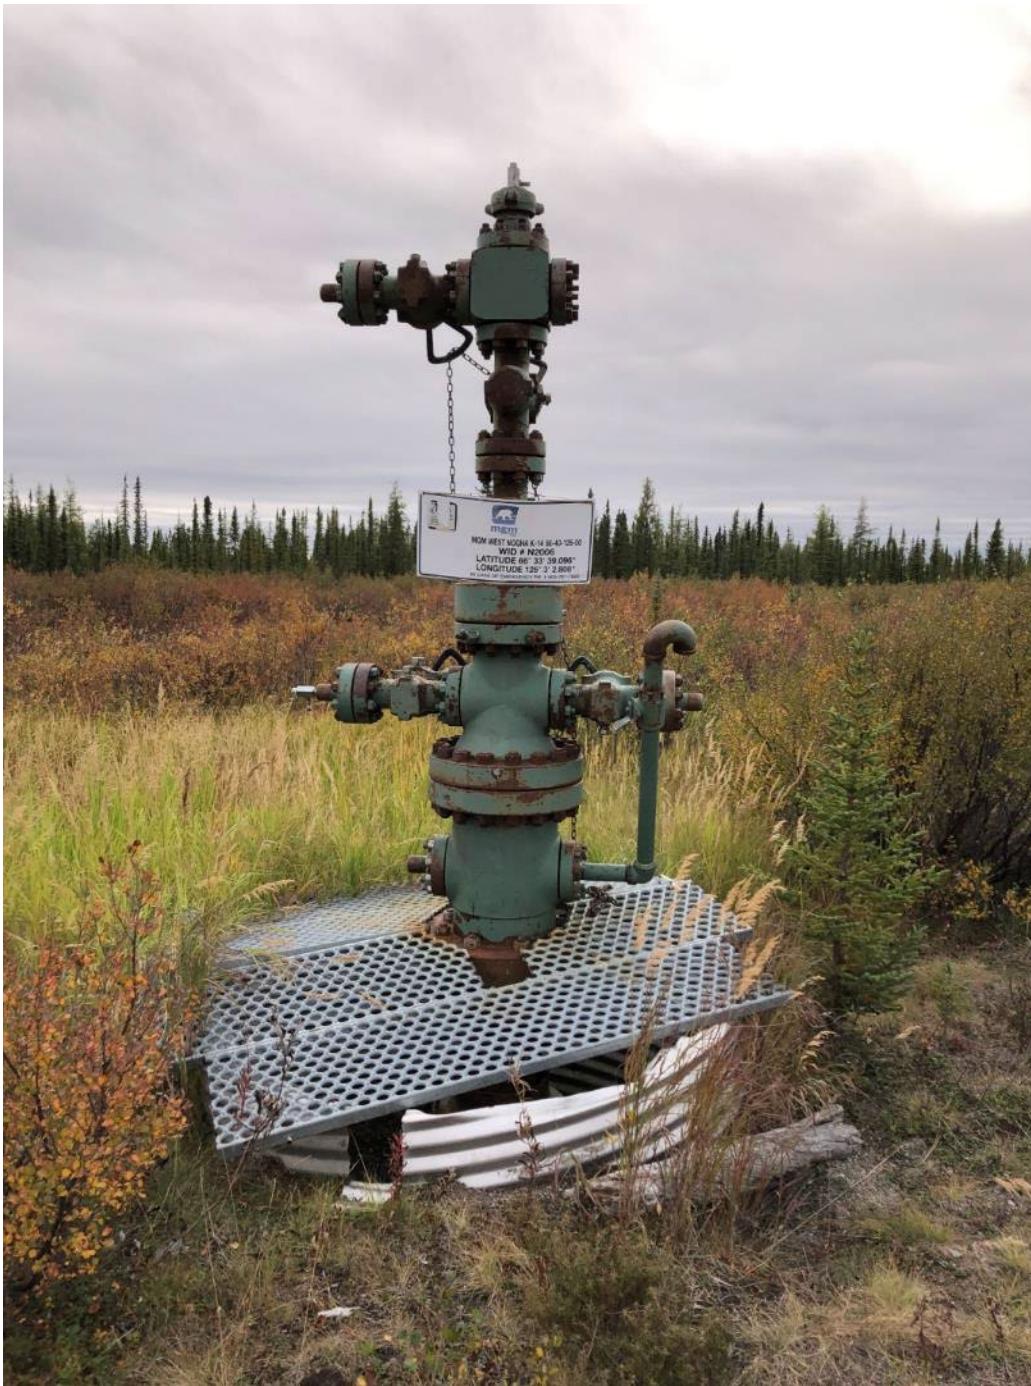
**Photo B.4      K-14 Wellsite Area and Sump Area: On-Site Materials**

Note: Northwest facing view of on-site materials showing wellhead, sign, protective culvert, and grating cover (August 30, 2023).

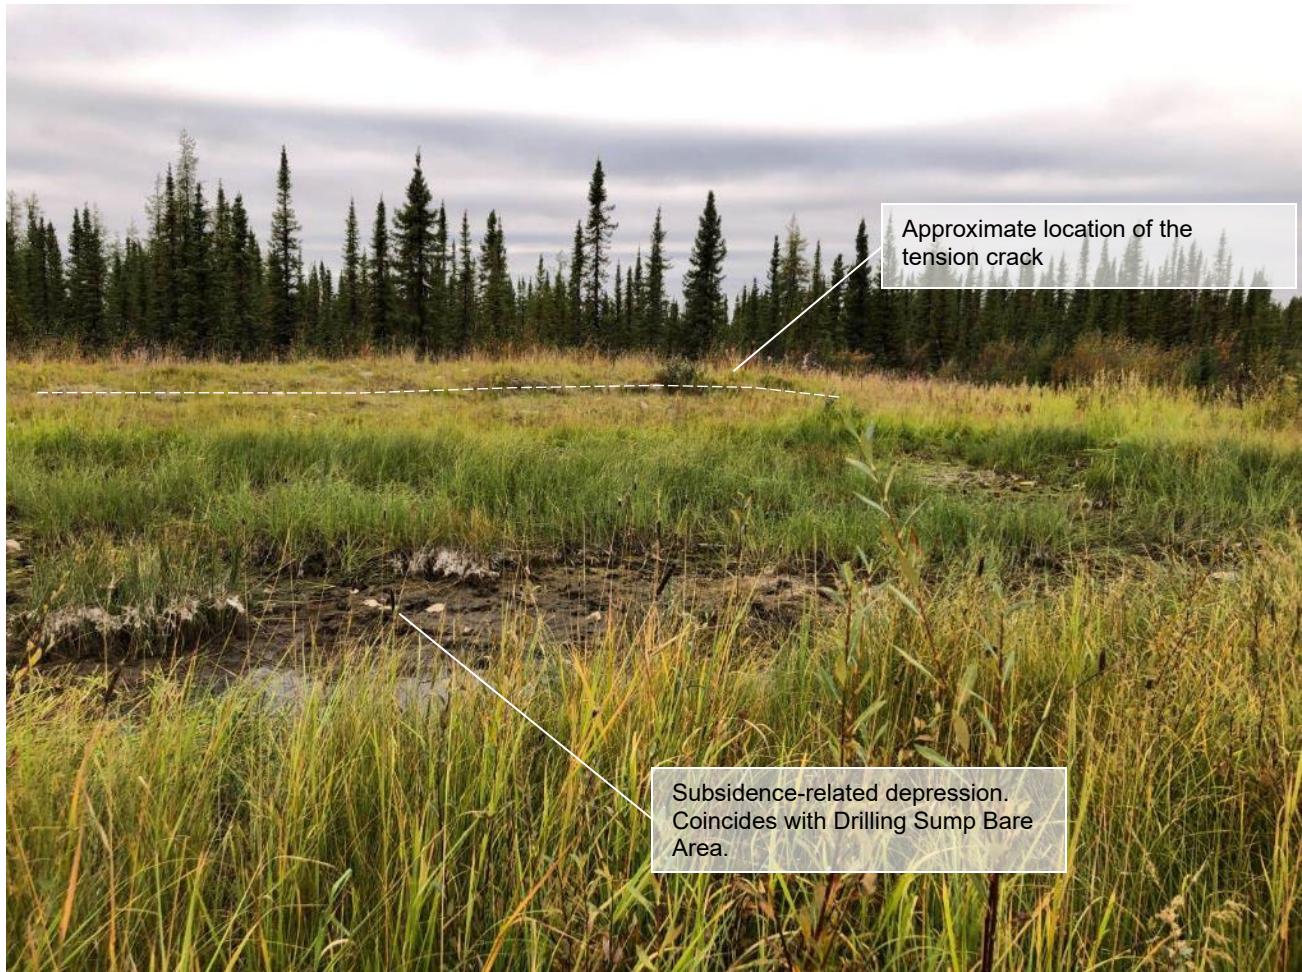
**Photo B.5      K-14 Wellsite Area and Sump Area: Terrain - Sump Area Conditions**

Note: West facing view of Sump Area. No changes observed in the overall sump topography as part of the 2023 site visit (August 30, 2023). The western portion of sump was observed to be raised approximately 1 m above the surrounding ground surface, while the eastern portion was subsided, allowing for the accumulation of standing water (very small volume present during the August 30, 2023 visit). The previously observed tension crack was not readily visible due to the presence of a healthy vegetation cover.

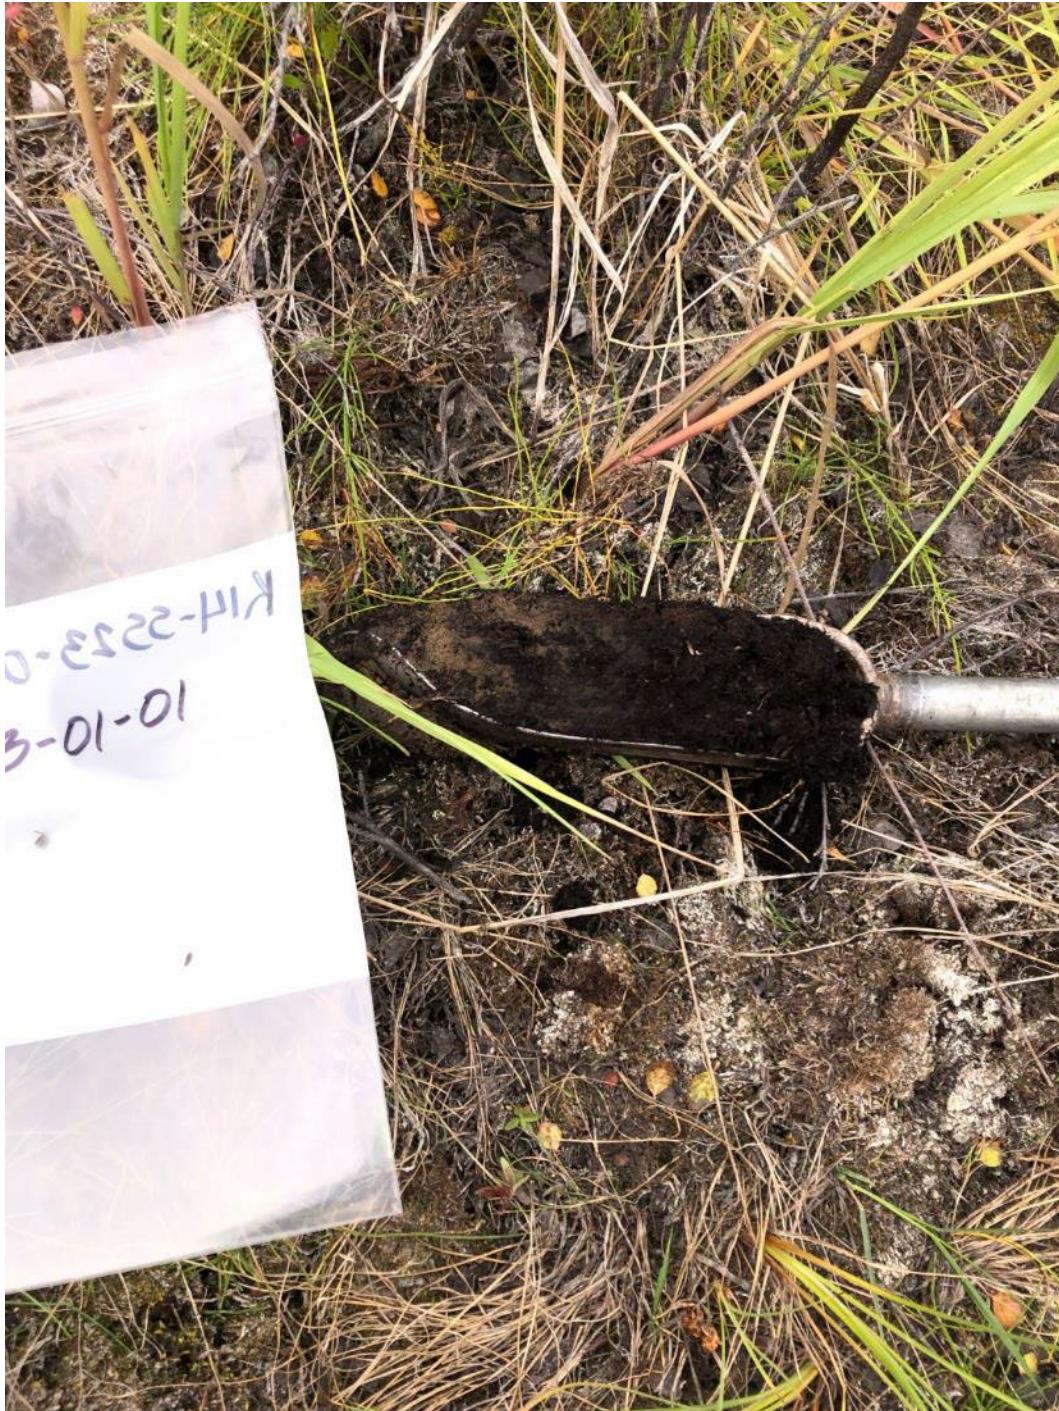
**Photo B.6      K-14 Wellsite Area and Sump Area: Soil Sampling Location - K14-SS23-01**

Note: View of soil sampling location K14-SS23-01 (August 30, 2023).

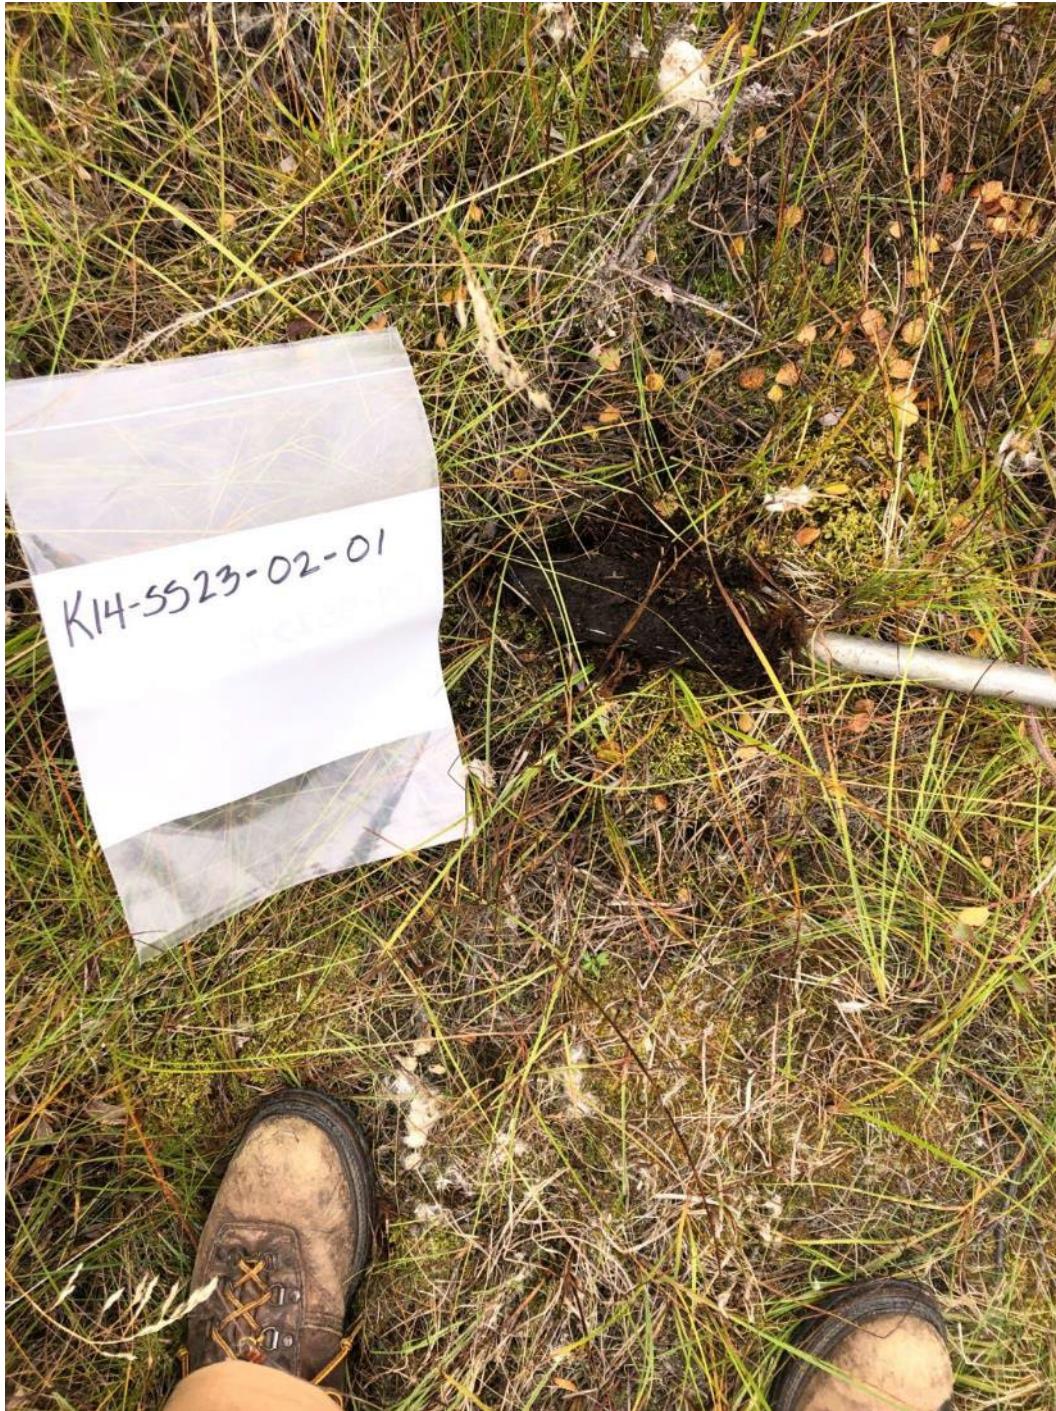
**Photo B.7      K-14 Wellsite Area and Sump Area: Soil Sampling Location - K14-SS23-02**

Note: View of soil sampling location K14-SS23-02 in the vicinity of the Wellhead (August 30, 2023).

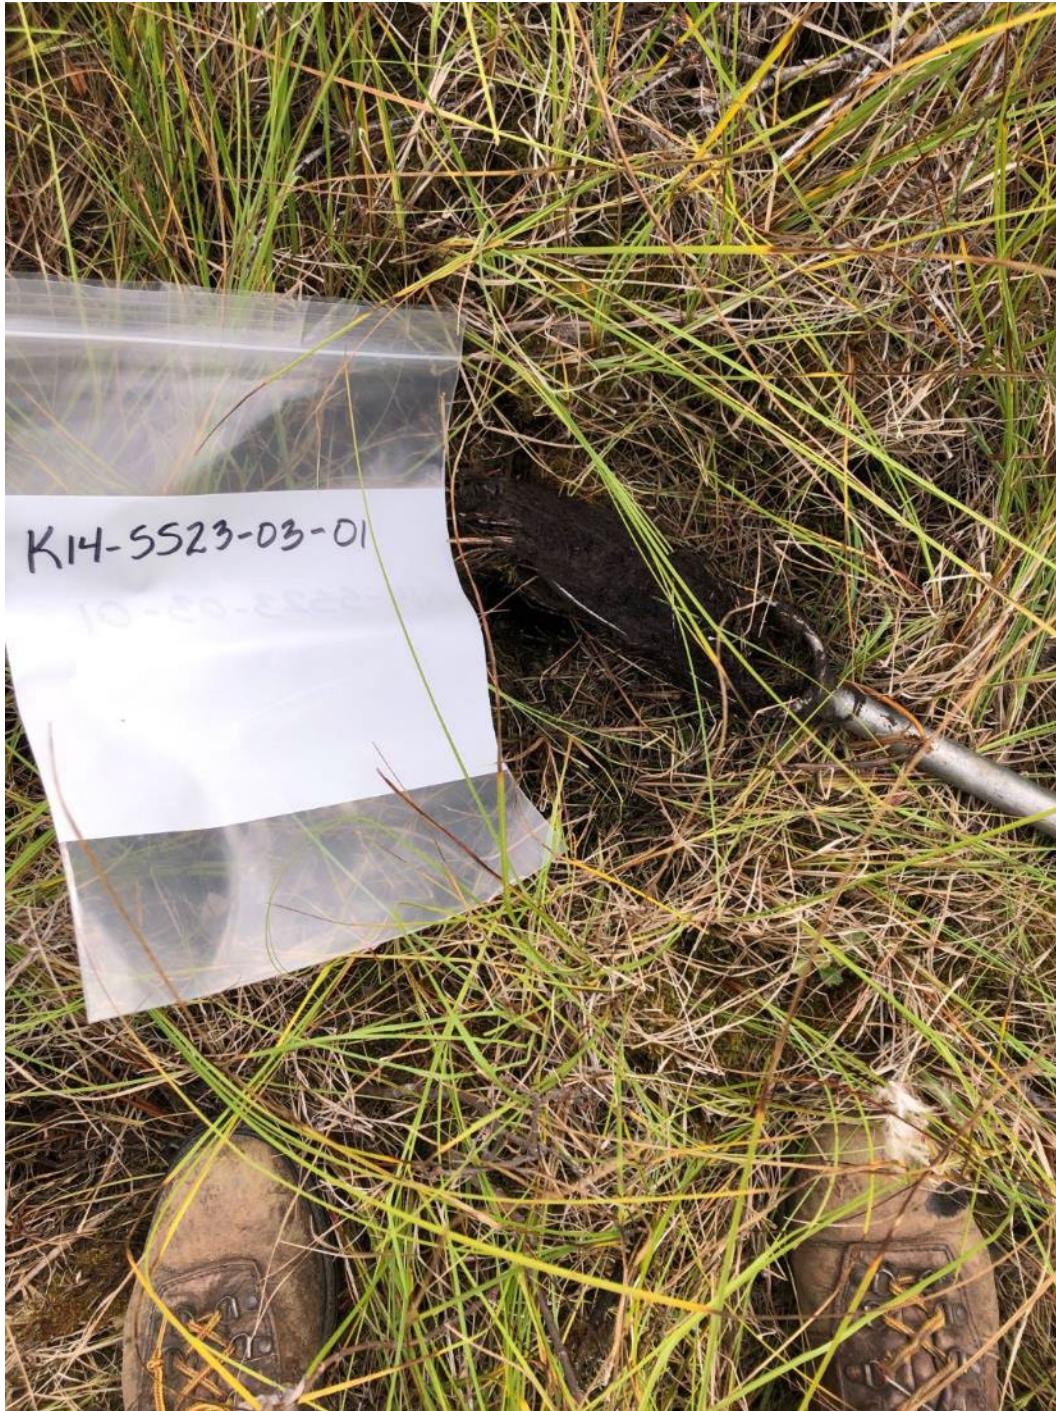
**Photo B.8      K-14 Wellsite Area and Sump Area: Soil Sampling Location - K14-SS23-03**

Note: View of soil sampling location K14-SS23-03 (August 30, 2023).

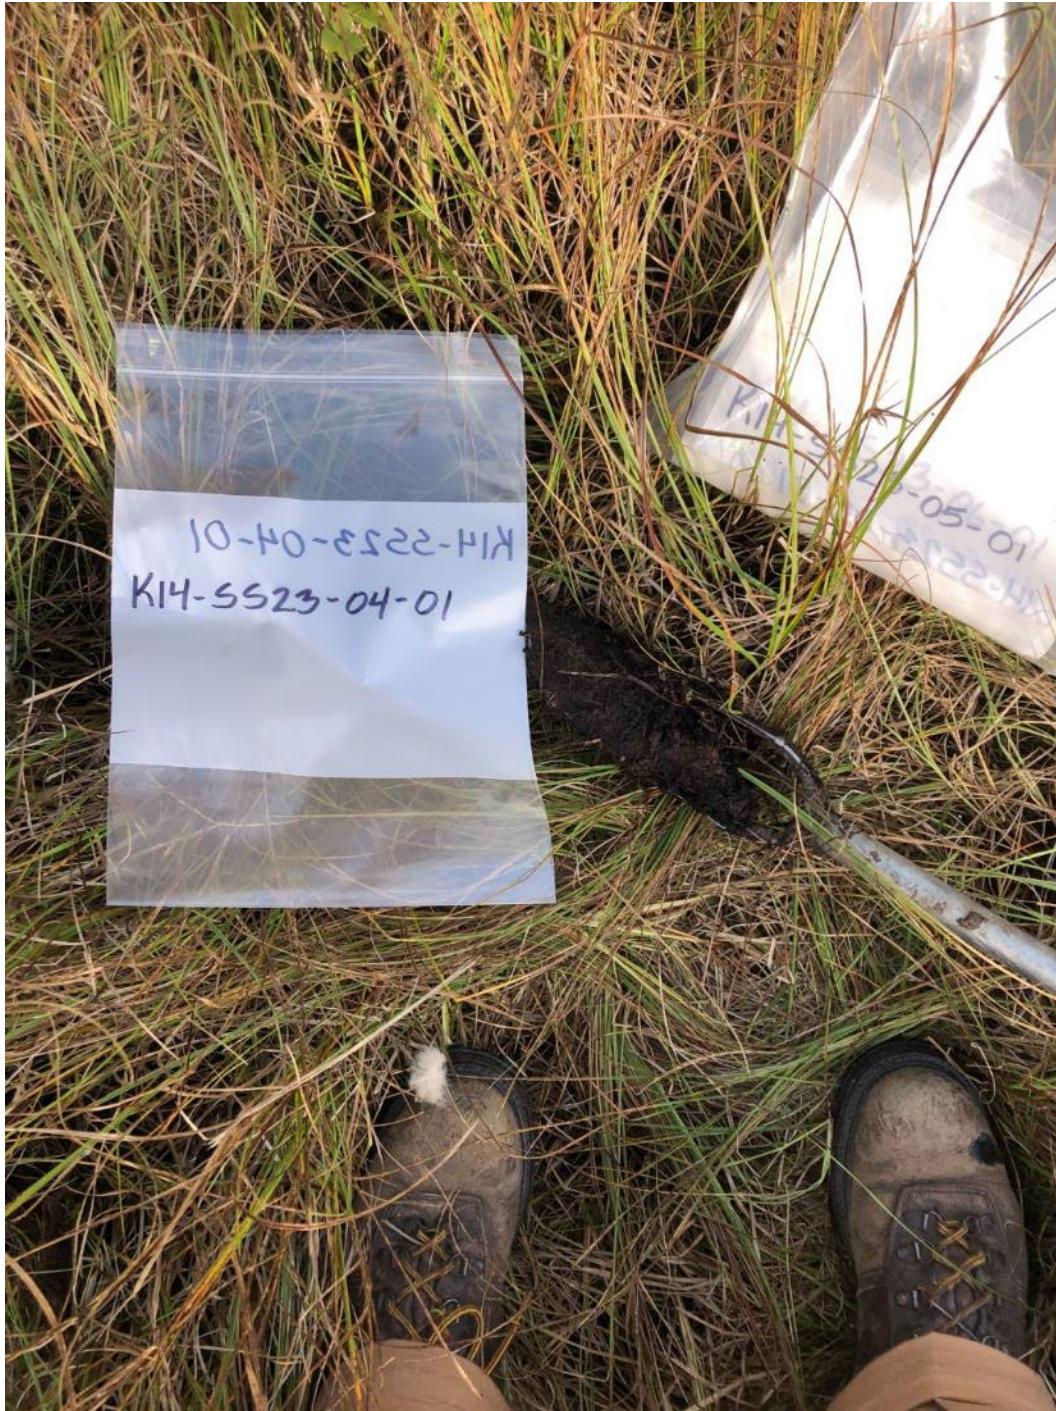
**Photo B.9      K-14 Wellsite Area and Sump Area: Soil Sampling Location - K14-SS23-04**

Note: View of soil sampling location K14-SS23-04 (August 30, 2023).

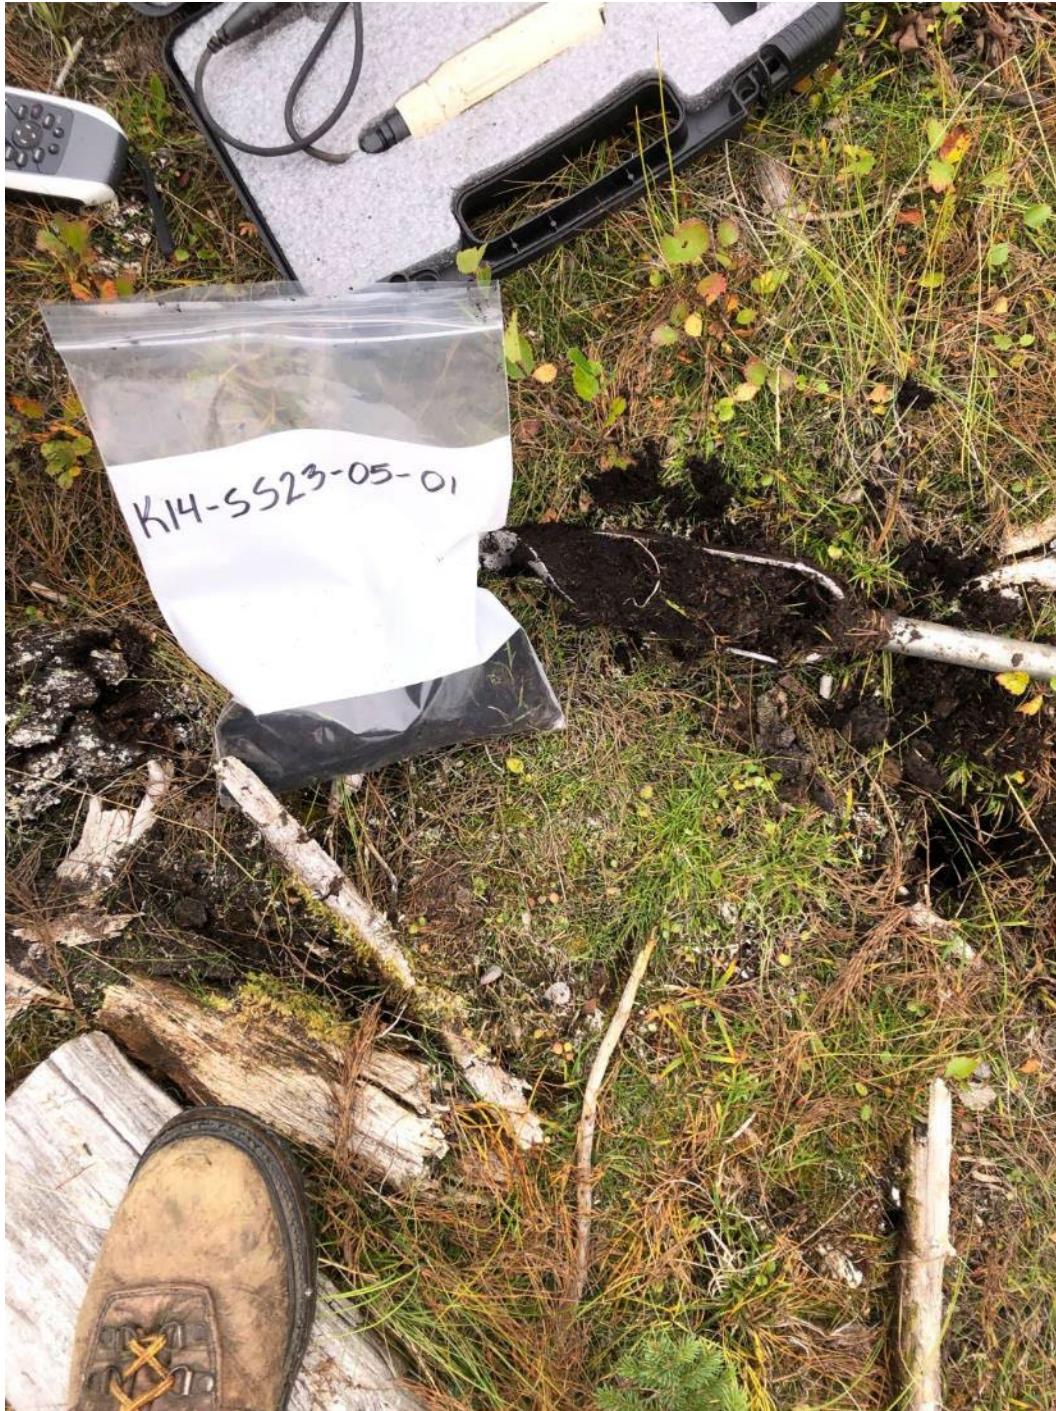
**Photo B.10 K-14 Wellsite Area and Sump Area: Soil Sampling Location - K14-SS23-05**

Note: View of soil sampling location K14-SS23-05 (August 30, 2023).
