**Reference: 2023 Environmental Site Monitoring Report: Nogha K-14 Wellsite Area and Sump Area**

The Nogha K-14 Wellsite Area and Sump Area (collectively called the Site) are located in the Sahtu Settlement Area (SSA), Northwest Territories (NT), approximately 147 kilometres (km) north of Norman Wells (Attachment A: Figure A.1). The Wellsite Area is 1.4 hectares (ha) and contains a wellhead. The Sump Area is 0.15 ha and contains a drilling sump. (Attachment A: Figure A.2 and Figure A.3). Photos of the Site are provided in Attachment B as Photo B.1 to Photo B.23.

## 1 Key Findings and Recommendations

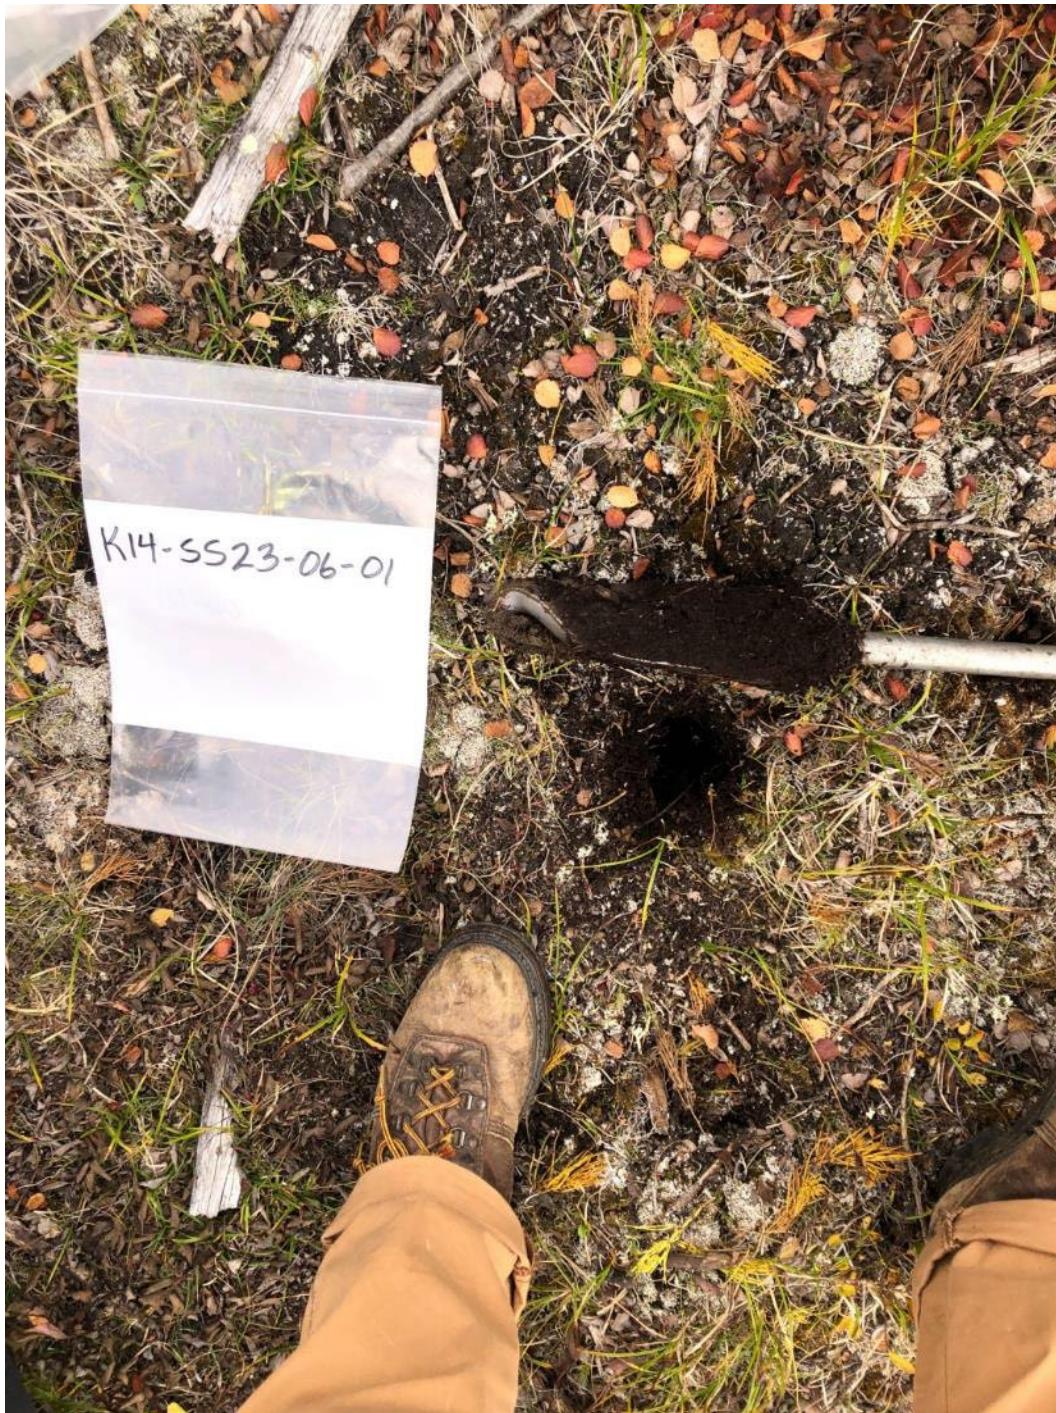
**Photo B.11     K-14 Wellsite Area and Sump Area: Soil Sampling Location - K14-SS23-06**

Note: View of soil sampling location K14-SS23-06 (August 30, 2023).

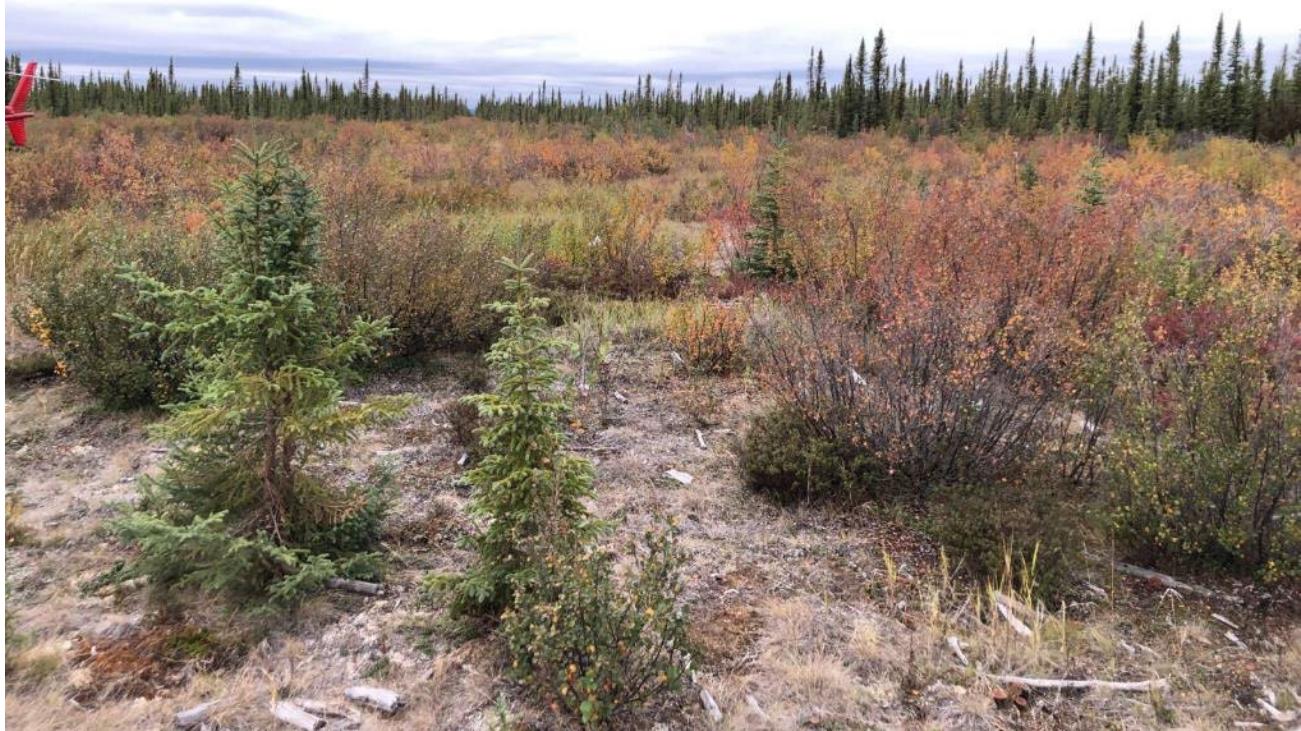
**Photo B.12     K-14 Wellsite Area and Sump Area: Vegetation Cover - Wellsite Area**

Note: Northwest facing view of ground and vegetation conditions in the Wellsite Area. Wellsite Area was undisturbed and the majority of the Site has revegetated with naturally established trees, shrubs, and forbs. Vegetation cover was observed to be meeting permit requirements (i.e., >70% cover and healthy condition) (August 30, 2023).

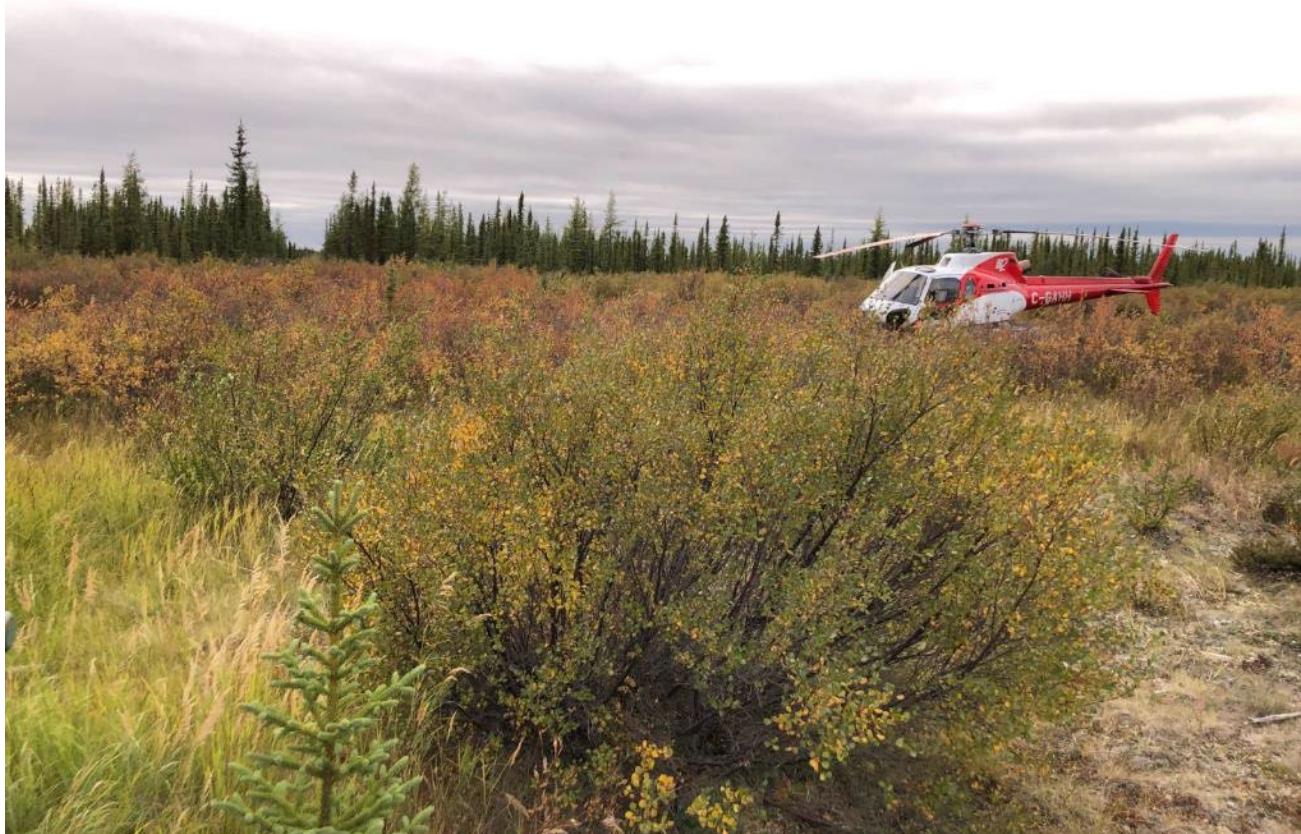
**Photo B.13     K-14 Wellsite Area and Sump Area: Vegetation Cover - Wellsite Area**

Note: Southwest facing view of ground and vegetation conditions in the Wellsite Area. Wellsite Area was undisturbed and the majority of the Site has revegetated with naturally established trees, shrubs, and forbs. Vegetation cover was observed to be meeting permit requirements (i.e., >70% cover and healthy condition) (August 30, 2023).

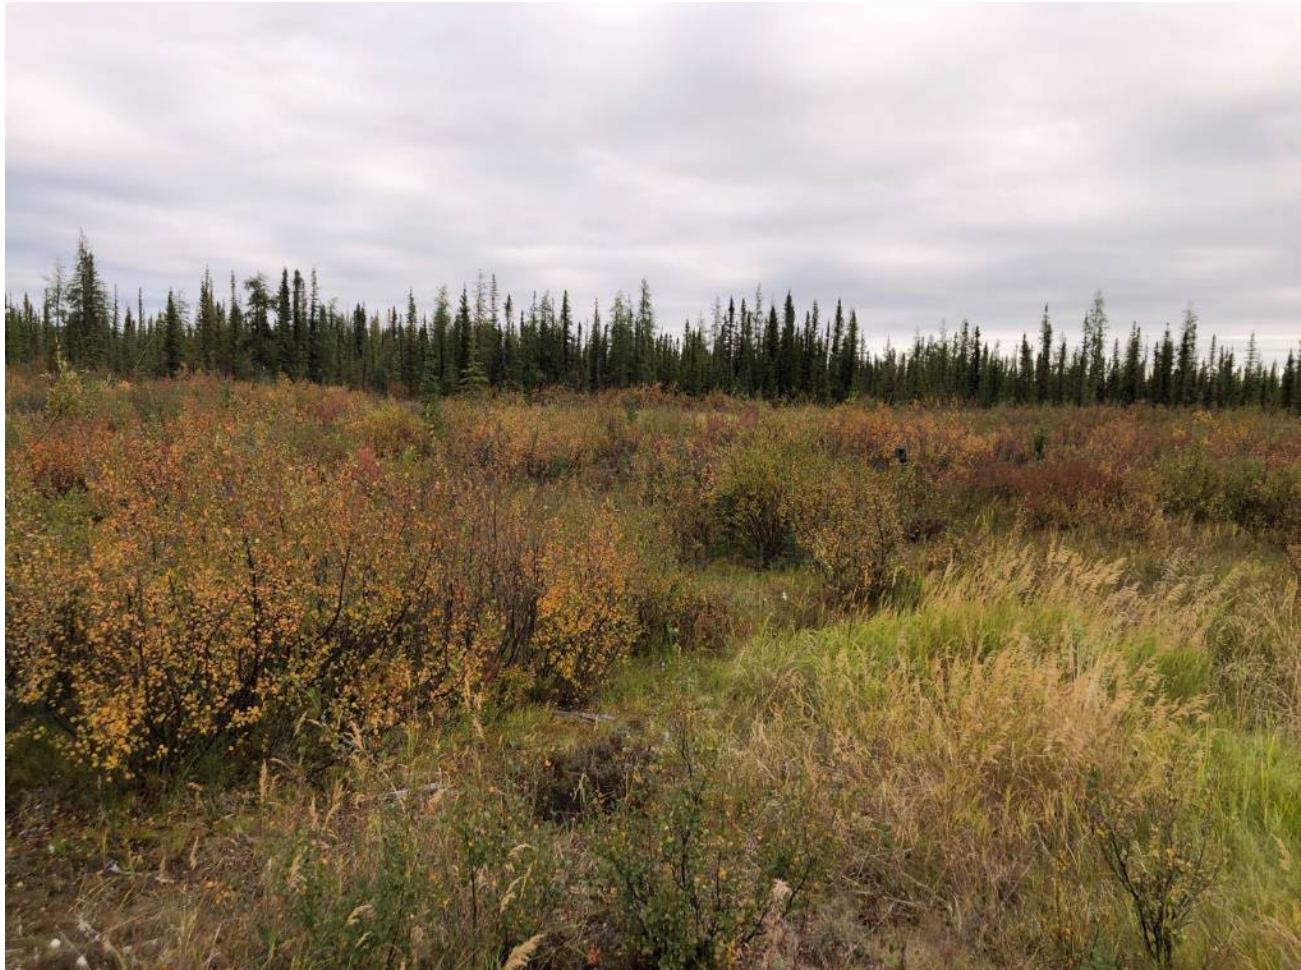
**Photo B.14     K-14 Wellsite Area and Sump Area: Vegetation Cover - Wellsite Area**

Note: Southeast facing view of ground and vegetation conditions in the Wellsite Area. Wellsite Area was undisturbed and the majority of the Site has revegetated with naturally established trees, shrubs, and forbs. Vegetation cover was observed to be meeting permit requirements (i.e., >70% cover and healthy condition) (August 30, 2023).

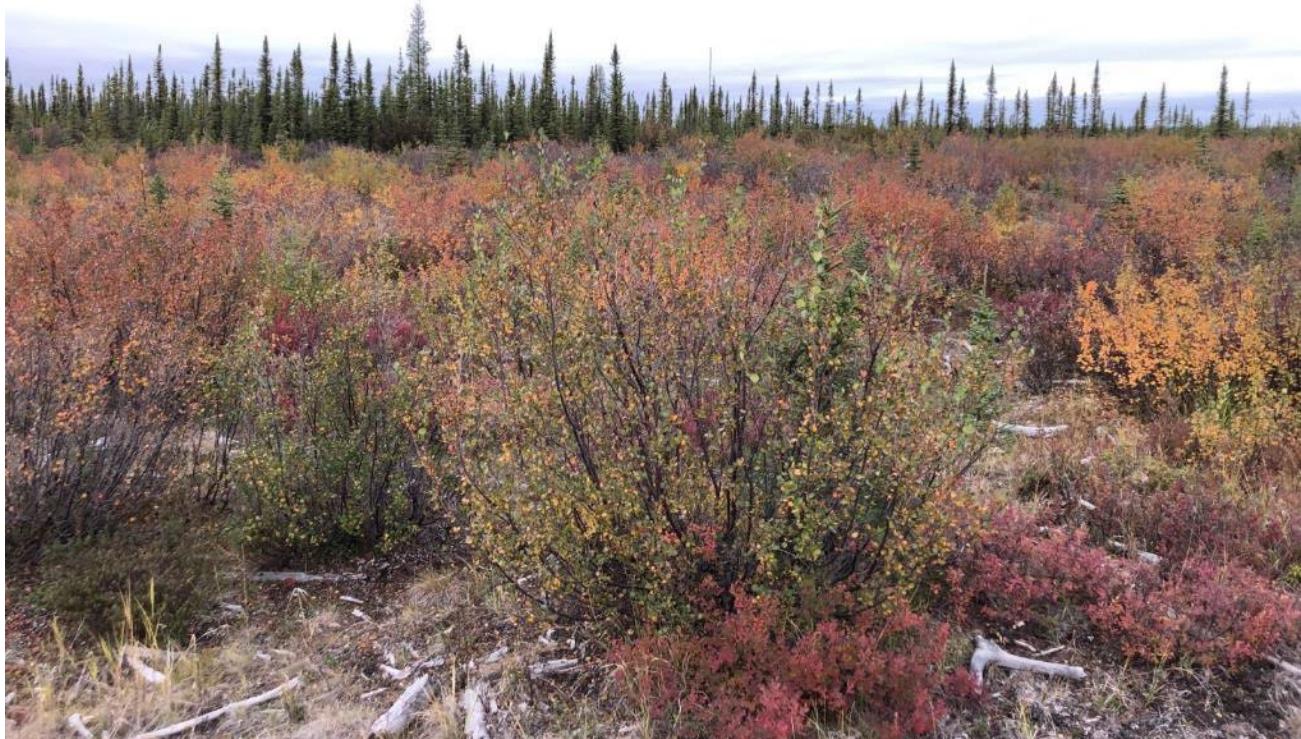
**Photo B.15     K-14 Wellsite Area and Sump Area: Vegetation Cover - Wellsite Area**

Note: Northwest facing view of ground and vegetation conditions in the Wellsite Area. Wellsite Area was undisturbed and the majority of the Site has revegetated with naturally established trees, shrubs, and forbs. Vegetation cover was meeting permit requirements (i.e., >70% cover and healthy condition) (August 30, 2023).

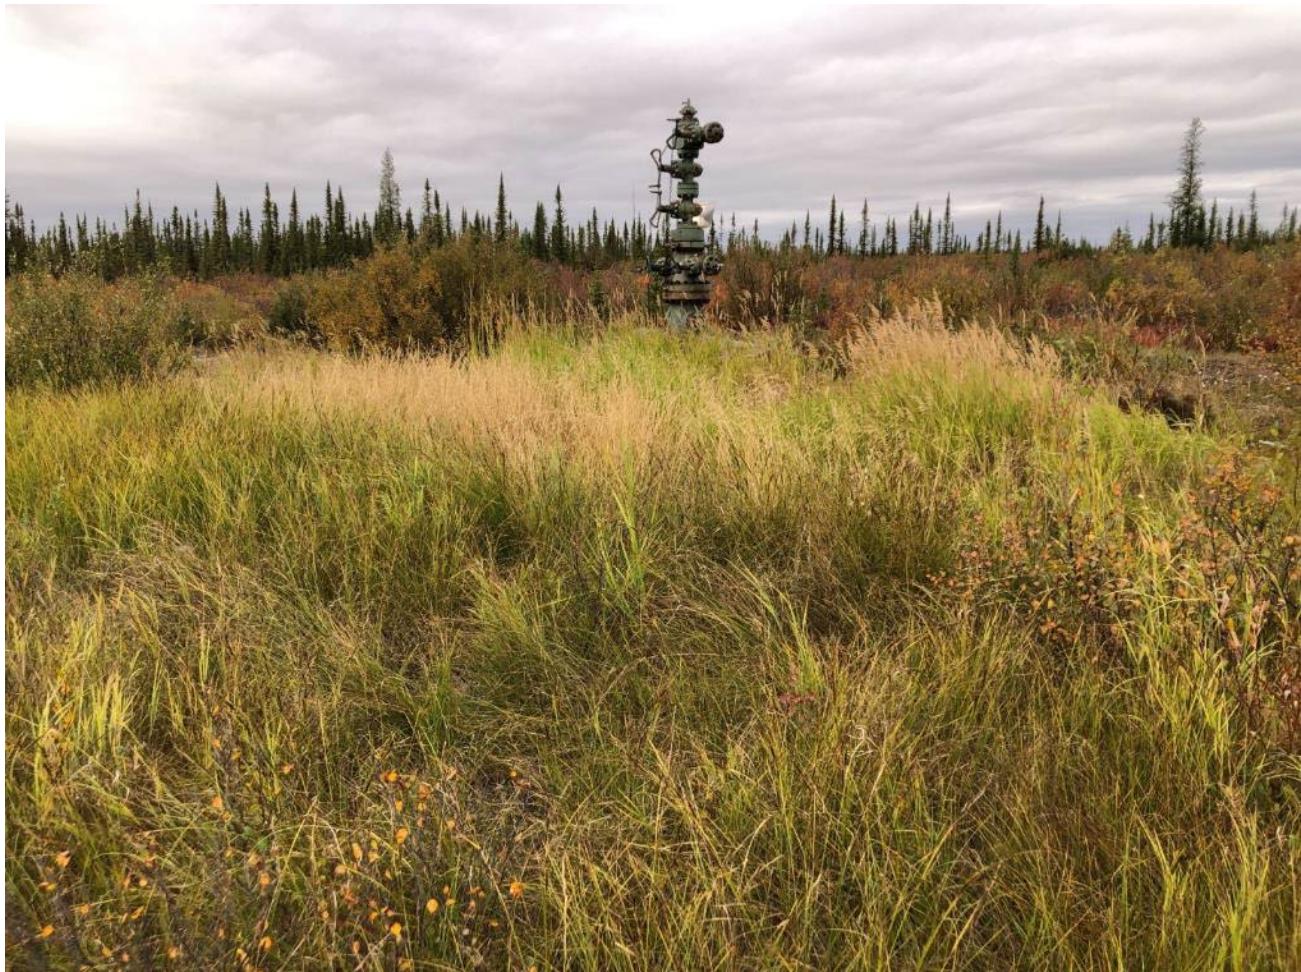
**Photo B.16     K-14 Wellsite Area and Sump Area: Vegetation Cover- Well Centre Wallow**

Note: North facing view of Well Centre Wallow showing ground and vegetation conditions. Area underwent reclamation treatments and was covered with wood debris in July 2019. Vegetation had re-established and did not appear grazed by ungulates, and the ground did not appear impacted by ungulate hoof traffic. Wood debris was still in place. Vegetation cover was approximately 80% to 85% cover, appeared healthy, and was meeting permit requirements (i.e., >70% cover and healthy condition) (August 30, 2023).

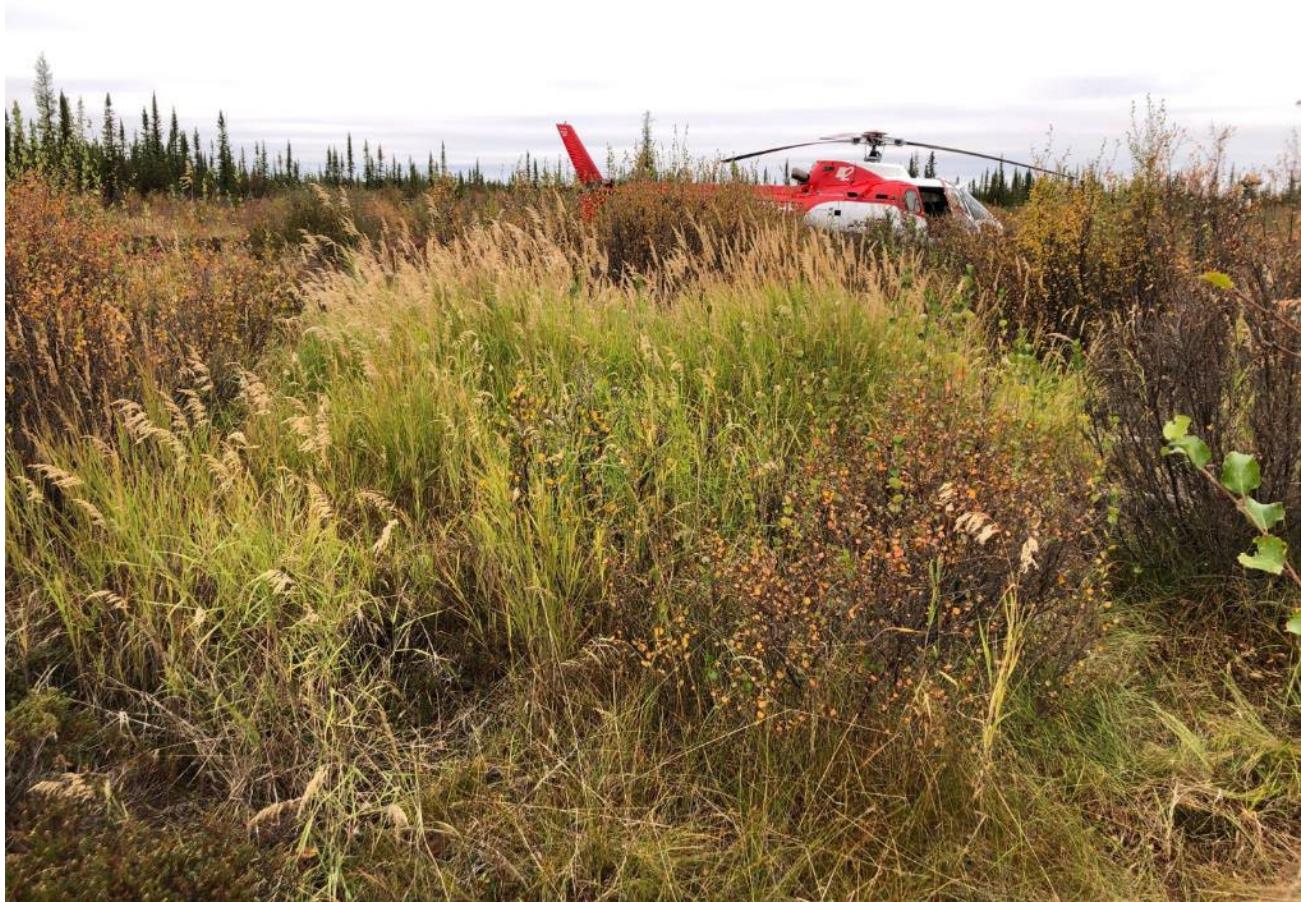
**Photo B.17     K-14 Wellsite Area and Sump Area: Vegetation Cover - Wallow 1**

Note: Northeast facing view of Wallow 1 showing ground and vegetation conditions. Area underwent reclamation treatments and was covered with wood debris in July 2019. Vegetation had re-established and did not appear to be grazed by ungulates, and the ground did not appear impacted by ungulate hoof traffic. Wood debris was still in place. Vegetation cover was approximately 80% to 85% cover, appeared healthy, and was meeting permit requirements (i.e., >70% cover and healthy condition) (August 30, 2023).

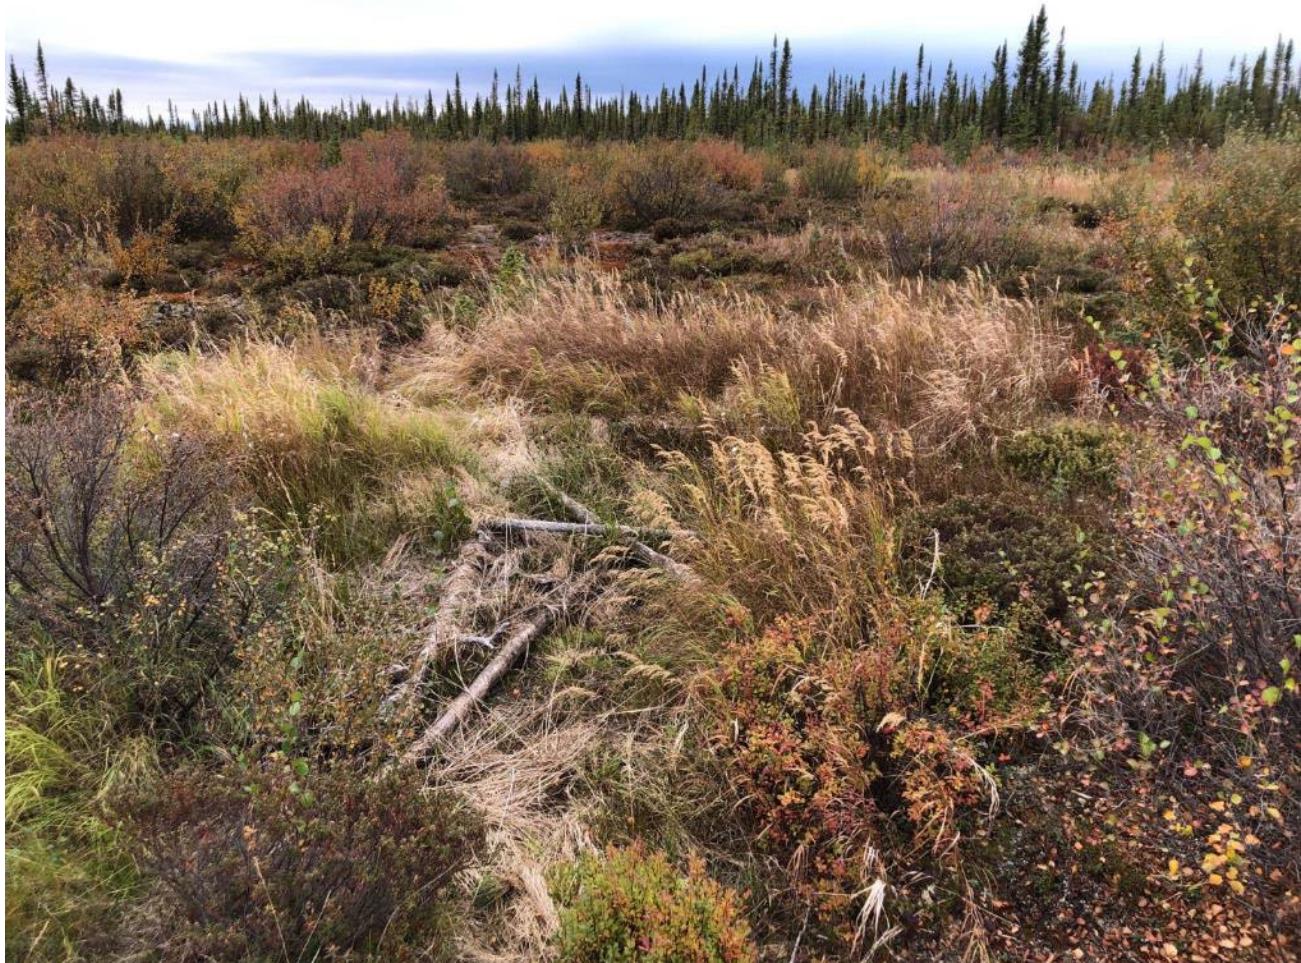
**Photo B.18 K-14 Wellsite Area and Sump Area: Vegetation Cover - Wallow 2**

Note: Northwest facing view of Wallow 2 showing ground and vegetation conditions. Area underwent reclamation treatments and was covered with wood debris in July 2019. Vegetation had re-established and did not appear to be grazed by ungulates, and the ground did not appear impacted by ungulate hoof traffic. Wood debris was still in place. Vegetation cover was approximately 90% to 95% cover, appeared healthy, and was meeting permit requirements (i.e., >70% cover and healthy condition) (August 30, 2023).

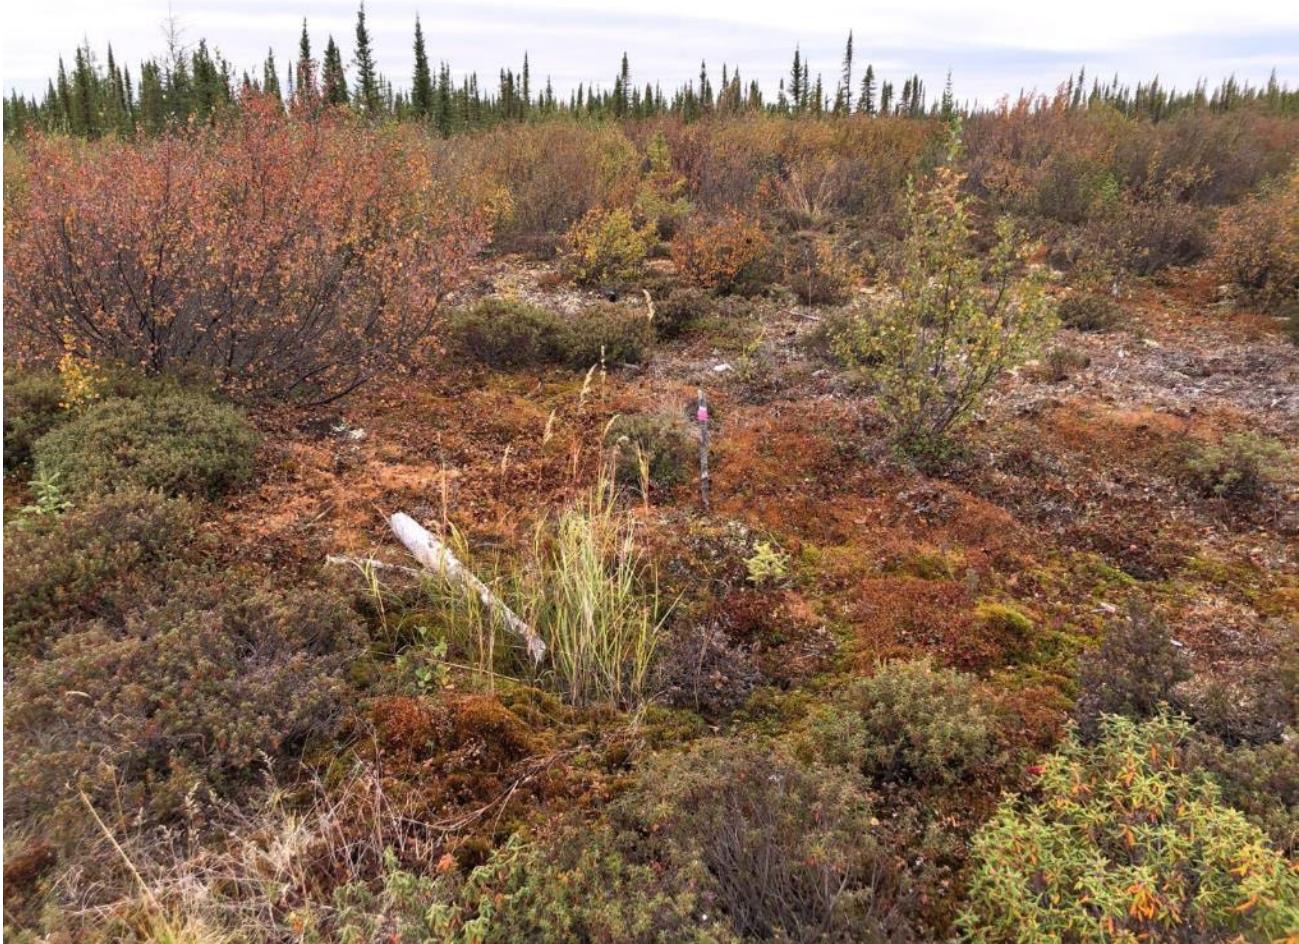
**Photo B.19     K-14 Wellsite Area and Sump Area: Vegetation Cover - Wallow 5**

Note: West facing view of Wallow 5 showing ground and vegetation conditions. Area underwent fertilizer application in July 2019 to enhance growth of naturally established native vegetation. Vegetation had reestablished and did not appear to be grazed by ungulates, and the ground did not appear impacted by ungulate hoof traffic. Vegetation cover was approximately 70% to 75% cover, appeared healthy, and was meeting permit requirements (i.e., >70% cover and healthy condition) (August 30, 2023).

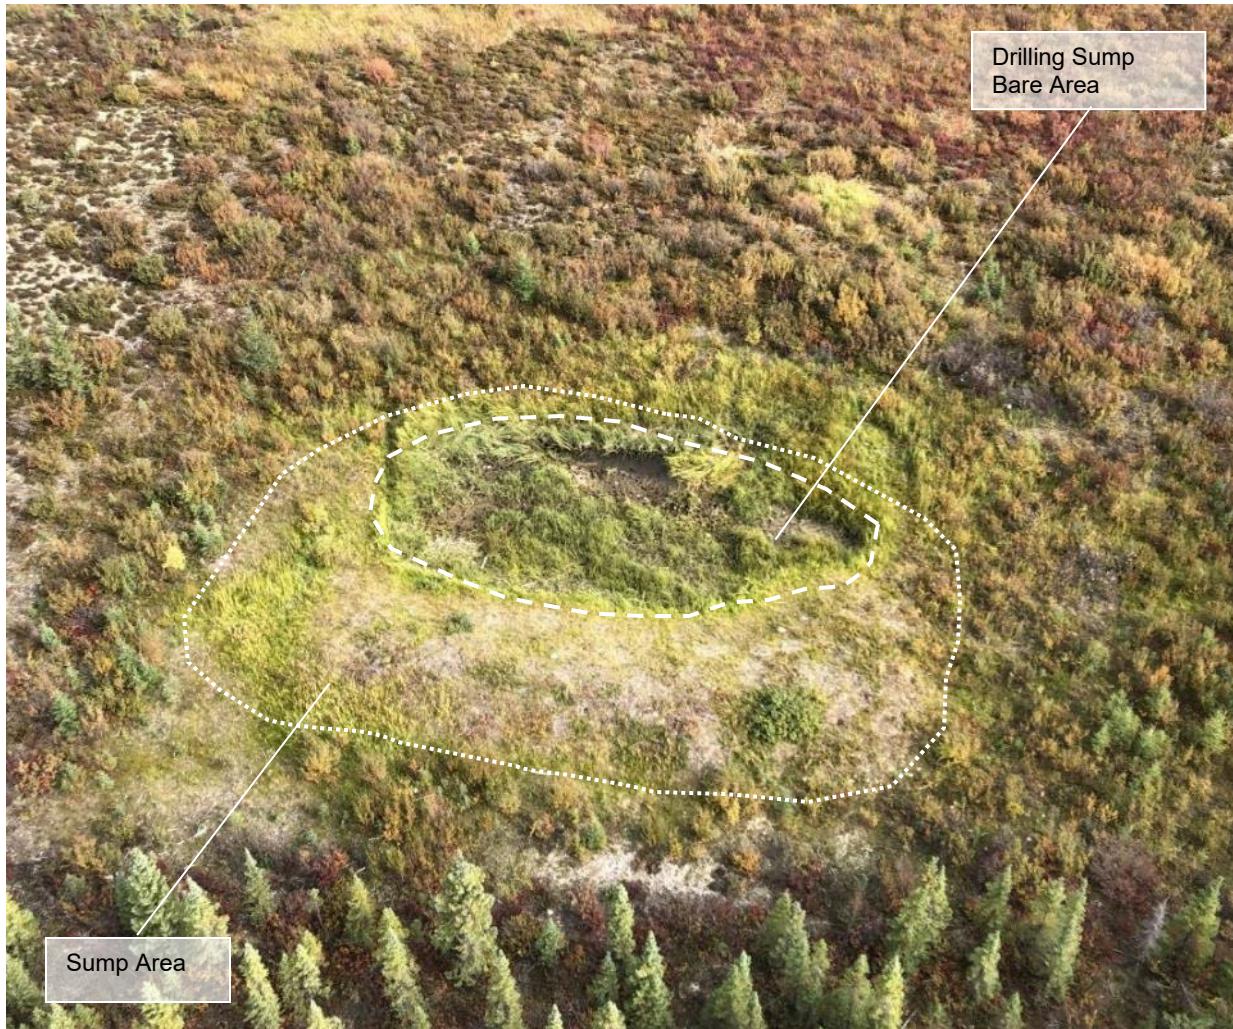
**Photo B.20 K-14 Wellsite Area and Sump Area: Vegetation Cover - Sump Area**

Note: Northeast facing view of ground and vegetation conditions on the Sump Area. Sump Area was revegetated with seeded grasses, and naturally established shrubs, and forbs. Vegetation cover met permit requirements (i.e., >70% cover and healthy condition). Drilling Sump Bare Area had cover consisting of seeded grasses, and naturally established sedges. Vegetation cover was approximately 70% to 75% cover, appeared healthy, and met permit requirements, at the time of the 2023 site visit (i.e., >70% cover and healthy condition) (August 30, 2023).

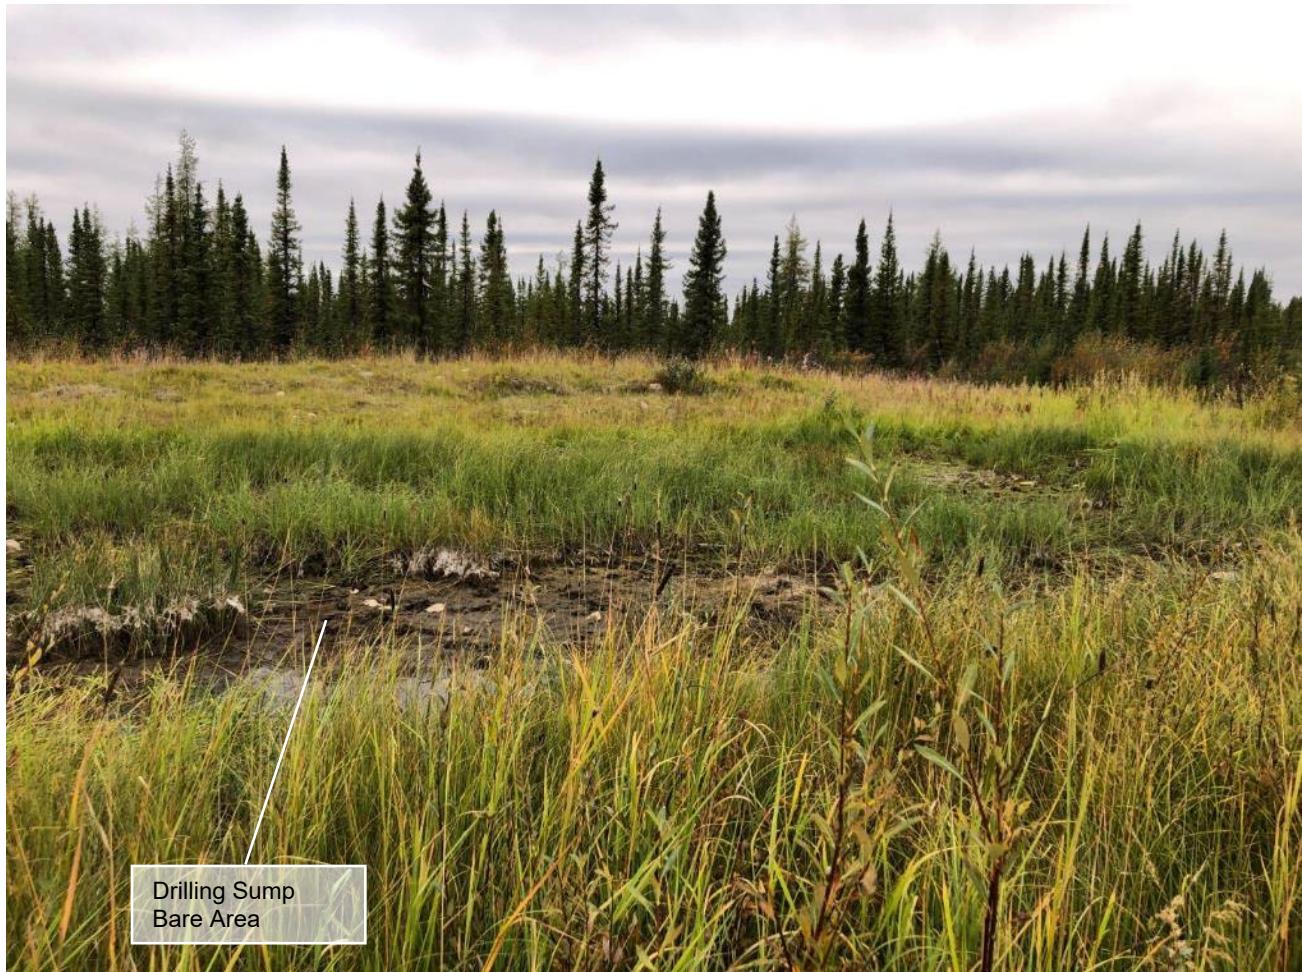
**Photo B.21 K-14 Wellsite Area and Sump Area: Vegetation Cover - Sump Area**

Note: West facing view of ground and vegetation conditions on the Sump Area and Drilling Sump Bare Area. Sump Area revegetated with seeded grasses, and naturally established shrubs, and forbs. Vegetation cover met permit requirements (>70% cover, healthy conditions). Drilling Sump Bare Area had cover consisting of seeded grasses, and naturally established sedges. Vegetation cover was approximately 70% to 75% cover, appeared healthy, and met permit requirements, at the time of the 2023 site visit (i.e., >70% cover and healthy condition) (August 30, 2023).

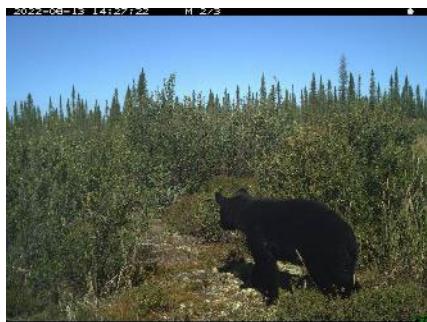
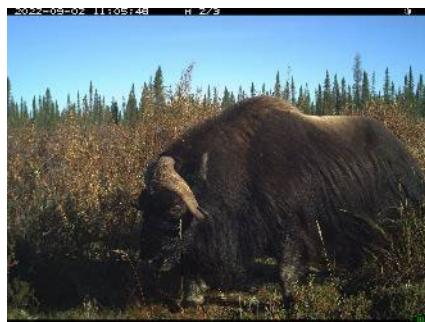
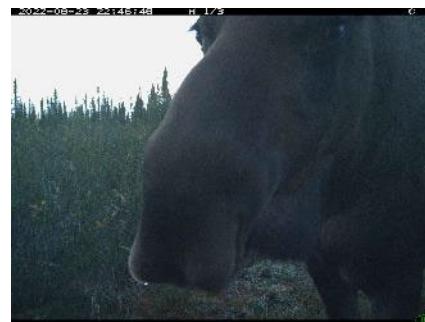
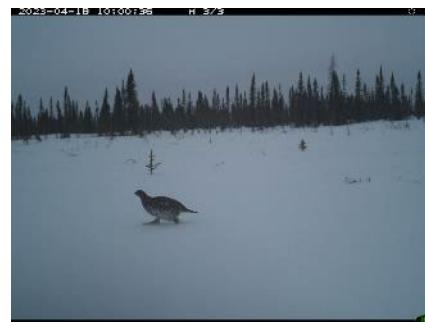
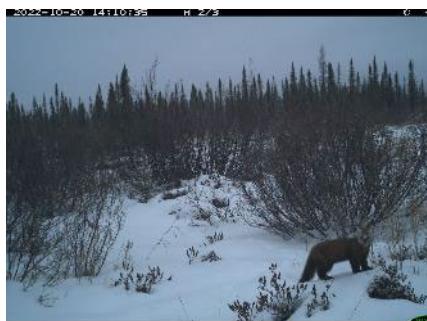
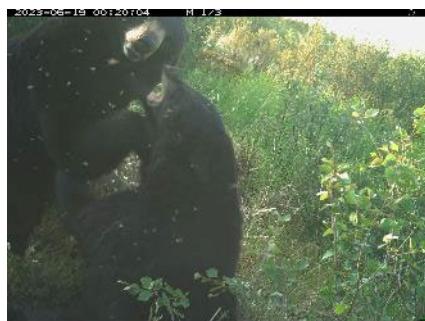
**Photo B.22 K-14 Wellsite Area and Sump Area: Wildlife Signs - Remote Camera Facing Wallow 1**

a) Black bear

b) Muskox

c) Moose

d) Ptarmigan

e) Marten

f) Black bears fighting

Note: Views of wildlife in vicinity of Wallow 1 (August 2022 – June 2023). On June 19, 2023, two black bears fighting next to the camera location knocked the camera out of position and no useful photos were taken for the remainder of 2023.

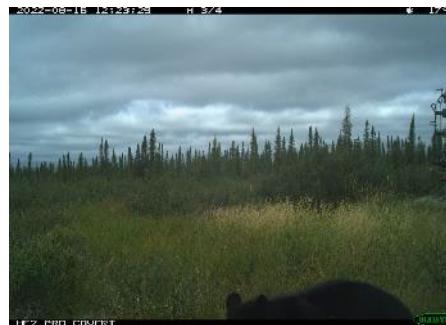
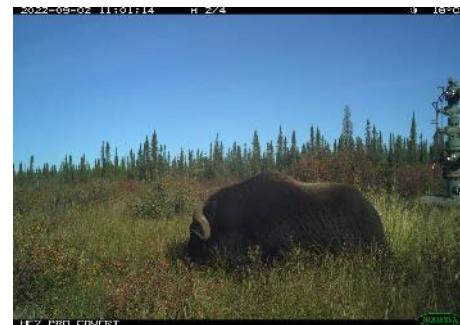
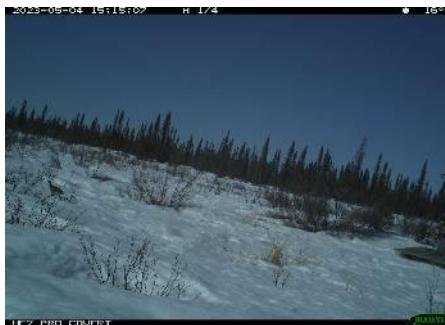
**Photo B.23 K-14 Wellsite Area and Sump Area: Wildlife Signs- Remote Camera Facing Well Centre Wallow and Wellhead**

a) Black bear

b) Muskox

c) Ptarmigan

Note: Views of wildlife in vicinity of Well Centre Wallow (August 2022 – May 2023). On May 8, 2023, an animal knocked the camera out of position and no useful photos were collected for the remainder of 2023.
