Oscar Creek Prospect #1

Quarry Development Plan v.1.1

November 2024

Oscar Creek Granular Prospects Geotechnical Assessment Report Oscar Creek, Northwest Territories

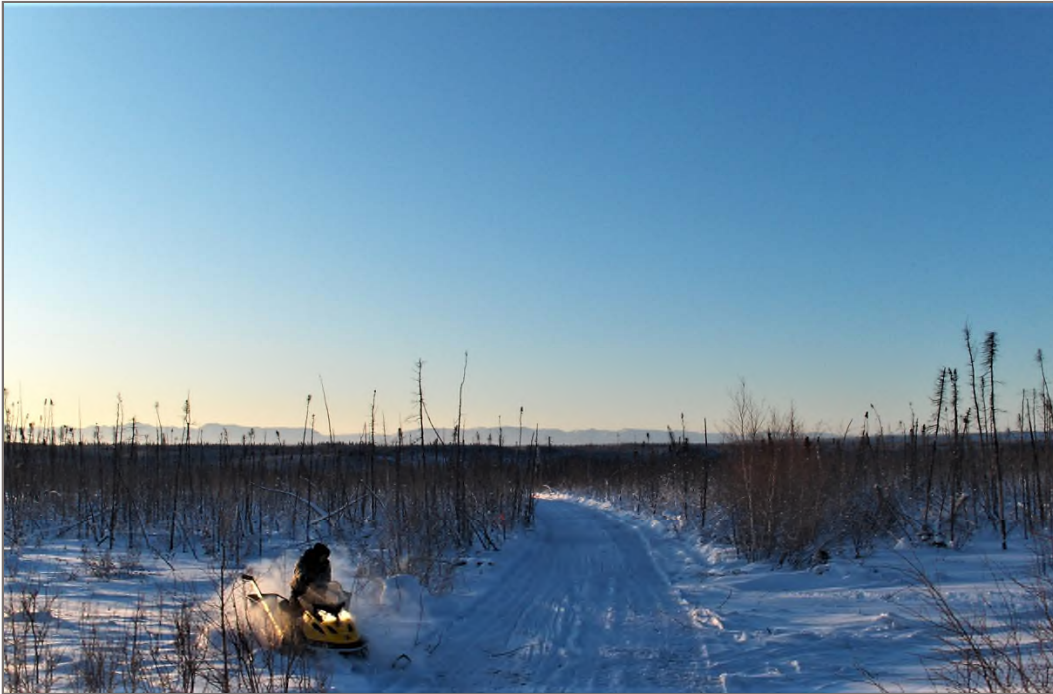
Photo 1: Cutline access from proposed Oscar Creek Bridge to Prospect 1.

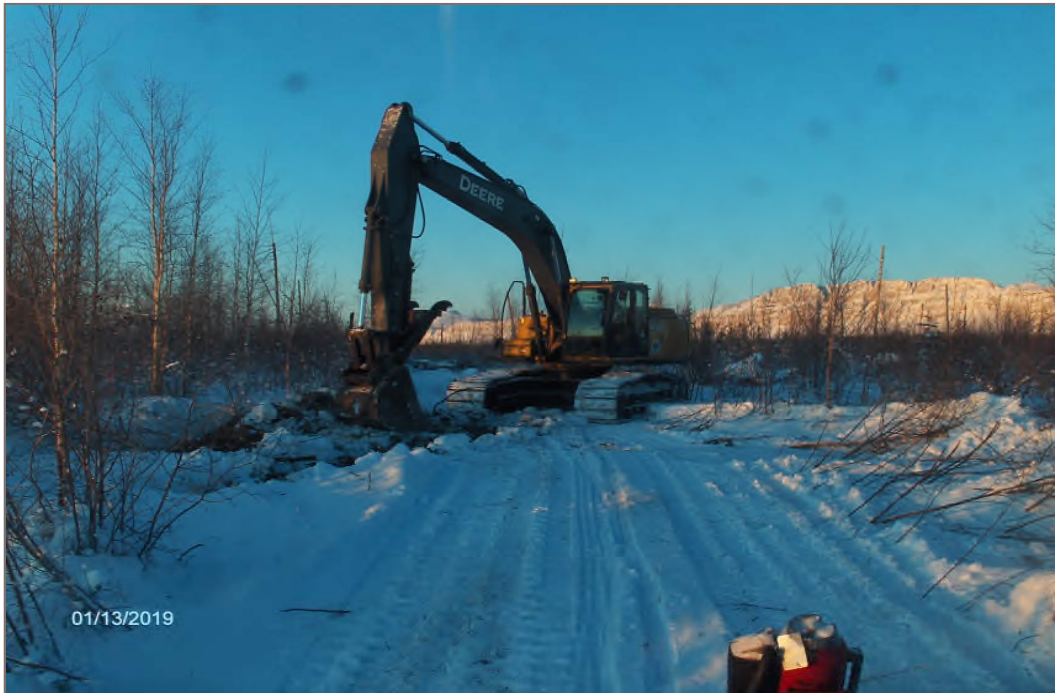
Photo 3: Excavating Testpit 6 at Prospect 1.

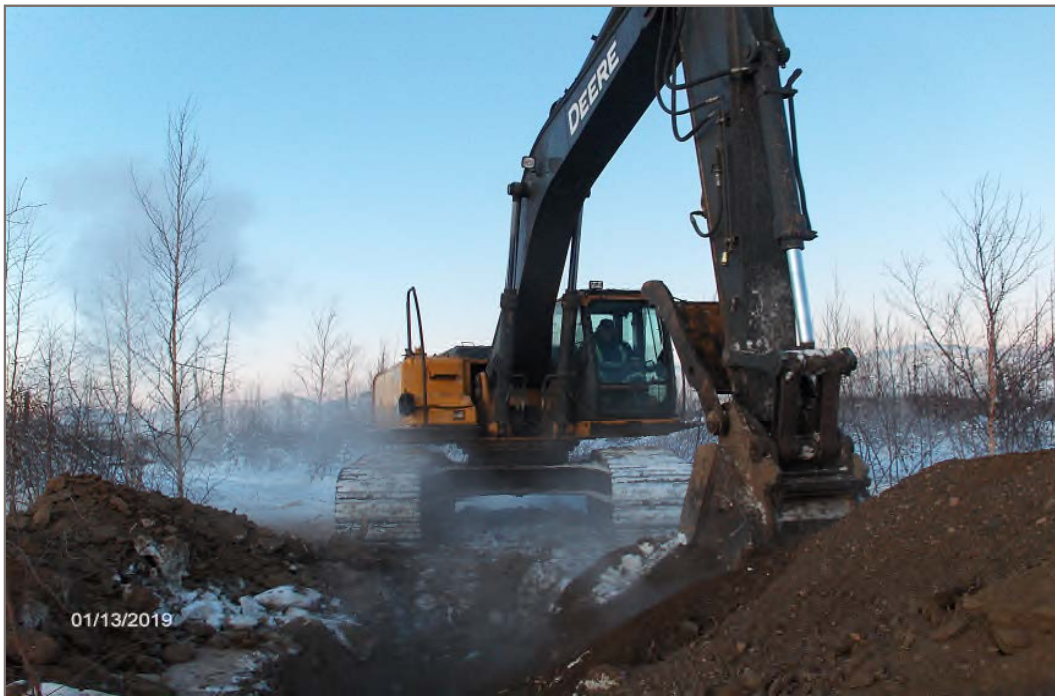
Photo 4: John Deere 270D LC excavator used for testpitting.

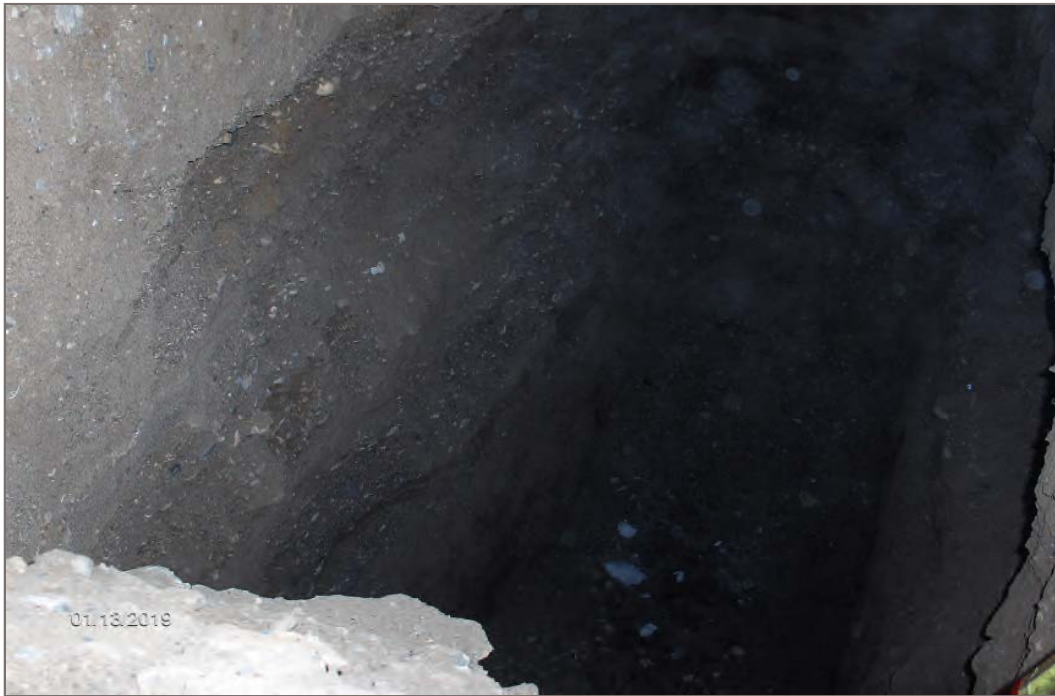
Photo 5: Prospect 1, Testpit 1.
Gravel, sandy below 1.0 m depth.

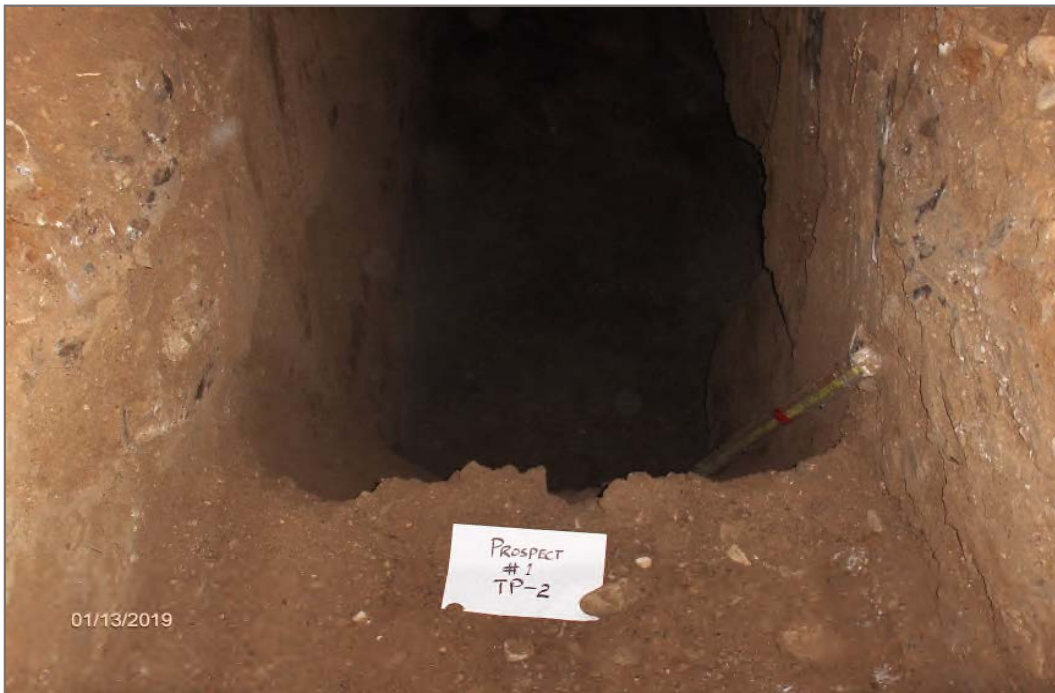
Photo 6: Prospect 1, Testpit 2.
Gravel and Sand.

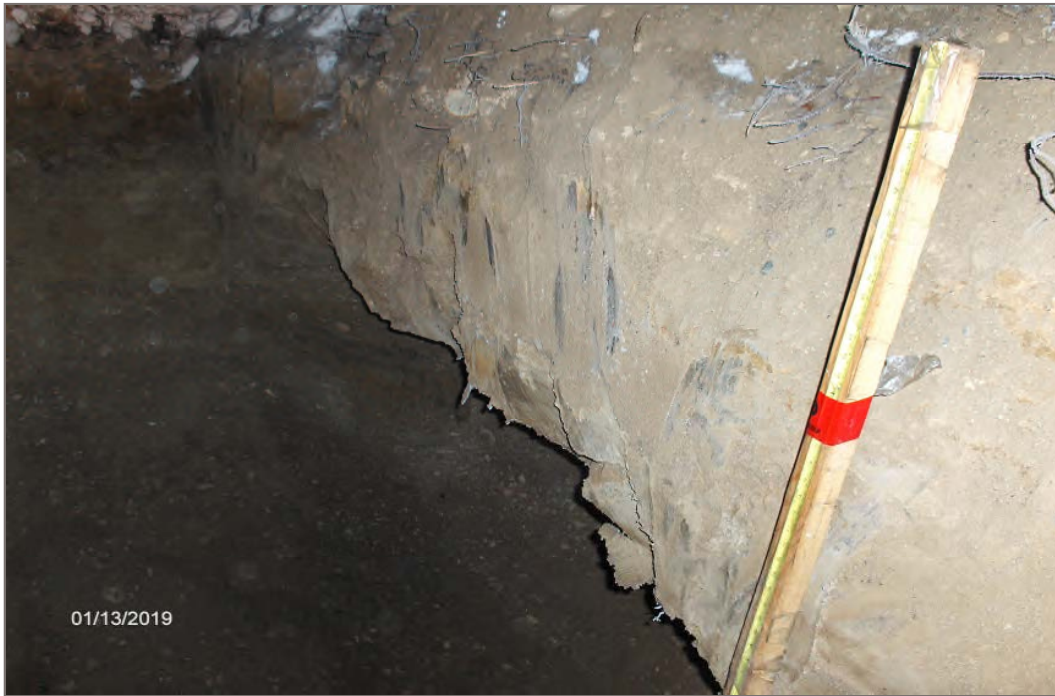
Photo 7: Prospect 1, Testpit 3.
Sand, silty underlain by topsoil.

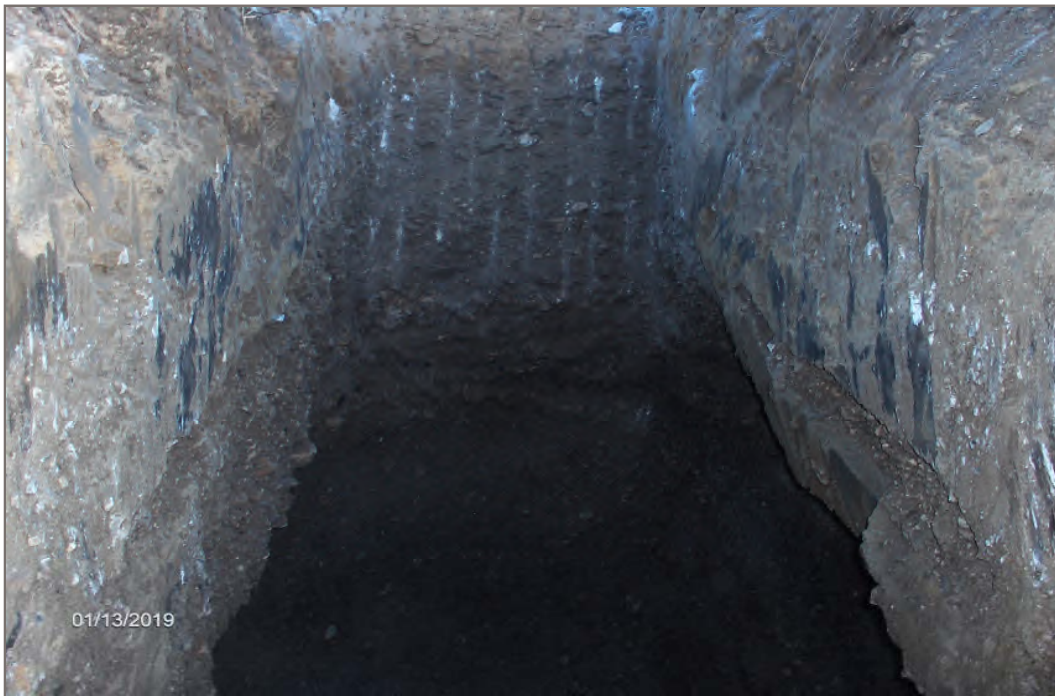
Photo 8: Prospect 1, Testpit 4.
Gravel at approximately 1.0 m depth underlain by gravelly sand.

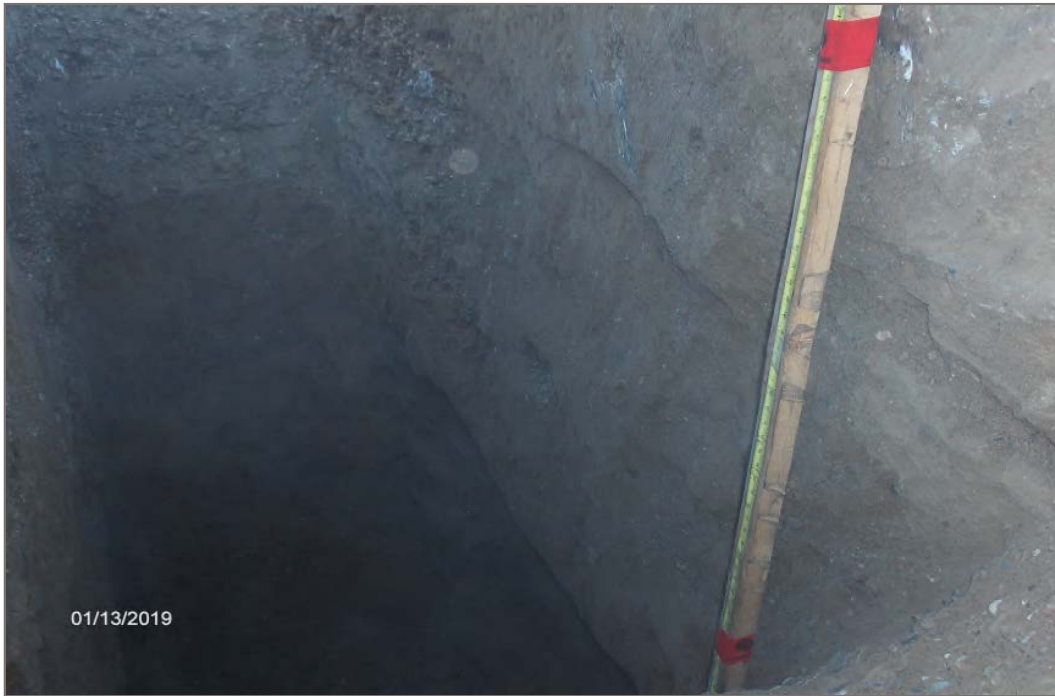
Photo 9: Prospect 1, Testpit 5.
Alternating layers of sandy gravel and silty sand.

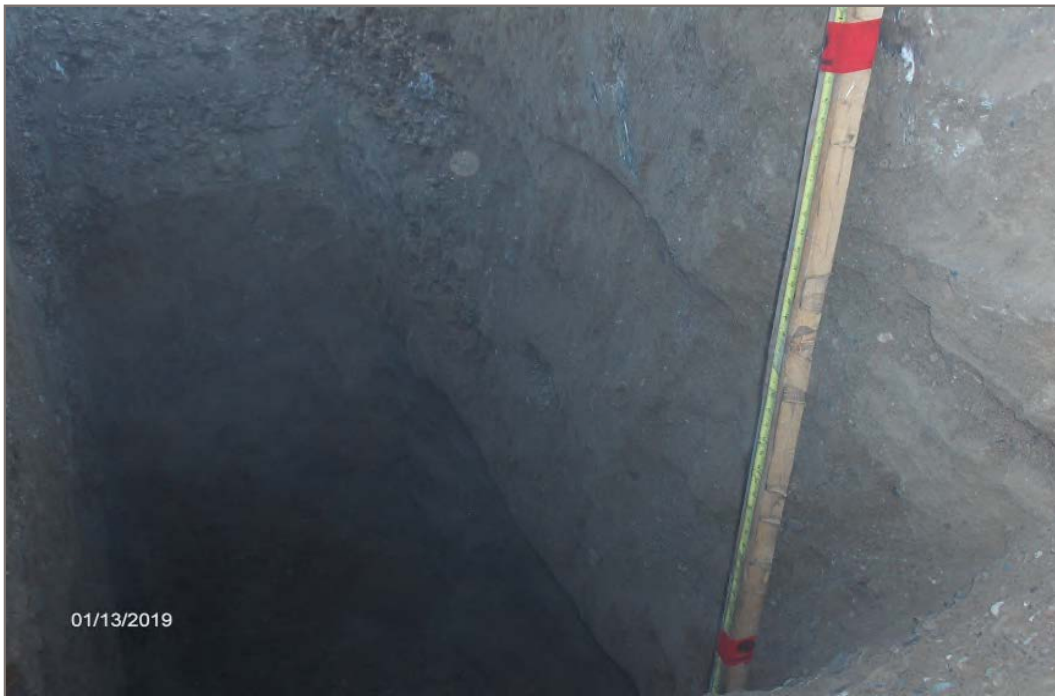
Photo 10: Prospect 1, Testpit 6.
Alternating layers of sandy gravel and silty sand.

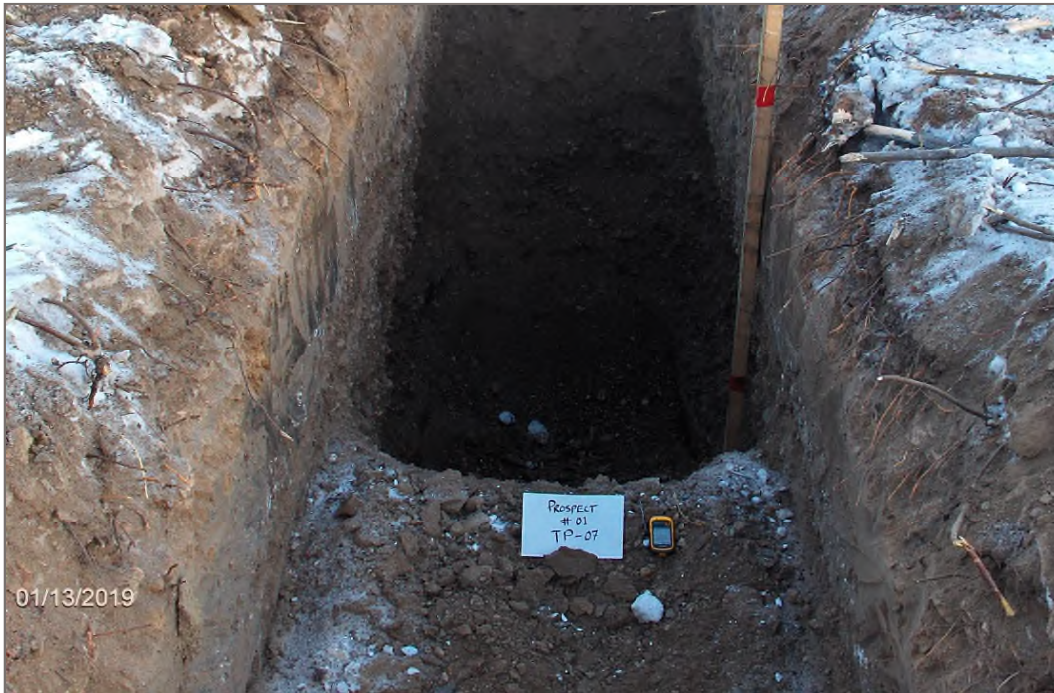
Photo 11: Prospect 1, Testpit 7.
Sand, silty underlain by topsoil and gravels to about 1.0 m depth.

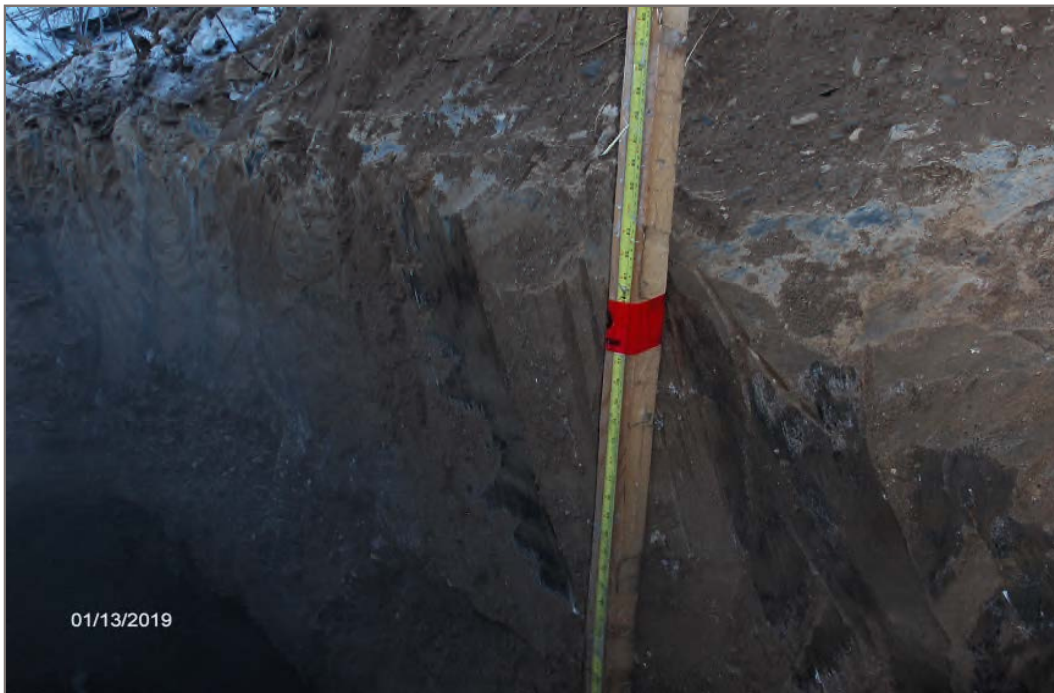
Photo 12: Prospect 1, Testpit 8.
Sand, silty underlain by gravel starting at about 1.5 m depth.

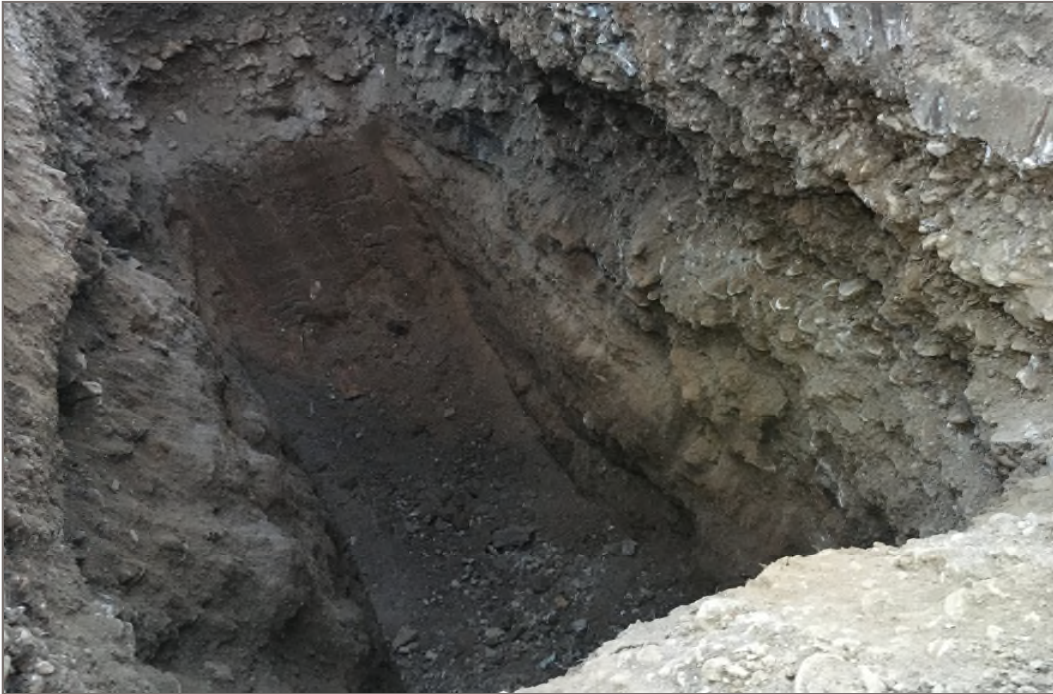
Photo 13: Prospect 2, Testpit 1.
Gravel, sandy from 0.4 m to 2.0 m depth.

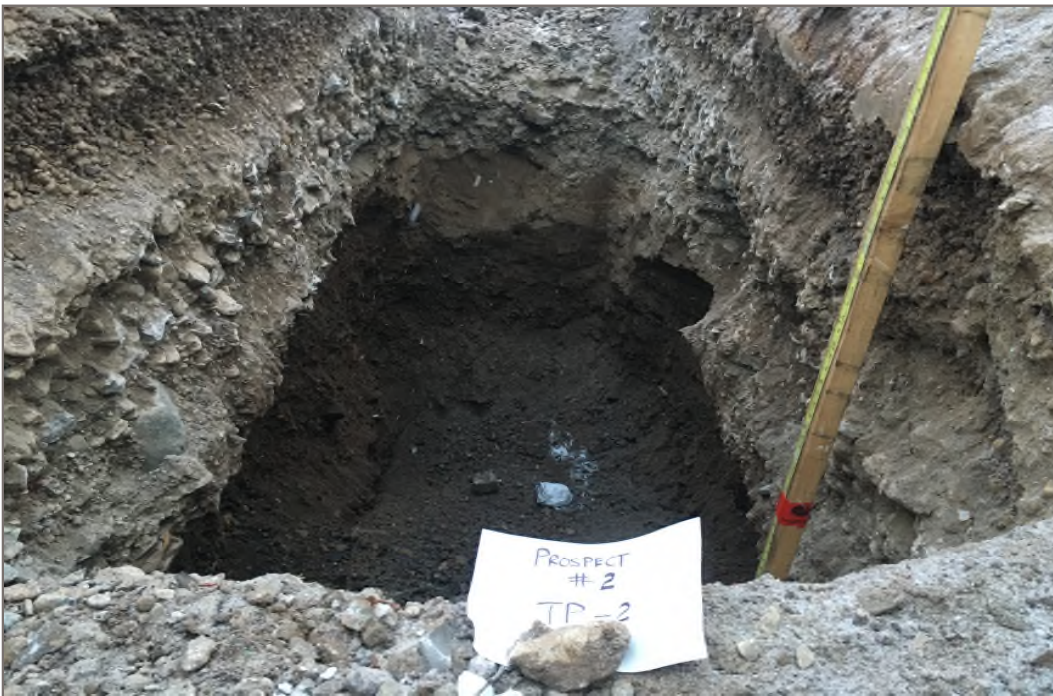
Photo 14: Prospect 2, Testpit 2.
Boulder can be seen in left wall.

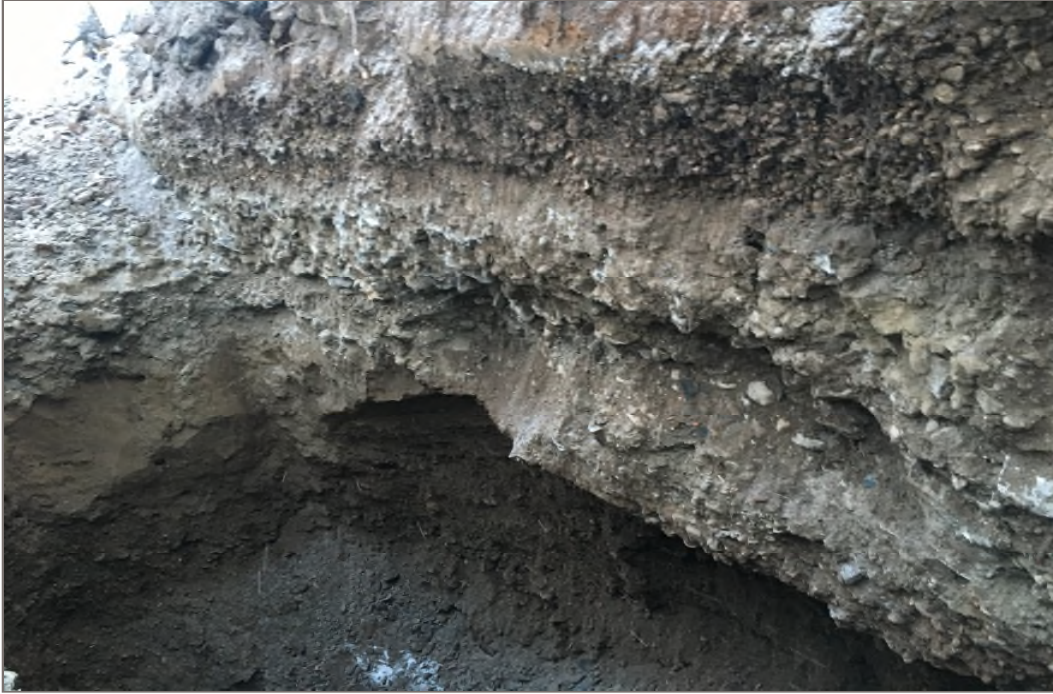
Photo 15: Prospect 2, Testpit 2.
Gravel from 0.8 m to 1.5 m depth.

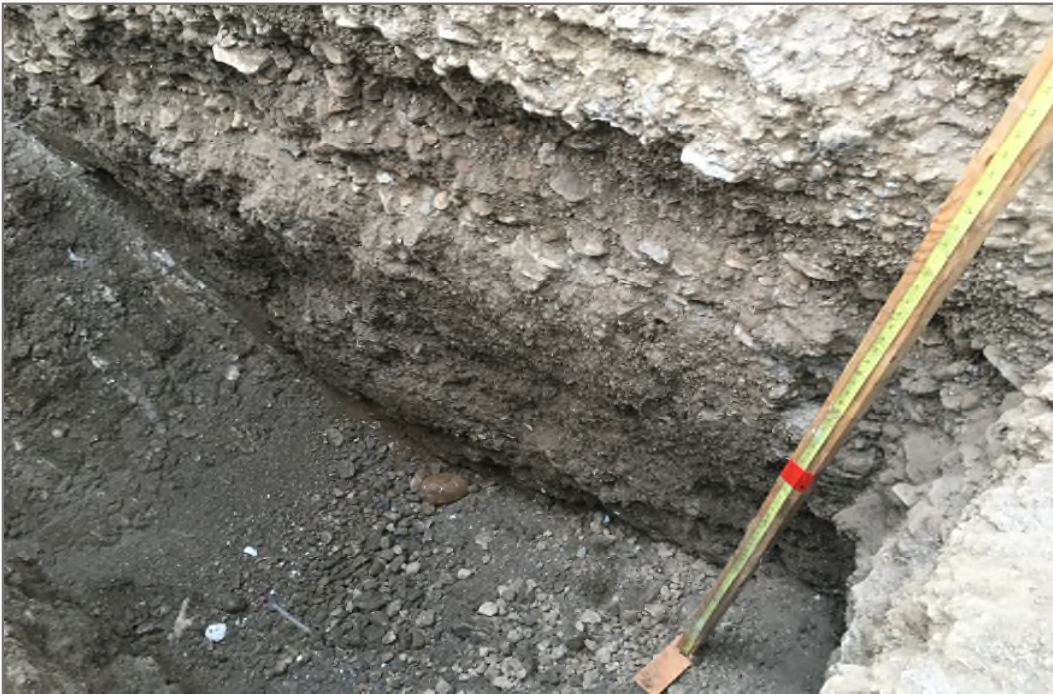
Photo 16: Prospect 2, Testpit 3.
Gravel, sandy from 0.3 m to 4.2 m depth.

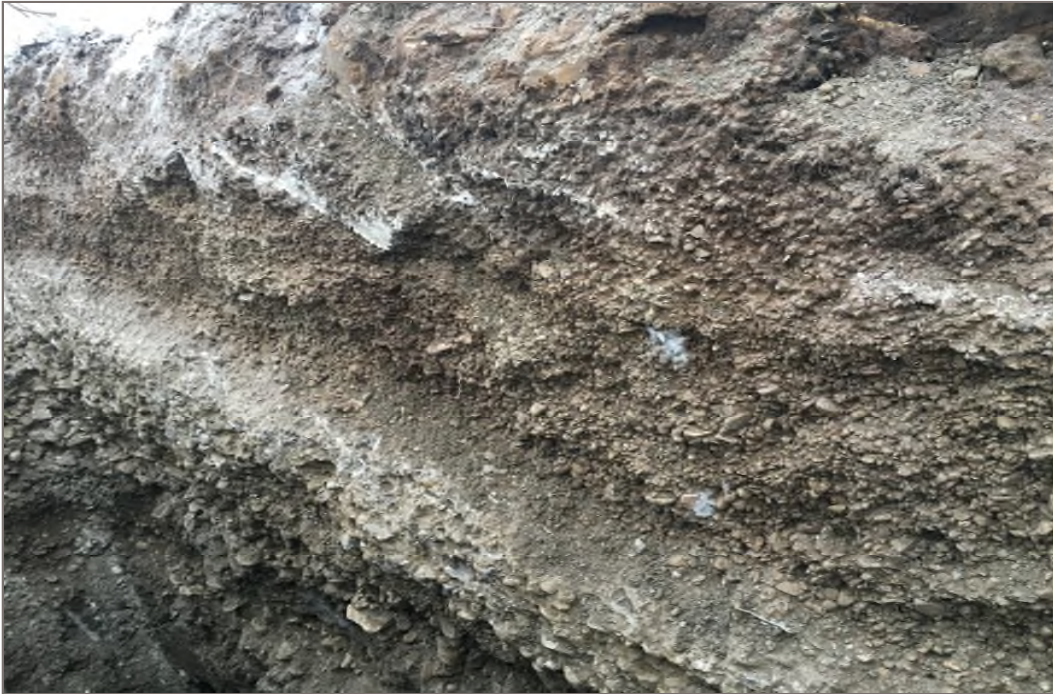
Photo 17: Prospect 2, Testpit 3.
Gravel, sandy from 0.3 m to 4.2 m depth.

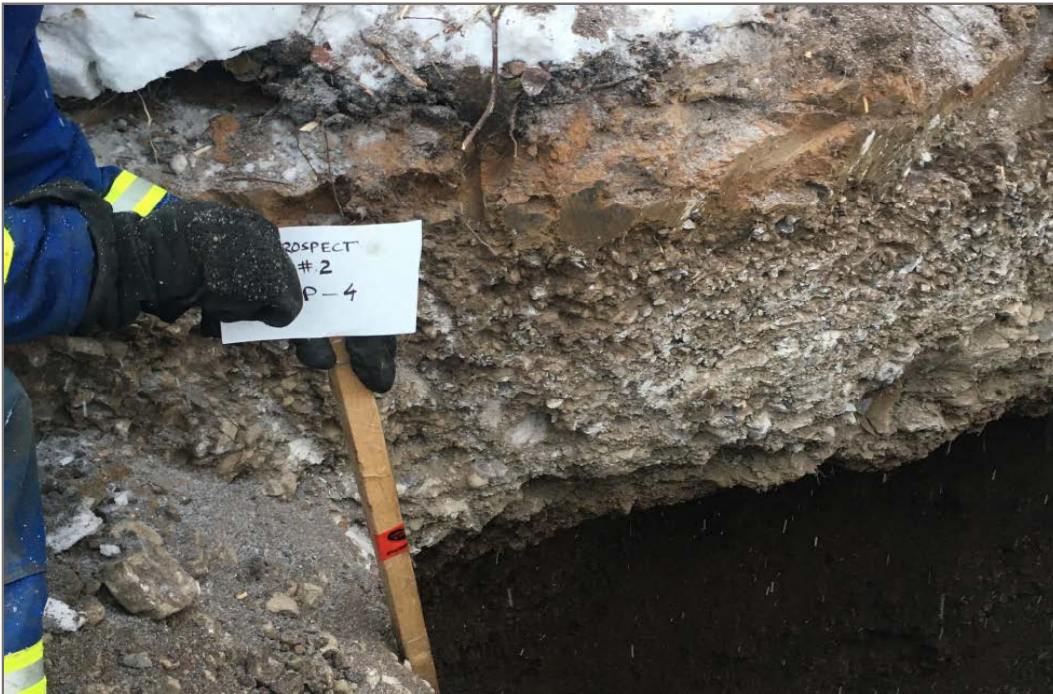
Photo 18: Prospect 2, Testpit 4.
Gravel, sandy from 0.3 m to 1.2 m depth.

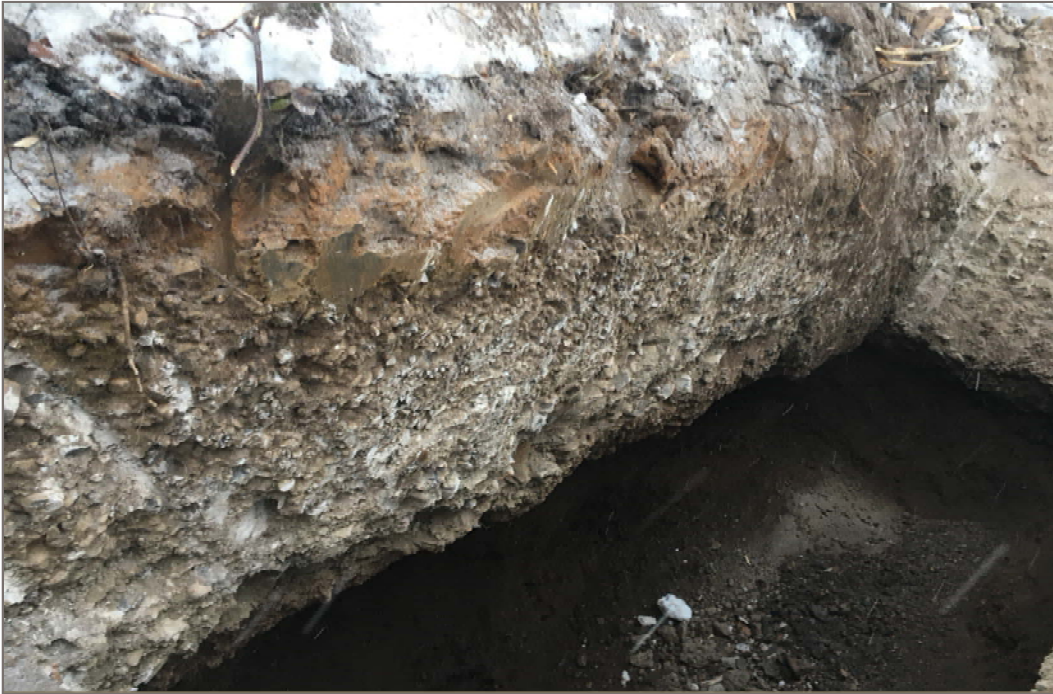
Photo 19: Prospect 2, Testpit 4.
Gravel, sandy from 0.3 m to 1.2 m depth.

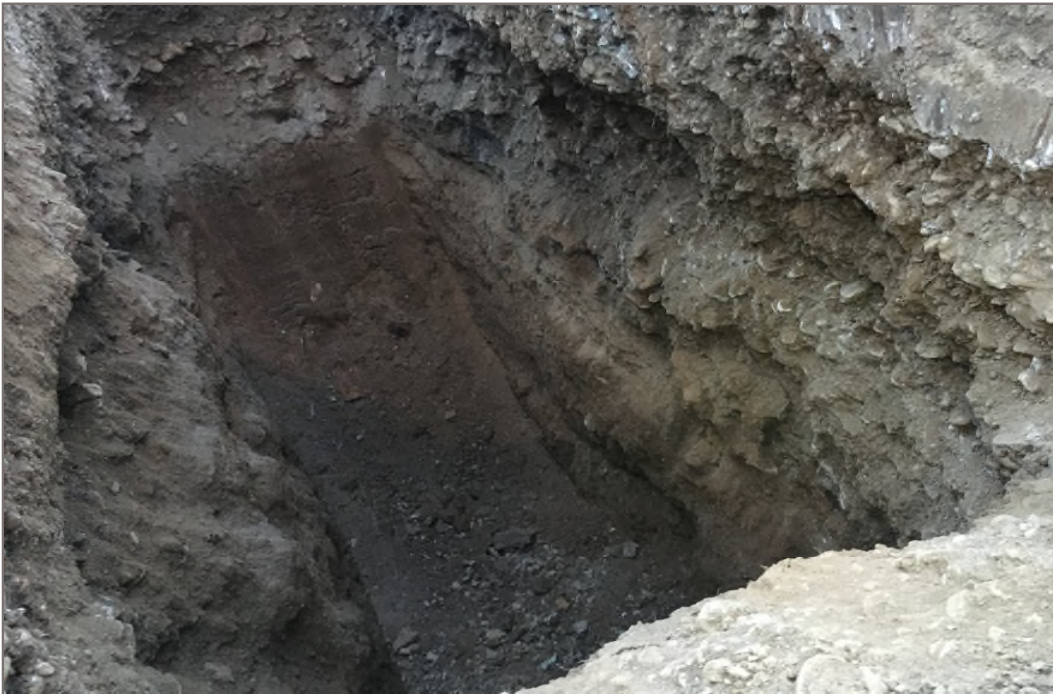
Photo 20: Prospect 3, Testpit 1.
Gravel, sandy from 0.4 m to 2.0 m depth.

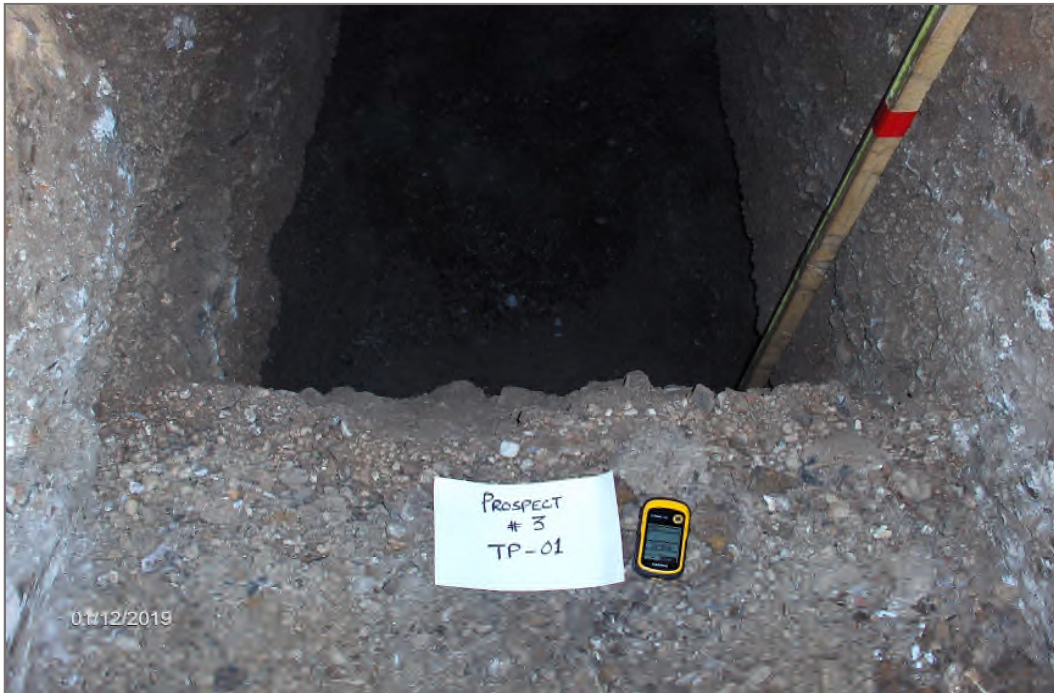
Photo 21: Prospect 3, Testpit 1.
Gravel, sandy from 0.4 m to 4.2 m depth.

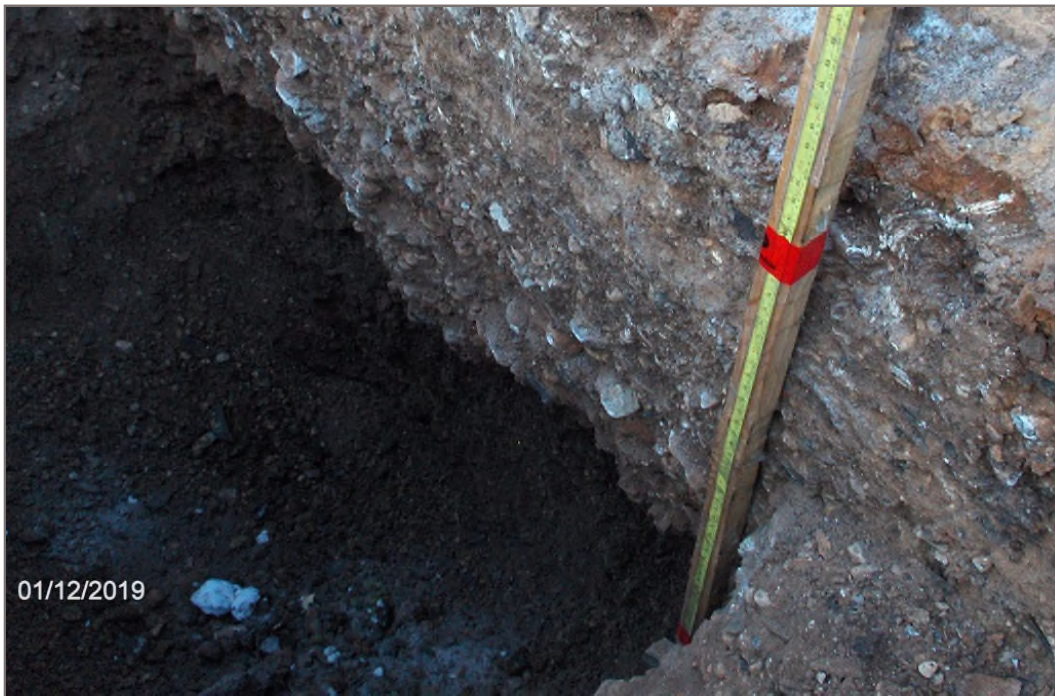
Photo 24: Prospect 3, Testpit 3.
Coarse-grained materials from 0.5 m to 1.6 m depth.

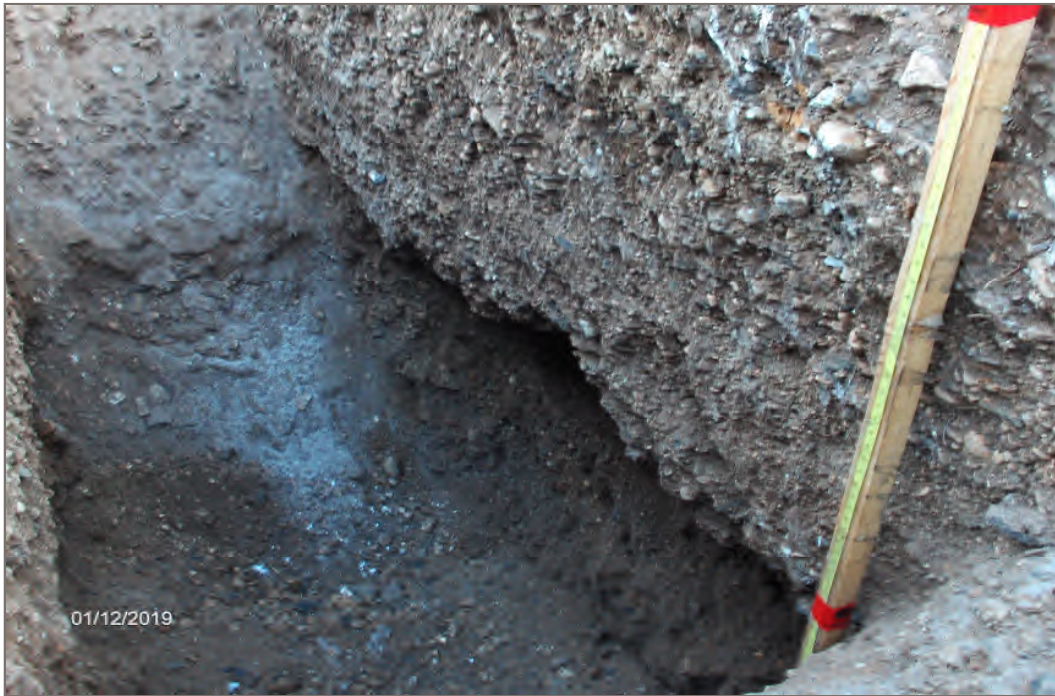
Photo 25: Prospect 3, Testpit 4.
Gravel from 0.6 m to 4.5 m depth.

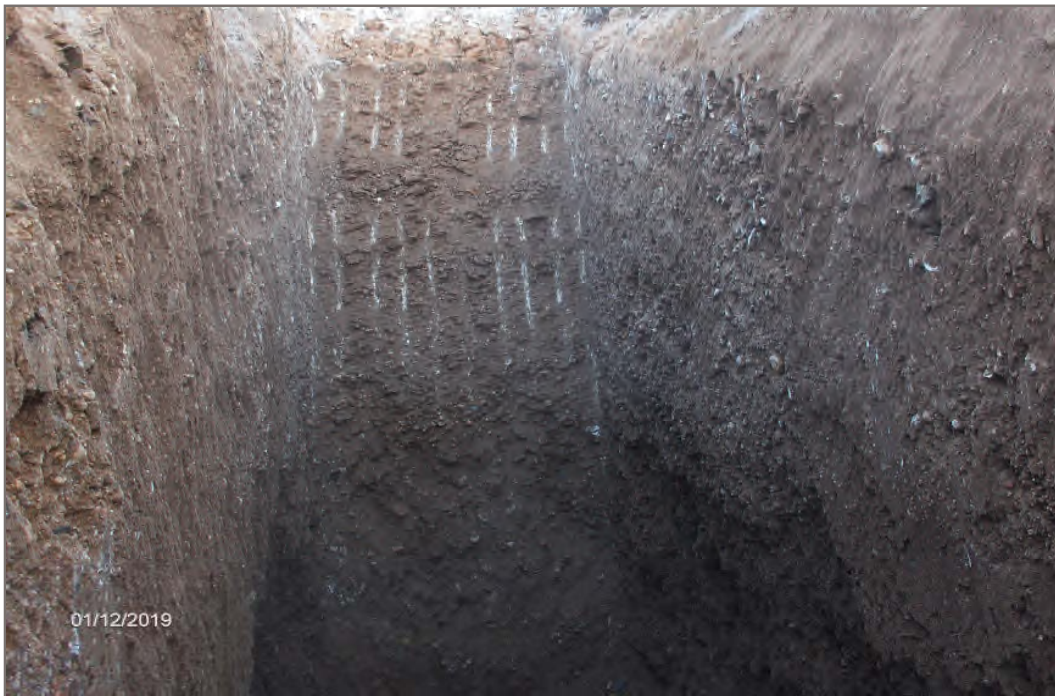
Photo 26: Prospect 3, Testpit 5.
Gravel, sandy from 0.4 m to 4.0 m depth.

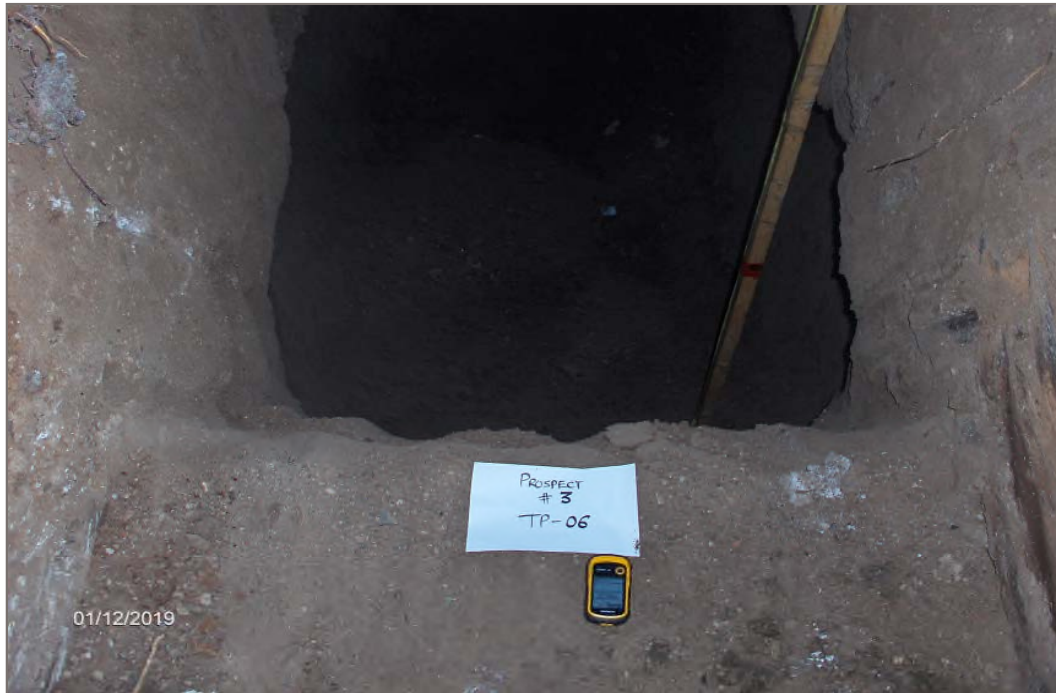
Photo 27: Prospect 3, Testpit 6.
Sand and gravel from 0.5 m to 4.5 m depth.

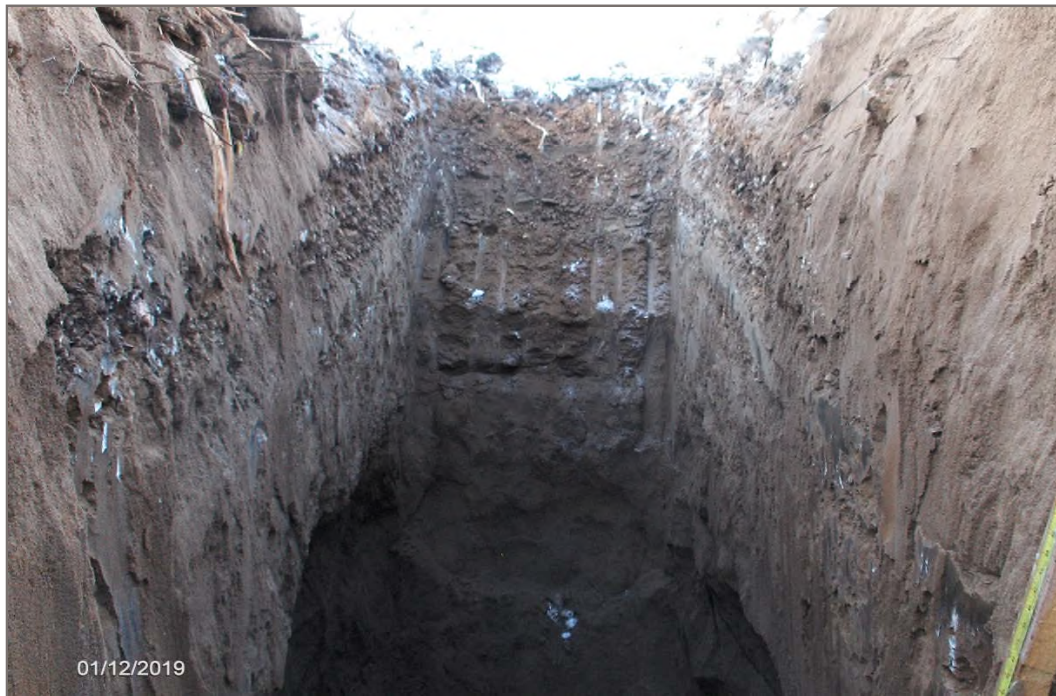
Photo 28: Prospect 3, Testpit 7.
Gravel, sandy from 0.6 m to 1.5 and sand, gravelly from 1.5 m to 3.5 m depth.

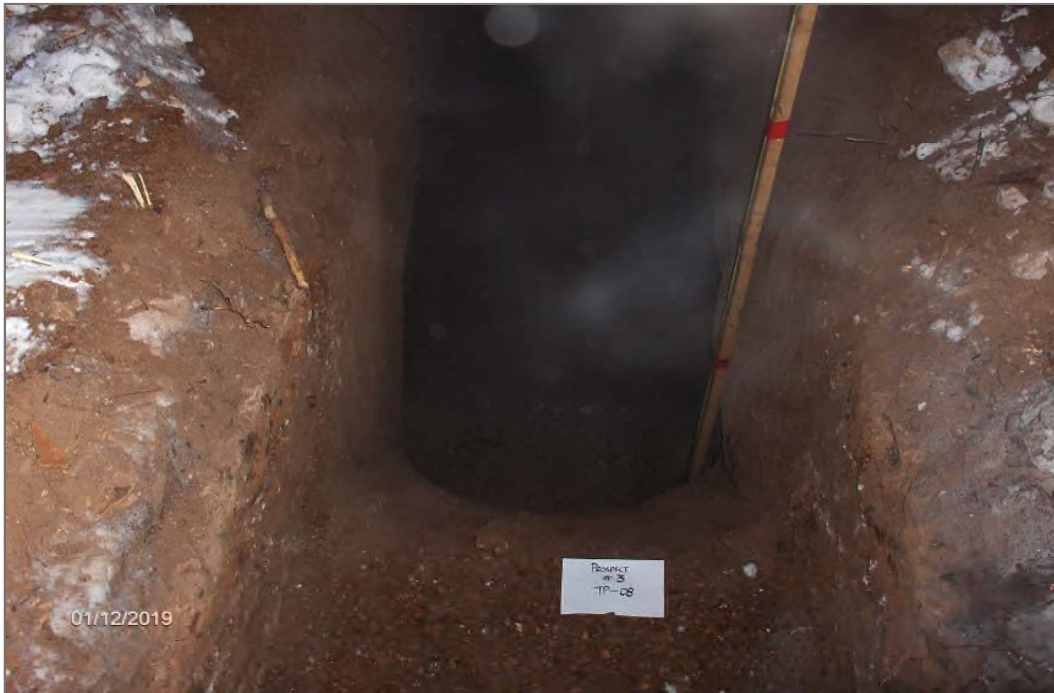
Photo 29: Prospect 3, Testpit 8.
Gravel and sand from 0.5 m to 4.5 m depth.

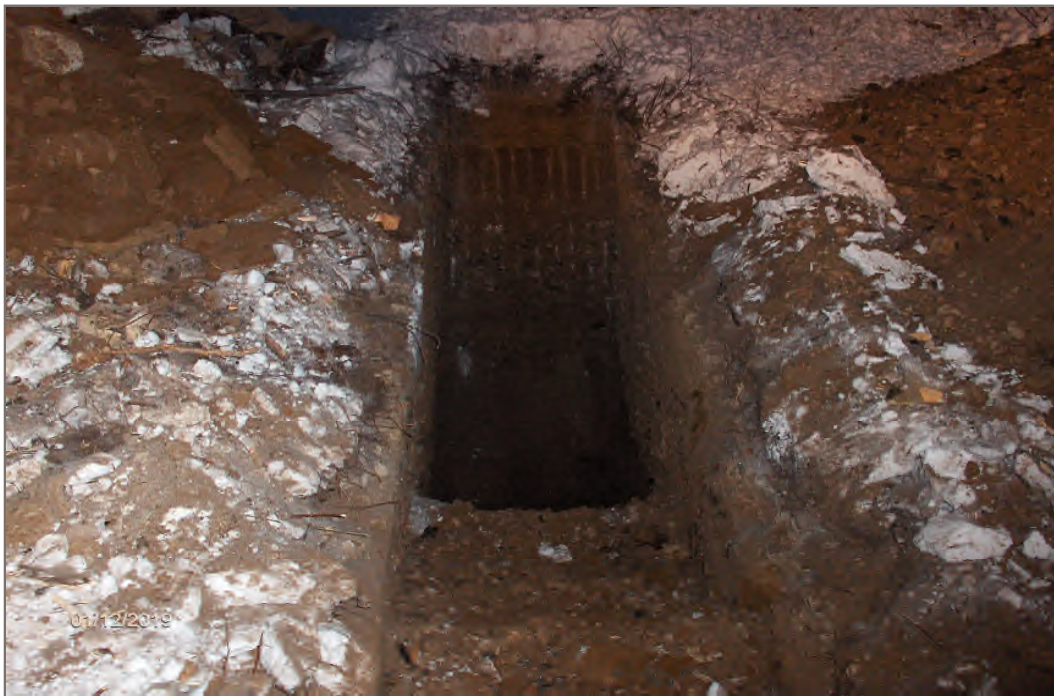
Photo 30: Prospect 3, Testpit 9.
Gravel, sandy and sand from 1.0 m to 4.0 m.
