SPIDER LAKE INTERIM CLOSURE AND RECLAMATION PLAN

REPORT

Merc Reclamation Land Use Permit Application 2012

Report Number: 11-1328-0040

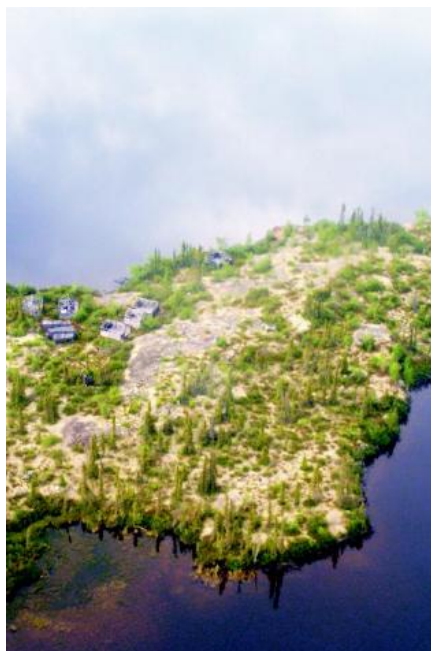
Figure 1: Mahogany Campsite (Southeast View) (EBA, 2010)

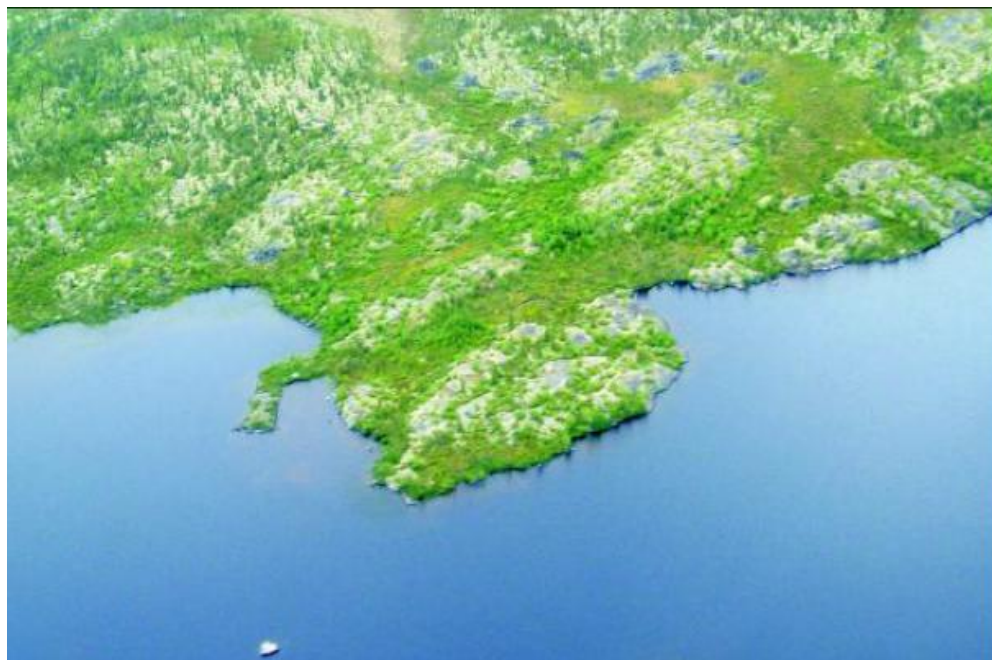
Figure 2: Spinet Campsite and Main Showing (North View) (EBA, 2010)

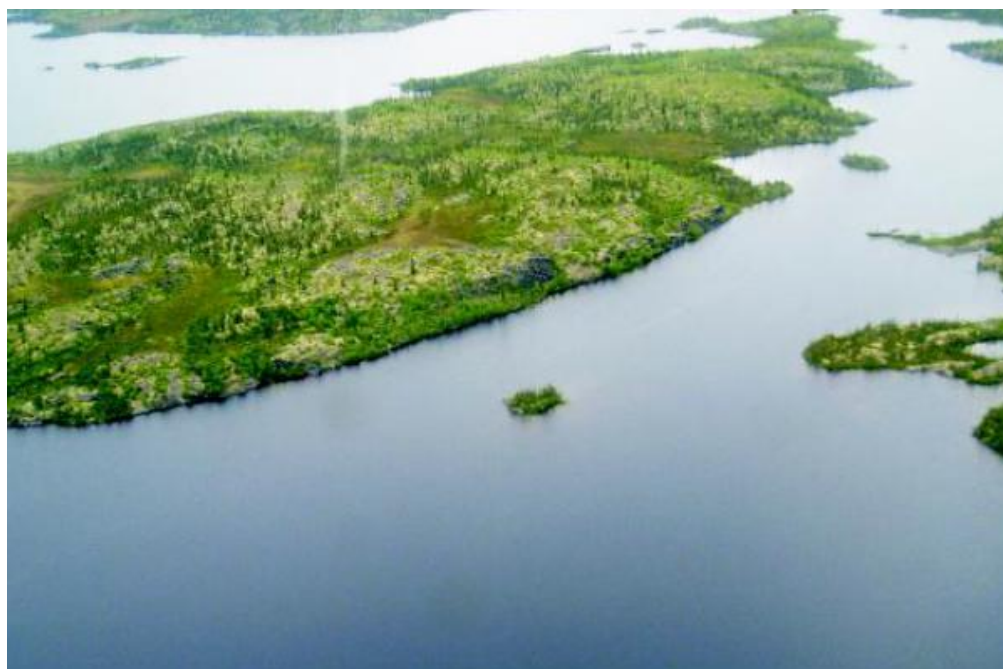
Figure 3: East portion of Treasure Island (EBA, 2010)
