Subject: 2024 Annual Dam Safety Inspection – Processed Kimberlite Mine Workings Facility, A418 Underground Hydrostatic Plugs

TECHNICAL MEMORANDUM

Reference No. CA0035294.6784-2557-TM-Rev0-7000

A418 UNDERGROUND HYDROSTATIC BULKHEAD SITE INSPECTION – 9130 AND 9080 LEVELS

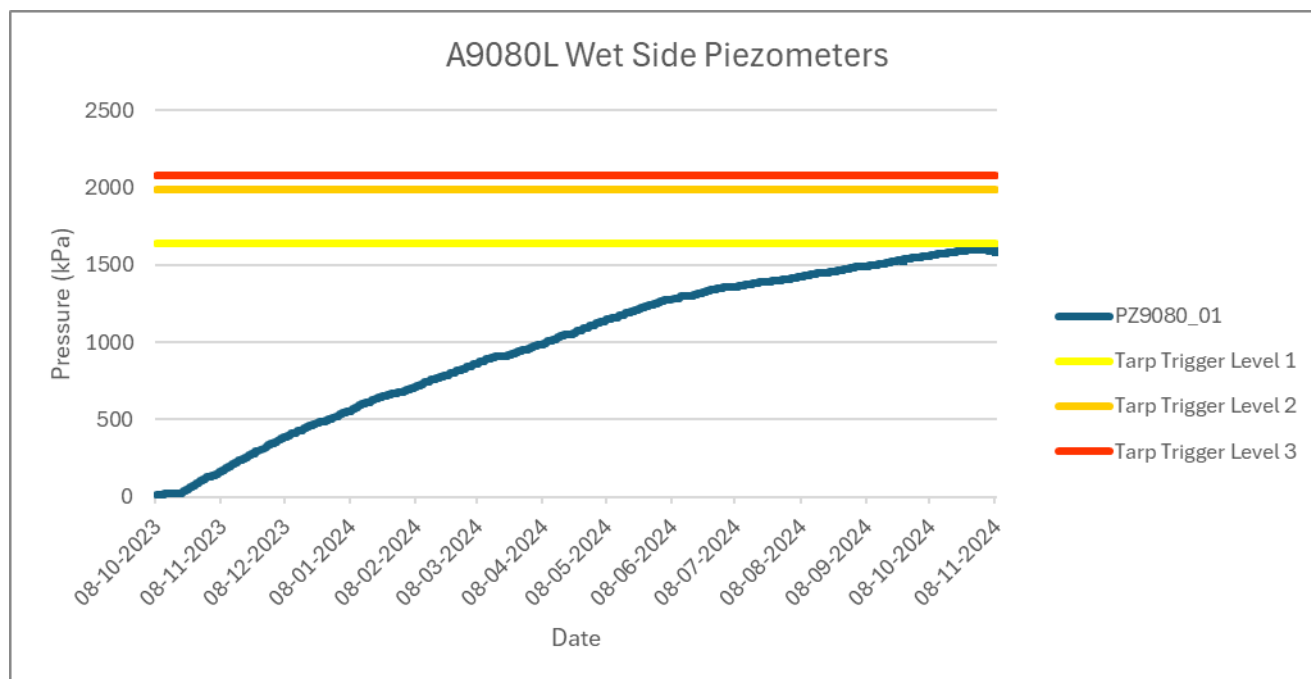
Figure 1: 9080-Level Wet Side Piezometer

The pressure acting on the piezometer, and therefore the 9080-level bulkhead, has gradually increased during the monitoring period to reach a maximum pressure of approximately 1598.7 kilopascals (kPa), which is below the Trigger Action Response Plan (TARP) Level 1 of 1642 kPa. The A418 PKMW hydrostatic bulkhead TARP is provided Attachment 2.

Figure 1 shows the increase in applied pressure at the 9080-level piezometer.

The maximum pressure shown on the 9080 and 9130 levels wet side piezometers was 1598.7 kPa and 1010.7 kPa respectively, which occurred on October 31, 2024. These pressures correspond to a water elevation in the A418 pit and underground of approximately 9244.9 m and 9243.5 m, which is approximately equal to the design operating level of 9245 m (DDMI 2023). The project has recorded the surveyed water level from surface at 9243.4 m. The comparative elevation of the water level as it relates to the pressures acting on the bulkhead are considered sufficient for the purposes of monitoring the performance of the bulkhead.

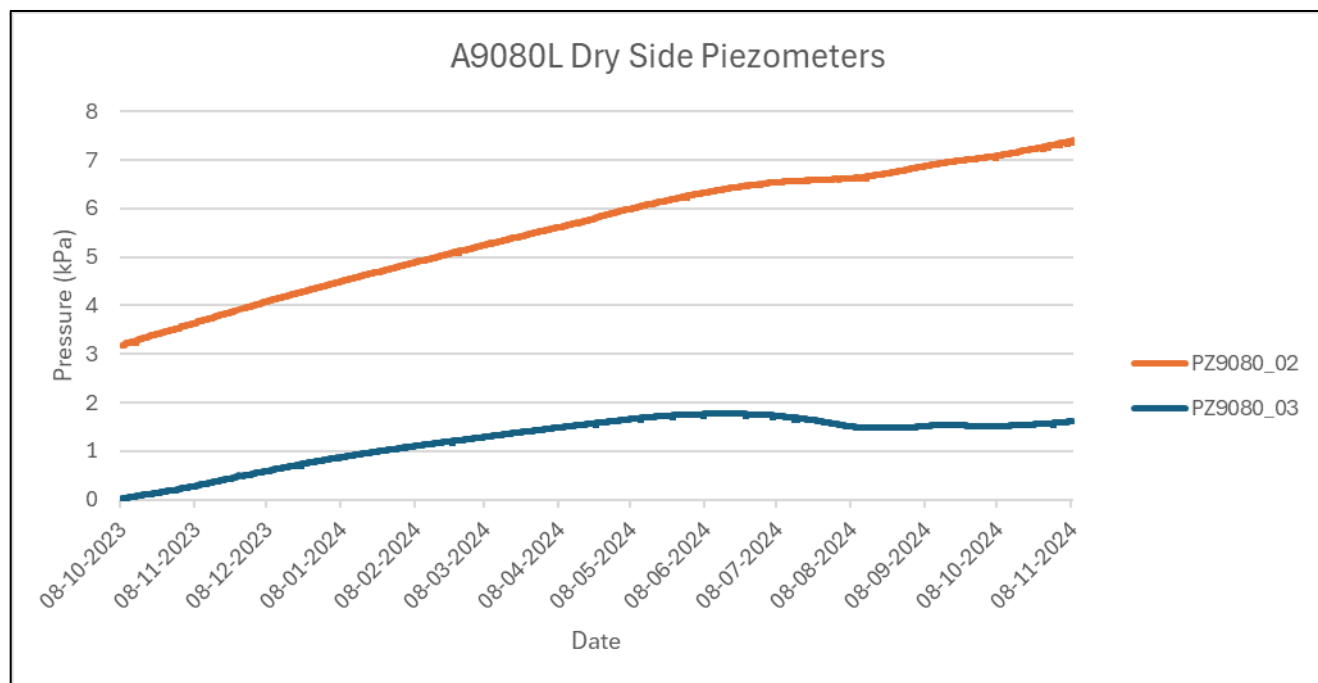
Figure 2: 9080-Level Dry Piezometers

The two piezometers (PZ9080_02 and PZ9080_03) installed into the ribs of the 9080 level between the rock and bulkhead are used to measure the pressure gradient across the plug (Figure 2).

Pressures recorded by these piezometers have remained low, reaching a maximum pressure of less than 8 kPa, which indicates the consolidation and contact grouting performed during construction has sufficiently reduced the permeability of the bedrock immediately surrounding the bulkhead.

The dry side piezometers at both the 9080 and 9130 levels have shown consistently low pore pressures compared to the applied pressure on the bulkheads. The low-pressure readings compared to the pressure acting on the bulkheads suggest consolidation and contact grouting has sufficiently closed water pathways between the wet and dry sides of the bulkhead. This is further demonstrated by the minimal volume of water observed on the dry side during the year.

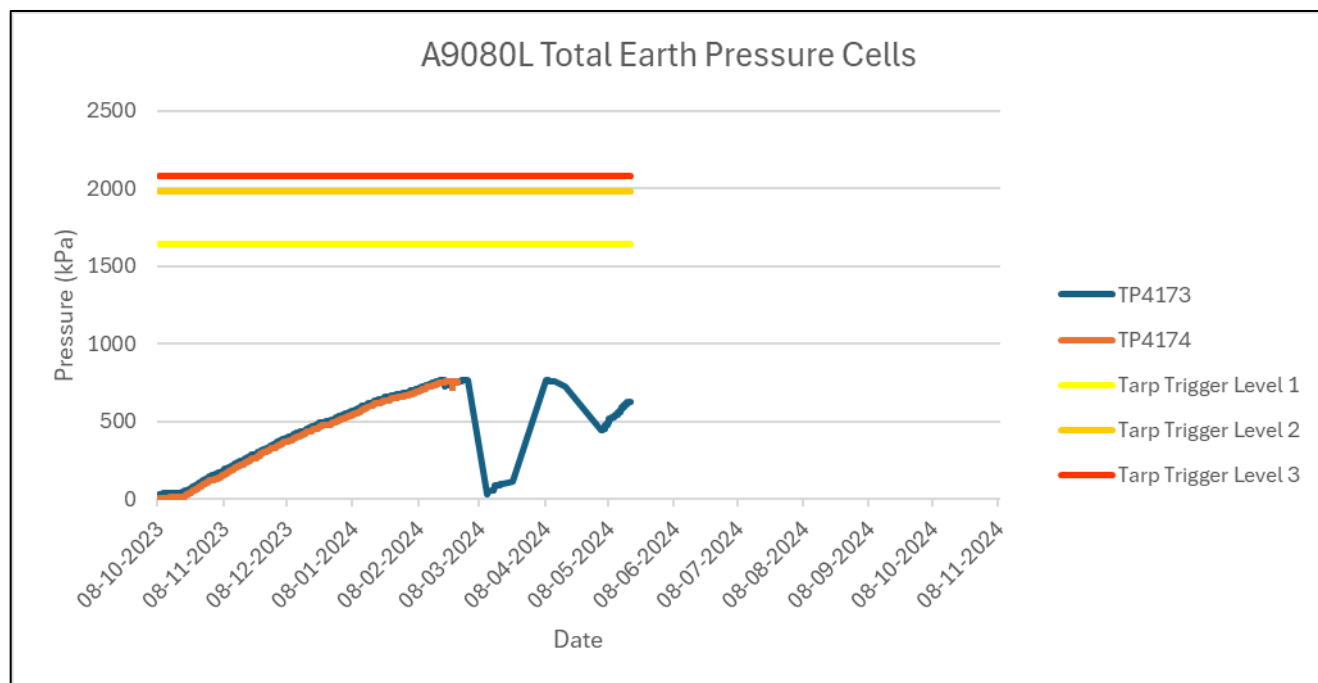
Figure 3: 9080-Level Total Earth Pressure Cells

Two TEPCs (PC9080-01 and PC9080-02) were installed on the bulkhead to measure the total pressure applied to the bulkhead from the water and FPK slurry (Figure 3). PC9080-01 stopped reading on February 25, 2024, while PC9080-02 stopped reading on March 2, 2024, due to pressures exceeding the capacity of the sensor. The loss of these pressure cells means the pressure applied to the bulkheads from the FPK slurry cannot be measured. The maximum pressure recorded was 758.1 kPa and 764.8 kPa on PC9080-01 and PC9080-02, respectively.

The five TEPCs have all stopped reading pressures due to the applied pressure exceeding the capacity of the installed instruments, and the applied load to the bulkheads from the FPK Slurry cannot be monitored. DDMI initiated the replacement of these TEPCs with higher pressure range TEPCs, completing the installation of a replacement TEPC and piezometer, into the 9080-level drift at the beginning of October 2024. Monitoring data for these instruments are being collected routinely and will be reported in the 2025 annual inspection report.

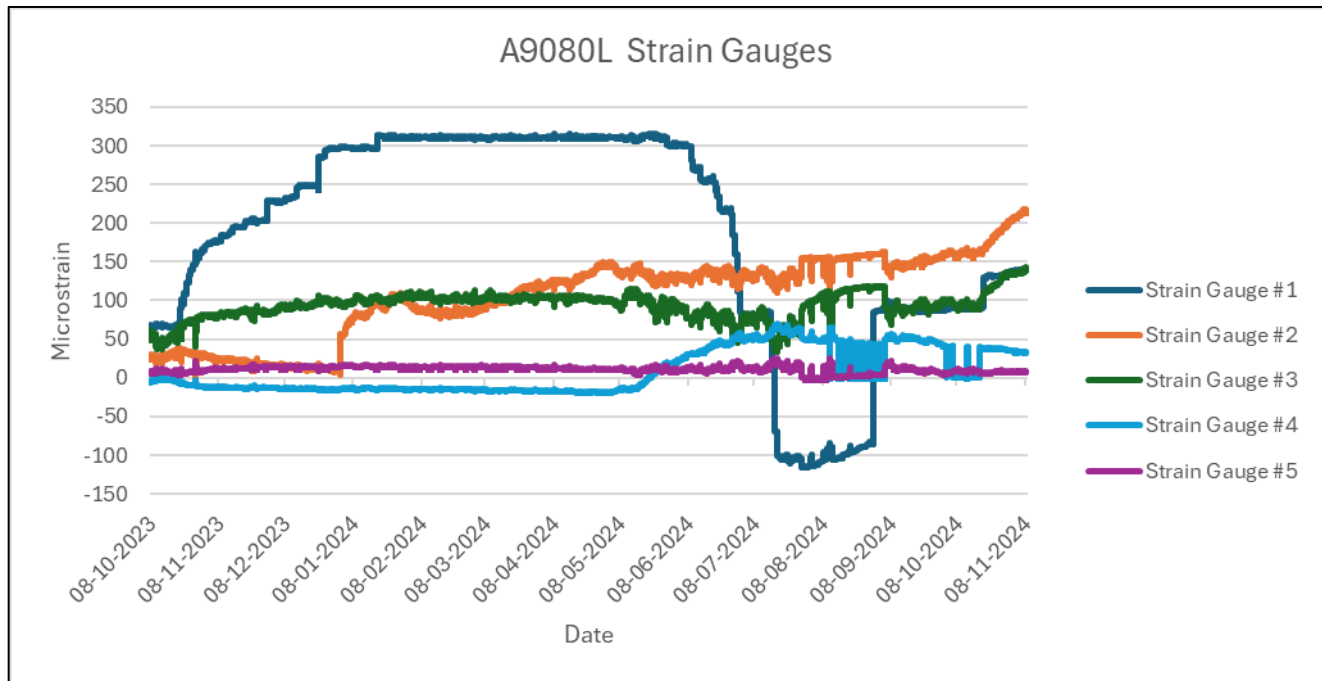
Figure 4: 9080-Level Strain Gauges

Five strain gauges, installed into the ribs and bulkhead, are used to monitor flexural stability and shearing of the bulkhead. During the reporting period, the strain gauges have experienced minimal strain (maximum micro strain of 316 $\mu\epsilon$), significantly below the Level 2 TARP of 3,000 $\mu\epsilon$ (Figure 4 and Attachment 2). There is no Level 1 trigger for the strain gauges.

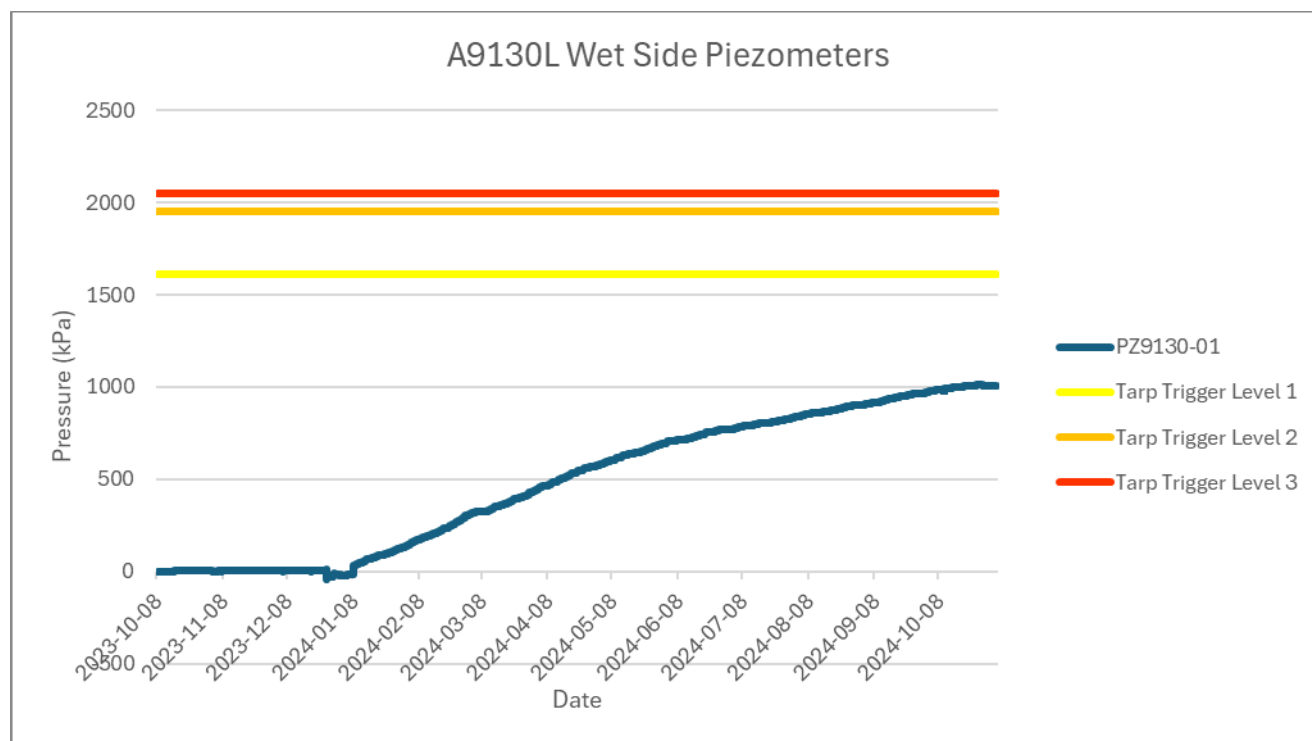
Figure 5: 9130-Level Wet Side Piezometer

The pressure acting on the piezometer, and therefore the 9130-level bulkhead, has gradually increased during the monitoring period to reach a maximum pressure of approximately 1010.7 kPa, which is below the TARP Level 1 of 1609 kPa (Attachment 2).

Figure 5 shows the increase in applied pressure at the 9130-level piezometer.

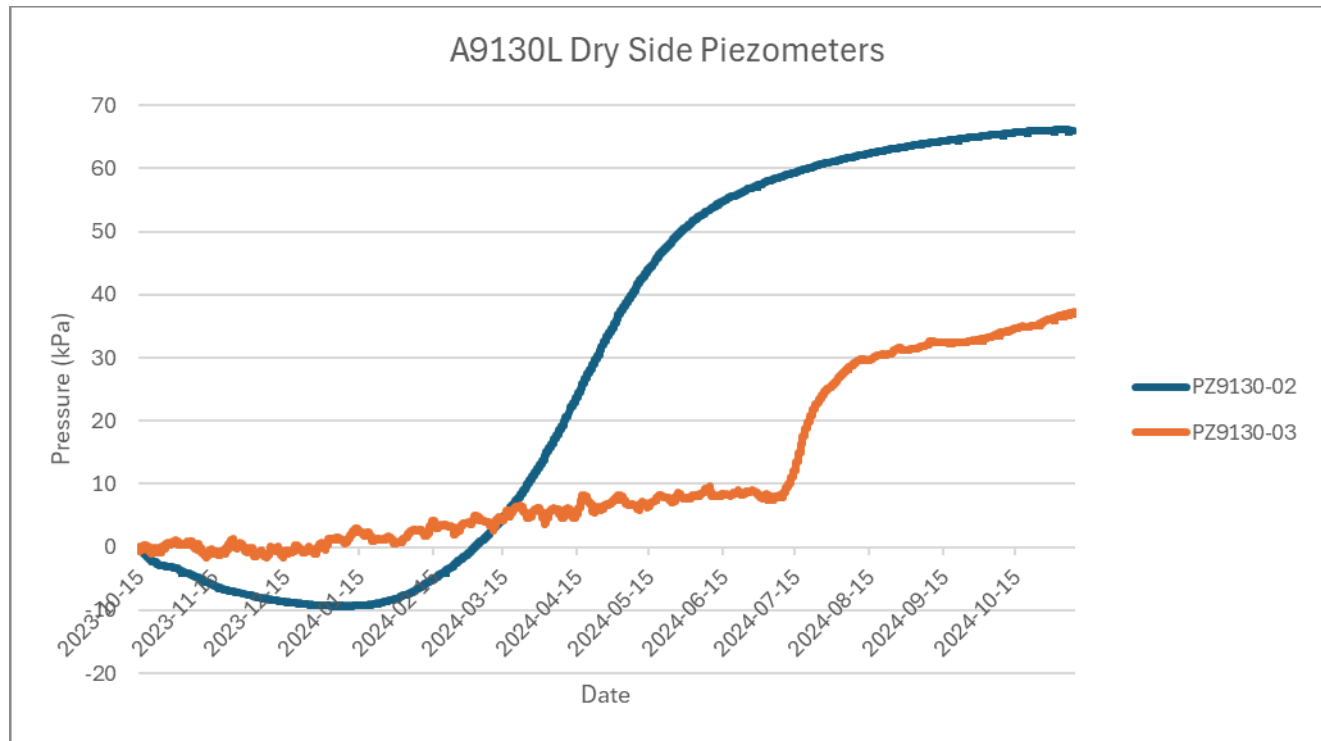
Figure 6: 9130-Level Dry Side Piezometer

The two piezometers (PZ9130_02 and PZ9130_03) installed in the ribs of the 9130 level between the rock and bulkhead are used to measure the pressure gradient across the plug (Figure 6).

A maximum pressure of less than 70 kPa for the reporting period was observed, which indicates the consolidation and contact grouting performed during construction has sufficiently reduced the permeability of the bedrock immediately surrounding the bulkhead.

Although the pressure shown in these piezometers is higher than from the 9080 level, pressures are still relatively low in comparison to the pressure acting on the bulkhead.

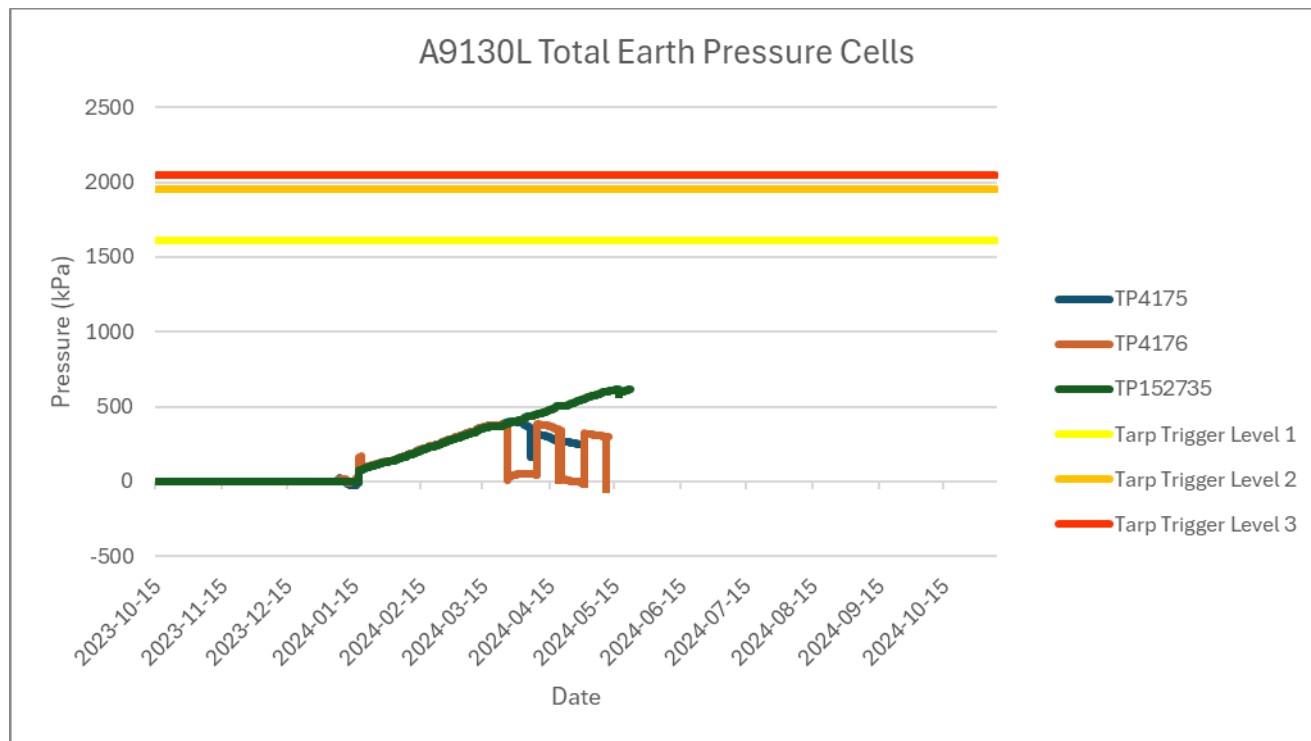
Figure 7: 9130-Level Total Earth Pressure Cells

Three TEPCs (TP4175, TP4176, and TP152735) were installed on the bulkhead to measure the total pressure applied to the bulkhead from the water and FPK slurry (Figure 7). TP4175 stopped reading on March 28, 2024, TP4176 stopped on March 25, 2024, while TP152735 stopped reading on May 21, 2024 due to pressures exceeding the capacity of the sensor. The loss of these pressure cells means the pressure applied to the bulkheads from the PK slurry cannot be measured. The maximum pressure recorded was 397.9 kPa, 384.2 kPa, and 617.8 kPa for TP4175, TP4176, and TP152735, respectively.

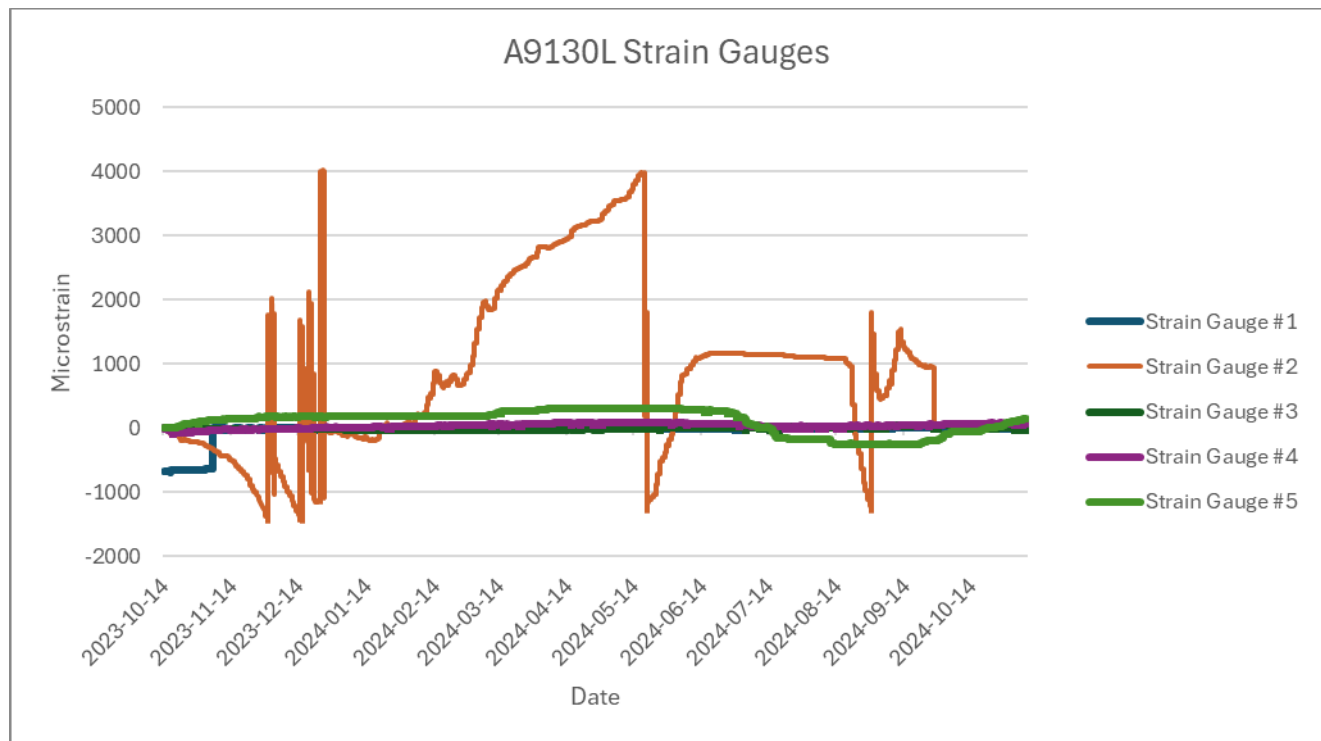
Figure 8: 9130-Level Strain Gauges

Five strain gauges, installed into the ribs and bulkhead, are used to monitor flexural stability and shearing of the bulkhead. Strain Gauge #2 has historically provided unreliable readings, with strain reaching and exceeding the Level 2 value of 3,000 $\mu\epsilon$ before dropping sharply (Figure 8). Due to reliability concerns for this instrument, DDML replaced the gauge in February 2024; however, the new instrument has continued to record erroneous results.

Apart from Strain Gauge #2, the other four strain gauges have experience minimal strain (maximum micro strain of 590 $\mu\epsilon$), significantly below the Level 2 TARP of 3,000 $\mu\epsilon$ (Figure 8 and Attachment 2). Note that there is no Level 1 trigger for strain gauges.

The strain gauges have generally shown minimal microstrain as a result of flexural or punching movement of the bulkhead. The exception is that Strain Gauge #2 on the 9130-level bulkhead has had erratic readings since it was installed. After replacing the instrument, data continued to show erroneous readings. During the site inspection, it was identified that one side of the strain gauge was installed into a piece of timber, which had remained after construction of the bulkheads.

ID	Location	Identified Issue	Recommendation	Priority	Recommended Timing for Action
A418-2024-02	9080 Bulkhead	Strain Gauge #2 has an erratic data output and the results cannot be relied upon.	The Strain Gauge #2 on the 9130-level bulkhead is to be repositioned such that the pins of the strain gauge are installed into concrete.	3	Q1 2025
A418-2024-03	9130 Bulkhead (wet side)	Total Earth Pressure Cell on the 9080 and 9130 Bulkheads have failed due to over pressure on the sensor.	Calibration and monitoring of the new TEPC and piezometer, installed into the 9080-level drift, should continue to be prioritized.	4	Q1 2025

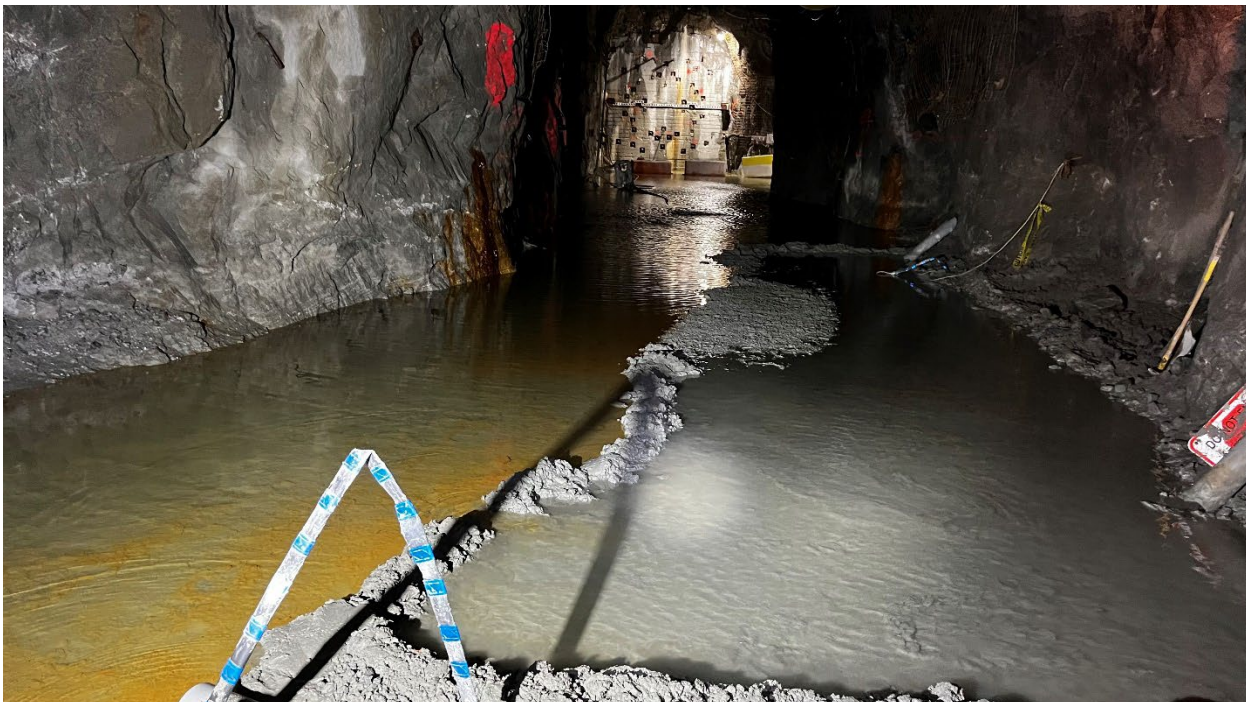
- Fresh air was being vented into the drive and directed at the bulkhead at the time of the site visit.
- Precipitate observed in bulkhead face and back of drift directly in front of bulkhead.
- The California pipe installed approximately 30 to 40 m from the bulkhead also captures and measures the water flow from the stub drift on the north side of the drive. Observations during the site visit suggest that the majority of the water being measured at the California Pipe is coming from the stub drift and not the bulkhead face.
- Water is flowing from the back and ribs within the stub drift.
- There is water dripping from the back of the 9080-level drift at a location approximately 10 m from the bulkhead face.
- Water reporting from the bulkhead is coming from the contact between the bulkhead and rock wall. Little to no water is coming through the bulkhead.

Photo 2: Ponding water at the 9080 Bulkhead

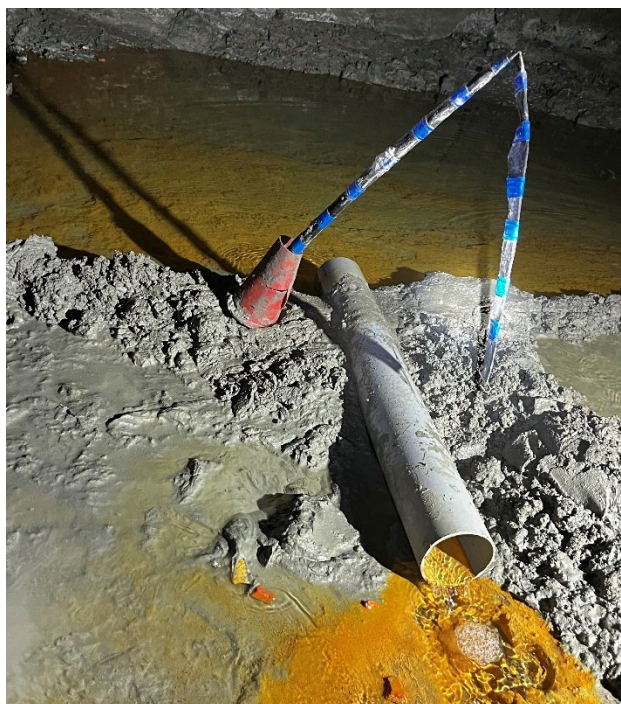
A California pipe was installed at the 9080-level bulkhead to measure the flow of water coming from the bulkhead face and stub drift just to the northeast of the bulkhead.

Photo 3: California Pipe used to measure Flow Rate at 9080 Bulkhead.

- Requested that the Strain Gauge #2 on the 9130-level bulkhead be relocated into concrete.
- Discussed the location of the California Pipe and addressed the observation that the water measured by the pipe is an accumulation of water from both the bulkhead and the stub drift to the side. It is understood by WSP that a design for a weir has been received by DDML in September 2024 and is currently under review. The weir will be constructed once the final design report is received by DDML.
- The replacement TEPC and vibrating wire piezometer was installed into the 9080 level and the data logger and instruments were in the process of being calibrated (WSP 2024).
- It is understood that the performance of this TEPC will be monitored before determining if the application is suitable for the intended purpose ahead of installing a TEPC into the drift on the 9130 level.

ID	Location	Identified Issue	Recommendation	Priority	Recommended Timing for Action
A418-2024-01	9130 Bulkhead	Volume of water reporting to the dry side of the bulkhead requires monitoring	The California pipe should be replaced with the weir as soon as possible to more accurately measure the flow of water that is reporting at the 9080-level bulkhead.	4	Q2 2025

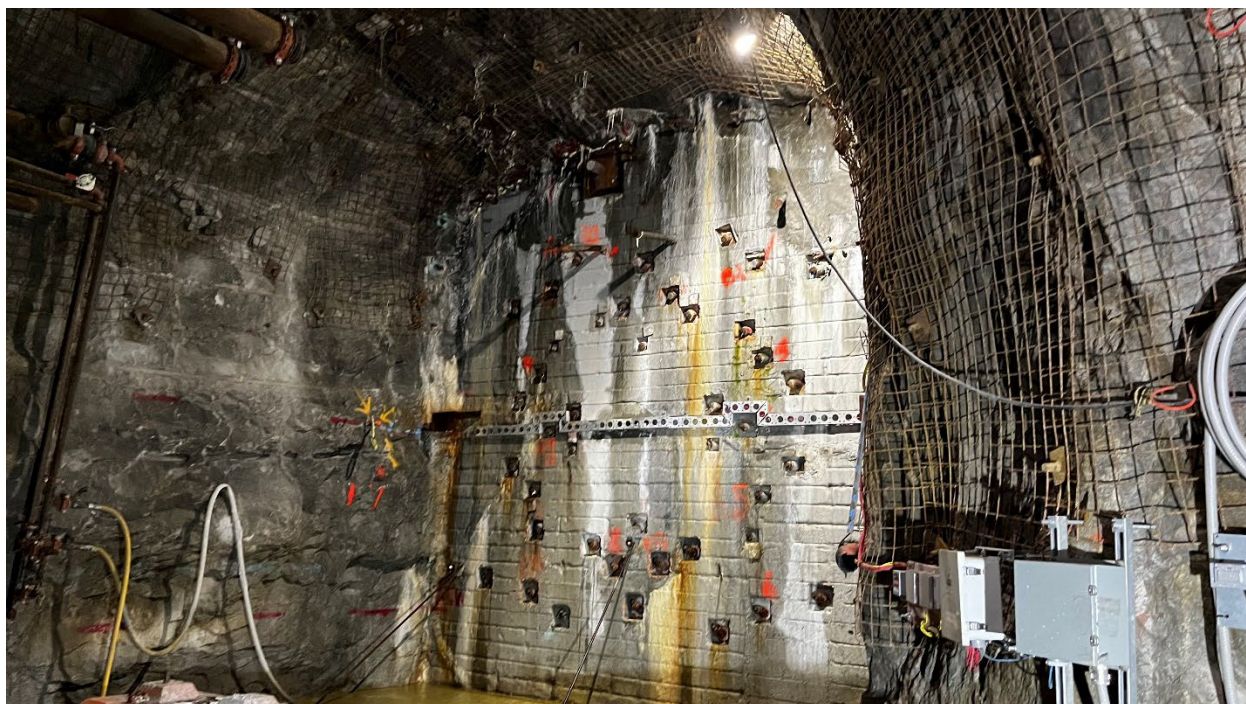
Photo 4: Damp conditions on face of 9080 Bulkhead. Some precipitate observed at Top Centre of Bulkhead.

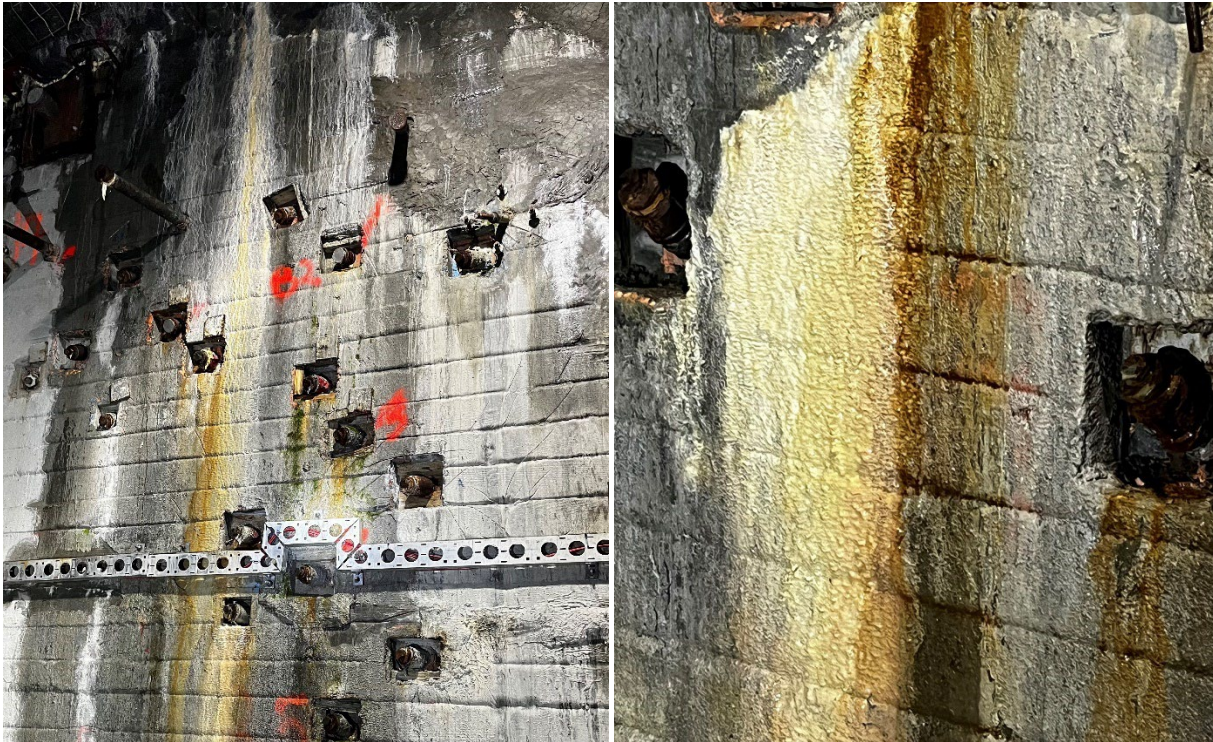
Photo 5: Precipitate on Face of 9080 Bulkhead (left). Close up of precipitate originating from fracture in bulkhead face (right).

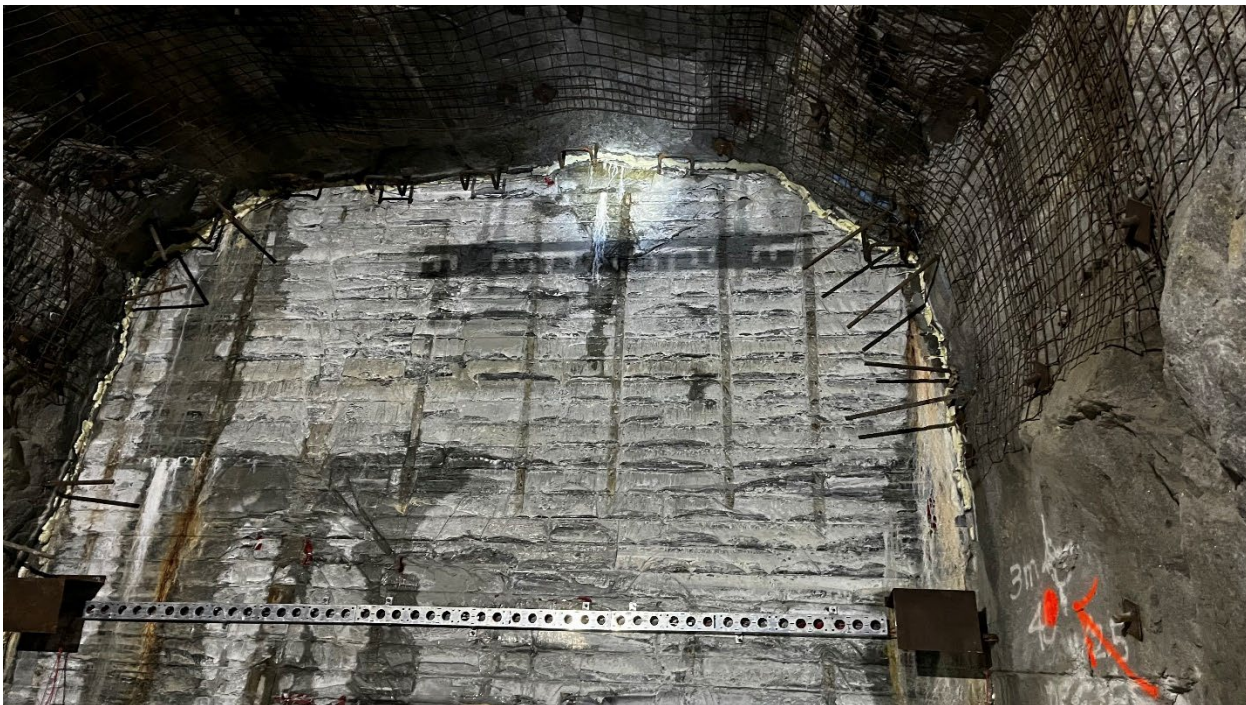
Photo 6: 9130 Bulkhead – Note the face is primarily dry with only small damp areas.

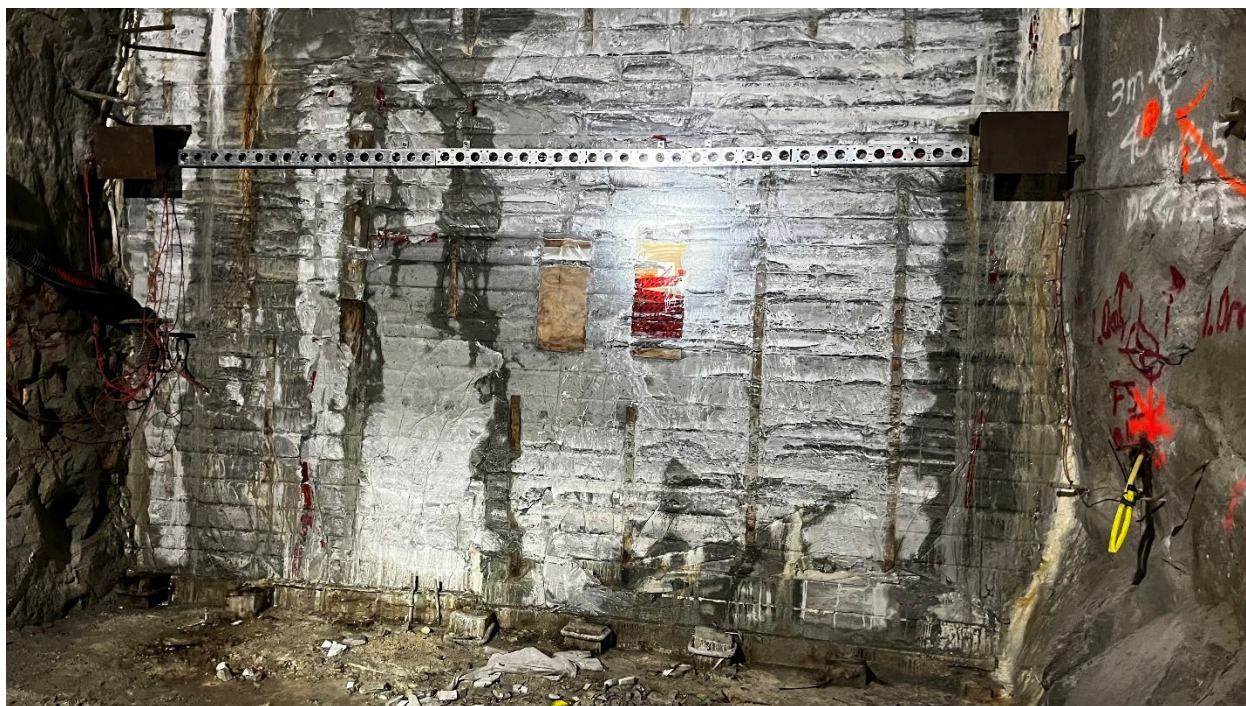
- The center of the bulkhead is dry, with minor damp spots observed on the two ribs at the concrete bedrock contact.
- At approximately 50 m from the bulkhead, water is flowing through a discontinuity in the back and left rib (when looking towards the bulkhead). Flow from the discontinuity was not measured at the time of the site visit, but was visually estimated to be less than 25 L/min.

Photo 7: Lower half of 9130 Bulkhead. Note face is primarily dry with only small damp areas.

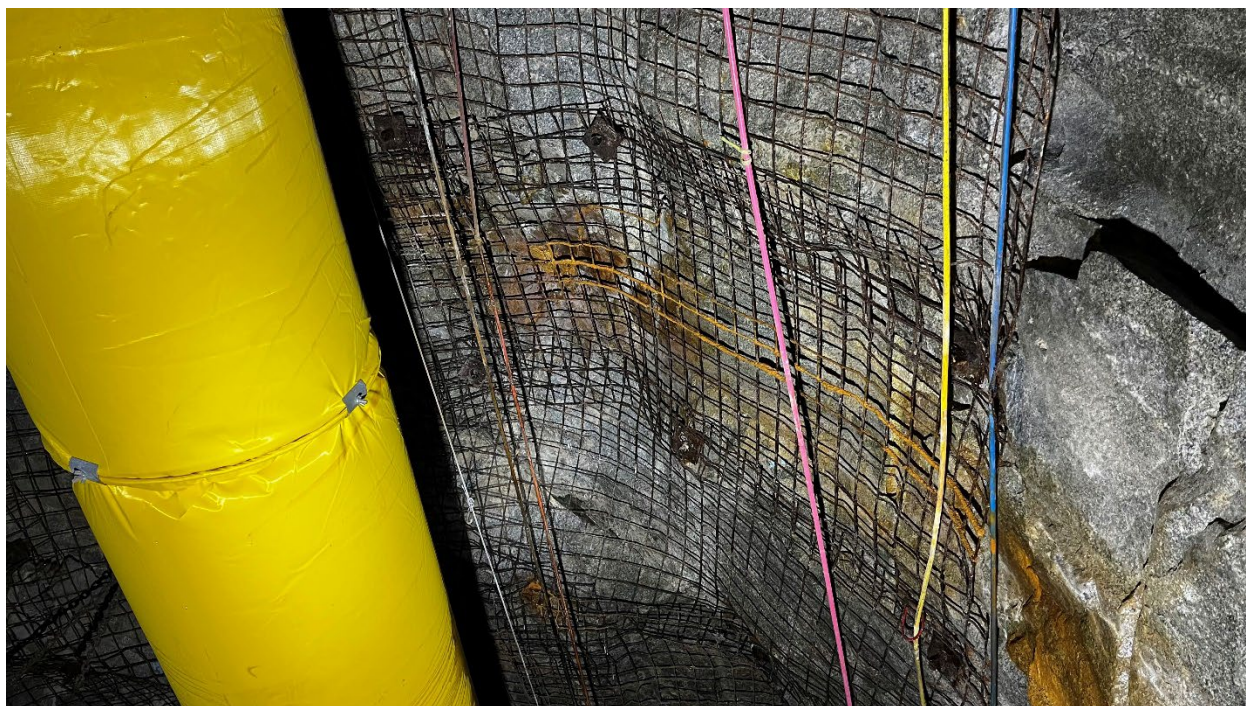
Photo 8: Source of water at location approximately 50 m from 9130 Bulkhead.

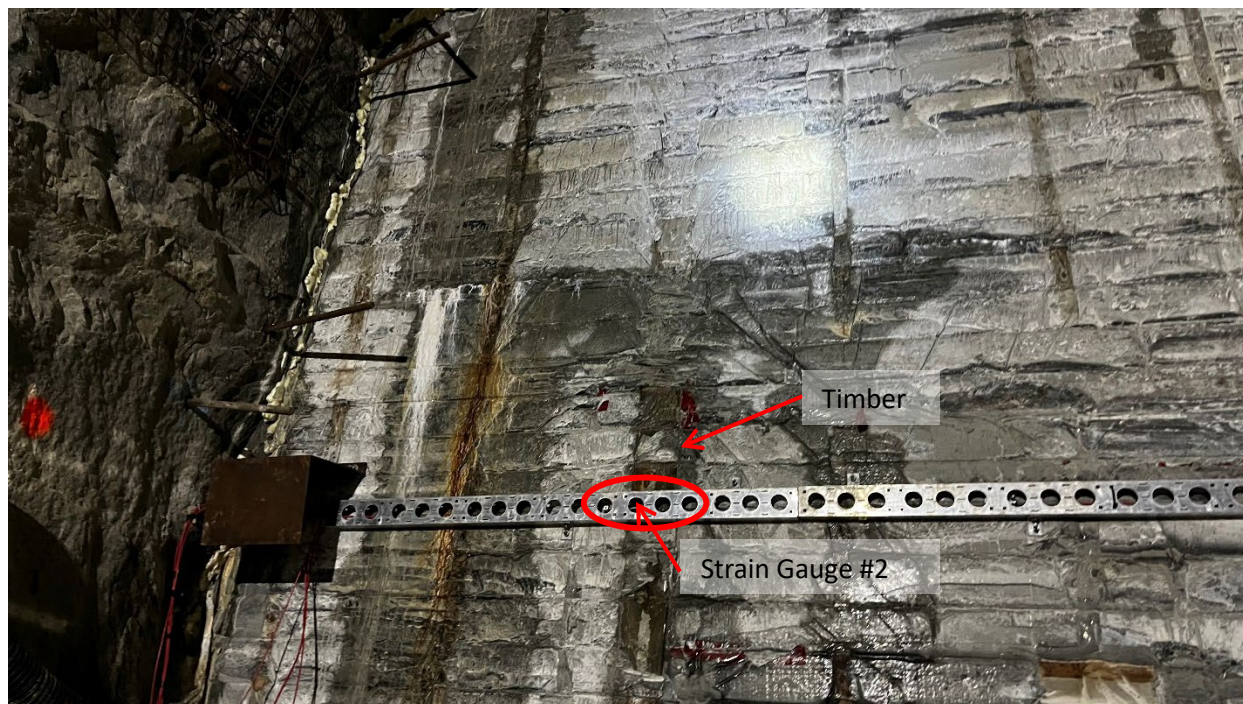
Photo 9: Strain Gauge #2 can be seen behind cable tray, at centre of photo. Right side is installed into timber.

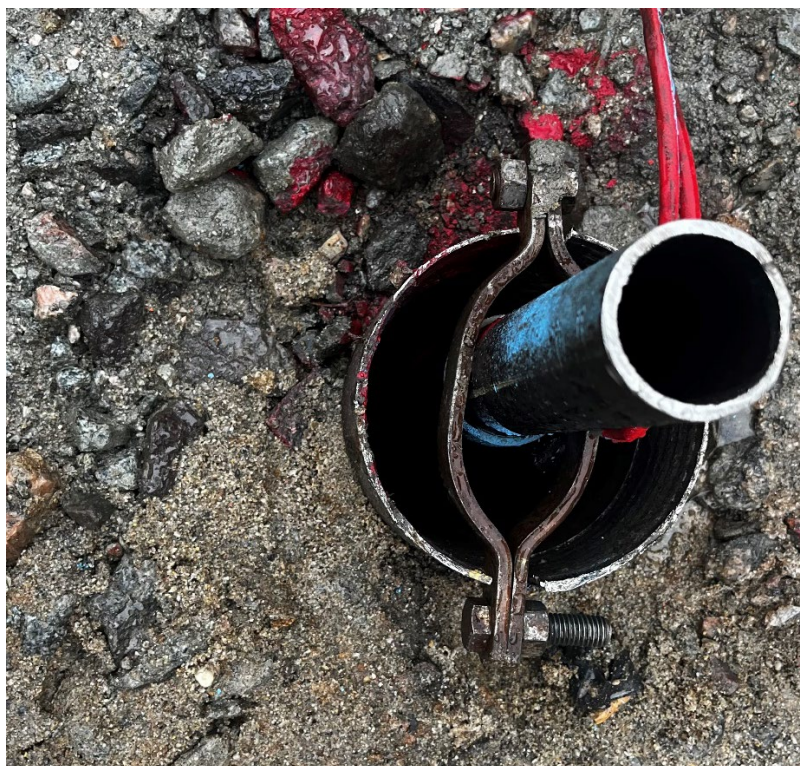
A replacement TEPC with a pressure rating of 3 MPa was installed into the drift behind the 9080-level bulkhead in October 2024 through a borehole drilled from surface.

Photo 10: Borehole collar with installed Total Earth Pressure Cell and Piezometer into the 9080 Level Drift.
