File Number	W2018L3-0001
Type of Operation	CLASS B - MUNICIPAL
Location	Gamètì, NT

WATER USE INSPECTION REPORT

LICENCE #:	W2018L3-0001	EXPIRY DATE:	December 21 st , 2028
LICENCEE:	Tłıchǫ Community Government of Gamètì	PREVIOUS INSPECTION:	March 12 th , 2024
COMPANY REP:	Sherbaz Muhammad	INSPECTION DATE:	June 06 th , 2024

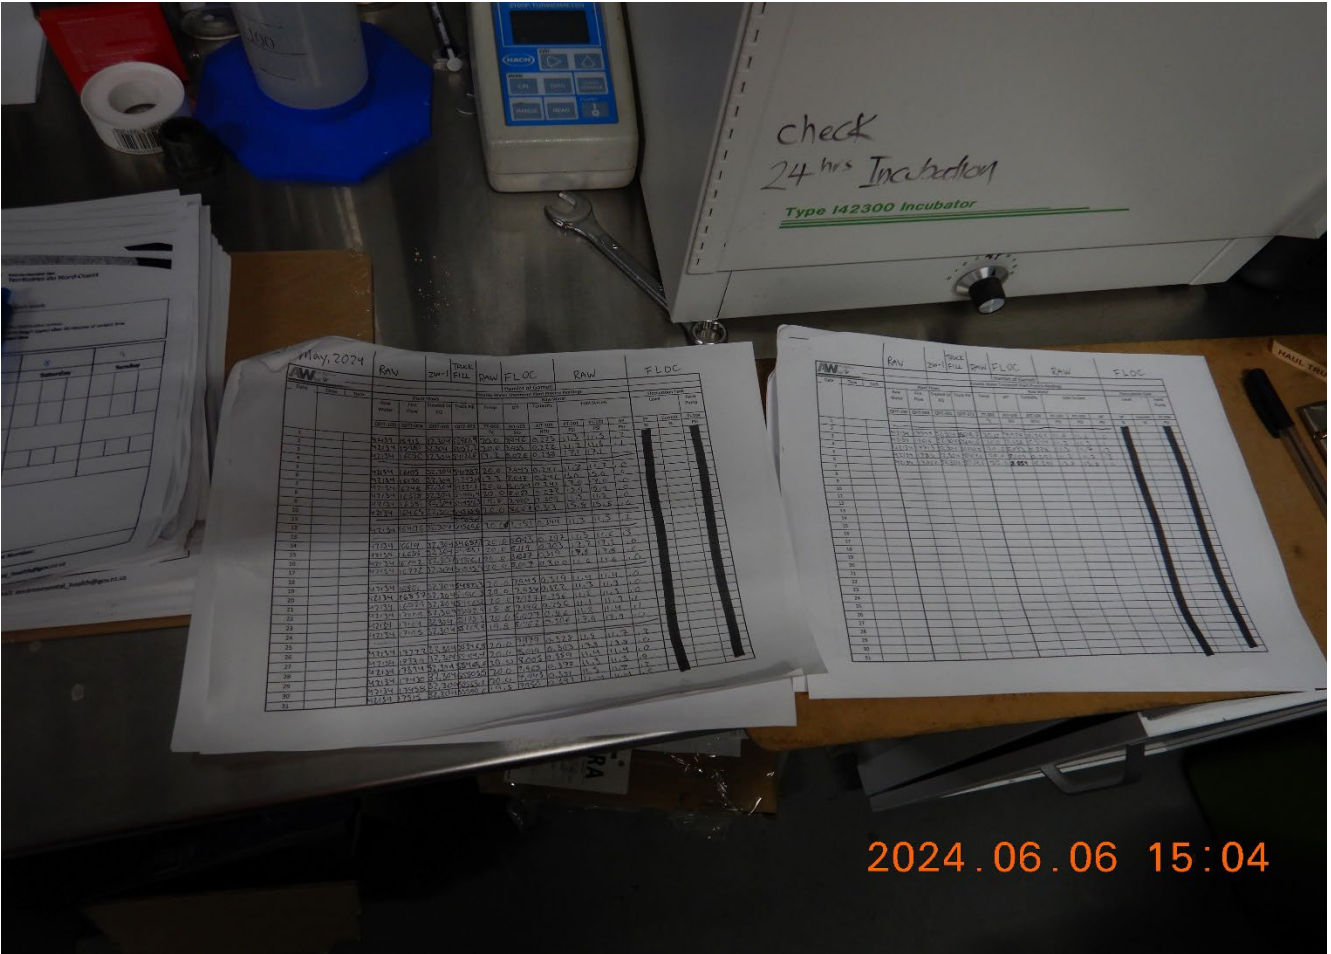
Photo 2: Logbook.

The water supply facilities were inspected and no major issues were noted. Meters were operational (Photo 2). Sensors were all online, log books were being filled out (Photo 2), and chemicals were stored appropriately.

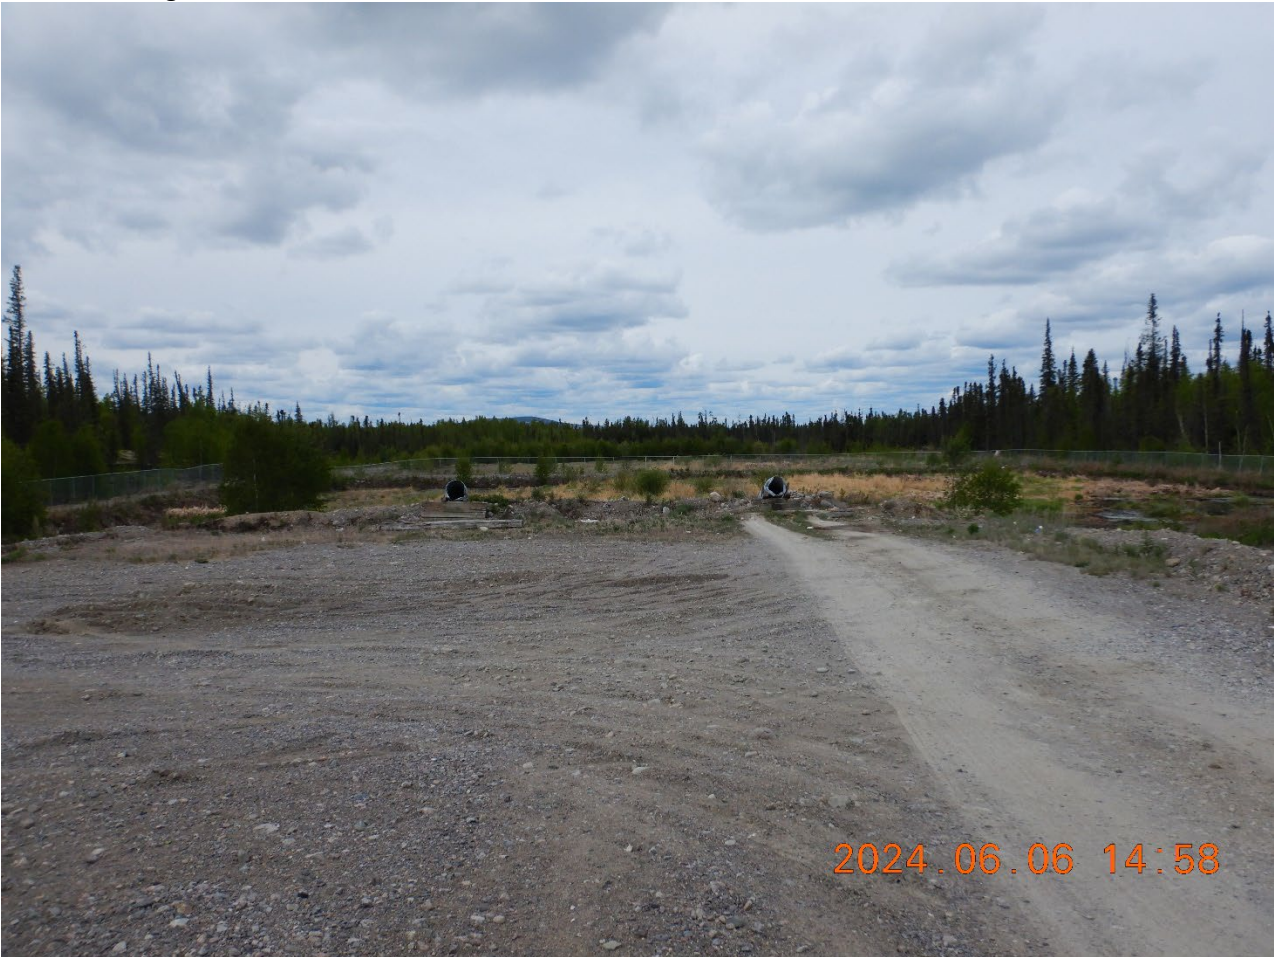
Photo 3: Sewage truck outfall.

The lagoon appeared to be in working order. Photo 3 shows the truck outfall. The cells, especially cell 2, appear to be growing over and may require brushing during future operations. Inspectors collected

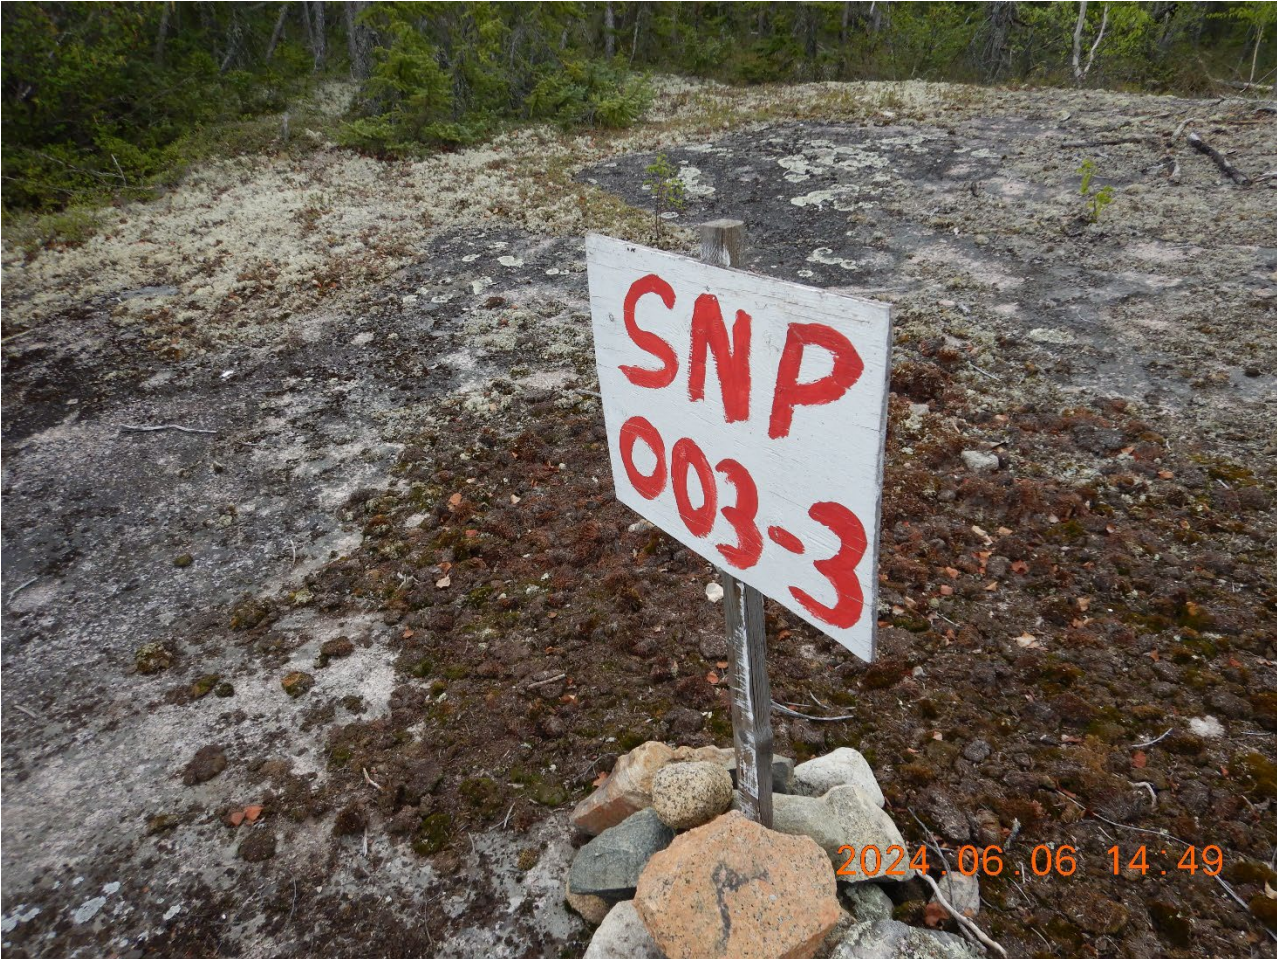
Photo 4: SNP-003-3 at Gameti.

a sample at Gameti (Rae Lake) downstream of the sewage disposal facility (Photo 4) and results indicate that the sewage disposal system is providing sufficient source water protection.

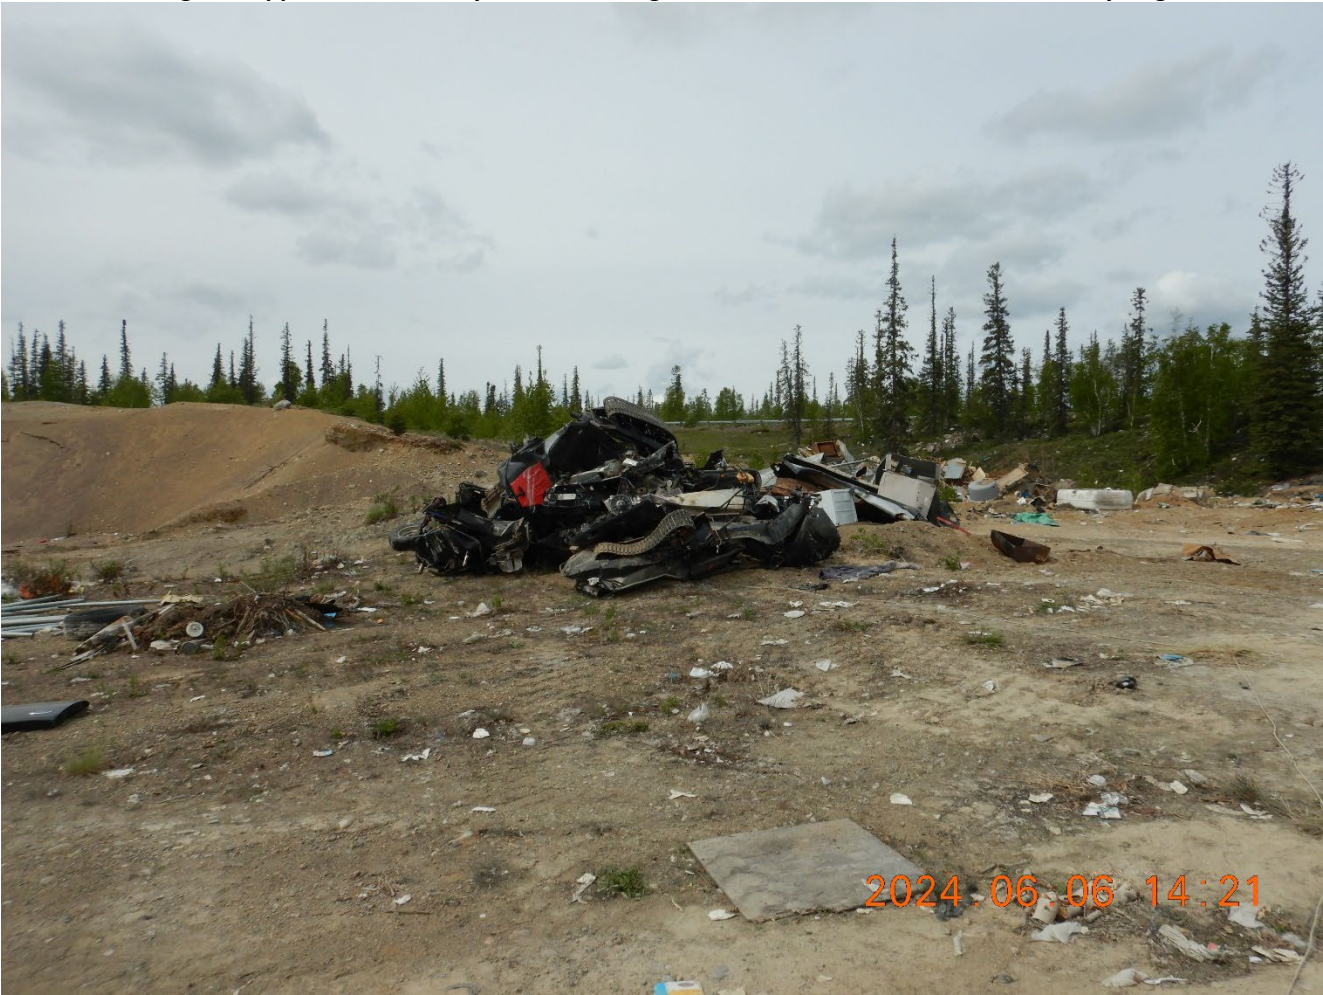
Solid Waste Comments:
The landfill was inspected and no major concerns were identified at this location. KBL was on site conducting waste segregation efforts to remove hazardous wastes from the main waste stream (Photos 5-8).

Photo 5: White goods appliances and bulky items are being removed from the waste stream for recycling.

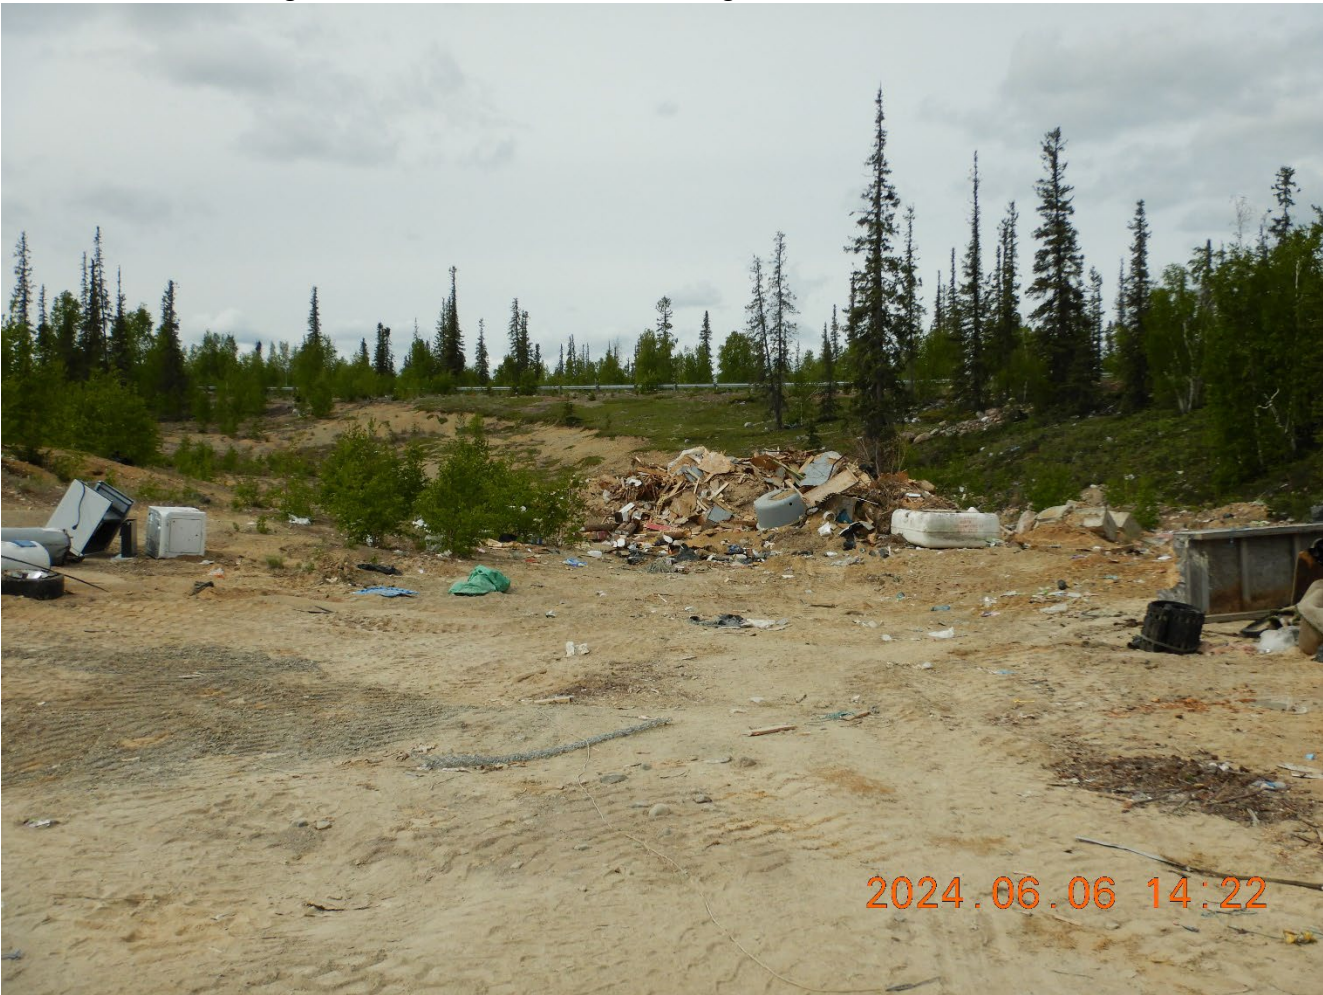
Photo 6: Wastes are being sorted and hazardous wastes are being removed from the waste stream.

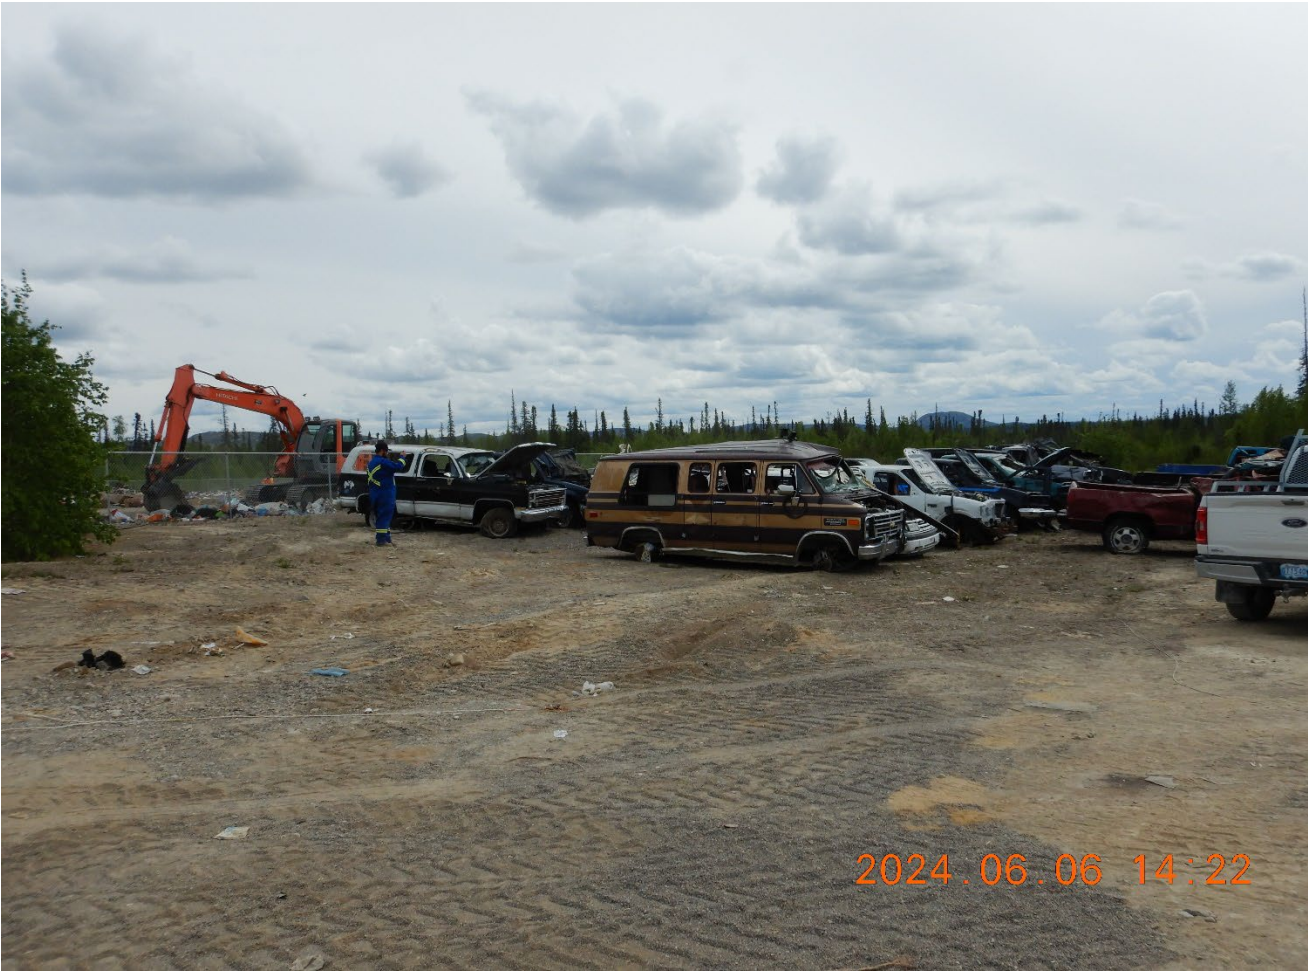
Photo 7: Vehicles are being organized and hazardous wastes are being removed.

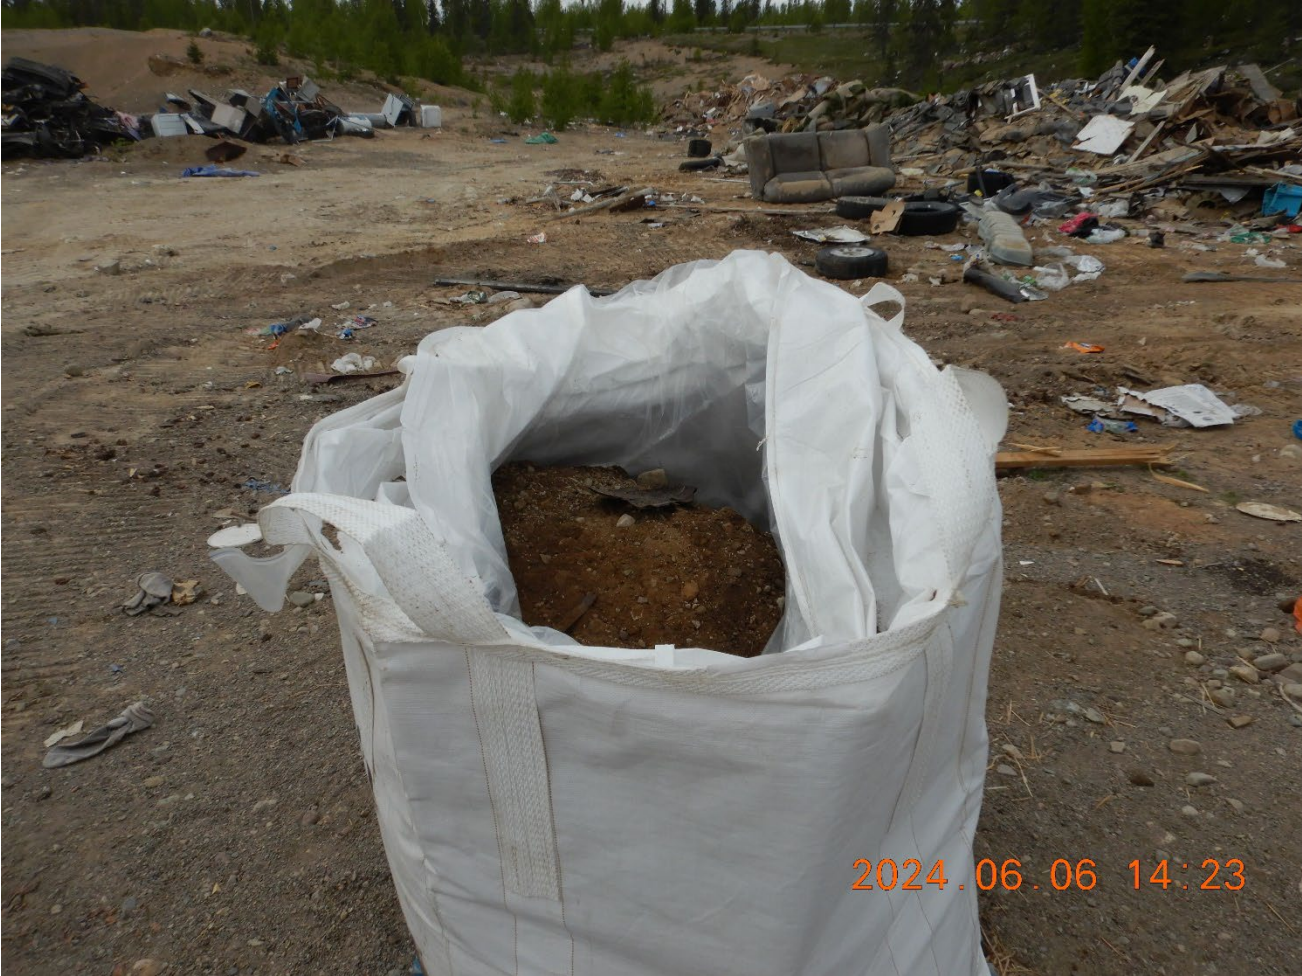
Photo 8: Hazardous wastes are being collected and stored for removal from the community.
