File Number	W2021L2-0004
Type of Operation	CLASS A - MINING AND MILLING
Location	Damoti Lake, NT

WATER USE INSPECTION REPORT

LICENCE #:	W2021L2-0004	EXPIRY DATE:	January 12, 2038
LICENCEE:	Nighthawk Gold Corp.	PREVIOUS INSPECTION:	September 20, 2023
COMPANY REP:	Gabriel Waychison	INSPECTION DATE:	June 6, 2024

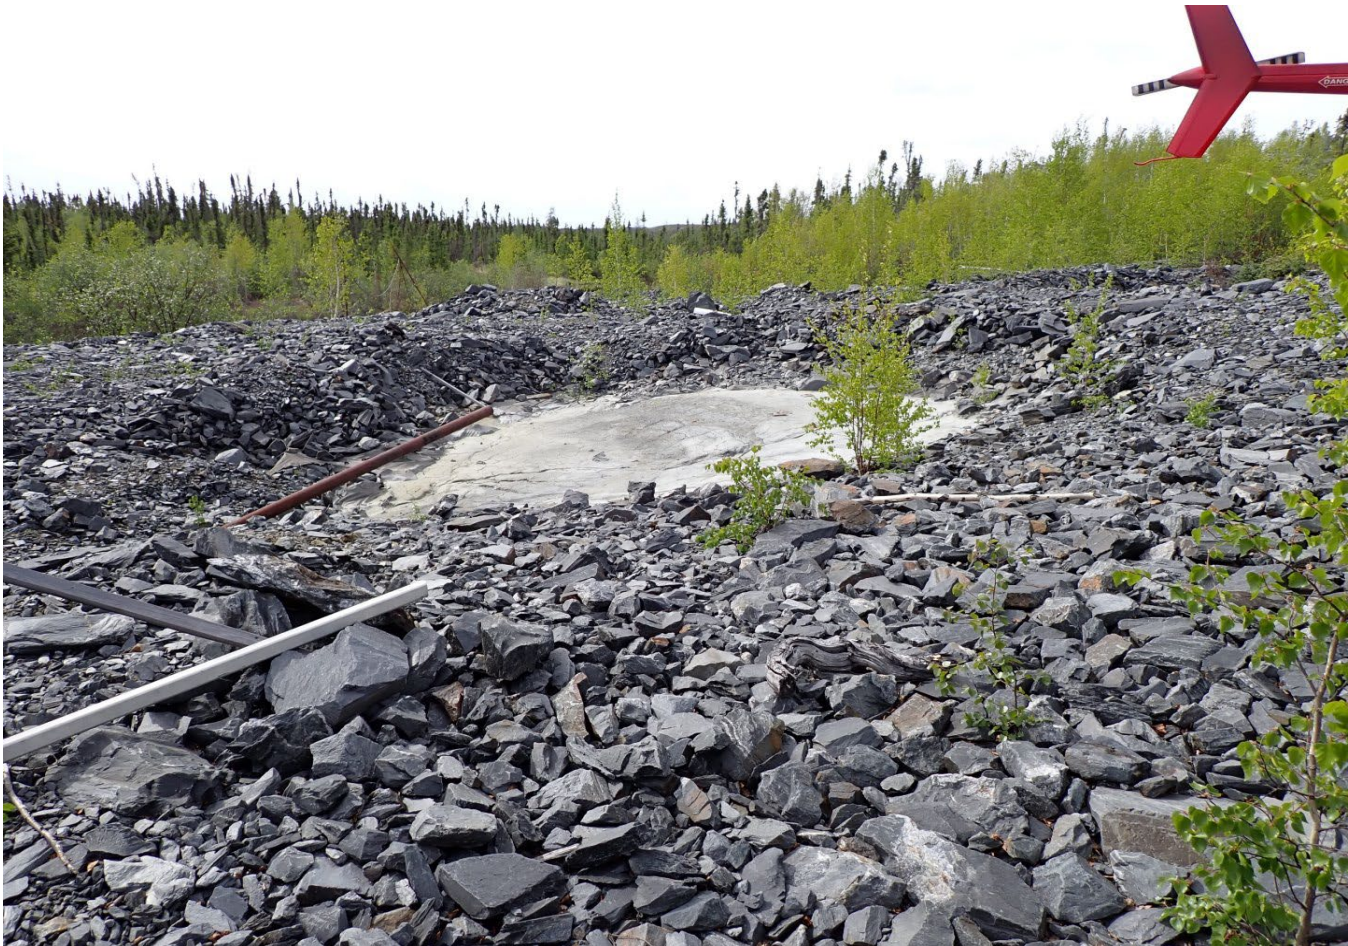
Figure 1. Settling Pond.

There was no infrastructure between the portal opening and the mine water settling pond to allow Nighthawk to Discharge water from the underground. The mine water settling pond was dry and had not been used since the last inspection (Figure 1).

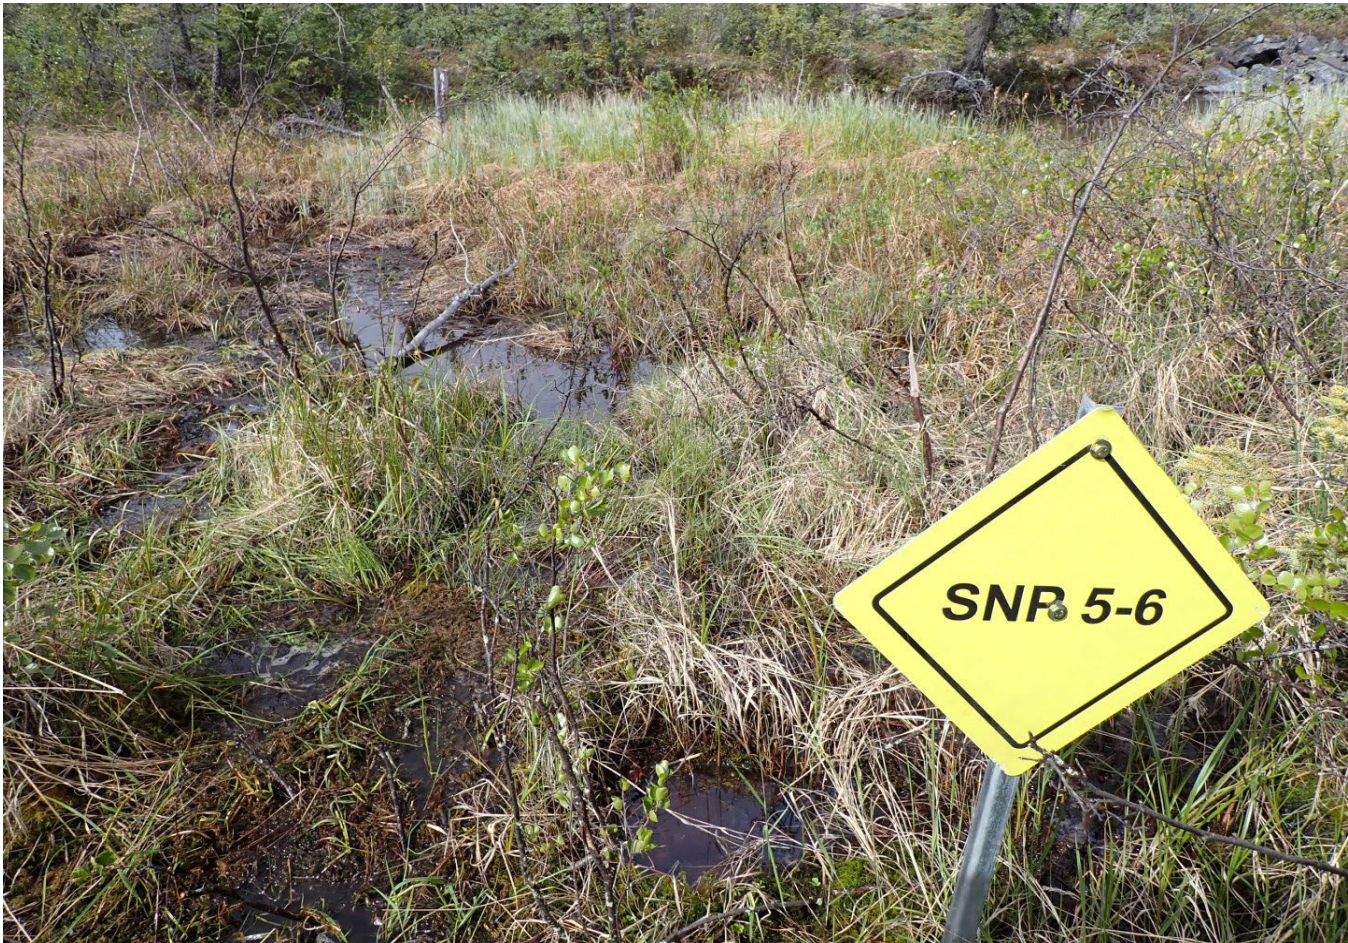
Figure 2. SNP Station 5-6.

An SNP sample was collected at SNP Station 5-6 (Figure 2). It was noted that the sample collected by the Inspectors reported 59 mg/L of Total Suspended Solids (TSS). The TSS measured by the Inspectors exceeded the maximum average concentration and maximum concentration of any grab sample required by Part F, Condition 12(a) of the Licence. Results can be found in Attachment 1. The Inspector recommends monitoring the TSS concentrations throughout the 2024 open water seasons to determine if there are any trends occurring. It was noted that the location of SNP Station 5-6 is within a vegetation dense area with limited ability to obtain a sample without disturbing the sediment and vegetation. If exceedances continue, additional sampling and/or investigation may be required.

Explanatory Remarks: The sample collected by the Inspector measured TSS as 59 mg/L which exceeds the maximum average concentration and the maximum concentration of any grab sample. At this time, the Inspector recommends monitoring TSS measured throughout the 2024 open water season to determine if there are any trends. If exceedances are consistent throughout 2024, additional sampling and/or investigation may be required.

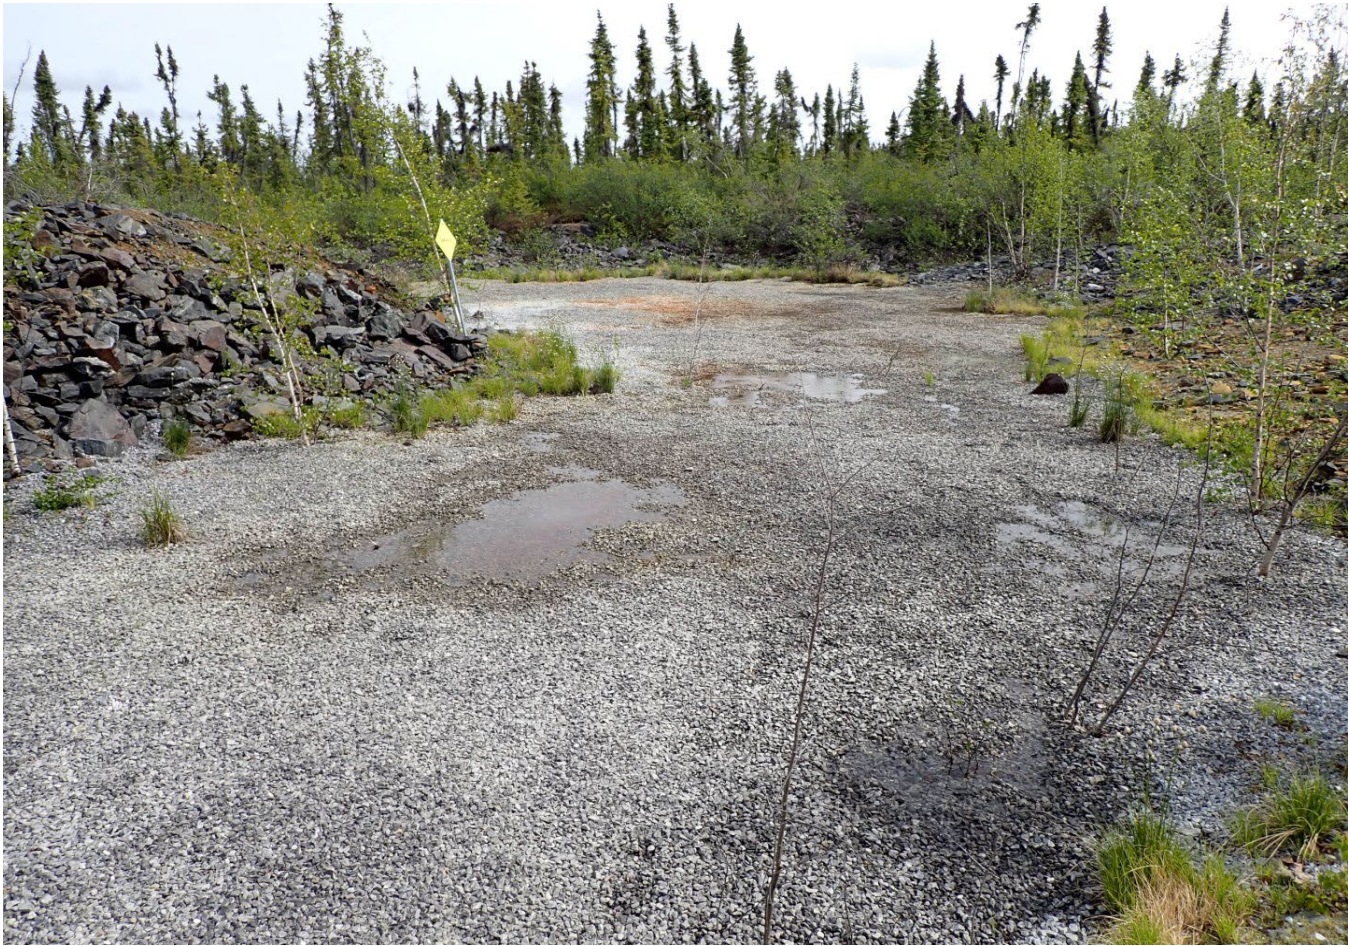
Figure 3. Location of Historical SNP Station 5-10.

On September 9, 2022, historic SNP station 5-10 was infilled after many issues with pH. During the Inspection, the inspector noted some surface discoloration at the location of SNP Station 5-10 and there was some surface water pooling (Figure 3). The Inspector recommends monitoring the progression of surface discoloration to ensure there are no residual impacts from infilling SNP Station 5-10.
