RE: W2023F0004 – Spill-2024424

Pursuant to Part C Condition 30(d) of Land Use Permit W2023F0004 – Ekati, Burgundy Diamond Mines Ltd. (Burgundy) is providing a detailed report on Spill-2024424 which occurred November 18, 2024, at 20:05.

Summary

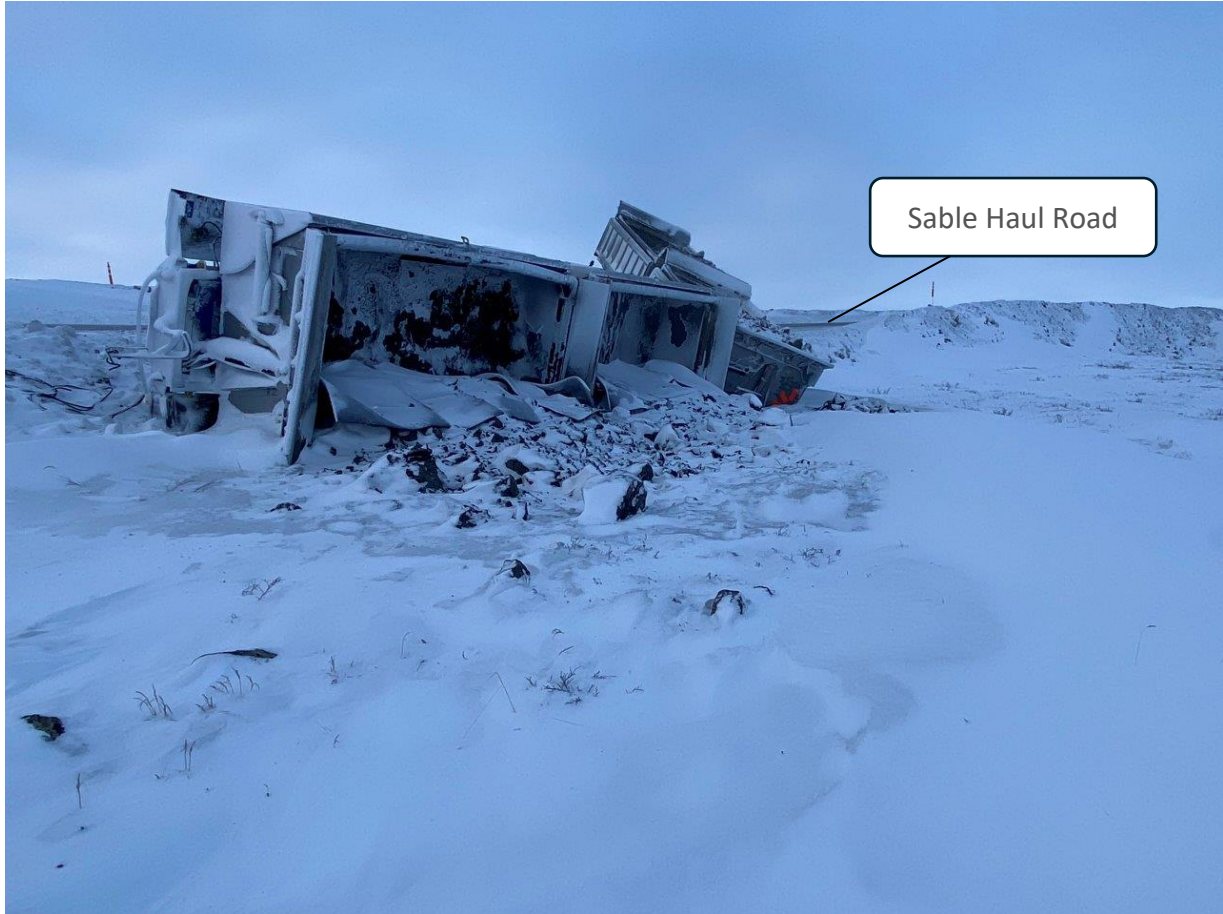
The operator was aware of caribou in the area and had reduced speed. Wildlife advisories for caribou on the Sable Haul Road had been issued to the site on November 17 at 16:36 and November 18 at 13:22. While driving the DPRT caribou appeared on the road near km 2, prompting the DPRT operator to apply the brakes. The rear trailers started to slide sideways towards the ditch on the opposite side of road. The operator tried to straighten out the unit but could not. The two rear trailers ended up in ditch and broke away from the tractor and power trailer.

The root cause was identified as insufficient road crush on the superelevated left-sweeping curve, which caused the brakes on trailer #4 to lock up, leading to the loss of control. Additionally, the operator was travelling at 37 KPH when the caribou was sighted.

Photo 1: View of kimberlite spill (spill-2024424) on tundra directly adjacent to Sable Haul Road. This photo was taken on November 20, 2024.

As of November 26, 2024, the spill was cleaned up. A cleanup bucket attachment on the excavator was used to remove the spilled kimberlite. 90 tons of kimberlite were loaded and hauled to the primary ore stockpile, and the trailer was removed off the tundra (see photos 1 and 2). The small amount of contaminated snow from the hydraulic lines, which contained gravel, was cleaned up and taken to the land farm. All spilled kimberlite and staining was targeted for cleanup. Environmental Specialists will inspect the area after the snowmelt, and if any concerns are identified they will be addressed.

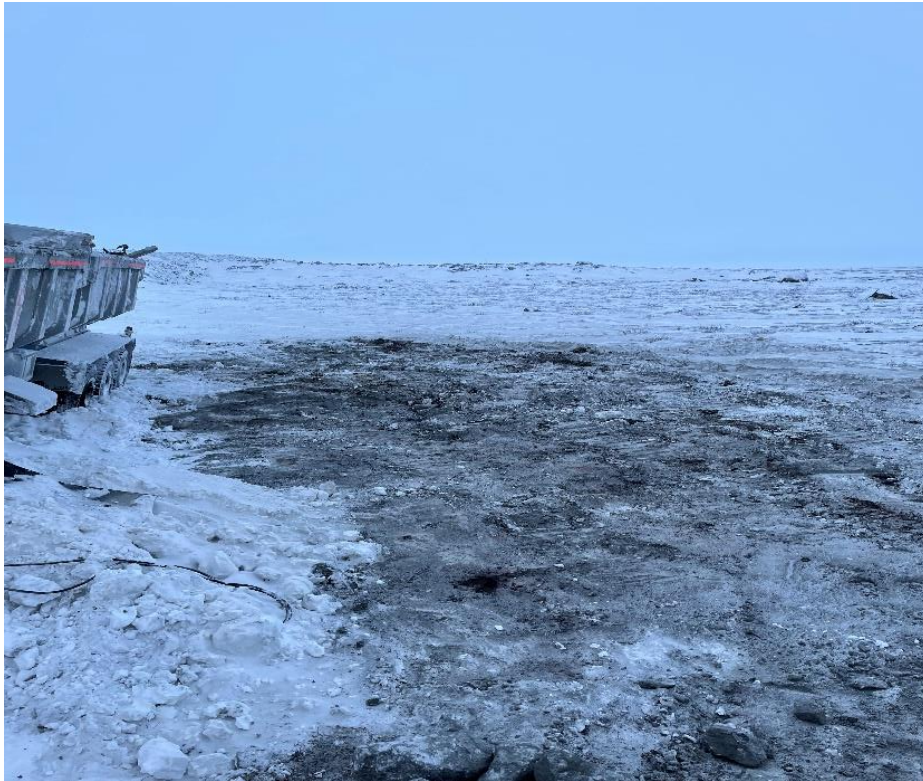
Photo 2: View of spill clean (spill-2024424) on the tundra directly adjacent to Sable Haul Road. An excavator clean-up bucket was used to gather the kimberlite and minimize disturbance to the tundra.
