**REPORT**  
**on**  
**2024 ANNUAL INSPECTION**  
**of**  
**NTPC DAMS**  
**at**  
**BLUEFISH, TALTSON & SNARE**  
**HYDROELECTRIC DEVELOPMENTS**

August 2024

COURAGE PROJECTS LTD.  
30 Meadowlark Crescent SW Calgary Alberta T2V 1Z2  
Ph 403-875-5583  
[courageprojects@shaw.ca](mailto:courageprojects@shaw.ca)

## FINAL

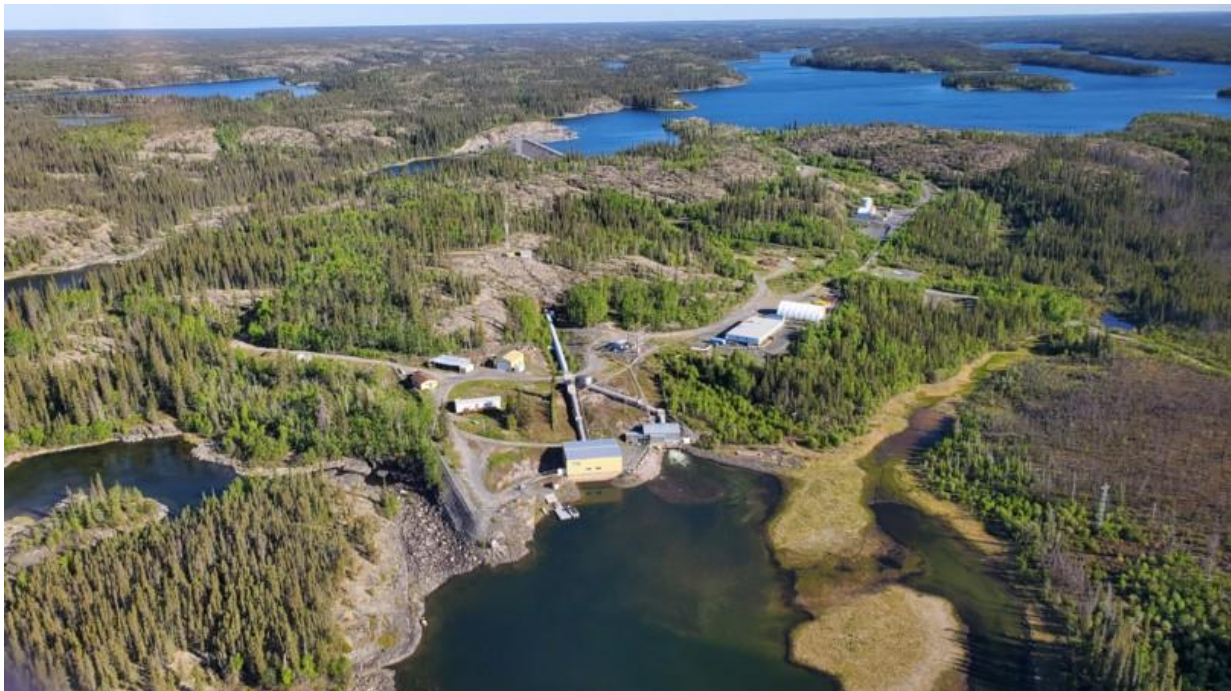
Photo 4. General view of the Bluefish Development The location of the new Rockfill Dam and Spillway constructed in 2012 can be seen near the top, middle of the photo. (see Photo 5)

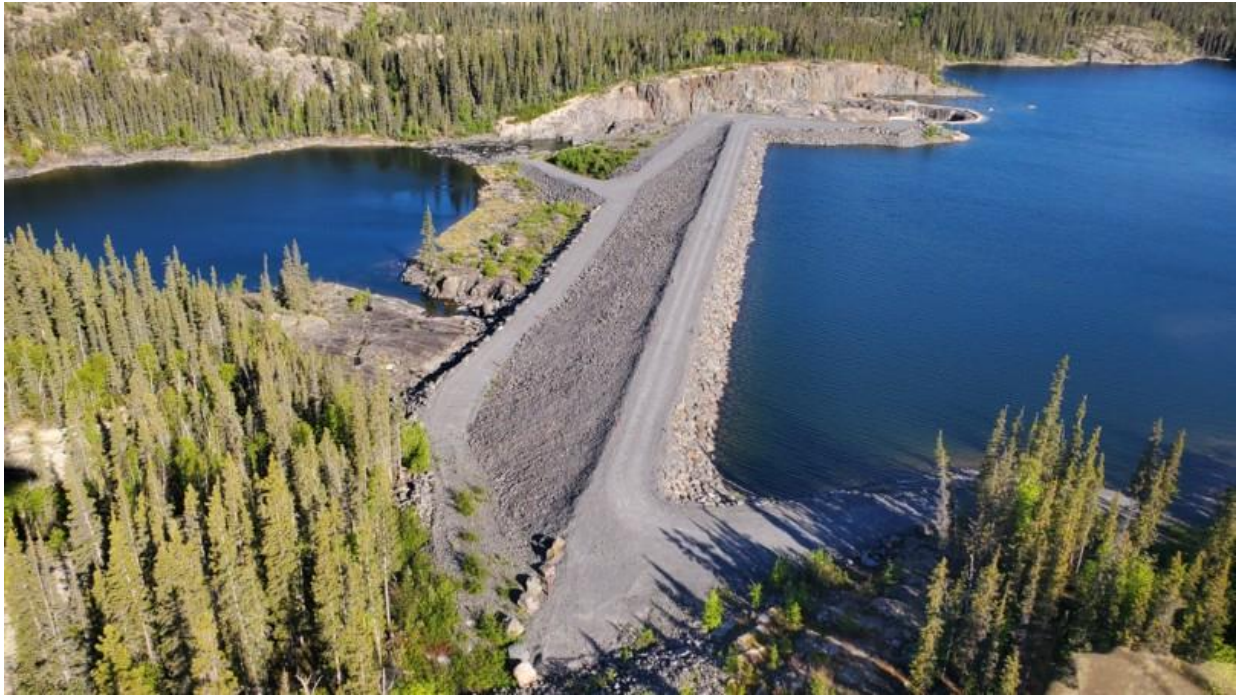
Photo 5. View of Bluefish Dam & Spillway from left side showing the spillway in the distance.

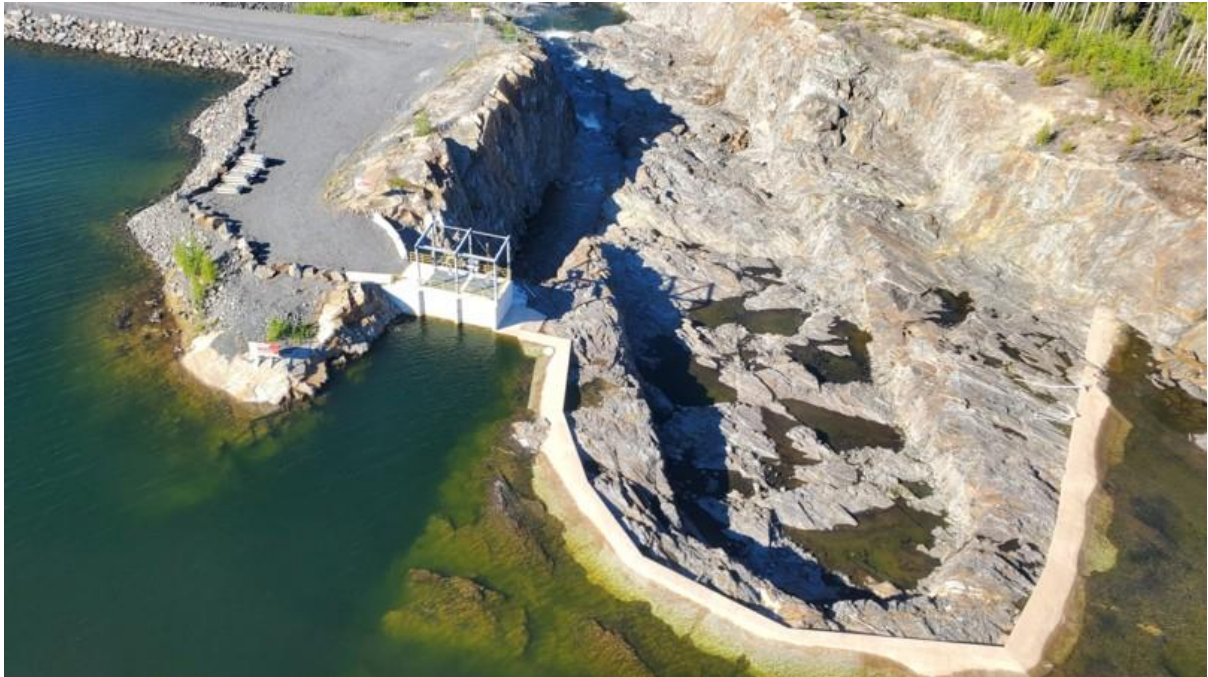
The overflow Spillway consists of a low horseshoe shaped concrete sill built on granite bedrock with a discharge channel and a gated low-level outlet on the left side of the Spillway. The Spillway and associated works all appeared in satisfactory condition.

Photo 7. Shows the horseshoe Spillway, Channel and Low Level Outlet.

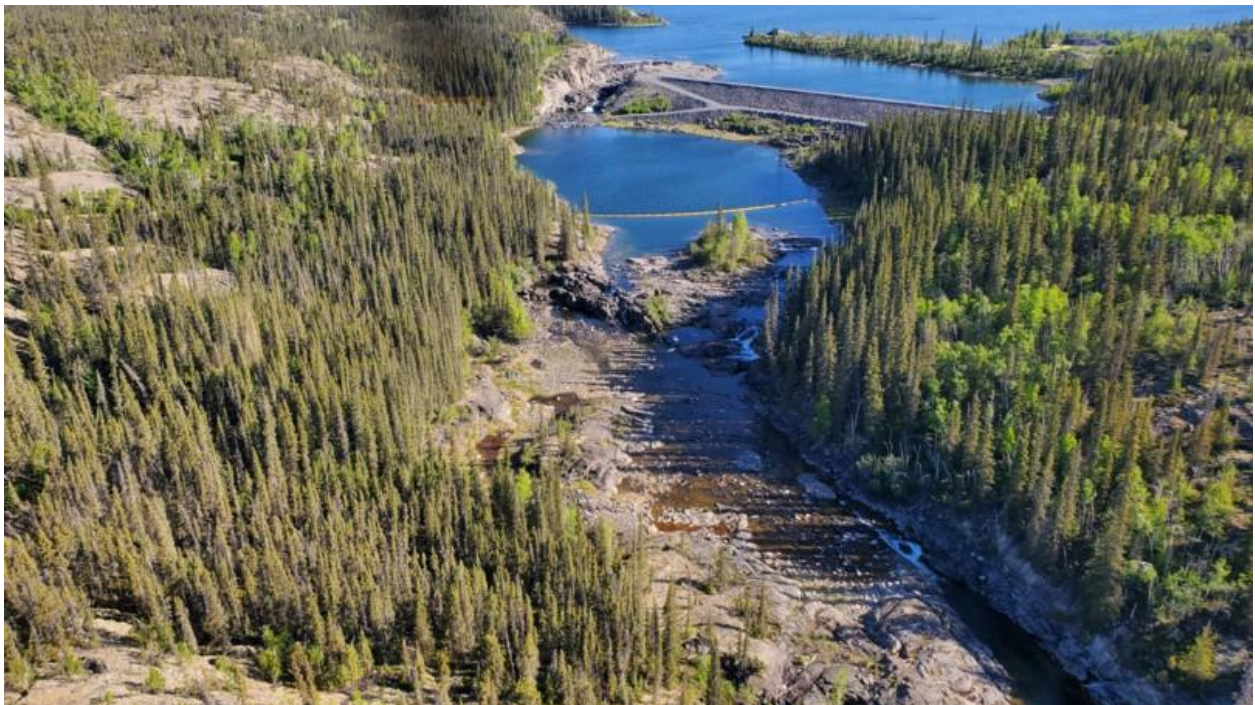
Photo 8. Upstream view. Shows compensation bypass water flow from the Low Level Outlet.

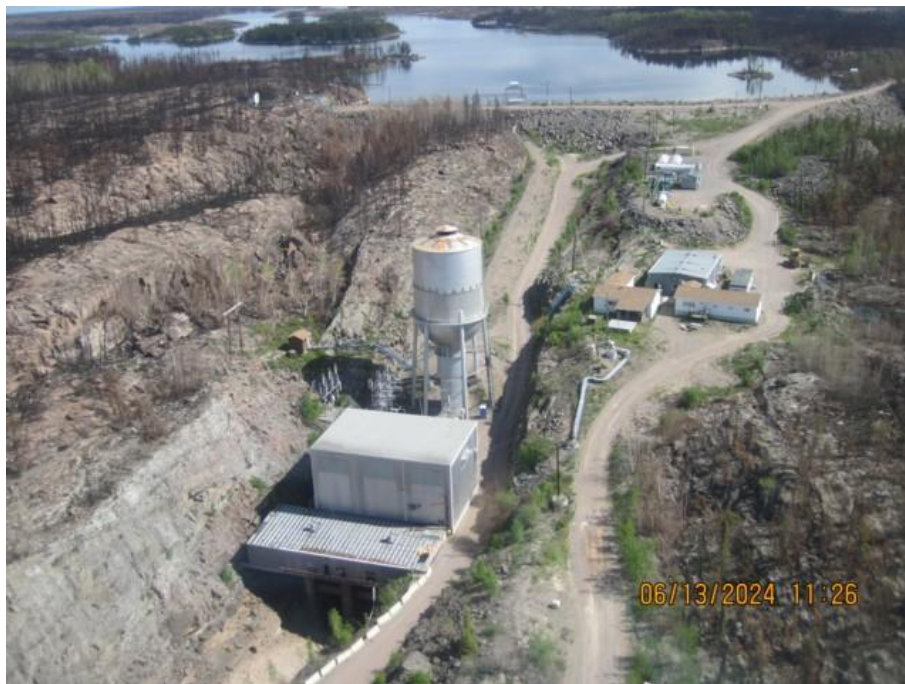
Photo 9. View of the Taltson Power Site showing the Twin Gorges Dam.

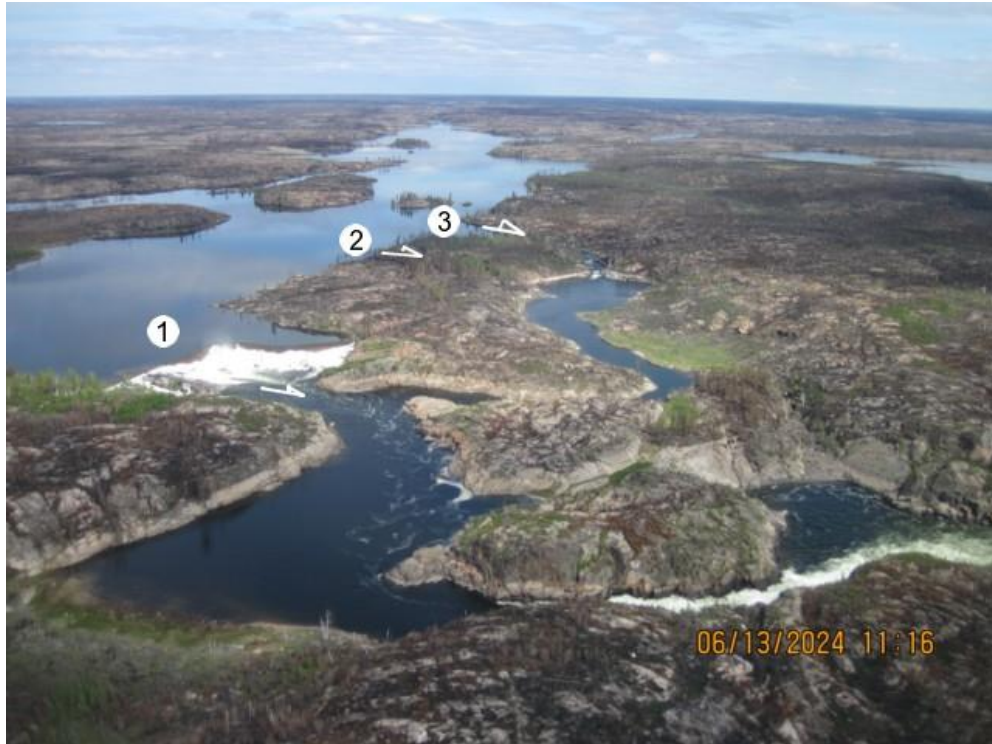
Photo 17. Shows the Main SVS Section 1, and two Low Draws 2 & 3.

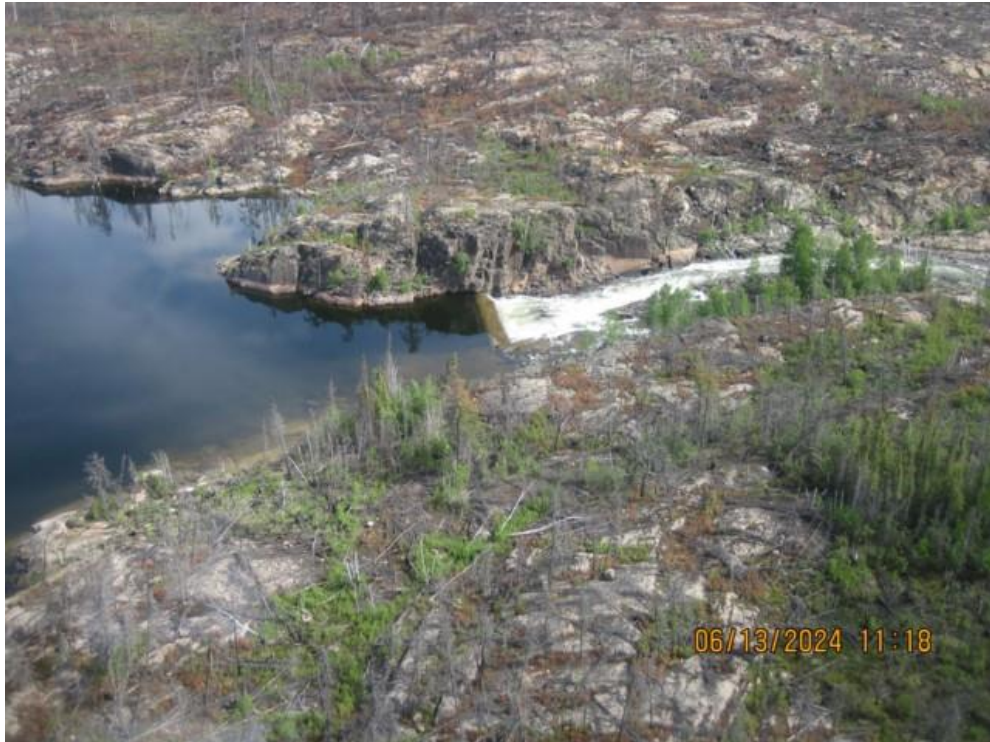
Photo 19. Spill channel at location 3 showing a concrete sill.

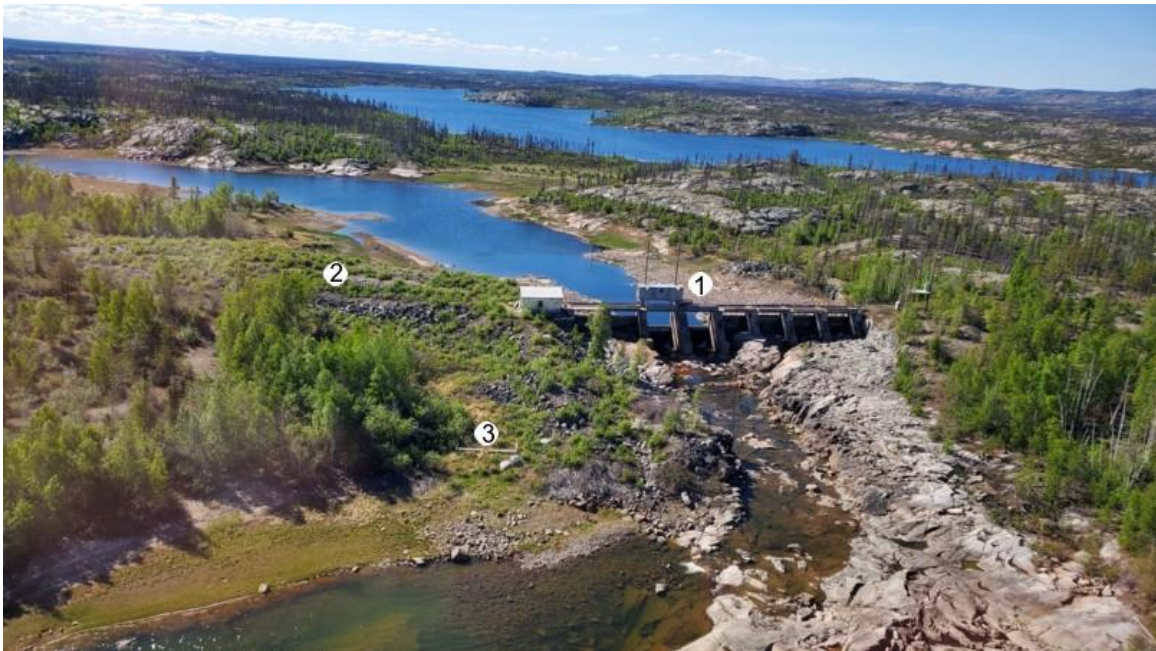
The 5B Dyke, shown in cross-section in **Figure 16** has a central impervious core surrounded by sand filters encased in rockfill. The inspection indicated the dyke to be in good condition. Leakage occurs from the dyke when the reservoir is above El 723+-. The flow has been observed to be clear without evidence of internal erosion of the dyke such as sedimentation along the downstream seepage path, nor has there been any sinkhole activity or settlement in the Dyke, which suggests leakage through bedrock. Leakage was noted to flow beneath the weir at the time of the 2020 inspection. The weir was repaired in 2024. Readings should be taken on occasion when NTPC Staff visit the site for stoplog operations.

Photo 21. Shows (1). 5B Spillway; (2.) 5B Dyke & (3) Weir.

- The 5B Spillway is in satisfactory condition. No maintenance required.
- Status: The weir located downstream of the Dyke was sealed along the face of the wall by placing silty glacial till this year, 2024. When taking readings record time, date & reservoir level.

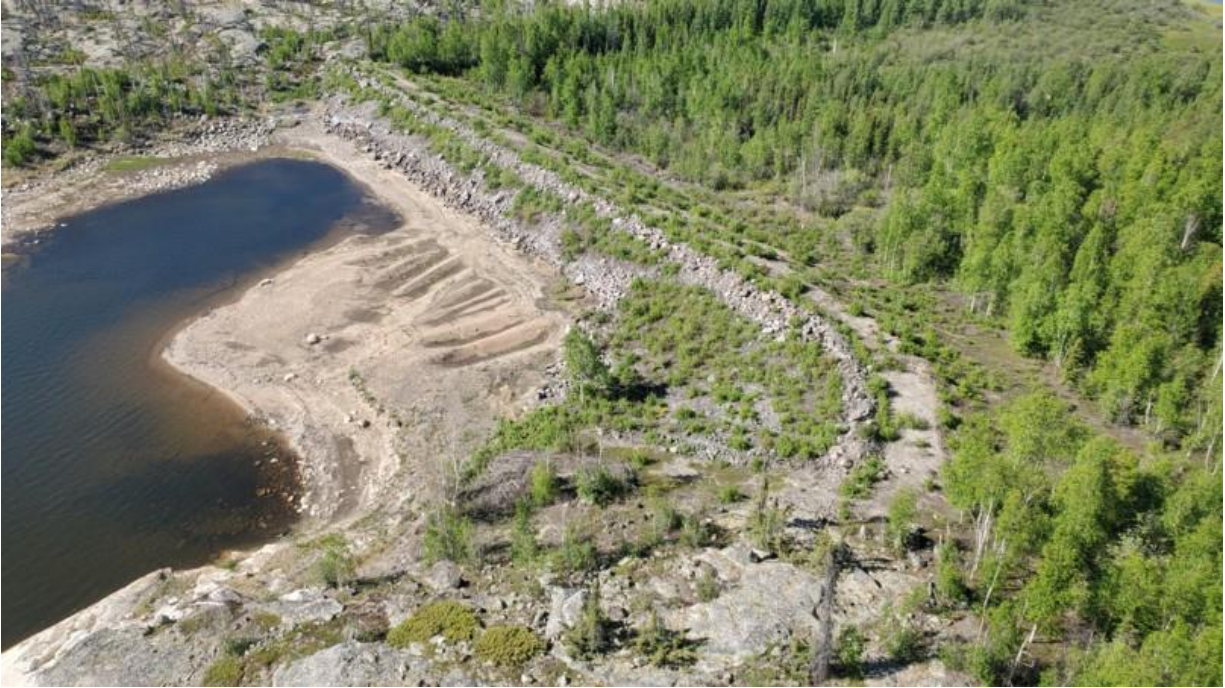
structure without evidence of slope instability, settlement or significant leakage. The performance is satisfactory.

Photo 22. Aerial view of Dam 4.

- Dyke 4 appears in good condition. No maintenance required.

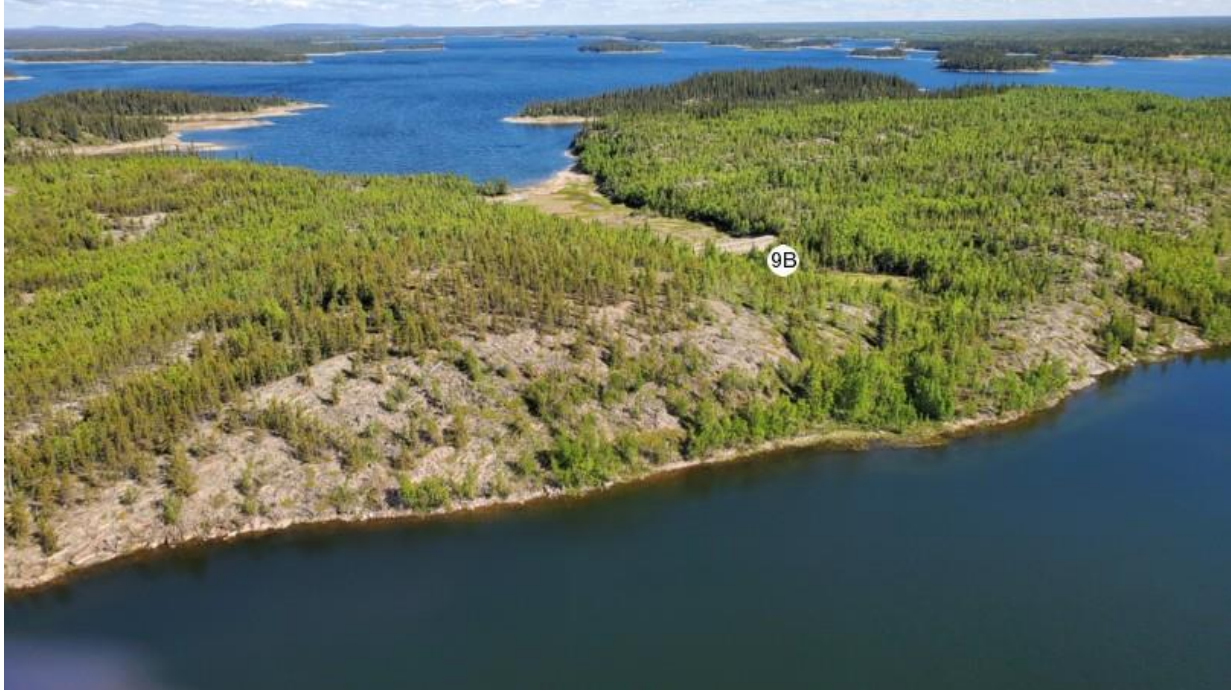
The 2021 inspection found the dyke in good condition with stable slopes without any significant signs of settlement, seepage or distress.

Photo 23. View of Freeboard Dyke 9B.

- Dyke 9B appears in good condition. No maintenance required.

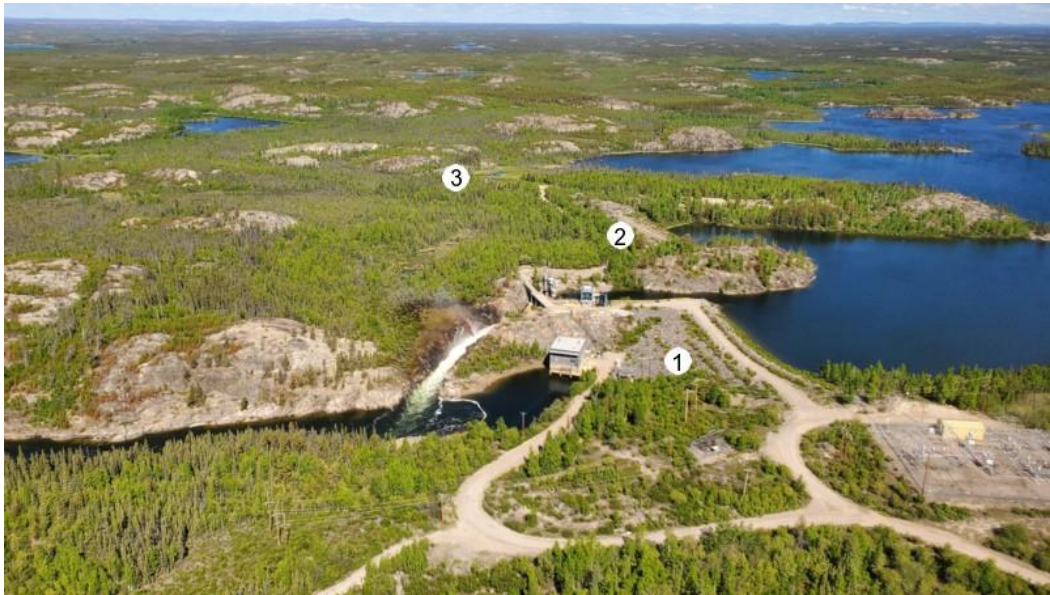
Similar to Saddle Dam #1, Saddle Dam #2, was constructed with a central core protected by sand & gravel shells and riprap. The crest elevation is substantially over built, higher than the Main dam. The dam appears in good condition. The Dam was last brushed in 2021. Clearing of vegetation is now again required to improve visibility when inspecting

Photo 24 Shows location of Falls Main Dam (1), Side Dams (2) & (3).

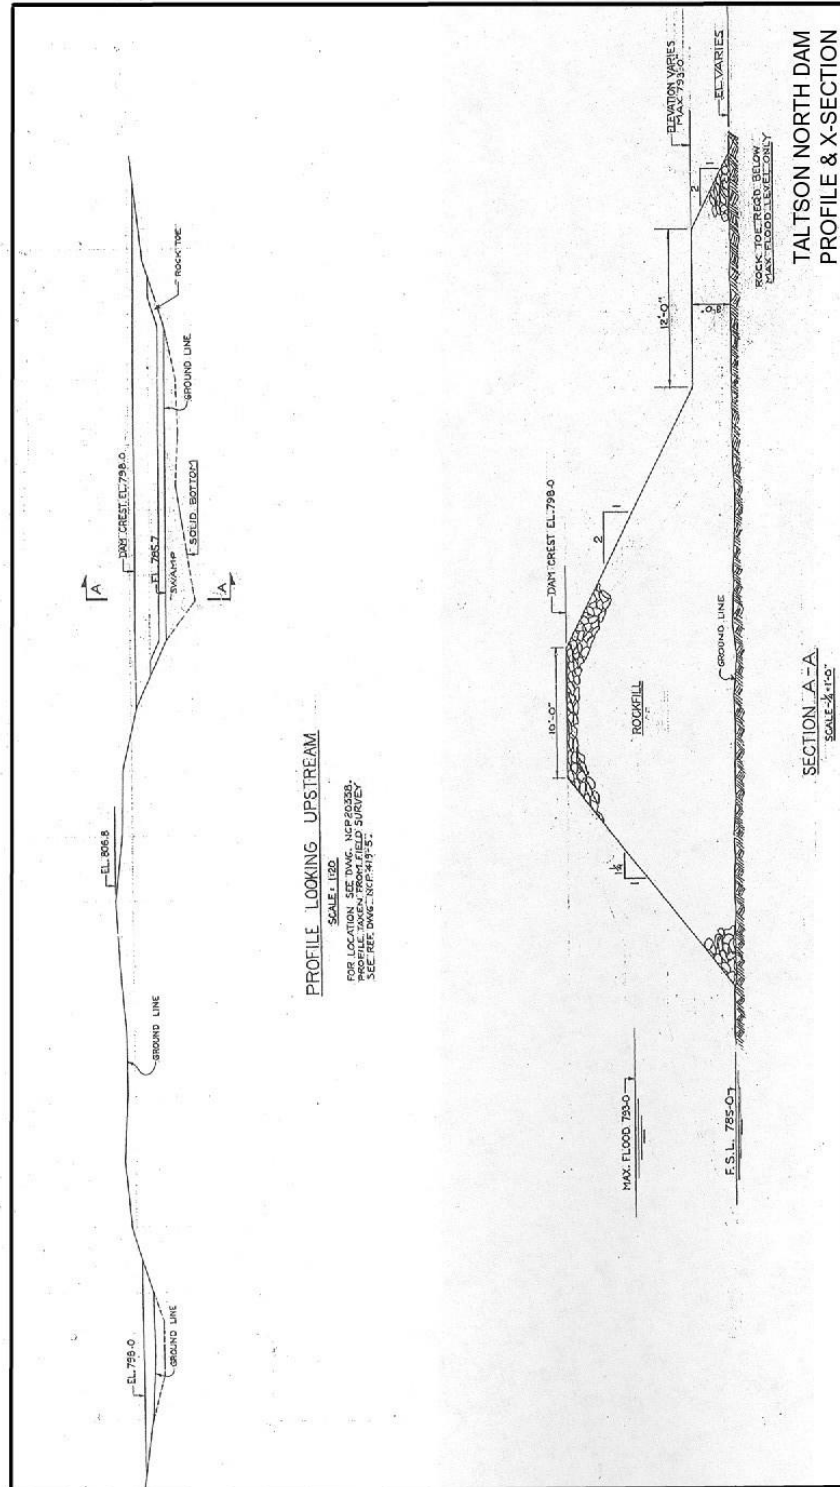
Figure 10. North Valley Dam.  
 PROFILE & X-SECTION

The embankment has no signs of instability however the crest has settled about 1.2m (4ft) since construction. At the time of construction (1963-65) the dam foundation was sounded to hard bottom (Figure 10) and is indicated to be built on about 12 feet of swamp (muskeg) which is compressible and accounts for the settlement over the years. The dam was overbuilt to allow for settlement of the foundation. The dam currently has adequate freeboard for both normal and Design Flood (IDF) inflows The dam is shown on the following Photo.

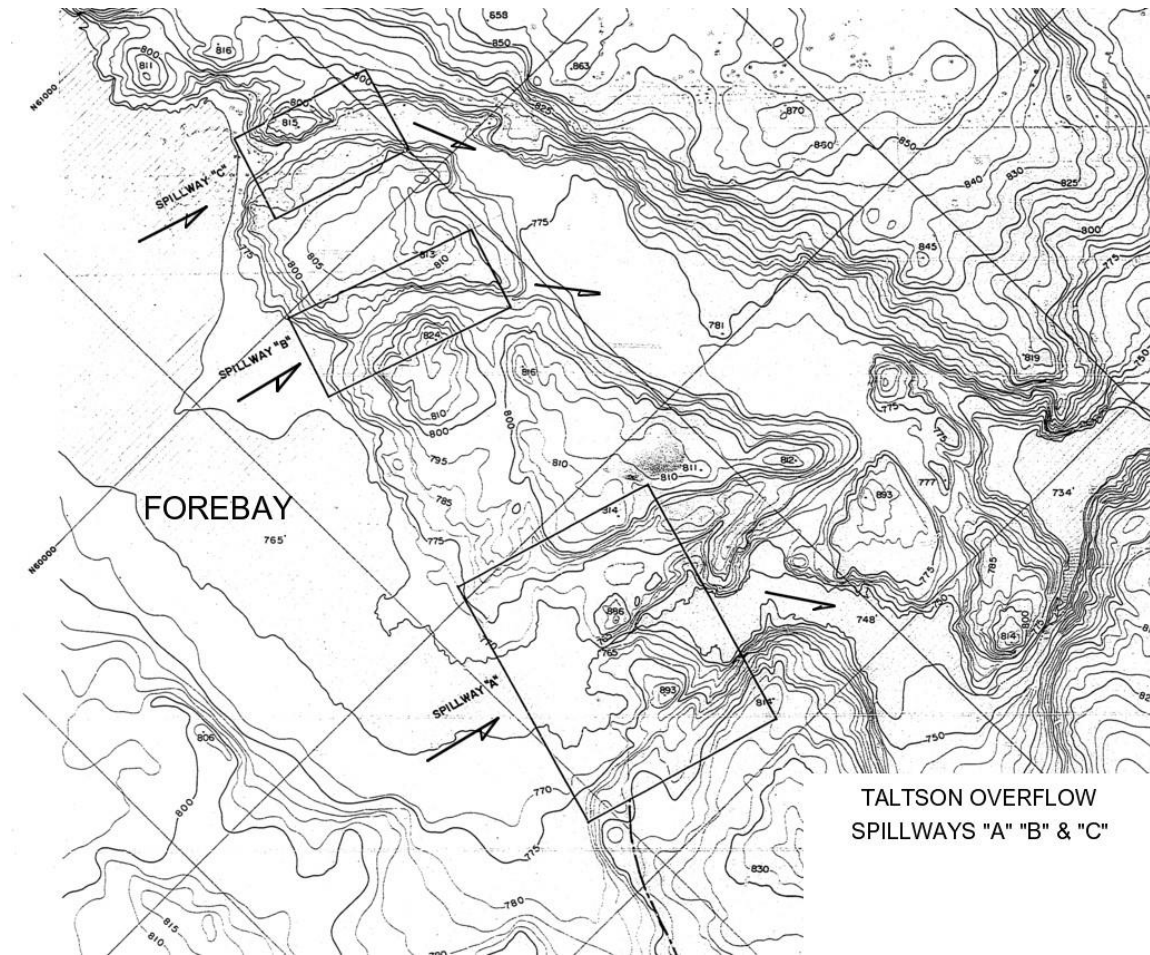
Figure 11. TALTSON SOUTH VALLEY SPILLWAYS.

Shows the topography at the Taltson Overflow Spillways at Sections A (Main Concrete Section), Secondary Channels B & C. The channel at location C is provided with a concrete sill overflow. The flow through Section B is contained in a rock cut without a concrete sill.

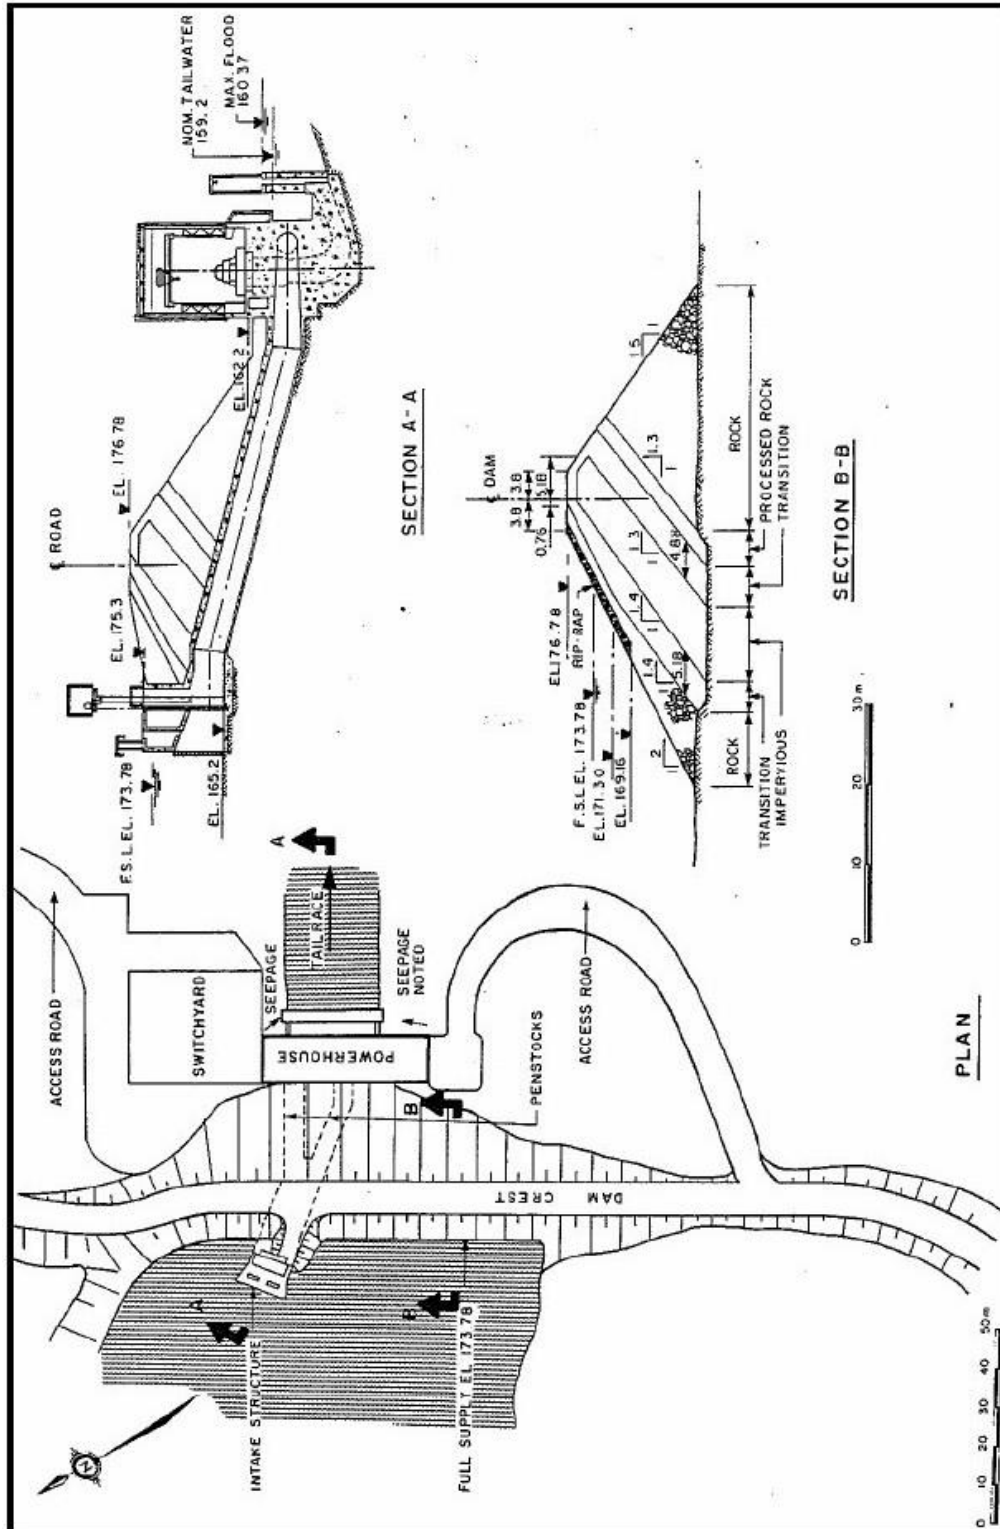
FIGURE 25.  
GENERAL ARRANGEMENT  
Forks Development

The Snare Forks Development is located on the Snare River downstream of Snare Cascades and was commissioned in 1976. It consists of the Strutt Lake Dam, North Dyke, Intake and Powerhouse, Freeboard Dykes 1, 2 & 3, Forks Main Dam and a Spillway Weir as shown in plan on **Figure 25**.
