# Bluefish Hydro Comprehensive Dam Safety Review

Northwest Territories Power Corporation  
January 2017  
Project: 159100263

Final Report

Prepared by:  
Stantec Consulting Ltd.

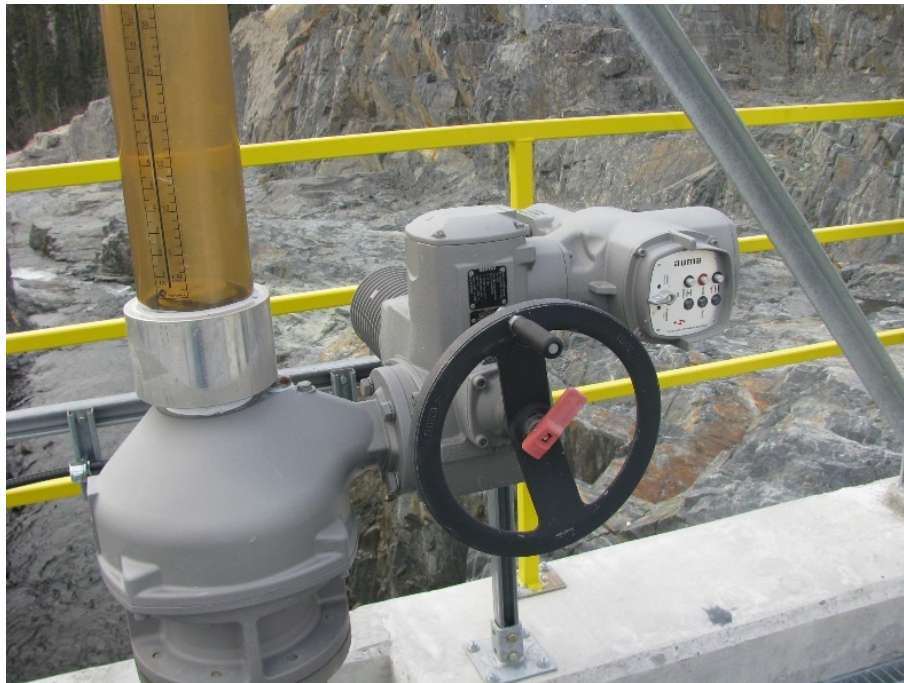
Figure 3-1: Bluefish IFR Gate Manual Control

In terms of flood control and based on the design documents, the overflow spillway can by itself discharge the full flow of the IDF without any overtopping of the embankment dam. So no operation of other existing gates is required for the IDF passage and do not need to be tested as per CDA Guidelines. The other existing gates at Bluefish dam are the bottom outlet structure (which used as diversion during the construction of the dam) and the IFR bypass gate (fish gate). Bottom outlet structure (low level gate) is operated using a generator of electric power or manually. The gate was not tested during the site visit to avoid losing water at the beginning of the winter. However, the fish gate was tested manually during the site visit and it seems in good operational conditions. Consequently, and since the gates operation is not required to discharge safely the IDF, the overall system can be considered adequate.

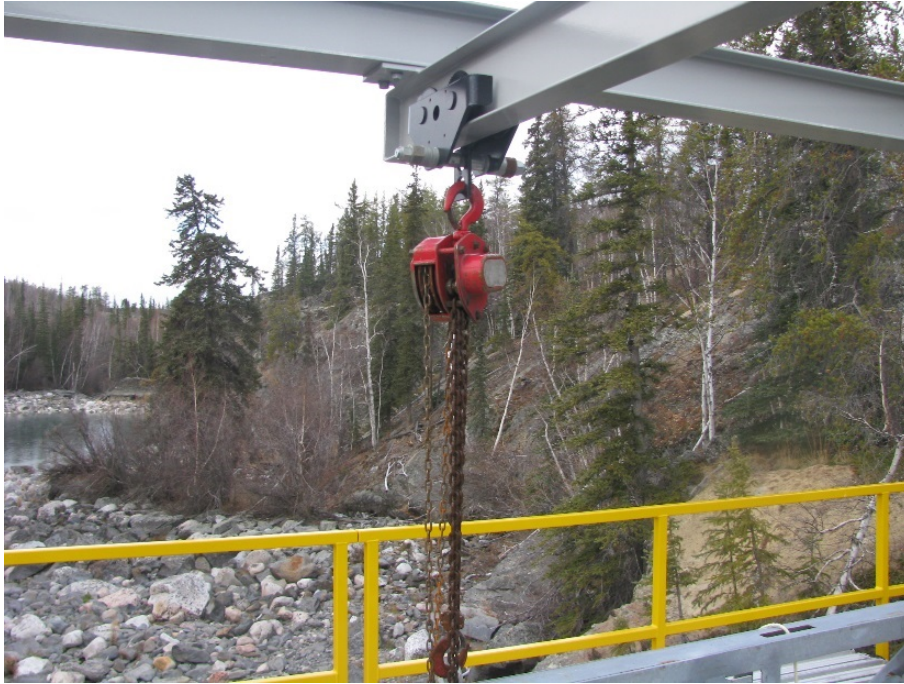
Figure 3-2: Duncan Manual Winch

Duncan Dam has a stoplogs sluiceway section in the middle of two overflow spillways. In order to achieve the IDF passage without overtopping, all stoplogs need to be removed. A manual winch system is used to remove the stoplogs and is relatively new and seems to be in good conditions. If system fails and the stoplogs are not removed during IDF passage, overtopping will occur, but as a concrete dam built on rock the dam overtopping should not be hazardous for the dam integrity. However, an inspection should be performed after any dam overtopping occurrence.

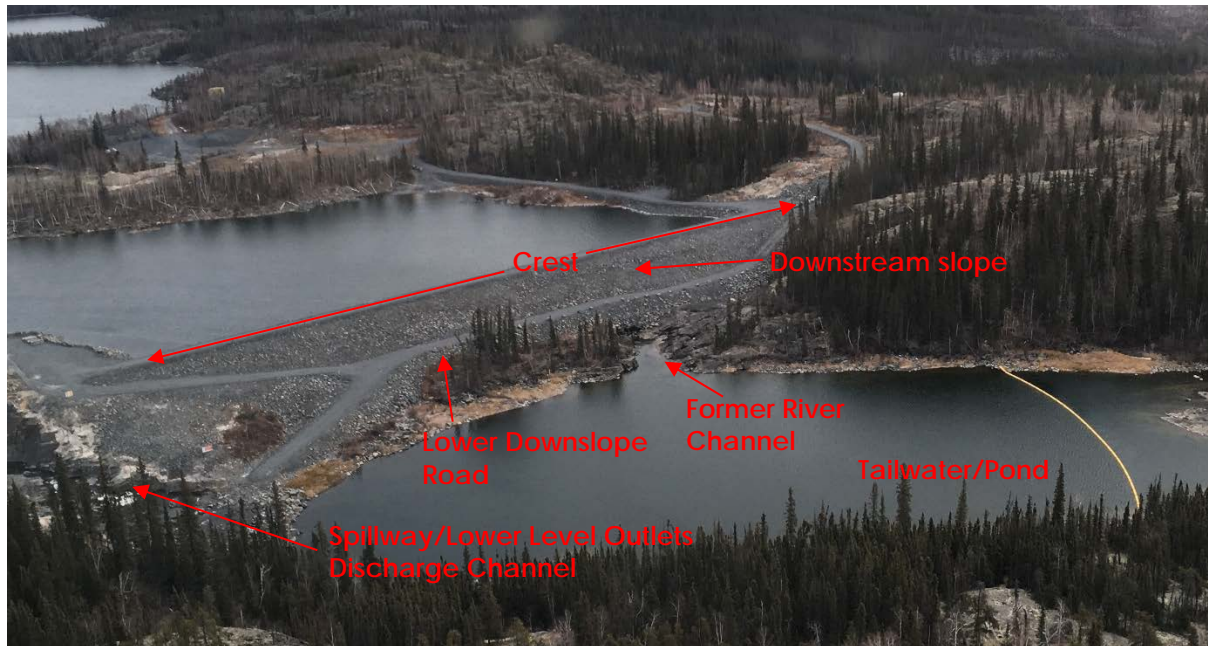
Figure 5-1: View of downstream side of the Bluefish Dam

No significant issues were noted during the site inspection of the Bluefish dam main embankment. Figures 5.1 and 5.2 demonstrate the various areas of the dam discussed in this section.

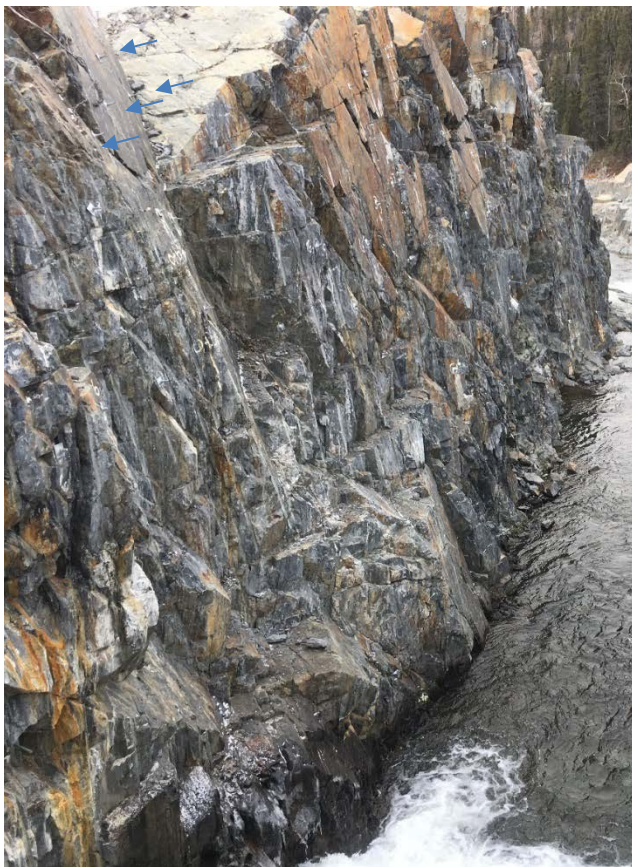
Figure 5-11: Low Level Outlet channel left wall with some anchor locations shown securing areas of the upper rock wall

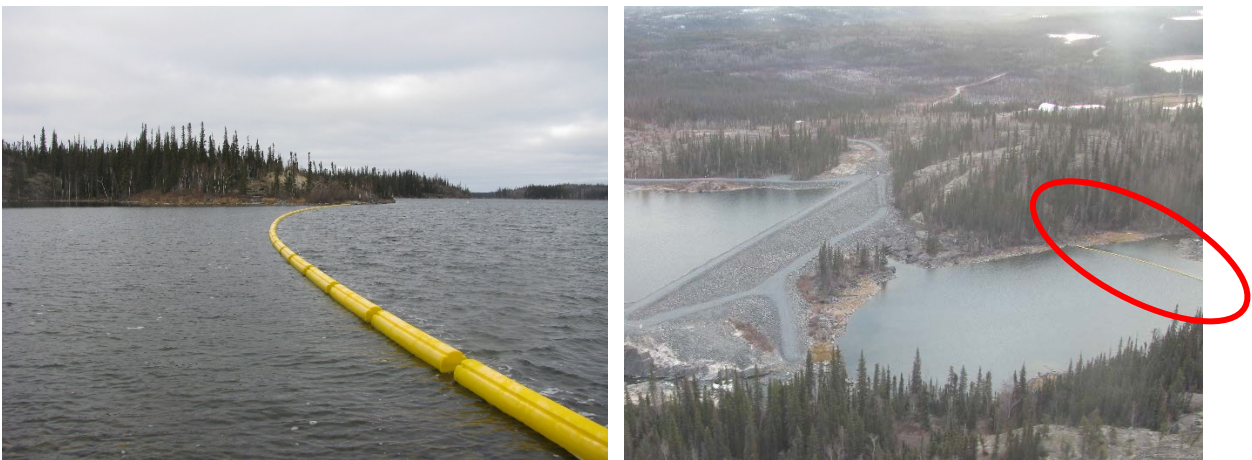
Figure 9-1: Safety booms upstream and downstream of Bluefish dam.

The north boom was designed for the expected water velocity of 1.1 m/s and the south boom was designed for the expected velocity of 0.86 m/s during IDF flow. They are correctly located and prevent access close to the dam.

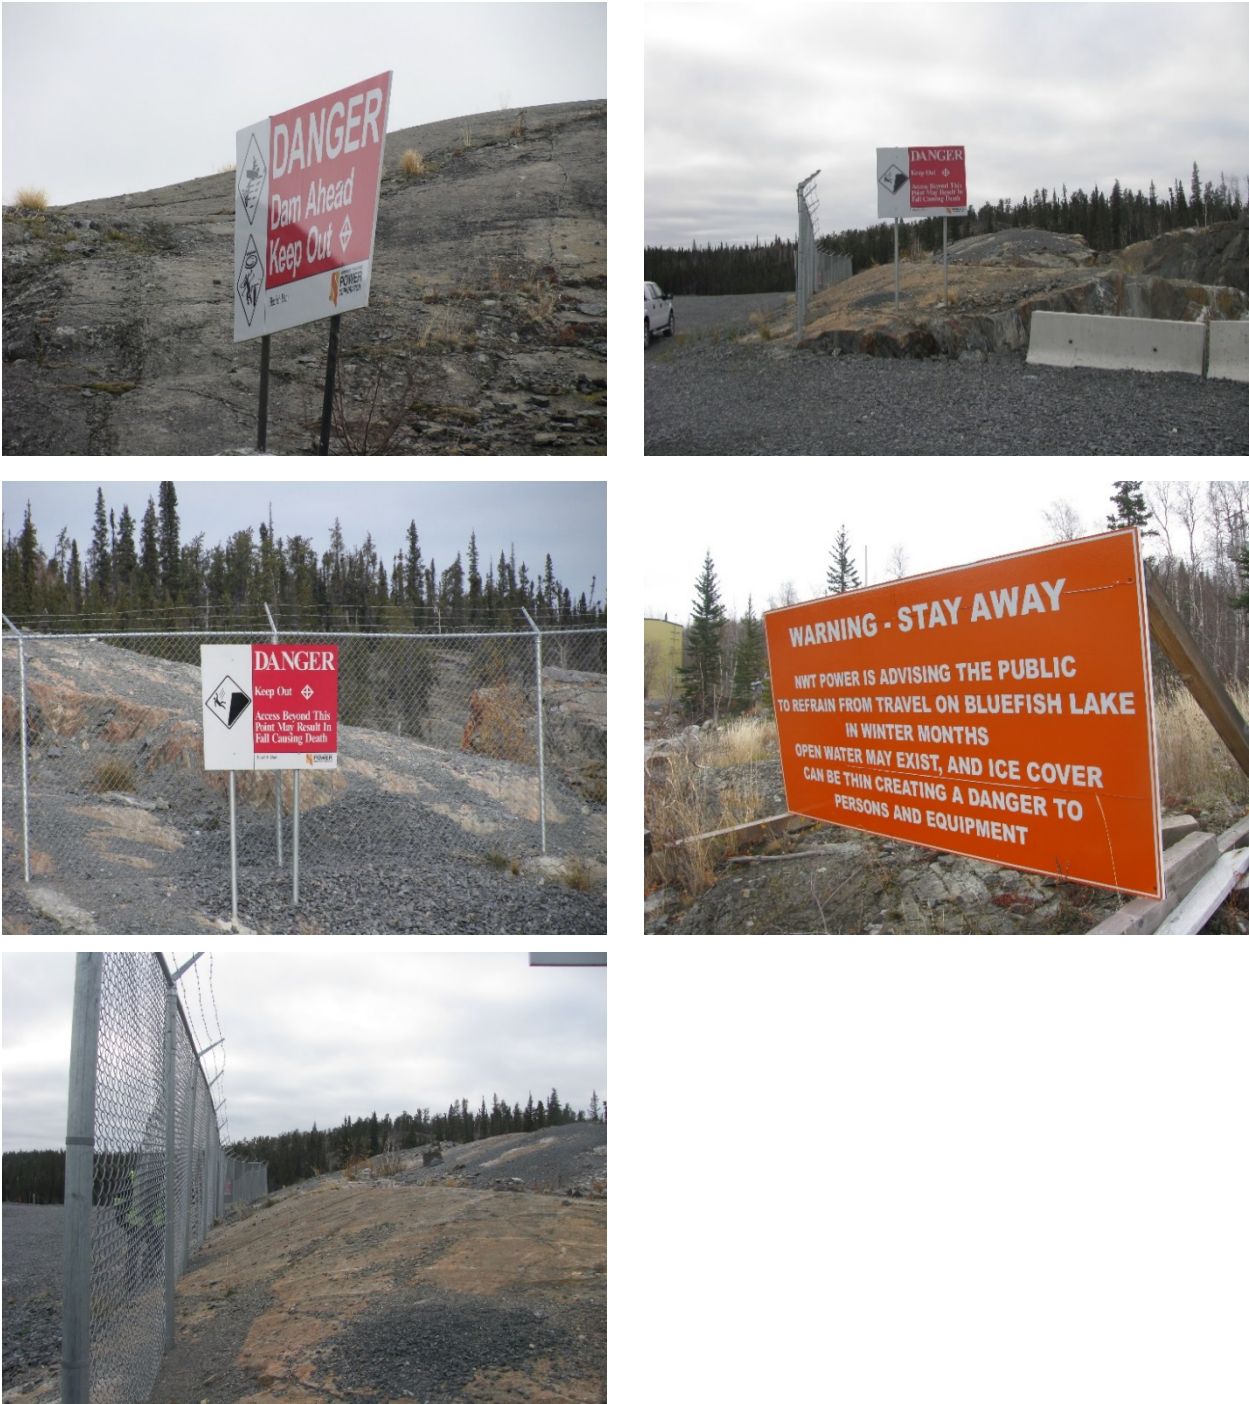
Figure 9-2: Signs and protection fence at Bluefish dam.

Sufficient signage and fences are presents at Bluefish so no more actions are required.

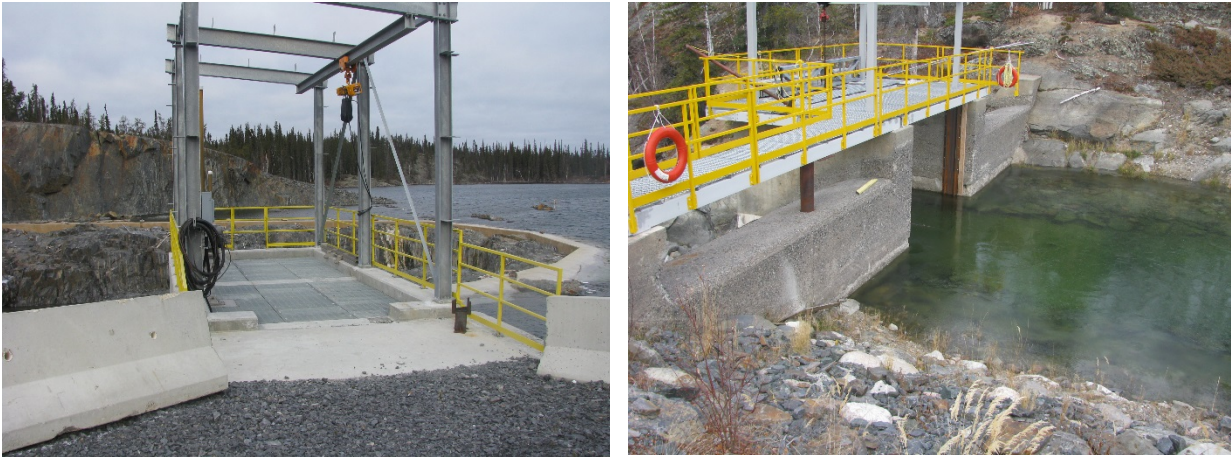
Figure 9-3: Guardrails

Guardrails are present at both locations. They are easily visible (yellow) and provide NTPC personnel safety. Buoys are present on the guardrails in case of fall in the water.

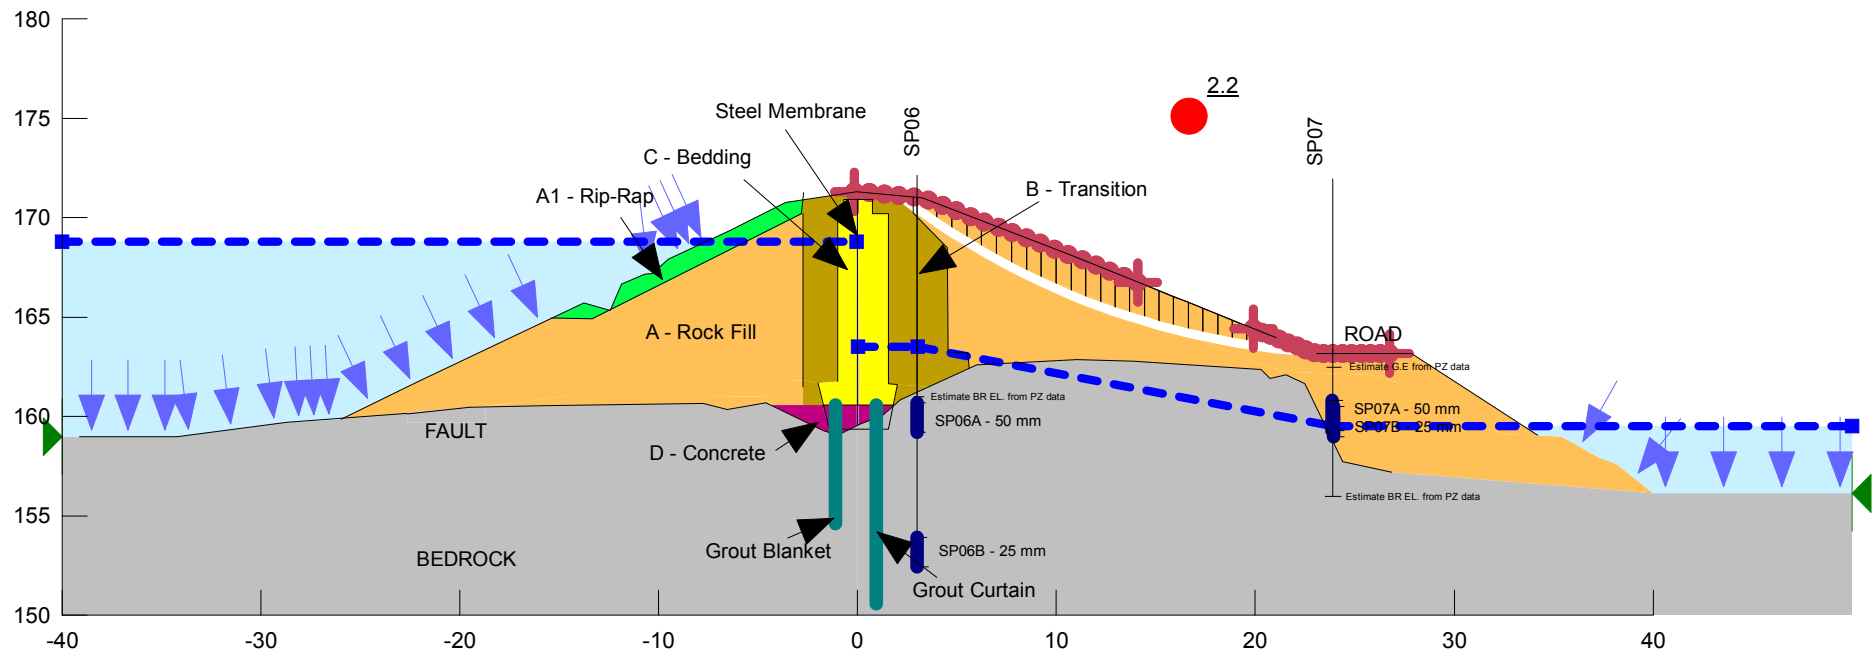
Bluefish Dam - Slope Stability Analysis  
 Station: 0+160  
 Name: 1. TOE - PZ readings = average  
 Case 1 Toe
