Re: MV2021L2-0004: Annual Geotechnical Inspection Report Submission, Prairie Creek Mine, NT

2024 ANNUAL GEOTECHNICAL INSPECTION PRAIRIE CREEK MINE, NORTHWEST TERRITORIES					
WATER STORAGE POND PLAN					
PROJECT NO. ENG.EARC03183-06		DWN EL	CKD TB	REV IFU	FIGURE 3
OFFICE EDMONTON		DATE NOVEMBER 2024

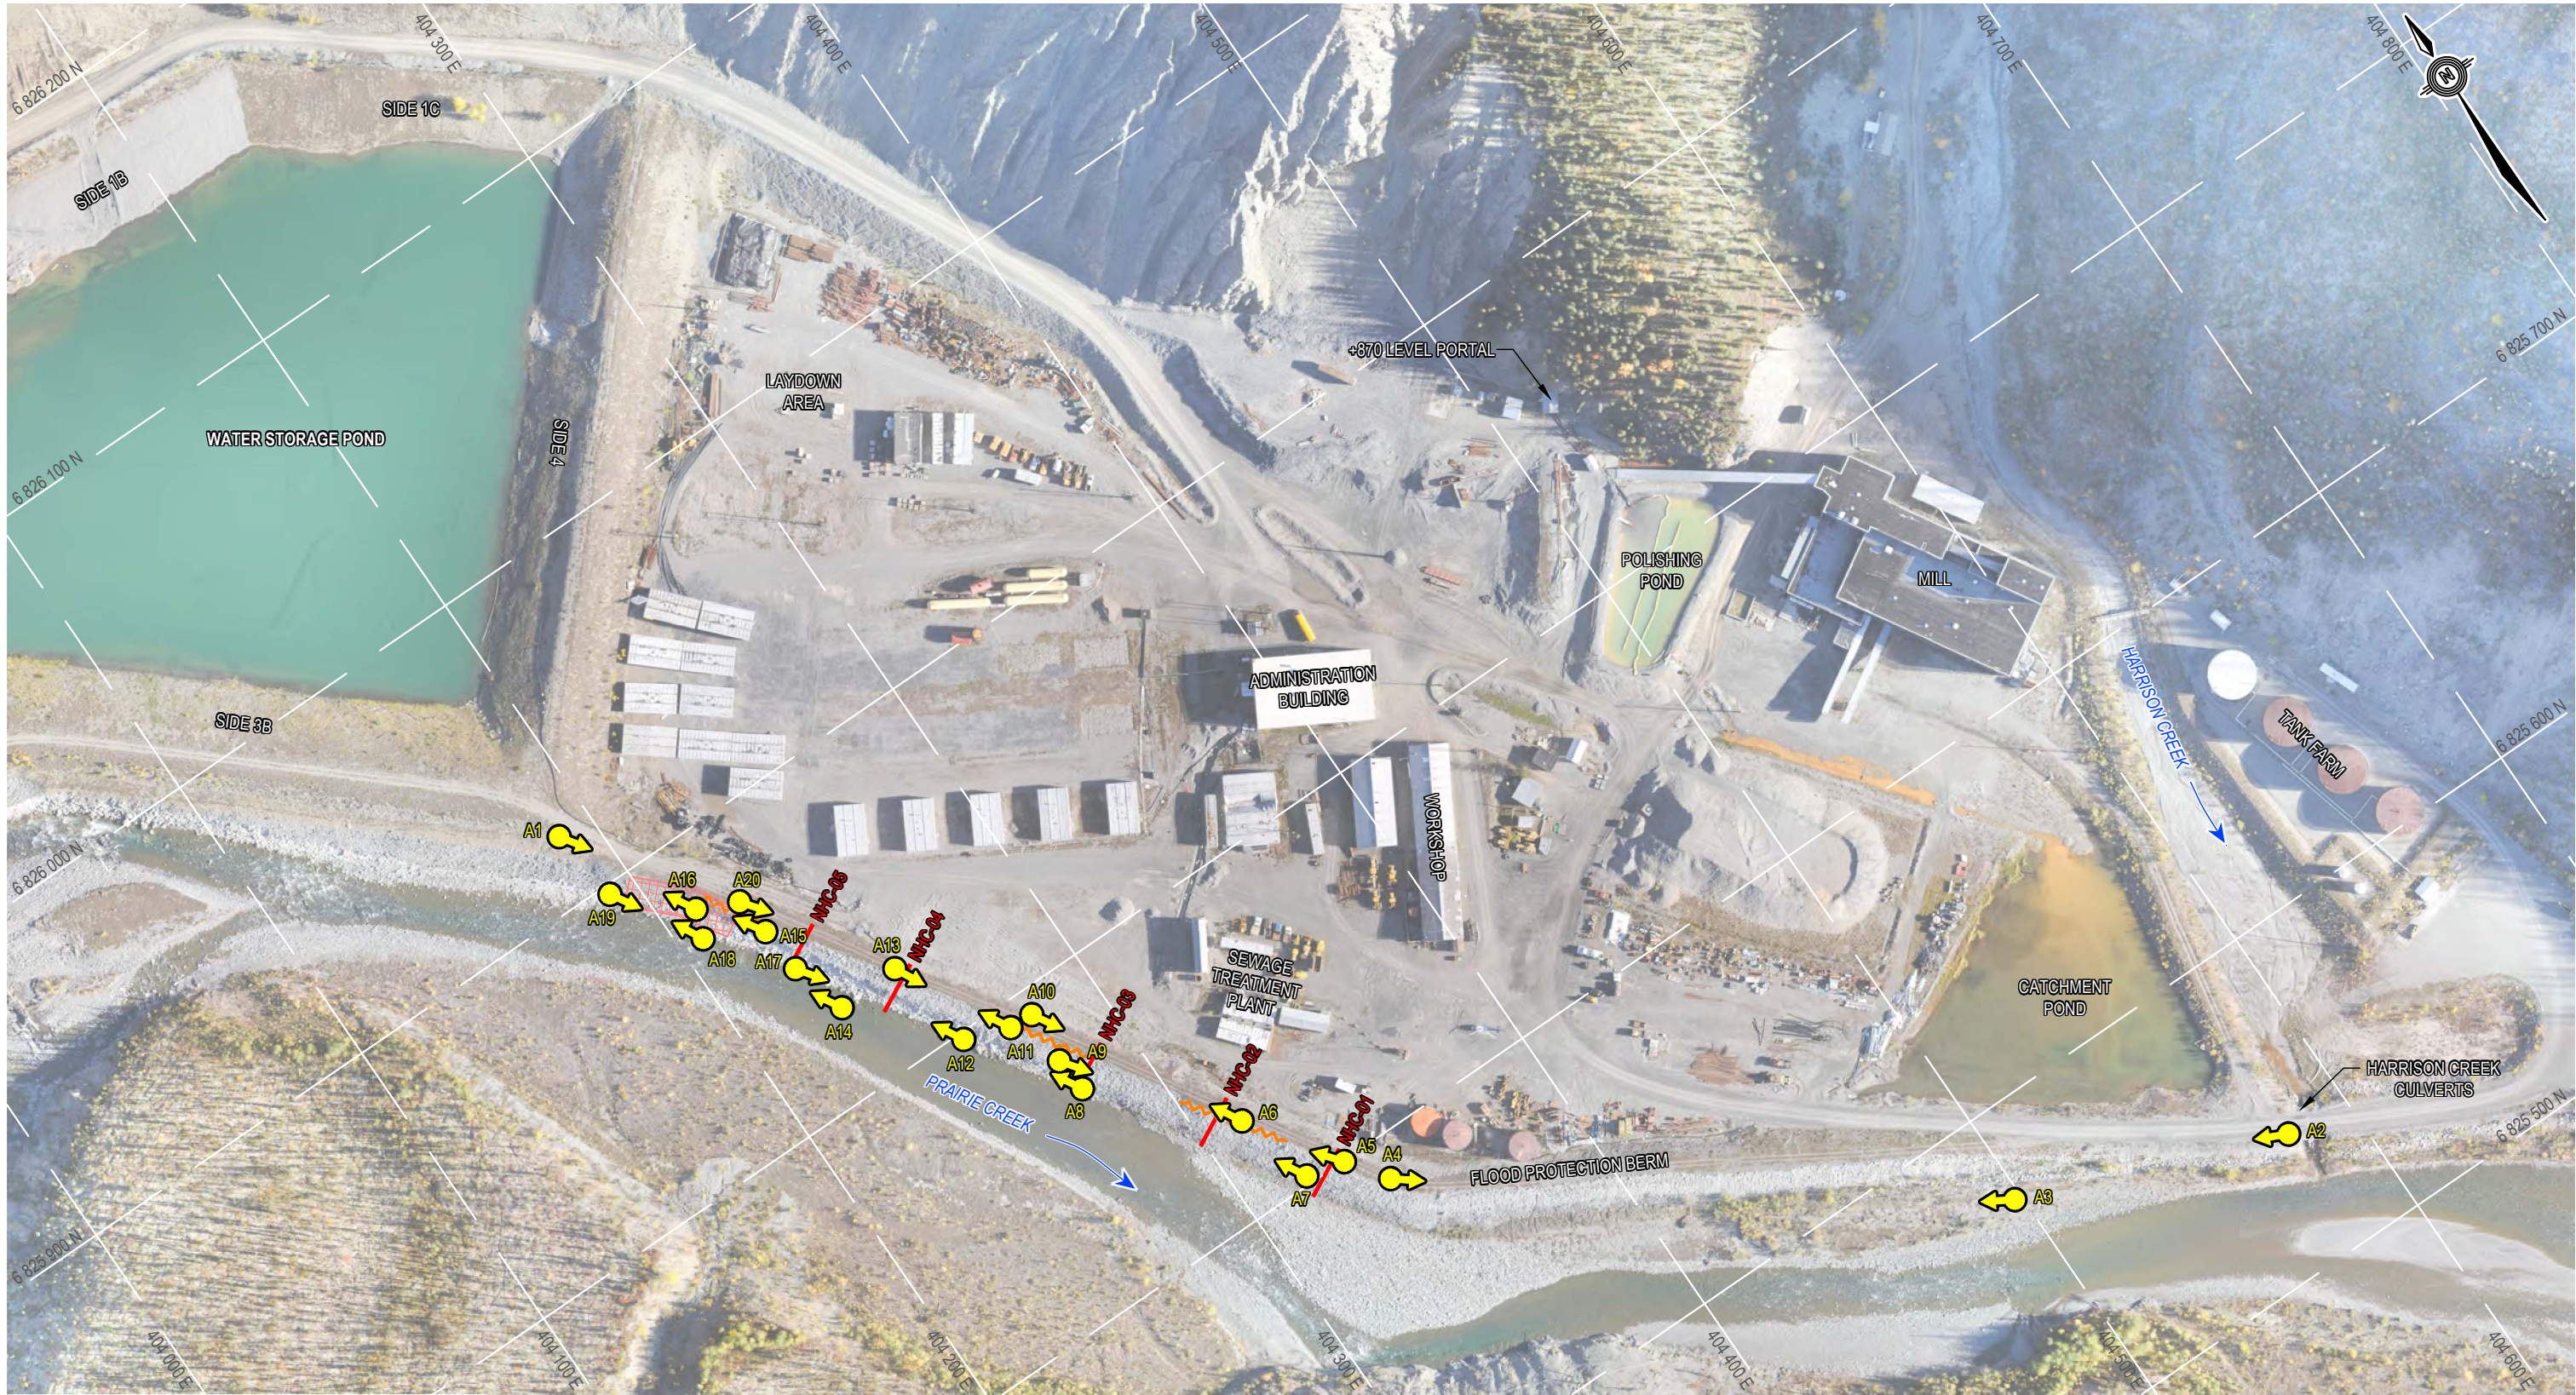
FPB observations made during the 2024 AGI were largely consistent with those from the 2023 AGI (Tetra Tech 2023b). The berm appears to be performing as intended; however, several areas of distress were noted along the creek side slope and top of the embankment. Appendix A presents photographs and observations from Tetra Tech's 2024 inspection of the FPB. The locations of each inspection issue, monitoring site, and photograph are illustrated on Figure 2.

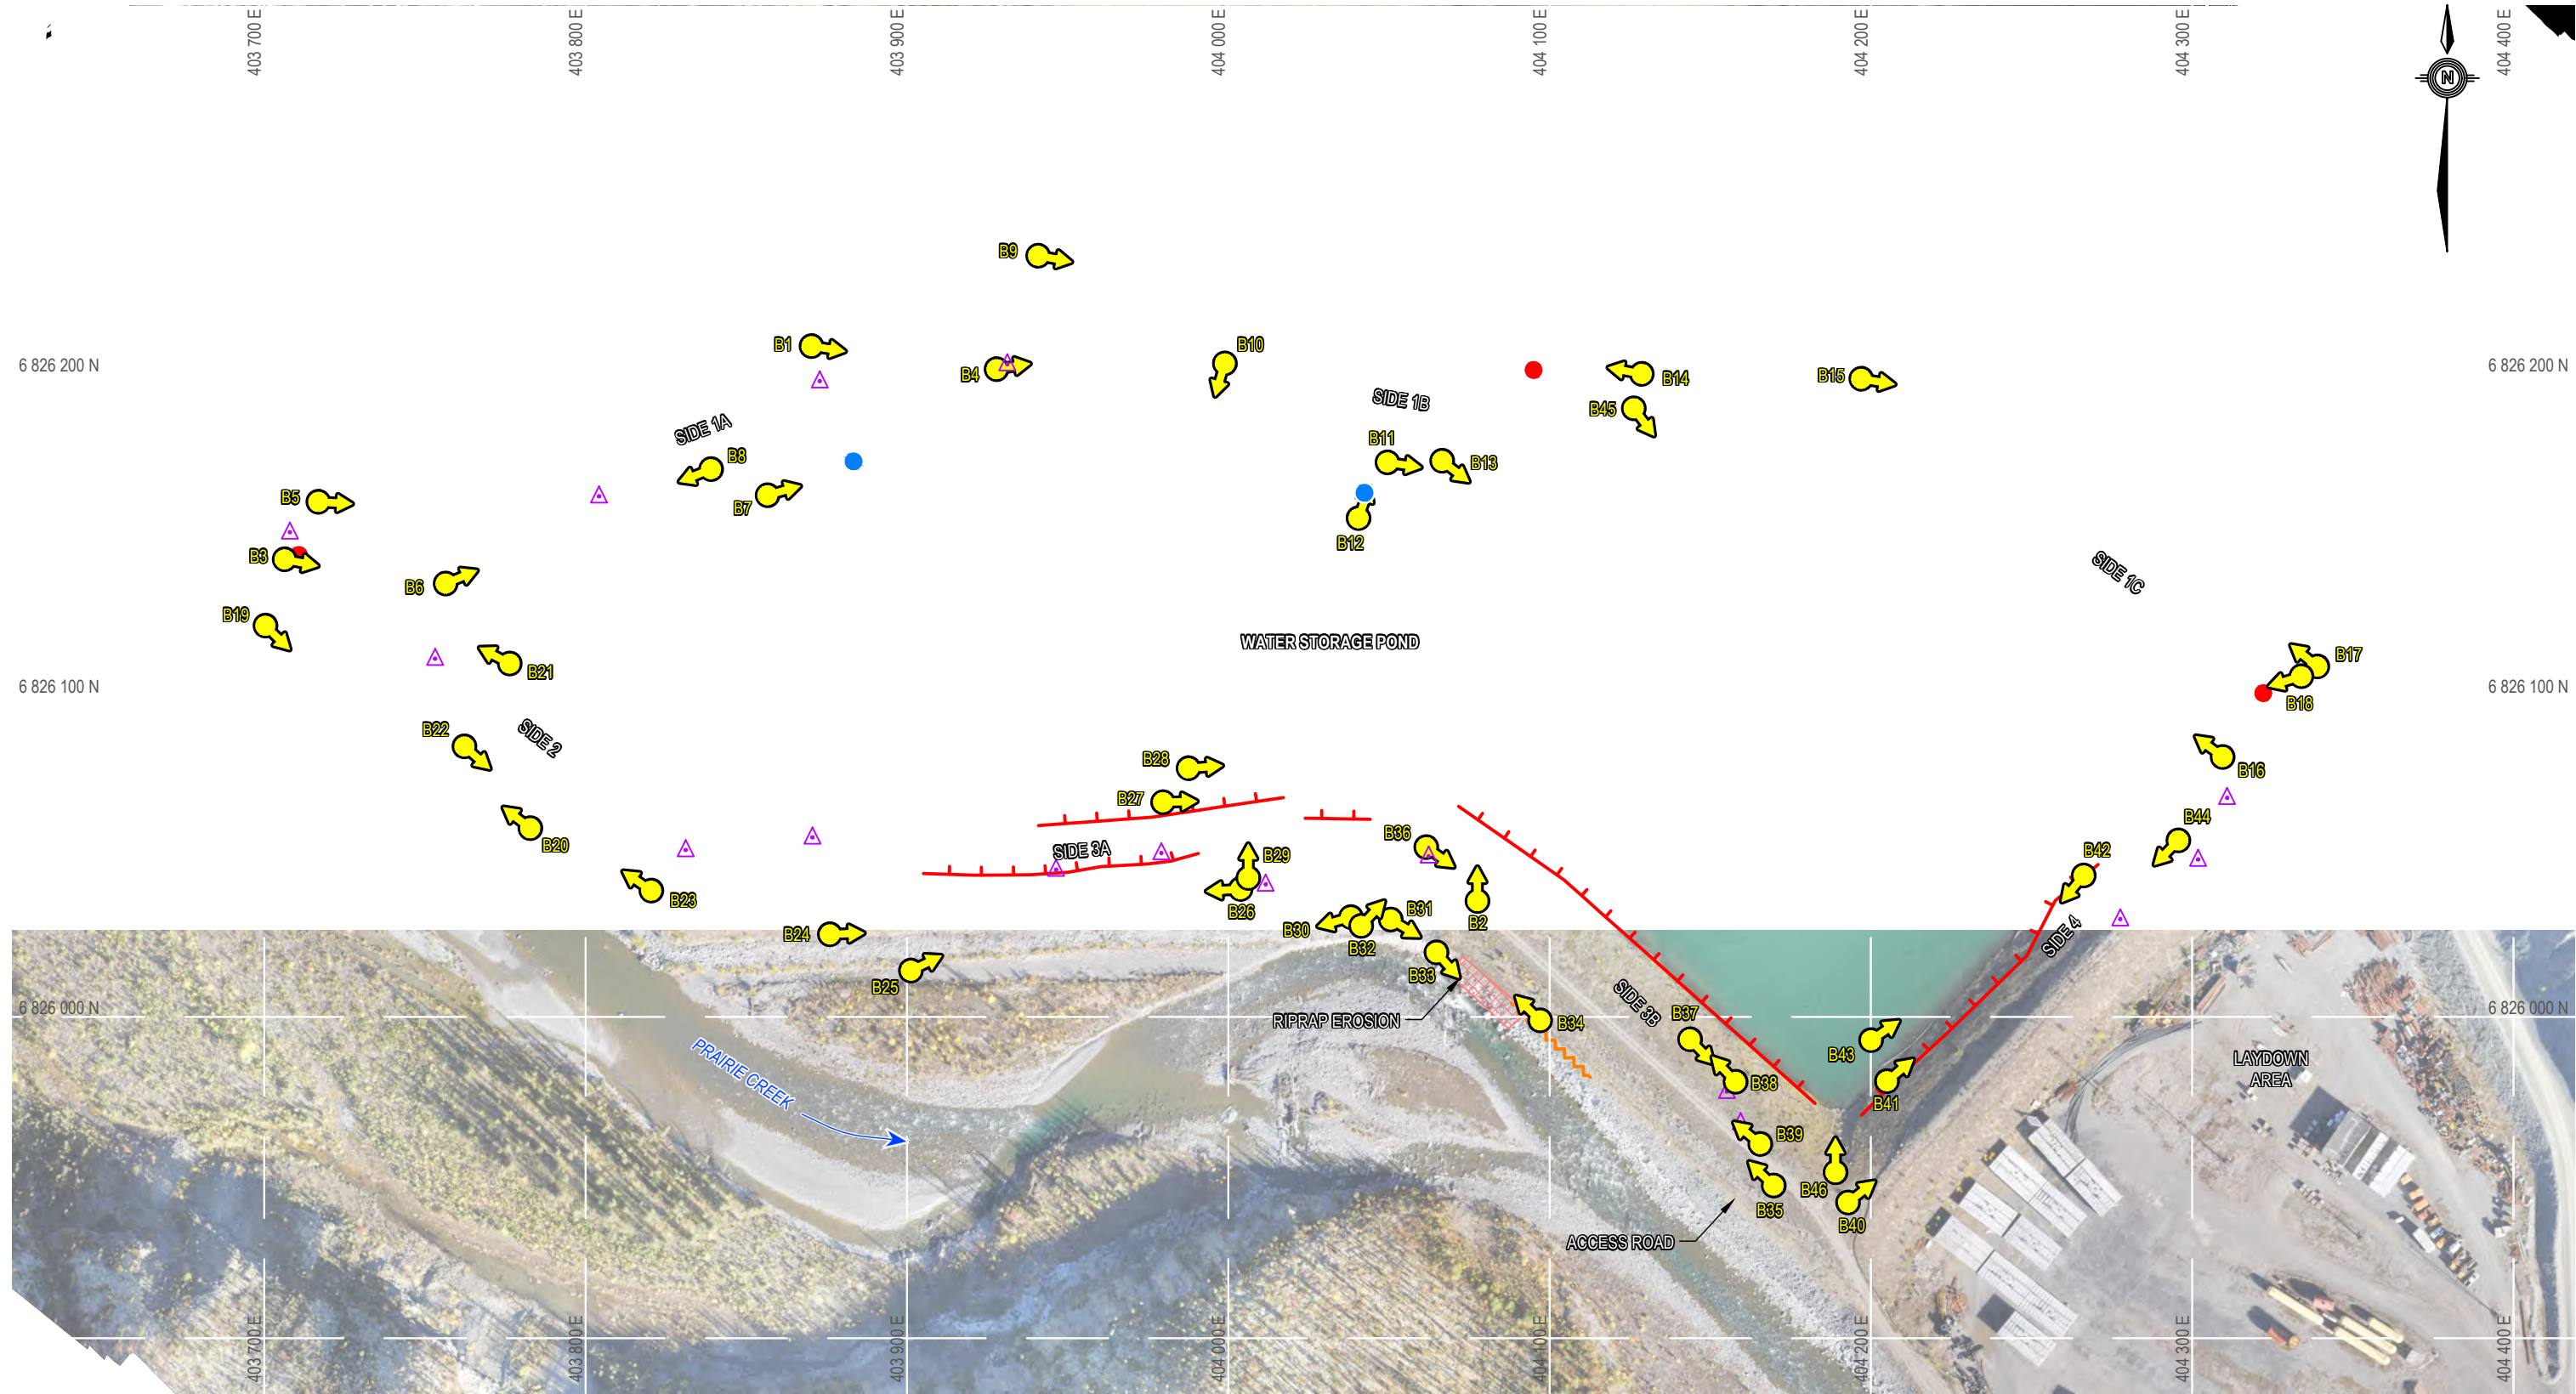
- A groundwater spring was observed in 2019 near the toe of Side 1A in the base of the WSP, as identified on Figure 3; and
- Evidence of a high water event in Prairie Creek was observed in 2021 on the riprap of the WSP, particularly on Side 2 where flood levels were estimated to have risen within 0.3 m of the top of the erosion protection. Areas of riprap erosion and subsidence were also noted, particularly along Side 3B of the WSP to the FPB.

Visual inspection of the WSP was conducted on August 21, 2024. The weather onsite during the inspection was cloudy with light winds and temperatures ranging between 4°C and 16°C. Observations made for the WSP during the 2024 AGI were largely consistent with those from the 2023 AGI (Tetra Tech 2023b). Appendix B presents photographs and observations from Tetra Tech's 2024 inspection of the WSP. The locations of each inspection issue and photograph are illustrated on Figure 3 (see Figures section).

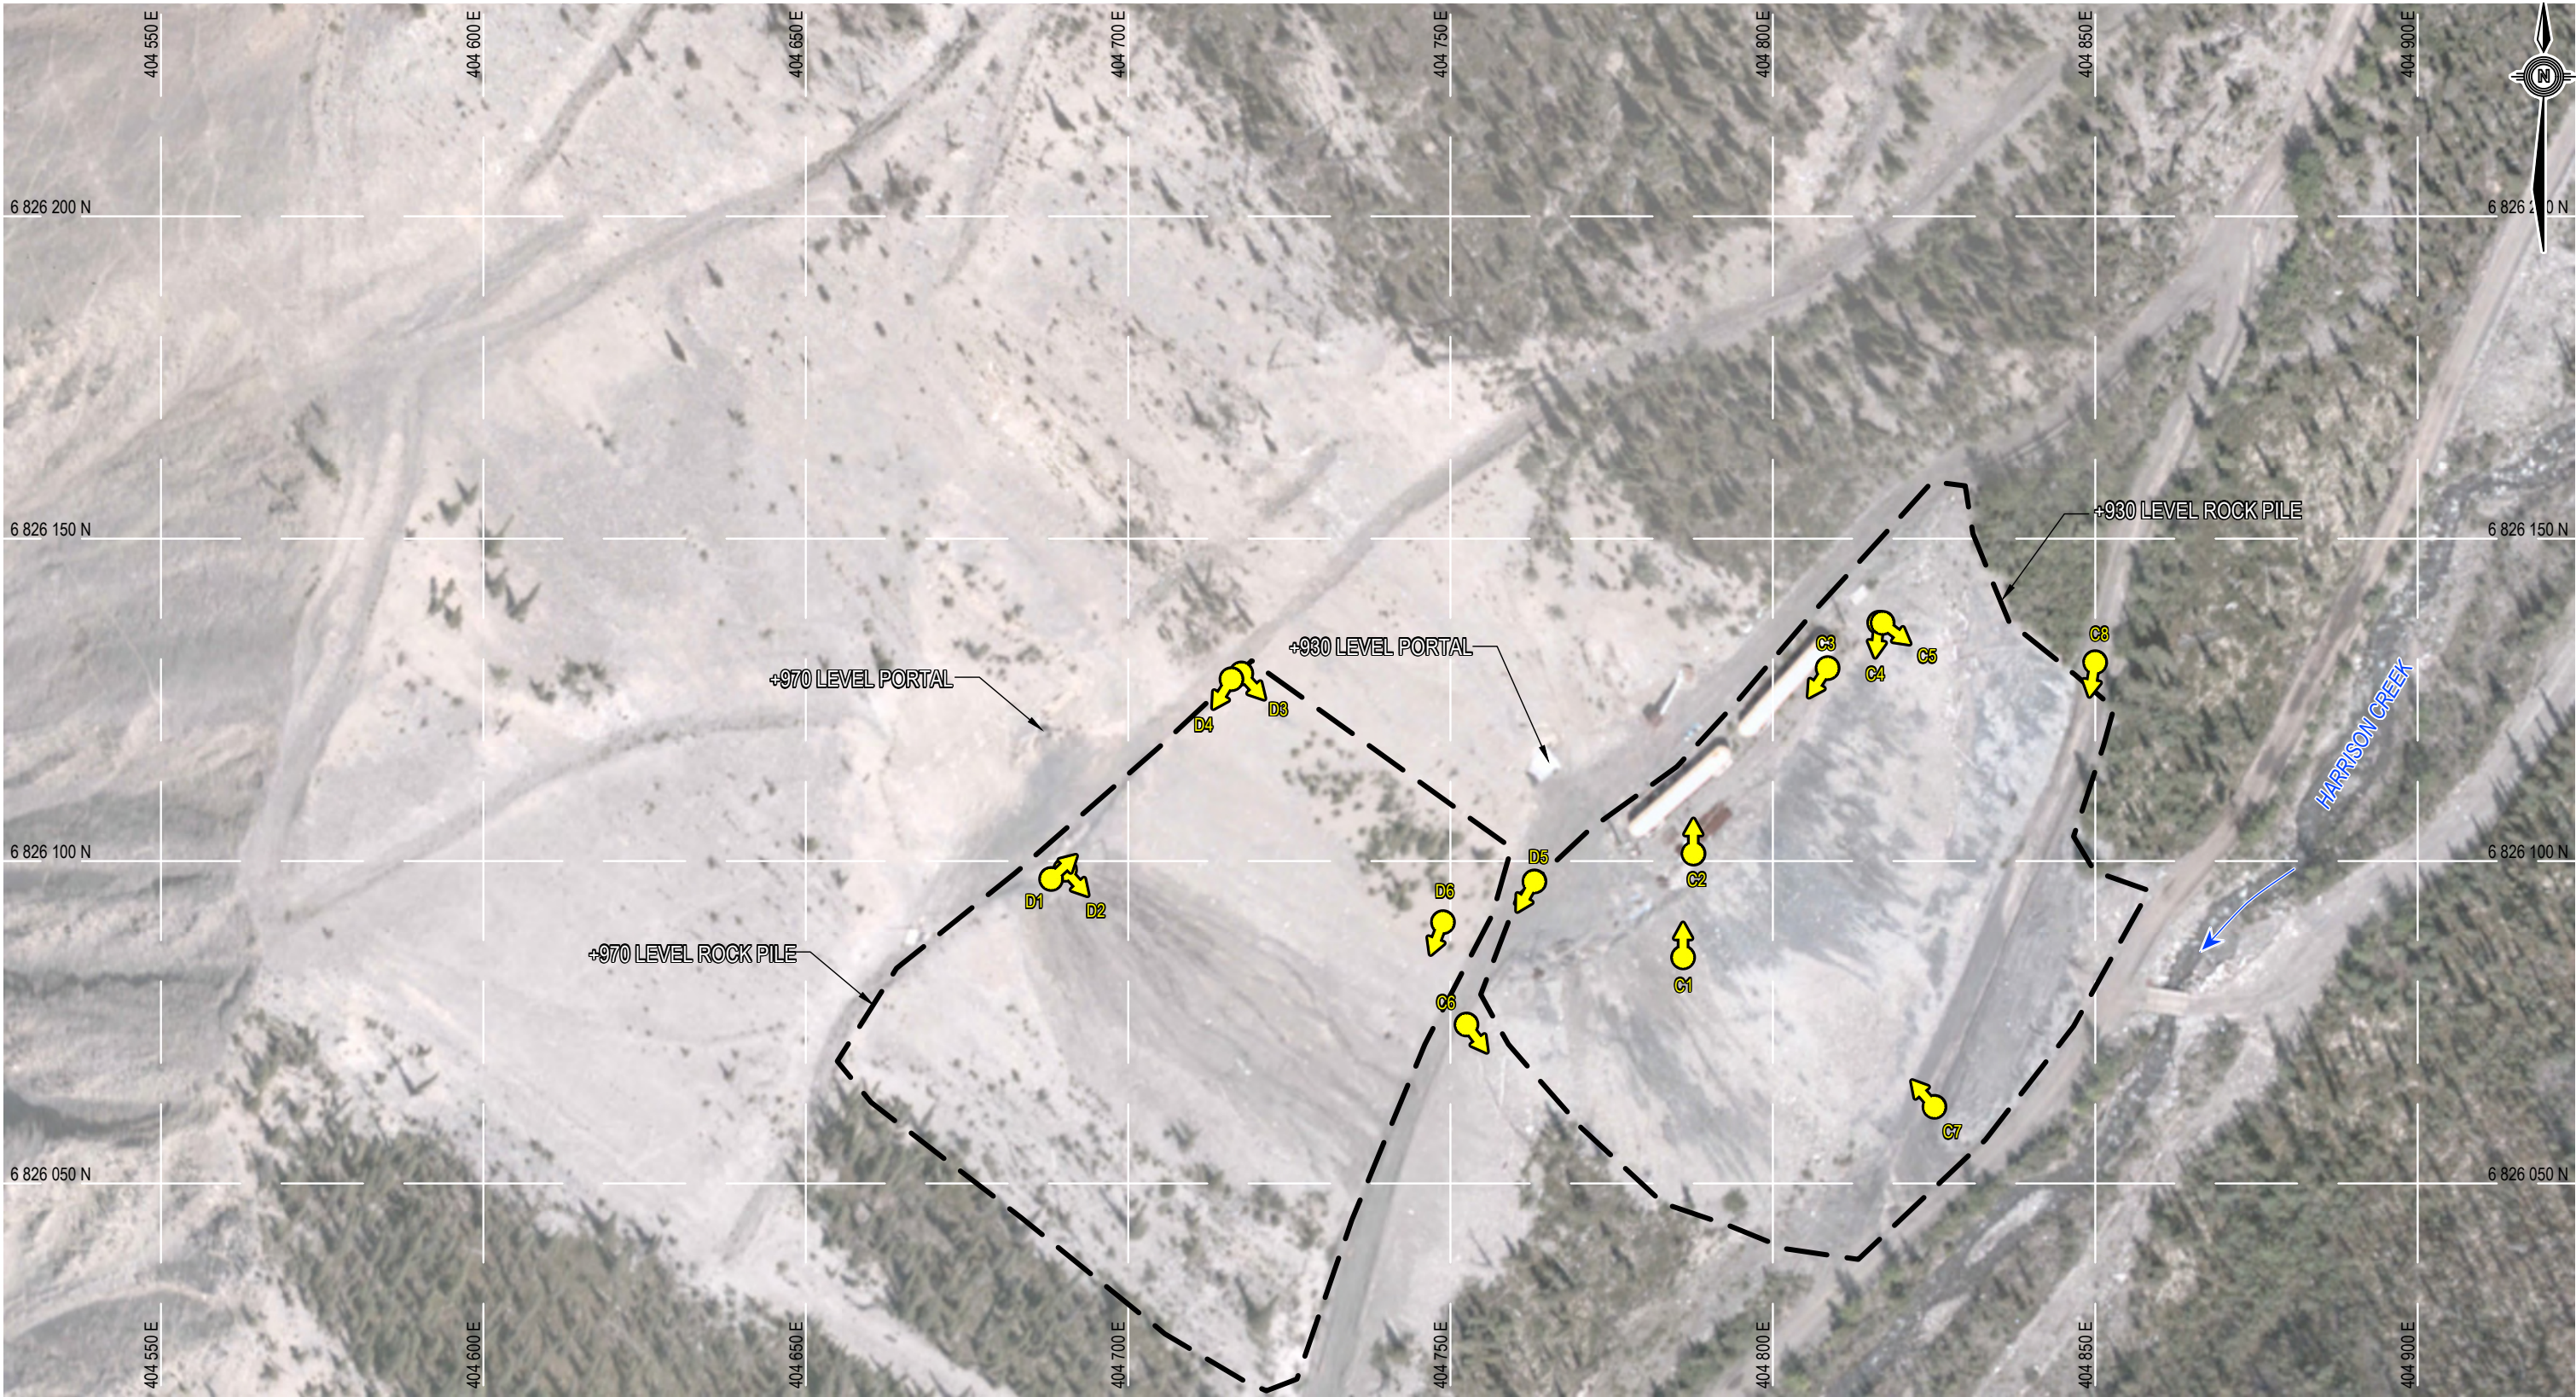
The +930 Level Rock Pile is located directly downslope of its associated portal at an approximate elevation of +930 m, as shown on Figure 4. The rock pile was generally in good condition with no significant signs of instability.

The +970 Level Rock Pile is located directly downslope of its associated portal at an approximate elevation of +970 m, as shown on Figure 4. The rock pile was generally in good condition with no significant signs of instability.

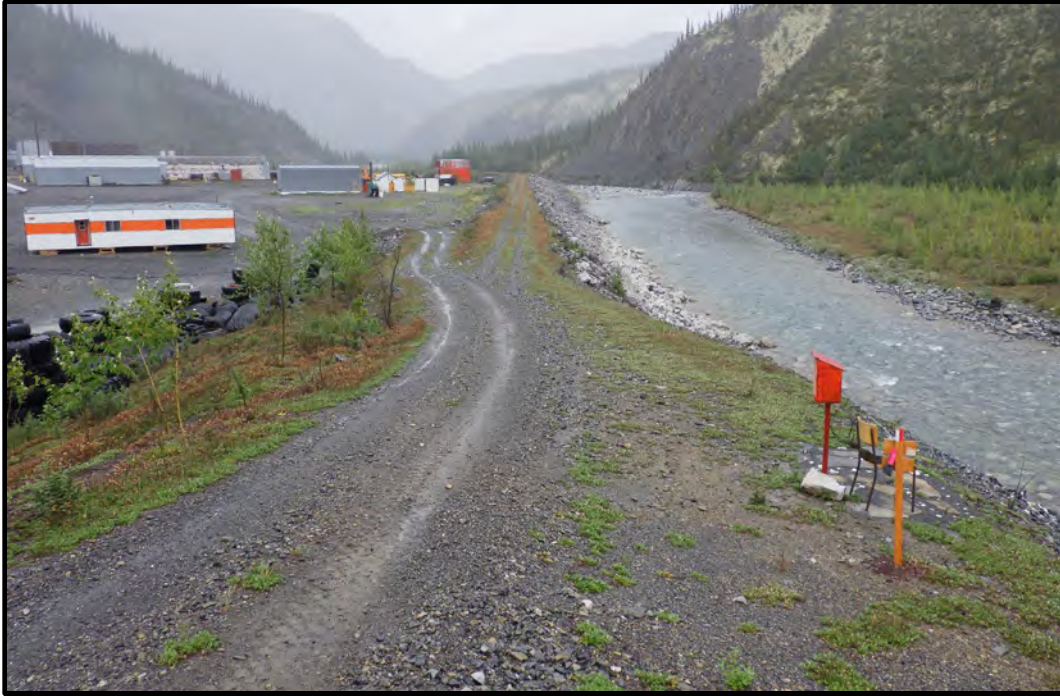
Photo A1: Flood Protection Berm
General view looking downstream from Water Storage Pond towards the Mine.
(photo taken August 20, 2024)

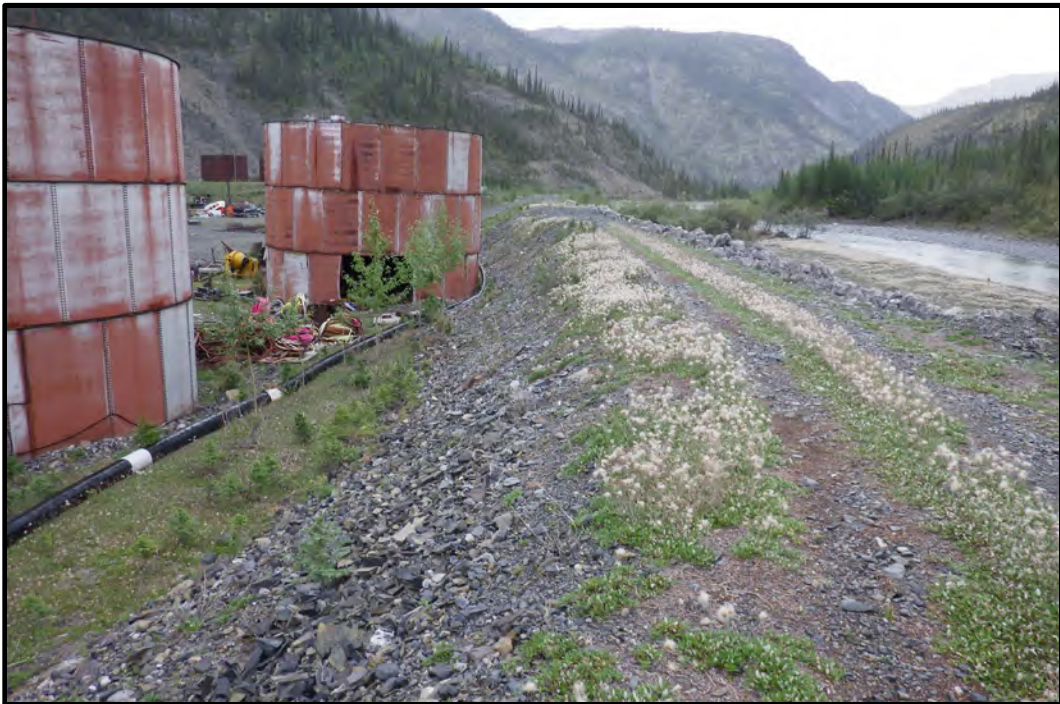
Photo A4: Flood Protection Berm
Crest of mine side slope looking downstream from near berm deflection point.
(photo taken August 20, 2024)

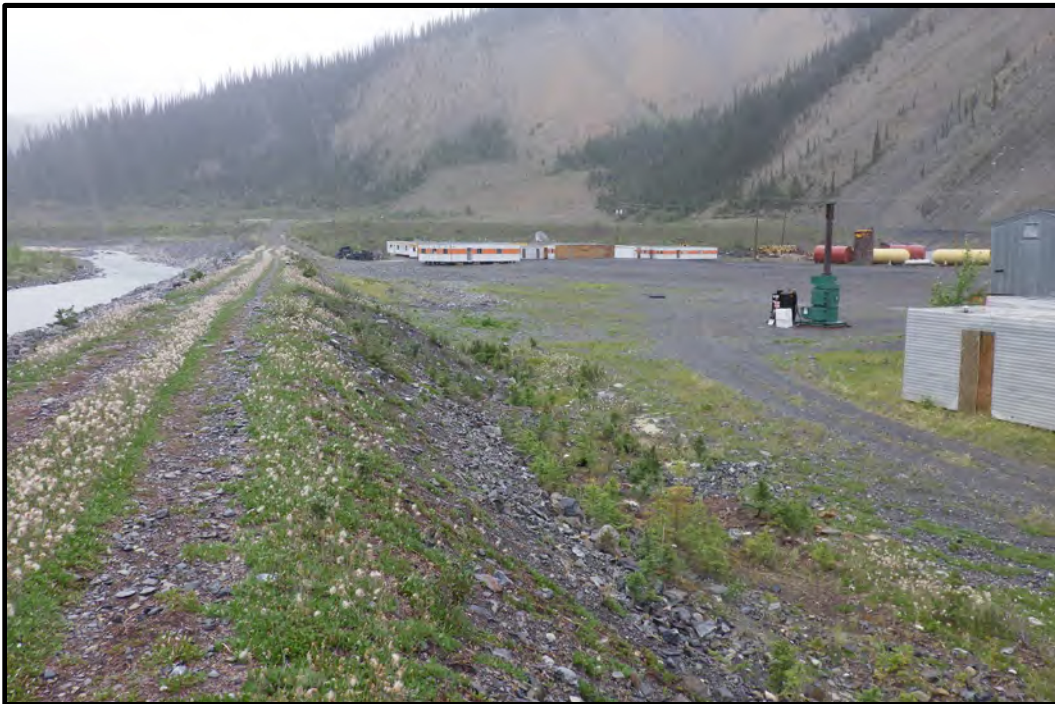
Photo A6: Flood Protection Berm
Crest of mine side slope looking upstream from near Monitoring Site NHC-02.
(photo taken August 20, 2024)

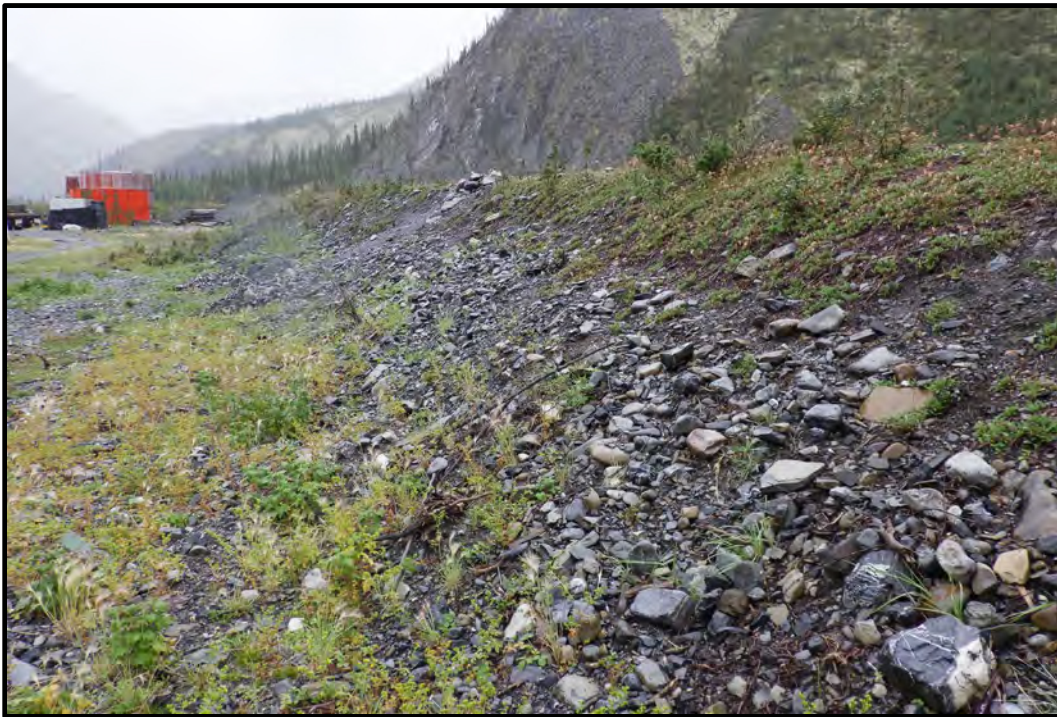
Photo A10: Flood Protection Berm, crest of mine side slope looking downstream from between Monitoring Sites NHC-03 and NHC-04.
(photo taken August 20, 2024)

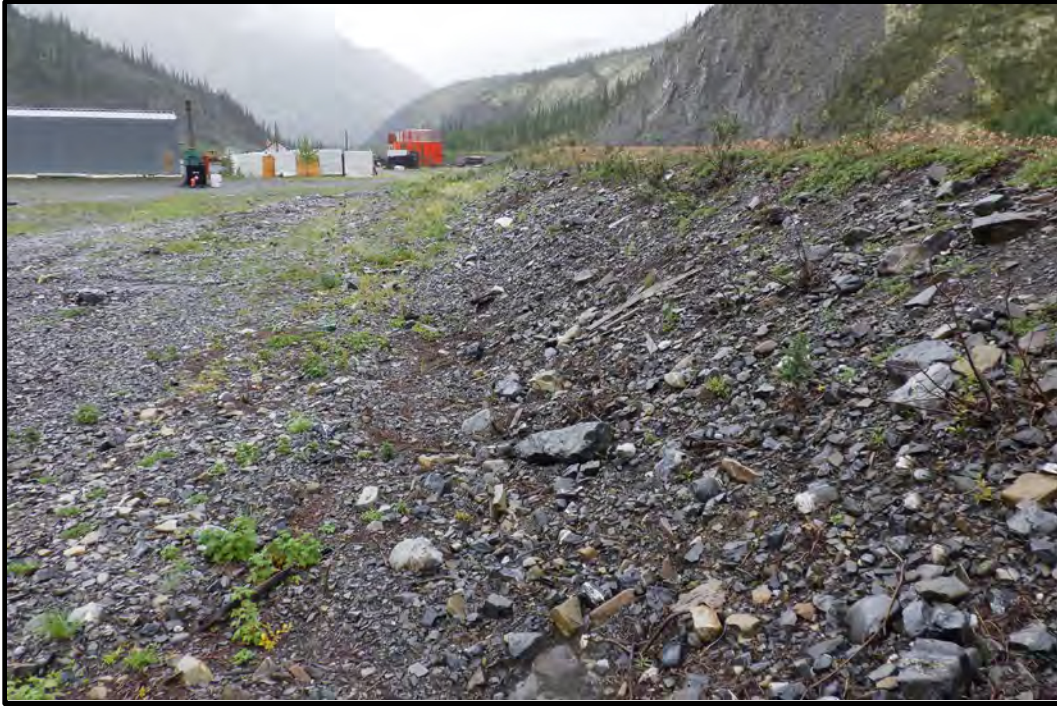
Photo A13: Flood Protection Berm
Crest of mine side slope looking downstream from near Monitoring Site NHC-04.
(photo taken August 20, 2024)
