AEC 43: Portal Fueling Station

Appendix A44 - Hazardous Materials Inventory

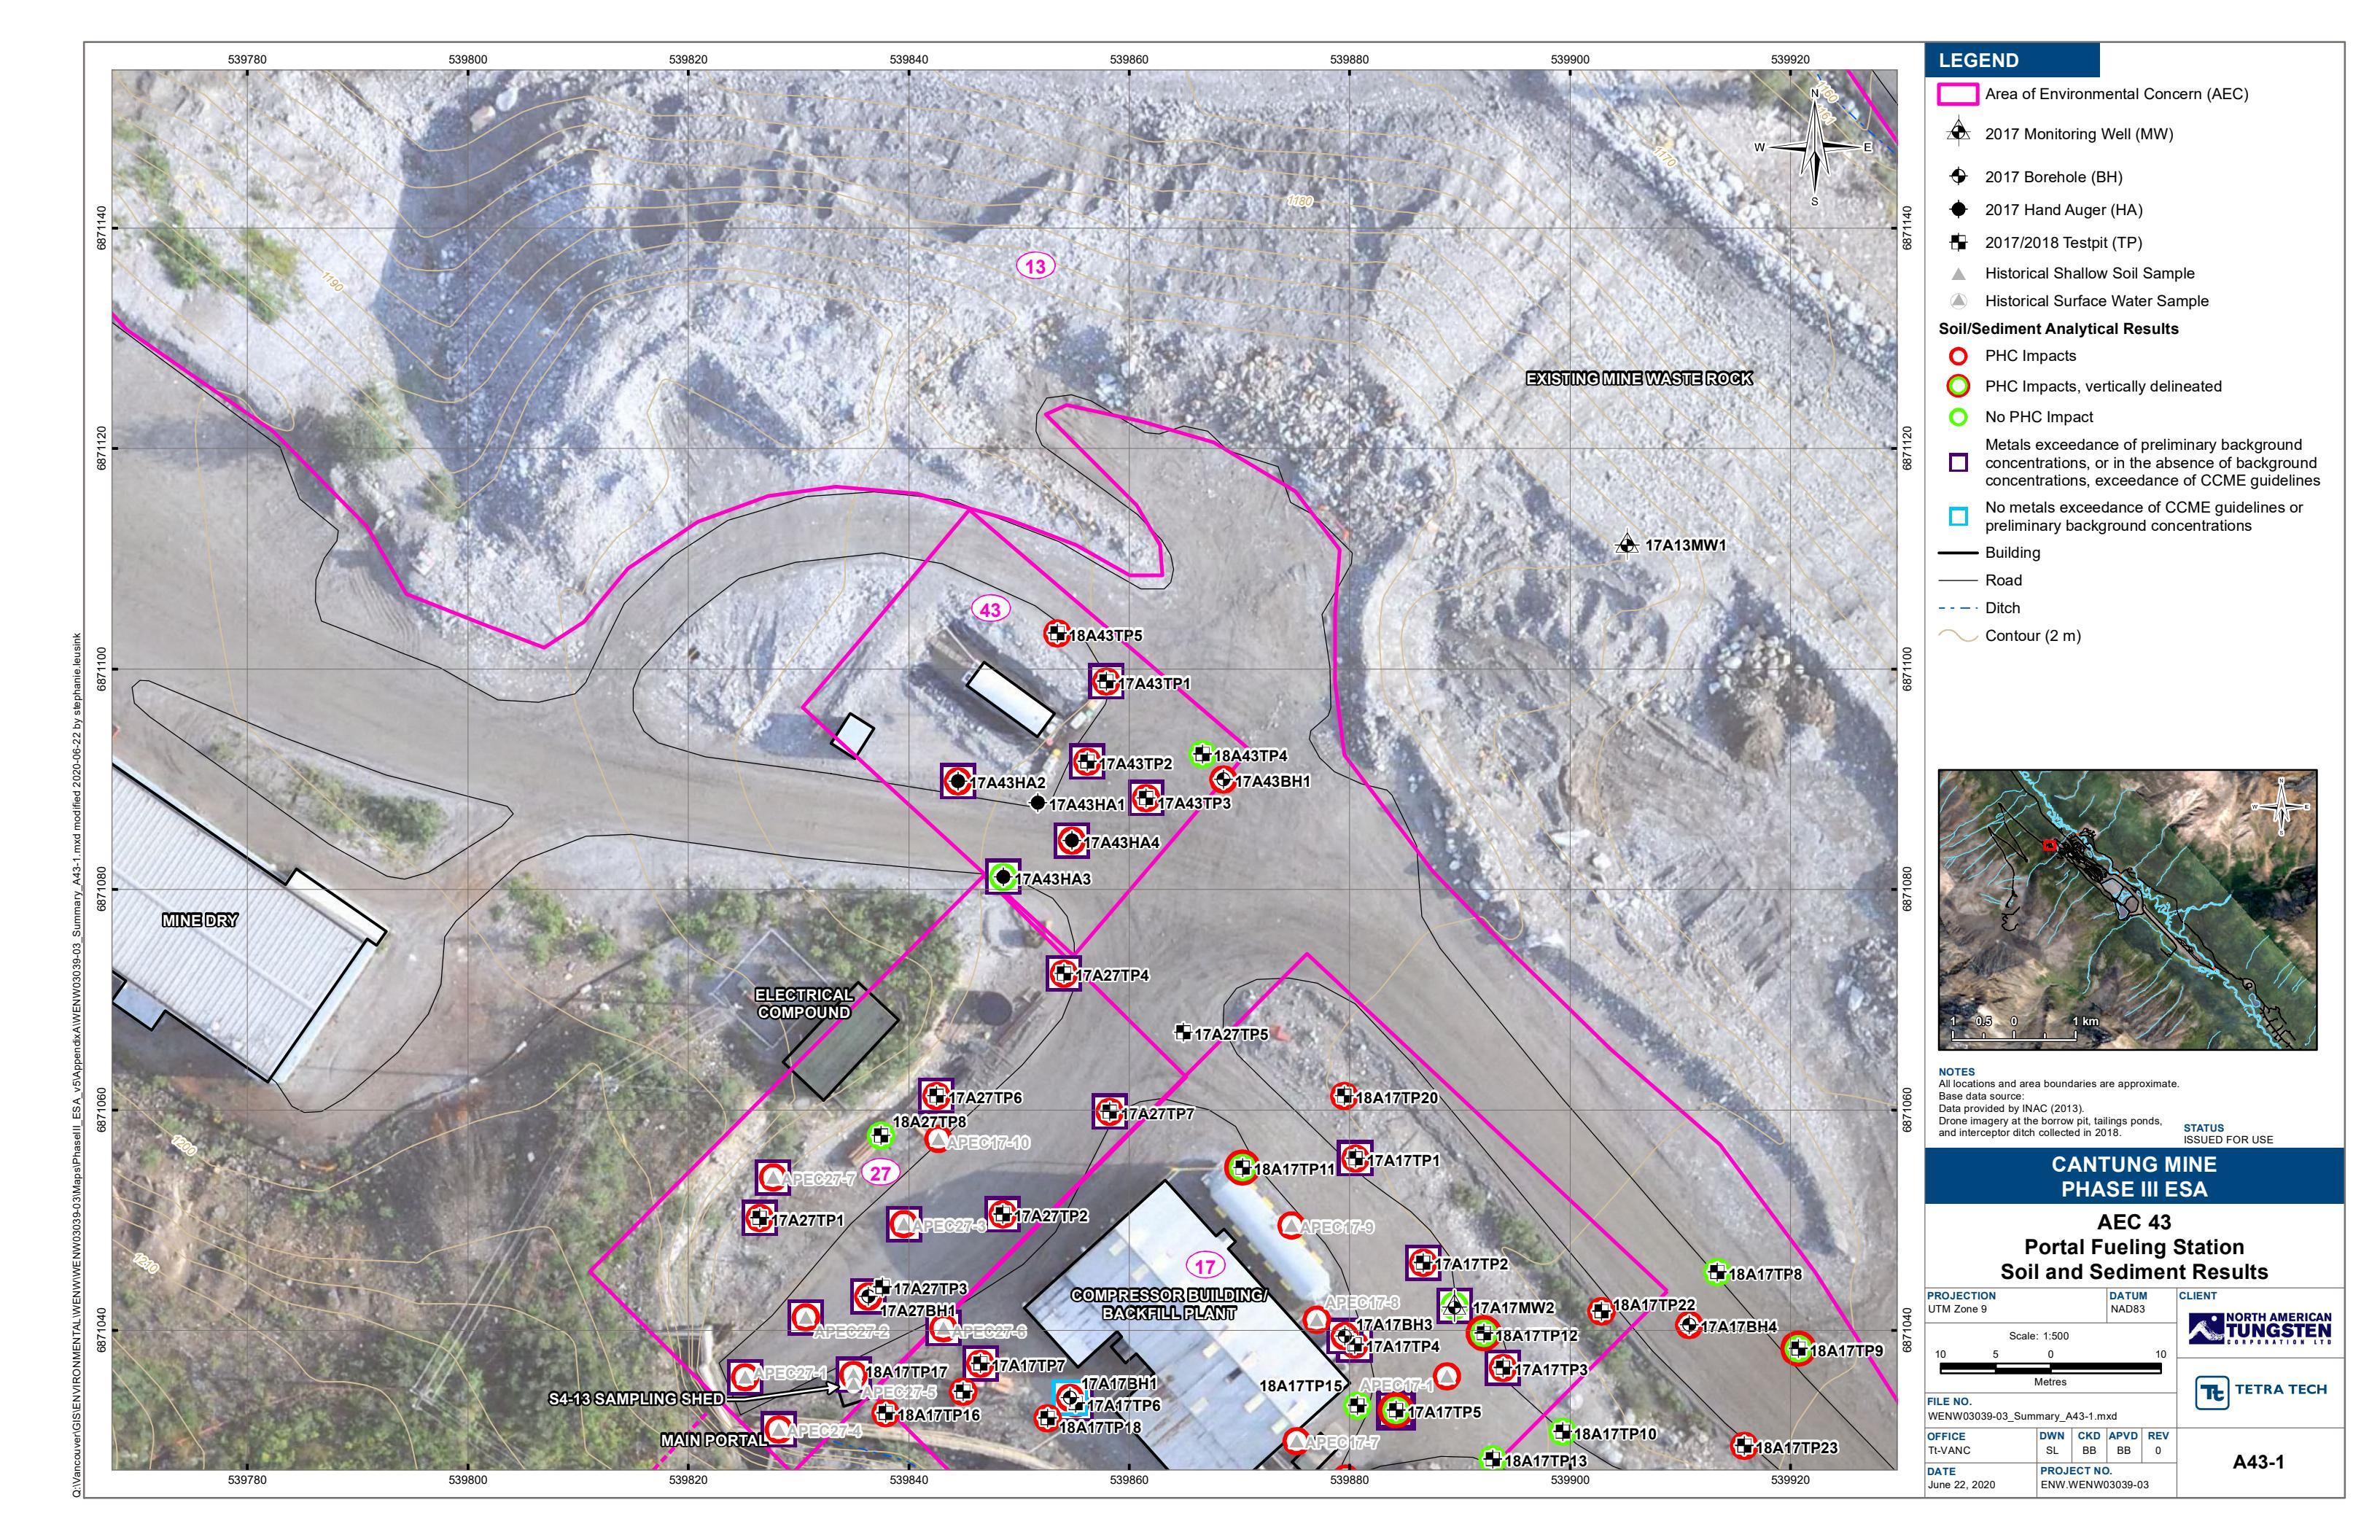
Free Product N/A
2017/2018 Environmental Site Assessment Results Summary
 Figure A43-1 shows borehole, hand auger, and test pit locations.
 Figure A43-2 shows nearby groundwater monitoring locations at other AECs.
 Table A43-1 summarizes soil lab results relative to guidelines and management limits.
General Site Observations
 The synthetic liner in berm appeared to be in good condition. Standing water was observed in berm.
 No sheen was observed on standing water.
 A slight hydrocarbon odour was identified at depth of approximately 2.5 mbgs in borehole 17A43BH1.
Soil: Petroleum Hydrocarbons (PHCs)
2017
 Laboratory results greater than the CCME/CSR guidelines with exception of:
 Sample 17A43HA3-1 at depth of 0.3 mbgs contained PHCs less than guidelines.
 Sample 17A43TP3-1E at depth of 0.25 mbgs contained PAHs less than guidelines.
In addition, one soil sample 17A43TP2-1 at a depth of 0.25 m contained PHC F2 concentration greater than the

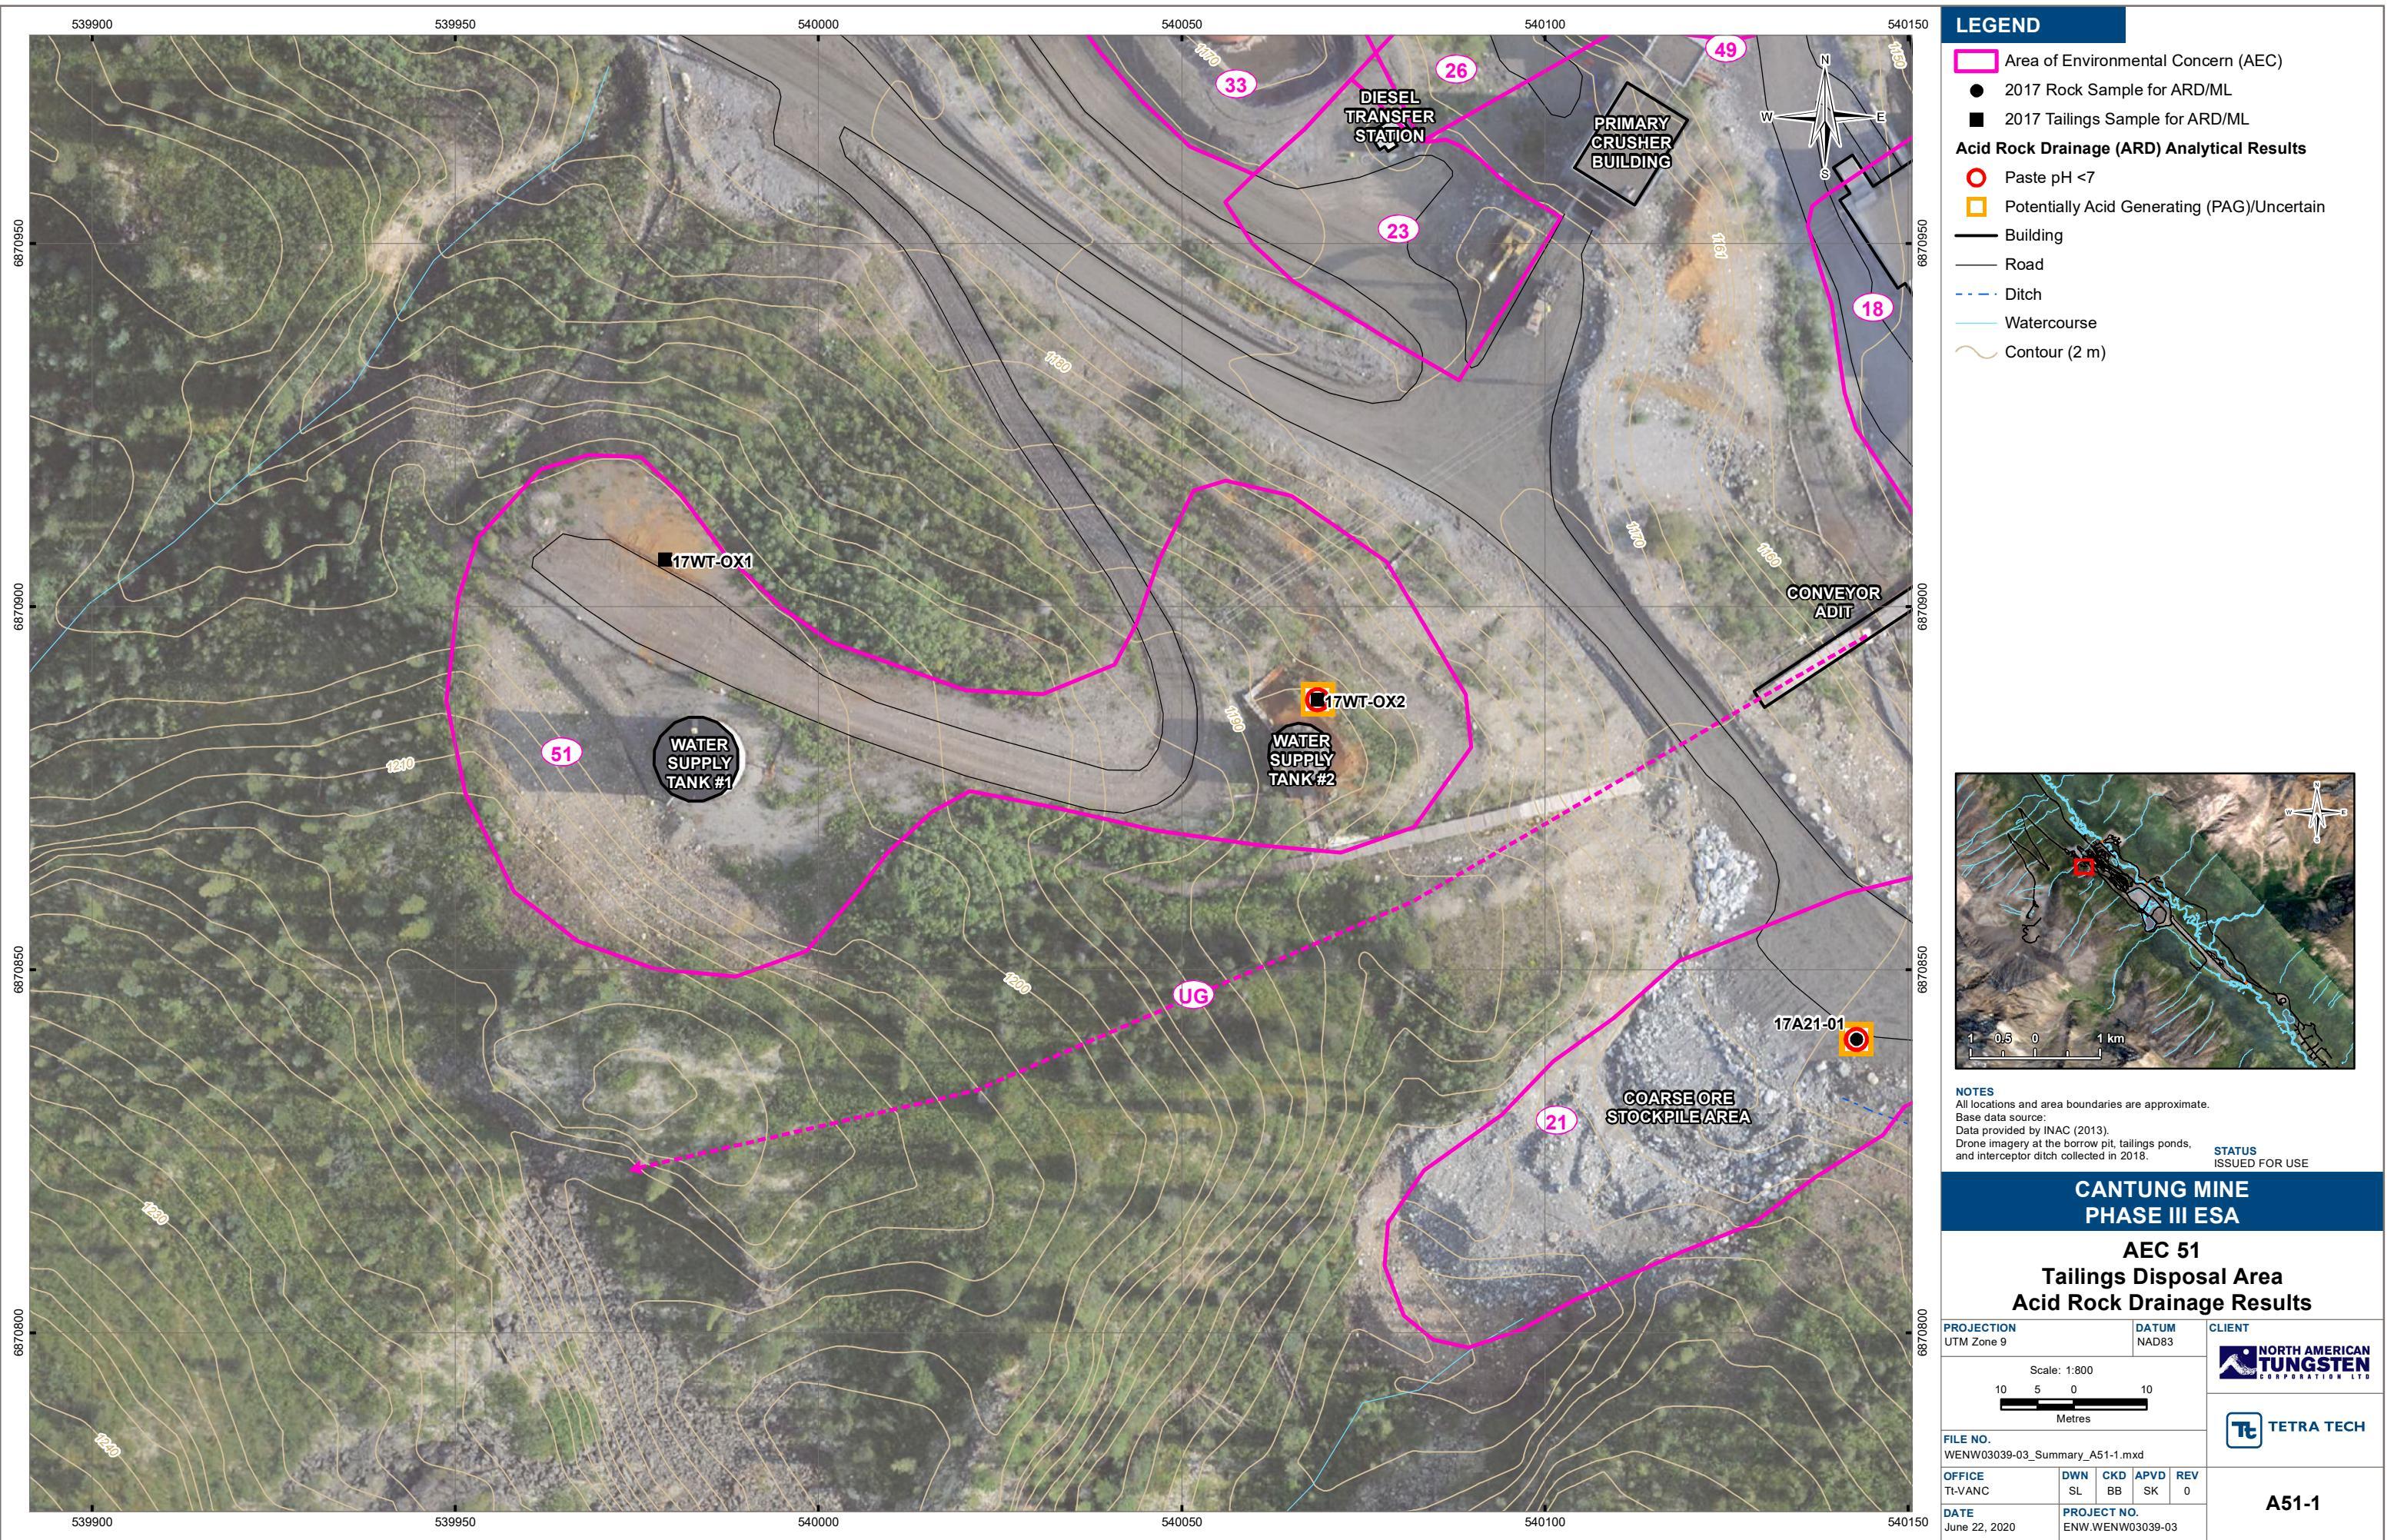
Photo 1: Oxidized tailings around the lower water tower (WT2). Sample 17WT-OX2. (October 3, 2017)
