Camlaren Mine Tailings Soil Containment Area Geotechnical Inspection

Gordon Lake Group Remediation Project

Project Number: 60710609

April 5, 2024

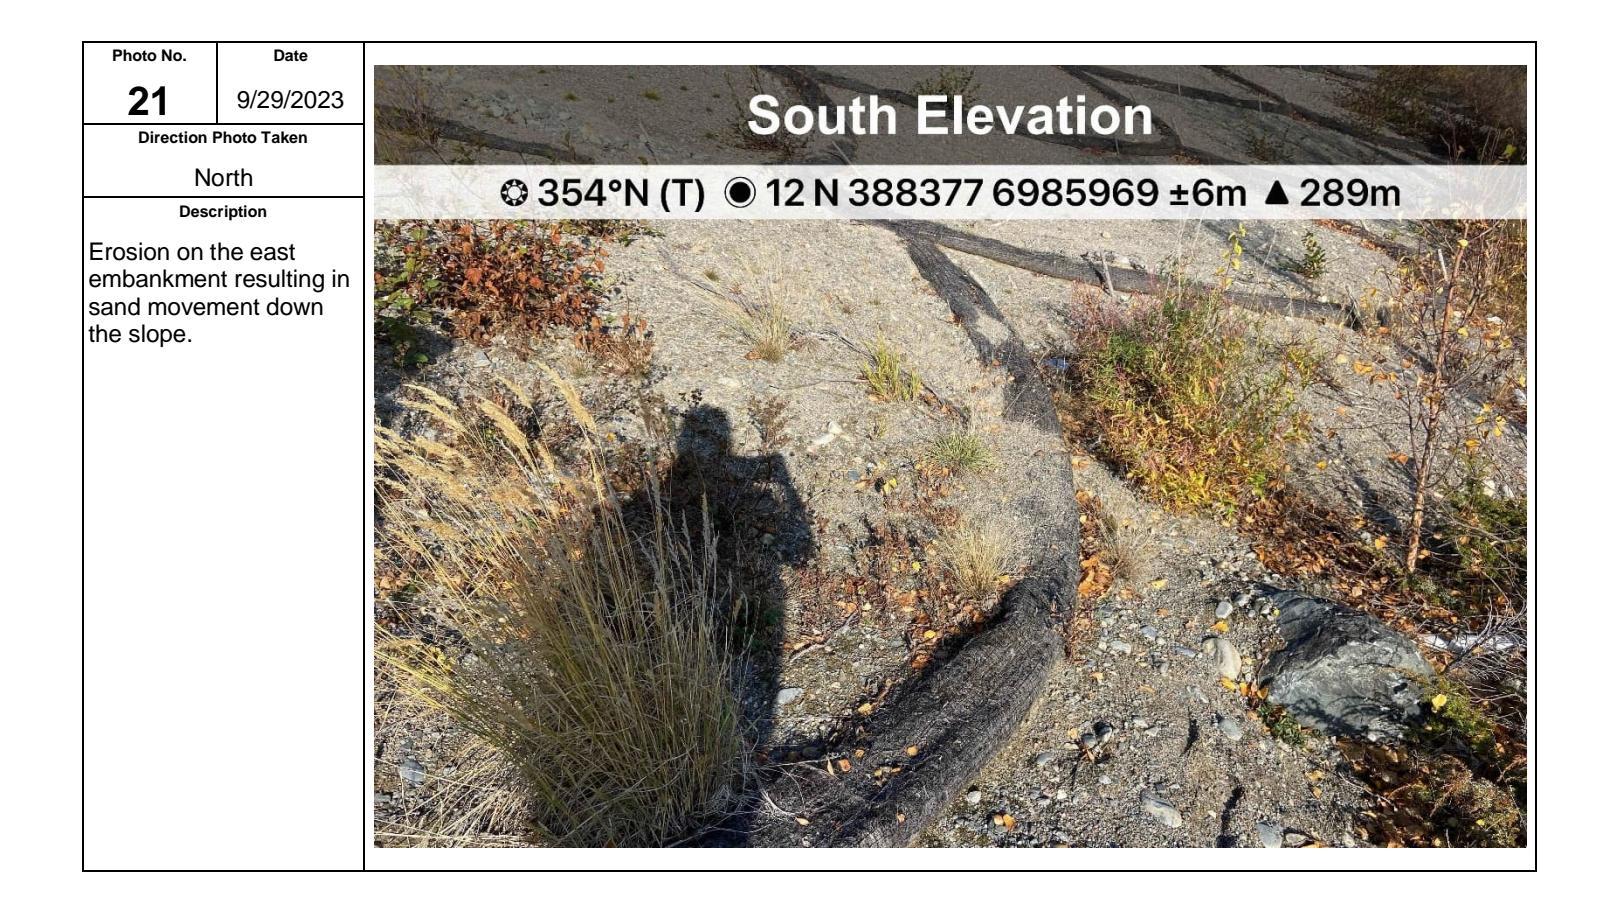
- East embankment has some vegetation growing along most of the embankment. (Photo 18, 19, and 20) Minor erosion is noted in several locations and washout sand is visible at some locations. (Photo 21). An erosion channel along the east embankment appears to have been stabilized with coarse aggregate (Photo 22).

Northwest Description An erosion channel appears to have been repaired using coarse aggregates placed within the channel.

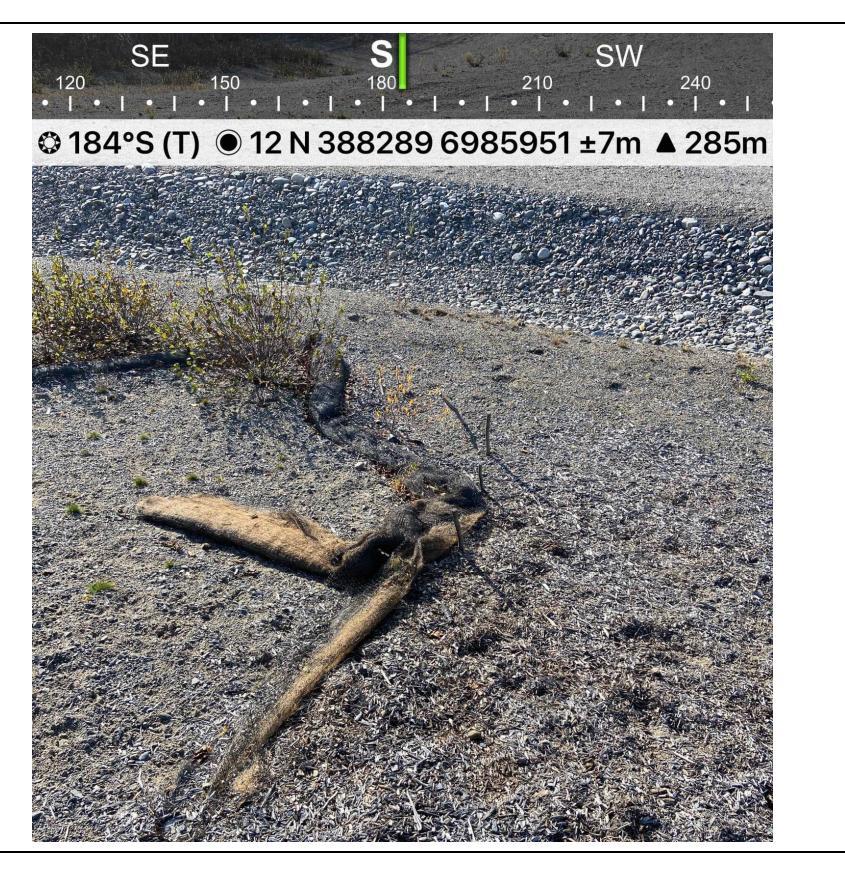
- South embankment has some vegetation and is generally stable (Photos 36 and 37).
- The erosion coir logs are in varying conditions. Some are pinned and in good condition, while others are loose or have degraded in condition (**Photos 38** and **39**). Along the south embankment, the coir logs have migrated up the slope. Along the east embankment, some of the coir logs have disappeared and migrated to different locations.

Photo No.	Date	
38	9/29/2023	
Direction F	Photo Taken	
Sc	South	
Desc	ription	
Erosion log embankmen and loose.	g on south t – degraded

The coir logs reduce erosion and aid in establishing vegetation. Some of the erosion coir logs on the east and south embankments have broken down, or torn, or have come loose and migrated elsewhere. Some of these logs should be replaced on the steeper slopes.

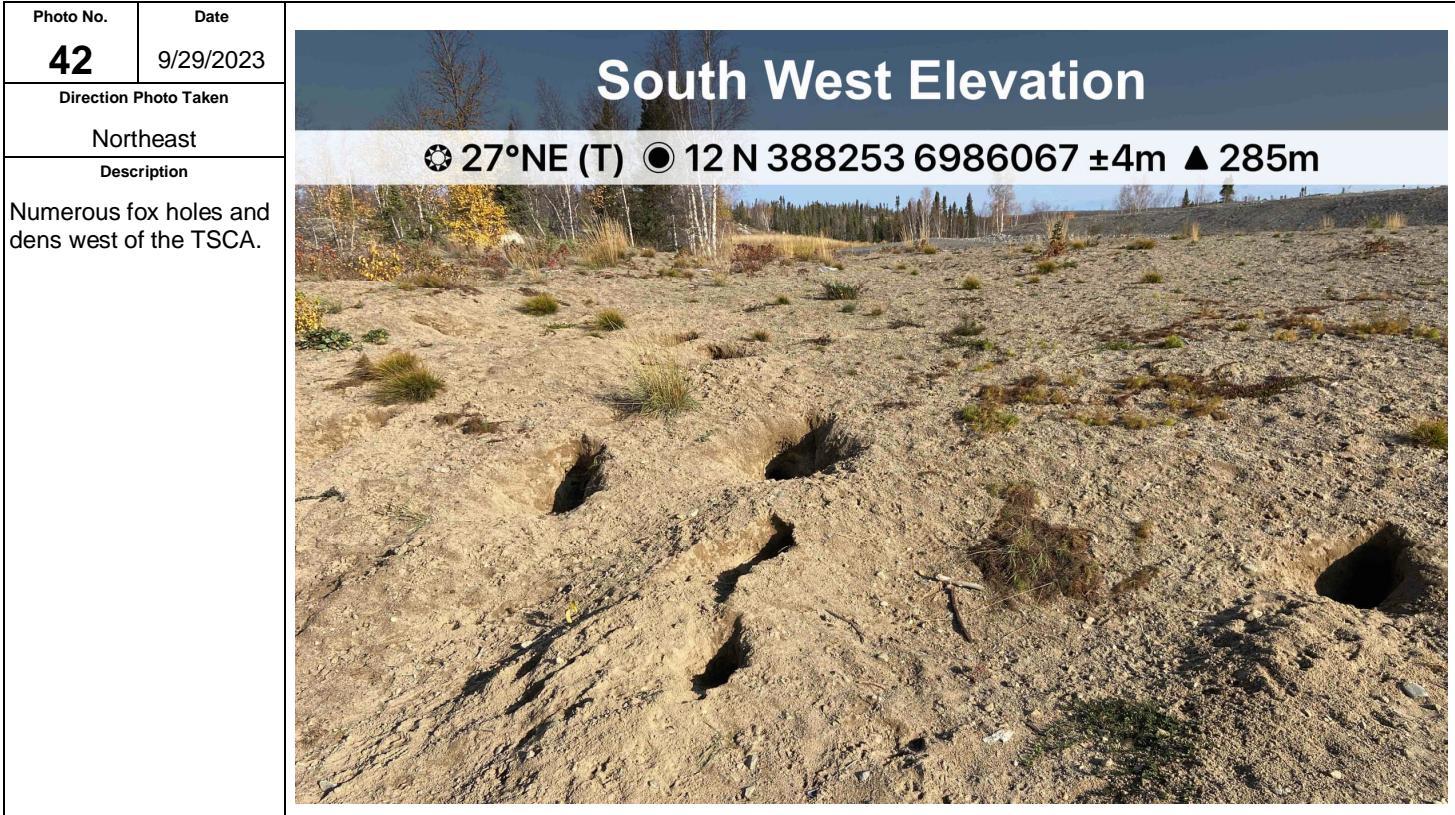
- The bituminous membrane was exposed along the south embankment near station 0+340 (**Photo 40**).
- Numerous holes were seen on and near the TSCA (Photo 41). The wildlife monitor indicated that
 they were likely from foxes that enjoy digging in the sand. An area located to the west of the TSCA
 appears to be occupied by foxes (Photo 42).
- A spot of oil contaminated soil (approximately 0.15 m³) was observed adjacent to the north drainage ditch west of the TSCA. (**Photo 43**).

Photo No.	Date	
43	9/29/2023	North Elevation
Direction I	Photo Taken	
r	n/a	© 160°S (I) ● 12 N 388273 6986036 ±4m ▲ 286m
Desc	ription	
Oil-stained s	soil west of
