Gordon Lake Group - Geotechnical Services Program - TSCA Geotechnical Investigation for Dam Declassification

Final Report | Version 00

Our reference no. 2207077.00

March 7, 2023

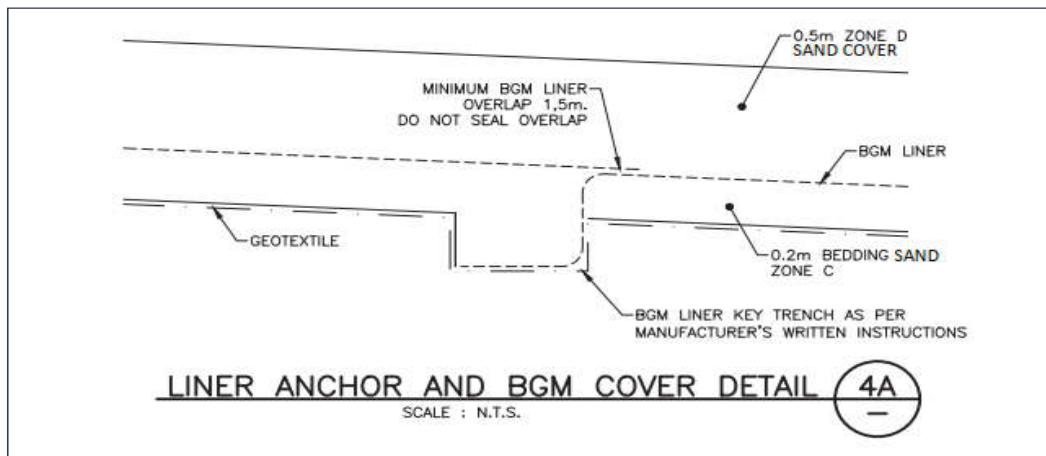
Figure 5.1: As-built design of soil liner system (Stantec Dwg. No. C-CAM-11A, 2018)

In terms of soil density, it is loose at the surface but is otherwise considered to be compact based on observation during the borehole advancements. Figure 4.1 Below illustrates the typical design section of the soil liner system:

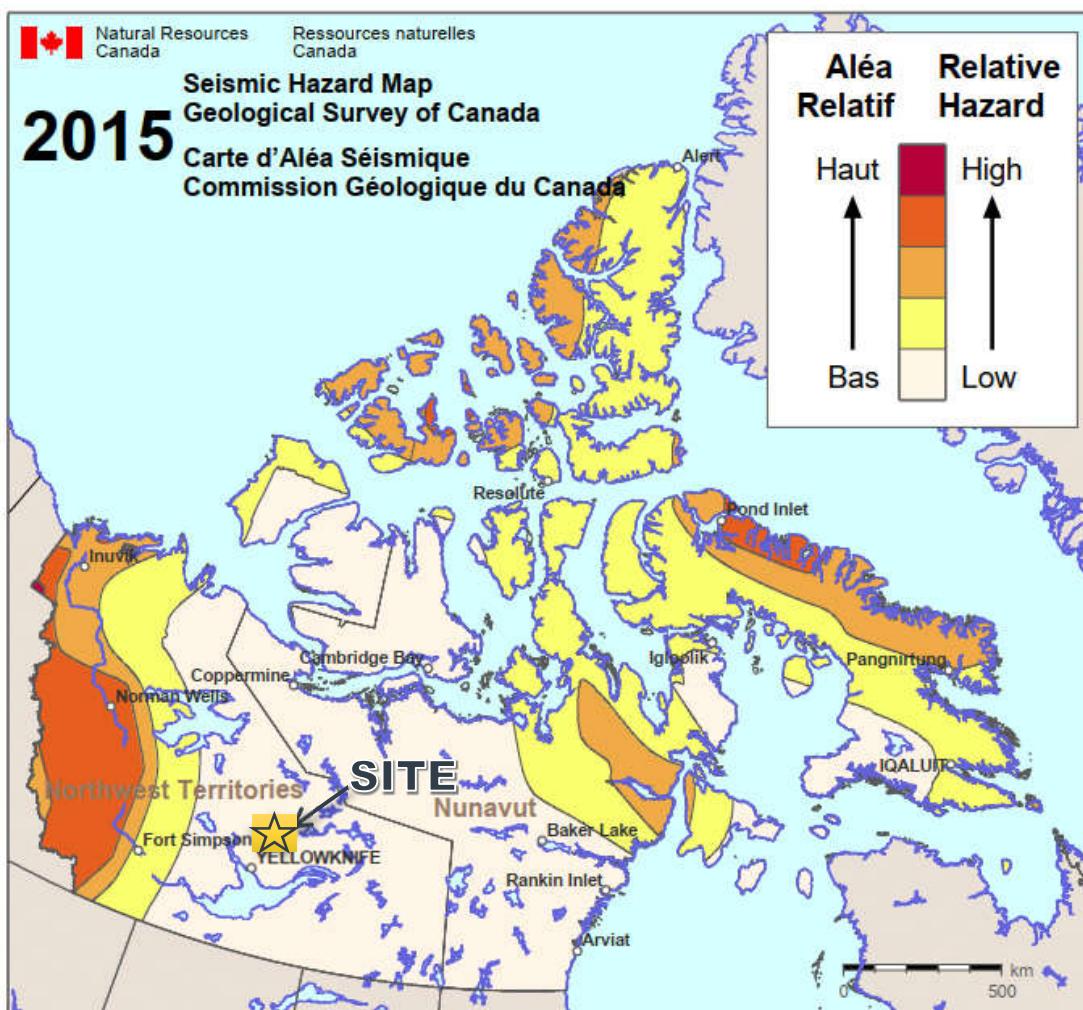
Figure 6.1: Simplified seismic hazard map for Canada, the provinces and territories (2015)

The Stantec 2018 Updated Design Basis Report used a 5% in 50 years (0.001 per annum) year return period in their modelling work for a 0.015 g site-specific PGA result. The 0.000404 per annum reoccurrence probability used in Englobe's modelling work is more conservative.

Further to the above assessments, the site's liquefaction potential would be classified based on the seismic hazard map published by Natural Resources Canada (NRC) as "low," as illustrated above in Figure 6.1.

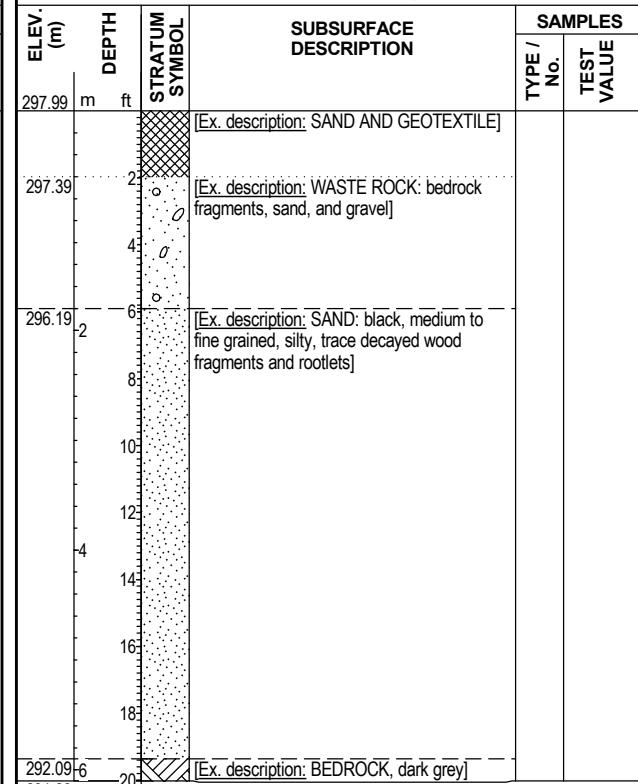
End of Borehole at 6.10m depth

Borehole terminated in bedrock.
Borehole advanced by Thurber Engineering Ltd. on 9/11/2018. Note: minor annotations are added to this record by Englobe to illustrate probable changes in material conditions from as-built drawings.
