SNARE HYDRO SYSTEM

2006 Comprehensive Dam Safety Review

FINAL

Kohn Crippen Berger

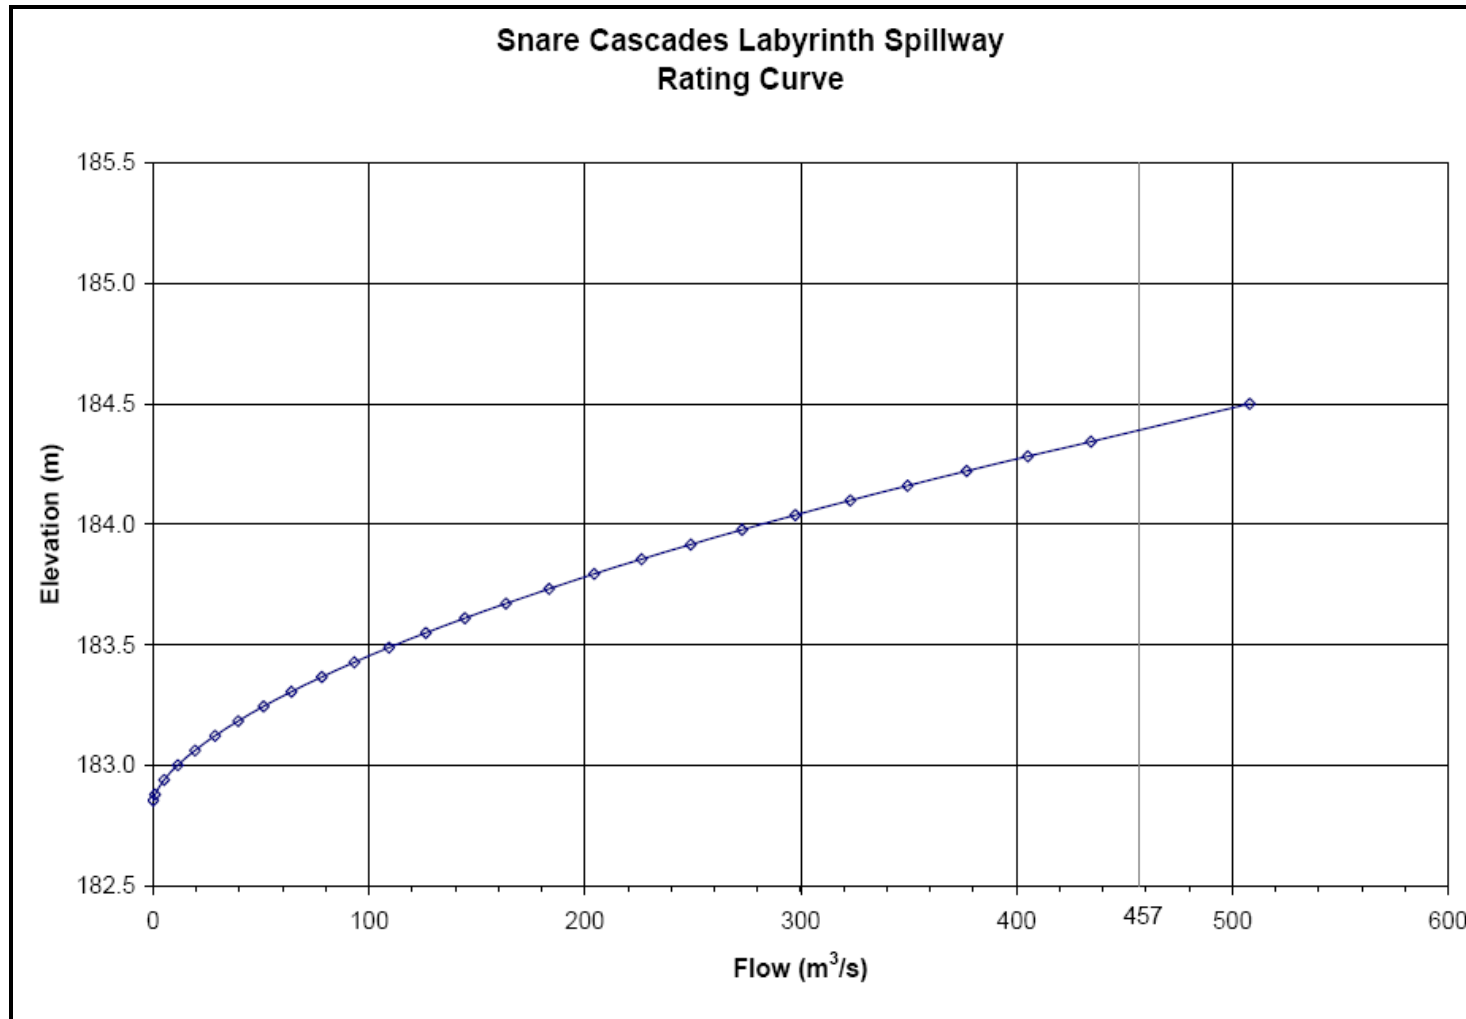
Figure 4-1: Snare Cascades – Labyrinth Spillway Rating Curve

Figure 4-1 illustrates the spillway rating curve for Snare Cascades. It is evident that the Snare Cascades labyrinth spillway has the capacity to safely pass the 1 in 1000 year routed IDF of $457 \text{ m}^3/\text{s}$. The top of the concrete cut-off in the Approach Channel Dyke is EL. 184.5 m.

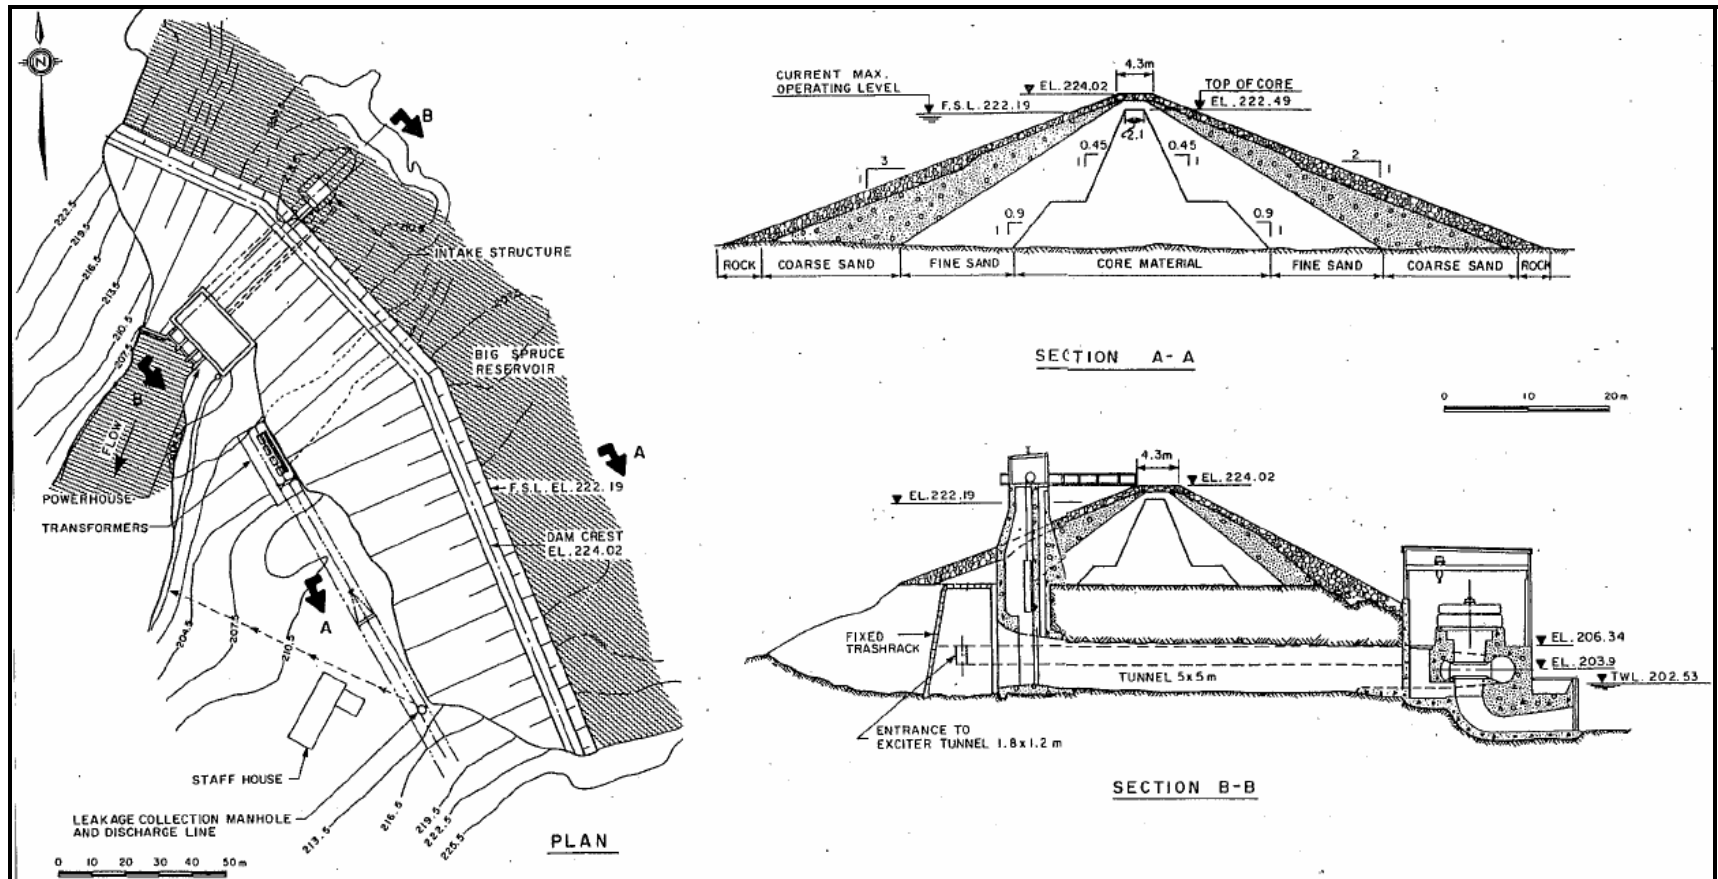
Figure 6-1: Snare Rapids G.S. – Layout and Typical Sections

The silt used for the core was “semi-liquid” (moisture contents approached the liquid limit) during dam construction. It is reported that there was some cracking of the crest several years after impoundment, however the cracks were filled with sand and have not reappeared. Investigations undertaken as part of the 2000 DSR revealed that post construction settlements of the core had been in the order of 3% of the height of the dam fill and that the reservoir was being routinely operated above the top of the dam core for extended periods of time. It was recommended that NTPC consider raising the core to above MOL level to reduce the potential for long term deterioration and performance problems. In 2002 the core was raised by approximately 1.0 m to a nominal elevation of EL. 223.0 m (EL. 731.6 ft). The new as-built profile is presented in Figure 6-2. Reference drawings such as Figure 6-1, should be updated to illustrate the current arrangements.

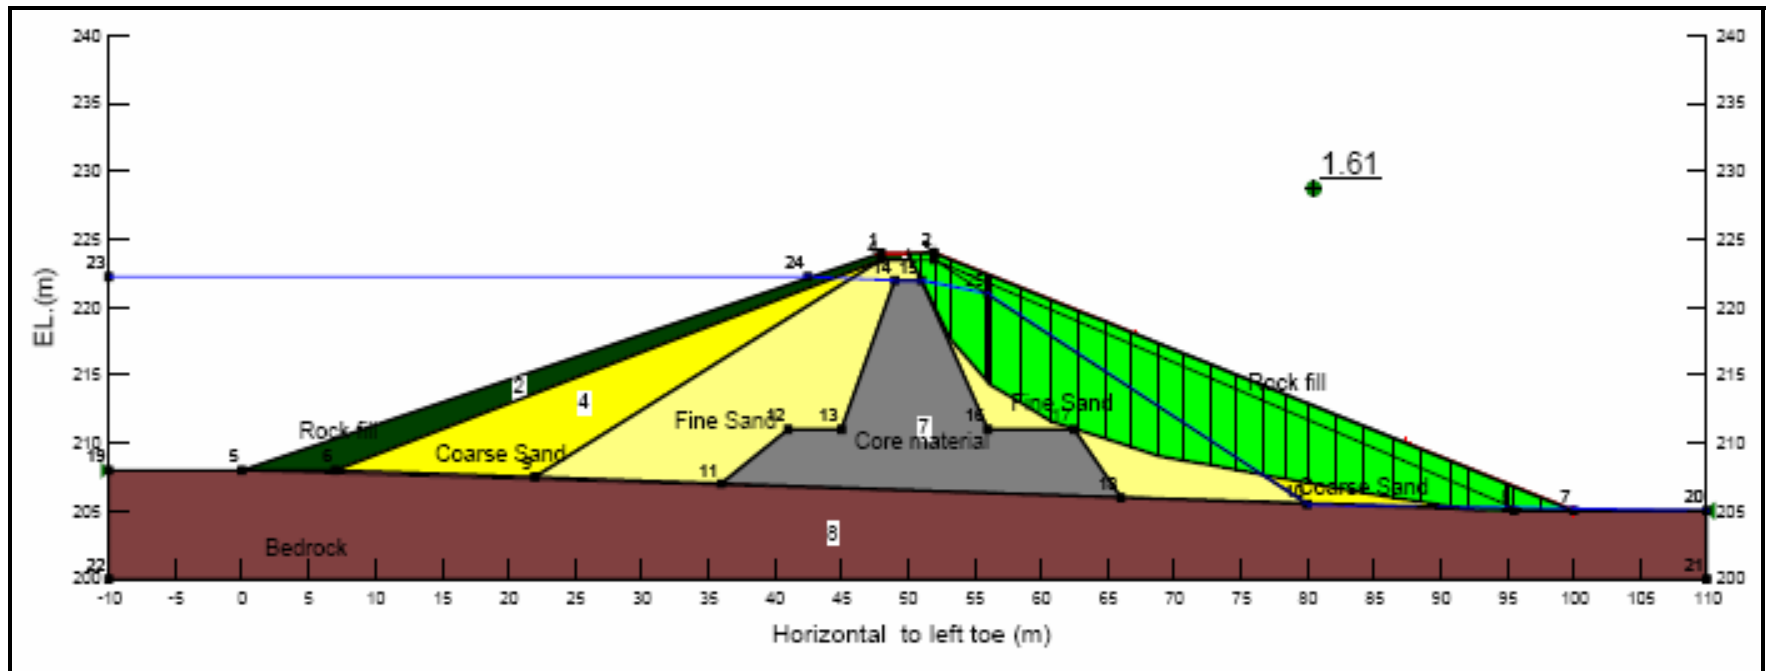
Figure 6-4: Snare Rapids Main Dam – Stability (Normal Load Case, FS = 1.61)

As illustrated on Figure 6-4 and Figure 6-5, the factors of safety for both the static and seismic load cases are considered to be satisfactory.

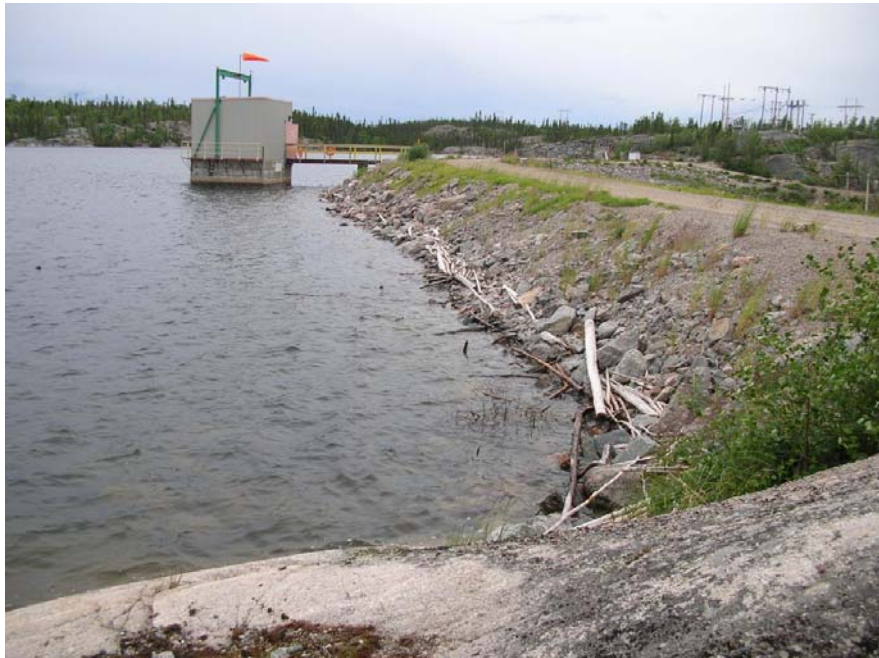
There are fairly regular accumulations of woody debris along the upstream face of the dam (Photo 2 and 3) which has the potential to dislodge the riprap during periods of high wind and waves. This material should be removed when brushing of the crest and slope is next undertaken to prevent deterioration of the riprap protection.

Photo 3 Snare Rapids Main Dam – woody debris accumulated along upstream face to be removed as part of regular maintenance.

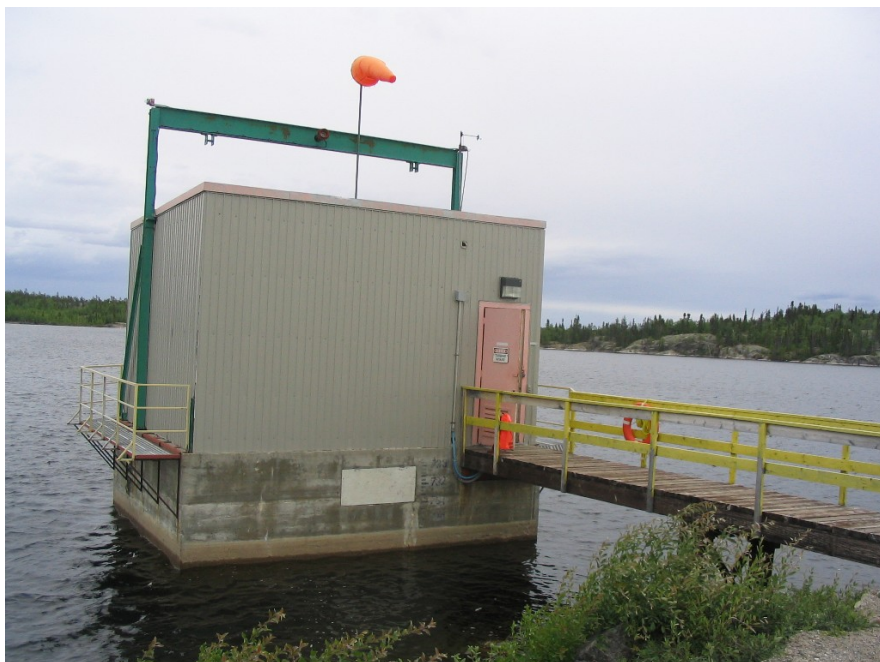
The concrete intake structure is founded on bedrock as illustrated on Figure 6-1. The gate hoist is housed within a sheet steel insulated enclosure on top of a reinforced concrete substructure (Photo 6). A foot bridge is provided for access as the gatehouse is approximately 5 m. offshore. The foot bridge has proper handrails and is in good condition. The gatehouse has power and communications to the control room.

Photo 6 Snare Rapids Intake – general arrangement

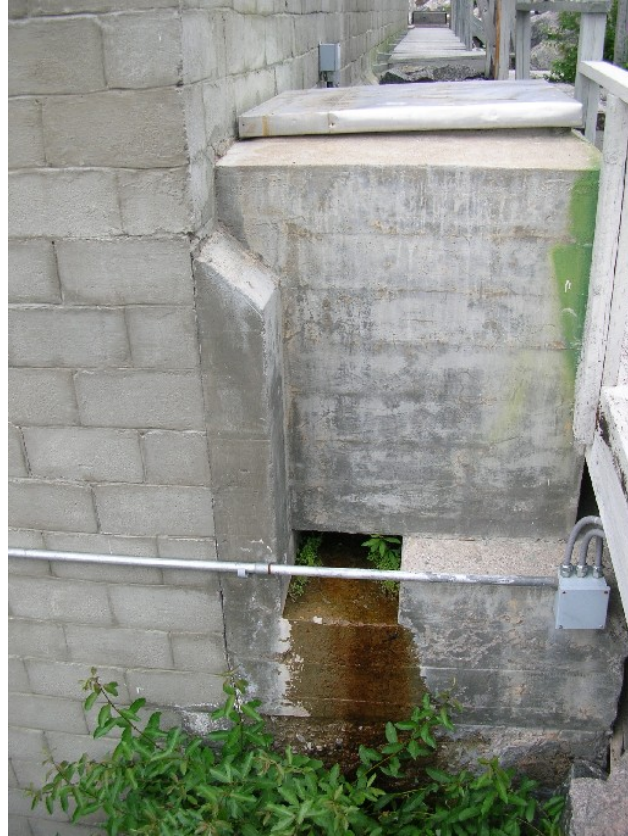
Photo 7 Snare Rapids Main Dam – seepage collection and measurement sump for seepage from the central portion of the dam.

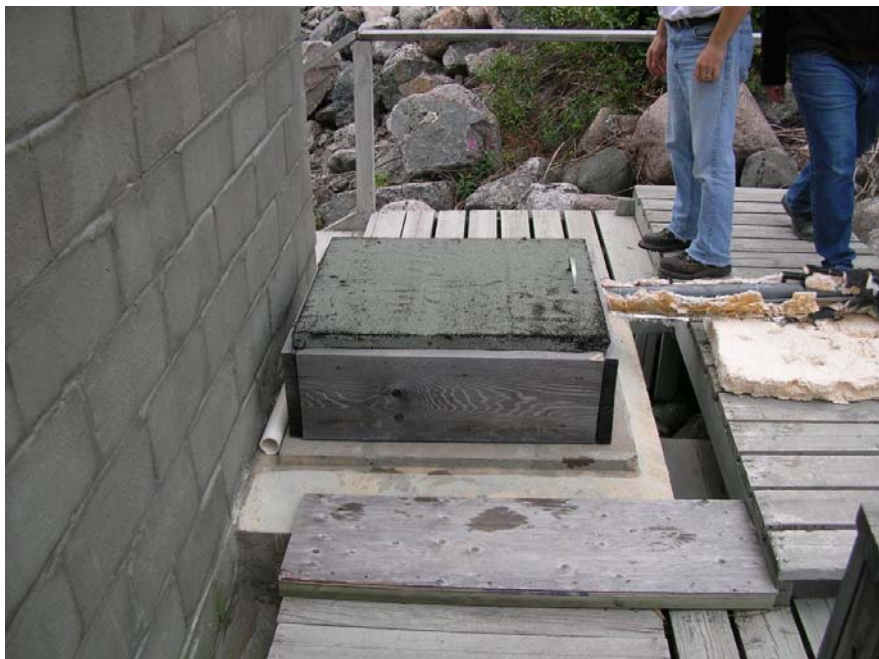
Photo 8 Snare Rapids Power Tunnel – seepage collection and measurement sump for seepage from the power tunnel.

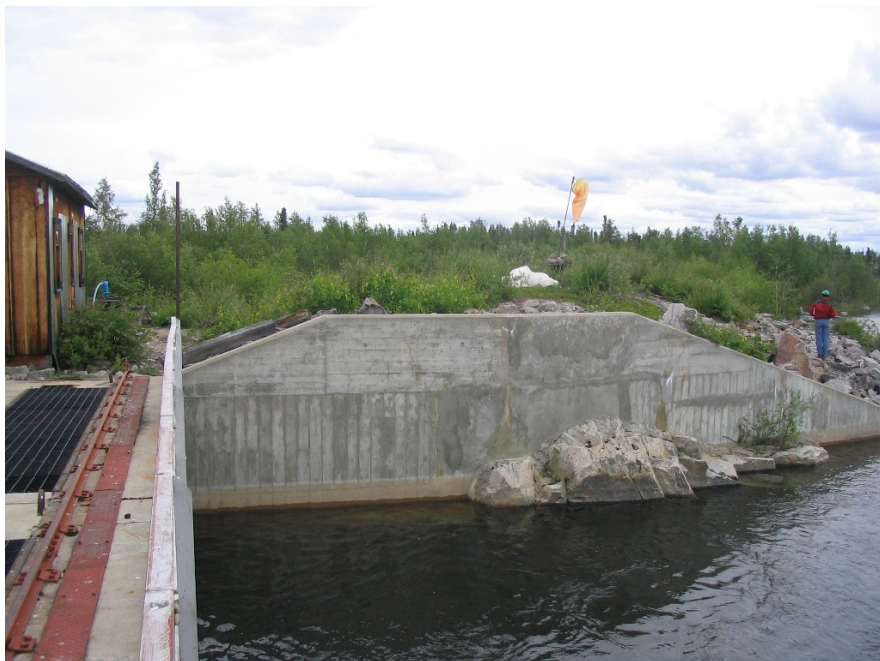
Photo 10 Spillway 5B – retaining wall along upstream right abutment retains fills from Side Dam 5B.

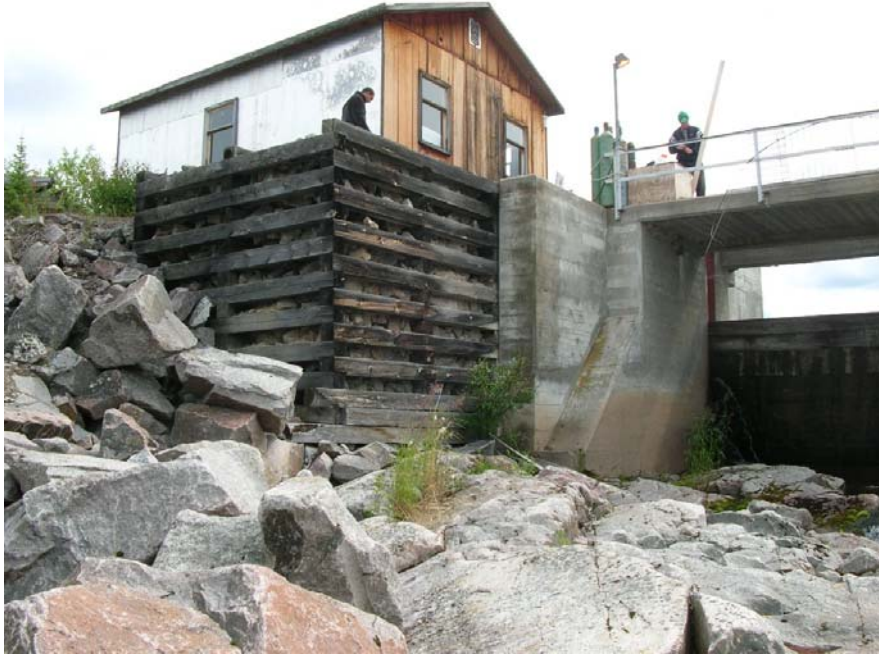
Photo 11 Spillway 5B - timber crib retaining wall at downstream right abutment retains Side Dam 5B fills.

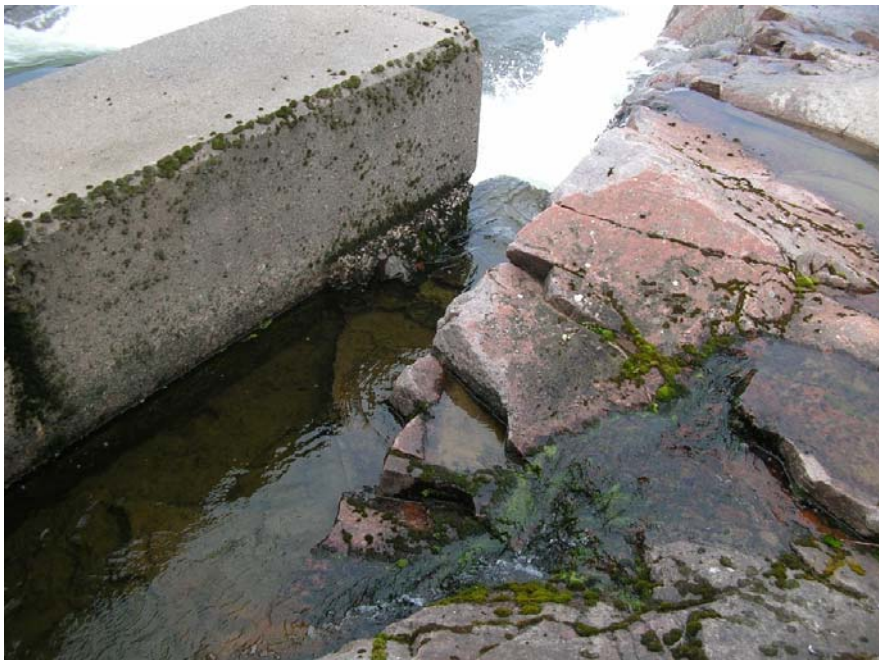
Photo 12 Side Dam 5B – undercutting of pier between spillway Bay 2 and 3

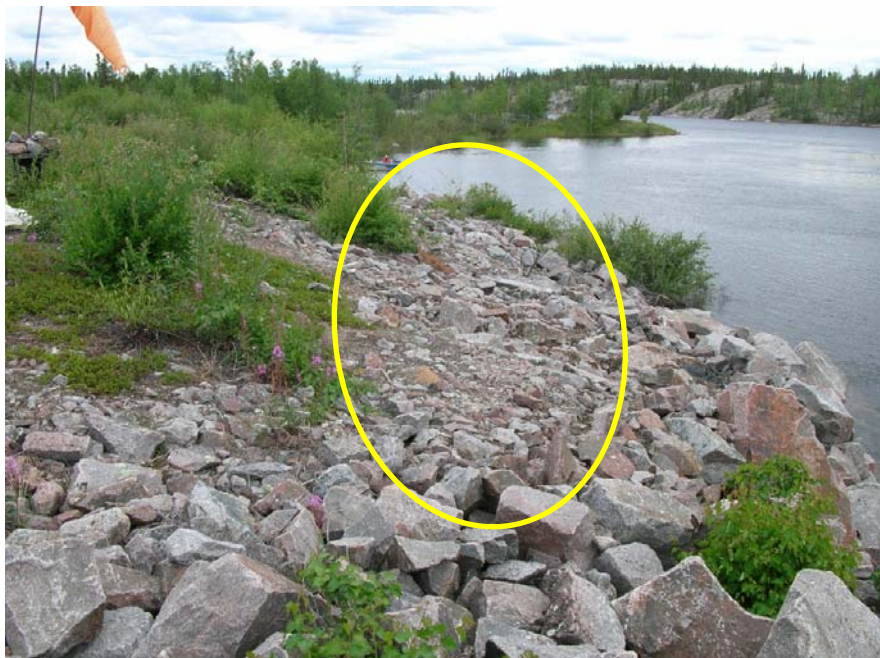
Photo 20 Side Dam 5B – finer riprap identified in some locations.

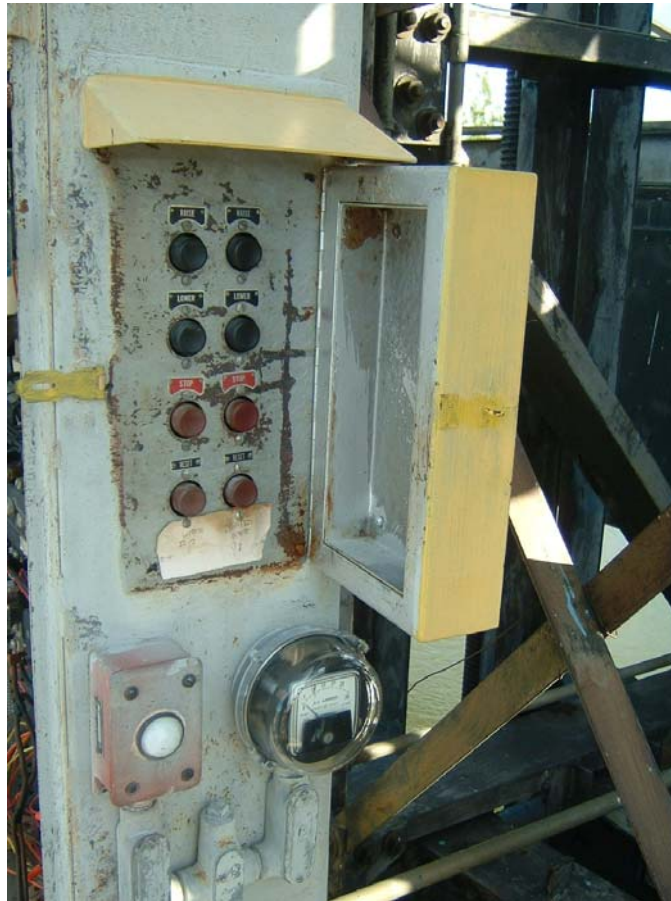
Photo 39 Snare Falls Spillway - gate operation is by manual pushbutton from the control panel at road level.

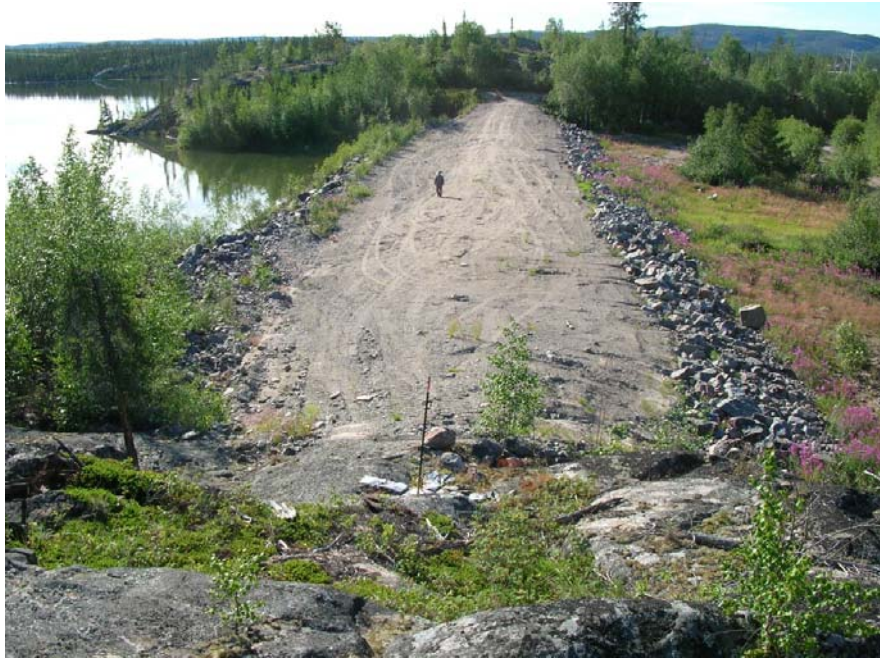
Photo 43 Saddle Dam No. 1 – crest lowered by 2.7 m in 2003 as an emergency flood handling improvement.

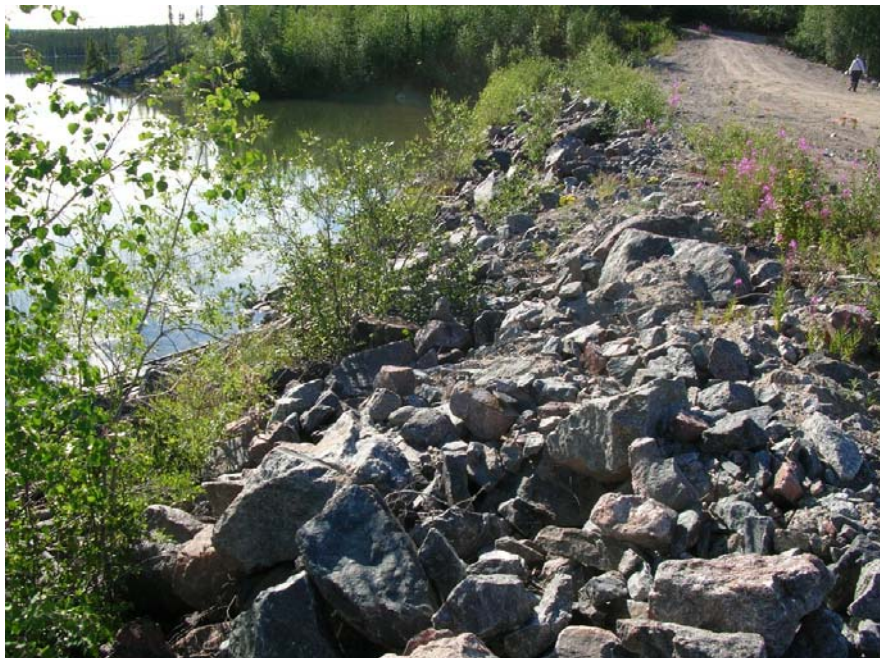
Photo 44 Saddle Dam No. 1 – upstream face satisfactory. Brushing required as part of on-going maintenance.

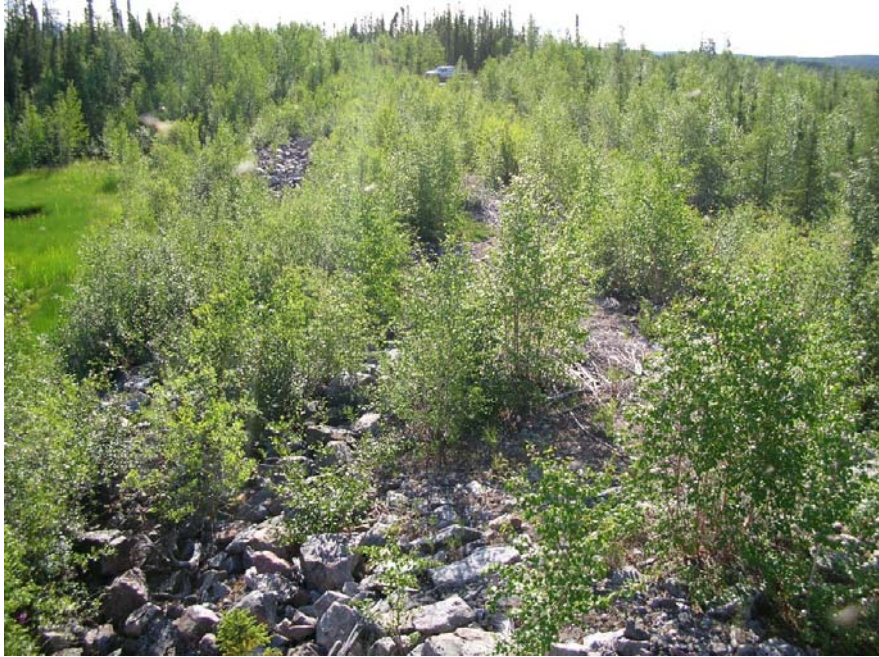
Photo 45 Saddle Dam No. 2 – Crest and slopes overgrown with saplings and dense brush. Brushing required to permit proper inspection.

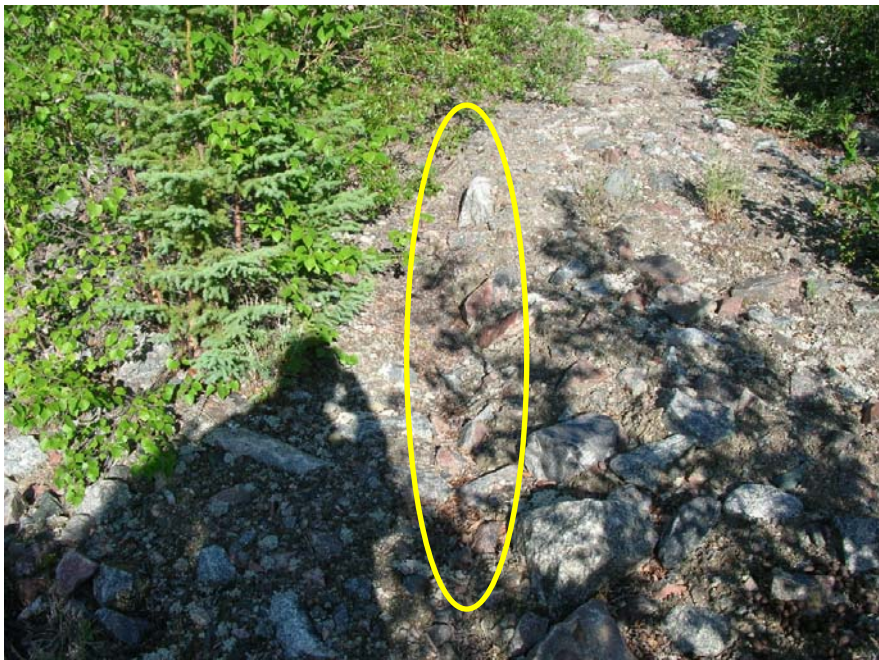
Photo 46 Saddle Dam No. 2 - discontinuous longitudinal depressions occurring near the upstream and downstream sides of the crest show no change from previous reports.

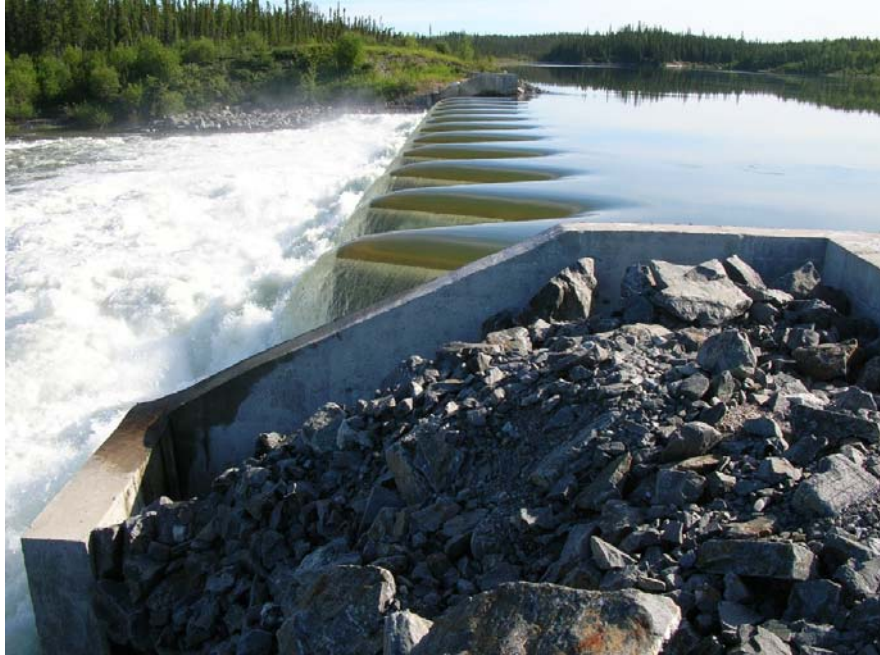
Photo 47 Snare Cascades Spillway – flow over the labyrinth spillway is smooth and uniform. $Q = 126 \text{ m}^3/\text{s}$

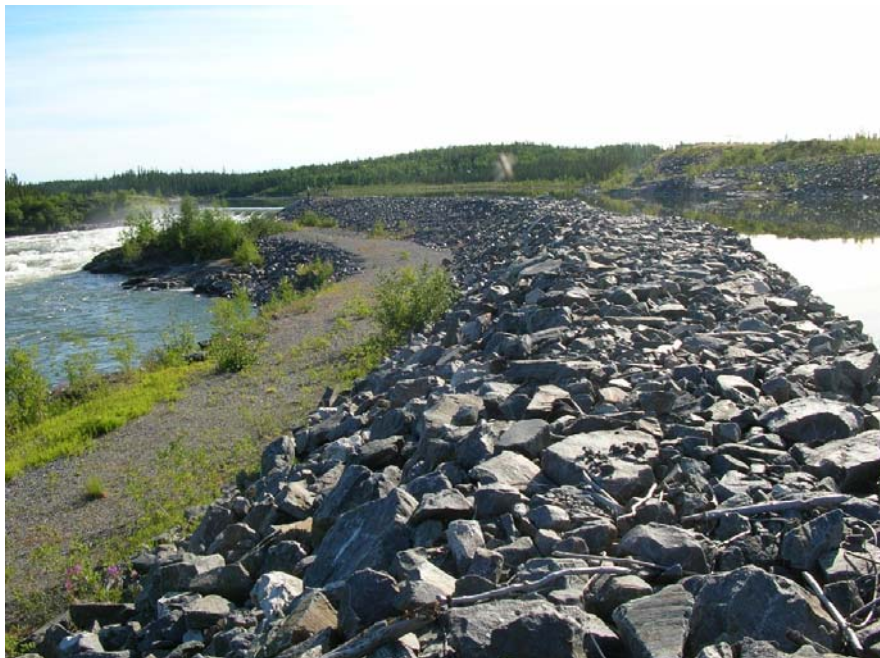
Photo 48 Snare Cascades Power Canal Dyke – crest typically planar with no obvious settled areas, erosion or abnormalities.

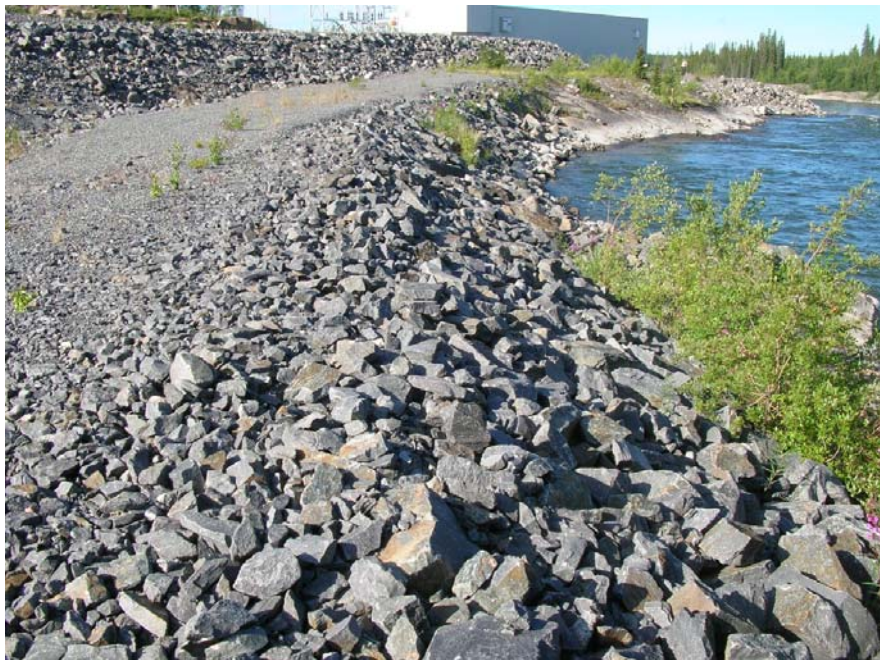
Photo 52 Snare Cascades Power Canal Dyke - crest of the lower bench is typically planar with no signs of instability or distress.

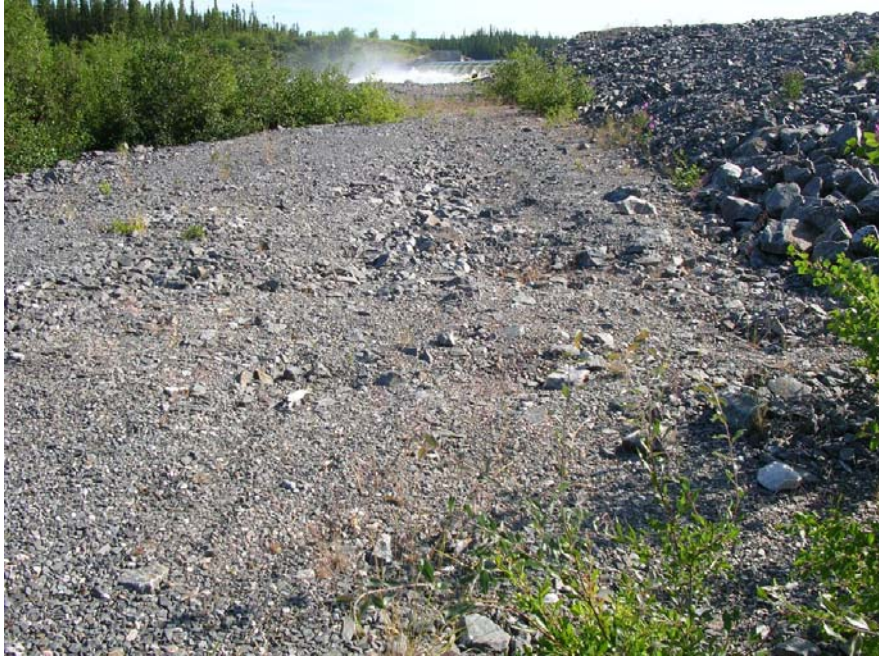
Photo 53 Snare Cascades Power Canal Dyke - some localized depressions in the surface of the lower bench crest near the upstream end.

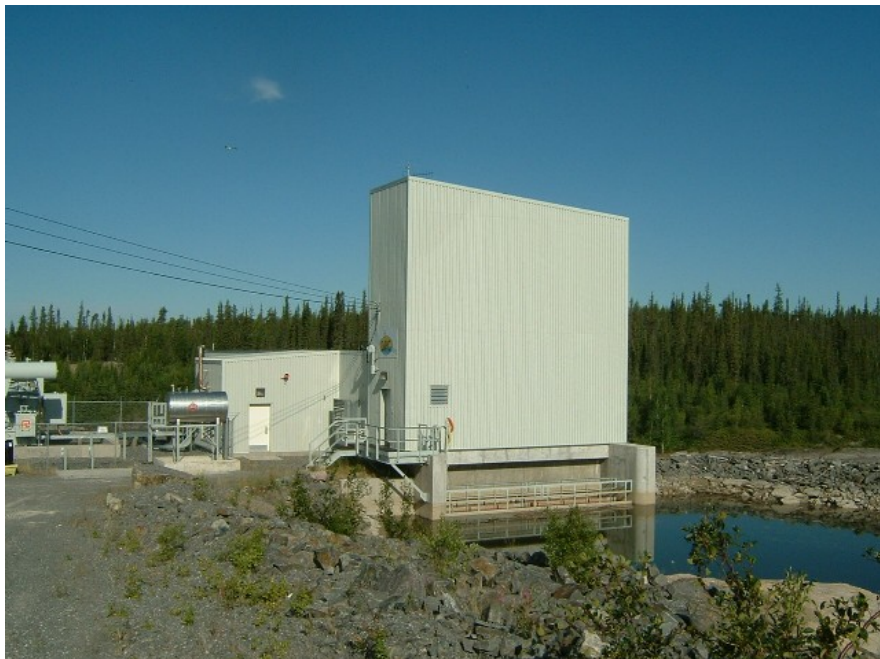
Photo 56 Snare Cascades Intake and Powerhouse – general arrangement.

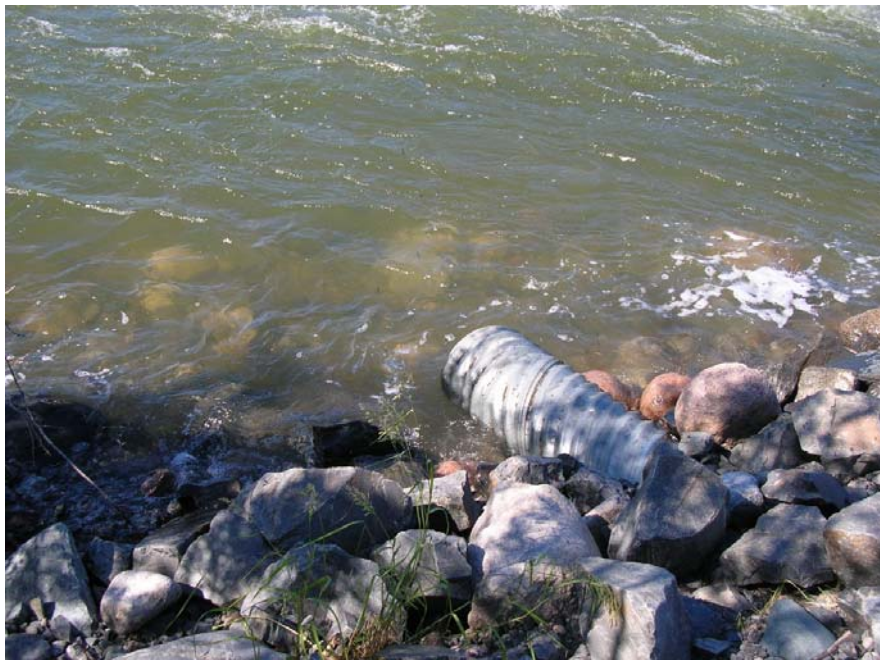
Photo 62 Snare Forks Dam – the outlet of the culvert through the cofferdam is partly submerged during spillway operation precluding seepage measurement.

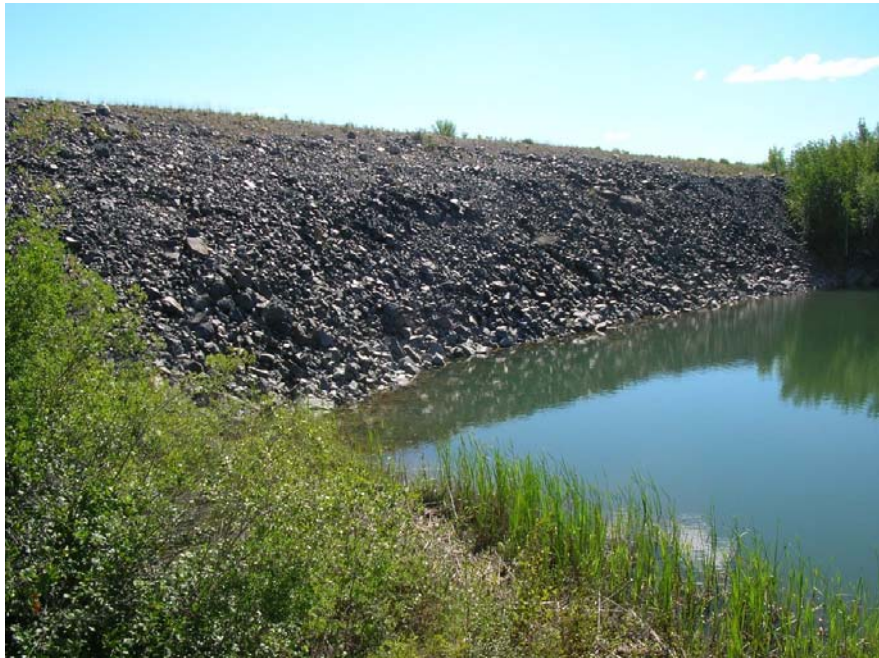
Photo 65 Snare Forks Dam - downstream shell is planar with no settled areas or evidence of instability.

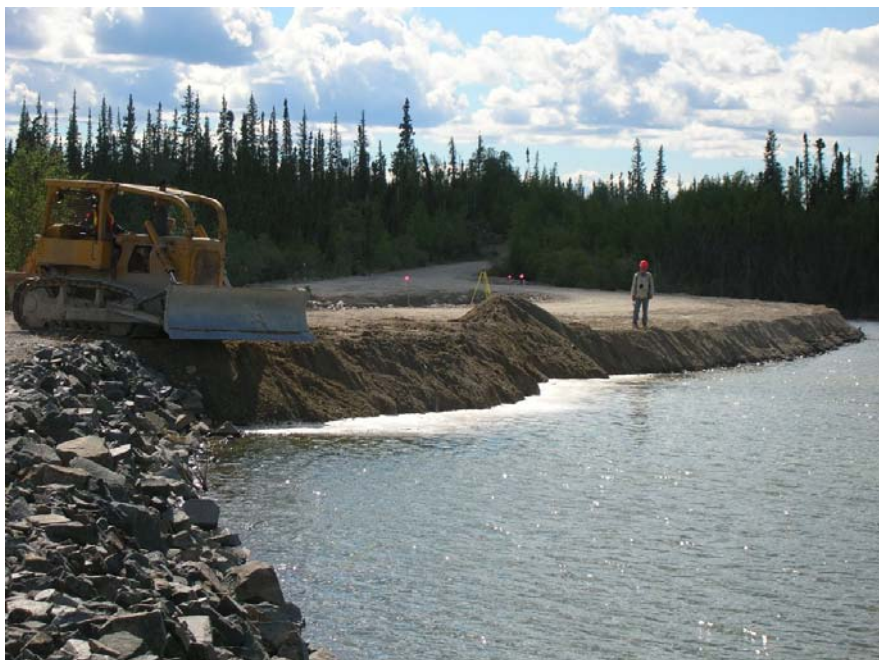
Photo 66 Freeboard Dyke 1 – reconstruction in progress following breach in June 2006.

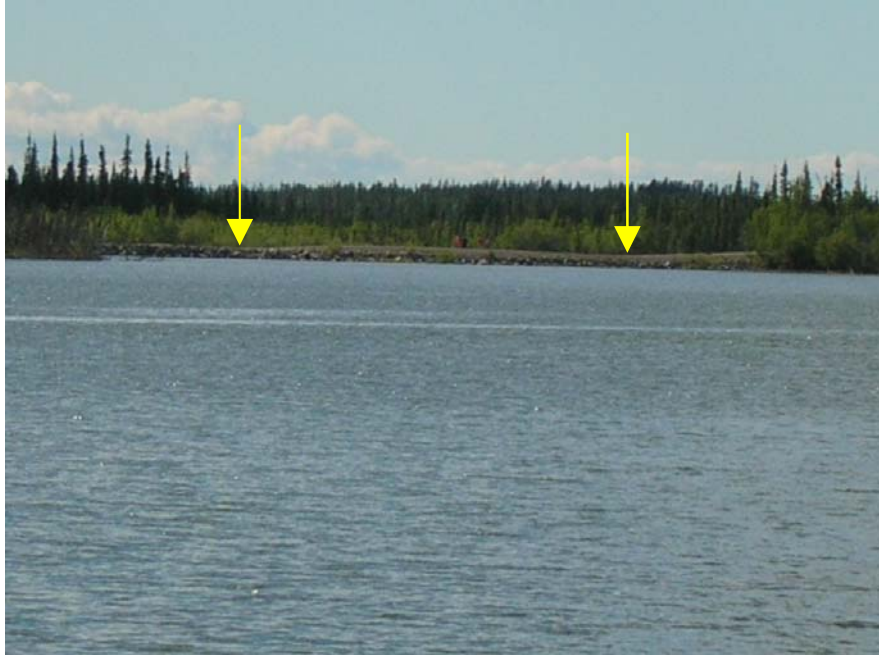
Although recently topped up, the crest exhibits an undulating profile with two visible depressions in the crest – one at each abutment - indicative of ongoing permafrost thaw (Photo 67). No longitudinal cracking was evident (Photo 68); however, cracking could have been masked by the recently placed sand fill. The downstream shoulder of the dyke appears lower than at the centerline (Photo 69), likely as a result of the hastily placed sand fill rather than an indication of settlement. The dyke design elevation should be reinstated for the full crest width. In this respect a new crest survey is recommended to determine the current profile and determine the amount of sand fill required to top up the dyke in order to reinstate the design level.

Photo 67 Freeboard Dyke 2 - crest exhibits an undulating profile with two visible depressions in the crest – one at each abutment.

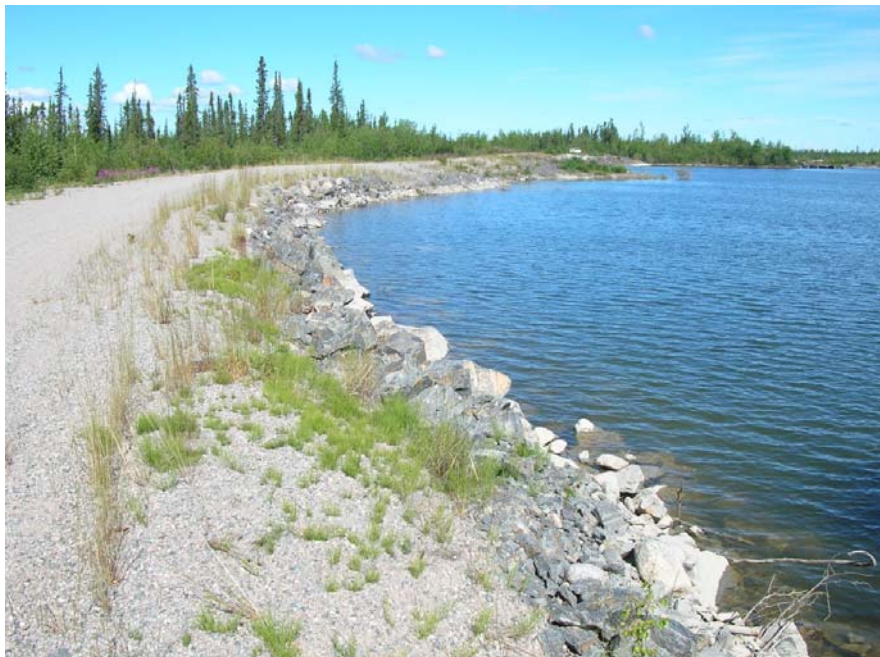
The upstream riprap (Photo 74) is generally in a satisfactory condition with no beaching or erosion damage, but there are some areas where it is locally finer and ongoing monitoring is recommended. The crest of the dyke shows no signs of cracking but the requirement for ongoing topping up indicates continued permafrost thaw and settlement. Despite being recently topped up, the area toward the right abutment still appears low when compared to other points along the profile. A crest survey is recommended to confirm the crest profile and determine the fill requirements to reinstate the design crest level.

Photo 74 Freeboard Dyke 2 - upstream riprap generally satisfactory.

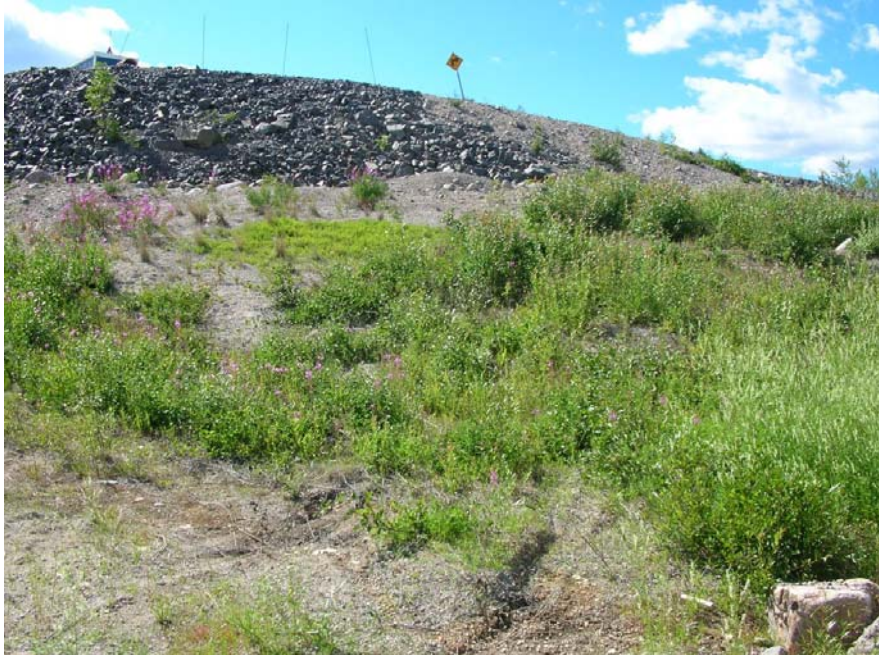
Three standpipe piezometers were installed in the localised wet area downstream of the left abutment of the dam (Photo 75) in March 2000, where earlier drilling showed a granular layer under minor artesian head overlying bedrock. NTPC do not have a record of piezometer measurements and discussion with site staff confirmed they are not read. Field observation during the current inspection indicated that the heads of the standpipe piezometers have been destroyed, likely during snow removal activities around the switchyard. It is recommended that the piezometer heads are reinstated and readings re-implemented.

Photo 75 Strutt Lake Dam – toe of dam in vicinity where 3 standpipe piezometers were previously installed in March 2000.

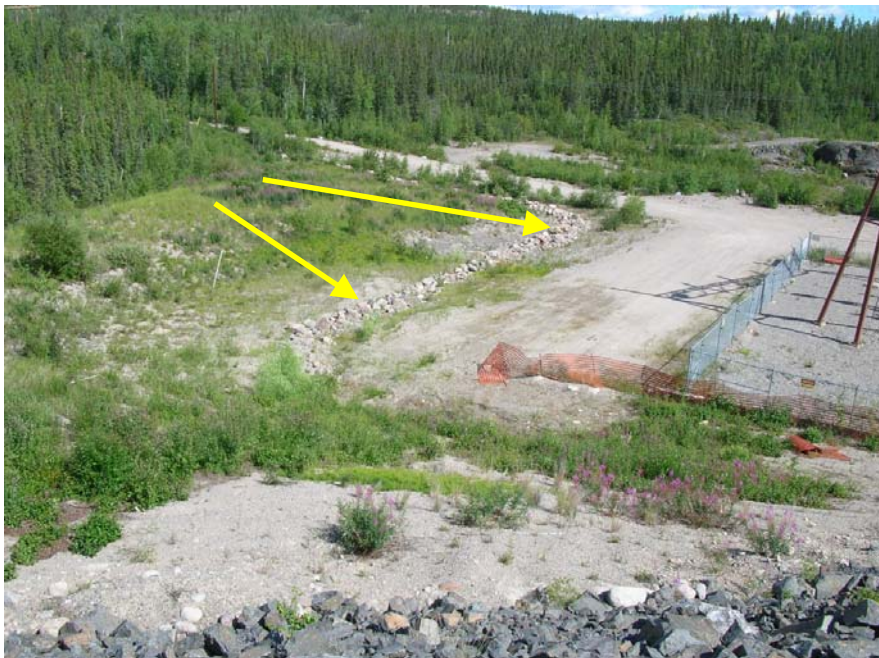
A rock fill French drain has been constructed as recommended in the previous DSR to help drain the area (Photo 76). It is not typically monitored and was dry at the time of inspection.

Photo 76 Strutt Lake Dam - rock fill French drain between downstream toe and switchyard. Drain outflows not monitored. Dry at the time of inspection.

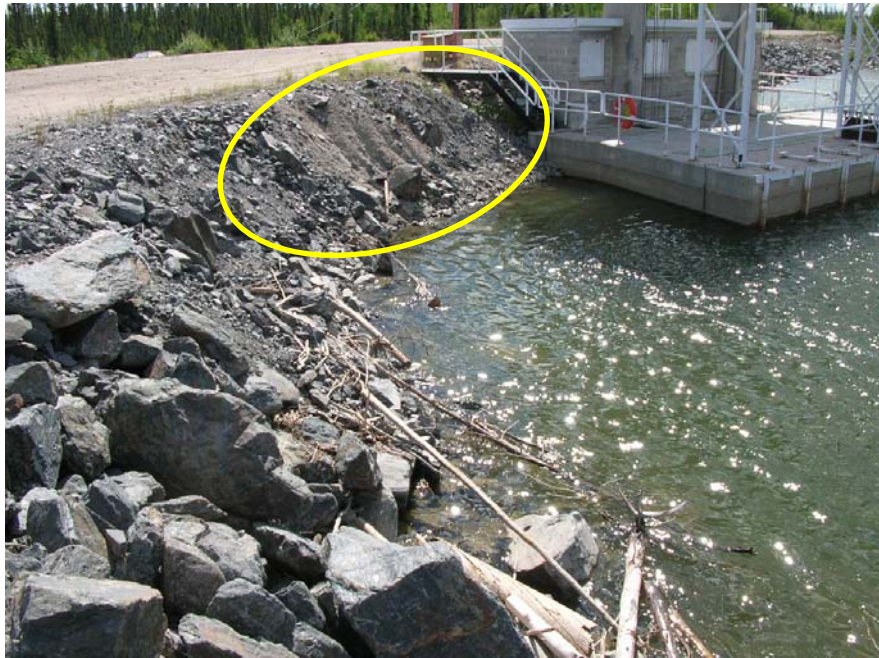
breakdown, beaching or deterioration, except in the vicinity immediately to the left of the intake where some larger size particles appear to be lacking (Photo 79). NTPC staff should visually monitor this area for any signs of deterioration in which case the localized area should be redressed with appropriately sized material.

Photo 79 Strutt Lake Dam - riprap on the upstream slope is generally satisfactory. Localized area immediately left of the intake lacks some larger size particles. Monitoring required.

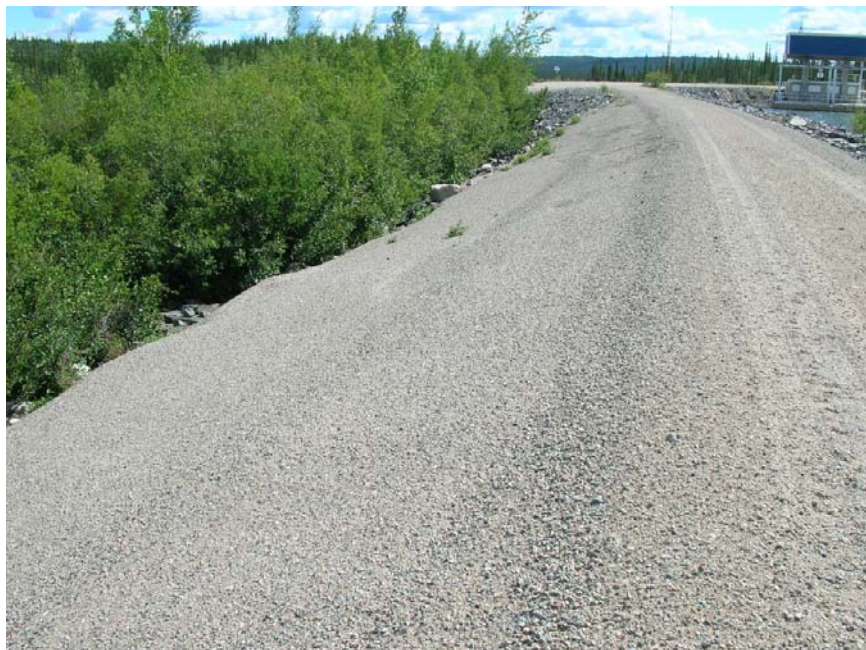
Photo 84 North Dyke - downstream shell is planar, with no erosion gulleys or evidence of seepage.

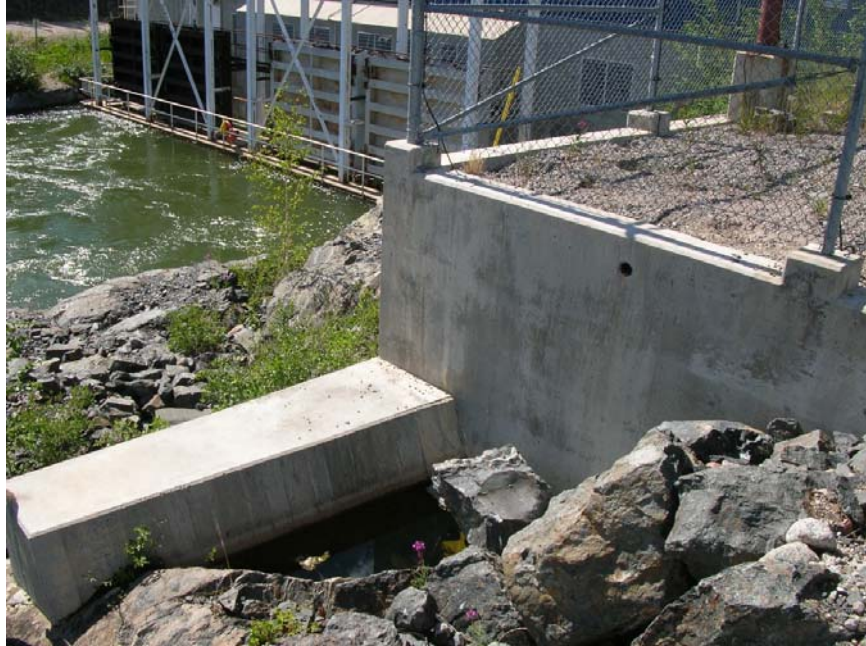
There is minor seepage still occurring through the bedrock near the southeast corner of the powerhouse and switchyard as evident by the ponded water at the switchyard retaining wall (Photo 85). This seepage has been reported during previous inspections and is not considered a dam safety issue. NTPC should continue to visually monitor existing leakage and report any evidence of increase for review.

Photo 85 Snare Forks Powerhouse - minor seepage through the bedrock near the SE corner of the powerhouse and switchyard as evident by the ponded water at the switchyard retaining wall.
