SNARE HYDRO SYSTEM

2006 Comprehensive Dam Safety Review

FINAL

Kohn Crippen Berger

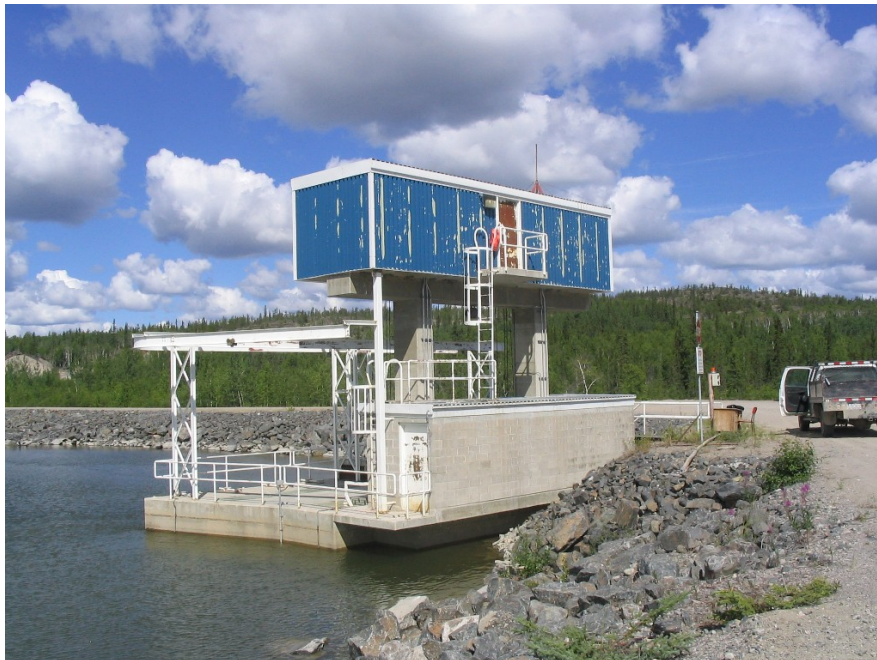
During the 2006 KCBL inspection, the water level was high (EL. 174.34. m) which limited the inspection of the substructure. The reinforced concrete columns, beam and floor slab superstructure appeared in good condition. Likewise the steel frame superstructure for stoplog handling is in good condition (Photo 86).

Photo 86 Snare Forks Intake – general arrangement.
