Report: Contact Lake Mine Remedial Action Plan with Project Update

RE: Contact Lake Mine Remedial Action Plan – Project Update

CONTACT LAKE MINE REMEDIAL ACTION PLAN

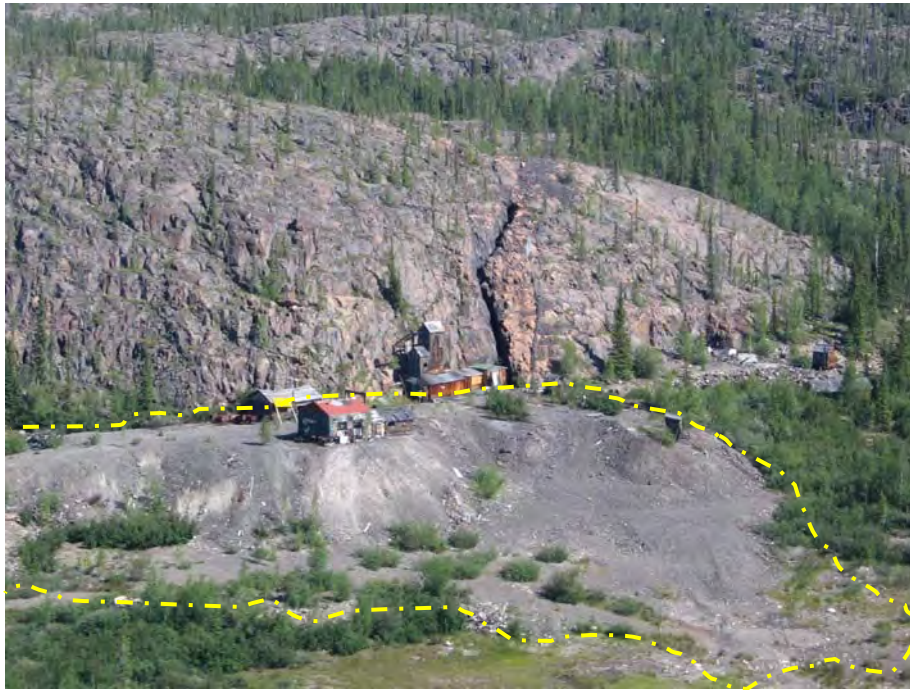
FIGURE 3.6-11
CONTACT LAKE WASTE ROCK

Mine waste rock from underground workings generated waste rock that was placed parallel and adjacent to the base of the cliff next to the adit and formed (as noted above) the mine yard and base for most of the mine buildings (see Figure 3.6-11). The surface of the waste pile and yard is generally flat until it slopes away from the yard area at its angle of repose or less. Waste rock slopes appear stable with no evidence of surface erosion. Estimated waste rock volumes range from 26,000 to 30,000 m³.

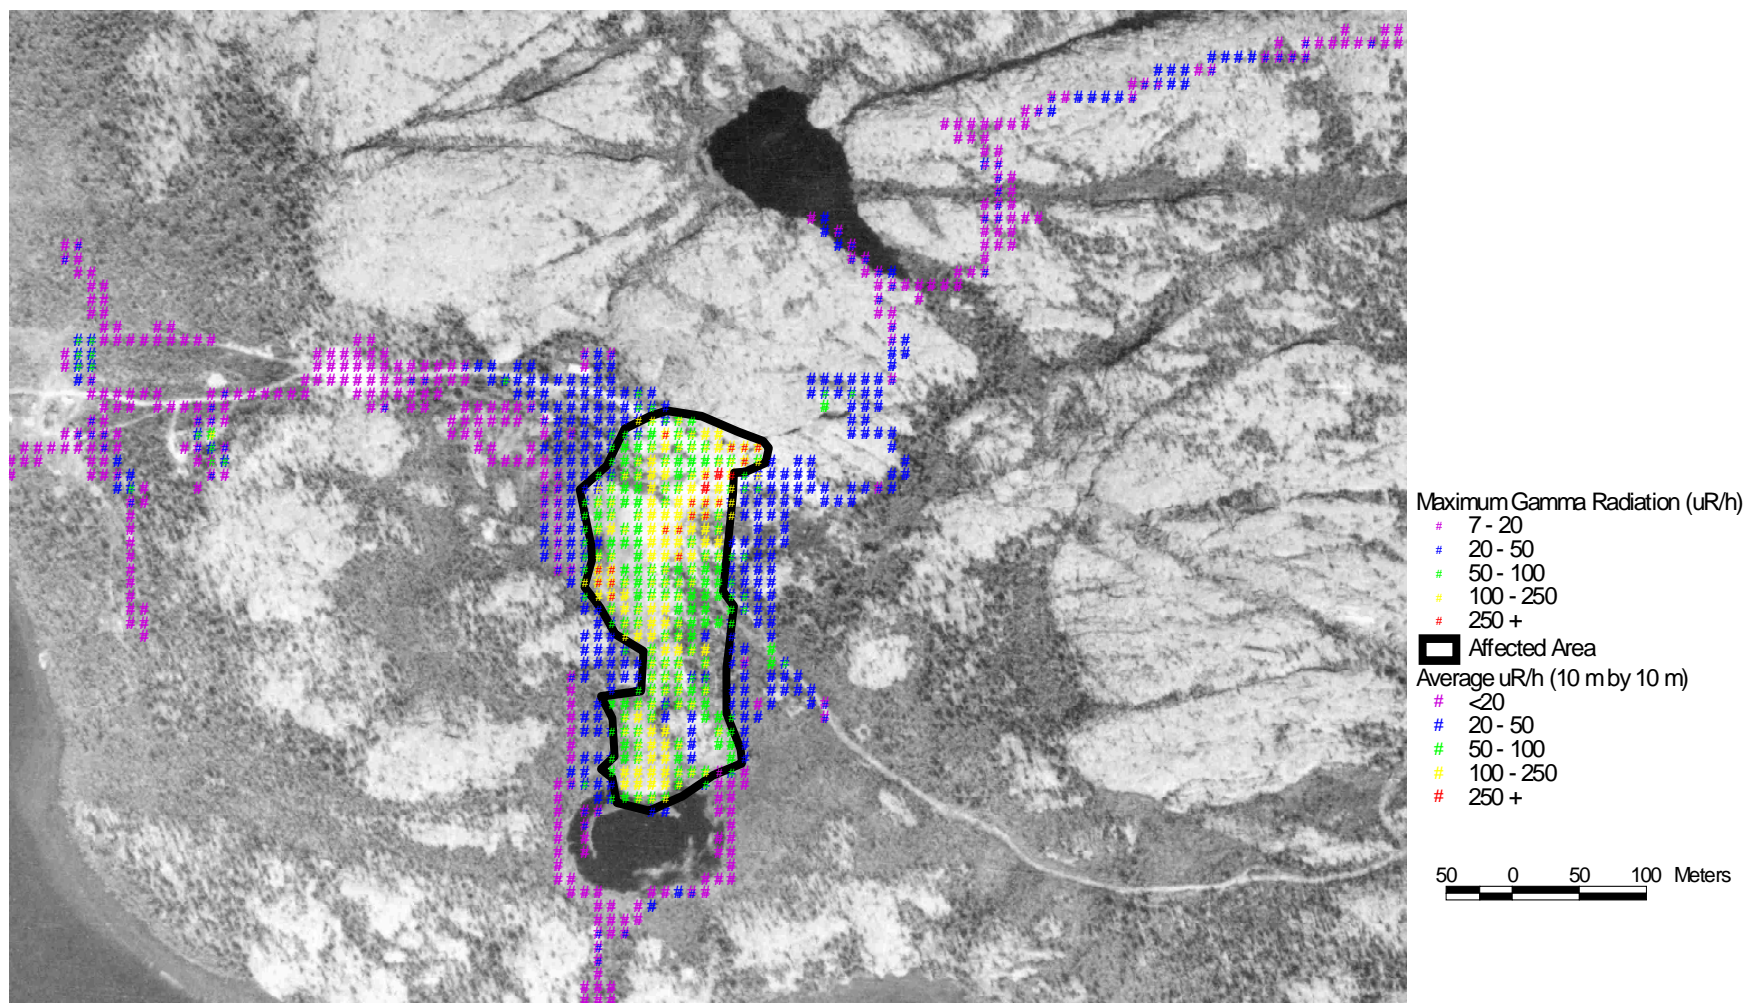
FIGURE 4.6-1
PROCESSED GAMMA RADIATION LEVELS (10 m GRIDS) (μ R/h)

Figure 4.6-1 shows the gamma radiation levels as statistically summarized in 10 m grids, with both the mean value and the maximum single measurements within the grid shown. The area outlined in the figure shows blocks on the site with gamma radiation levels generally above 50 $\mu\text{R/h}$, which not surprisingly coincide with the locations of the waste rock and the tailings. The elevated gamma radiation levels in these areas are believed to be associated with the historic mining activities. The highest mean for a 10 m grid equalled 336 $\mu\text{R/h}$, while the highest individual measurement was 598 $\mu\text{R/h}$.

Table 4.6-2 summarizes the number of grid cells as categorized by gamma radiation level. As can be seen from Table 4.6-2, the terrestrial gamma survey found that only a very small portion of the waste rock and tailings areas (less than 200 m^2) had terrestrial gamma radiation measurements exceeding 250 $\mu\text{R/hr}$, less than a hectare (about 0.74 ha) had terrestrial gamma radiation measurements between 100 and 250 $\mu\text{R/hr}$, and that the remainder of the surveyed area, about 7.8 ha, had terrestrial gamma radiation measurements below 100 $\mu\text{R/hr}$.

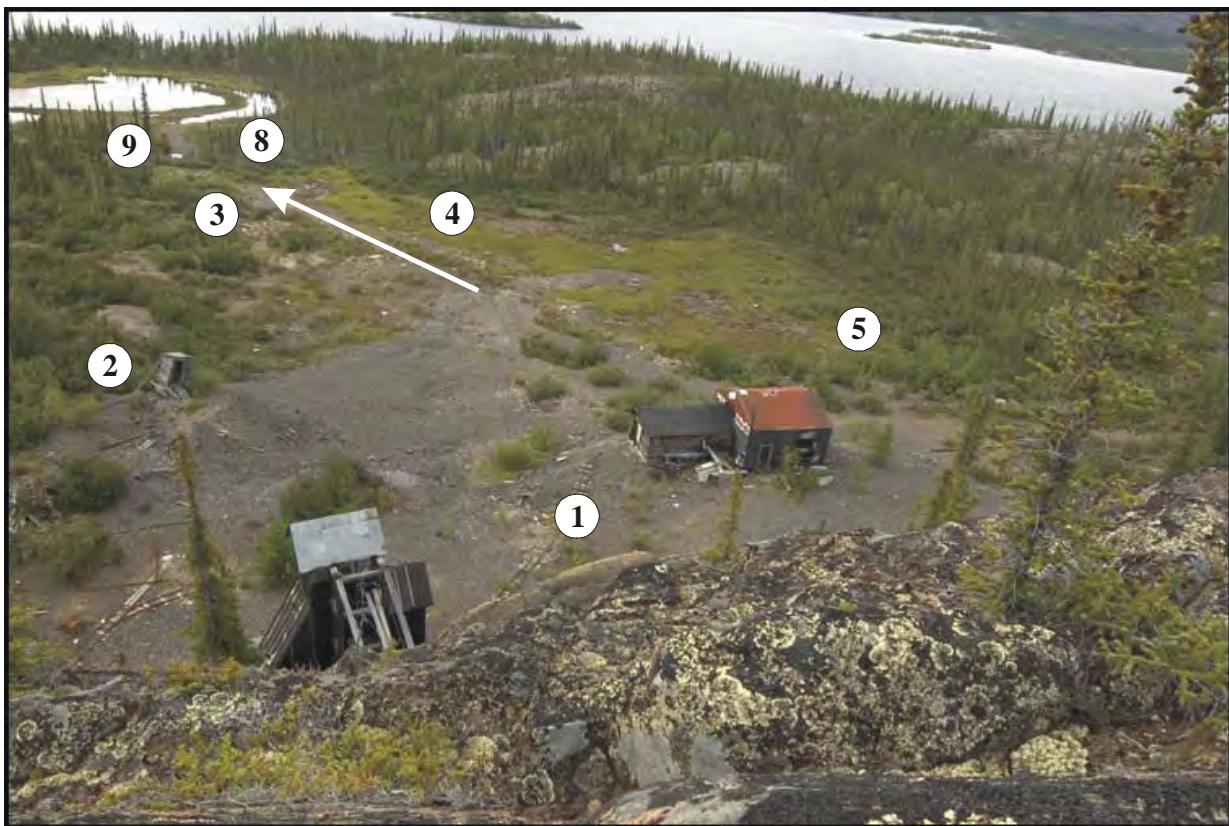
FIGURE 4.7-1
ILLUSTRATION OF SAMPLING LOCATIONS

Notes: Elevated photo of the Contact Lake Mine showing sampling sites for the vegetation and soil collections. Arrow shows the general direction of surface water flowing downslope from the waste rock pile. Supplemental samples of sedges were taken from areas of standing water at the foot of the pile (adjacent to the arrow shown in the picture).

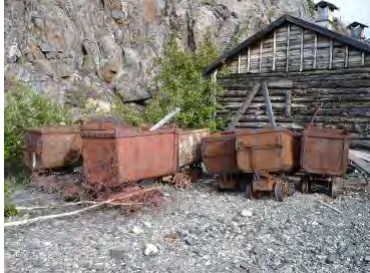
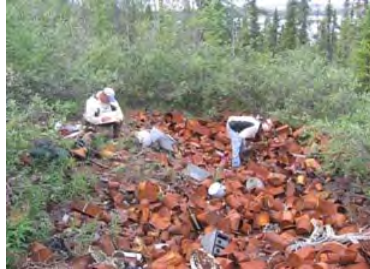
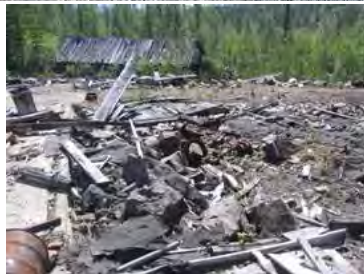
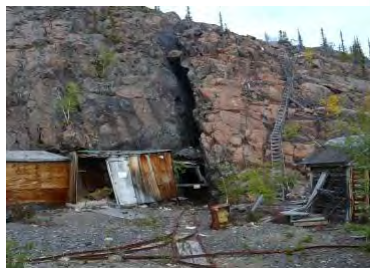
Small Dumps and Debris

- Small areas of soil with elevated metals (for example arsenic, lead, and zinc) and hydrocarbons (oil)
- No PCBs were detected
- Could be uptake of metals by wildlife and plants
- Physical hazard – could be injury to people and animals

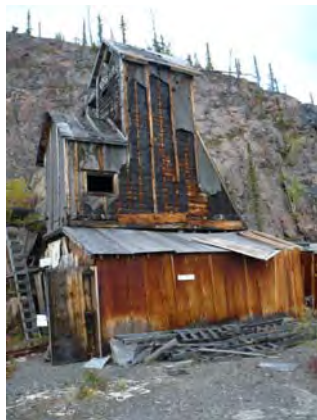
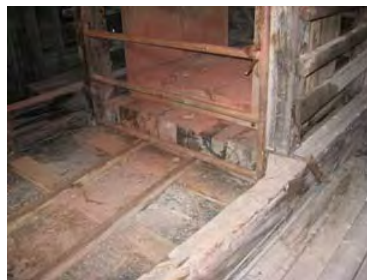
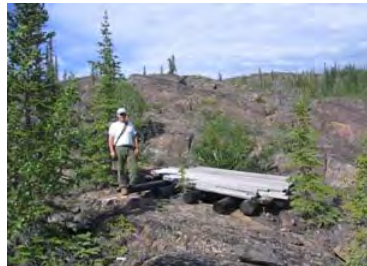
Mine Openings

- Contact Lake
 - 1 mine raise and 1 mine shaft
 - Falling hazards

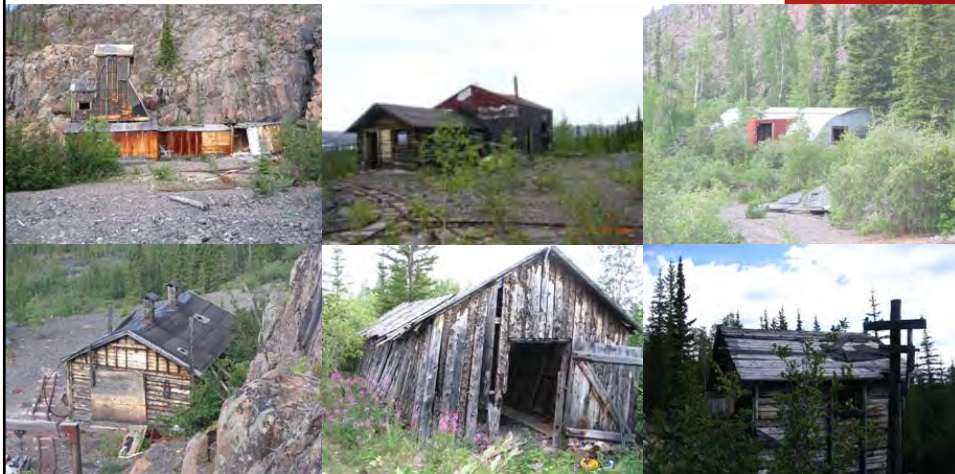
Mine Buildings

- Safety Hazard
- Visual attraction to site
- Some chemical hazards (lead paint, DDT, asbestos)

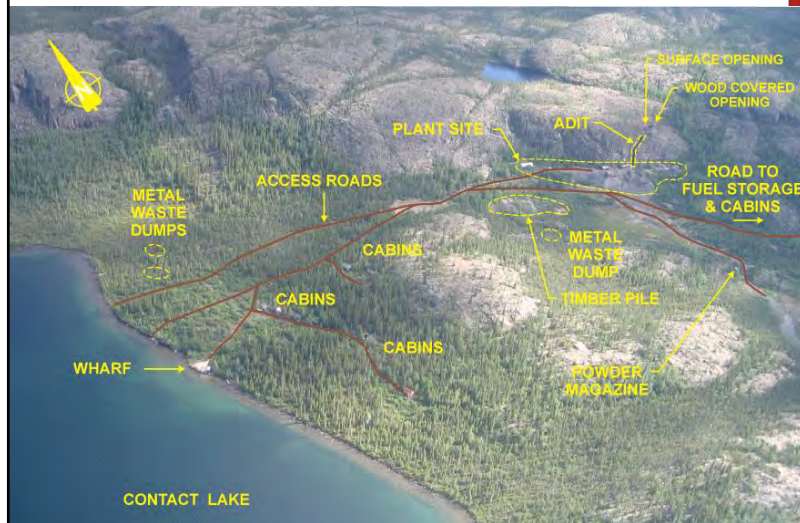
Dumps, Household and Metal Debris

- Small areas of soil with elevated metals (for example arsenic, lead, and zinc) and hydrocarbons (oil)
- No PCBs were detected
- Could be uptake of metals by wildlife and plants
- Physical hazard – could be injury to people and animals

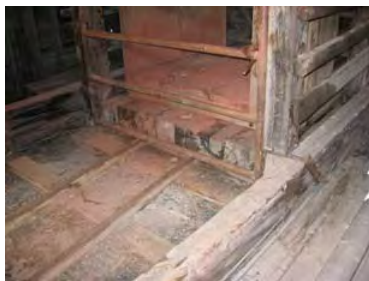
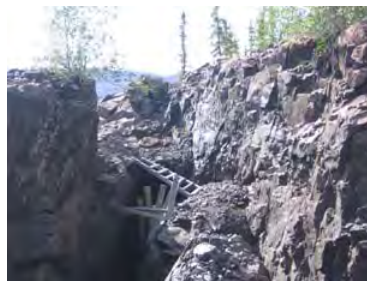
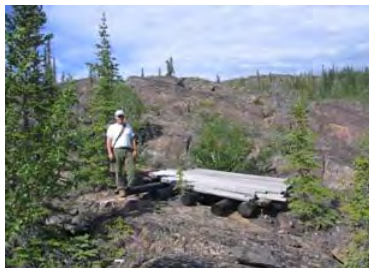
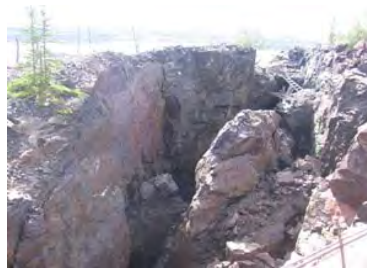
Mine Openings

- Contact Lake
 - 1 mine raise, 2 open stopes, 1 mine shaft, and small pits and trenches
- Falling hazards

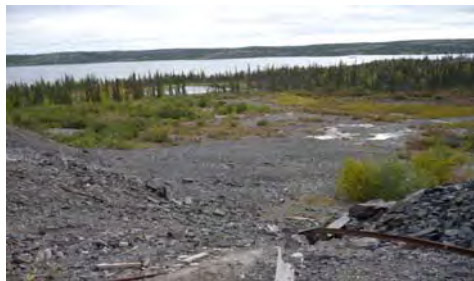
On-Land Tailings

One land tailings	Jimmy	After so many years, why is nothing growing there again?	Jessica	The vegetation is actually growing on the tailings (as shown in this picture) because the rock has been broken up into smaller pieces (tailings). The vegetation is more sparse on the waste rock because the rocks are bigger and it's hard for things to grow there.

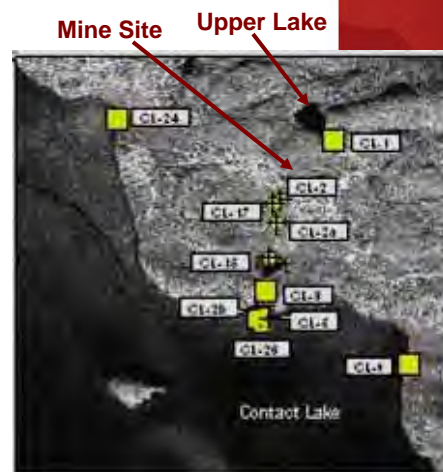
Water Quality – Waste Rock area

- Results were above guidelines for arsenic, copper, iron and uranium
- One sample (CL-2) was above the guideline for radionuclides

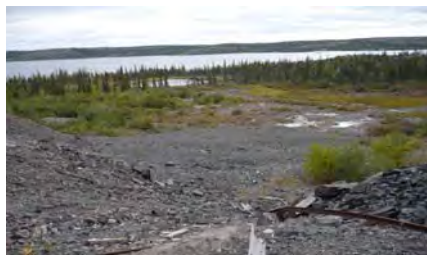
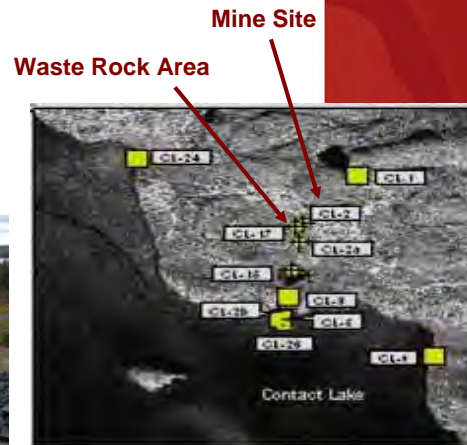
Water Quality – Tailings Pond

- Results were elevated for arsenic, copper, silver and uranium
- Radionuclides were below the guideline

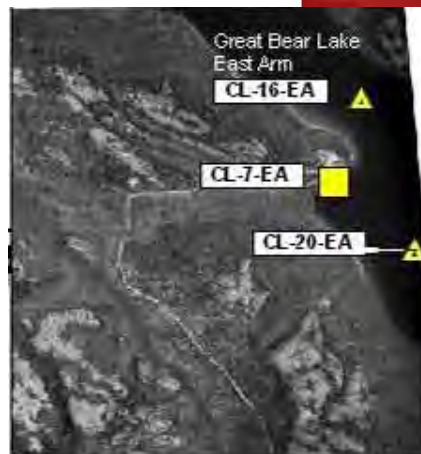
Sediment Quality in the East Arm of Echo Bay – Great Bear Lake

- At dock, results were above the guidelines for (e.g. arsenic and mercury)
- At dock, hydrocarbon results and radionuclides were elevated
- Away from the dock, the results were below the guidelines for all
- More study was required to determine effects
- Benthic study results are not complete

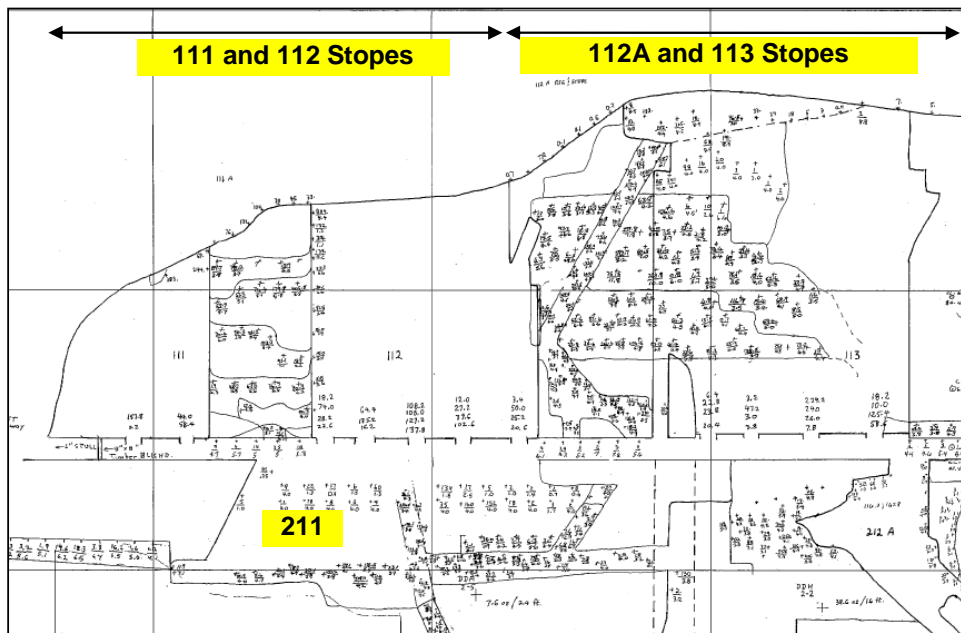
Stoping in the 111 and 112 Stope Areas
