**To:** MGM Energy2800, 421 - 7 Avenue SW
Calgary, AB T2P 4K9**File:** 123514551**From:** James Hymers, Project Manager
K'alo-Stantec Ltd.

Date: January 22, 2024

Reference: 2023 Environmental Site Monitoring Report: East Mackay I-78 Wellsite Area and Staging Area

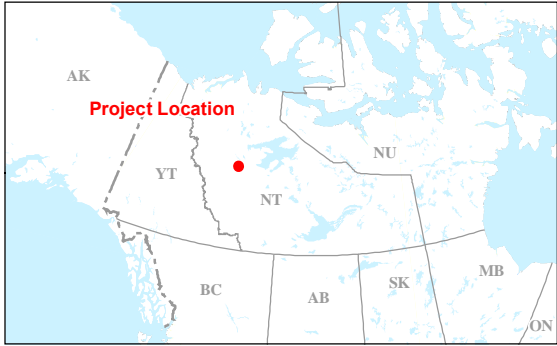
Title
**East Mackay I-78 Wellsite Area –
Reclamation Assessment**

*Wildfire was actively burning in the Wellsite Area at the time of the 2023 site visit. Approximately 50 percent of the area was completely burned/damaged.
