**Report: Contact Lake Mine Remedial Action Plan with
Project Update**

CONTACT LAKE MINE REMEDIAL ACTION PLAN

March 2008

FINAL

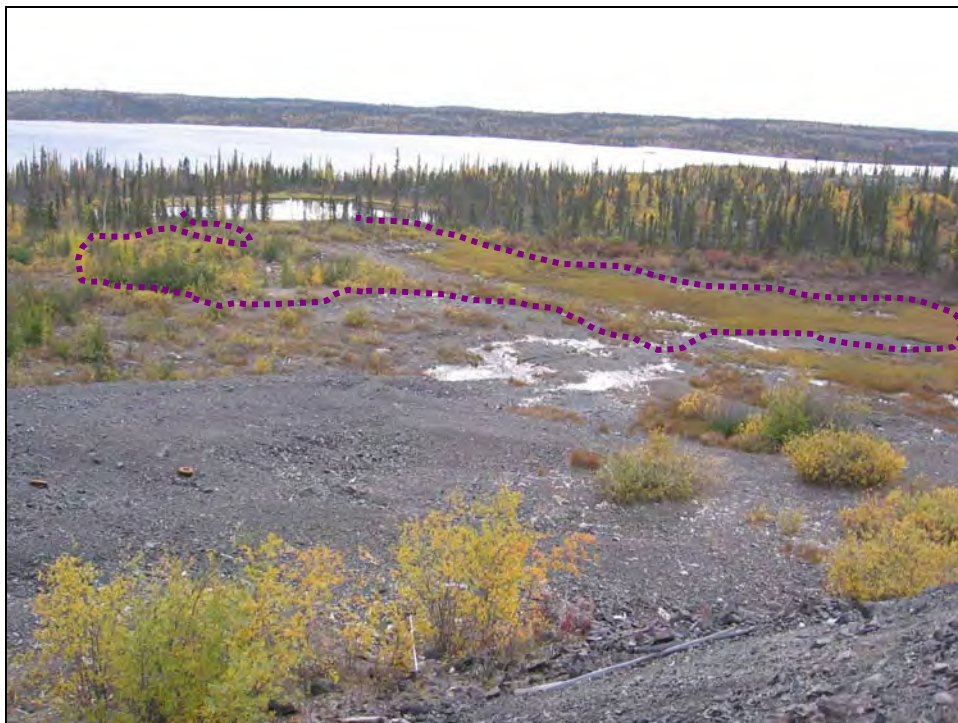
FIGURE 3.6-12
CONTACT LAKE SURFACE TAILINGS

From document reviews, 1969 estimates of tailings (see Figure 3.6-12) on site were in the order of 5,000 tons. This estimate was refined to 2,264 tons in 1973 by Bill Knudsen (Knudson 1973) of Echo Bay Mines. Subsequently, records indicate that 2,085 tons of tailings were removed by winter road to Echo Bay's Port Radium mill in 1975. The residual surface tailings remnants (less than 200 tons, 2264 less 2085) are thinly spread across the flat area below the waste rock pile that is bounded on each side by rock outcrops. The remaining surface tailings have likely been subject to sheet erosion over time with eroded materials migrating down gradient to a natural pond that acts as a natural sump. This pond is a natural stable structure that is bounded by rock outcrops on all sides.

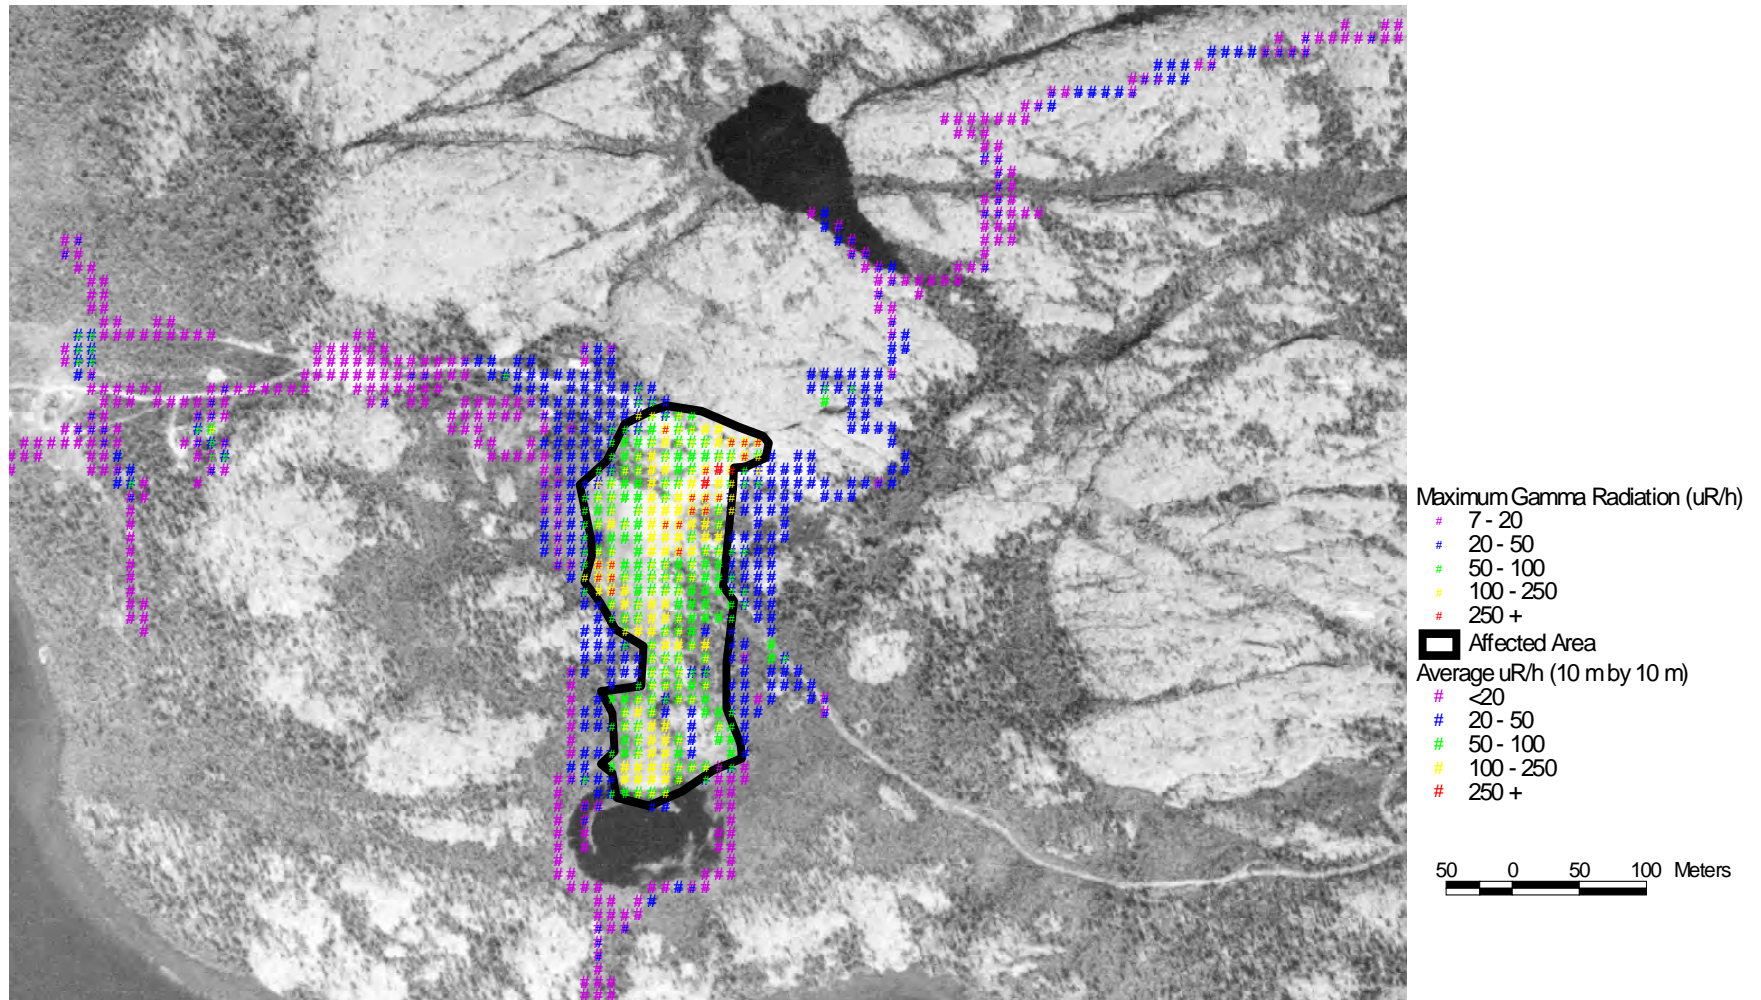
FIGURE 4.6-1
PROCESSED GAMMA RADIATION LEVELS (10 m GRIDS) (μ R/h)

Figure 4.6-1 shows the gamma radiation levels as statistically summarized in 10 m grids, with both the mean value and the maximum single measurements within the grid shown. The area outlined in the figure shows blocks on the site with gamma radiation levels generally above 50 $\mu\text{R/h}$, which not surprisingly coincide with the locations of the waste rock and the tailings. The elevated gamma radiation levels in these areas are believed to be associated with the historic mining activities. The highest mean for a 10 m grid equalled 336 $\mu\text{R/h}$, while the highest individual measurement was 598 $\mu\text{R/h}$.

Table 4.6-2 summarizes the number of grid cells as categorized by gamma radiation level. As can be seen from Table 4.6-2, the terrestrial gamma survey found that only a very small portion of the waste rock and tailings areas (less than 200 m^2) had terrestrial gamma radiation measurements exceeding 250 $\mu\text{R/hr}$, less than a hectare (about 0.74 ha) had terrestrial gamma radiation measurements between 100 and 250 $\mu\text{R/hr}$, and that the remainder of the surveyed area, about 7.8 ha, had terrestrial gamma radiation measurements below 100 $\mu\text{R/hr}$.

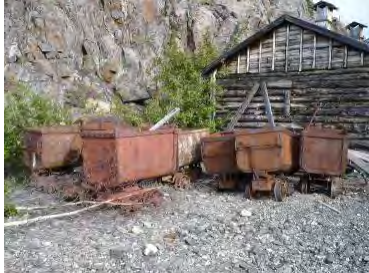
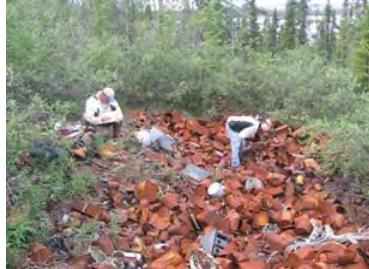
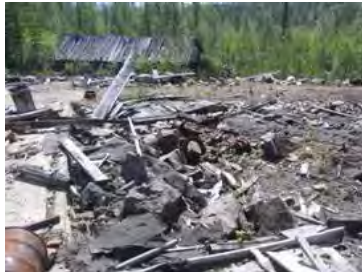
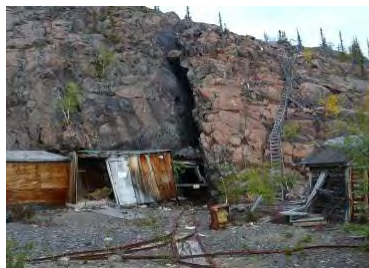
Small Dumps and Debris

- Three small dumps
- Old equipment, house hold garbage, vehicle parts
- Metal scrap

- Small areas of soil with elevated metals (for example arsenic, lead, and zinc) and hydrocarbons (oil)
- No PCBs were detected
- Could be uptake of metals by wildlife and plants
- Physical hazard – could be injury to people and animals

Goals / Options Dumps and Debris – All options include general site clean up	Leave as is	Cover with soil	Cover with soil and plant vegetation	Move to new landfill (including soil with metals at dumps)
Health and safety	Bad	OK	OK	Good
Protect fish, wildlife and vegetation	Bad	OK	OK	OK
Protect water quality	Bad	OK	OK	Good
Minimize environmental impacts during remediation	Good	OK	OK	OK
Minimize Long term care and maintenance	Bad	OK	OK	OK
Return site to its original condition where possible	Bad	OK	OK	Good
Is cost effective	Good	OK	OK	OK
A / P / NA	Not acceptable	Not Acceptable	Acceptable	Preferred

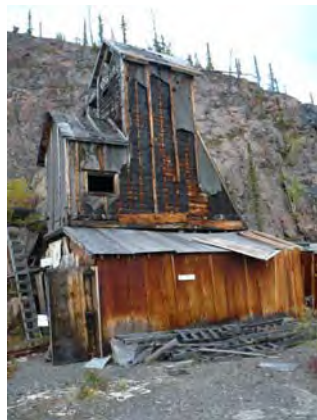
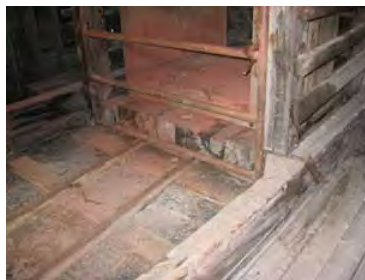
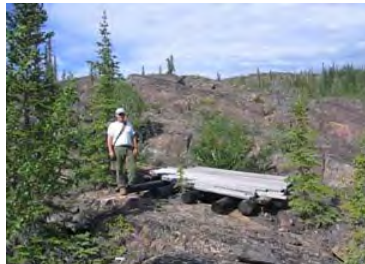
Mine Openings

- Contact Lake
 - 1 mine raise and 1 mine shaft
 - Falling hazards

Goals / Options Mine openings (shafts and raises)	Leave as is	Cap	Build fence around areas
Health and safety	Bad	Good	OK
Protect fish, wildlife and vegetation	Bad	Good	Bad
Protect water quality	NA	NA	NA
Minimize environmental impacts during remediation	Good	OK	OK
Minimize Long term care and maintenance	Bad	Good	Bad
Return site to its original condition where possible	Bad	Good	Bad
Is cost effective	Good	OK	OK
A / P / NA	Not acceptable	Preferred	Not acceptable

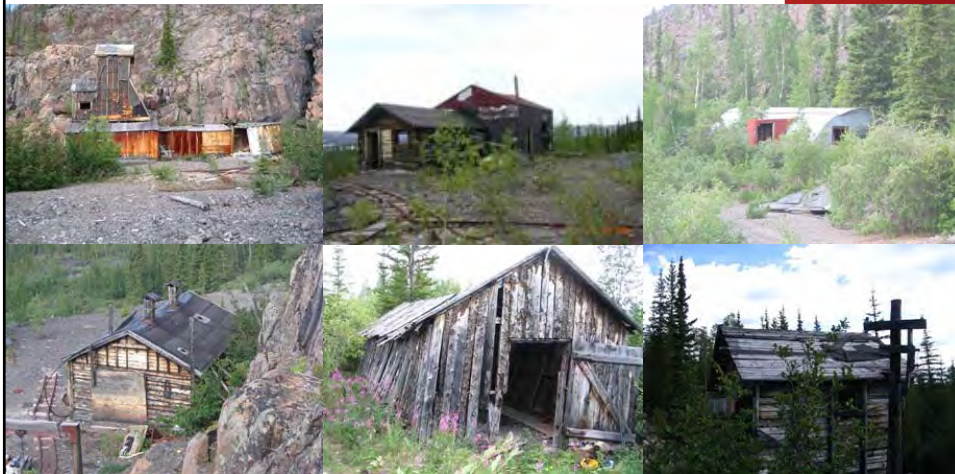
Mine Buildings

- Safety Hazard
- Visual attraction to site
- Some chemical hazards (lead paint, DDT, asbestos)

Goals / Options Buildings (all options include decontamination)	Leave as is - for other use	Demolish buildings
Health and safety	Bad	OK
Protect fish, wildlife and vegetation	OK	OK
Protect water quality	NA	NA
Minimize environmental impacts during Remediation	Good	OK
Minimize Long term care and maintenance	Bad	Good
Return site to its original condition where possible	Bad	Good
Is cost effective	Good	OK
Acceptable / Preferred / Not Acceptable	Not Acceptable	Preferred

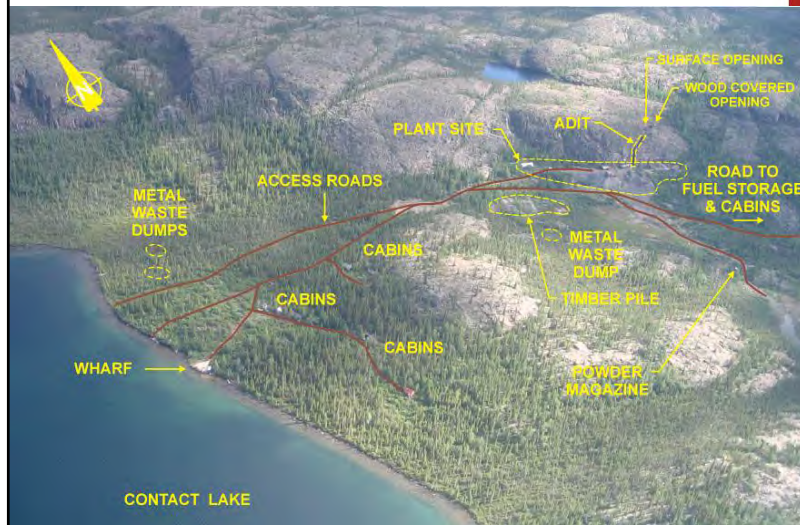
Dumps, Household and Metal Debris

- Small areas of soil with elevated metals (for example arsenic, lead, and zinc) and hydrocarbons (oil)
- No PCBs were detected
- Could be uptake of metals by wildlife and plants
- Physical hazard – could be injury to people and animals

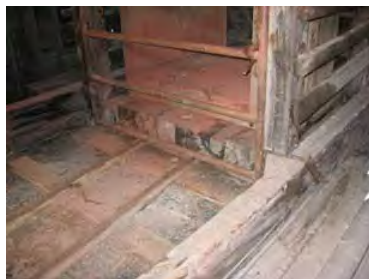
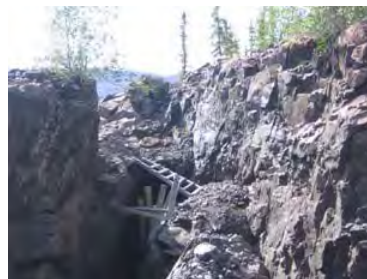
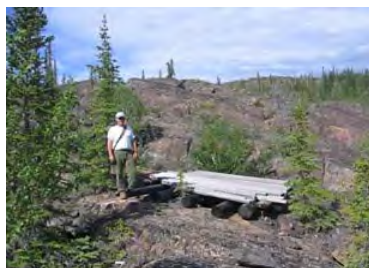
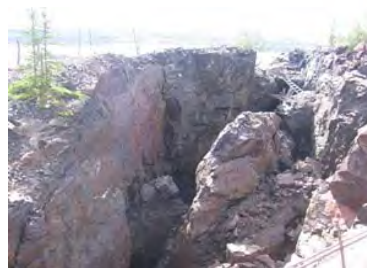
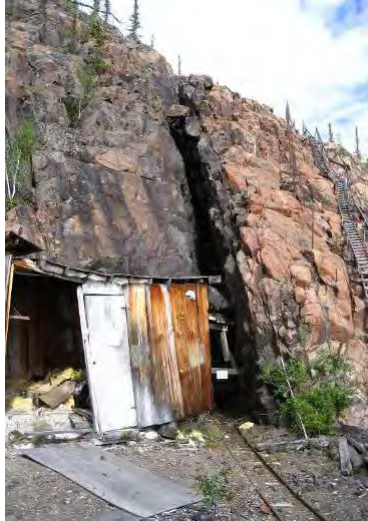
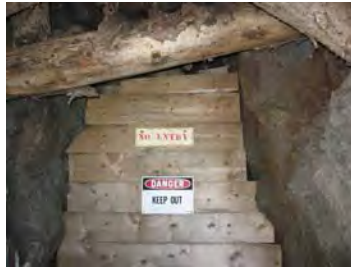
Mine Openings

- Contact Lake
 - 1 mine raise, 2 open stopes, 1 mine shaft, and small pits and trenches
- Falling hazards

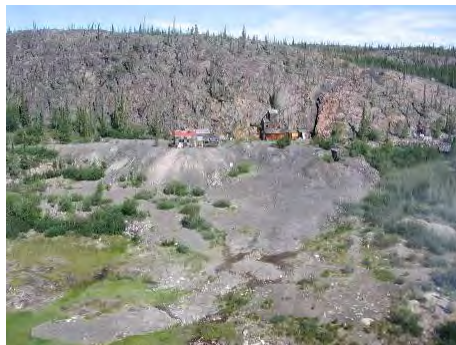
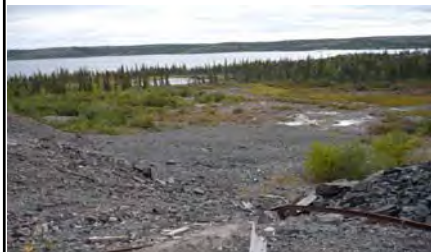
Waste (Mine) Rock

- Main Pile (26,000 m³ over 1.6 hectares)
- Slopes appear to be stable
- Limited leaching of metals (e.g. arsenic)
- Waste Rock (non-acid generating)
- The waste rock has elevated levels of gamma radiation – 200 m² averaged over 250 uR/h

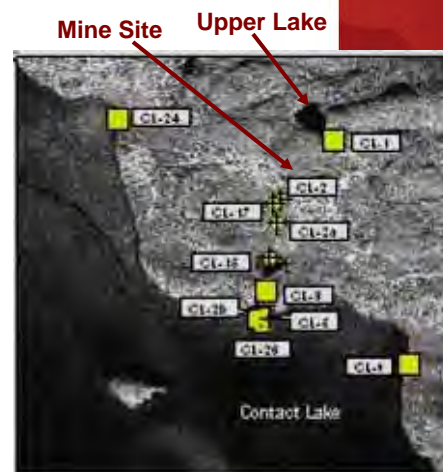
Water Quality – Waste Rock area

- Results were above guidelines for arsenic, copper, iron and uranium
- One sample (CL-2) was above the guideline for radionuclides

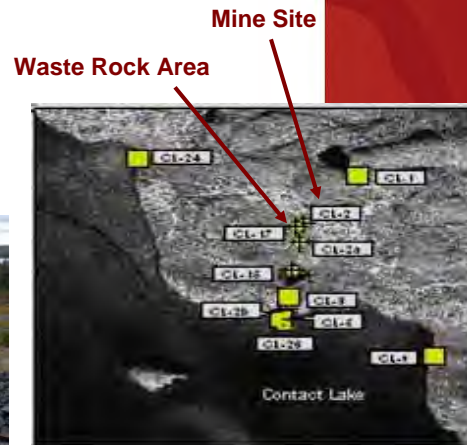
Water Quality – Tailings Pond

- Results were elevated for arsenic, copper, silver and uranium
- Radionuclides were below the guideline

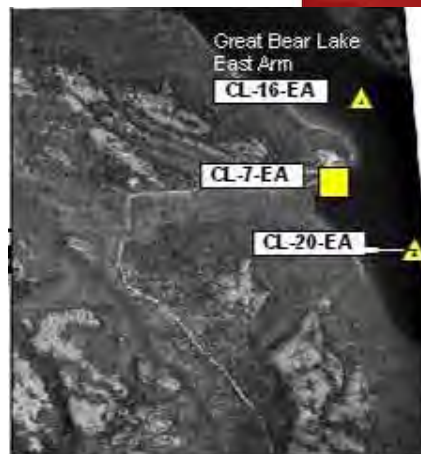
Sediment Quality in the East Arm of Echo Bay – Great Bear Lake

- At dock, results were above the guidelines for (e.g. arsenic and mercury)
- At dock, hydrocarbon results and radionuclides were elevated
- Away from the dock, the results were below the guidelines for all
- More study was required to determine effects
- Benthic study results are not complete

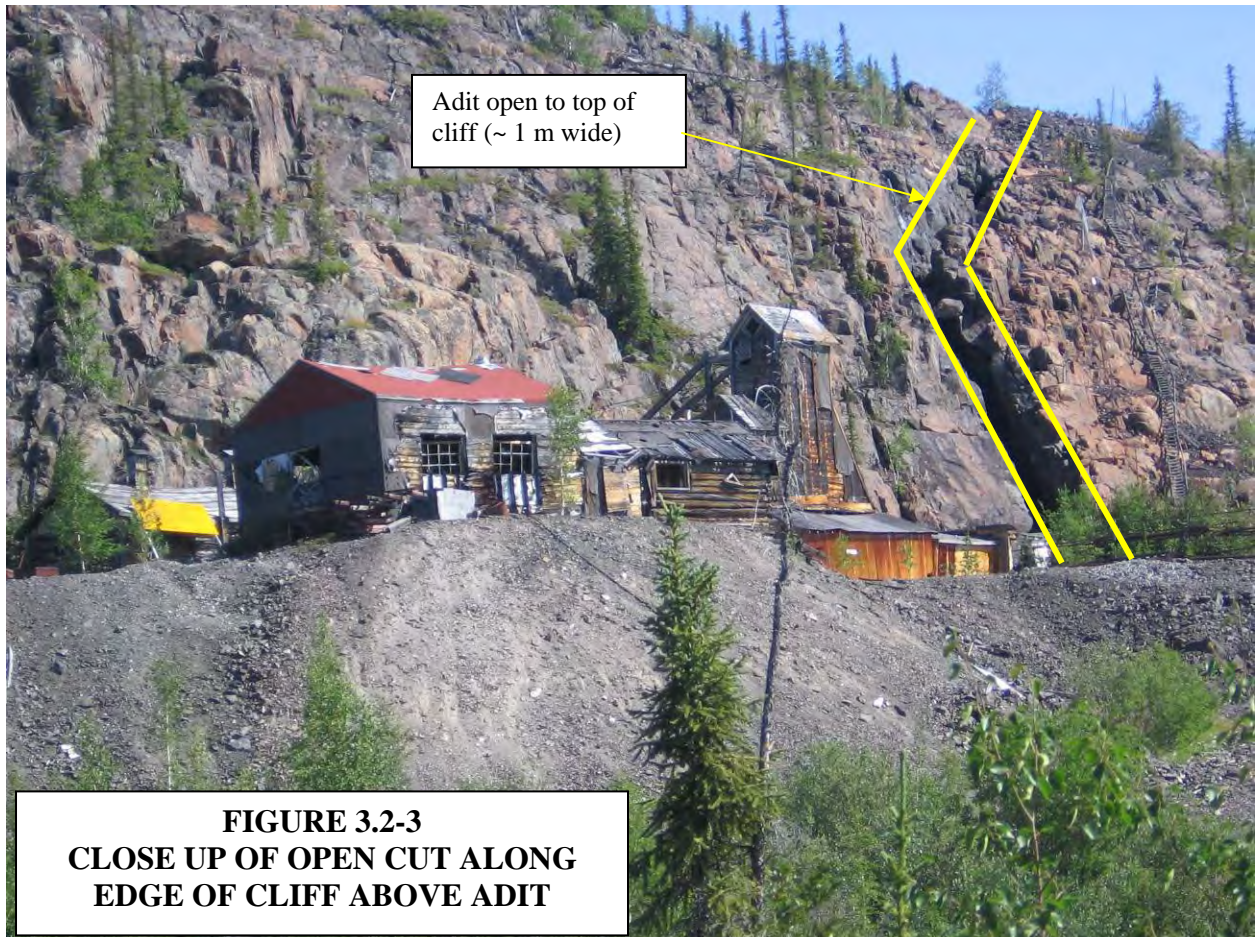
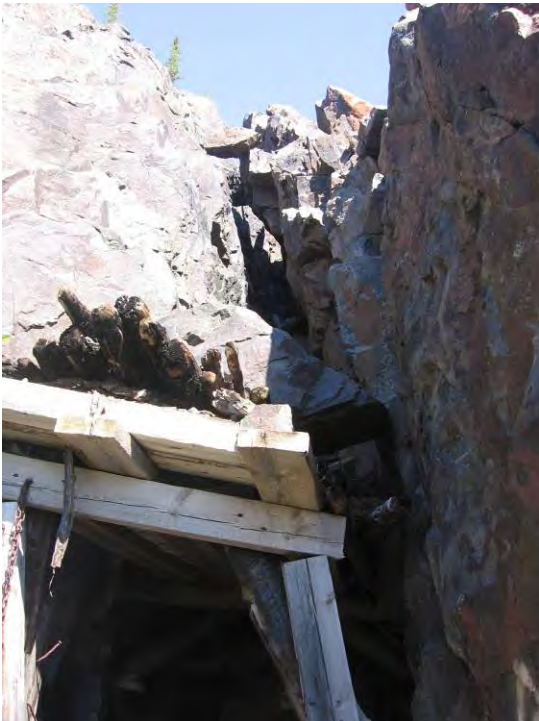
**FIGURE 3.2-4
CLOSE UP OF OPEN CUT ALONG
EDGE OF CLIFF**

**FIGURE 3.2-5
CLOSE UP OF WEST END OF OPEN STOPE**

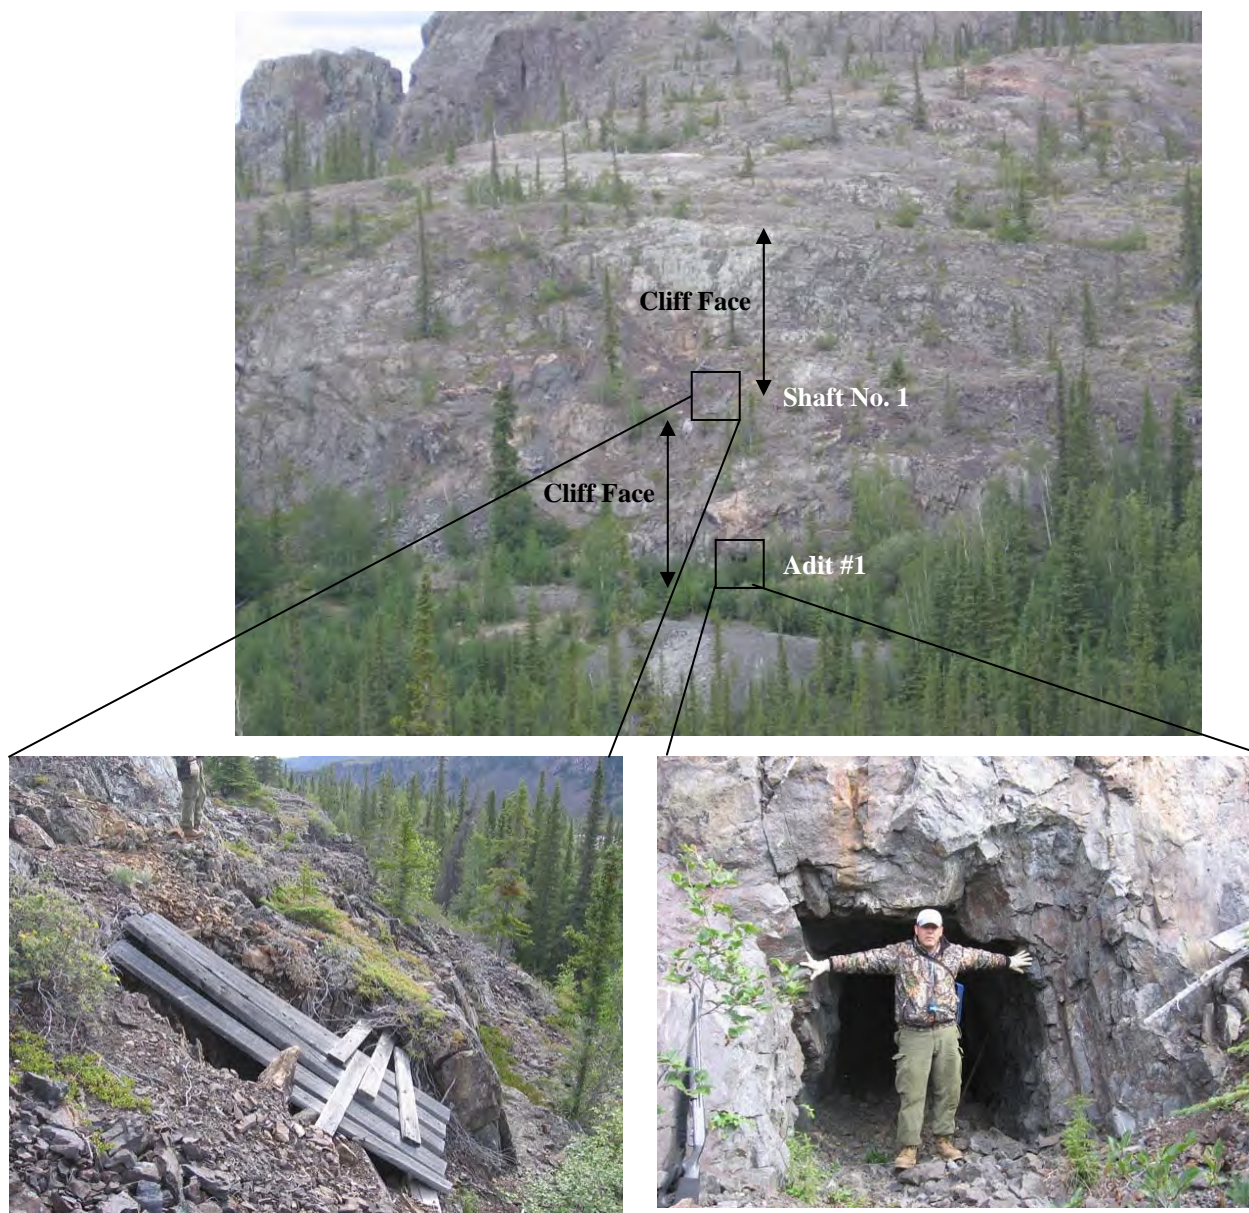
**FIGURE 3.6-1
EL BONANZA NO. 1 SHAFT**

Three shafts, one adit, and several areas with surface trenches and small test pits are found at the El Bonanza Mine site. The No. 1 shaft is located on the side of a steeply sloping hill at the edge of a cliff, above the adit located at the base of the cliff. The No. 2 shaft is located in the headframe, and the No. 3 shaft is located uphill from the headframe. Pictures of the shafts are presented on Figures 3.6-1 to 3.6-3, while examples of surface pits and trenches are shown on Figure 3.6-4.

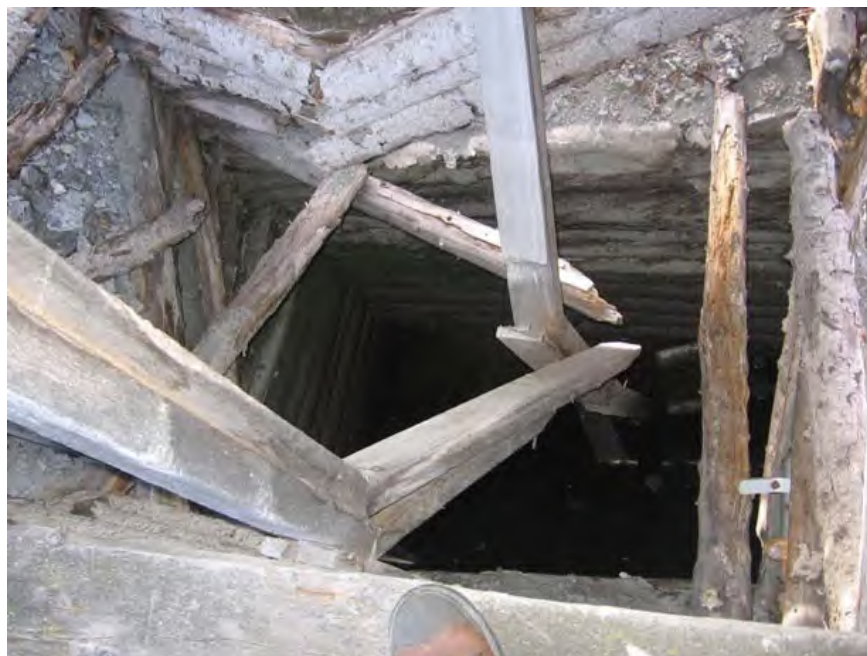
FIGURE 3.6-5
BONANZA SHAFT

At the Bonanza property, a short shaft was sunk in 1937 to a depth of 100 feet (30 m) and approximately 300 feet (91 m) of lateral advance was performed. Pictures of the shaft and surface trenching at the Bonanza Mine are shown on Figures 3.6-5 and 3.6-6.

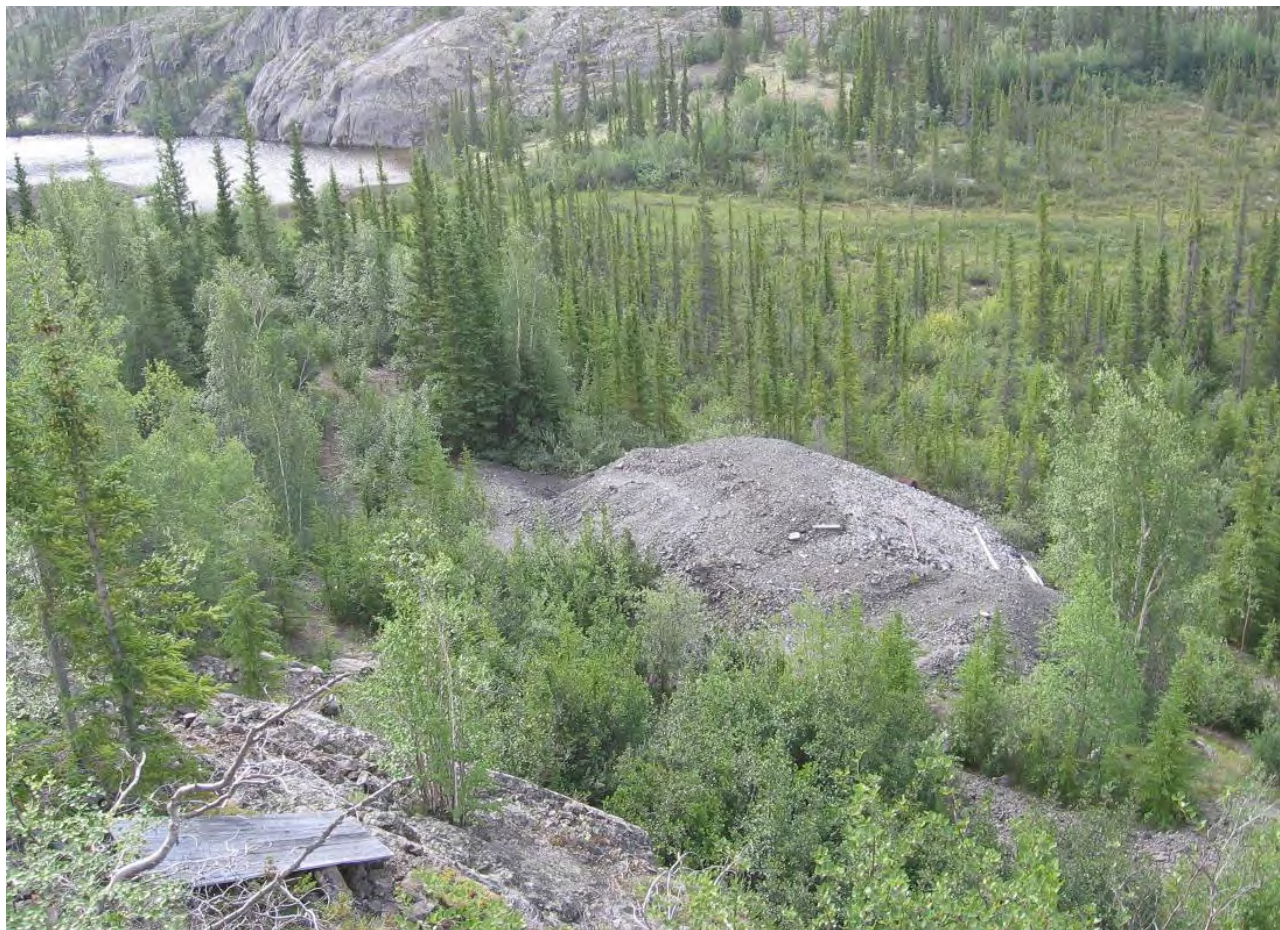
FIGURE 3.7-1
EL BONANZA NO. 1 ADIT WASTE ROCK PILE

Two waste rock deposits are located at the El Bonanza Mine with a combined estimated volume of 3,000 m³ and one at the Bonanza Mine with an estimated volume of 600 m³. The first pile at El Bonanza is located adjacent to the No. 1 shaft at the east end of the site. Limited erosion has taken place since the placement of the pile and existing slopes appear stable. No sources of seepage or standing water were observed in the vicinity of the pile during the July 2006 site assessment (SENES 2007a). The second El Bonanza waste rock pile is located adjacent to the No. 2 shaft on the main portion of the mine site. Slopes appear to be stable and on-land erosion minimal. A portion of the waste rock pile extends into Silver Lake to a depth of approximately 1 m. Due to the size of Silver Lake, erosion from wave action is not expected to be a significant issue. Pictures of the El Bonanza waste rock piles are provided on Figures 3.7-1 and 3.7-2. The small waste rock pile at the Bonanza Mine is located immediately adjacent to the Bonanza shaft/headframe and can be seen on Figure 3.3-1. A discussion of results related to the chemistry of the waste rock is provided in Section 4.12.1.

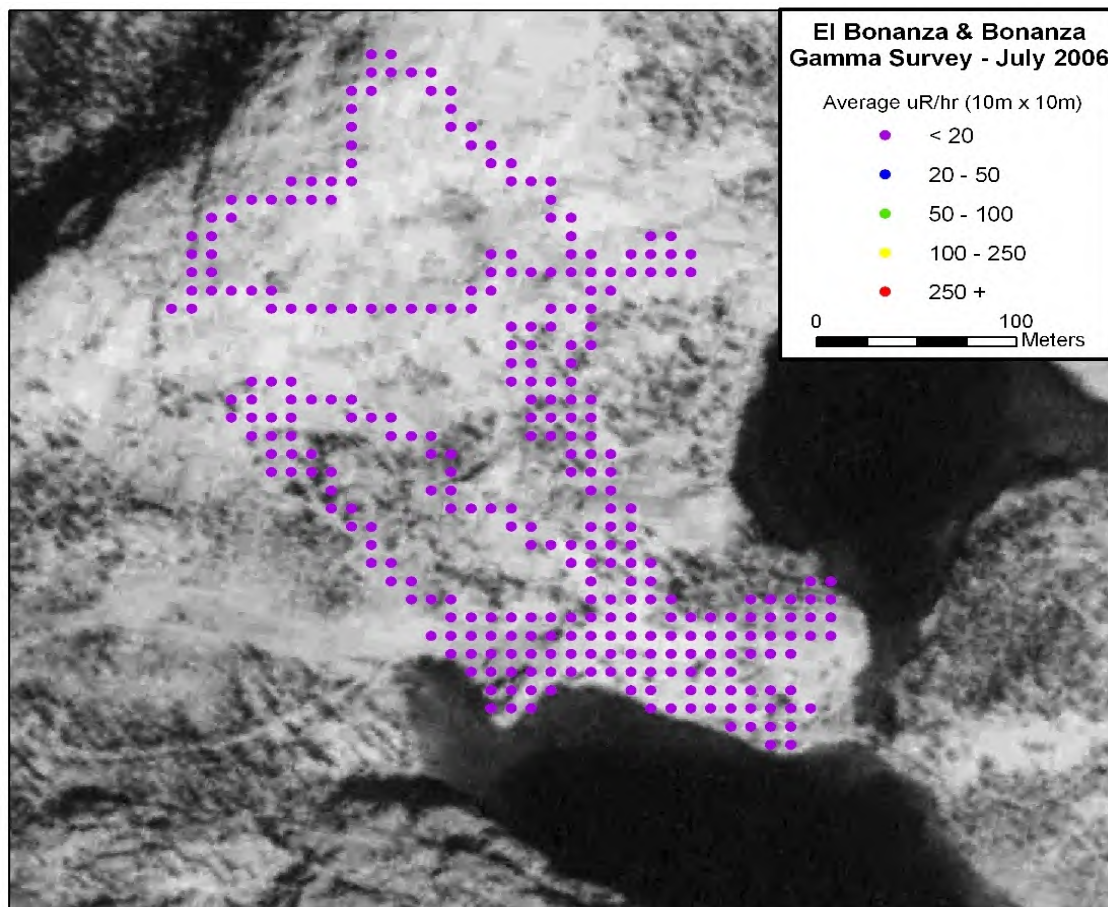
FIGURE 4.6-1
PROCESSED GAMMA RADIATION LEVELS ($\mu\text{R/h}$)

The individual gamma radiation data were statistically summarized to 10 m grids. These data are shown on Figure 4.6-1 and summarized on Table 4.6-1. The highest individual measurement was 29 $\mu\text{R/h}$, the highest calculated grid result was 17 $\mu\text{R/h}$, and the mean of the grid results was 11 $\mu\text{R/h}$. From a risk perspective, these levels are considered within the range of background for the area and pose no incremental risk to human health or ecological receptors.

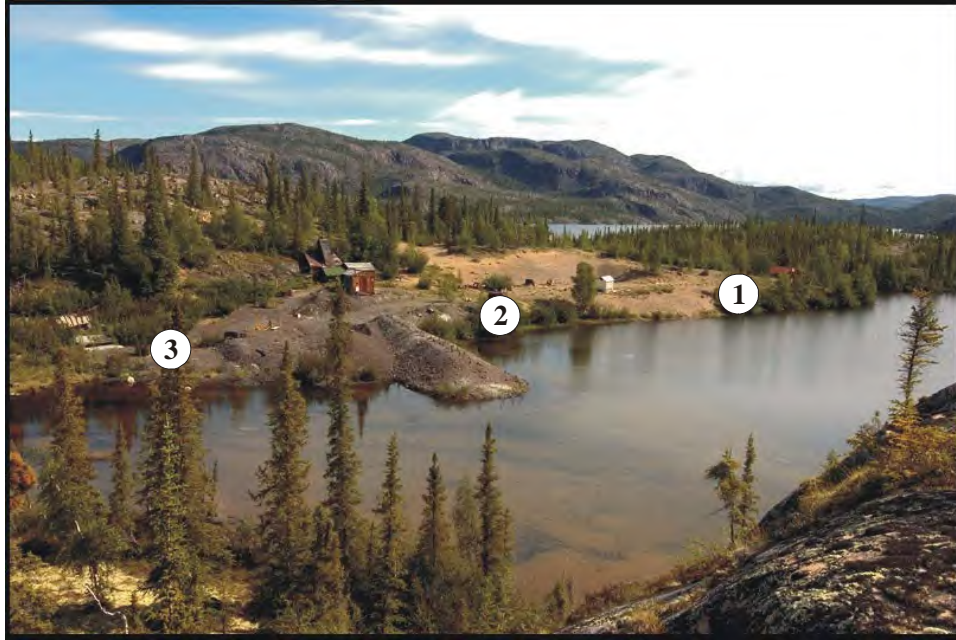
**FIGURE 4.7-1
PHOTO OF THE EL BONANZA MINE SITE
SHOWING SAMPLING SITES 1, 2 AND 3**

Wide variation was also noted in zinc concentrations which ranged from a minimum of 82 mg/kg dw to a maximum of 9,070 mg/kg dw (see Table 4.7-1). The lowest zinc concentrations of 82 and 90 mg/kg dw were measured in duplicate samples collected at Site 2 along the face of the waste rock, followed by concentrations of 277 and 361 mg/kg dw measured in duplicate samples collected at Site 1 at the main mine site. The highest zinc concentrations of 9,070 mg/kg dw and 4,910 mg/kg dw were measured at Sites 6 and 7, respectively, below the

small waste rock pile at the El Bonanza adit, followed by concentrations of 1,280 mg/kg along the face of the waste rock (Site 3) and 1,100 mg/kg dw at Site 9 on the airstrip. Based on this data set, zinc was the only COPC considered in the HHERA that was found to marginally exceed the screening index value for wildlife ingesting soil and vegetation (i.e. grouse/ptarmigan at mine site; see Chapter 5 for further discussion).

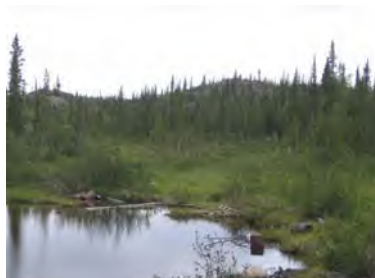
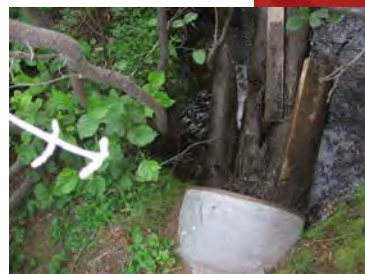
Roads – Culverts

Culverts exist at the inlet and outlet of Silver Lake. Debris is found in and around the culverts including both wood and logs in the culverts and steel drums in front of the culvert outlet.

The culvert that connects Mile and Silver lakes likely forms a significant barrier for fish migration in the spring and possibly year-round. The DFO recommended that the culvert be removed to fully re-establish connectivity between the two water bodies. The closure plans should be developed to ensure proper stream channel design, fish passage, and maintenance of the current water level in Mile Lake (Watson 2005).

- Two culverts at Silver Lake
- Water levels are different by about 1 foot between Mile Lake and Silver Lake
- Water drainage and fish movement is effected because wooden debris and drums around culverts
- DFO would like drainage restored
- Additional culvert on roadway to airstrip

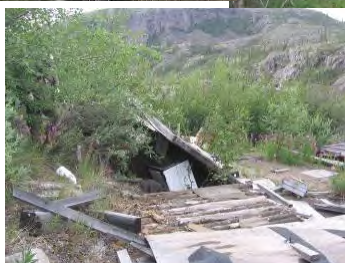
El Bonanza Sheds and Collapsed Buildings

- Safety Hazard
- Visual attraction to site
- Some chemical hazards (lead paint, DDT, asbestos)
- Gasoline, diesel & oil contaminated soils ~ 355m³

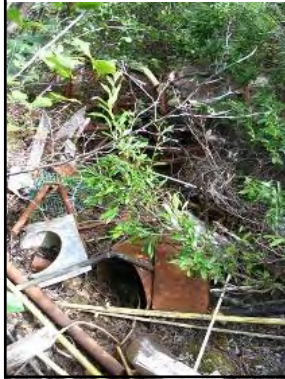
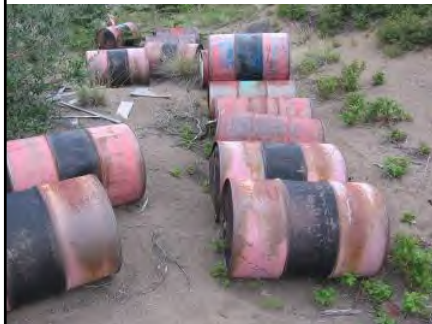
El Bonanza Dumps and Debris

- Six small dumps
- Equipment, garbage, vehicle parts
- Metals in the soil (e.g. copper, silver, lead and zinc)
- Diesel and oil in the soil ~60m³

- PCBs in the soil around the transformer at the power house
- Some barrels with diesel fuel

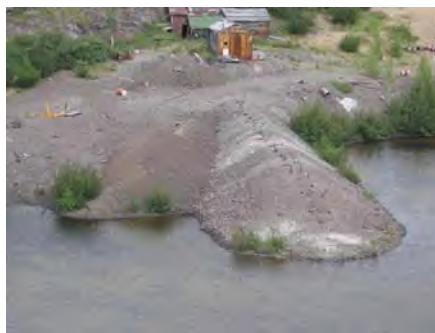
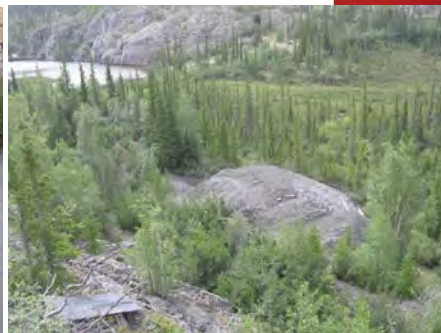
El Bonanza Waste Rock

- El Bonanza (3000 m³)
Bonanza (600 m³)
- Non acid generating
- Slopes appear to be stable
- No evidence of metal leaching
- No elevated gamma readings

Goals / Options Waste Rock	Leave as is	Re-slope, cover, and vegetate
Health and safety	Good	Ok
Protect fish, wildlife and vegetation	Good	Ok
Protect Water Quality	Good	Bad
Minimize Environmental Impacts during Remediation	Good	Ok
Minimize Long term care and maintenance	Good	Ok
Return site to its original condition where possible	Bad	Ok
Is cost effective	Good	Ok
A / P / NA	P	A

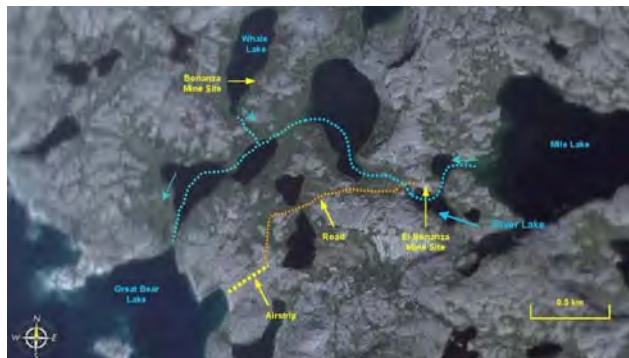
Whale Lake Conditions next to Bonanza Mine

- Water quality meets guidelines

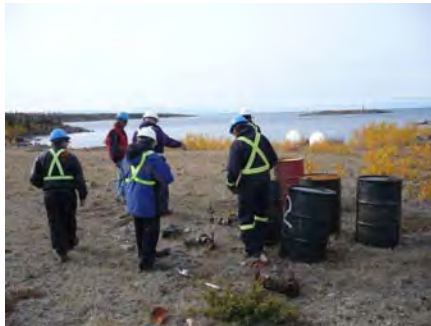
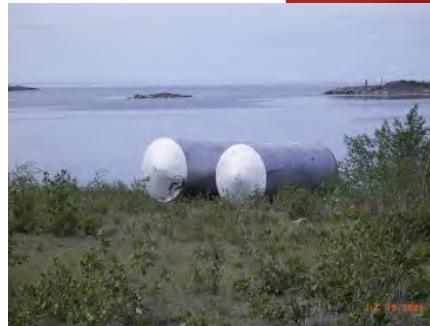
Great Bear Lake Water Quality (next to airstrip)

- Water samples meet guidelines
- Sediment samples meet guidelines
