Subject: 2022 Annual Dam Safety Review – A418 Dike

2022 Dam Safety Review

A418 Dike Diavik Diamond Mine, Northwest Territories, Canada

NOVEMBER 9, 2022
ISSUED FOR USE
FILE: 704-ENG.EARC03226-03

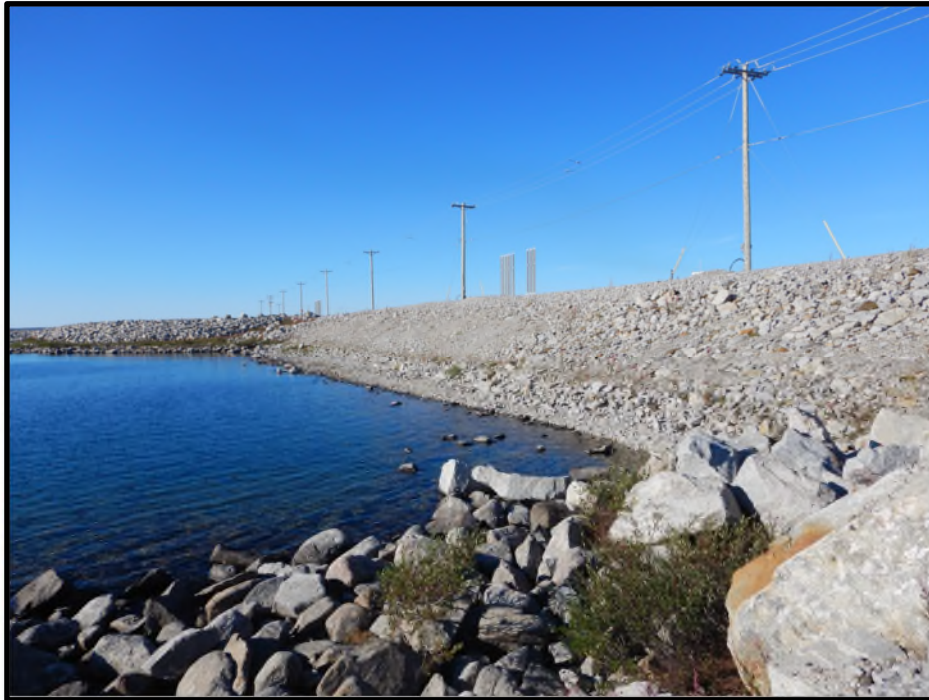
Photo D1: North Abutment upstream slope near Station 0+000, looking south from the A154 Dike.

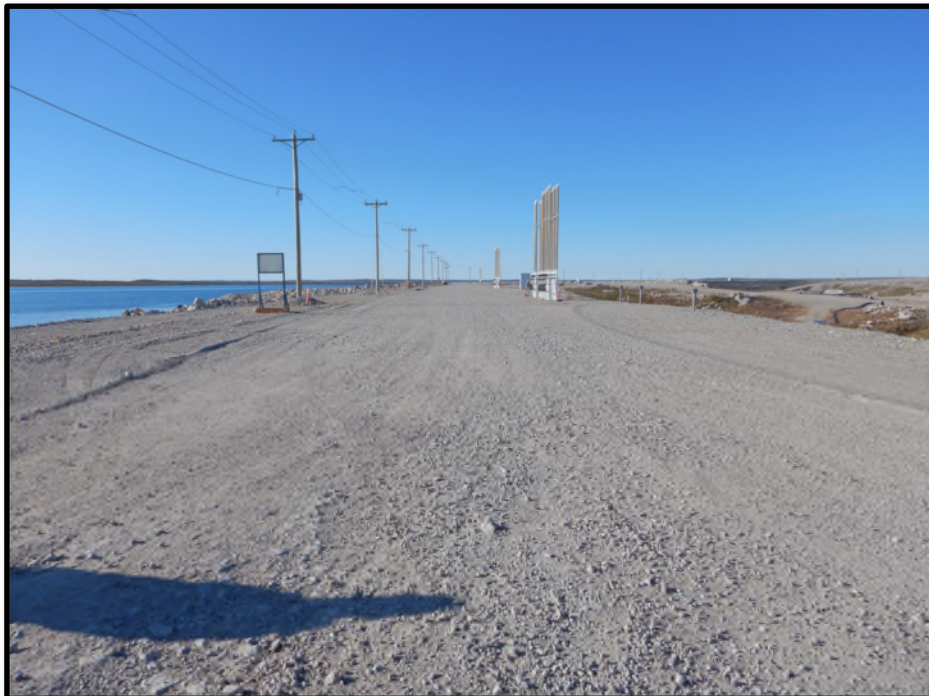
Photo D2: North Abutment top of dike near Station 0+000, looking south.

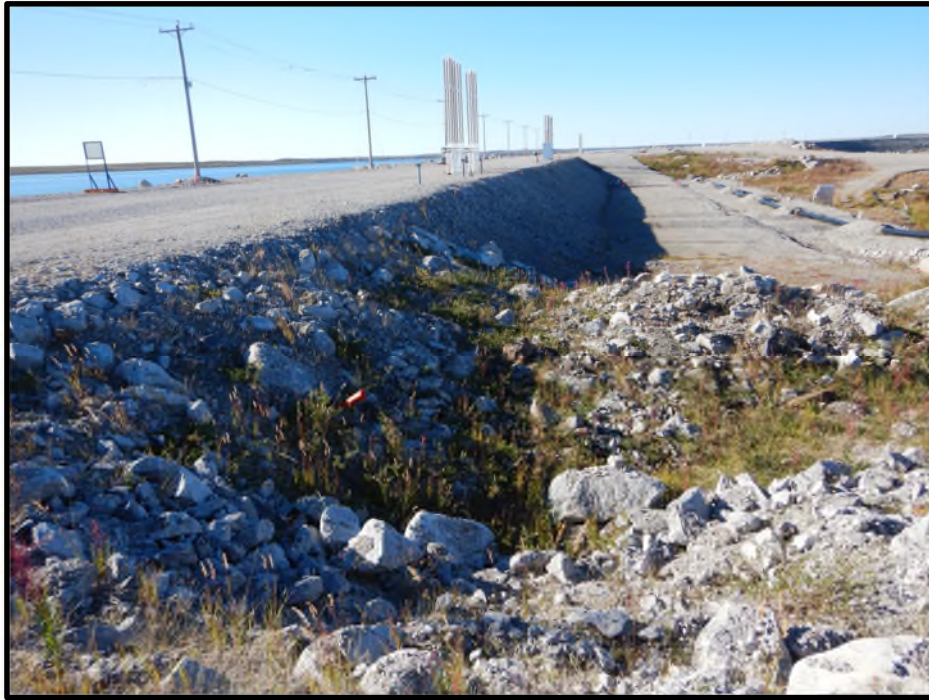
Photo D3: North Abutment downstream slope near Station 0+000, looking south from the A154 Dike.

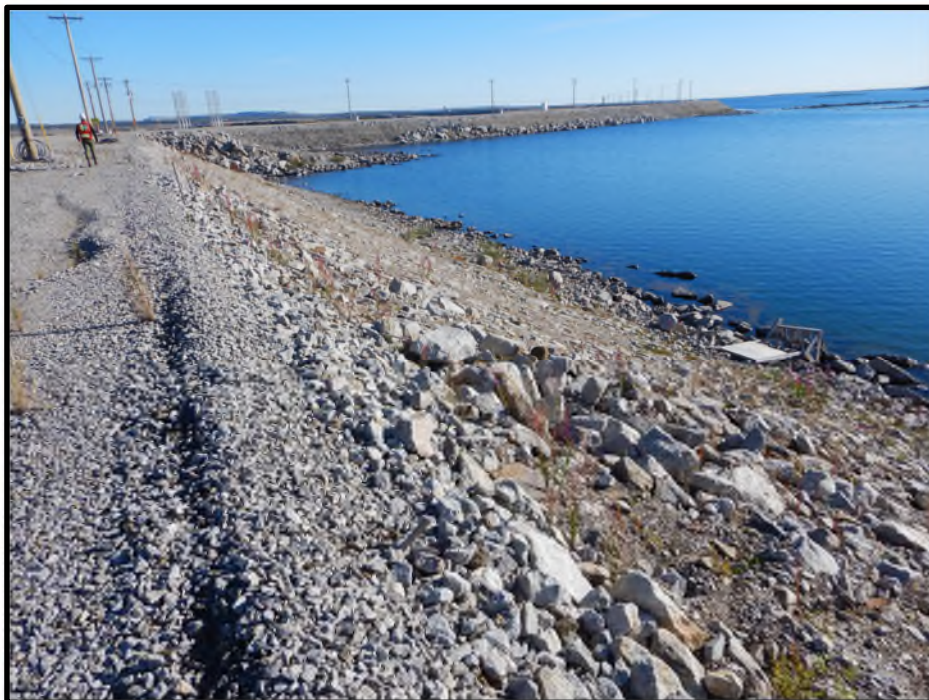
Photo D4: North Abutment upstream slope near Station 0+150, looking north toward A154 Dike.

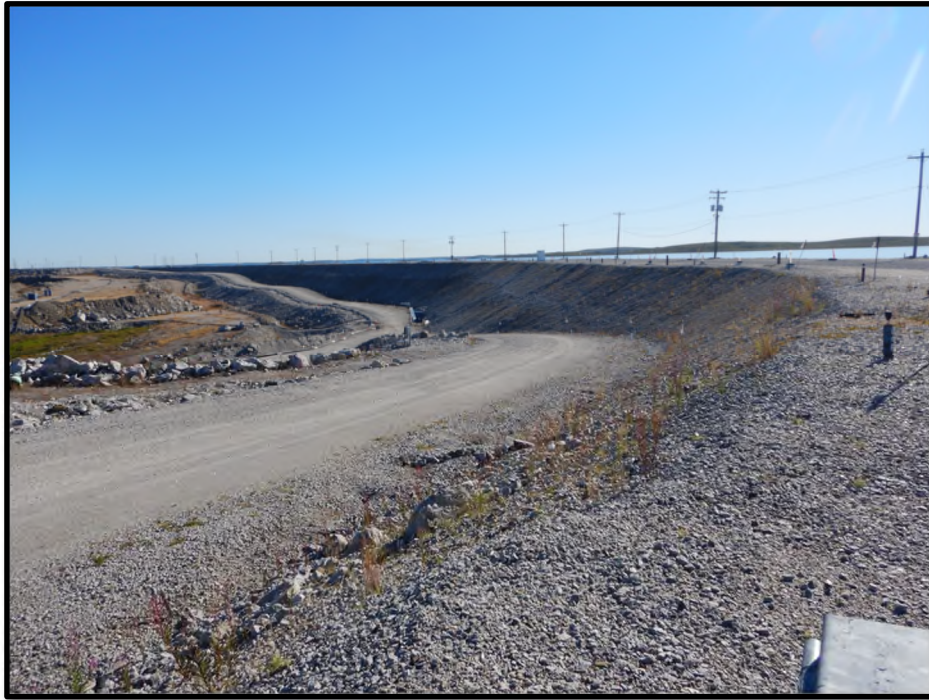
Photo D5: South Abutment downstream slope near Station 1+000, looking east.

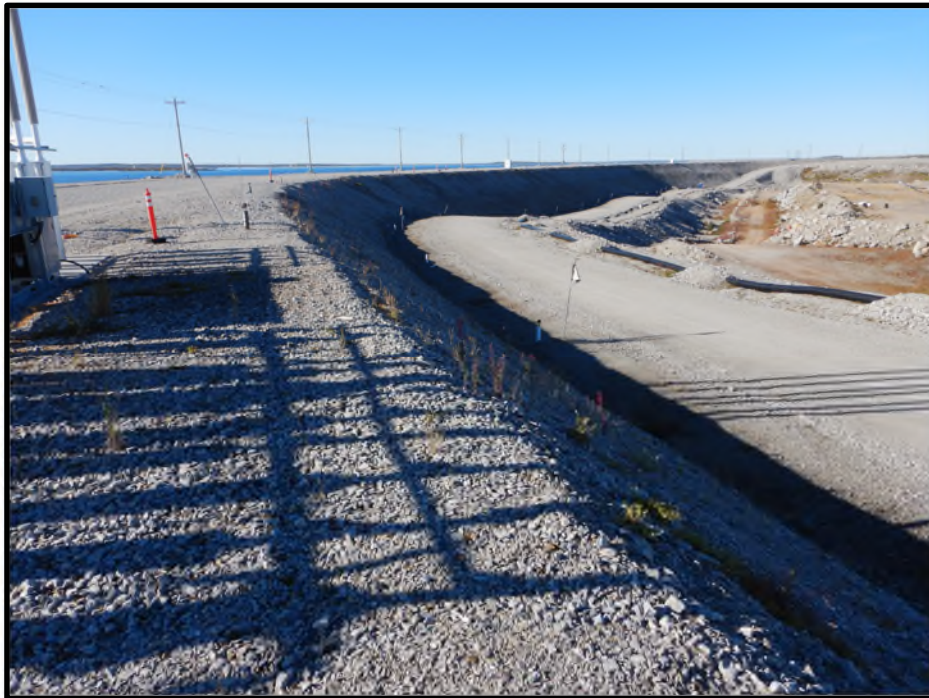
Photo D6: Downstream slope near Station 0+350, looking south.

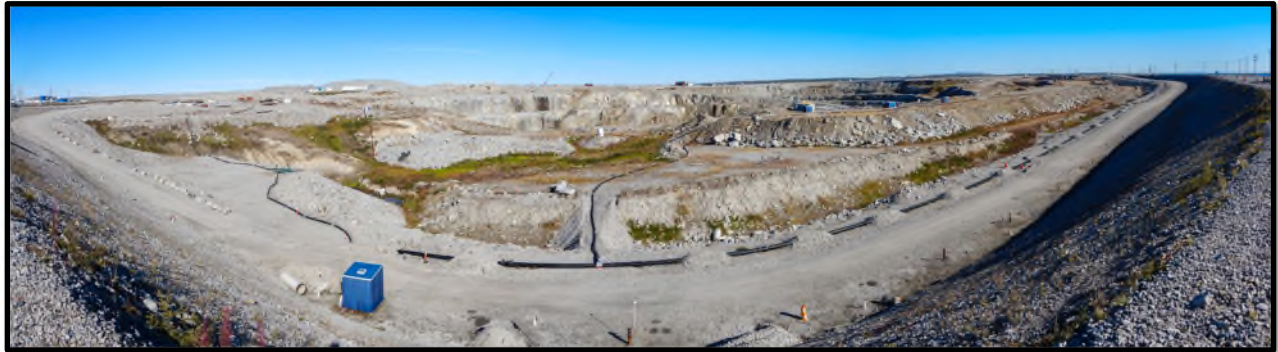
Photo D7: General view of the DPS-6 infield area from the downstream crest of the A418 Dike near Station 0+800.

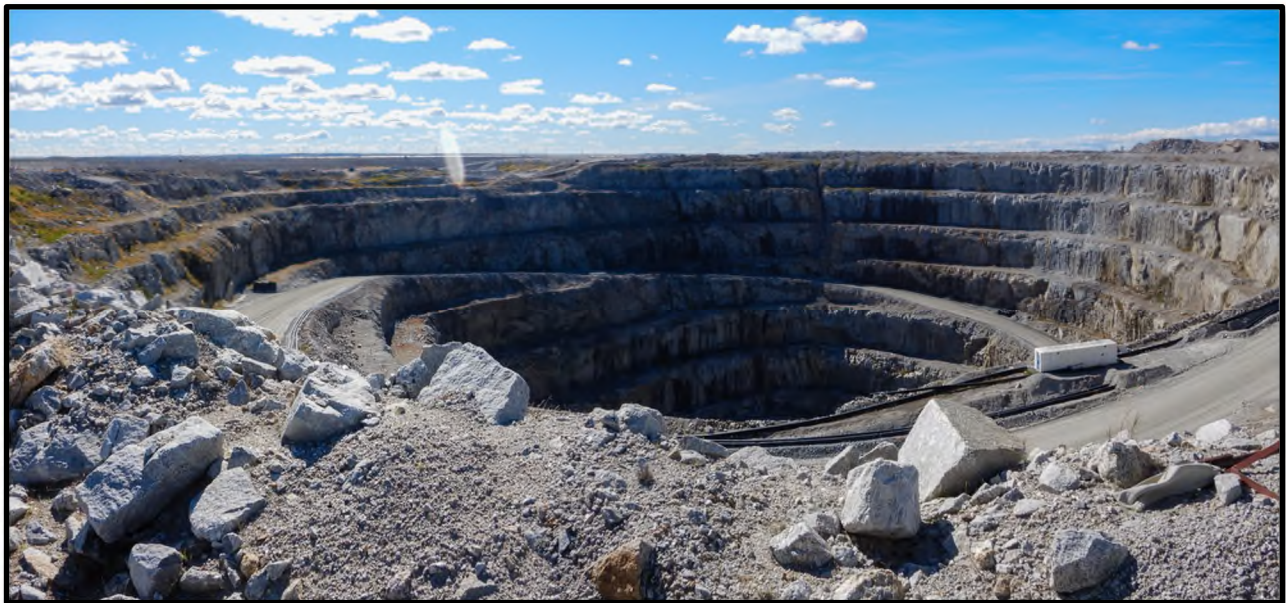
Photo D8: General view of the A418 Open Pit with the A418 Dike in the background.
Photo taken from the far side of the open pit.

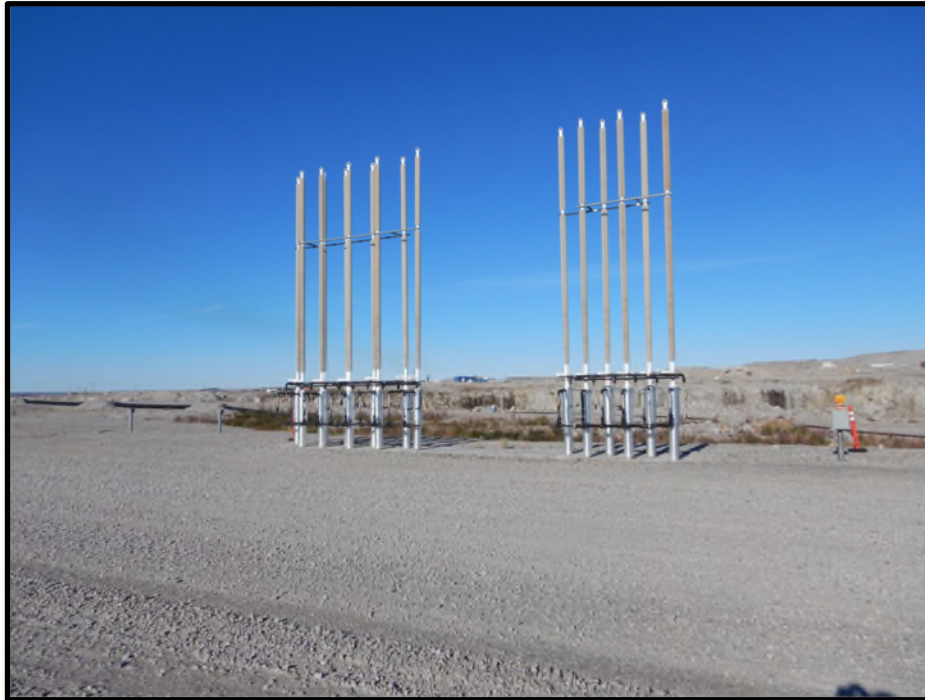
Photo D9: South Abutment Thermosyphon Cluster.

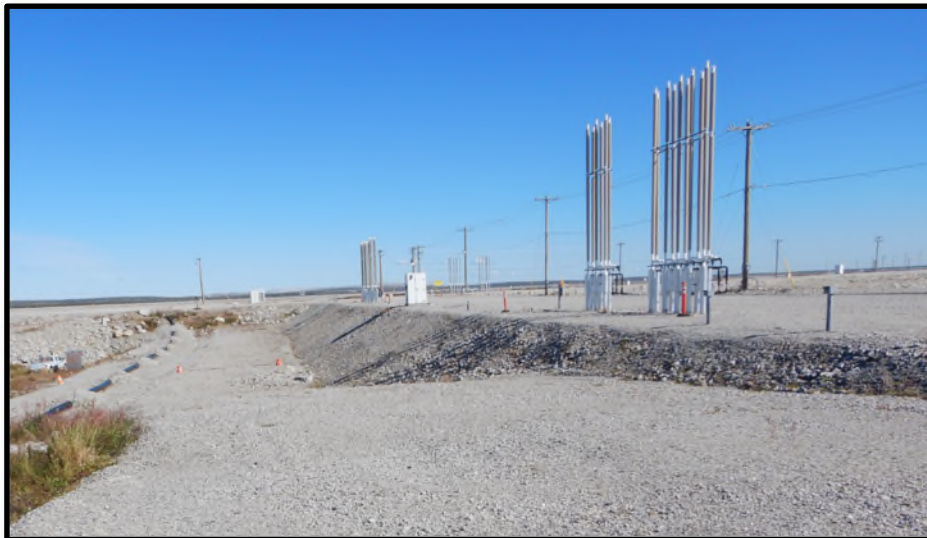
Photo D10: North Island C Thermosyphon Cluster (shown in foreground) and North Abutment Thermosyphon Cluster (shown in background).

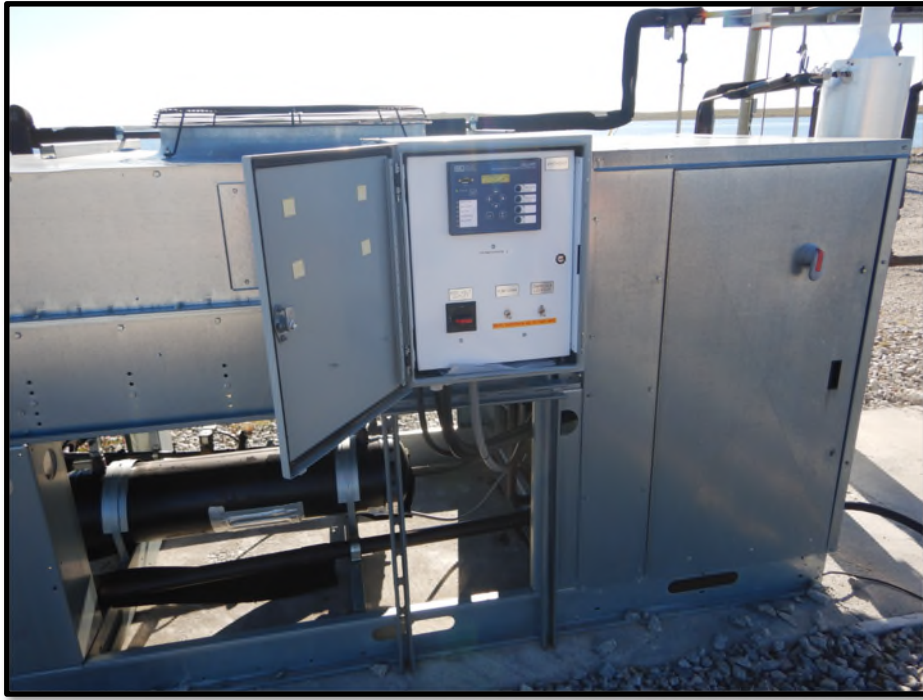
Photo D11: General view of thermosyphon cluster control panel.

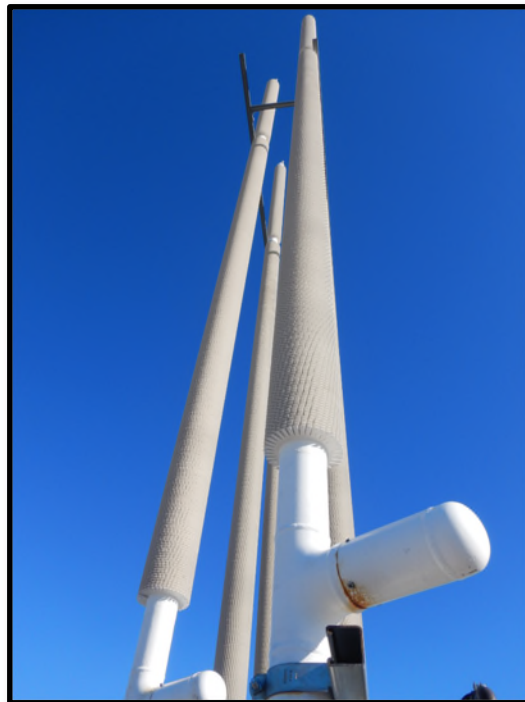
Photo D12: General view of thermosyphon radiators.

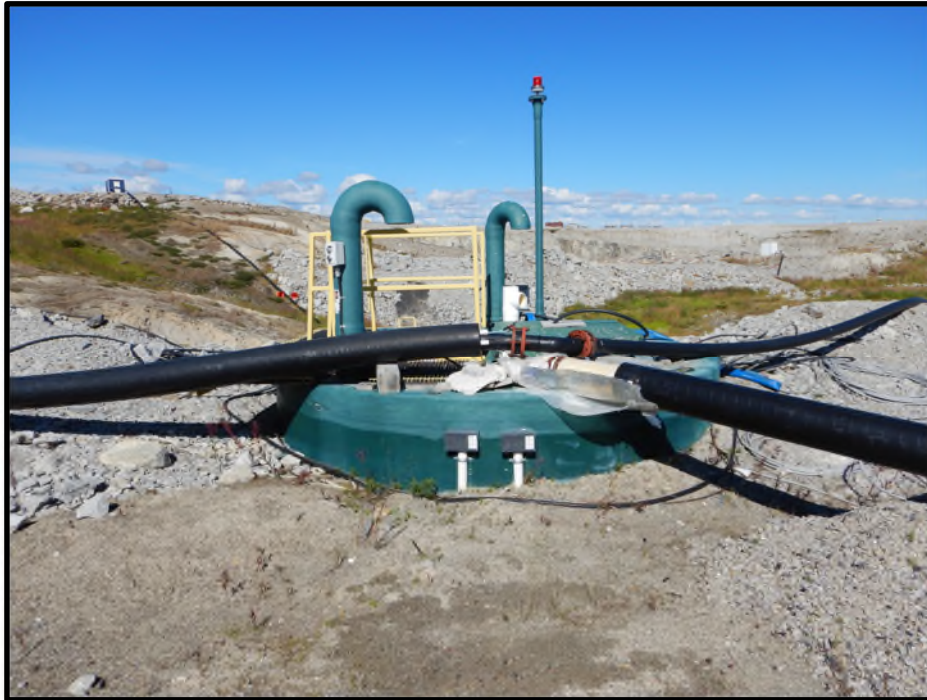
Photo D13: DPS-6 dike pumping station with connected pipelines to relief wells and infield collection sumps.

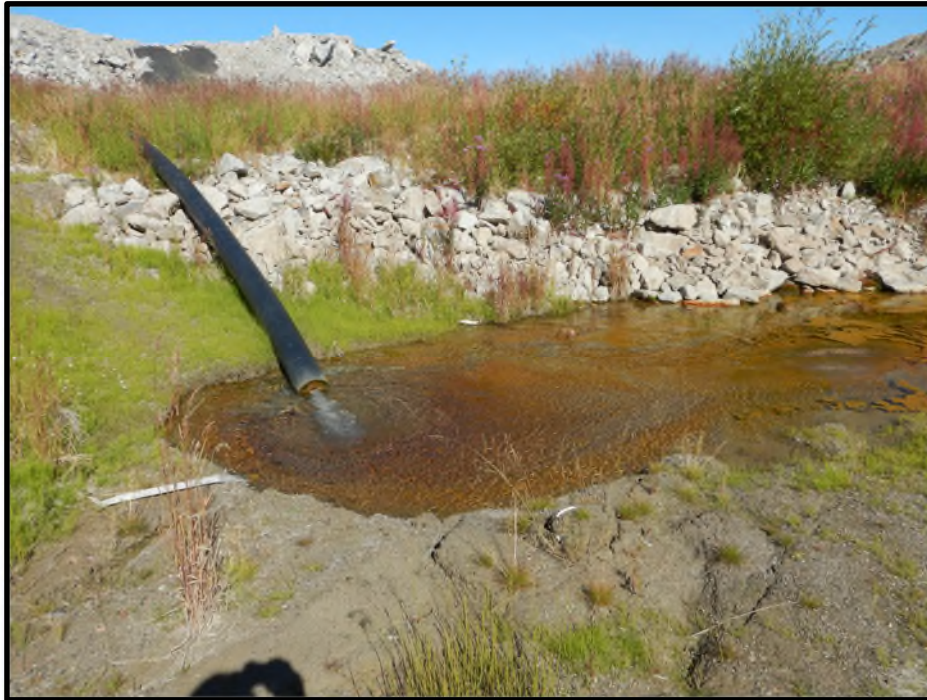
Photo D15: Redirected water from one depressurization well being discharged into DPS-6 intake pond.

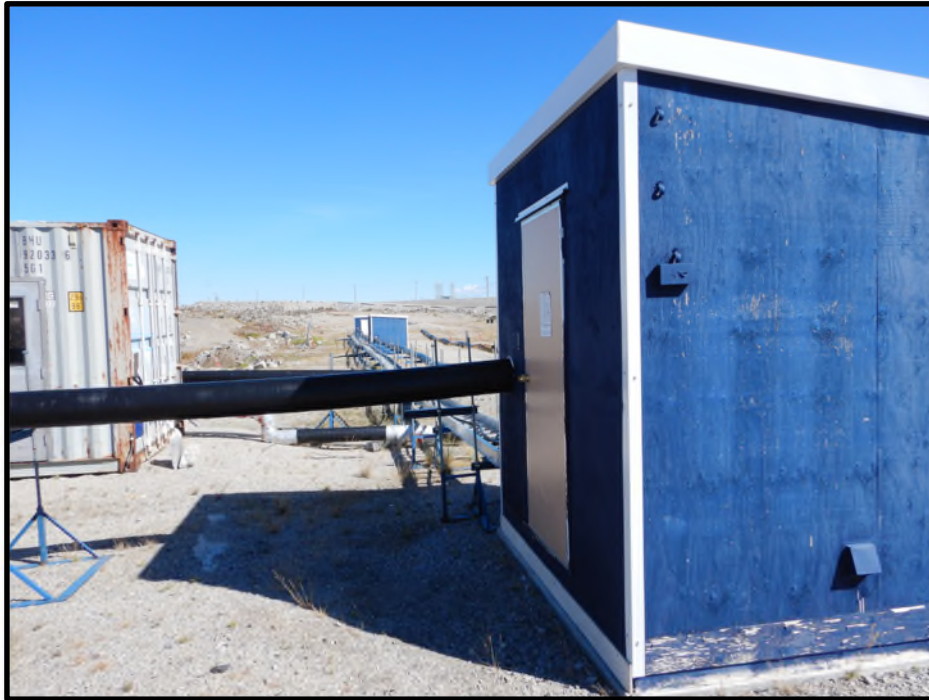
Photo D17: Protective shelters housing the infield depressurization headers and pipework.

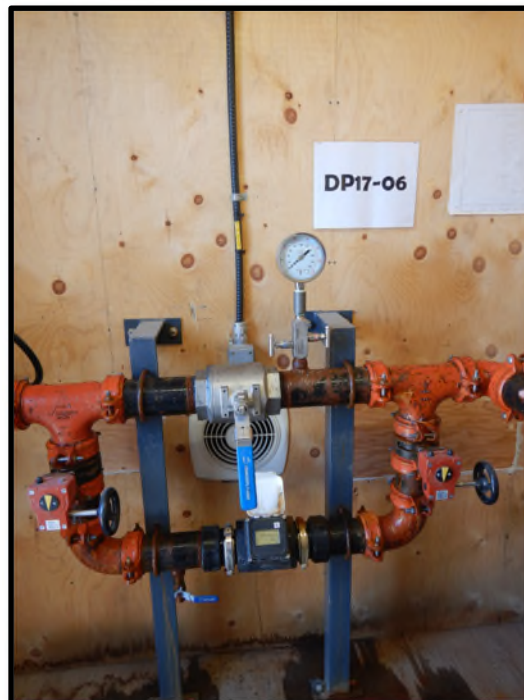
Photo D18: Infield depressurization headers and pipework within protective shelters.

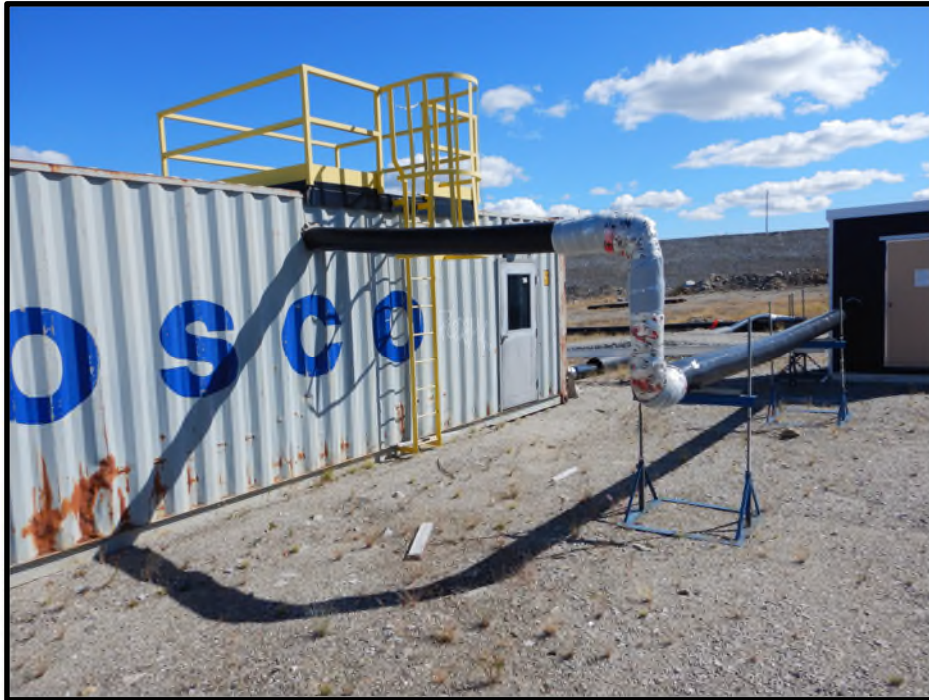
Photo D19: Sea can enclosure for the infield depressurization water collection system and booster pump.

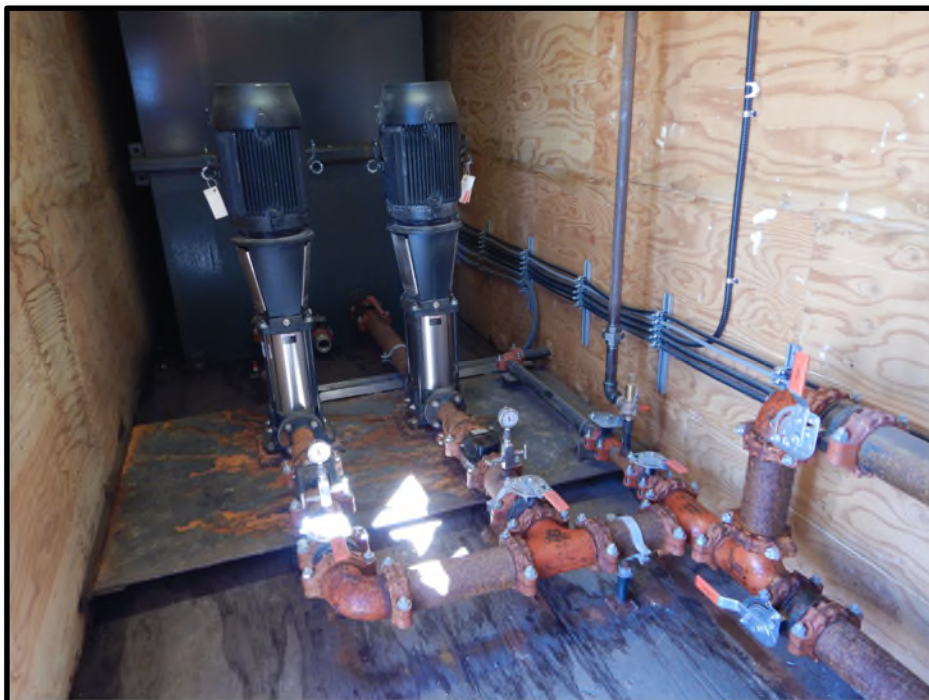
Photo D20: Booster pump and header pipes within the sea can enclosure shown on Photo D19.

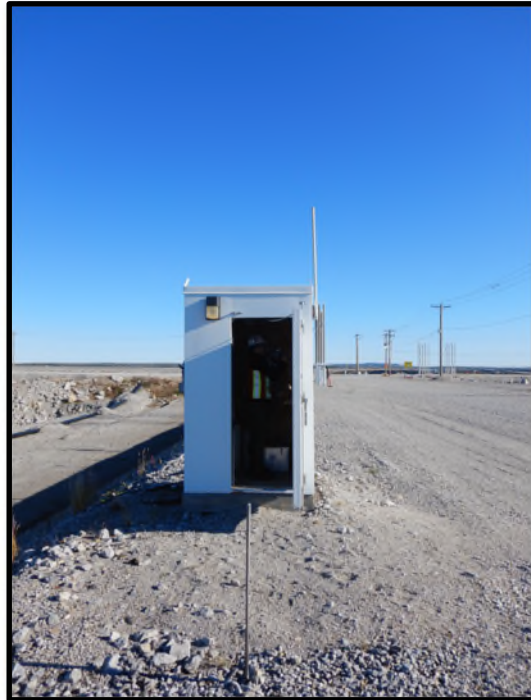
Photo D27: One of three data logger shelters along the downstream crest of the A418 dike.

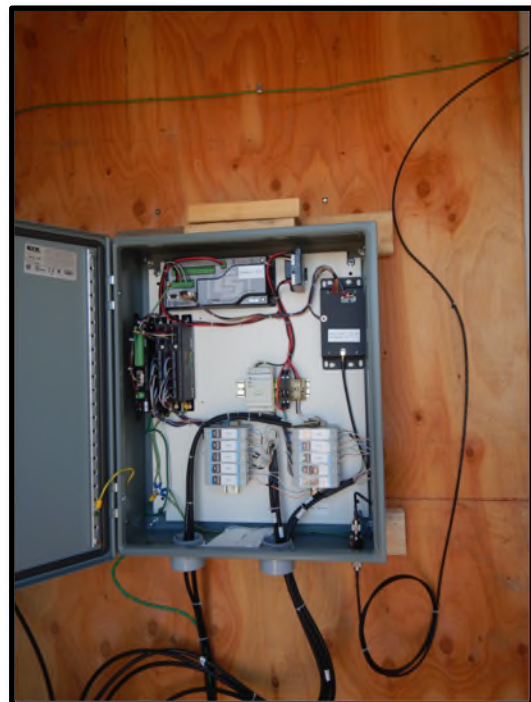
Photo D28: Multi-channel instrumentation data logger within data logger shelter.

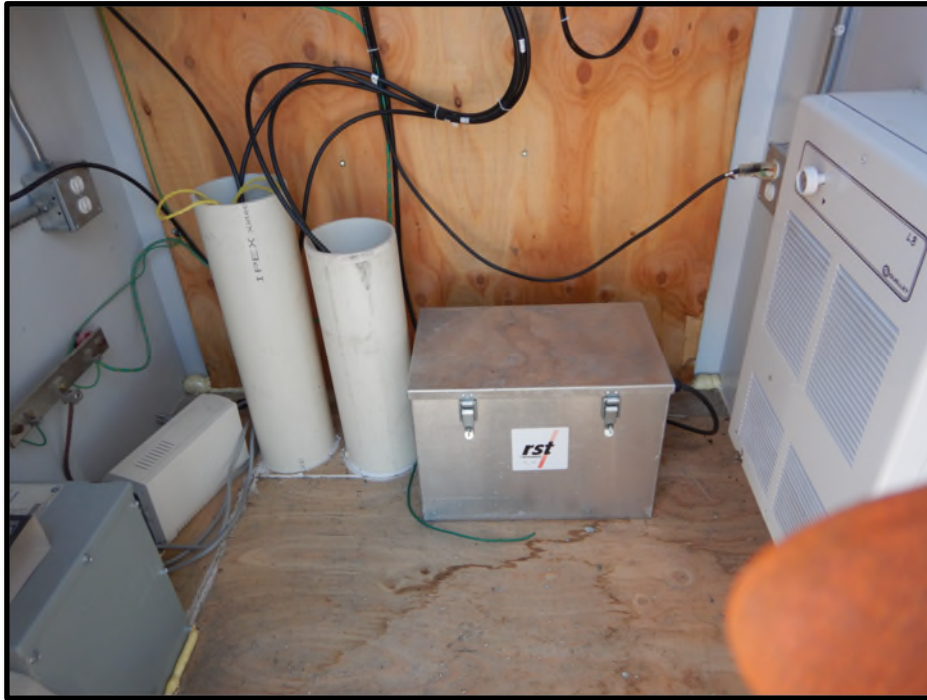
Photo D29: Backup battery pack for multi-channel instrumentation data logger within data logger shelter.

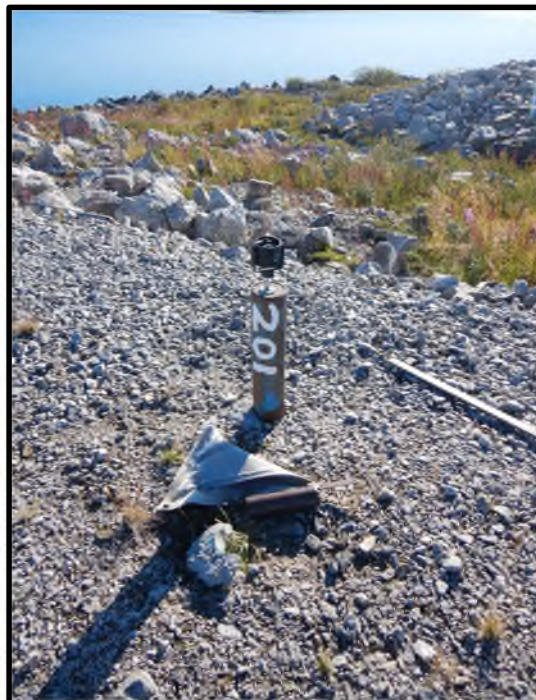
Photo D30: Survey prism monument (survey marker) along the downstream crest.

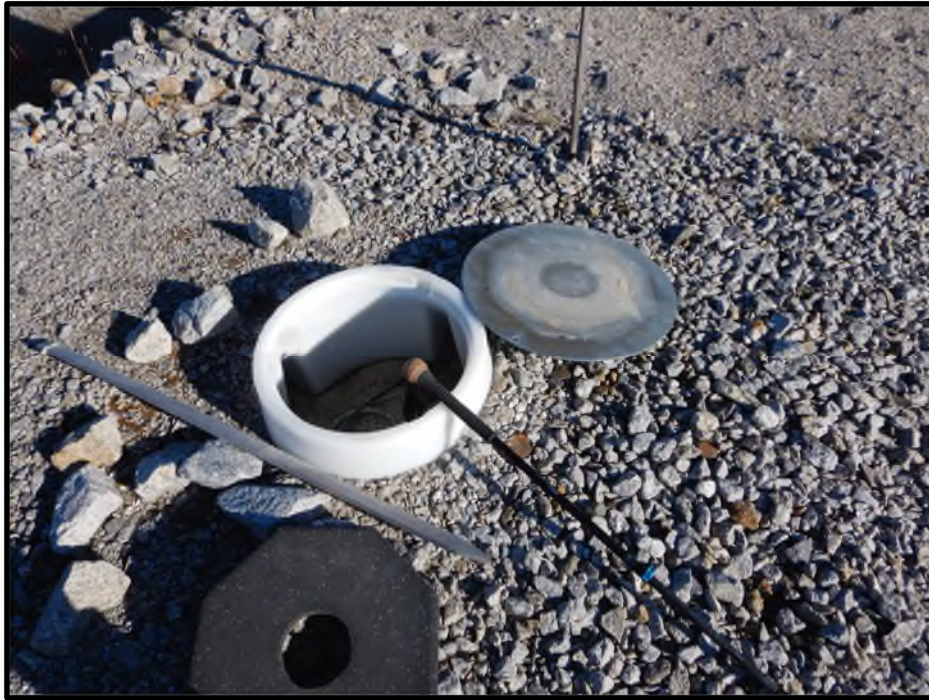
Photo D31: Protective instrumentation housing for vibrating wire piezometers along the downstream crest.

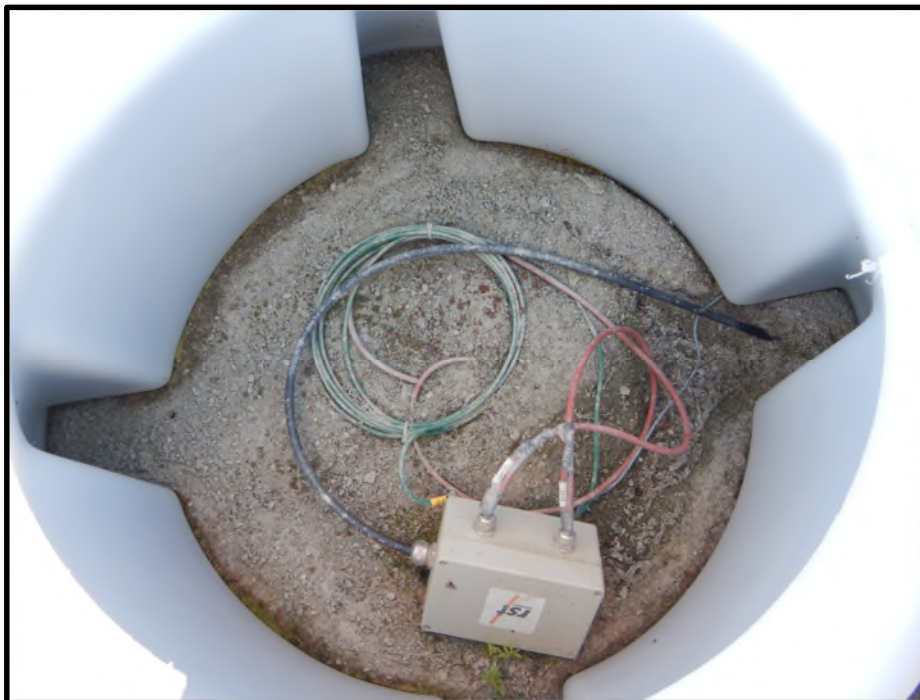
Photo D32: Vibrating wire piezometer junction box within a protective instrumentation housing.

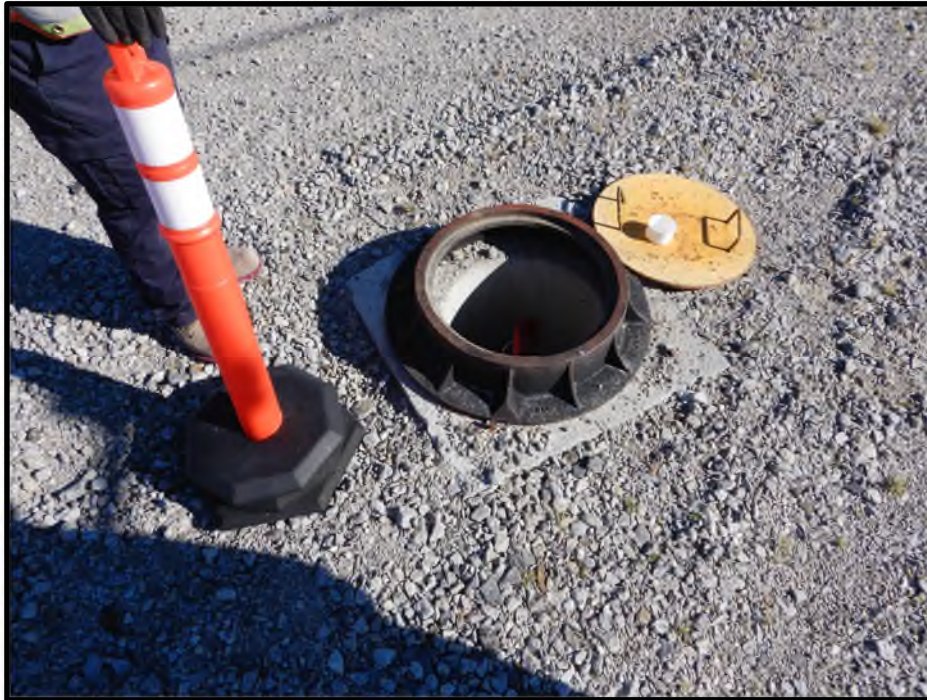
Photo D33: Protective instrumentation housing for an inclinometer along the upstream crest.

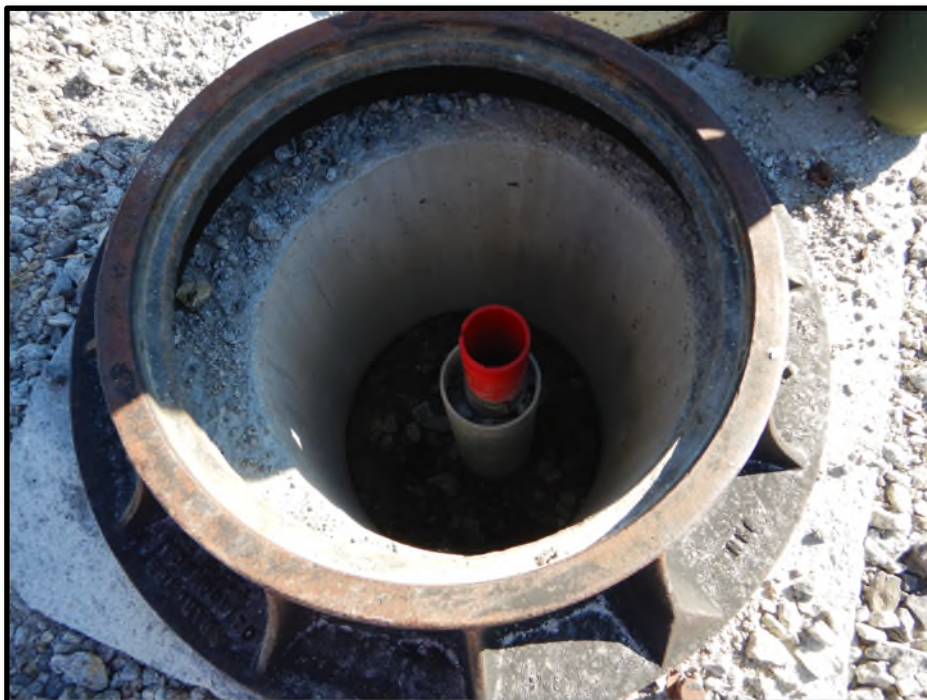
Photo D34: Inclinometer casing within the protective instrumentation housing shown in Photo D33.

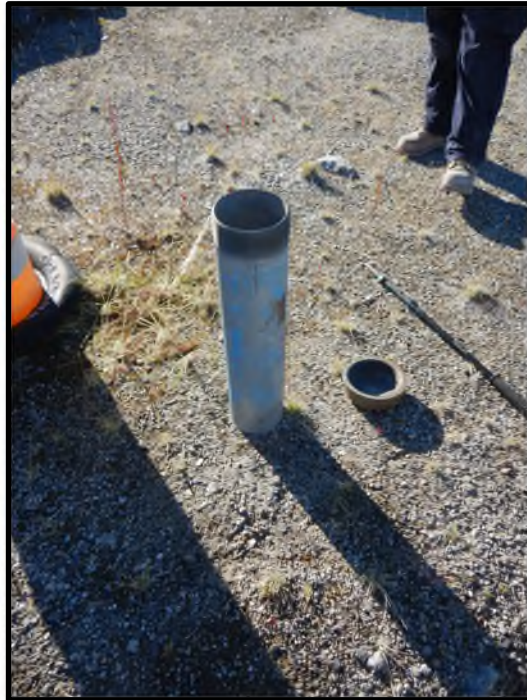
Photo D35: Protective casing for a survey monument.

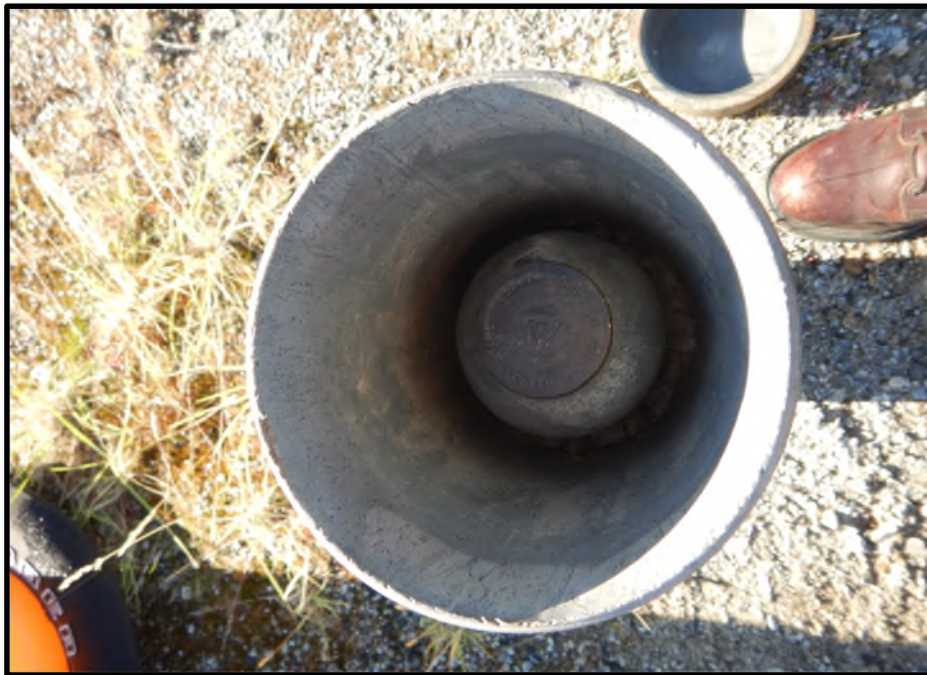
Photo D36: Survey monument within the protective casing shown in Photo D35.

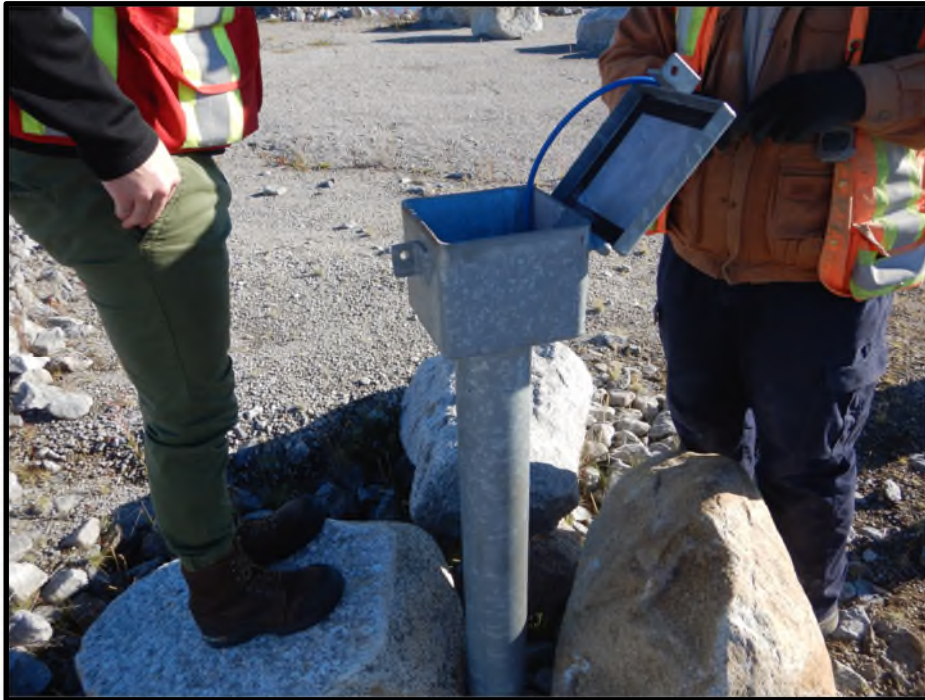
Photo D37: Protective instrumentation housing for a ground temperature cable installed along the top of dike.

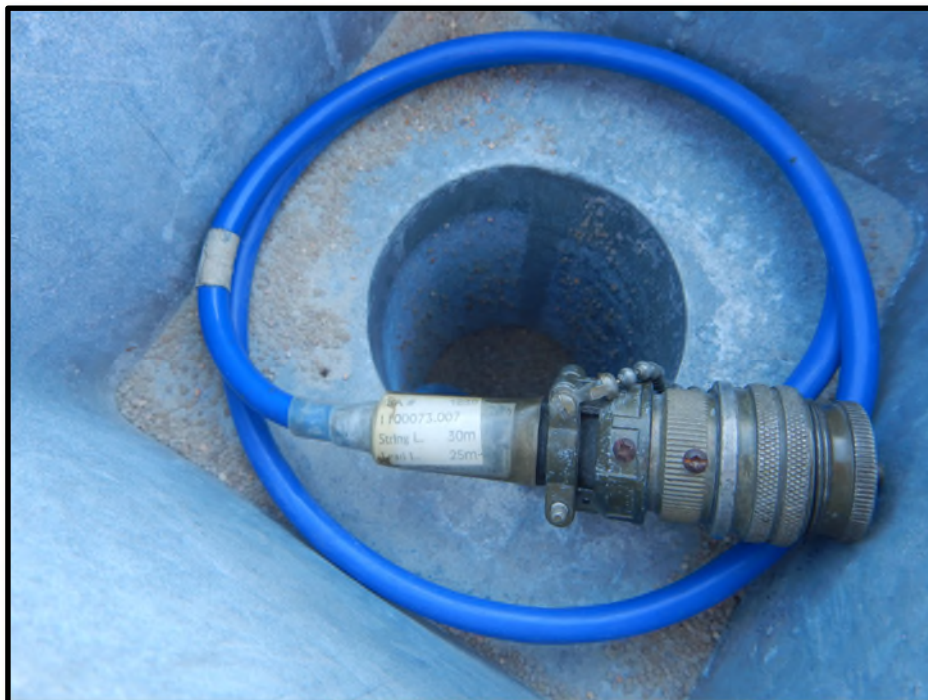
Photo D38: Ground temperature cable connector within protective instrumentation housing showing in Photo D37.

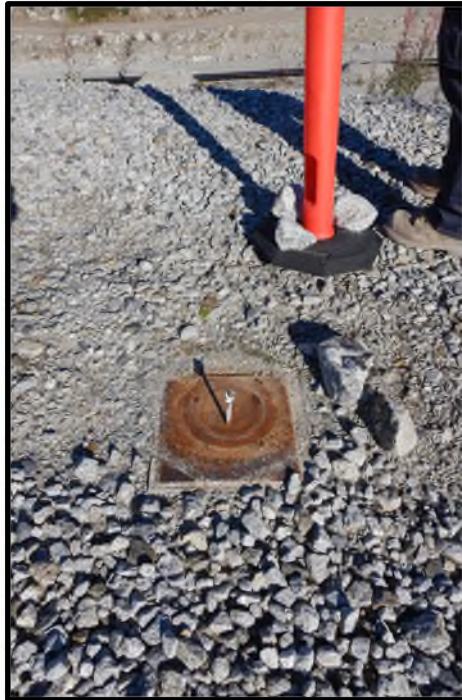
Photo D39: Blast vibration monitoring geophone mounting plate installed along the downstream crest.

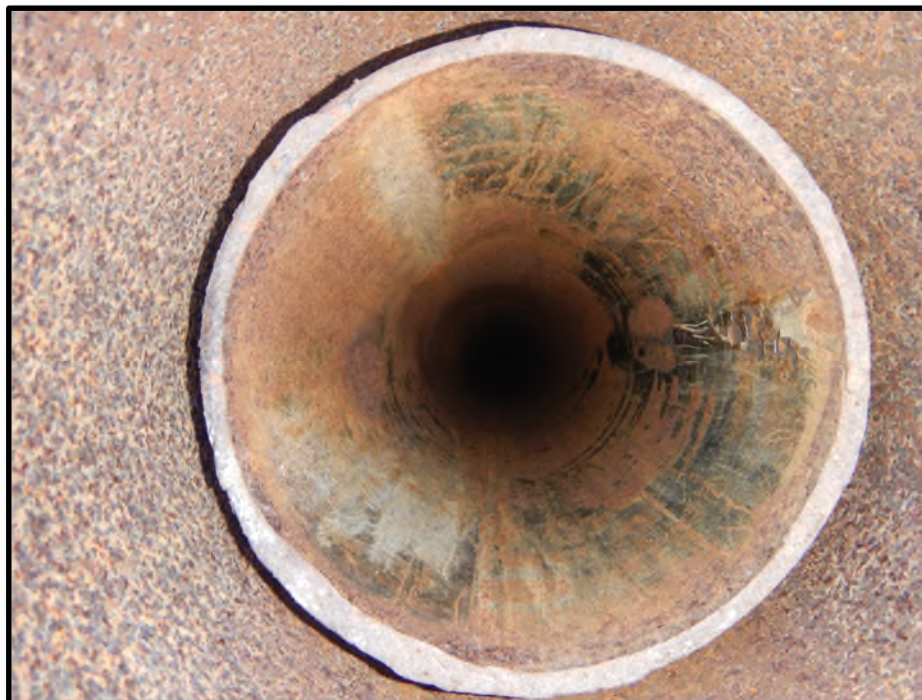
Photo D40: Inactive pressure relief well along the downstream crest.
