Subject: 2024 Annual Dam Safety Inspection – Processed Kimberlite Containment Facility and Water Management Pond System

Attachments: Report on PKCF and Water Management Ponds – 2024 Annual Dam Safety Inspection for Diavik Diamond Mines (2012) Inc. by WSP Canada Inc. – November 2024

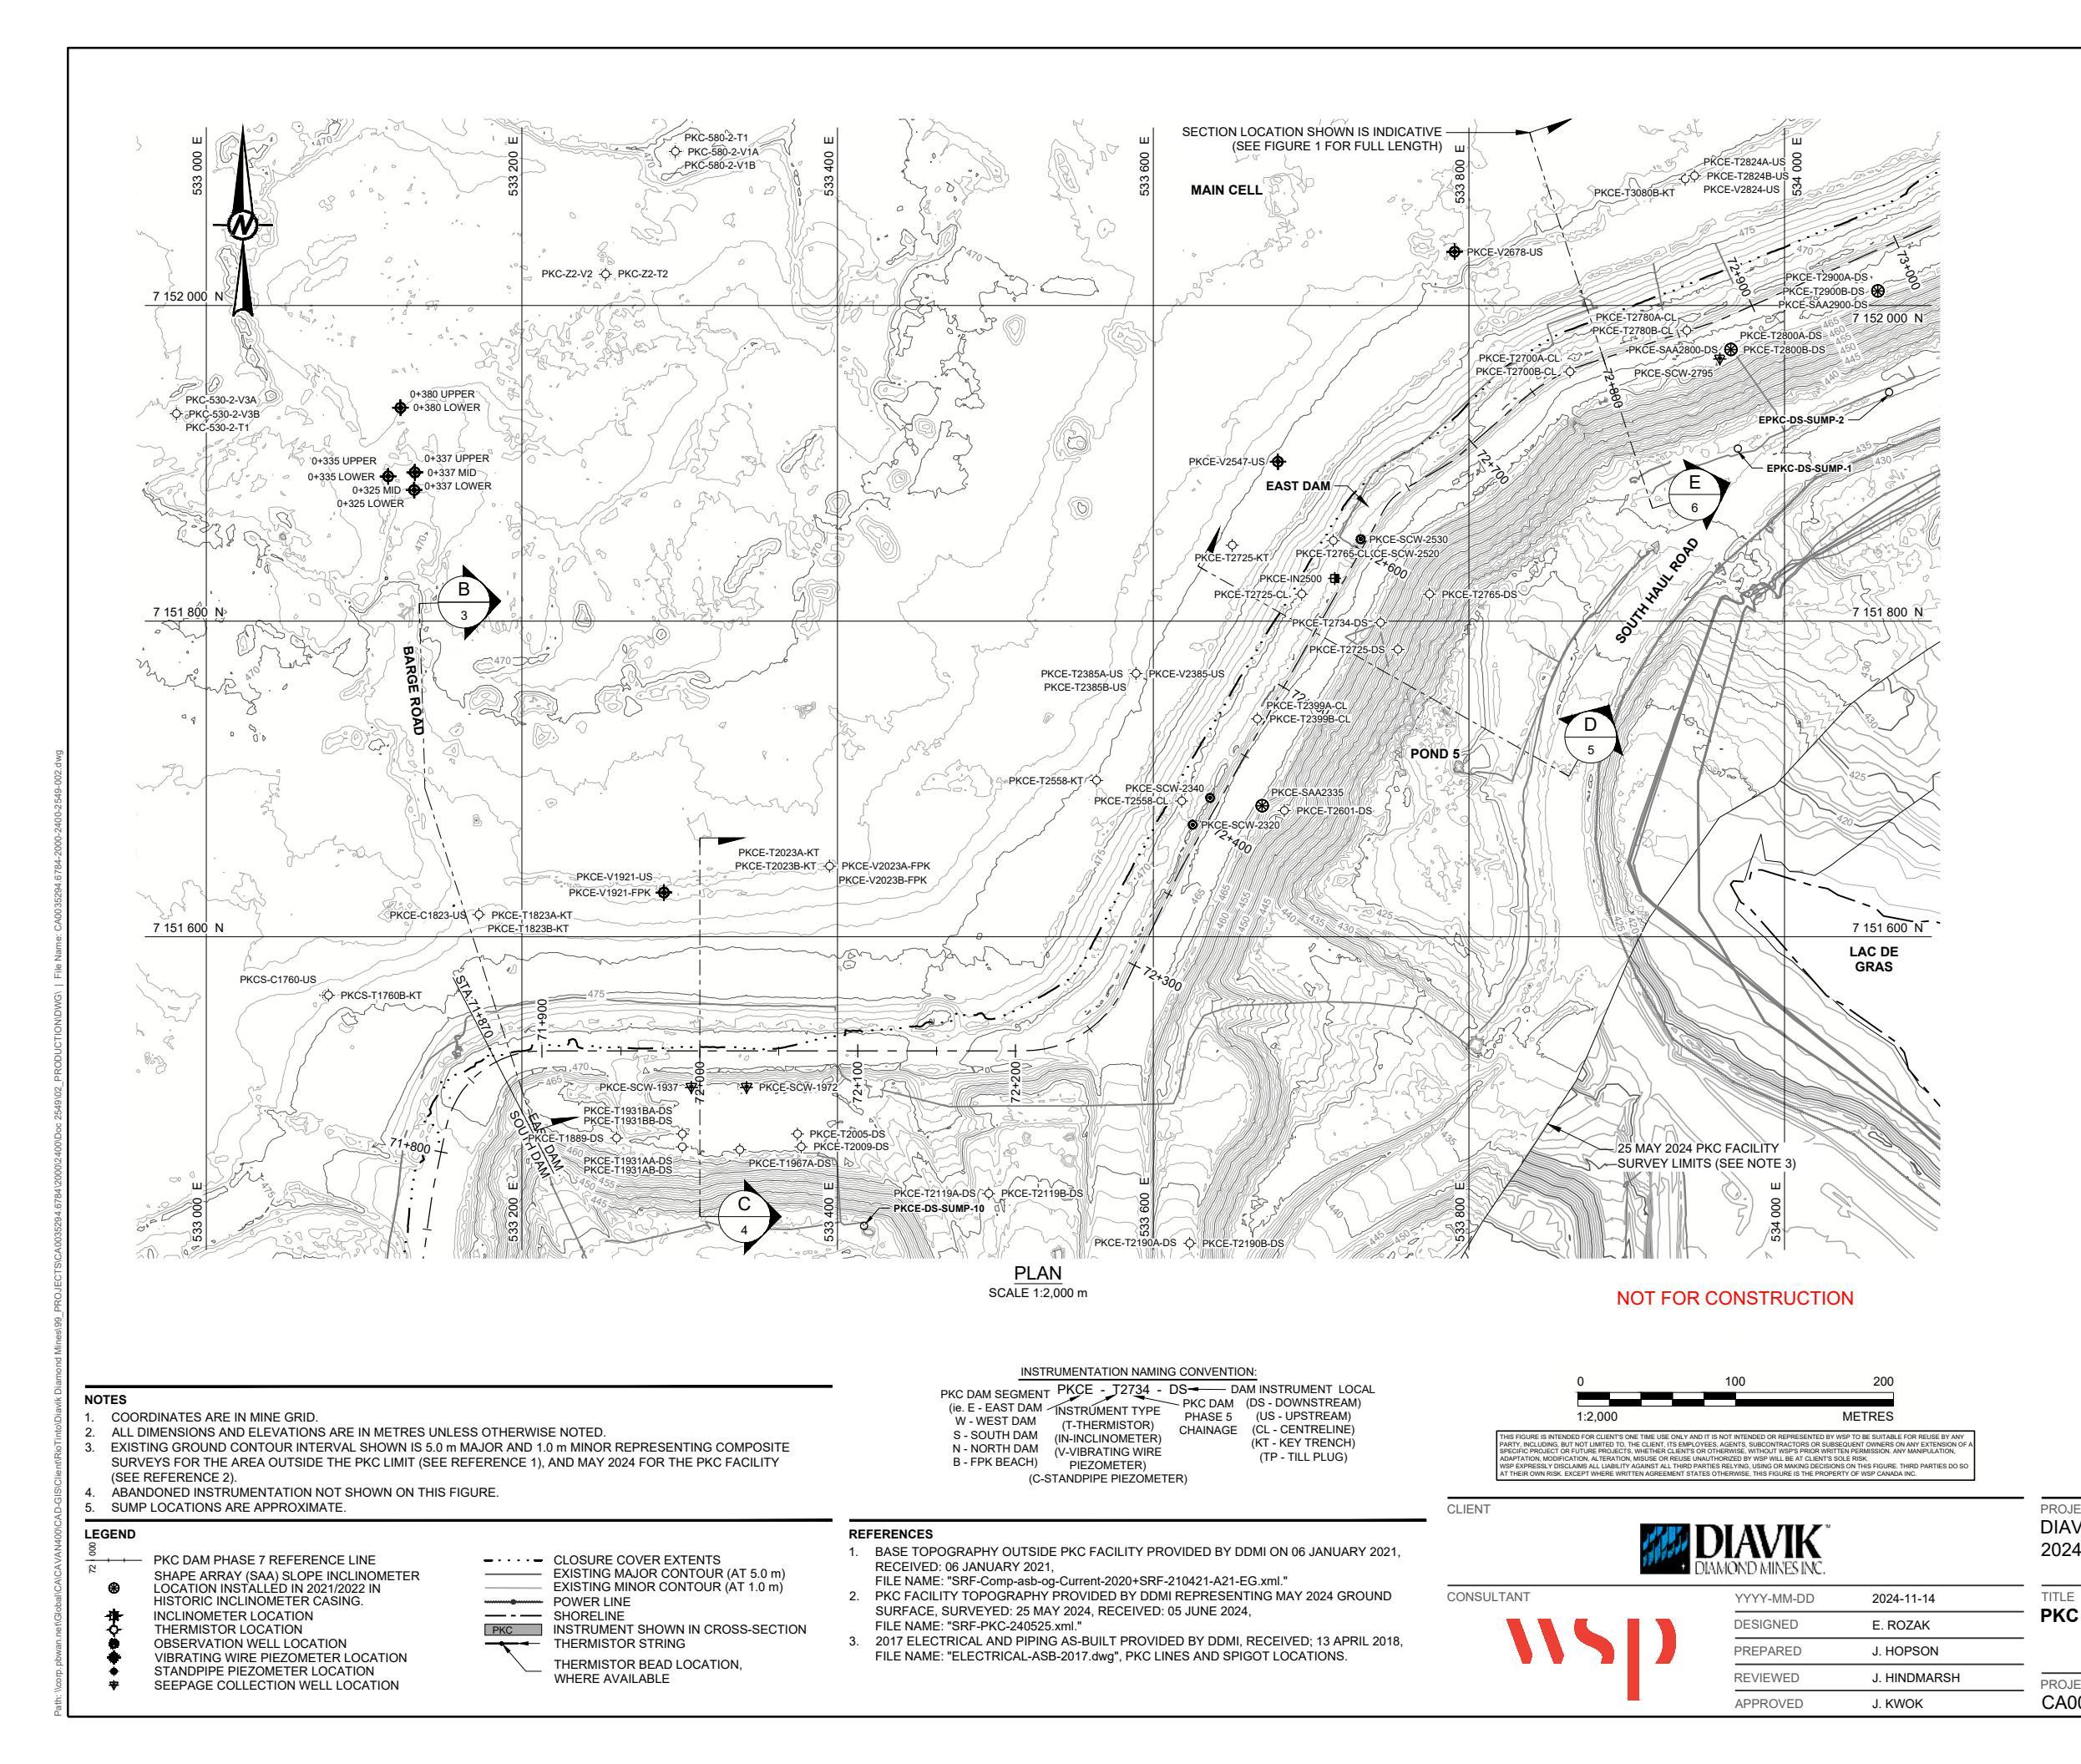
PKC INSTRUMENTATION PLAN - 2 OF 2

⁽⁷⁾ DECOMMISSIONED IN JUNE 2024.
⁽⁸⁾ REQUIRES ELECTRICAL REPAIR TO RESUME PUMPING.

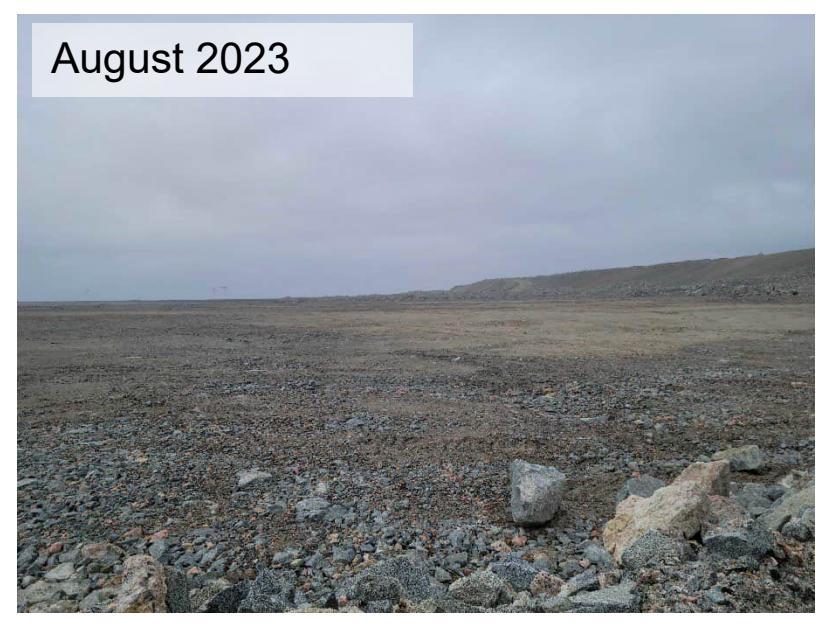
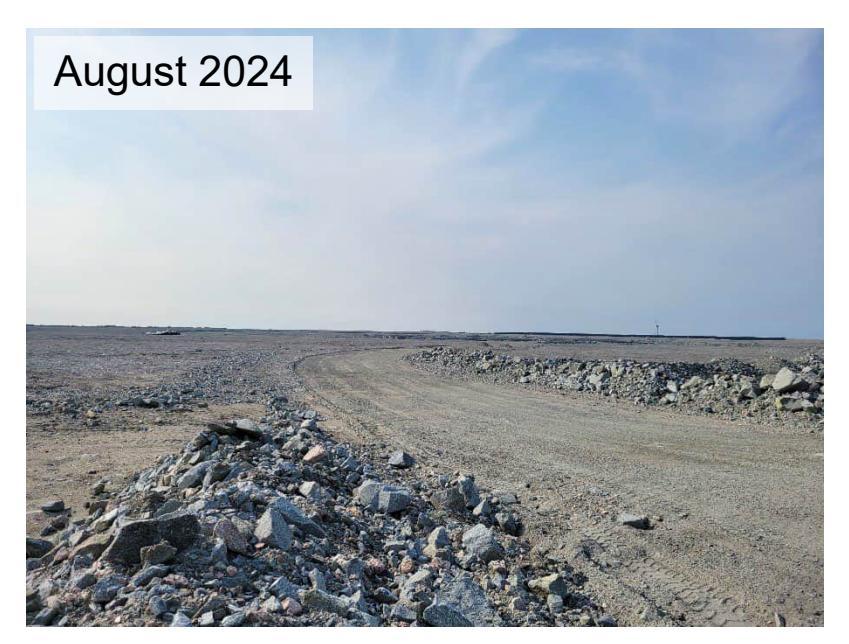
Photograph North PKC Dam – 1: Upstream along North PKC Dam looking west (2023) and southwest (2024). PKC closure cover constructed in 2023 over the length of the North Dam and ties into the NCRP closure cover. PKC closure cover does not yet extend upstream along the FPK beach from Sta. 73+900 to 74+200.
