**From:** Katie Oliver <koliver@kblenv.com>  
**Sent:** August 23, 2022 3:34 PM  
**To:** AlecSandra Macdonald; Leonard DeBastien; Lloyd Gruben  
**Cc:** Norman Snowshoe; Wendy Bidwell; Jeff Dirks; Richard Reimer; Lance Hayman  
**Subject:** RE: Water Licence Inspection Report\_KBL Environmental Ltd\_ G17L1 -002, July 28, 2022  
**Attachments:** 2022-07-28 Discharge point.JPG; 2022-08-22 KBL Facility - Reported cracks inspection.jpg; 2022-08-22 KBL Facility confirmation of fencing.jpg

**Subject:** Water Licence Inspection Report\_KBL Environmental Ltd\_ G17L1 -002, July 28, 2022

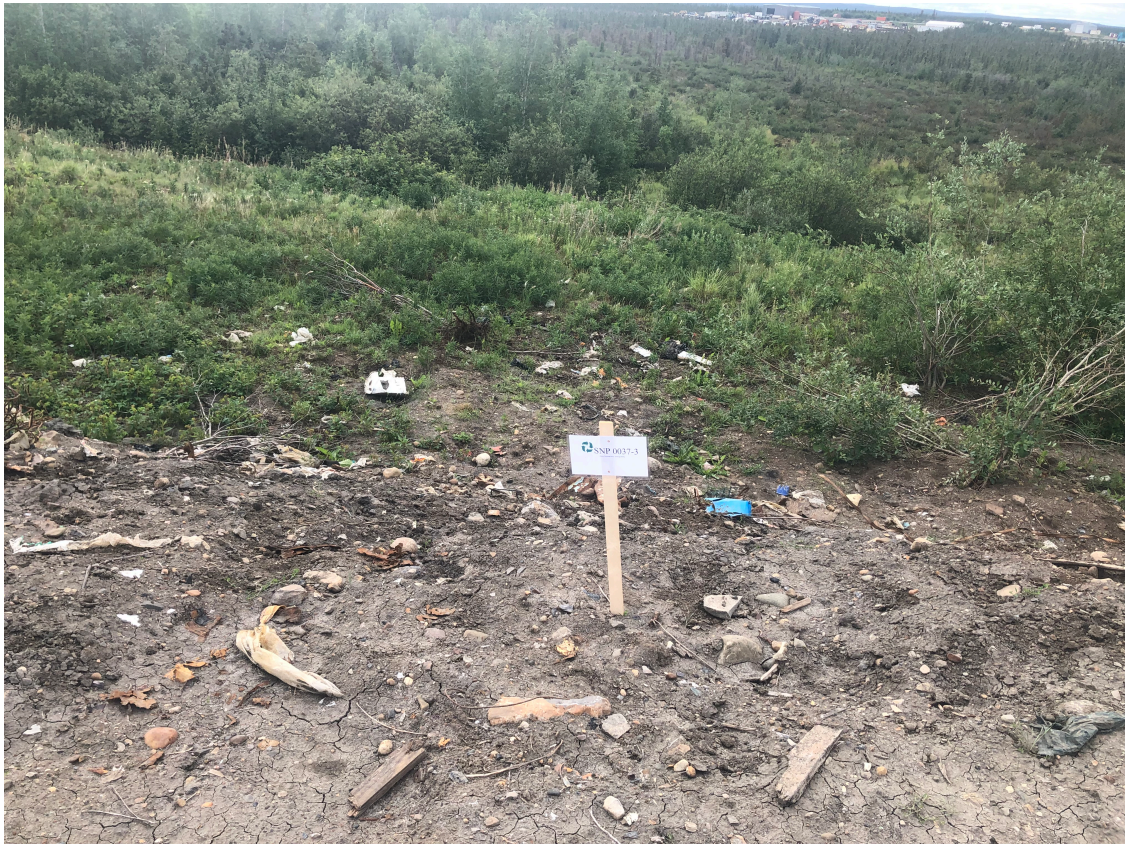
- D. Check if all debris in and around the facility has been picked up and properly disposed of.
    - a. Two types of debris were observed in the inspection. Figure 1 illustrates debris to the south of the STF. The STF was construction on a former landfill site and erosion is causing debris to protrude from the hillside. In addition, debris from the adjoining landfill has blow to the areas surrounding the KBL lease area. Would ENR please clarify if it is the intent that KBL remove landfill debris from outside the fenced KBL STF lease area?
