# Government of Northwest Territories

## Dempster Highway – Culvert Replacement Project

### Design Memo – KM 40.2

DOCUMENT No. 2567-CCI-Design Memo  
CCI PROJECT No. 2567

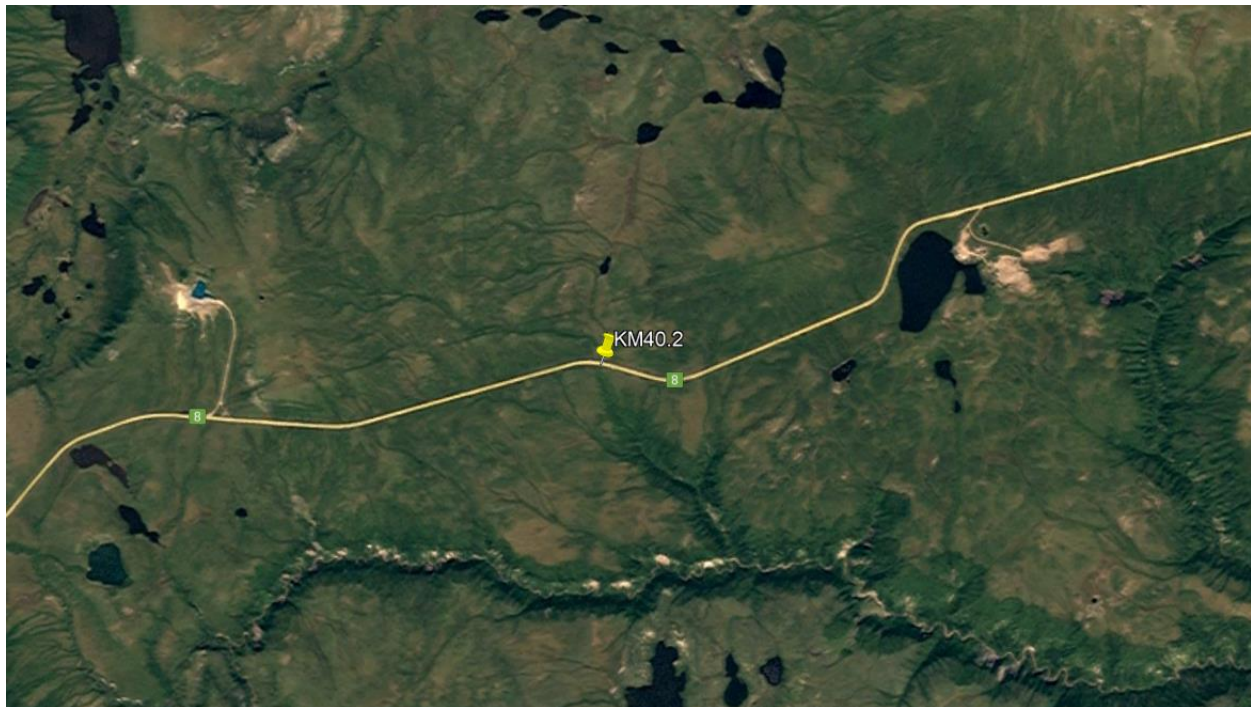
Figure 1: KM40.2 Crossing Location

The survey at this location was performed by White Bear Geometrics Ltd. and can be found in Appendix A. The imagery of the site location can be seen below:

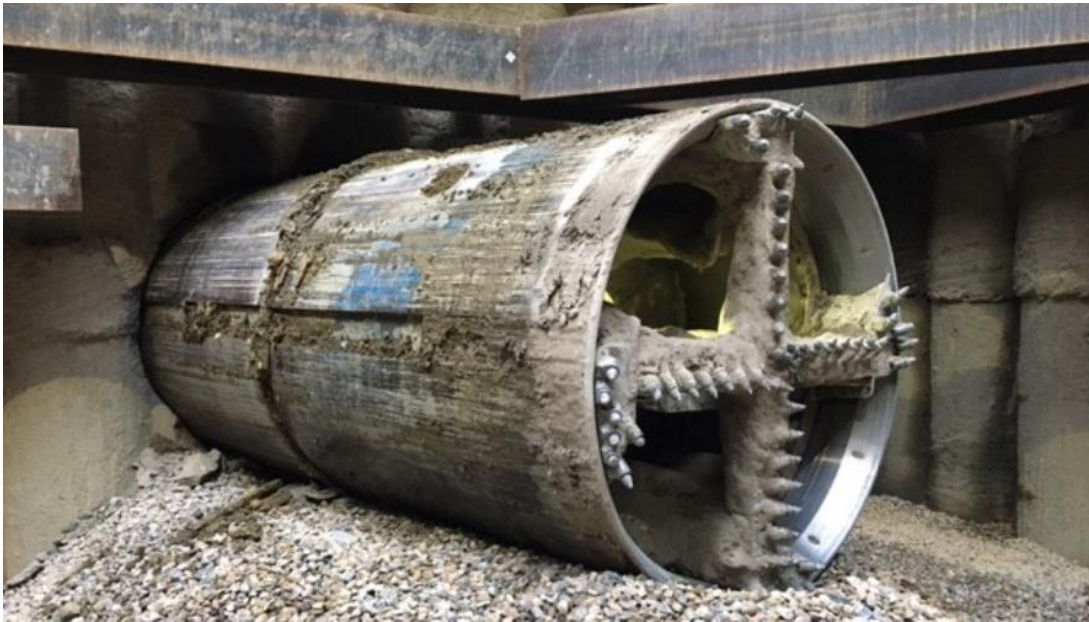
Figure 7. Tunnel Boring Machine

The TBM comes in a range of sizes between 1219.1mm (48") to 4267mm (168"), custom sizes are available from the manufacture upon request. The overcut for these machines typically is 0.75" radially.

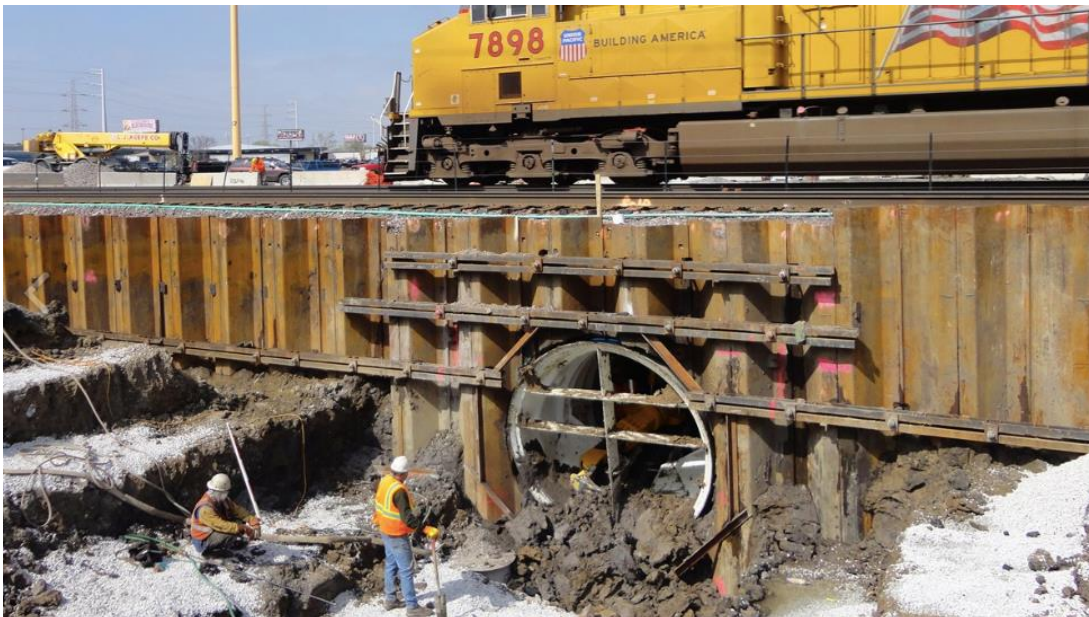
Figure 8. Tunnel Boring Machine Showing Shields and Excavator “Claw”

The native material at the face that is being excavated can be supported using the hydraulically operated sand shields, these sand shields prevent excessive material from sluffing in causing over excavation. This style of TBM works best in sand, medium to stiff clay, dry or dewatered soil and weather rock in regions without groundwater present. The excavator backhoe claw has a full range of motion connected to the EX-50 boom and can reach beyond the face of the bore to remove or breakup material before they are carried by the conveyor system.

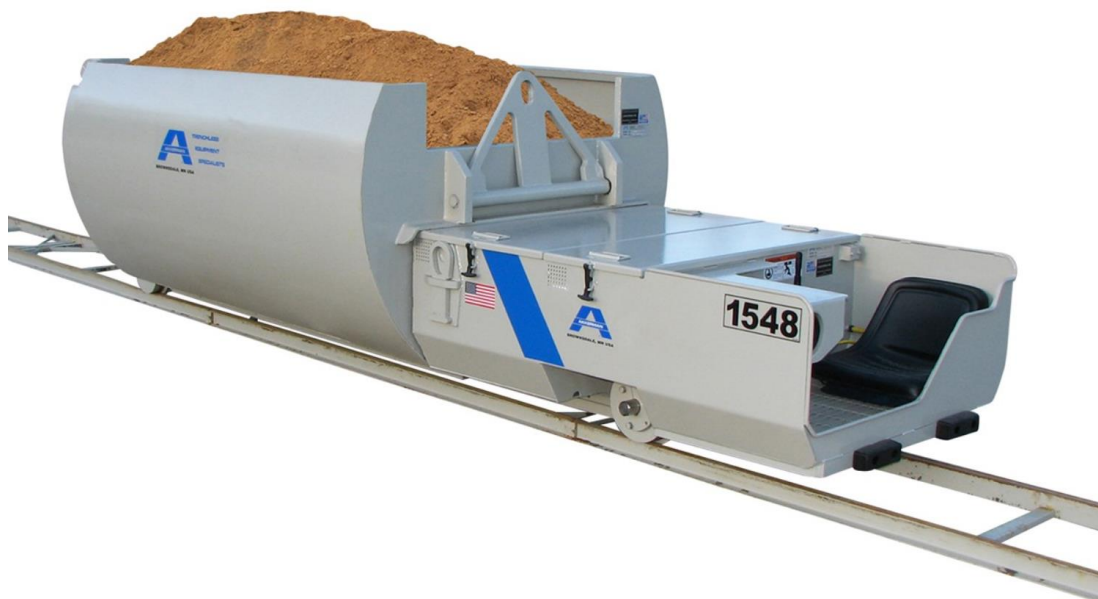
Figure 13. Muck Bucket and 1548 Haul Unit

Cuttings are transported from the face to the muck bucket using a conveyor belt suspended from the roof of the EBS. Once the muck bucket is full the haul unit is electrically operated and travels along the installed rail system to bring the cuttings into the launch pit. A crane or piece of lifting equipment lifts the muck bucket to surface where it is emptied out. The empty muck bucket is then lowered back down onto the haul unit and returns to the EBS so tunnelling can resume.

The tooling at the face excavates the material and cuttings transported along a conveyor belt back to where the muck bucket and haul unit (figure 4) are situated. Once full, the haul unit is electrically driven along a pre-installed rail system to the launch pit / shaft. A piece of lifting equipment then removes the muck bucket from the pit and unloads to the cuttings on surface before the bucket is lowered back onto the rail system and shuttled back to the conveyor belt.

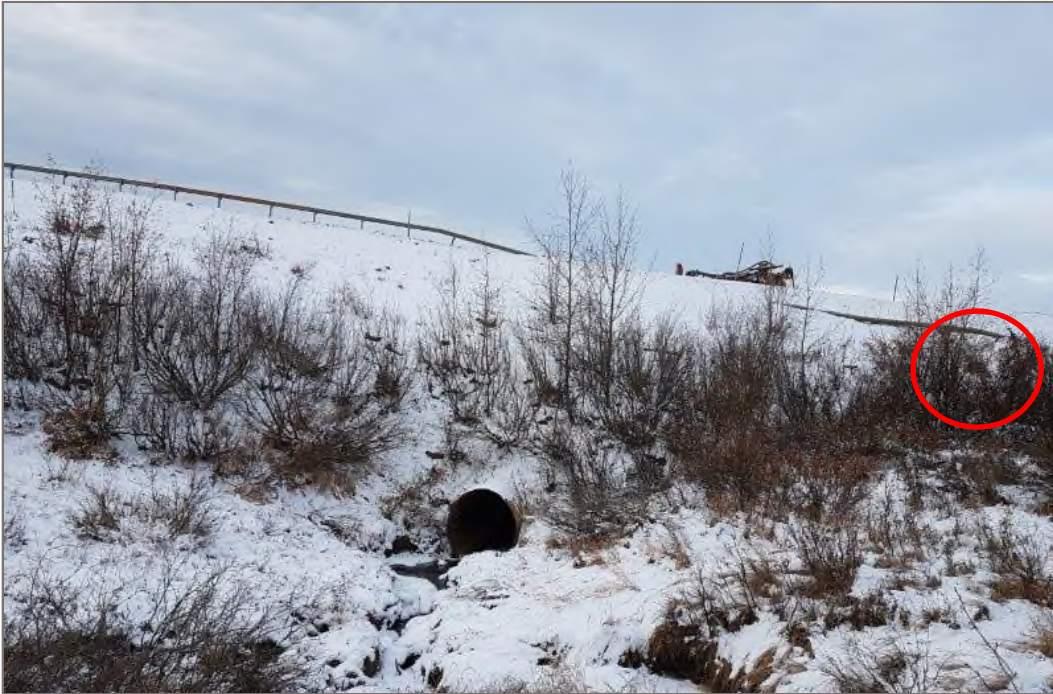
**Photo 5:** Both culverts on the north side of the highway embankment; view looking south. The larger lower 1.8 m culvert is centred in the photo. The upper 1.2 m culvert is circled.

Photo 5 shows both culverts on the north or upstream side of the highway. There does not appear to be evidence of extensive flooding that would result in water passing through the upper culvert. Therefore, it may be possible that the upper culvert has never actually been used.

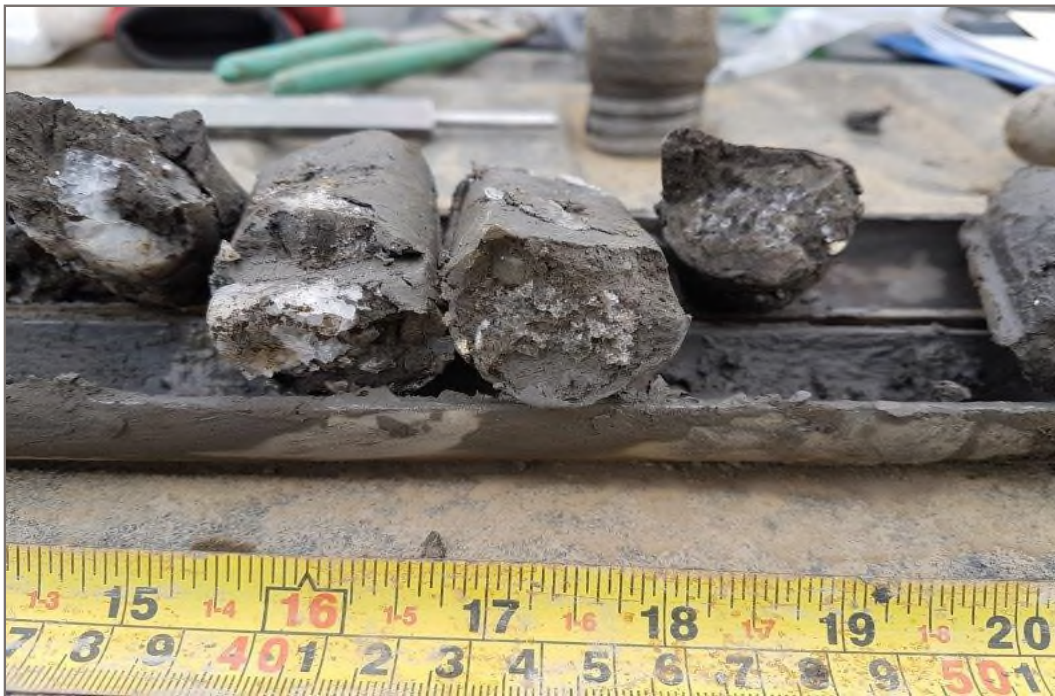
**Photo 14:** BH-04 14.4-15.0 m SPT sample 2.

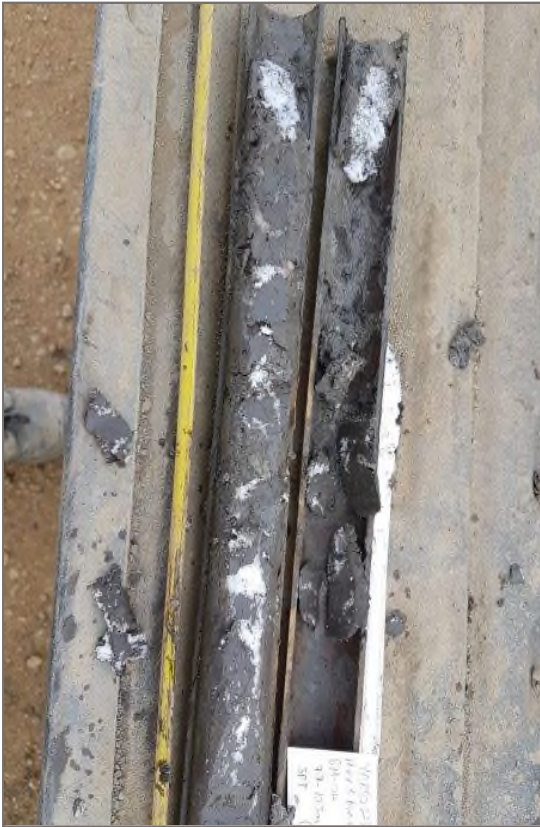
**Photo 15:** BH-04 9.9-10.5 m SPT sample 2.

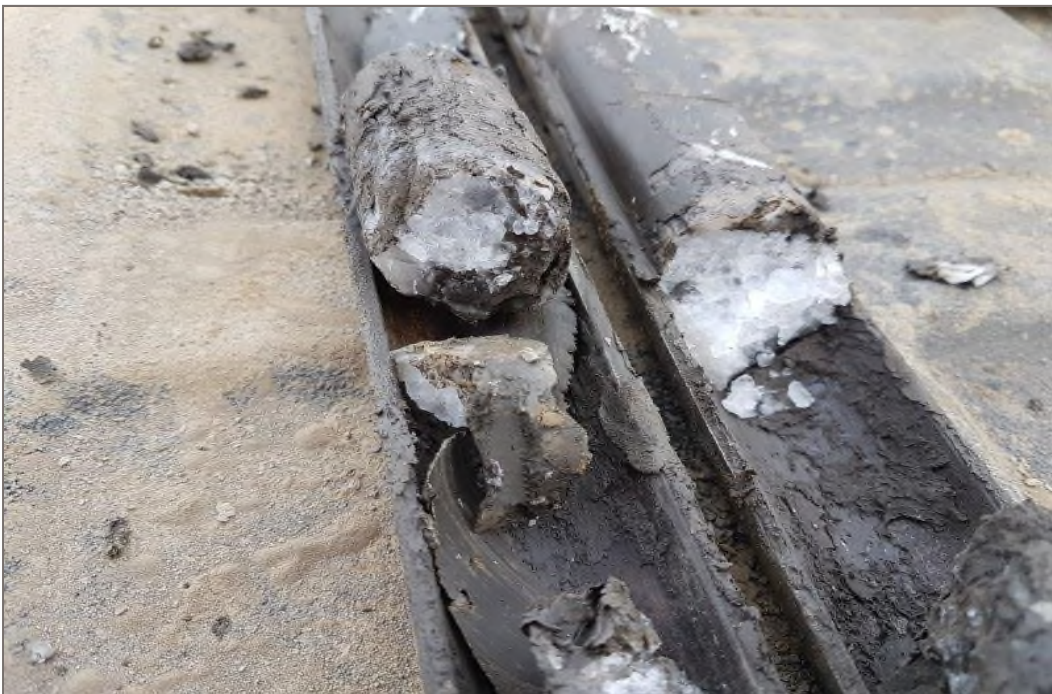
**Photo 16:** BH-04 11.4-12.0 m SPT sample 2.

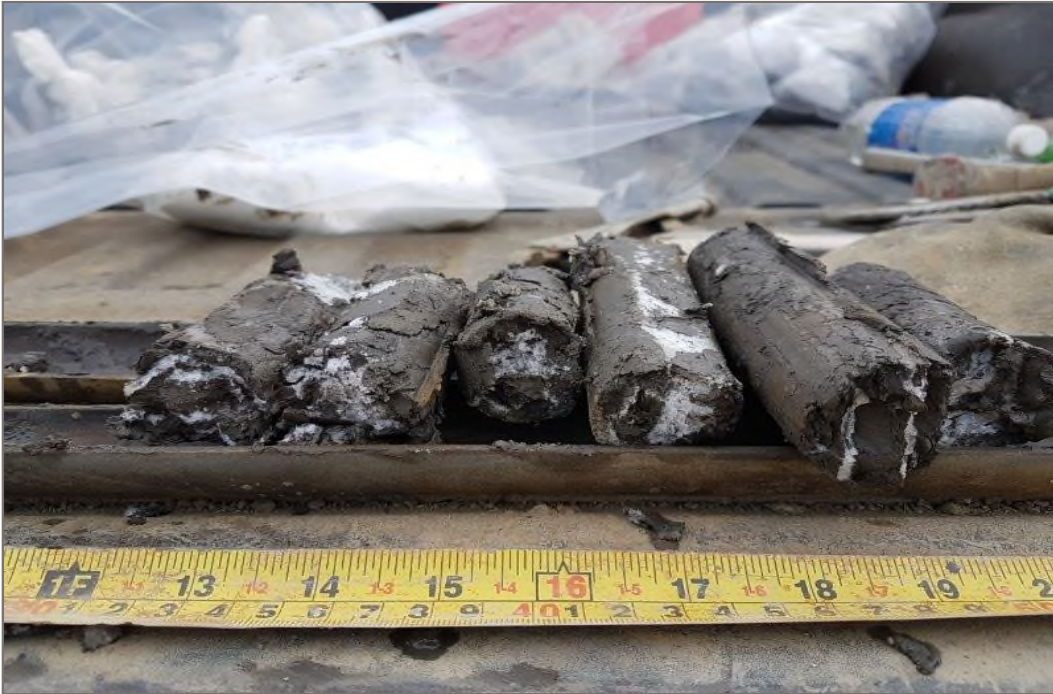
**Photo 17:** BH-04 9.9-10.5 m SPT sample 3.

Photo 1	Overall site, facing west.
Photo 2	South side of embankment, facing east.
Photo 3	South side of embankment, facing north.
Photo 4	Erosion above top culvert on south side of embankment.
Photo 5	Both culverts on the north side of the highway embankment; view looking south
Photo 6	Closeup of the lower 1.8 m diameter culvert on the north side of the highway embankment.
Photo 7	Creating trench for thermistor cables for BH-04, facing west.
Photo 8	Clearing thermistor cable trench for BH-04.
Photo 9	Upper (dry) culvert on the north (upstream) side of the highway embankment.
Photo 10	SPT sample collection for BH-04, facing west.
Photo 11	BH-04 9.9-10.5 m SPT sample.
Photo 12	BH-04 11.4-12.0 m SPT sample.
Photo 13	BH-04 14.4-15.0 m SPT sample.
Photo 14	BH-04 14.4-15.0 m SPT sample 2.
Photo 15	BH-04 9.9-10.5 m SPT sample 2.
Photo 16	BH-04 11.4-12.0 m SPT sample 2.
Photo 17	BH-04 9.9-10.5 m SPT sample 3.
Photo 18	BH-04 11.4-12.0 m SPT sample 3.

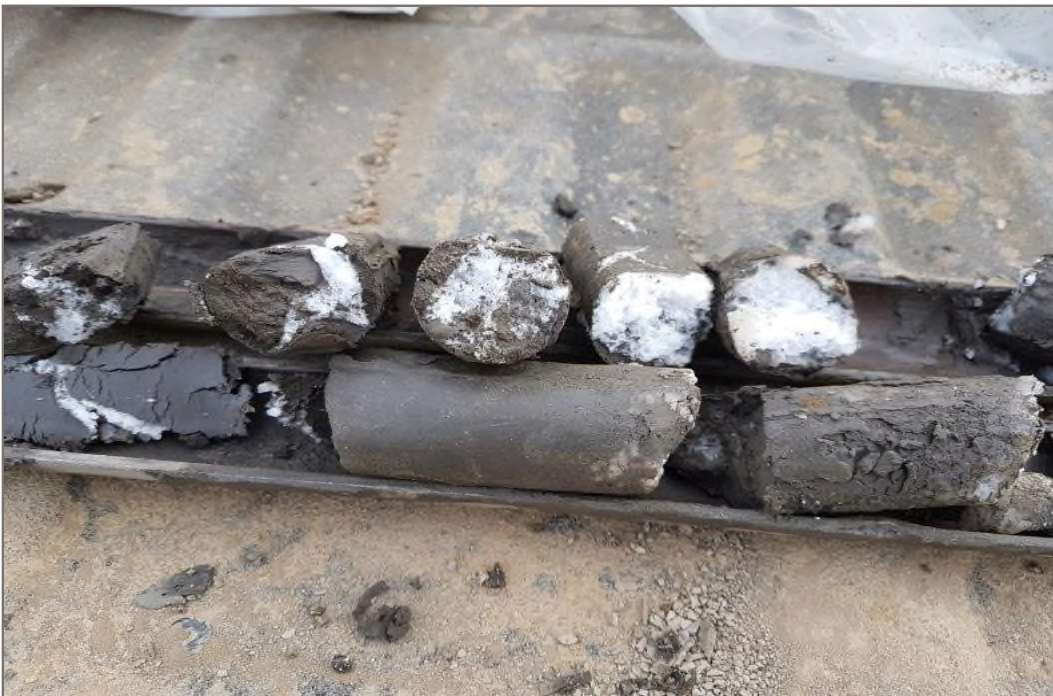
**Photo 18:** BH-04 11.4-12.0 m SPT sample 3.

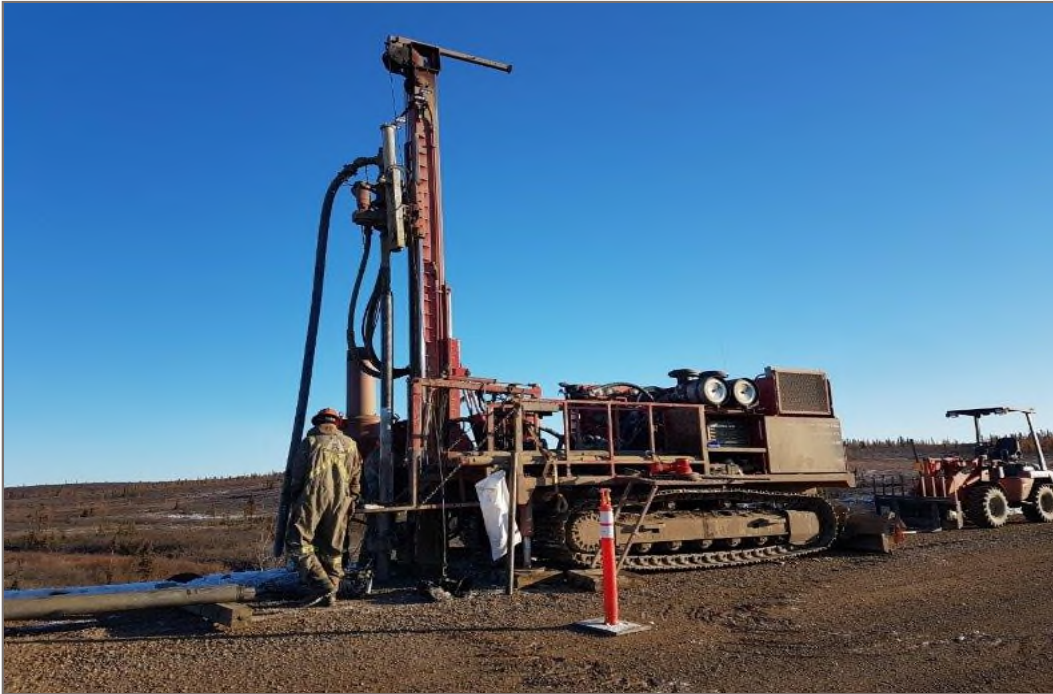
**Photo 19:** Drill setup for BH-05, facing north.

Photo 19	Drill setup for BH-05, facing north.
Photo 20	Highway backfilled from thermistor cable trenching for BH-05, facing north.
Photo 21	Thermistor cable trench for BH-05.

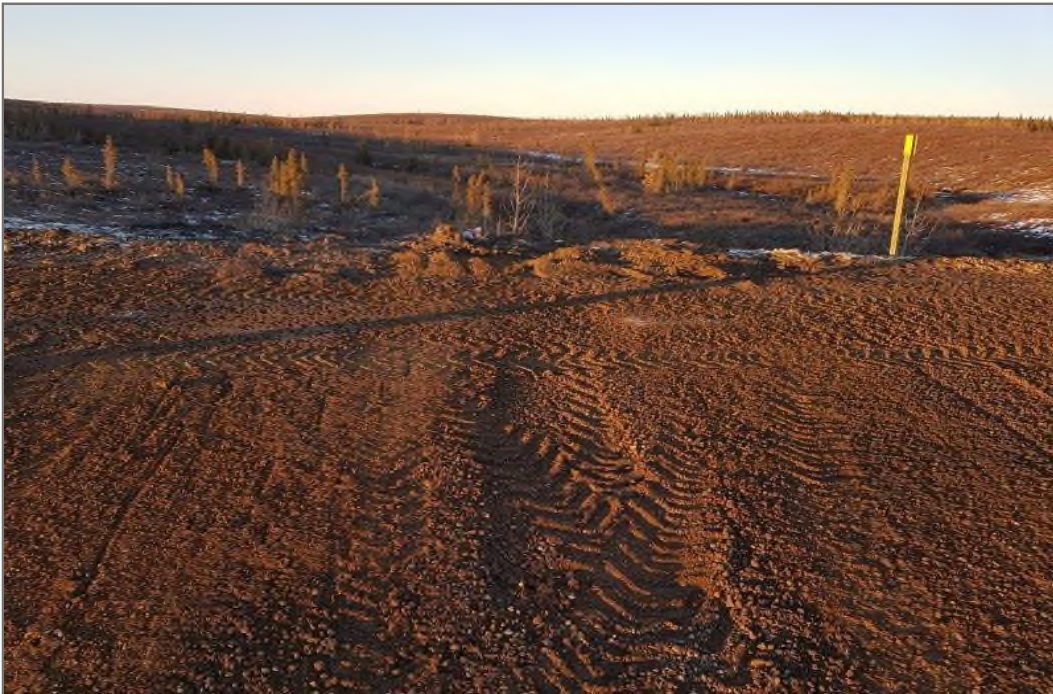
**Photo 20:** Highway backfilled from thermistor cable trenching for BH-05, facing north.

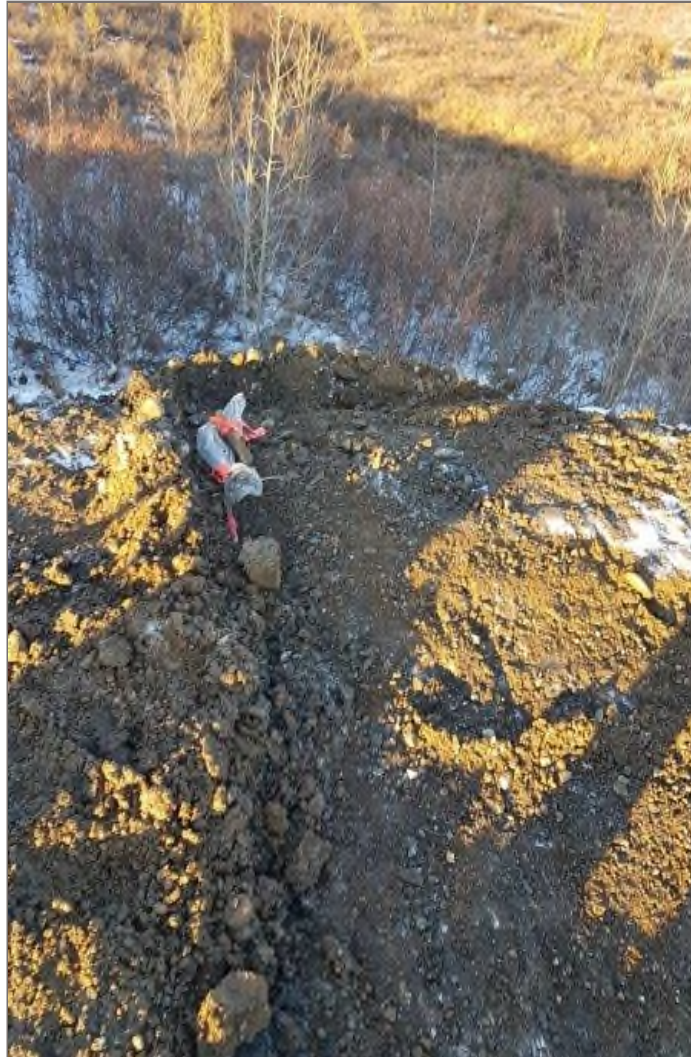
**Photo 21:** Thermistor cable trench for BH-05.

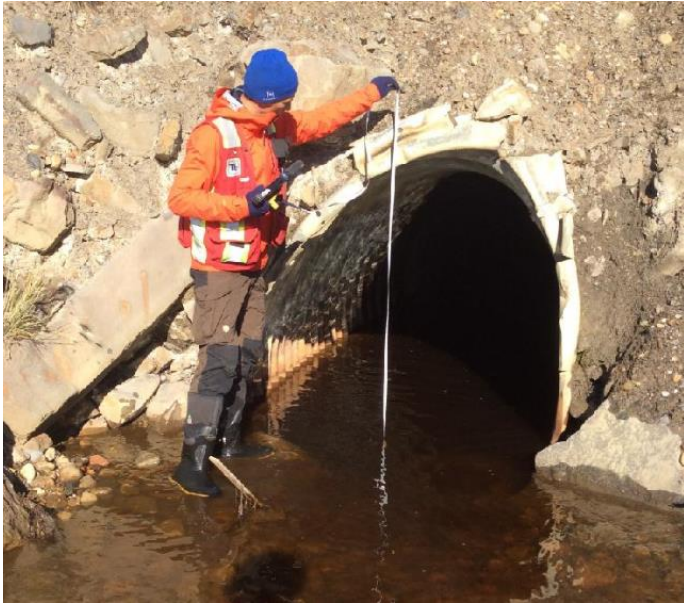
Photo 99: Crossing 33/25 distorted outlet.

Located at KM No. 40.2 of Highway No. 8, Crossing 33/25 is a 44 m long CSP culvert with varying heights from 1.8 to 2.0 m and projecting ends. The culvert geometry is distorted, most noticeably at the downstream end. Due to incomplete measurements, subsequent modeling was done using the RFT-reported culvert diameter of 1.83 m. The culvert is at a 63° angle to the road and is in only fair condition due to distortion at outlet. At this crossing there is an additional smaller culvert in excellent condition situated significantly higher (at least 2 m) than the main culvert. The purpose of the secondary culvert is presumably to provide emergency relief in the event of a blockage of the main culvert or its collapse. Site conditions are shown in Appendix A Photos 99 to 102.

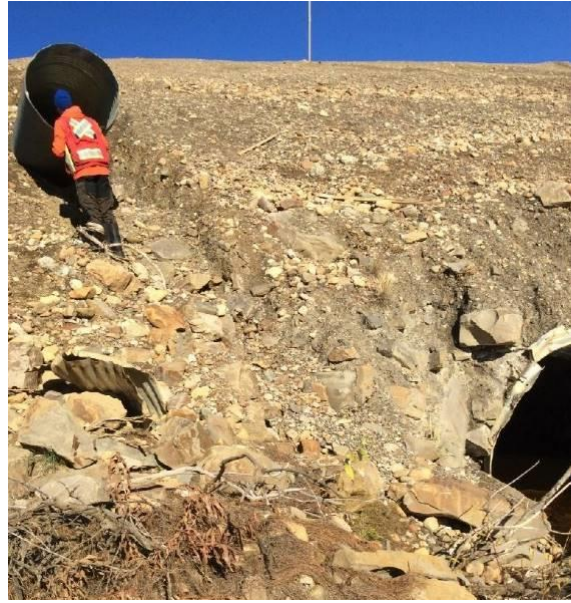
Photo 100: Crossing 33/25 auxiliary raised culvert.

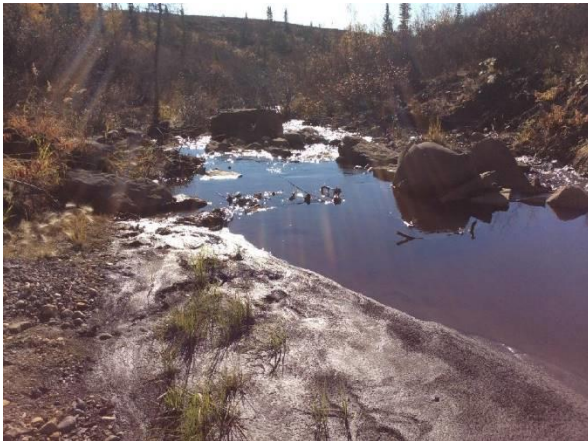
Photo 101: Crossing 33/25 looking downstream at condition of channel and bank vegetation.

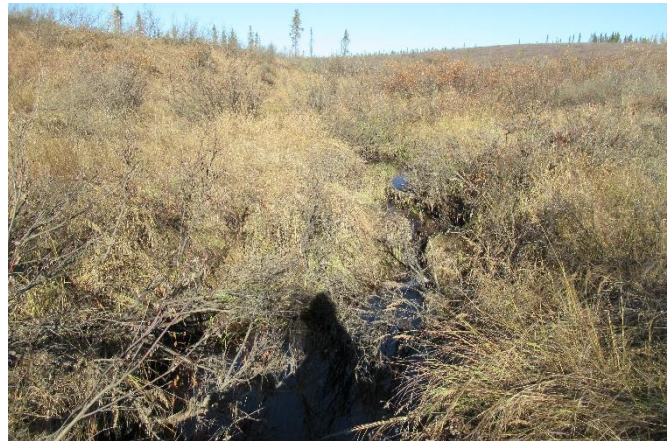
Photo 102: Crossing 33/25 looking upstream at condition of channel and bank vegetation.
