**FINAL REPORT: GORDON LAKE
GROUP REMEDIAL ACTION
PLAN**

Prepared for:
Public Works and Government
Services Canada and Aboriginal
Affairs and Northern
Development Canada

Prepared by:
Stantec Consulting Ltd.

March 31, 2016

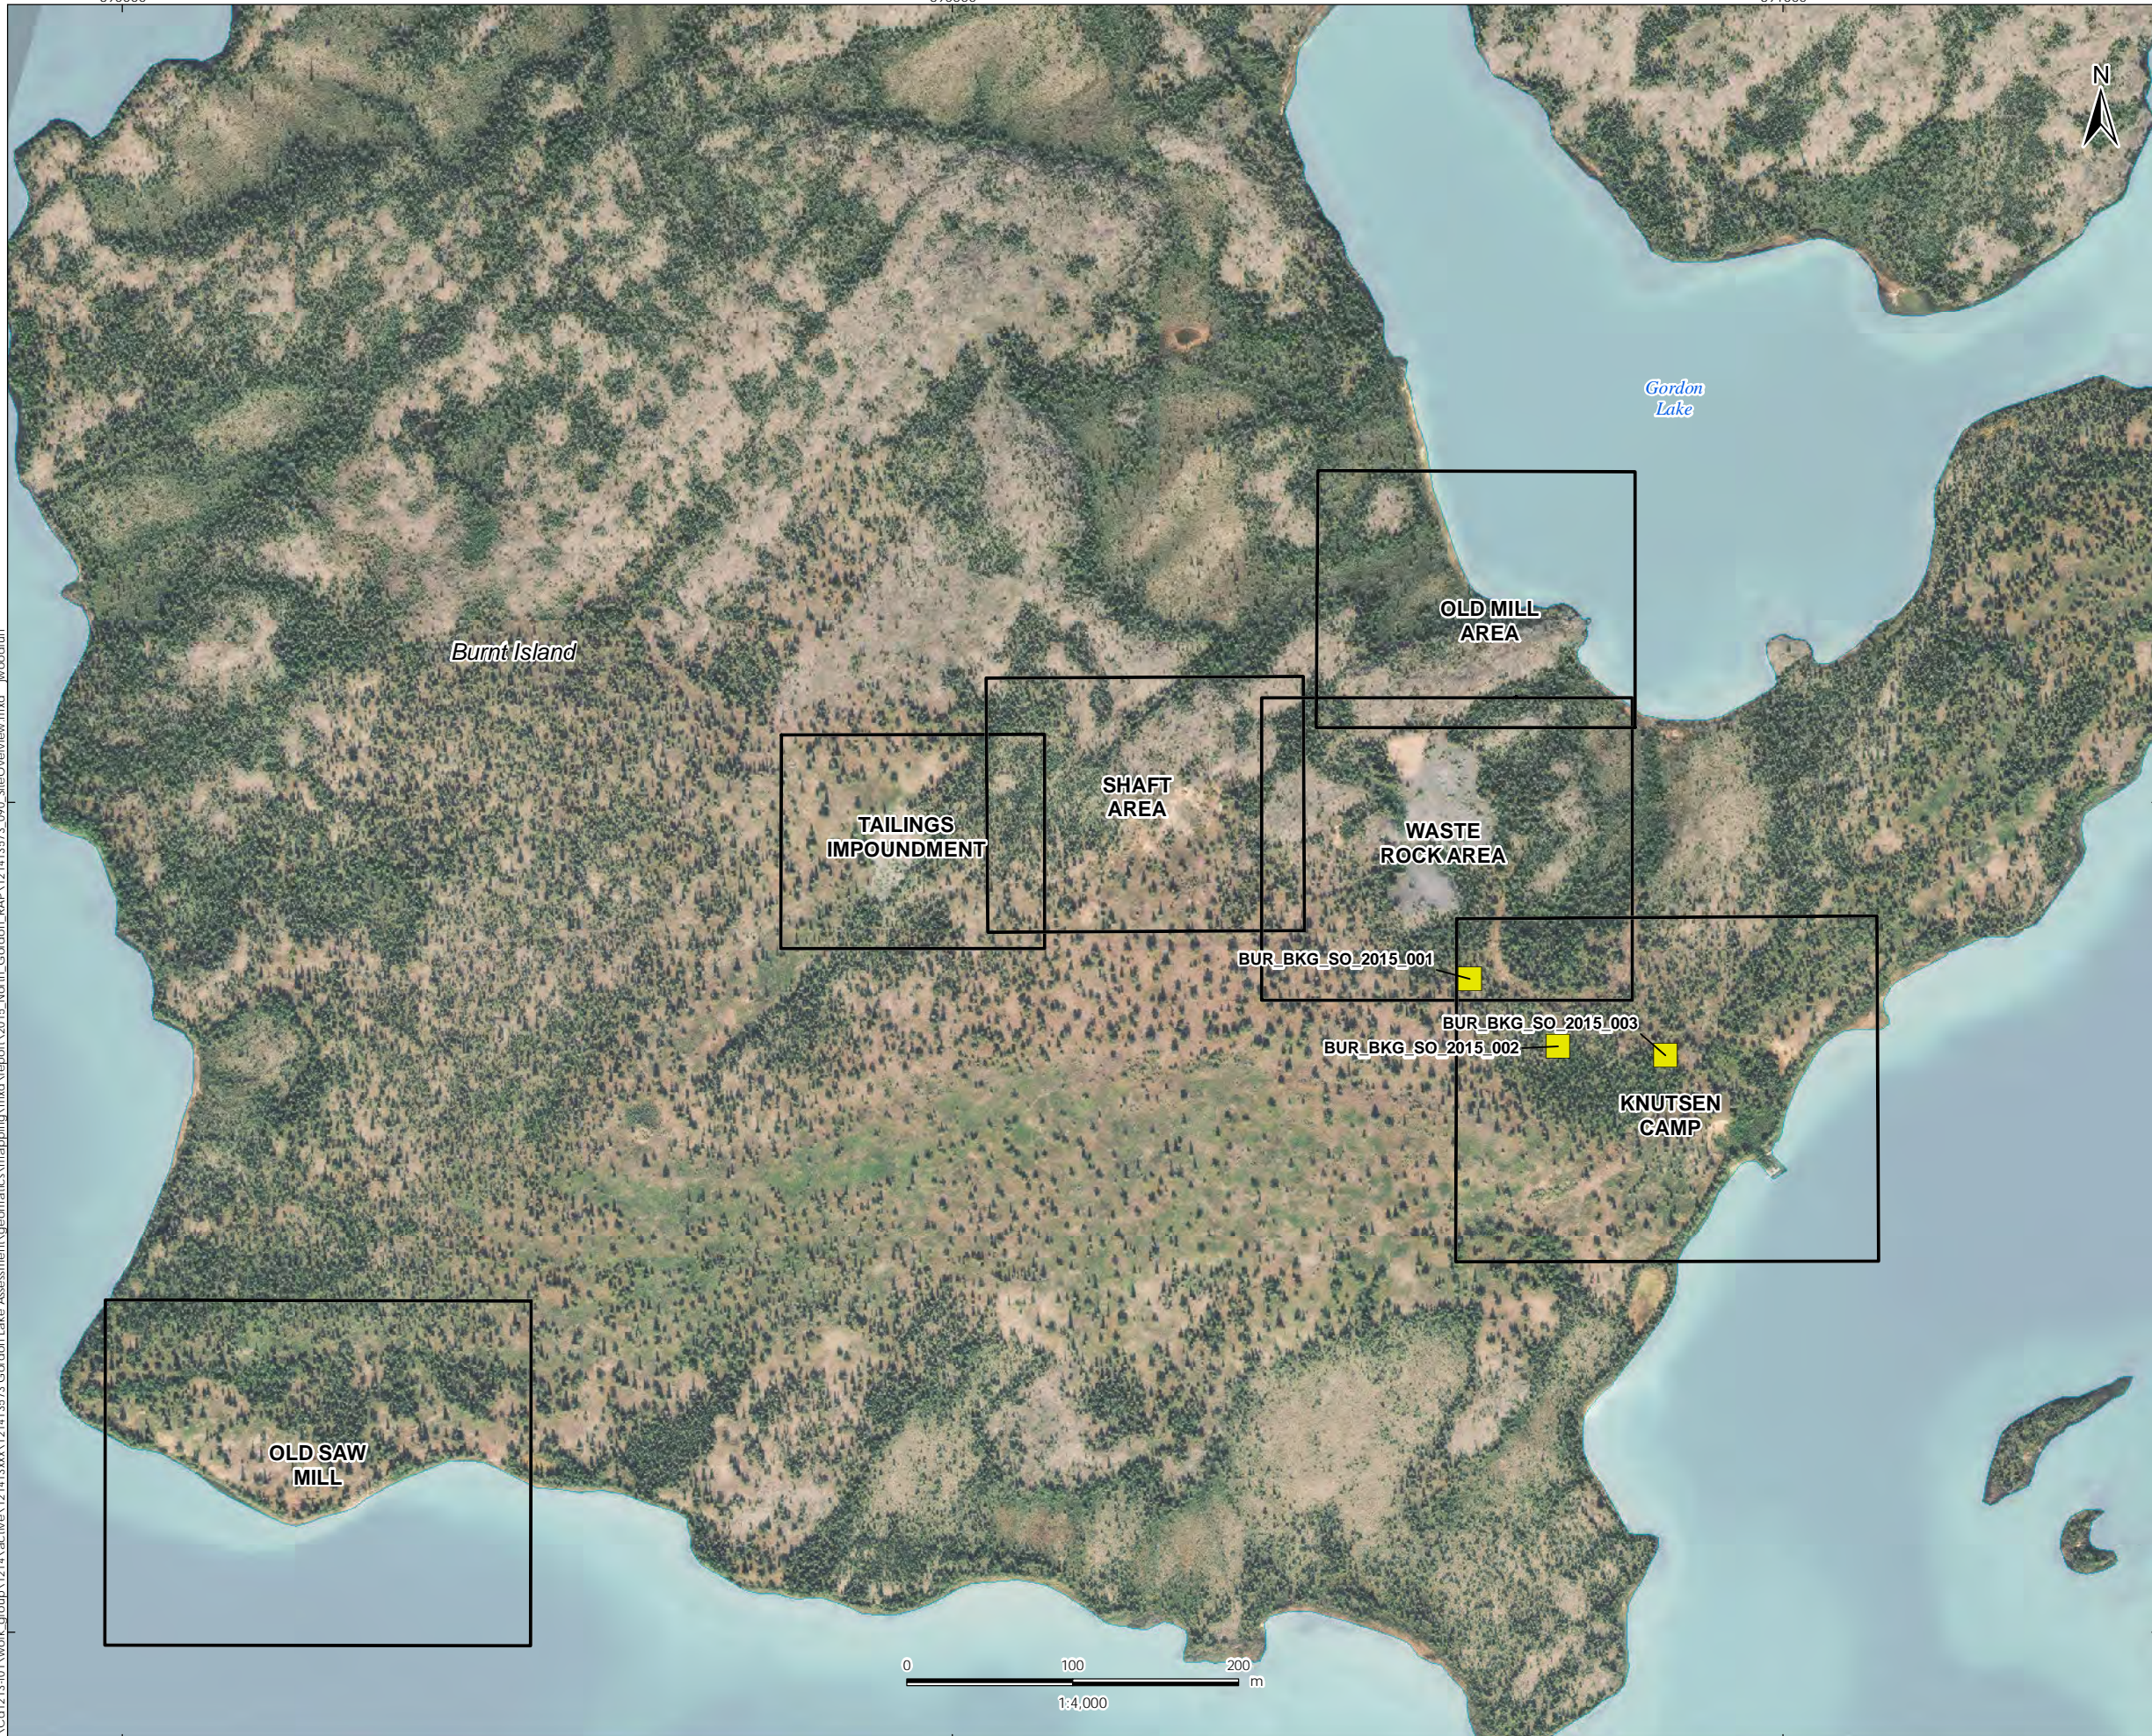
Title
**Burnt Island
 Site Overview**

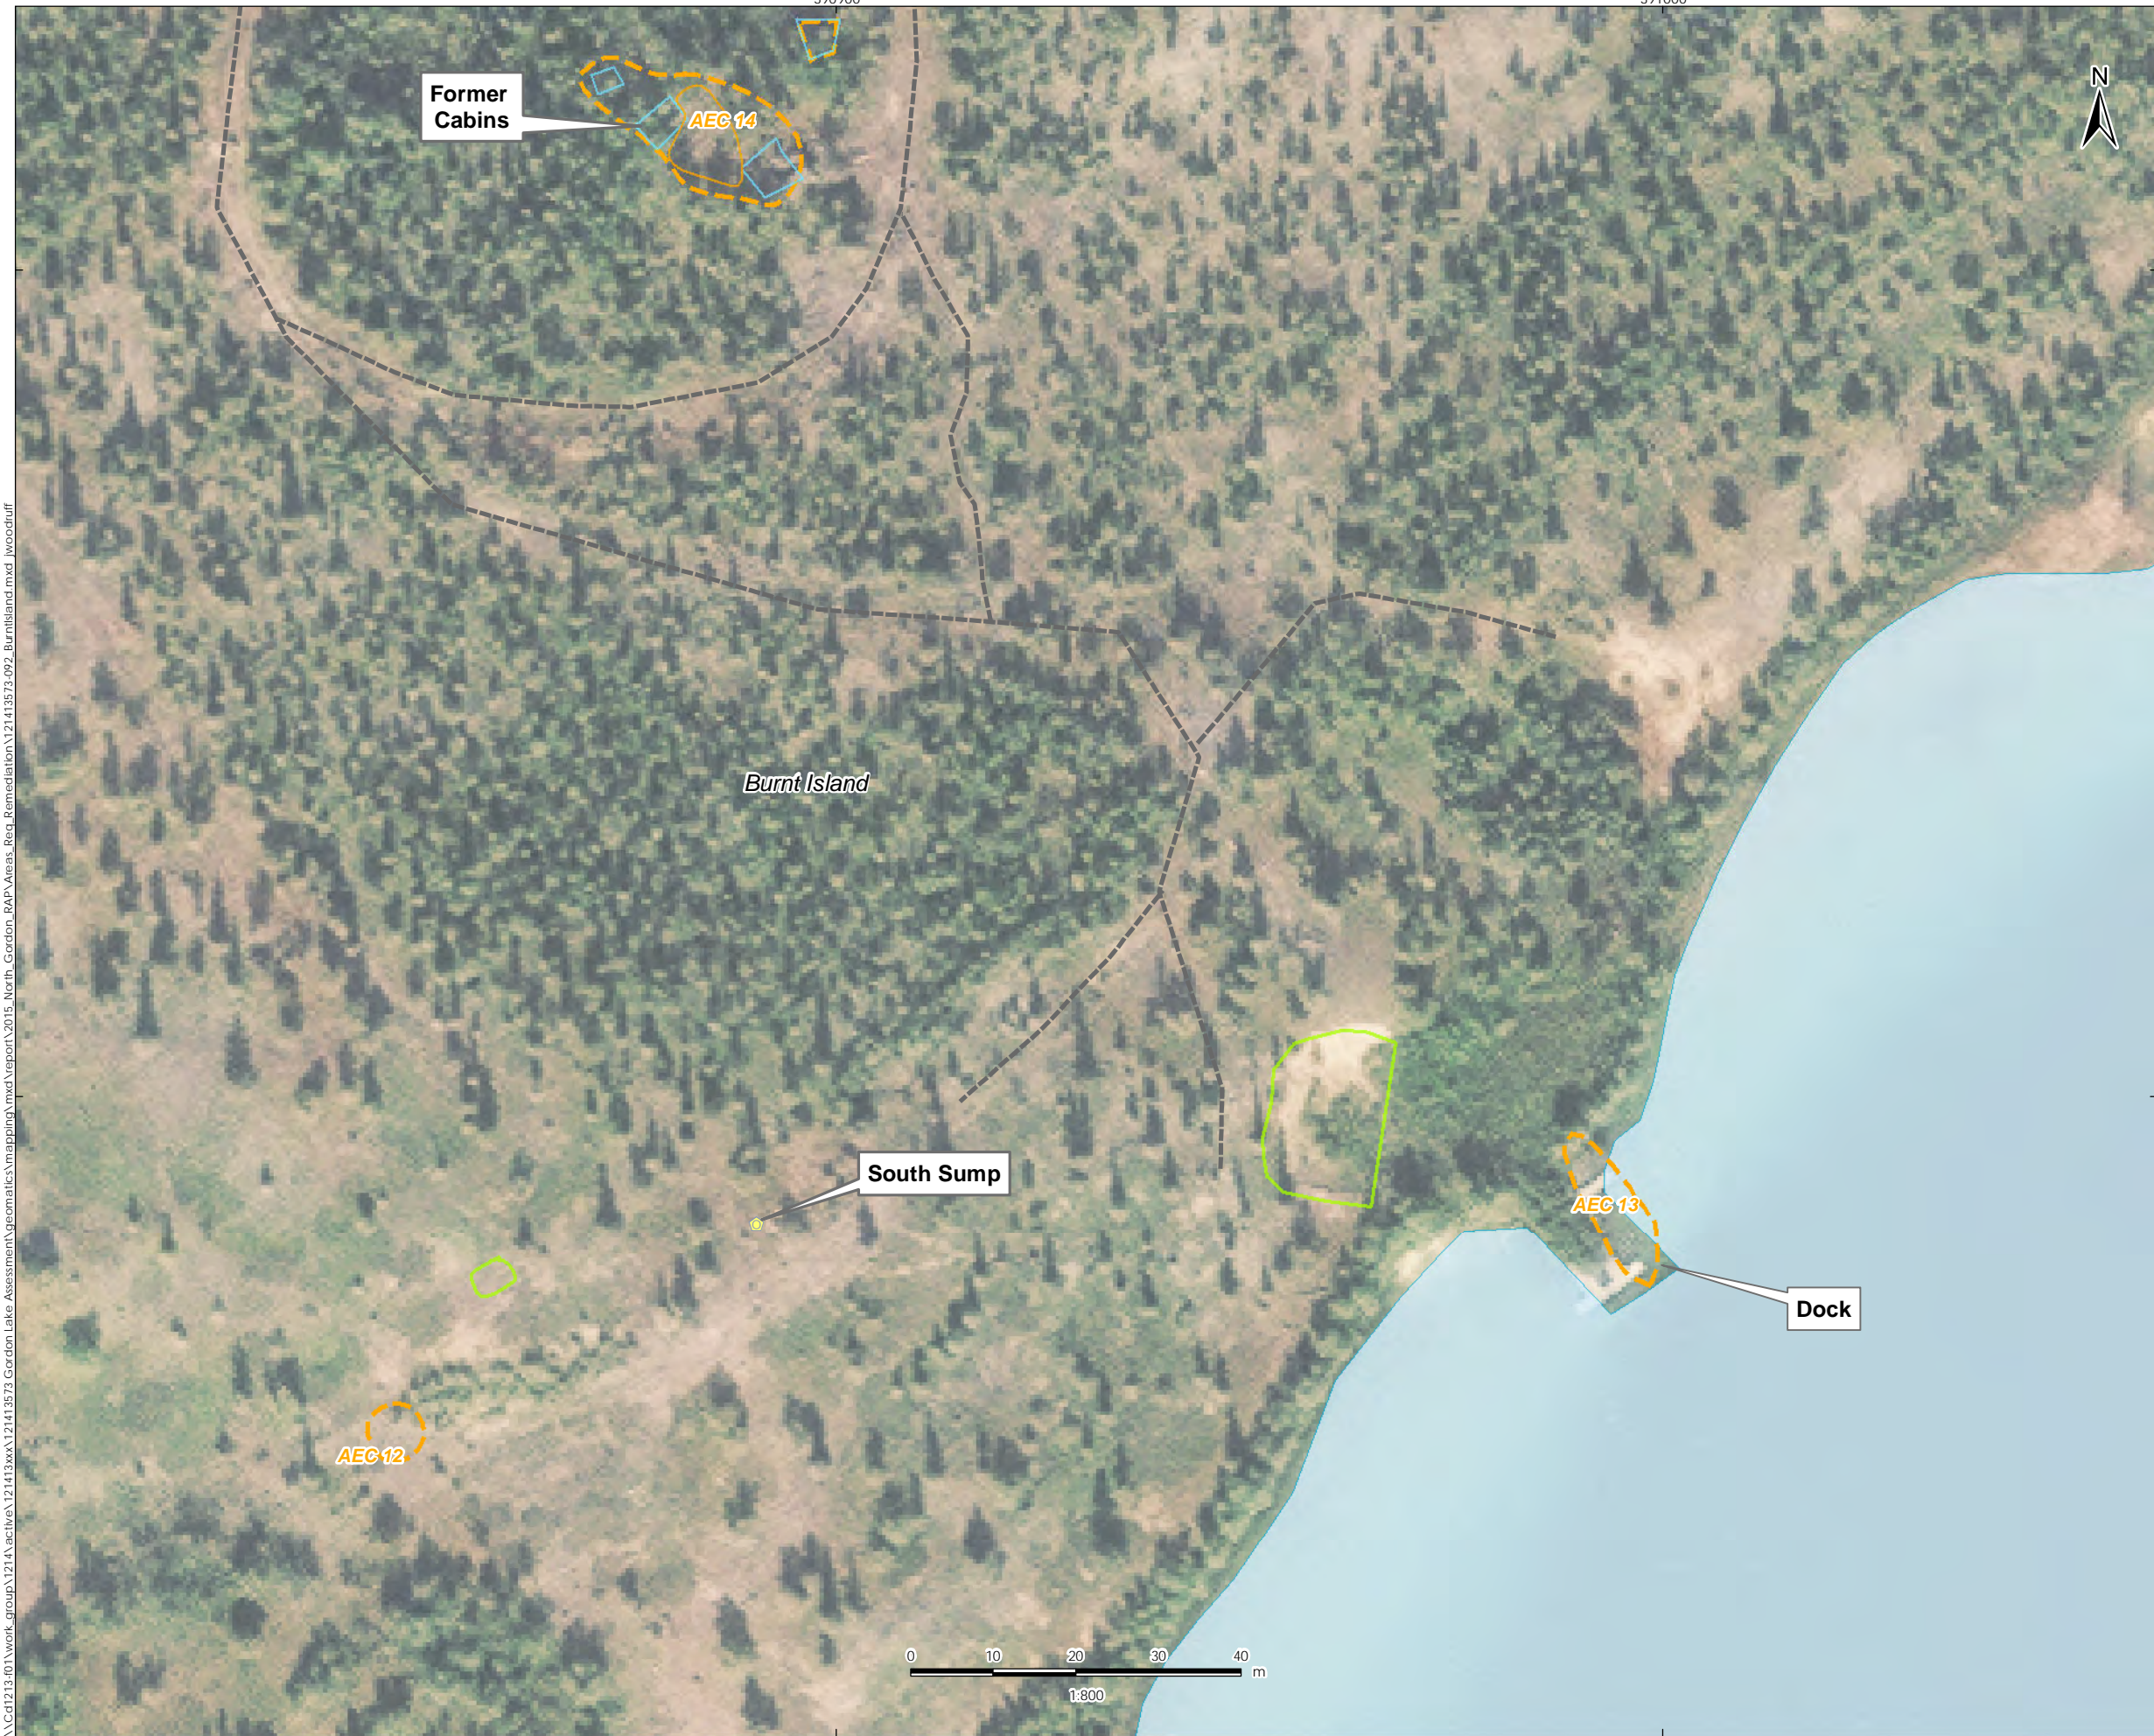
Figure No.
A-2

Title
Burnt Island - Knutsen Camp
Summary of Hazard Components

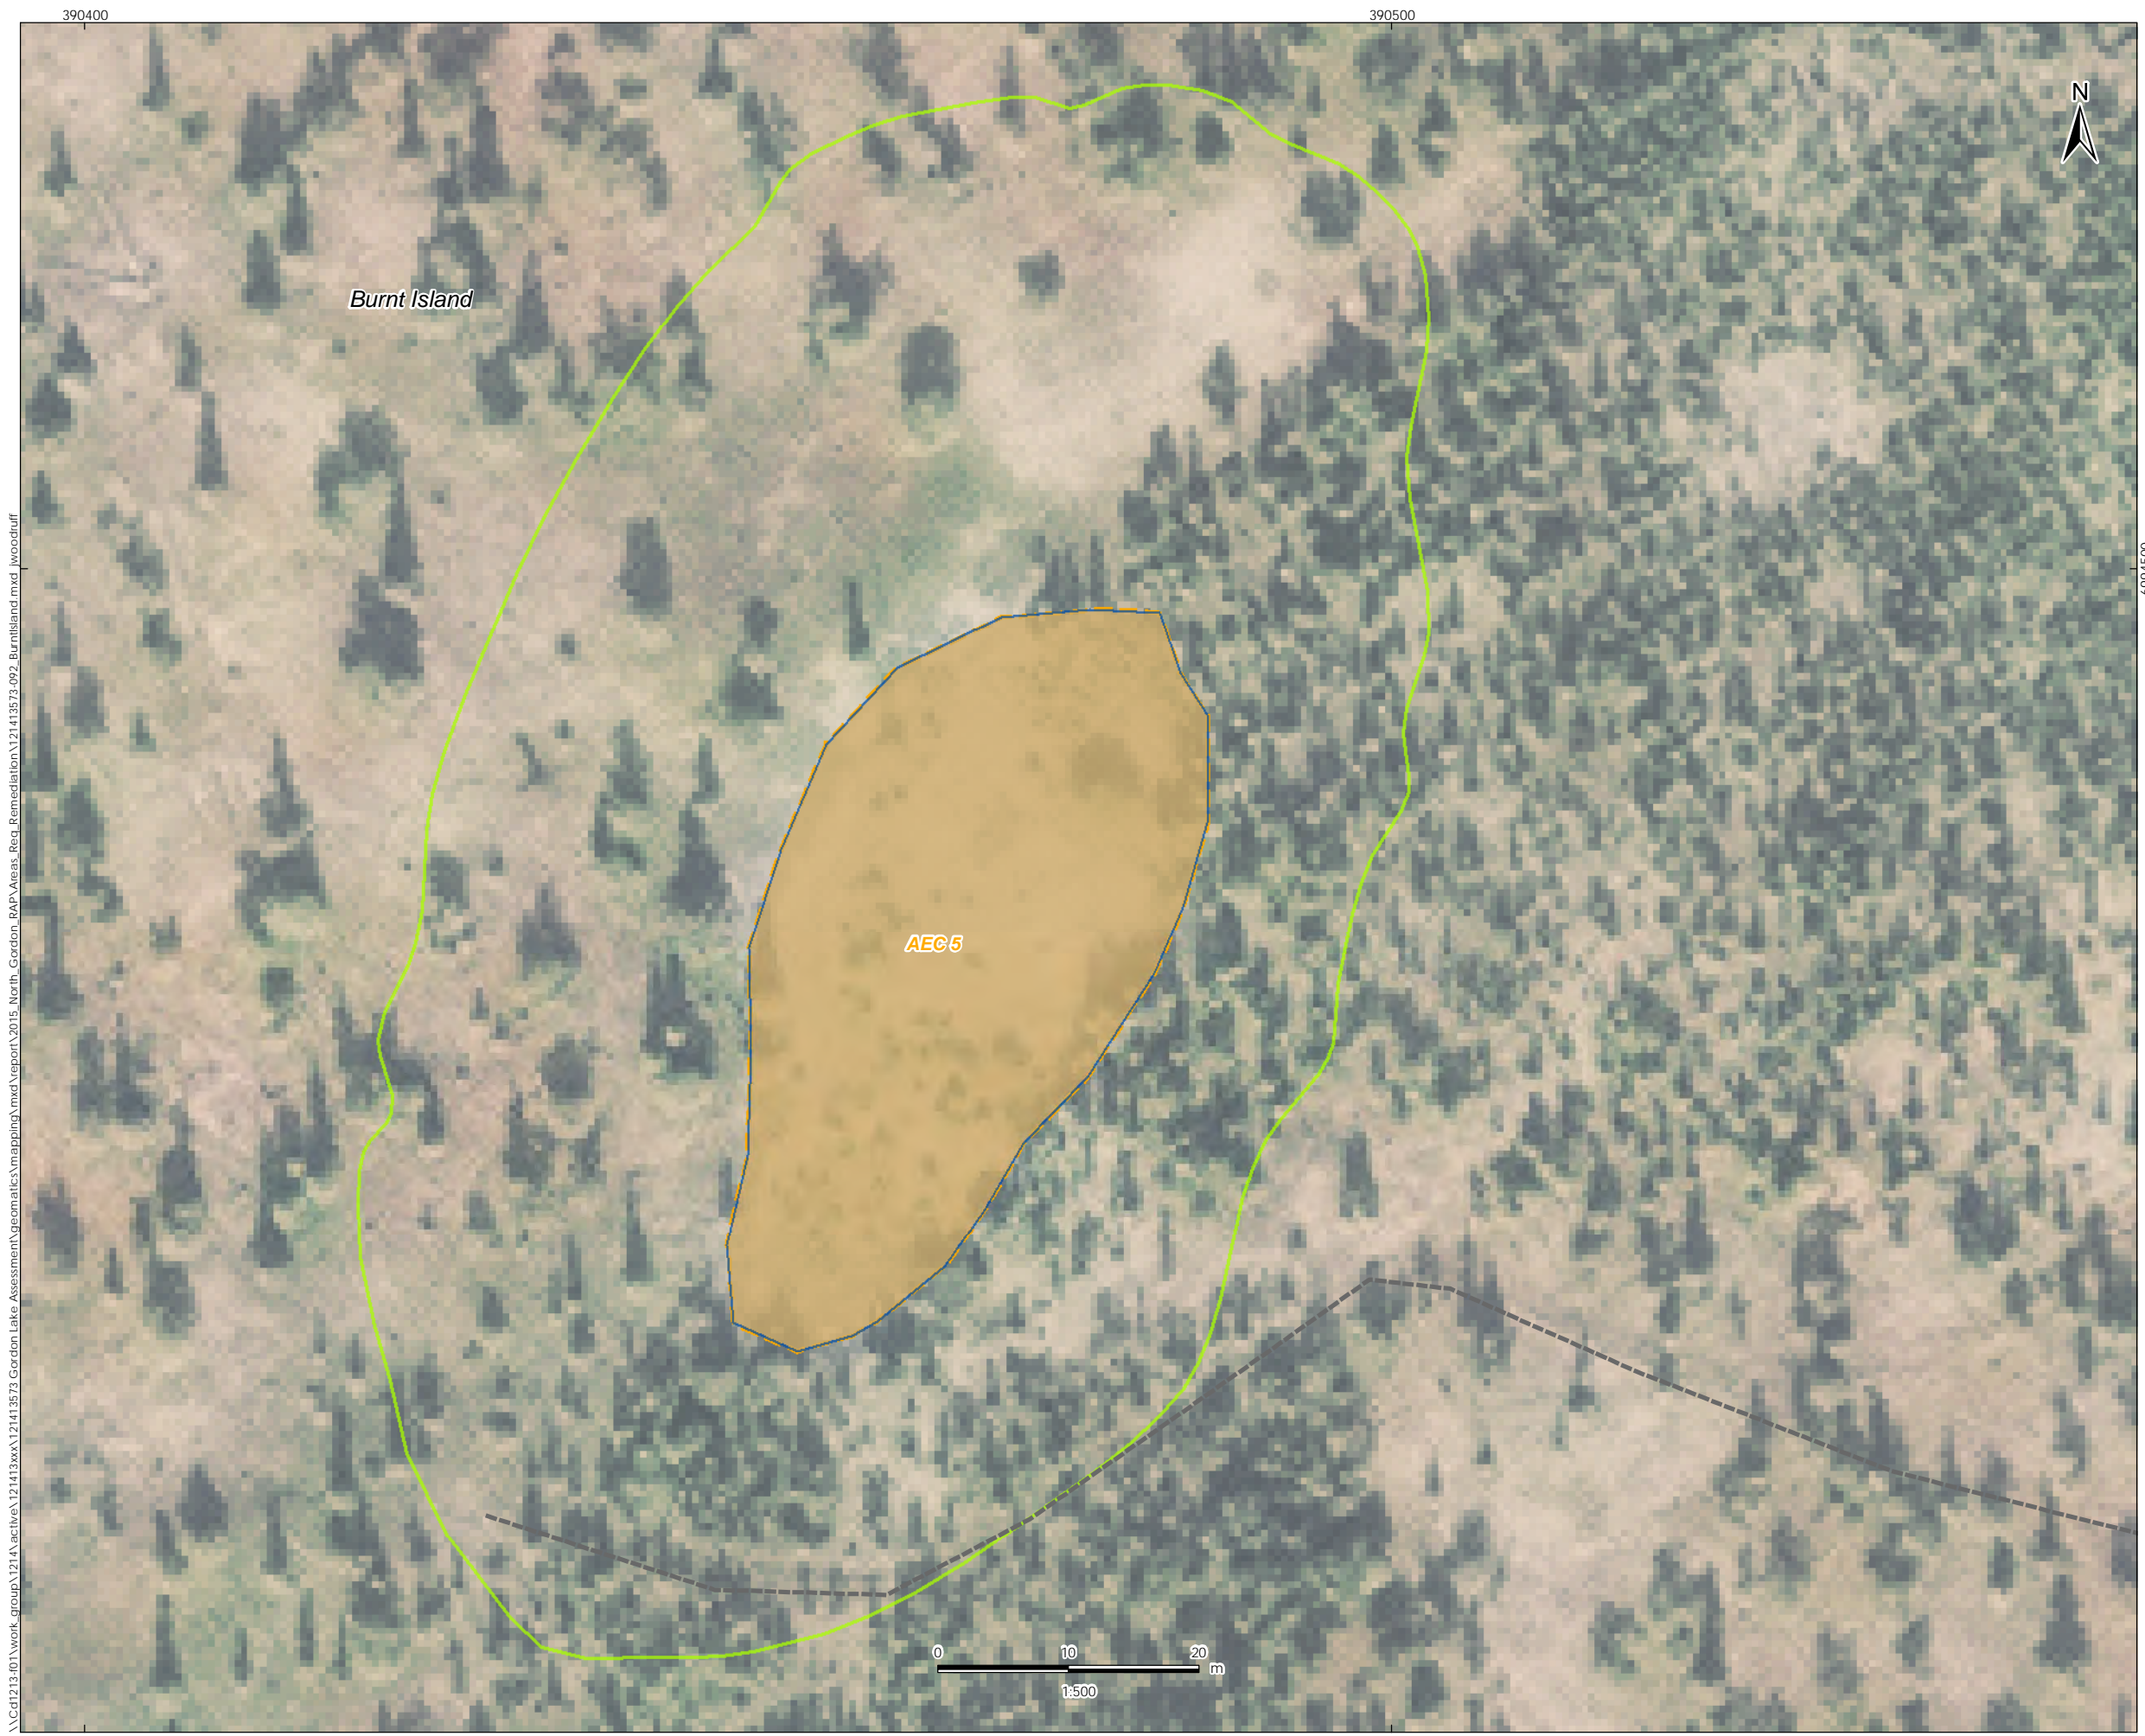
Title
**Burnt Island - Tailings Impoundment
Summary of Hazard Components**

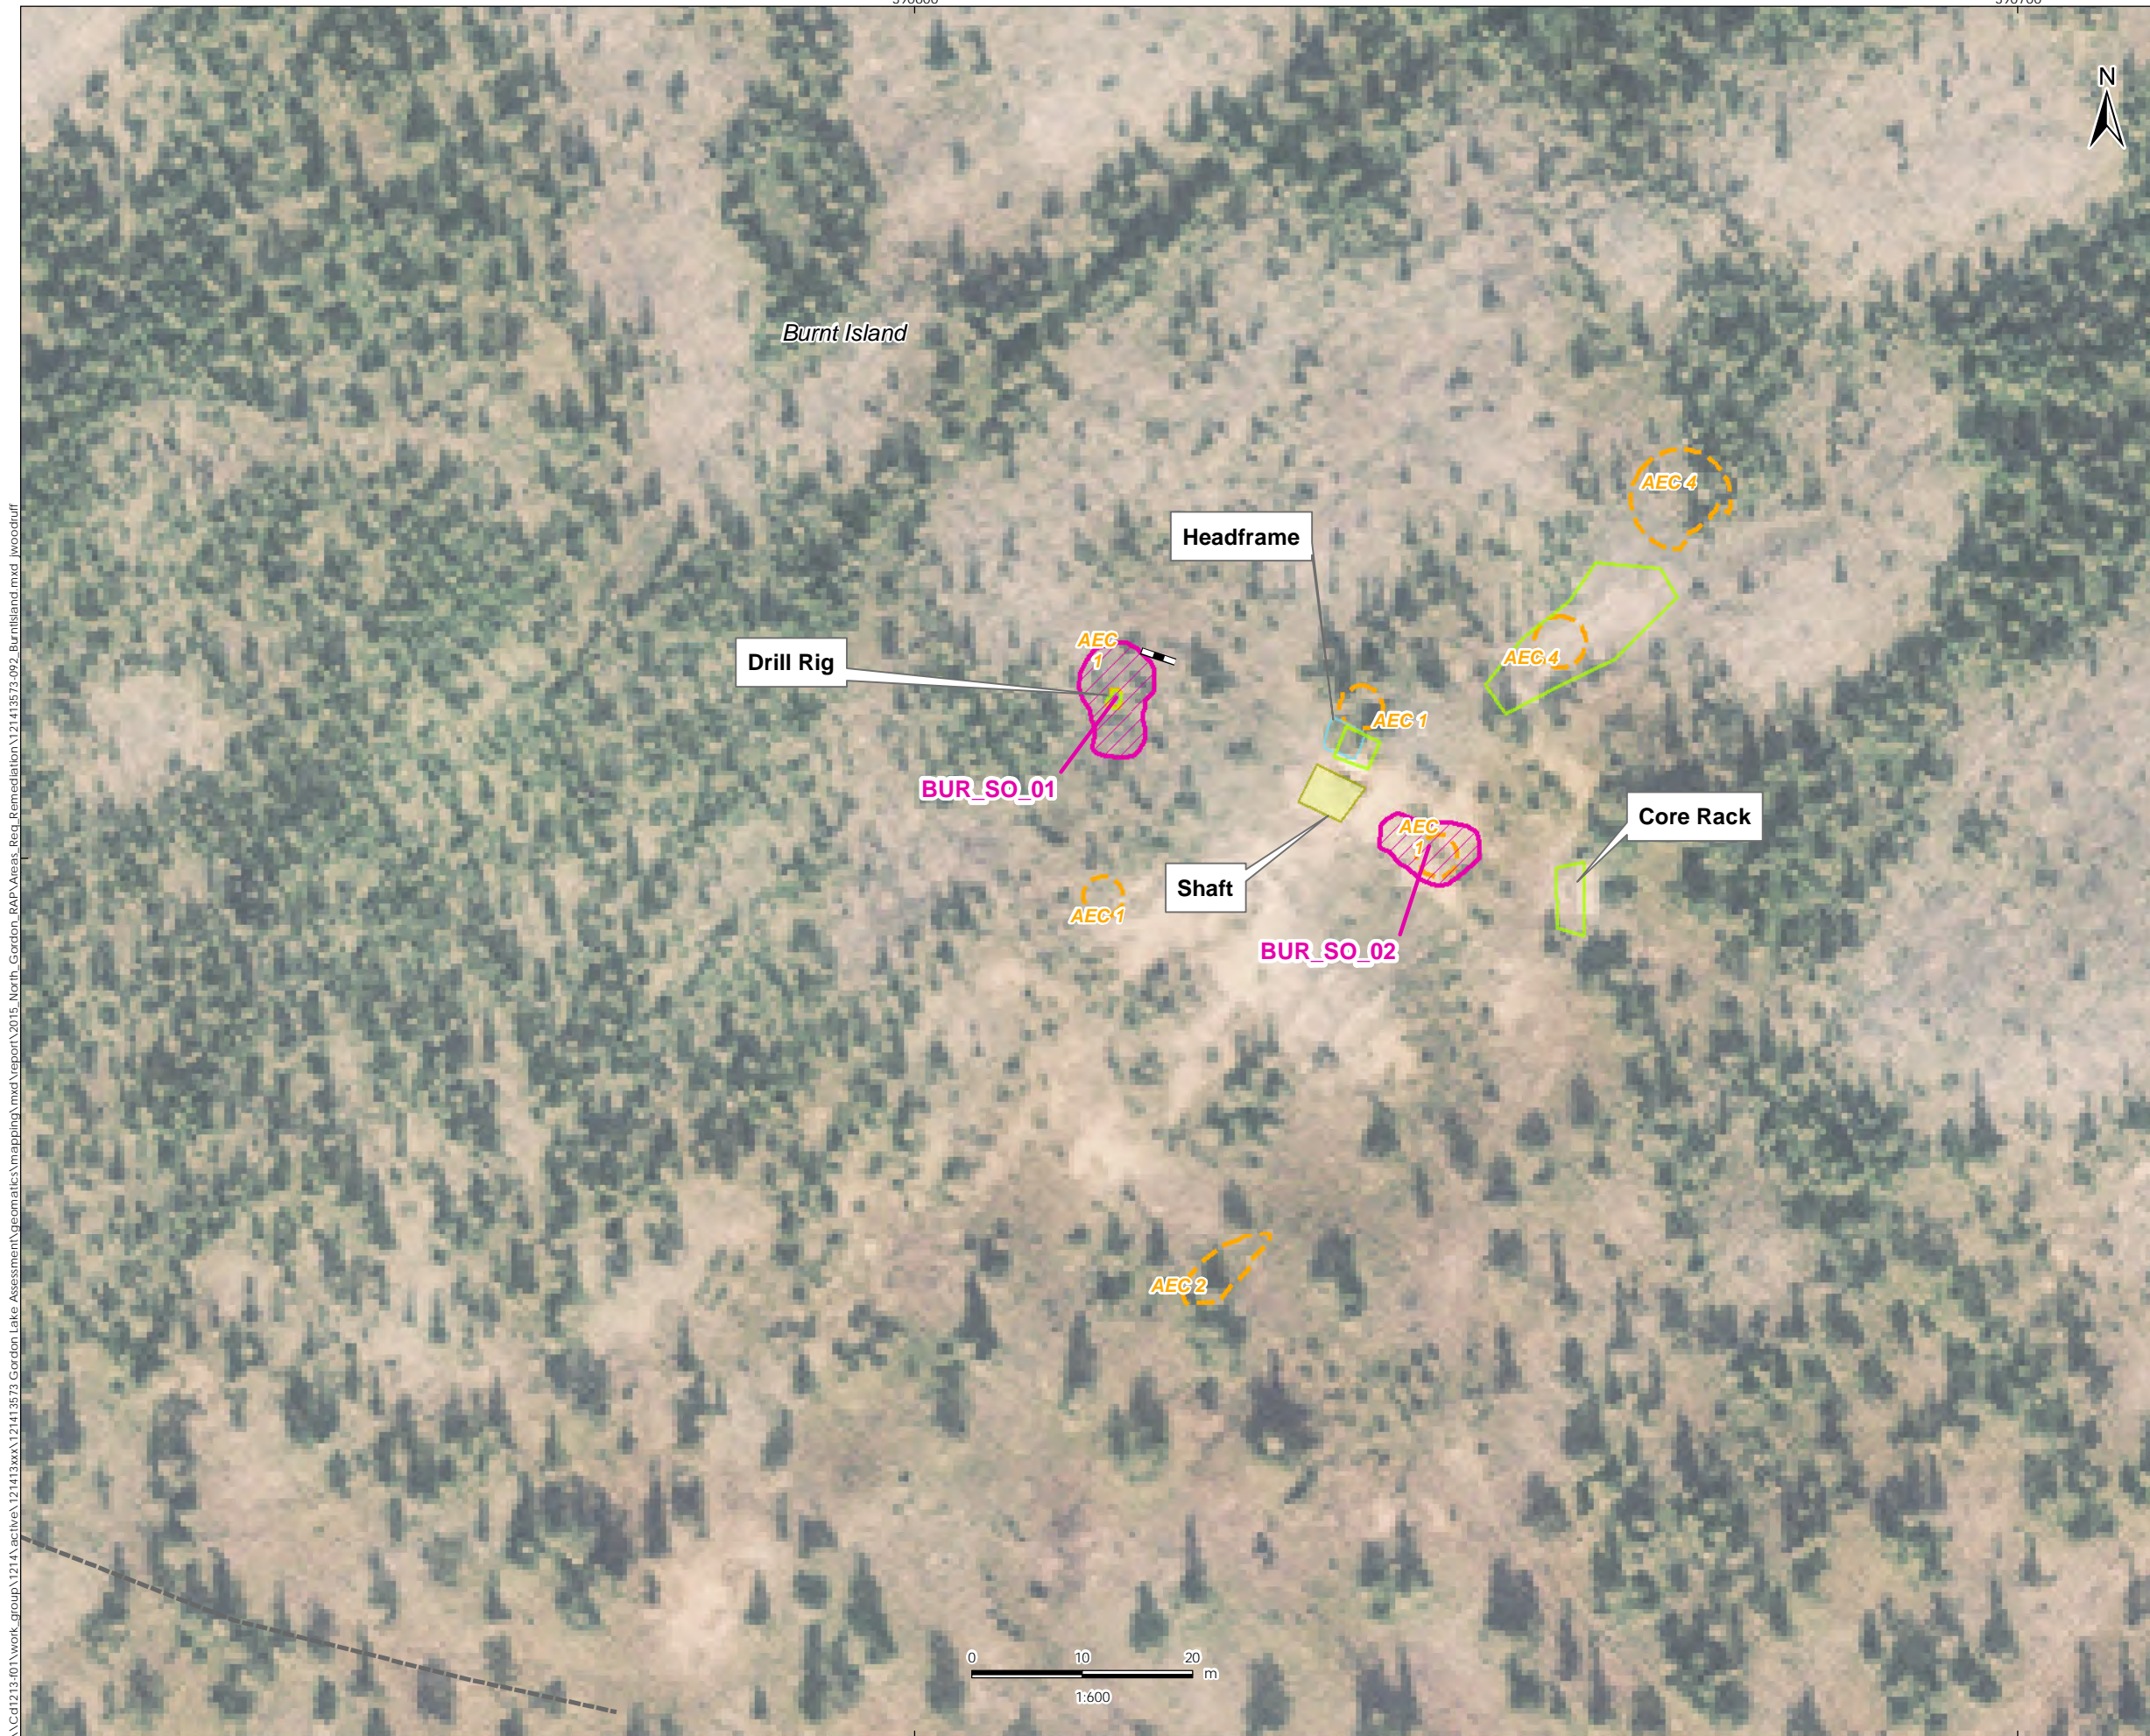
Burnt Island - Shaft Area
Summary of Hazard Components

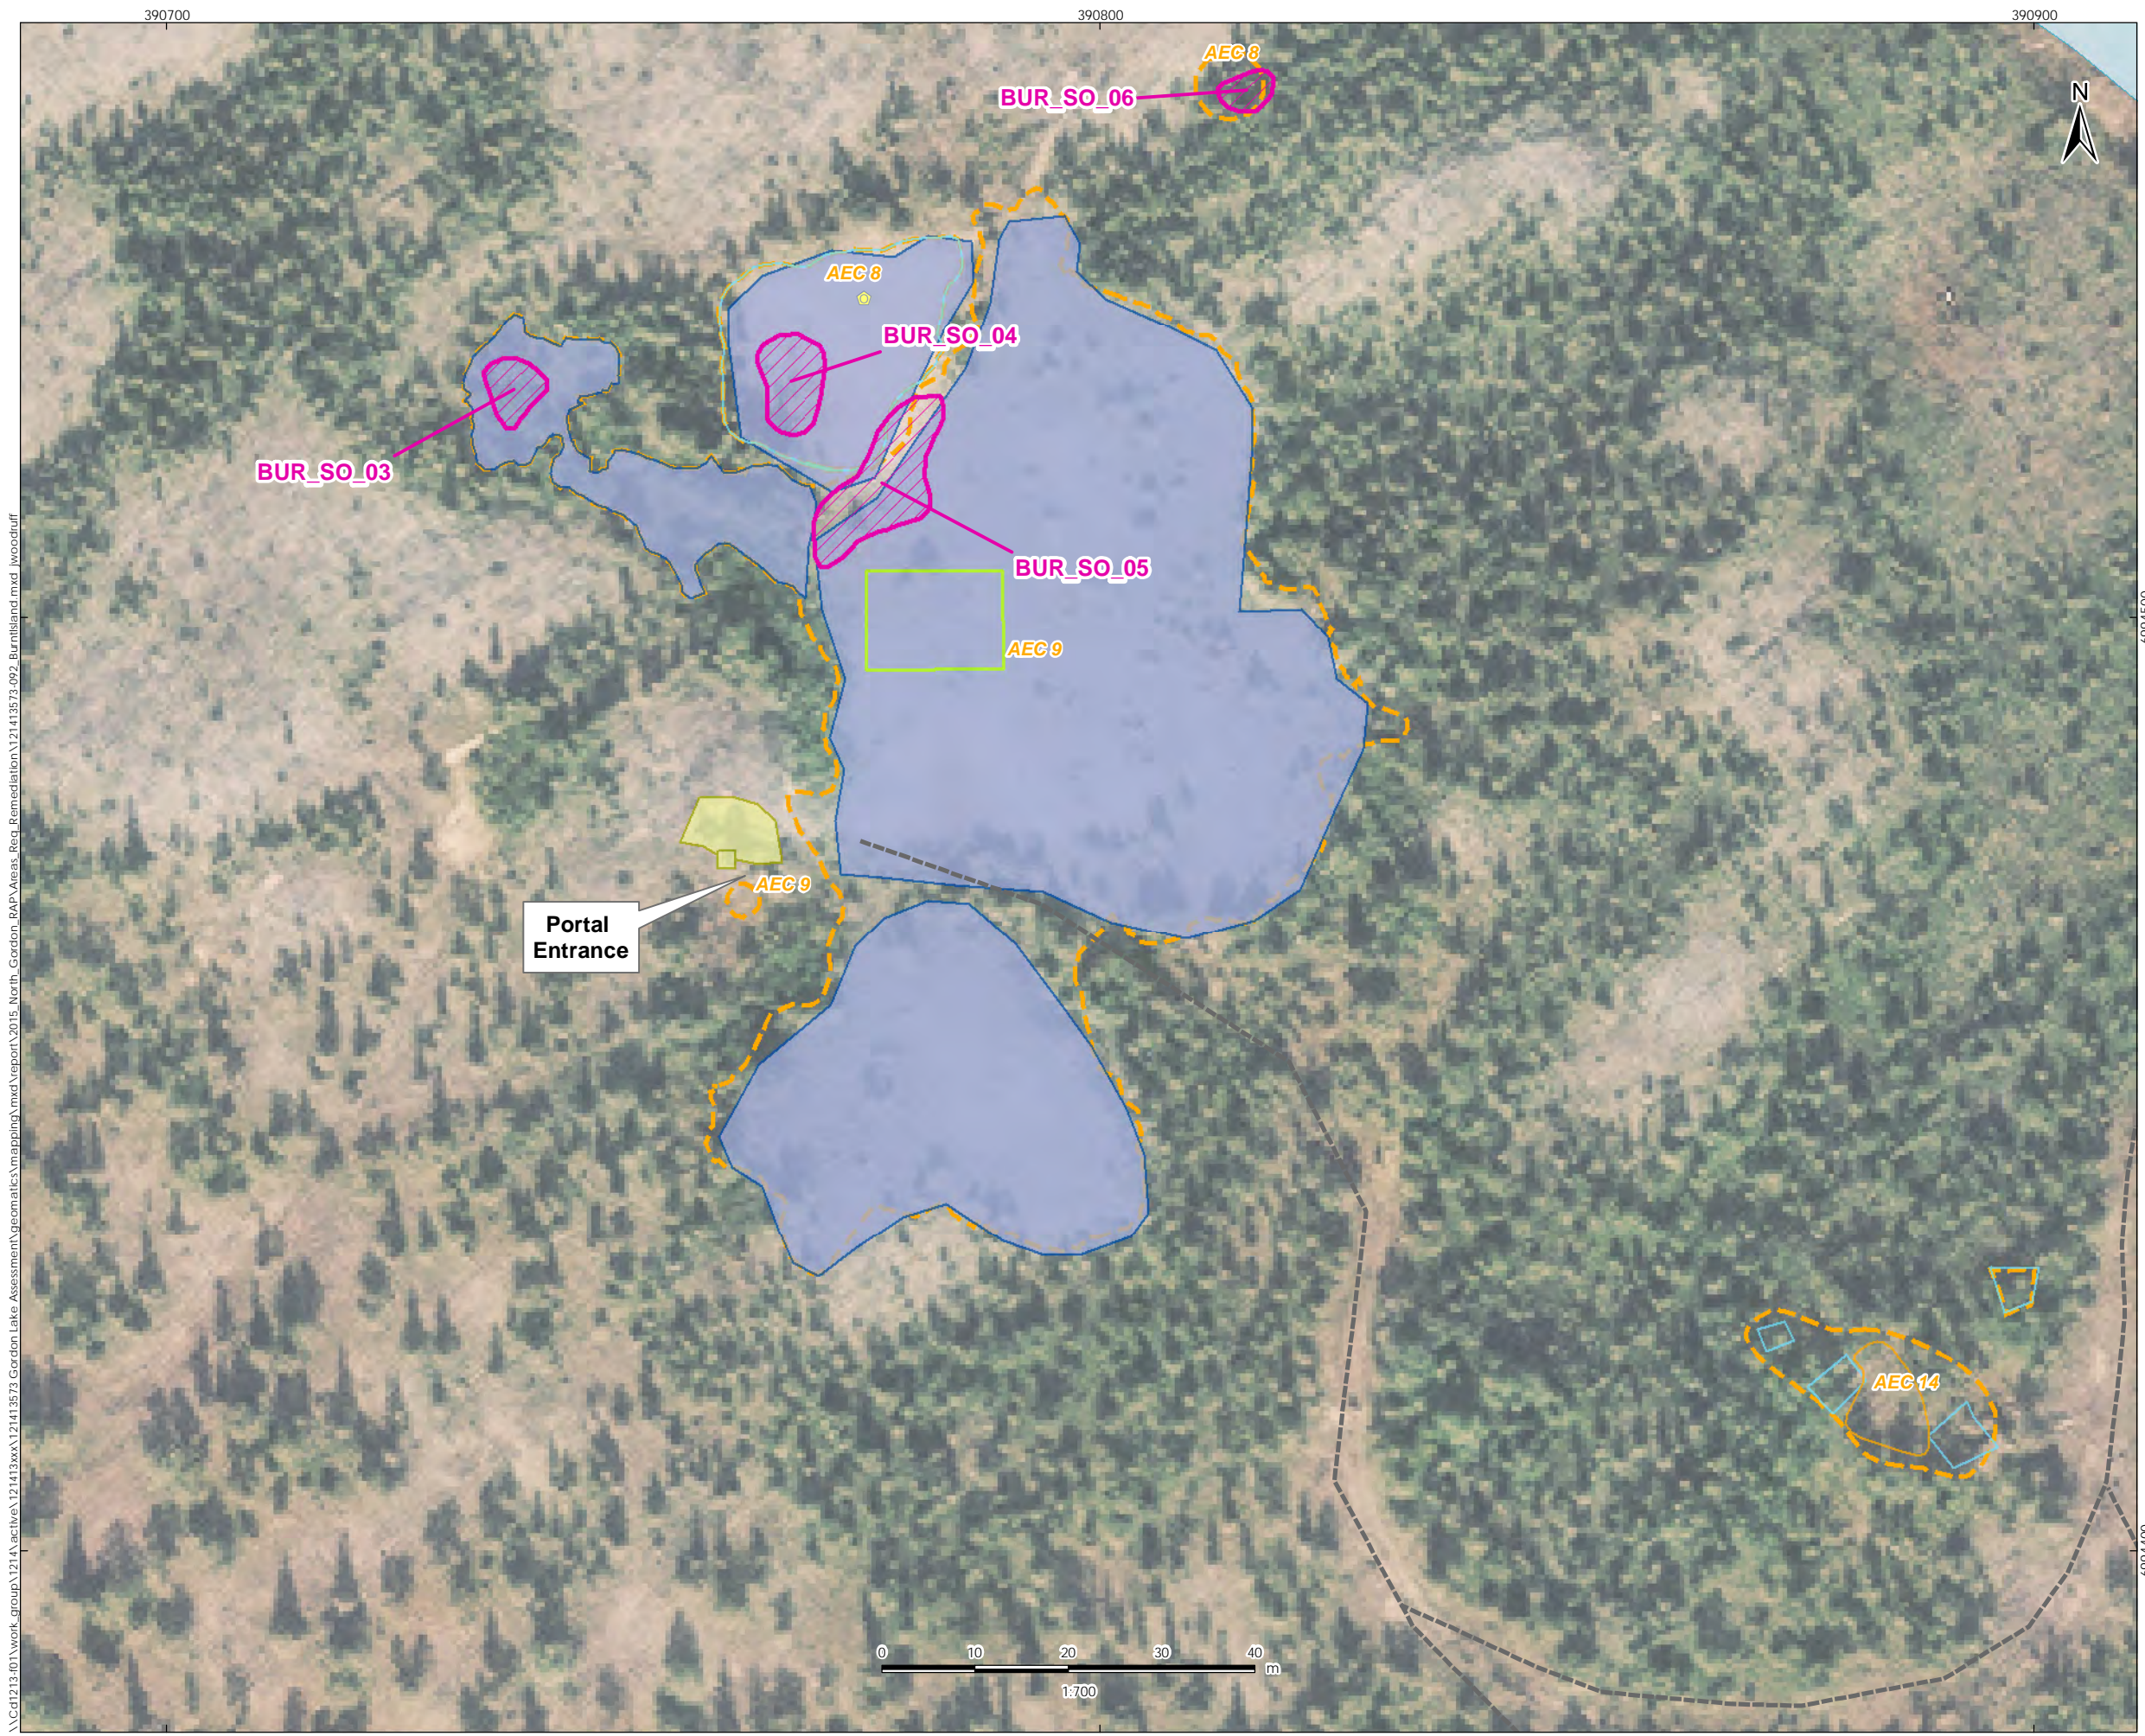
NAD 1983 UTM Zone 12N
 Client/Project
 Public Works and
 Government Services Canada
 Gordon Lake Group Remedial Action Plan
 Figure No.
A-5
 Title
**Burnt Island - Waste Rock Area
 Summary of Hazard Components**

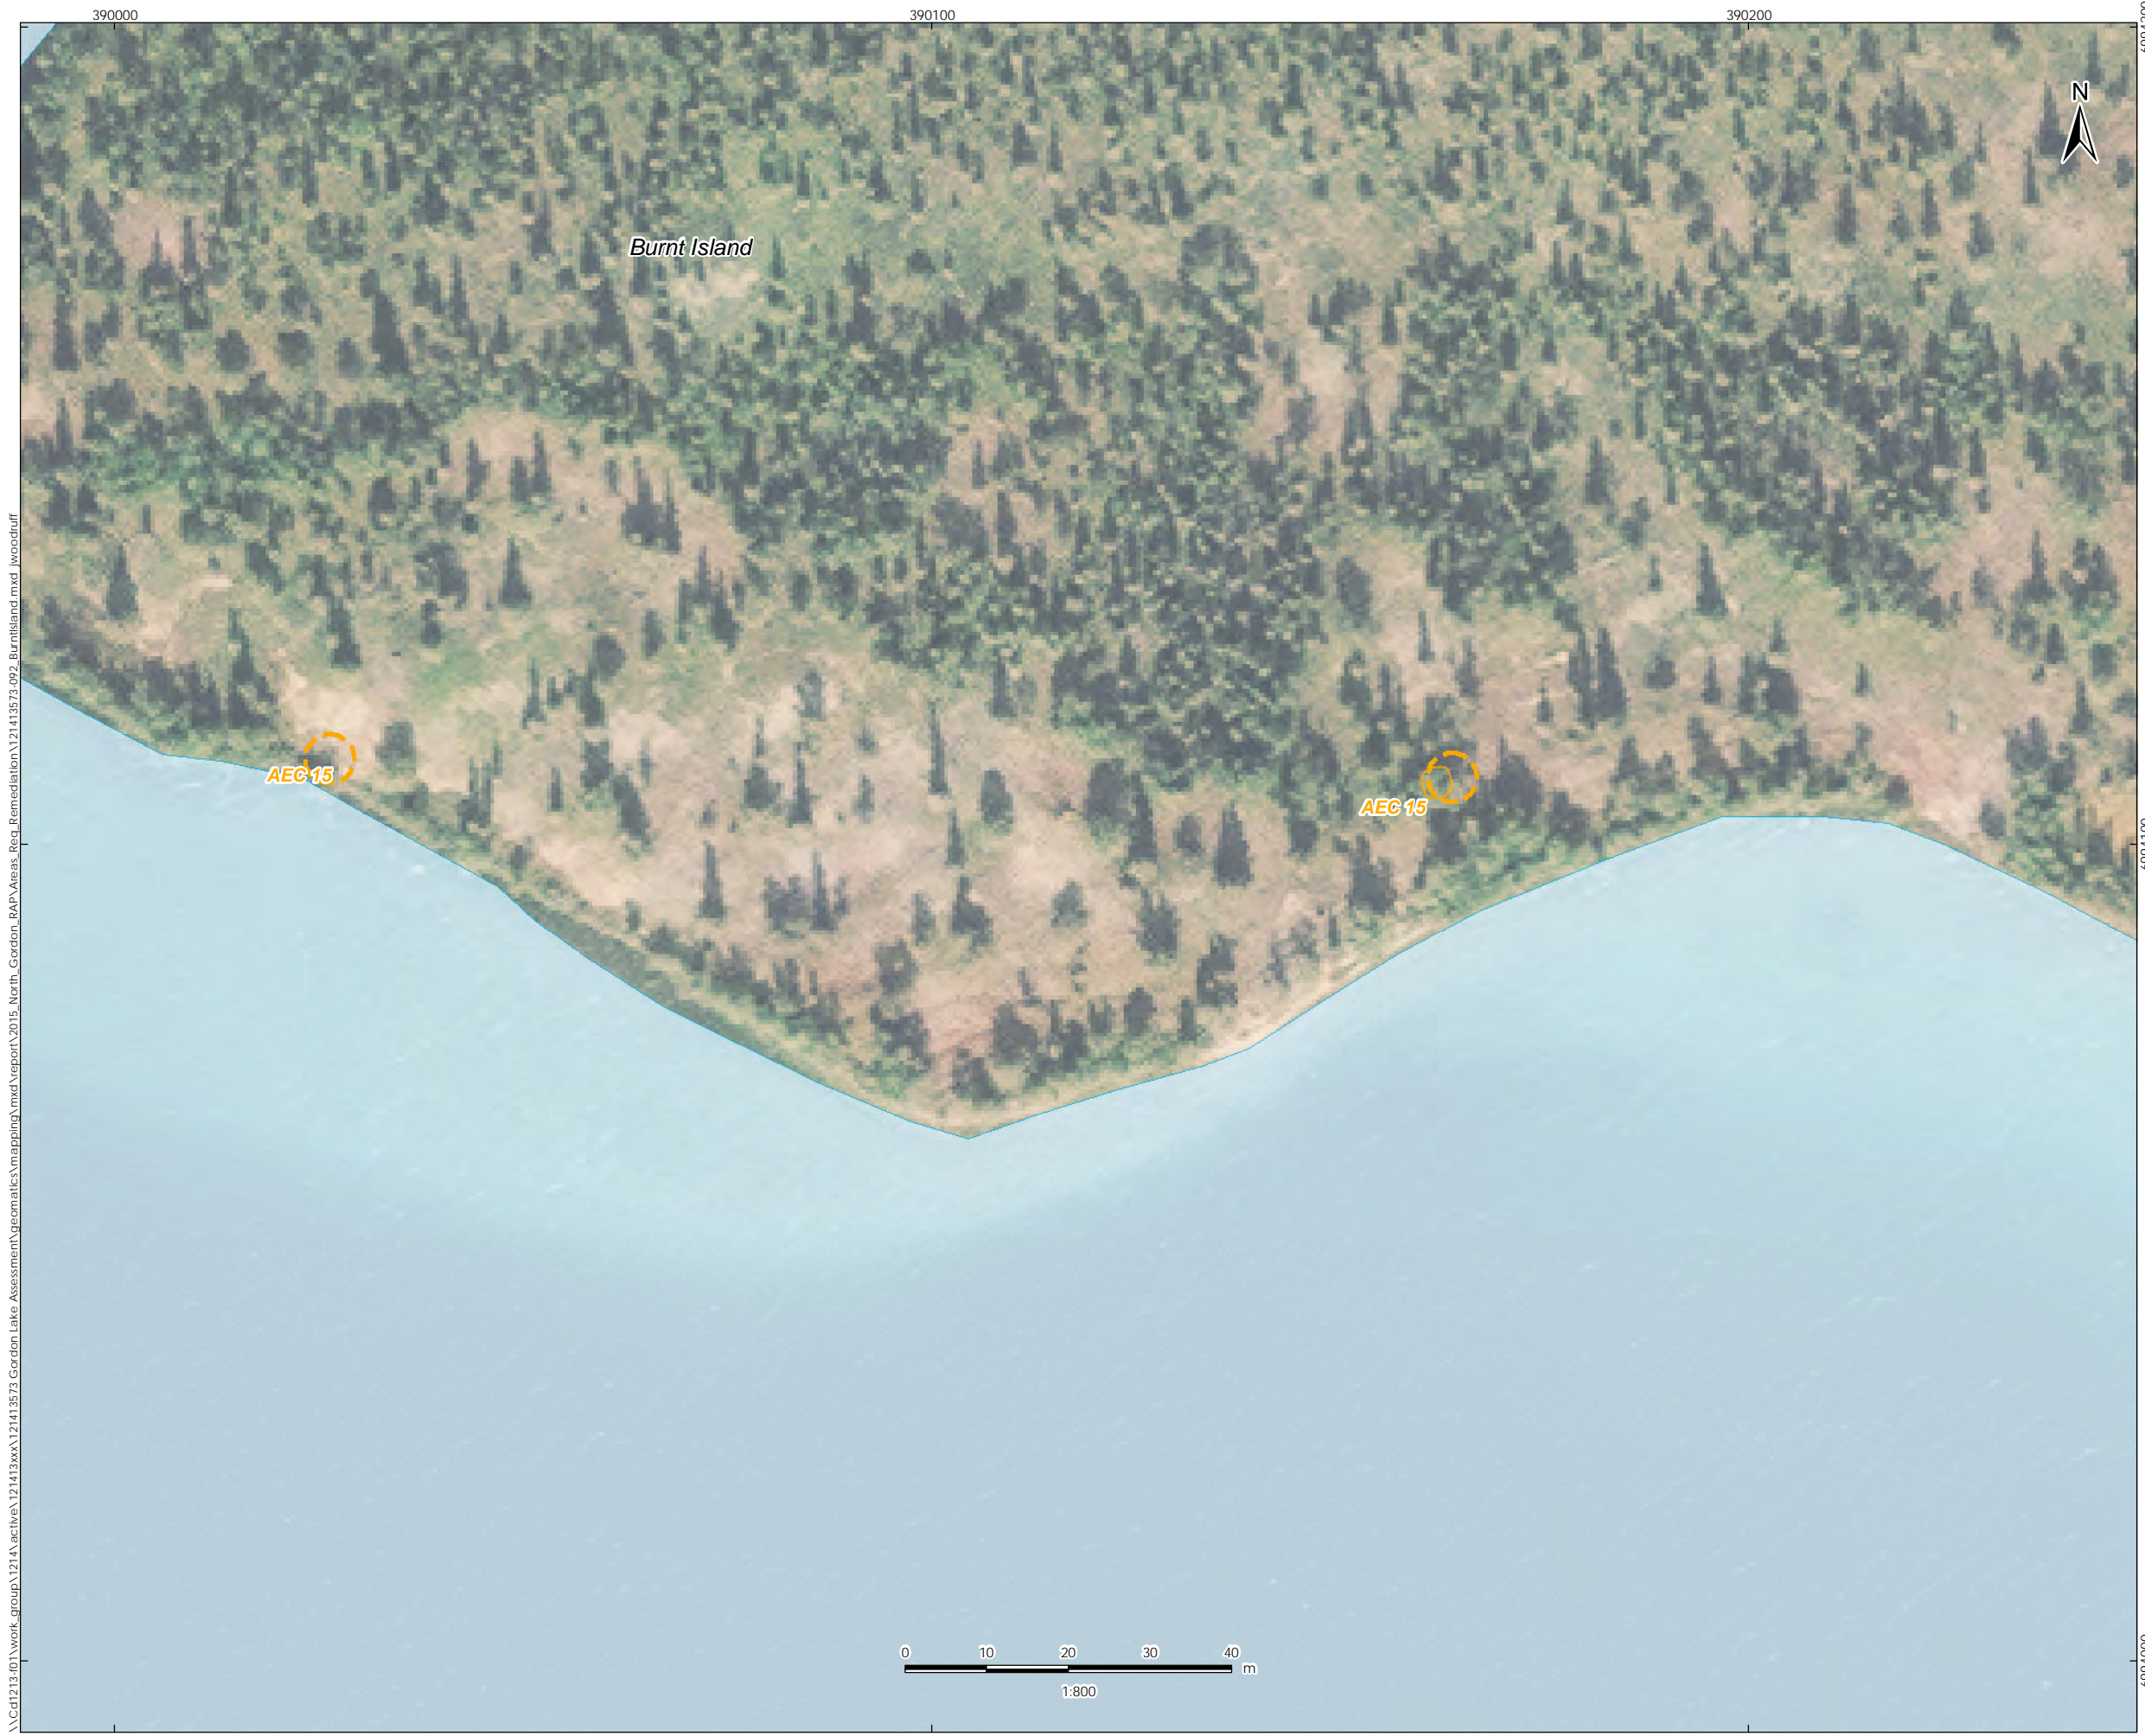
Title
**Burnt Island - Old Saw Mill
Summary of Hazard Components**
