**FINAL REPORT: GORDON LAKE
GROUP REMEDIAL ACTION
PLAN**

Prepared for:
Public Works and Government
Services Canada and Aboriginal
Affairs and Northern
Development Canada

Prepared by:
Stantec Consulting Ltd.

March 31, 2016

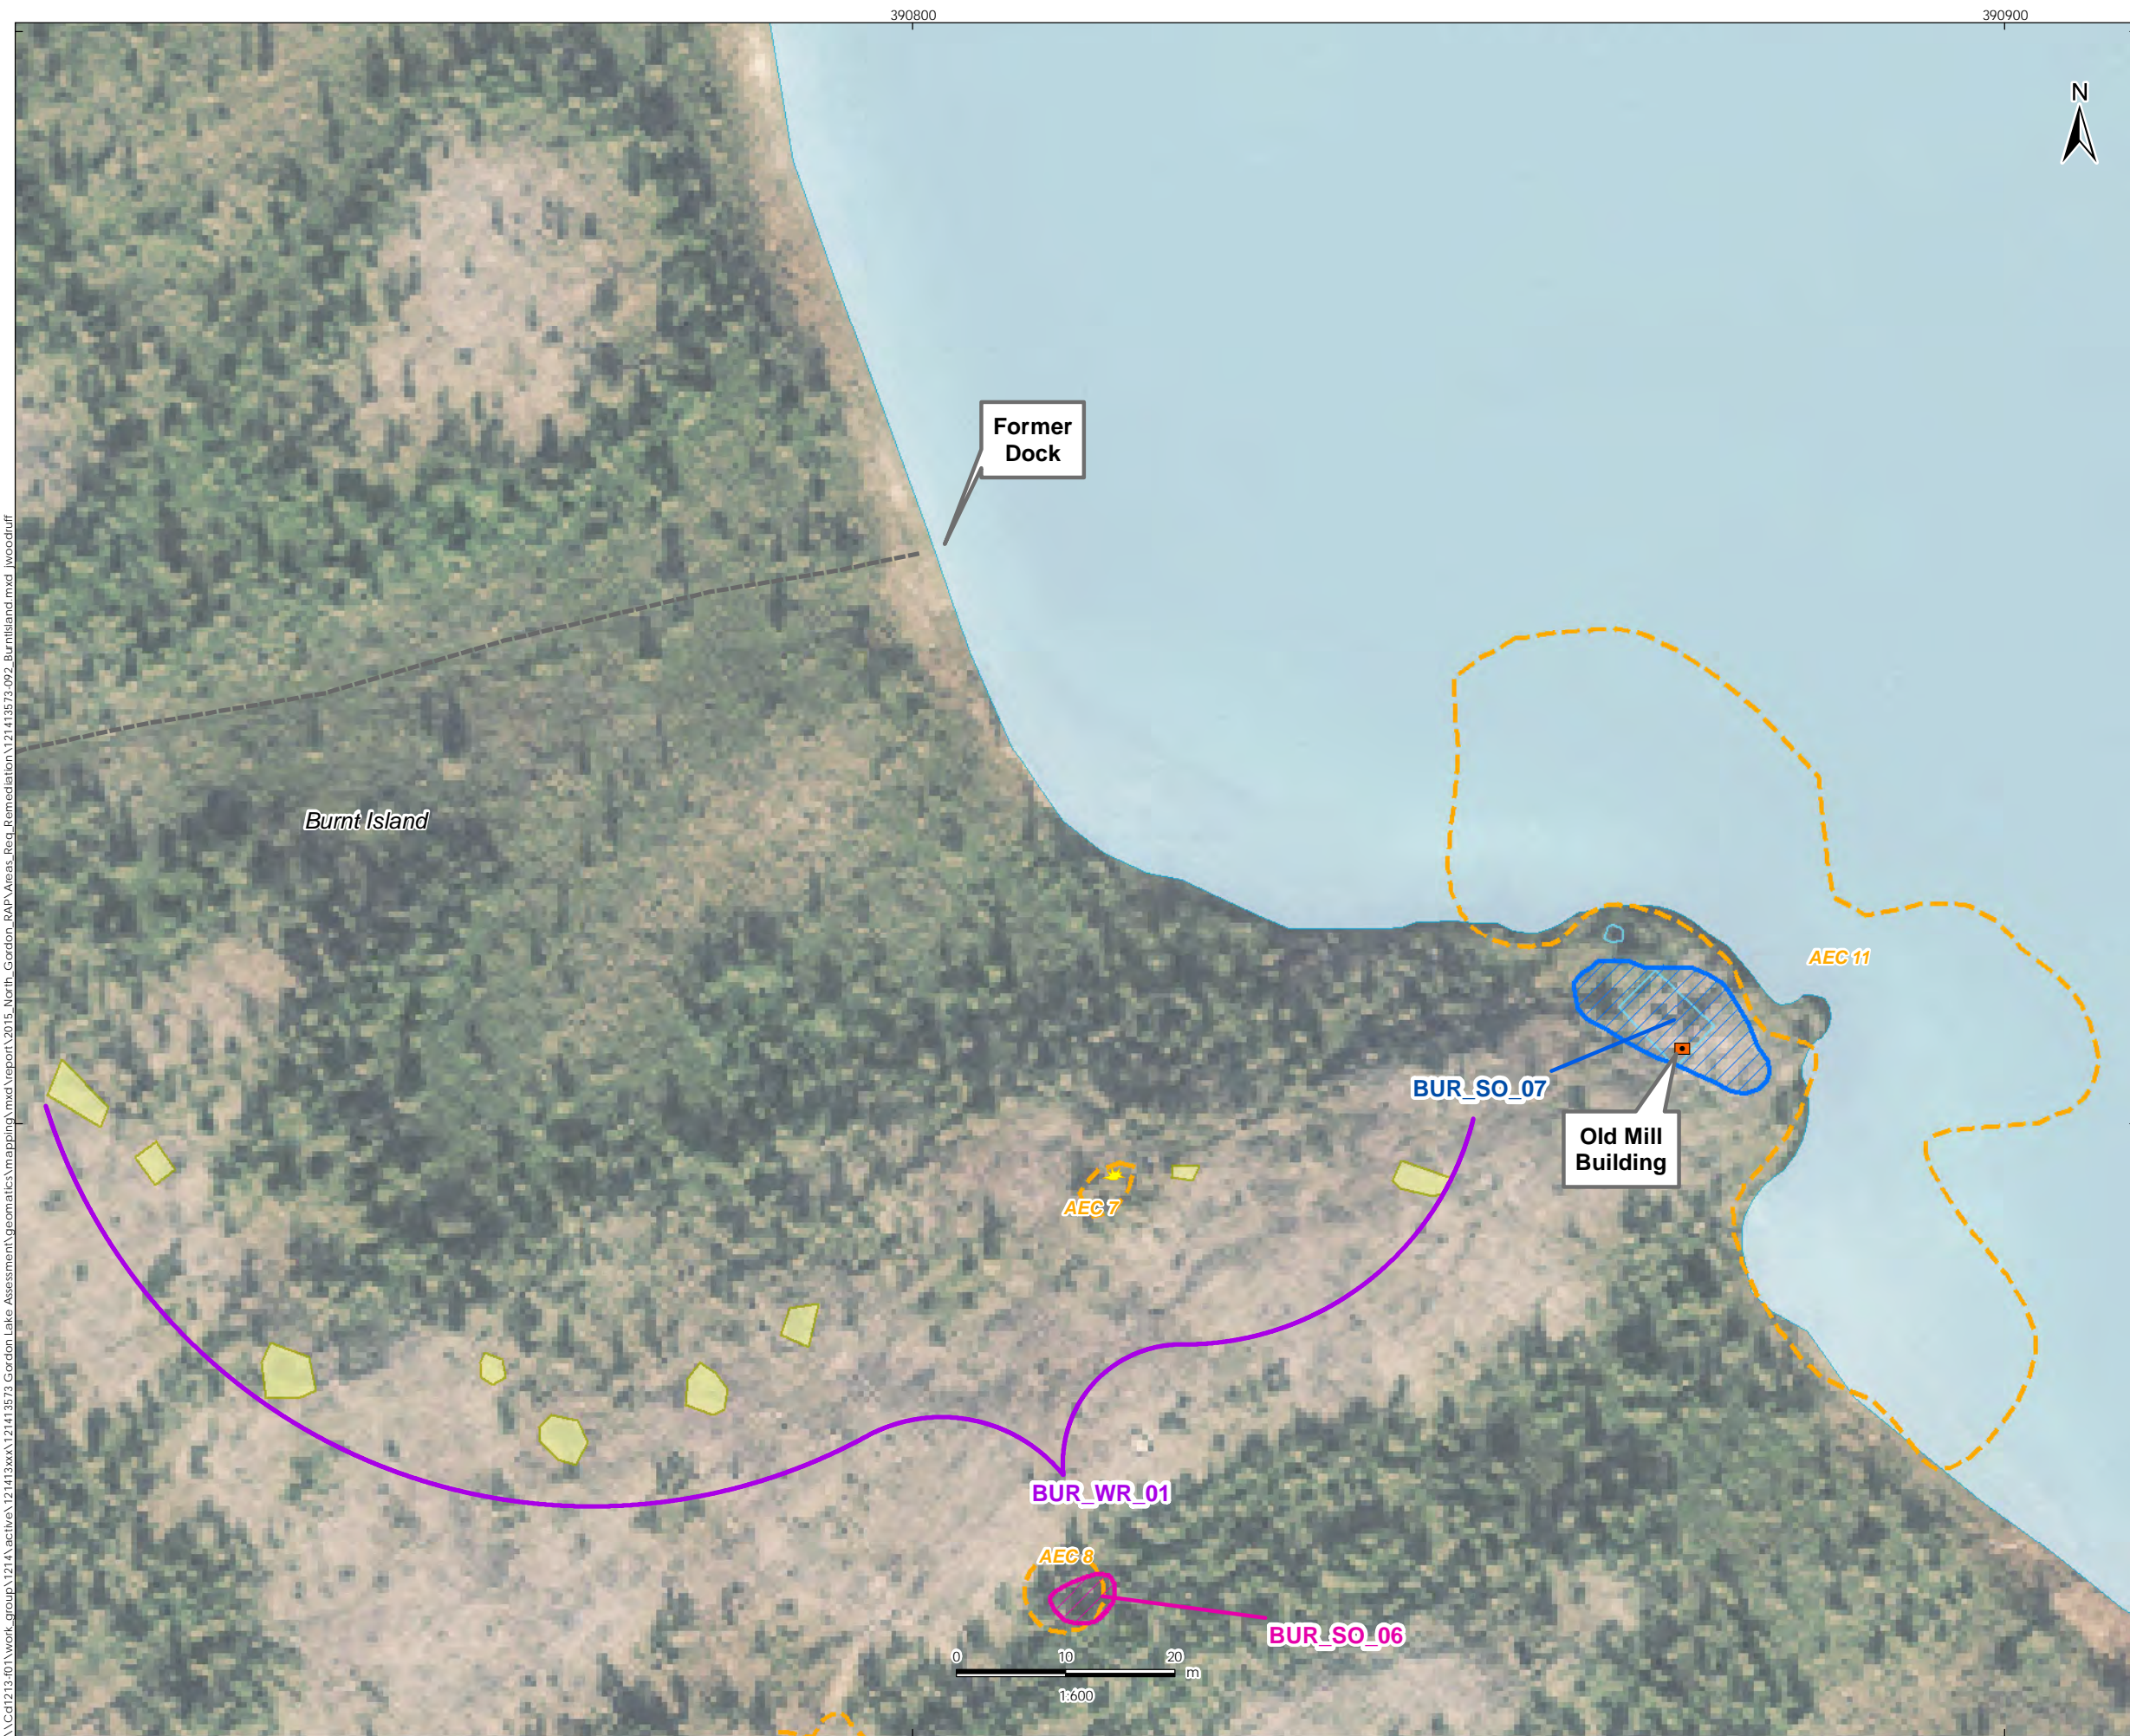
Title
**Burnt Island - Old Mill Area
Summary of Hazard Components**

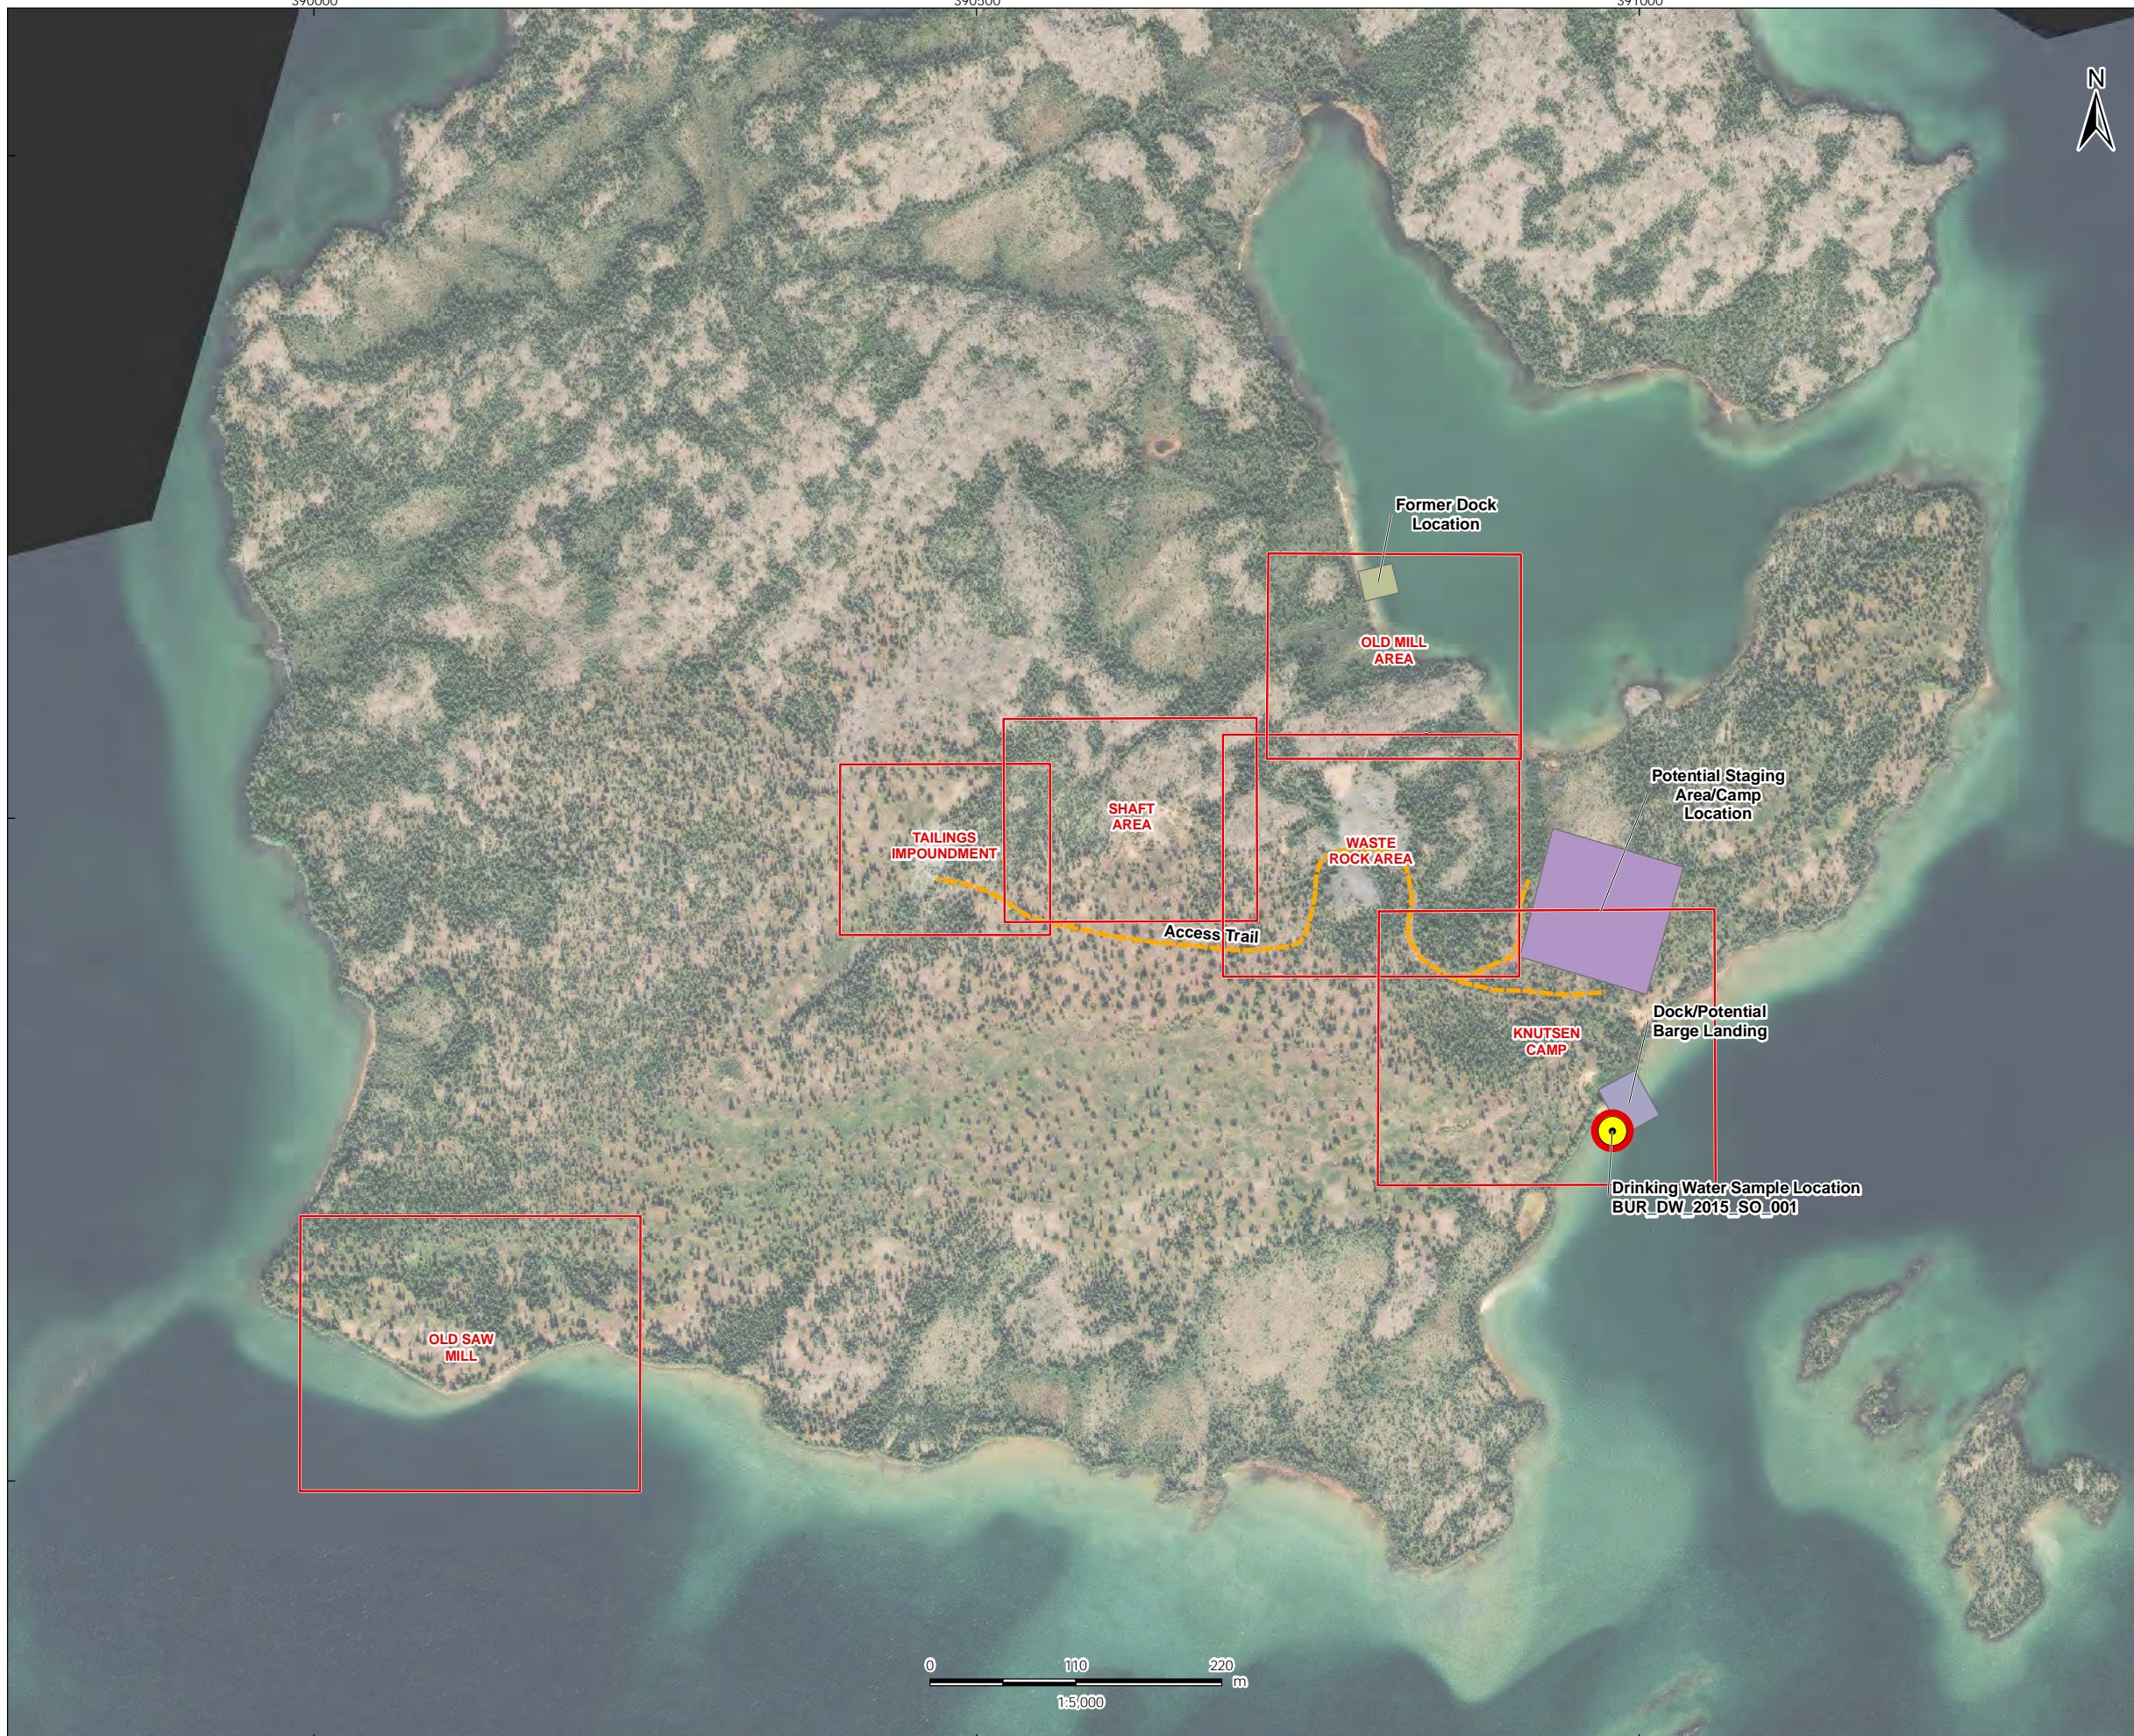
- Exceedance of Applicable Guidelines
- Drinking Water Sample Location
- Access Trail
- Infrastructure Type
 - Dock/Potential Barge Landing
 - Former Dock Location
 - Potential Staging Area/Camp Location

Title
 Burnt Island
 Infrastructure Overview

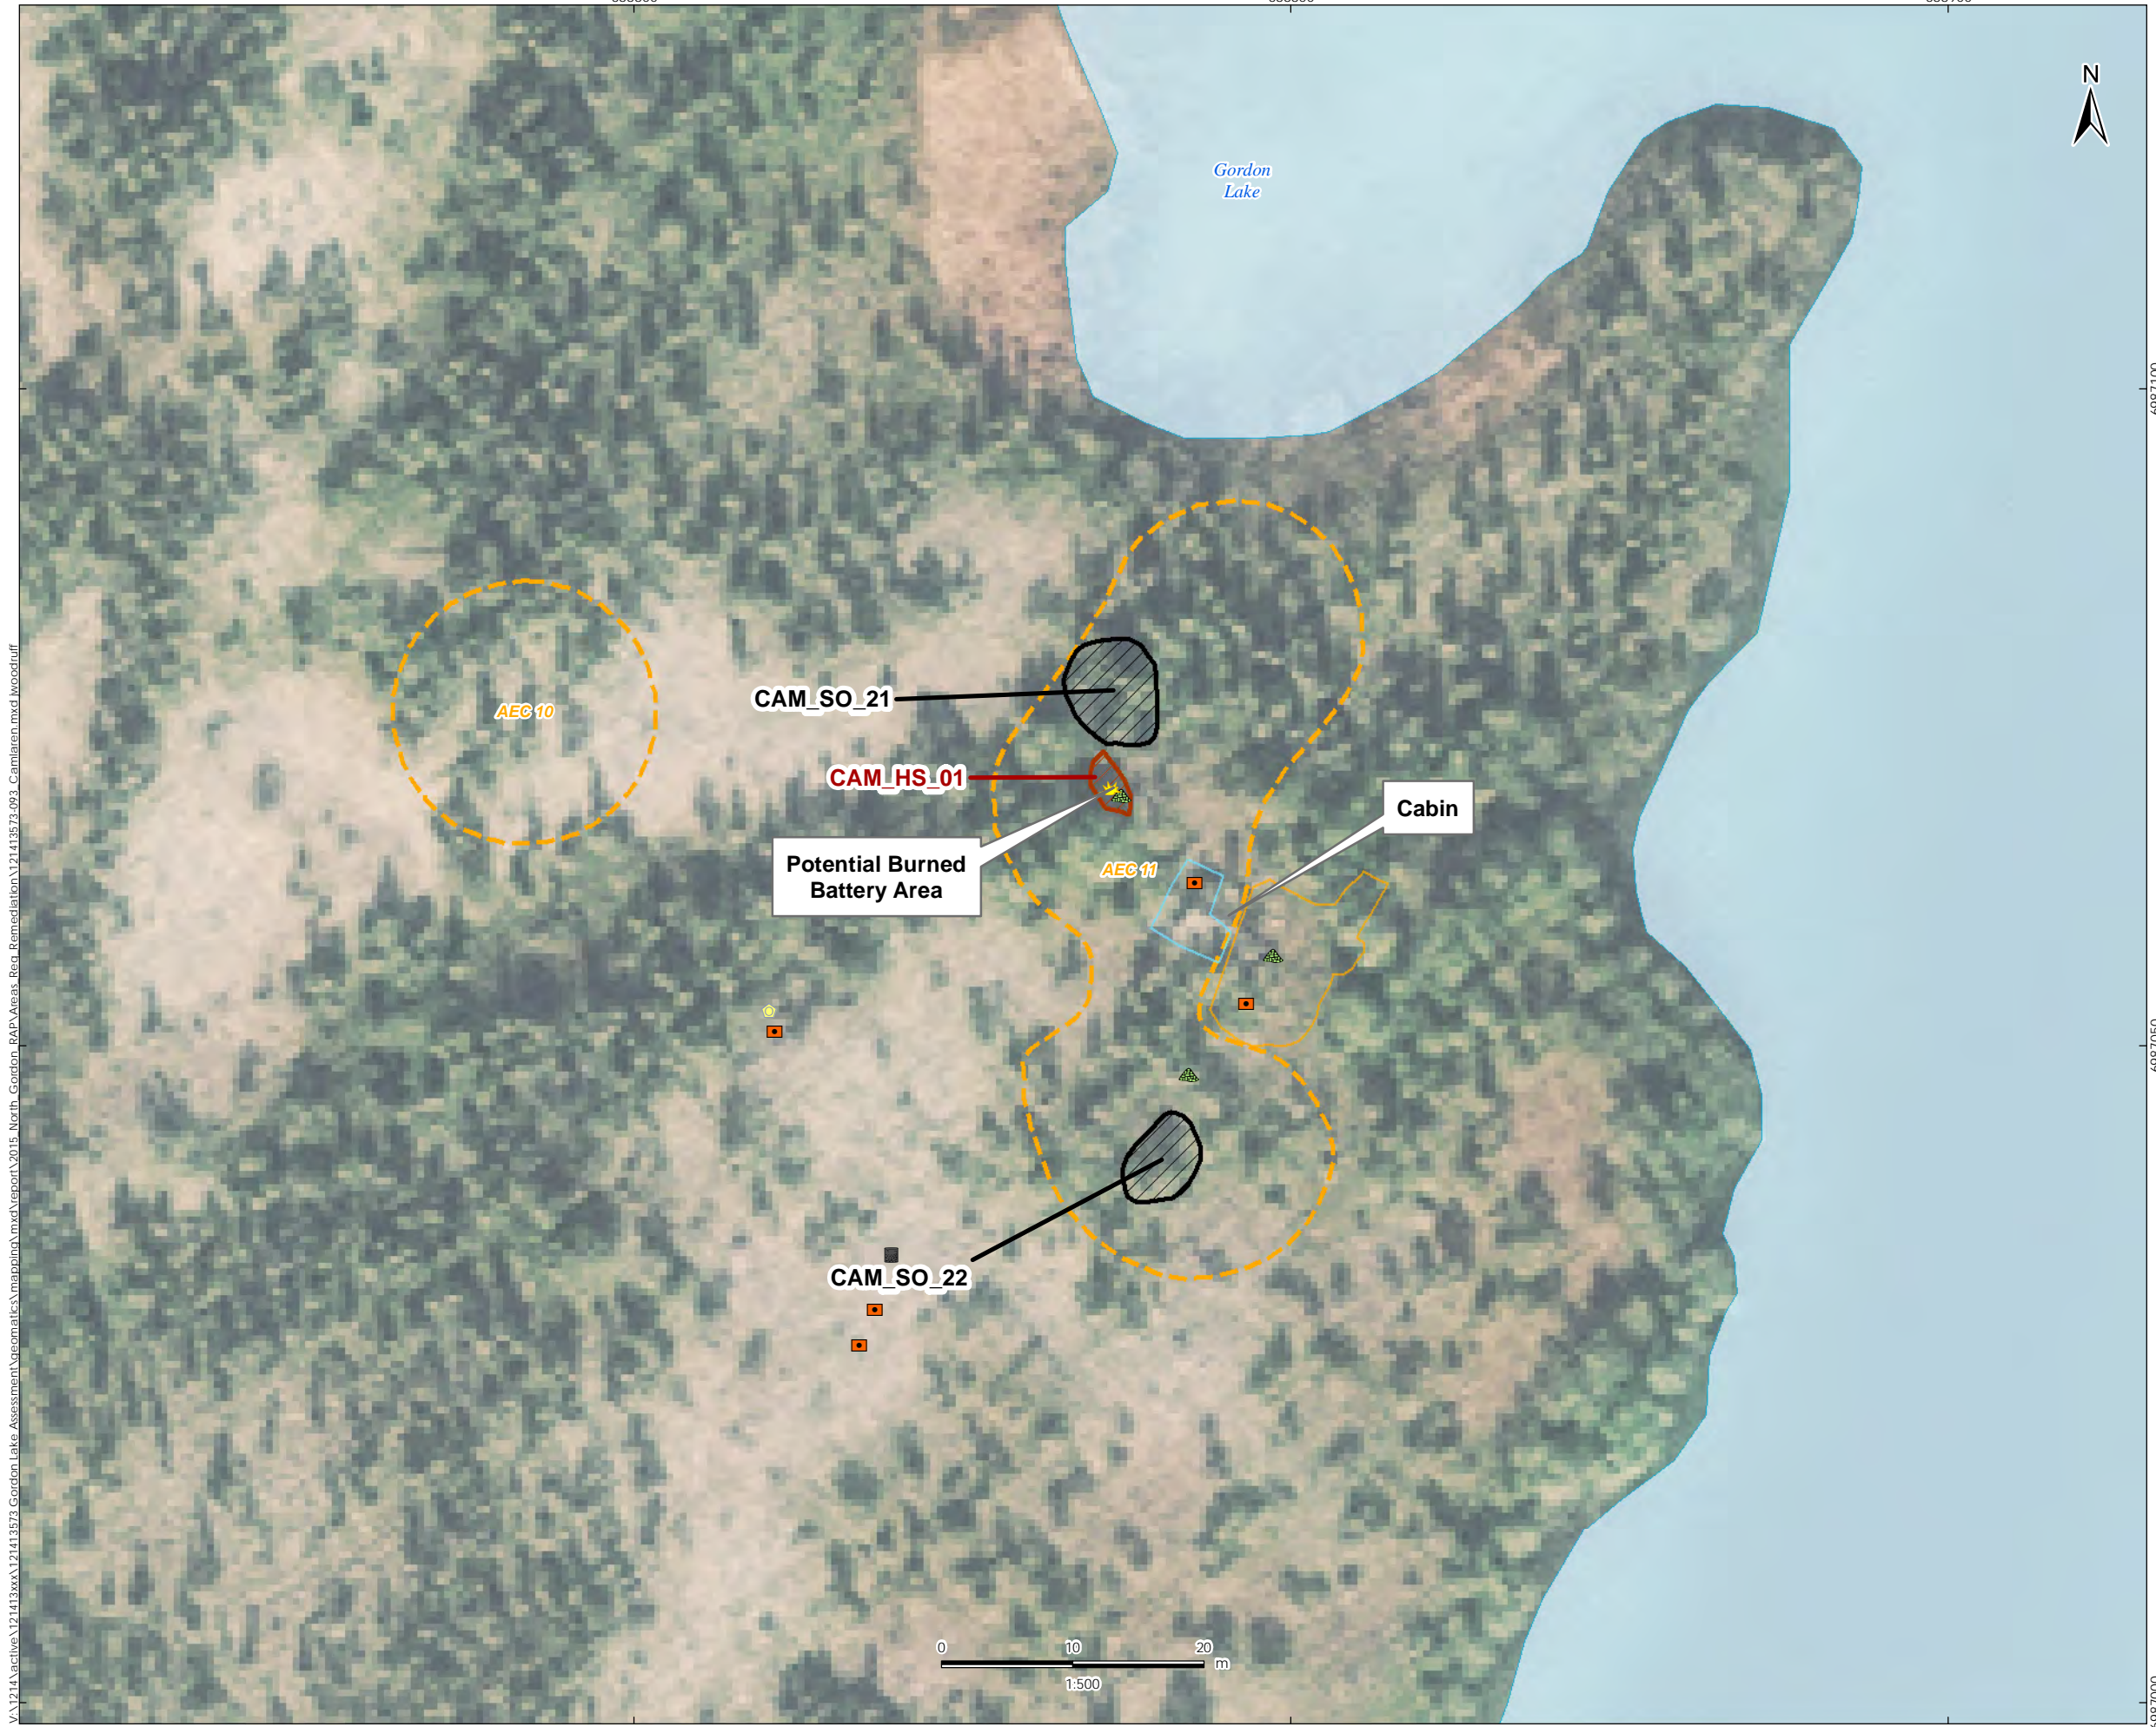
Title
Camlaren - North Cabin
Summary of Hazard Components

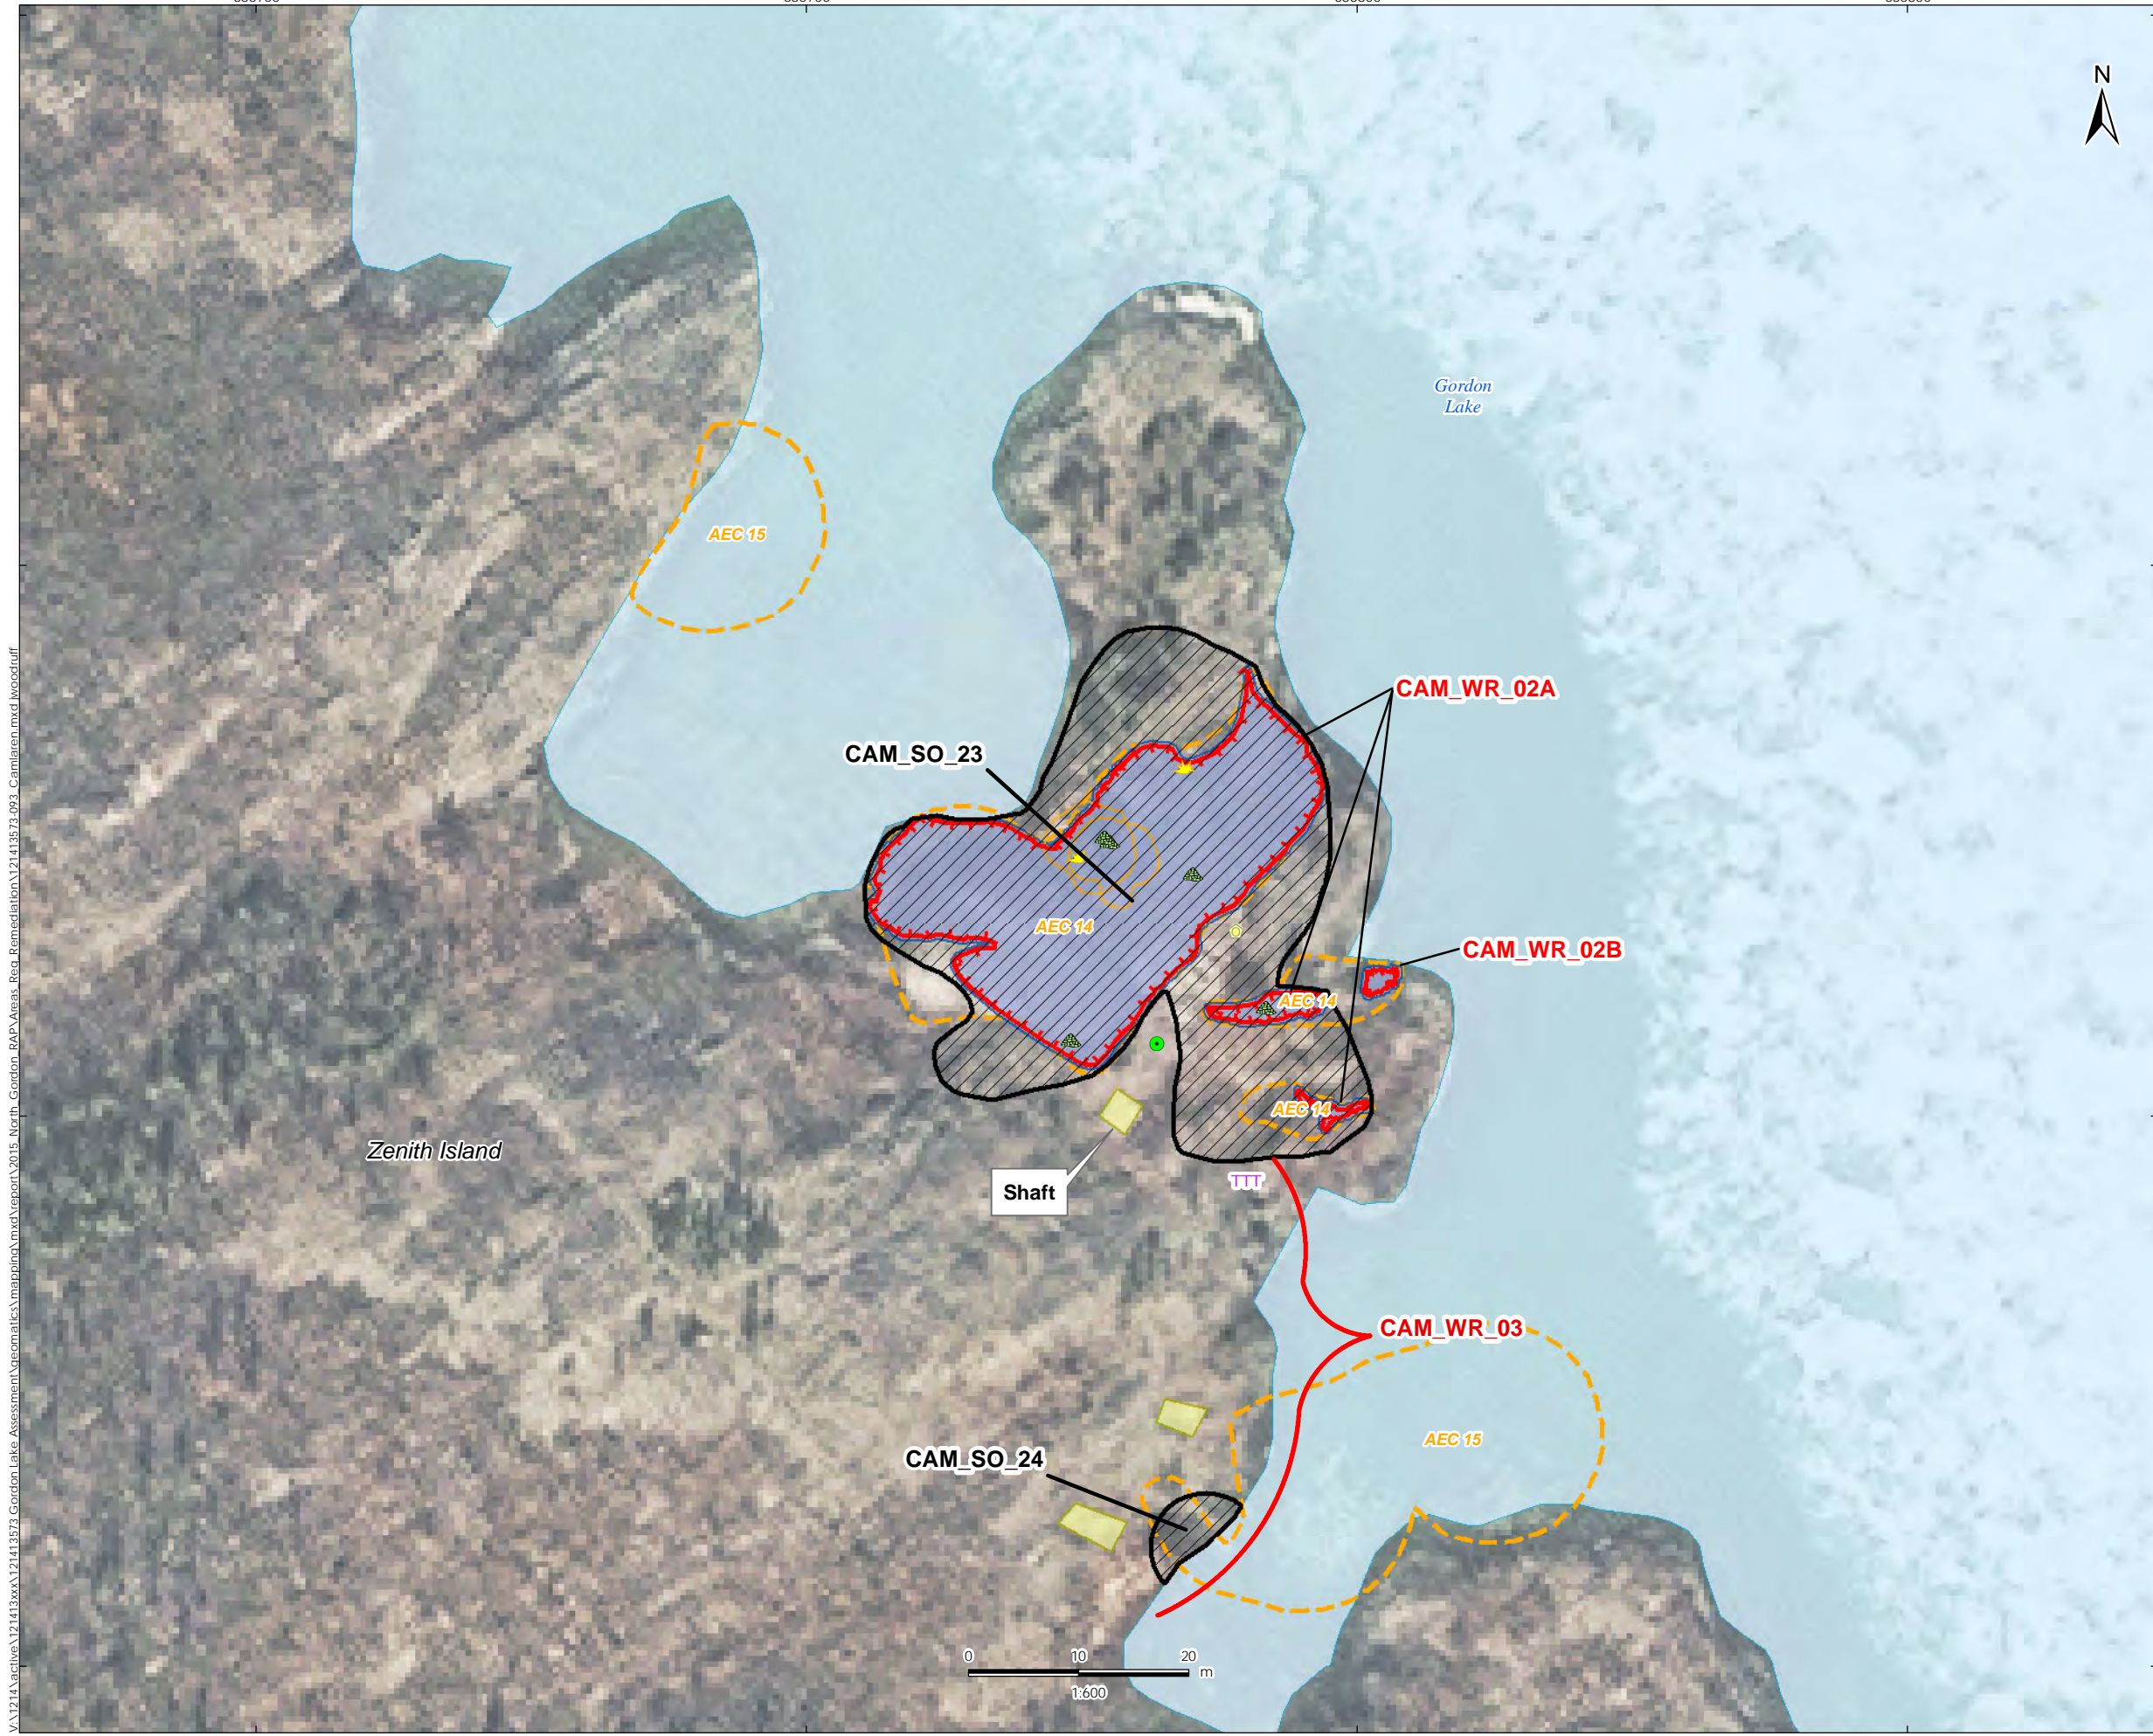
Title
Camlaren - Zenith Island
Summary of Hazard Components

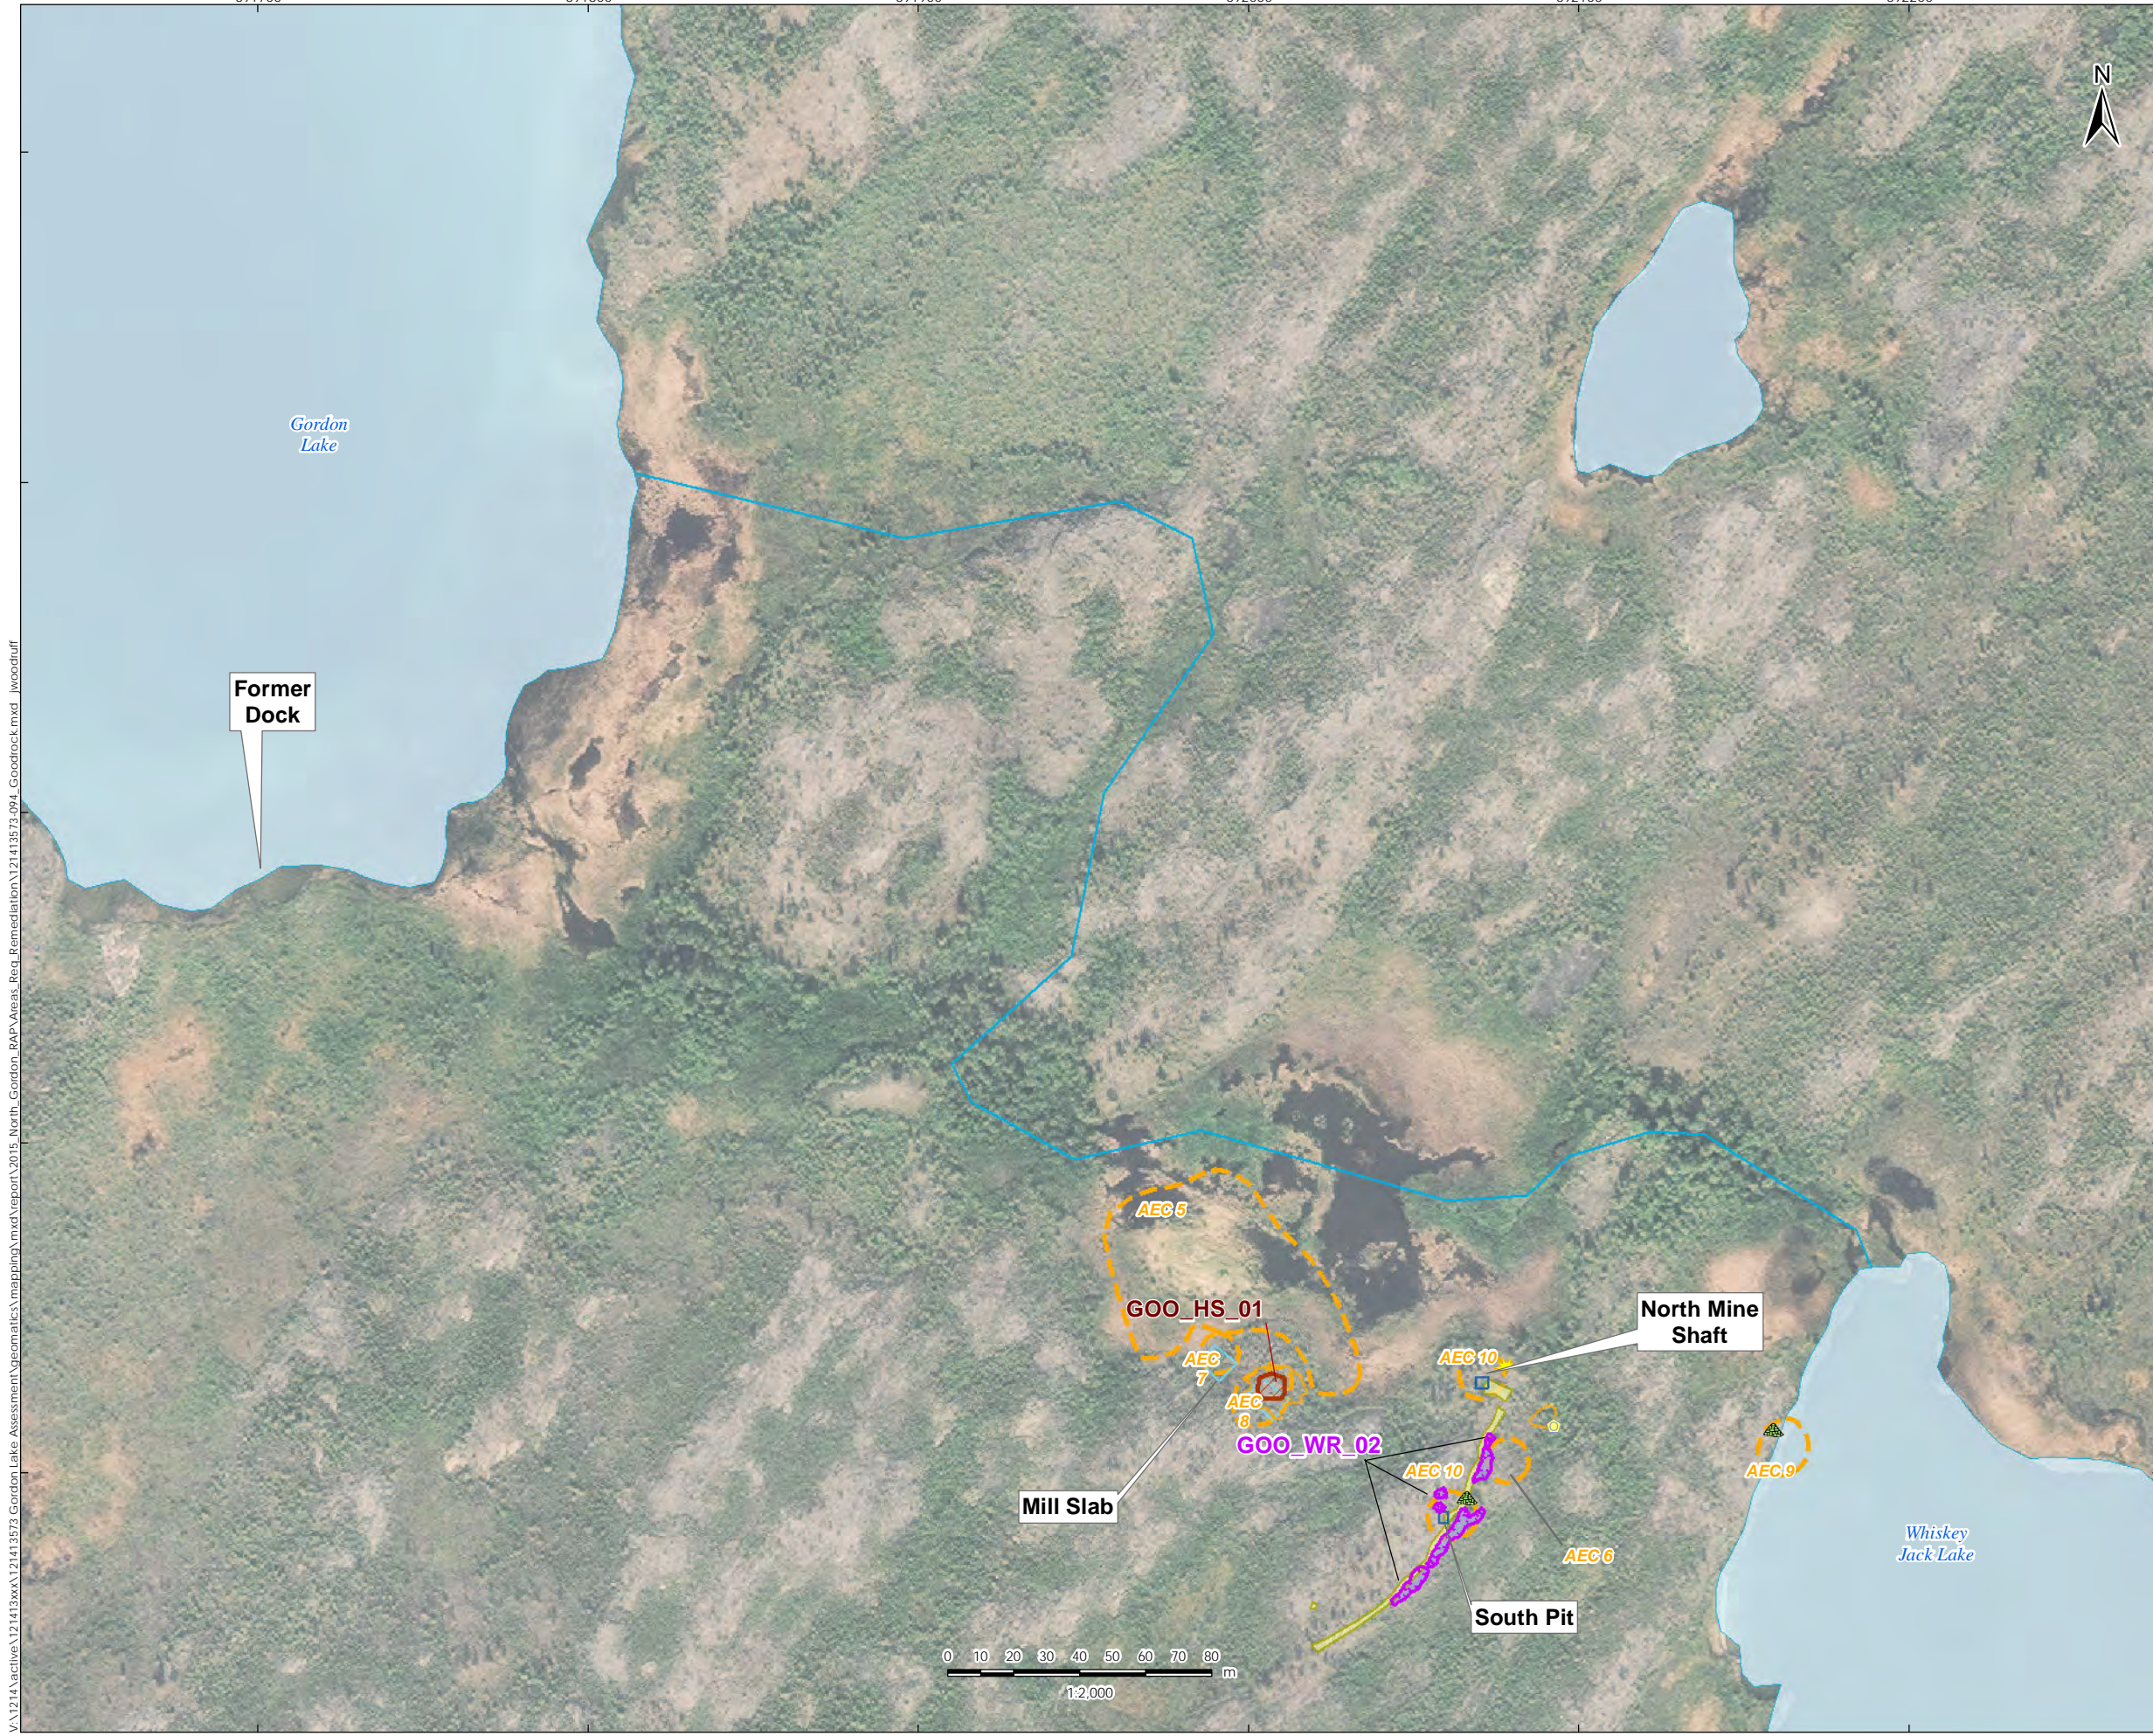
Title
Goodrock Mine - Mill Area
Summary of Hazard Components

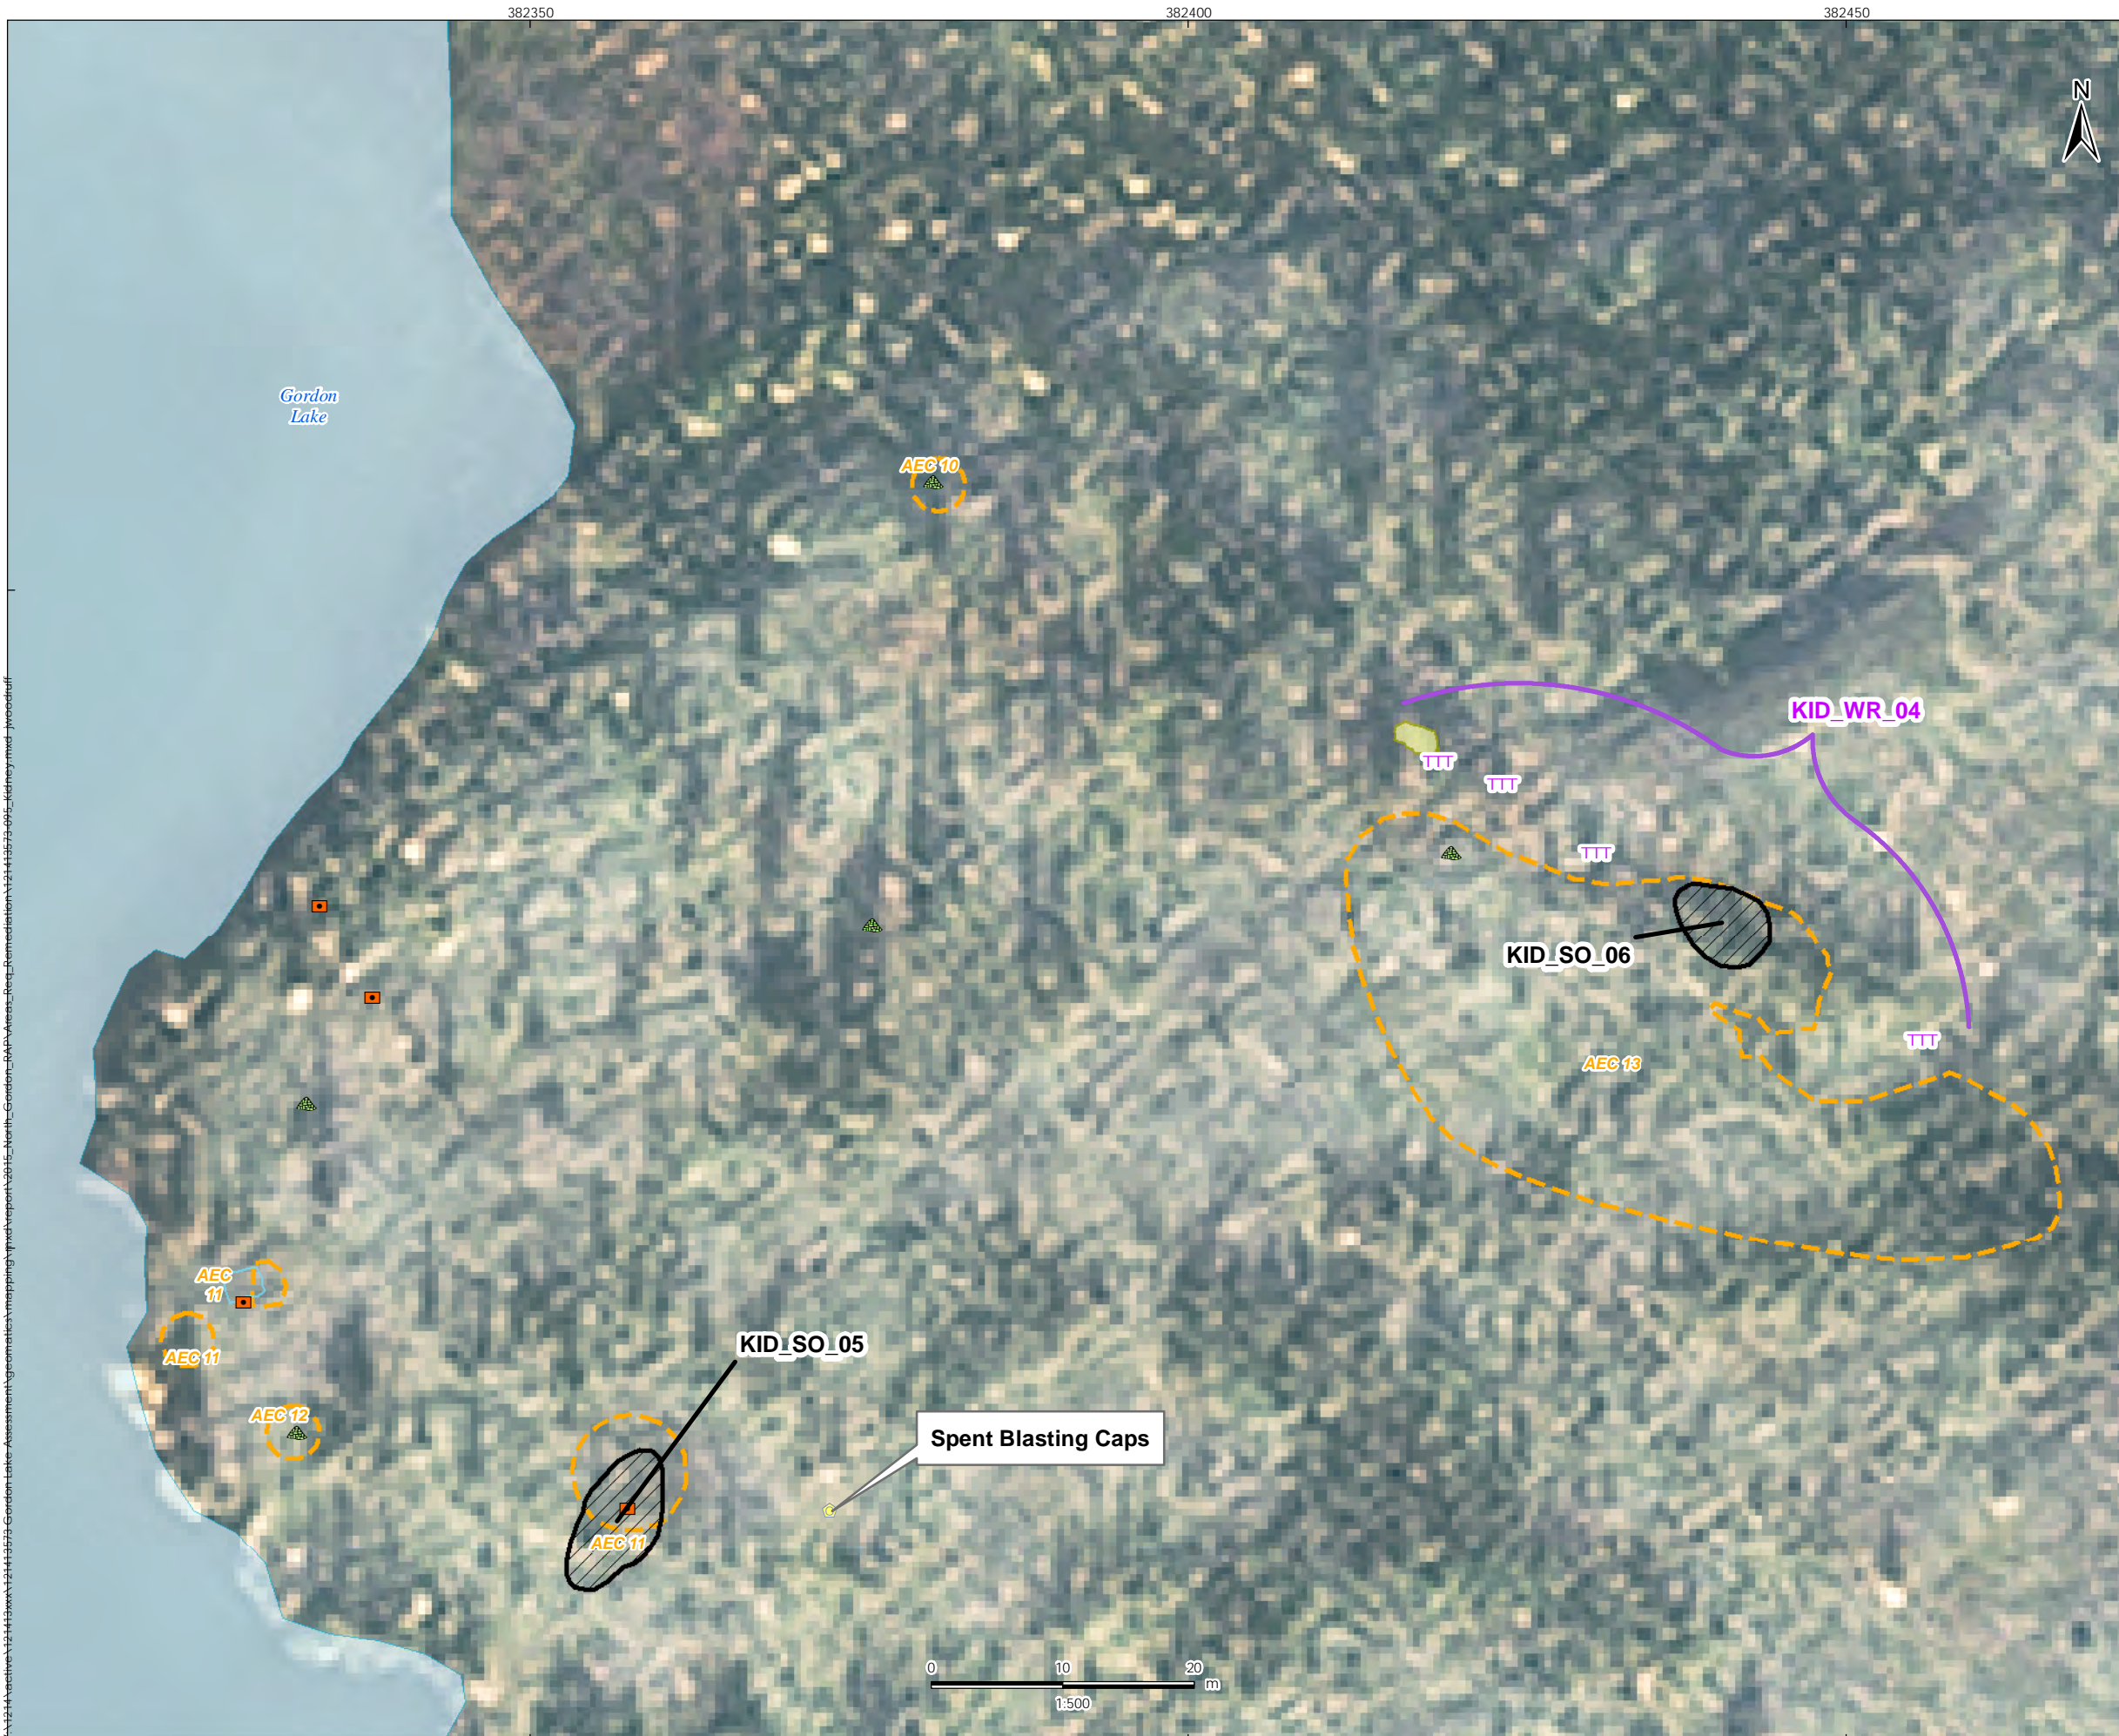
Title
**Kidney Pond - 1983 Camp
Summary of Hazard Components**

Impact Type	Features Observed
Metals	Debris
Moderate Risk Impacting Material	Other (as labeled)
	Structure Remains
	Trench
	Structure Remains
	Trench/Shaft
	Areas of Environmental Concern (AEC)
	Watercourse
	Water body
	Map Extent
